**BI-MONTHLY SAFETY AUDIT INSPECTION OF KACHEGUDA STATION OF
HYDERABAD DIVISION FOR THE PERIOD MARCH & APRIL**

No. Safety. 195/Bi-MSA/2/2016/KCG

Date: 03.6.2016

**BI-MONTHLY SAFETY AUDIT INSPECTION OF KACHEGUDA STATION OF
HYDERABAD DIVISION FOR THE PERIOD MARCH & APRIL 2016**

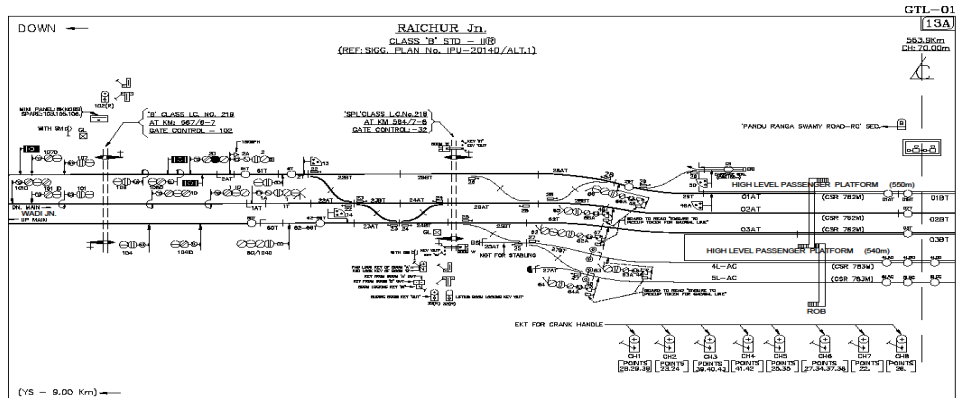
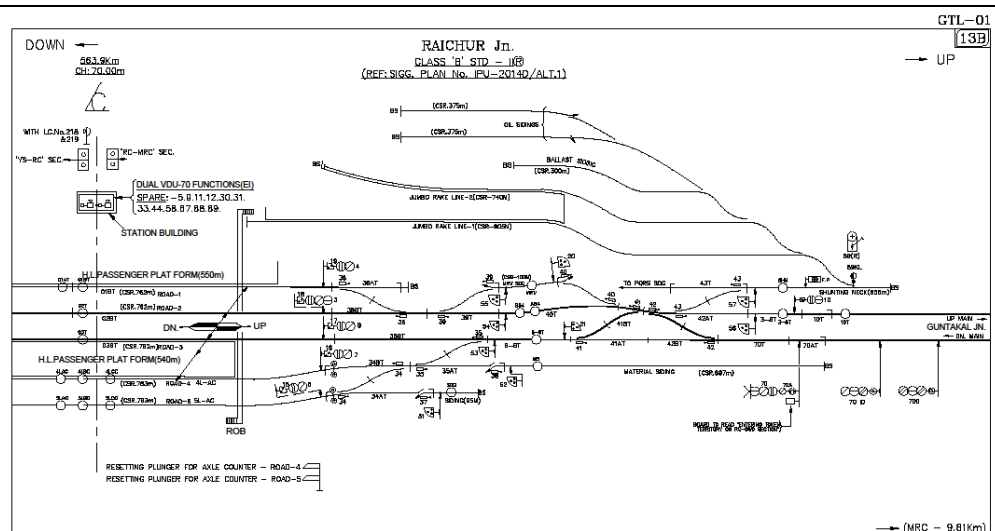
In the following Para, SWR diagram of RC station and the CRS approvals given for the SWR of RC station is given for the reference of the Division to process on the same principles.

CRS/SCC's approval No.SC/1/13-14 dated 18-04-2013 has been obtained for reckoning the adequate distance under provision of G.R.3.40 (1) (B) as detailed below.

- For the reception of an Up train from WD/Down train from GWD on Road 1, the adequate distance is reckoned as 144 metres from starter No.4 when point No.36

<p>normal set to Buffer Stop.</p> <p>ii. For the reception of an Up train from WD/Down train from GWD on Road 3, the adequate distance is reckoned as 240 metres from starter No.8 up to the end of 35 BT.</p> <p>iii. For the reception of an Up train from WD/Down train from GWD on Road 4, the adequate distance is reckoned as 250 metres from starter No.7 when point No.35 normal and with Trap point No.38 Normal(open) set to material siding.</p> <p>iv. For the reception of an Up train from WD/Down train from GWD on Road 5, the adequate distance is reckoned as 144 metres from Starter No.6 when points No.34 normal and with trap point No. 37 Normal (open) set to Siding.</p> <p>v. For the reception of a Down train from GTL on Road 1, the adequate distance is reckoned as 280 metres from starter No.66 when point No.28 normal and with L.C.No.218 open.</p> <p>vi. For the reception of a Down train from GTL on Road 2, the adequate distance is reckoned as 150 metres from starter No.65 up to the end of 28 BT.</p> <p>vii. For the reception of a Down train on from GTL Road 3, the adequate distance is reckoned as 165 metres from starter No.62 up to the end of 62T with L.C.No.218 open.</p> <p>viii. For the reception of a Down train from GTL on Road 4, the adequate distance is reckoned as 240 metres from starter No.63 when point No.25 normal set to Buffer Stop.</p> <p>ix. For the reception of a Down train from GTL on Road 5, the adequate distance is reckoned from starter No.64 when point No.27 normal set to Sand Hump.</p>

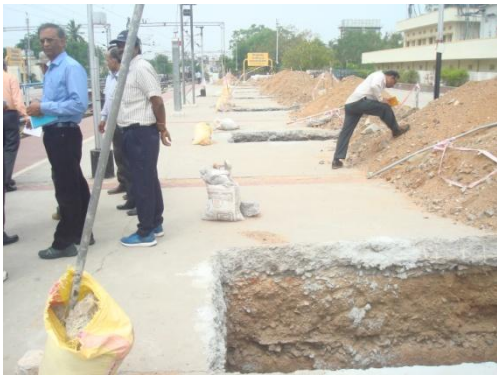
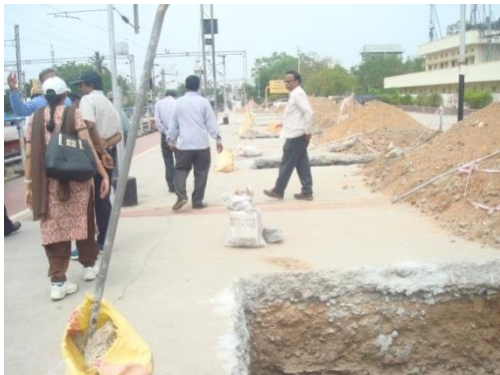
6.0	<p>On PF No.1 Cover Over Platform work is in progress. Engineering staff / Contractor did not provide ‘work in progress’ warning board and also no barricading was provided which is necessary.</p> <div style="display: flex; justify-content: space-around;">

</div> <p><u>Also, deep pits dug for foundation were not protected.</u></p>

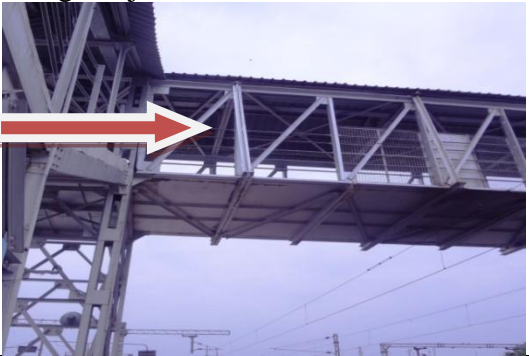
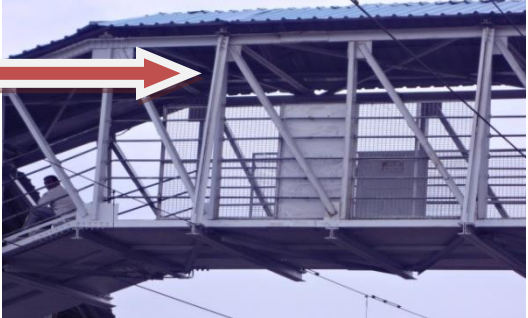
<p>8.1</p>	<p>For FM end FOB on PF-3 & 4 full length screen to be provided to avoid throwing of foreign objects from FOB.</p>

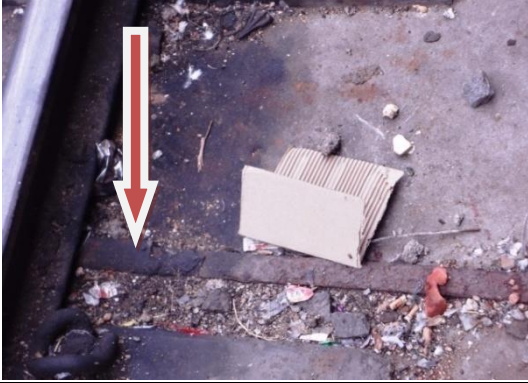
<p>8.2</p>	<p>At loc. KCG/1038 bond seems to be rusted. To check and replace if needed.</p>

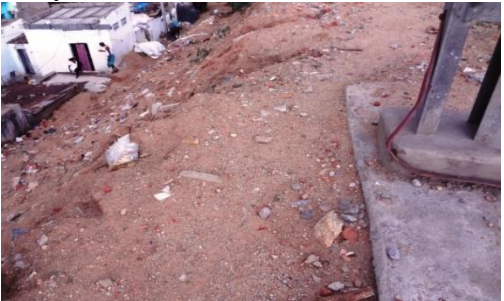
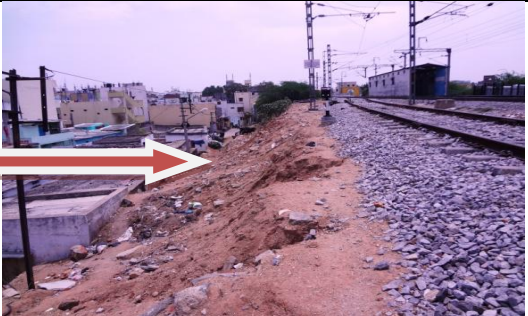
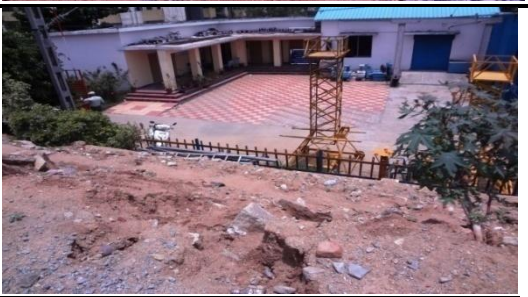
<p>8.3</p>	<p>The embankment soil of stabling line near OHE depot is eroding due to continuous rains. A retention wall to be constructed to avoid exposing of OHE mast foundation KCG/SBL2. Also to avoid falling/flowing of soil in to the OHE depot, this is also a breakdown activity centre.</p>

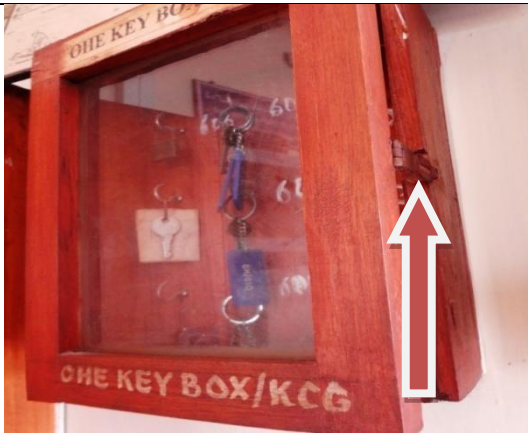
8.4	<p>In panel room, for isolator key box lock not available. Also isolator key issuing register not available</p> <p>Safety Gloves and Register are required to be provided.</p> <p>.</p>

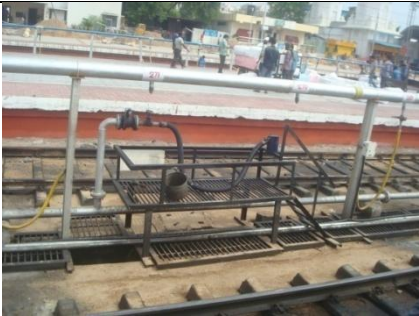
10.0	At most of the fuel point locations in the yard, “warning boards” are not kept.

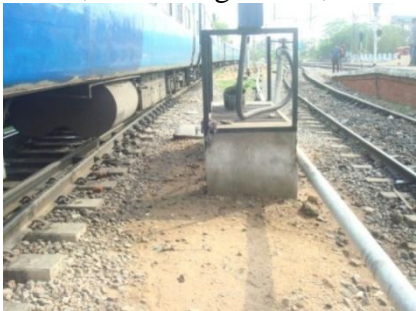
<p>Fuelling point location in between Road No.3 & 4 (PF No.3); fire preventive arrangements are not provided i.e., fire extinguishers, sand etc.,</p>

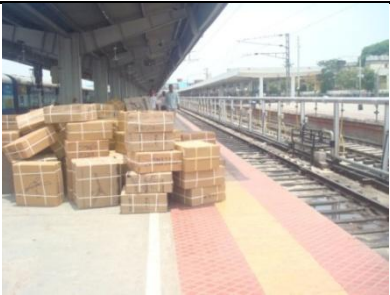
11.0	On PF No.4 (SC end) lot of parcel cartoons kept on Platform which are obstructing to free passage of train passengers.

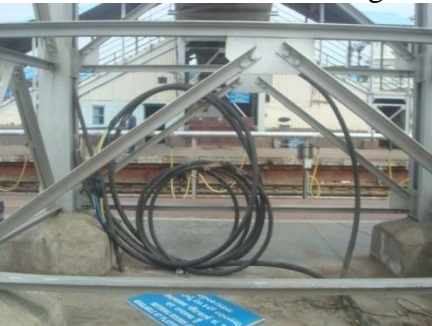
12.0	On P.F.No.4&5 FM end, below FOB - cables are coming outside and found scattered.

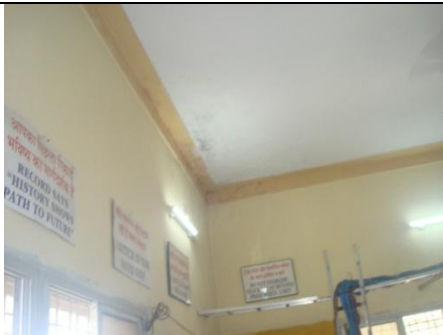
14.0	Checked Battery readings in battery room and found are adequate. Multimeters are not calibrated from so long.	
15.0	In Relay room, roof seepage at one corner

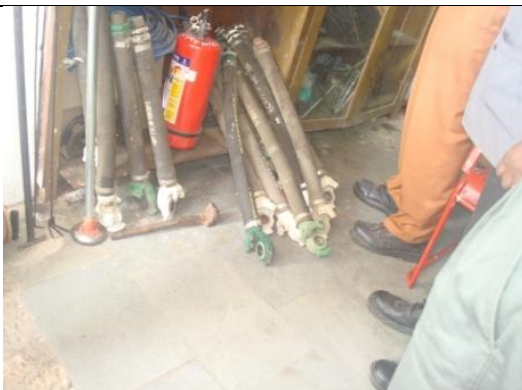
19.0	<u>Observations of Mechanical Department:</u>	
19.1	<p><u>Coaching depot/KCG:</u></p> <p>In Mini Store (round the clock) Sri Ashok Kumar, Fitter (Gr-I) was not knowing how to use fire extinguishers. <u>BP & FP pipes (Mfg. 04/2015) are not having dummy caps</u>. For 12 Nos. caps are missing.</p>
