**EXECUTIVE SUMMARY ON THE BI-MONTHLY INTERNAL SAFETY AUDIT OF
BITRAGUNTA STATION OF VIJAYAWADA DIVISION FOR THE PERIOD
NOVEMBER & DECEMBER 2013**

No. Safety. 195/Bi-MSA/6/2013/BTTR

**BI-MONTHLY SAFETY AUDIT INSPECTION OF BITRAGUNTA
STATION OF VIJAYAWADA DIVISION FOR THE PERIOD NOVEMBER
& DECEMBER 2013**

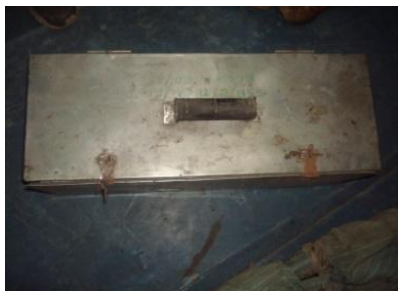
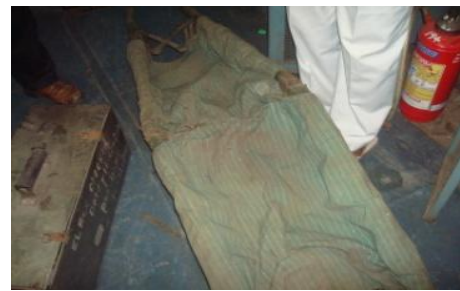
- 1.1 **Checked rear SLR SR00719 of T.No.12604 Express at SC station:** Guard was not equipped to break the OTL and use of EL box. The EL box door covers are provided with bolt & nut and sealed which got jammed and the Guard could not open the EL box. Stretcher was not in good condition. Folding connecting rods are bent. SSE/E/TL&AC/Erode maintenance and SM/Erode need to ensure these two items are attended for immediate use which is needful at the time of emergencies.

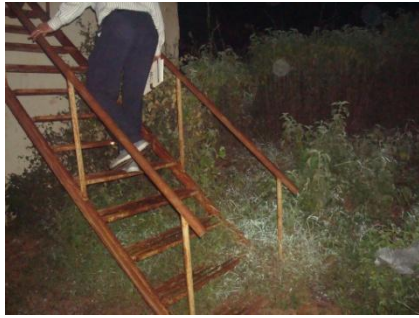
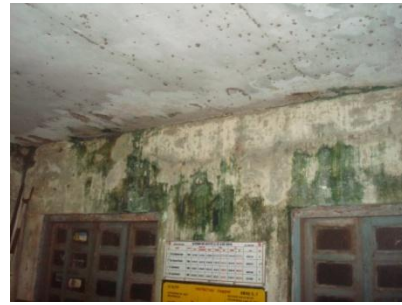
- This LC Gate is operated from the erstwhile cabin. The old lever frame with 4 levers is still in operation. **General cleanliness of the cabin is very shabby and not tidy.** The **condition of the Cabin needs immediate attention apart from brightening work.** The ladder provided to climb the gate lodge is also in very dangerous condition surrounded with vegetation. The gate lodge needs to be rebuilt. Existing road surface on track portion is more than 3 to 4m height. **There is feasibility to eliminate this LC Gate by provision of LHS at this location, the same may be explored.**

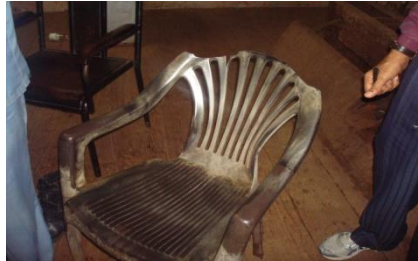
- d. **Furniture** provided at the gate lodge is in **damaged** condition and needs immediate replacement.

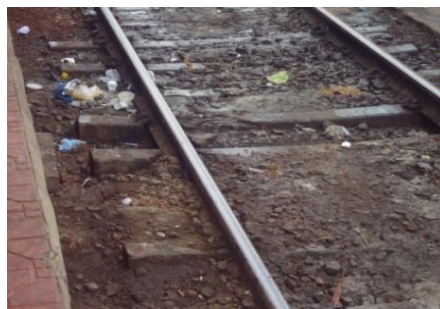
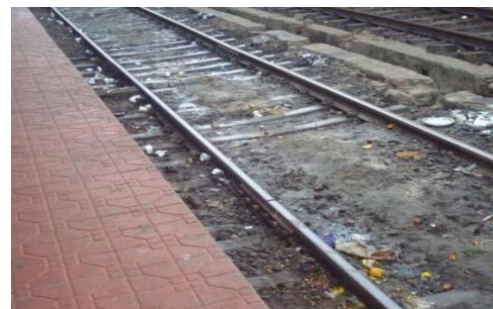
- a. During the surprise BA test conducted on **Sri. Sk. Kareemulla, SE/C&W/GDR at GDR station who was performing rolling ‘in’/’out’ examination was tested positive** with 40 and 49 mg/100ml of blood.
- b. Road No.1, inadequate drainage and broken PSC sleepers needs to be replaced. Pumping joints & Broken/missing ERCs are to be recouped. These defects are found and mentioned in earlier inspections of CSO/SC on 15.11.2012, 28.02.2013 & Dy.CSO/Engg/HQ on 28.9.2013. Even though these defects are not yet attended. Same should be attended on top priority.

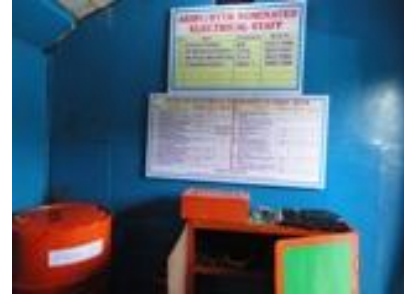
List of electrical equipments to be provided in ART as per scale is displayed. Out of 40 nos. of 150 W MH fittings, 10 nos. are available. Sr.DEE/M/BZA informed that PO for balance quantity released and the firm has supplied poor quality fittings which were rejected by the consignee. The same are to be recouped at the earliest.

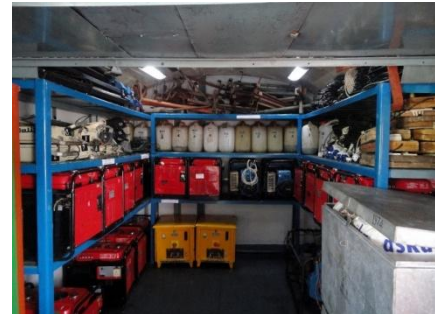
12.3 Stacking of available equipments in racks are very good and item wise name boards are also provided on racks for easy identification of the equipment.

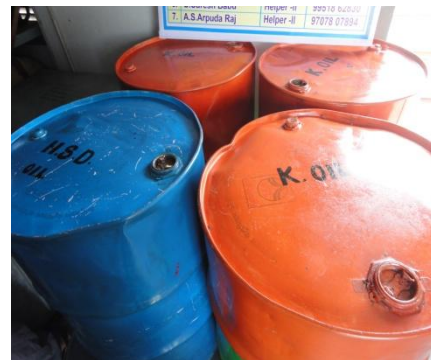
12.5 Kerosene oil and HSD oil were painted with different colours on drums for easy identification and to prevent accidental mixing of oils. It is suggested to procure 2nos. of barrels pumps for pumping oil from the kerosene and HSD oil drums.

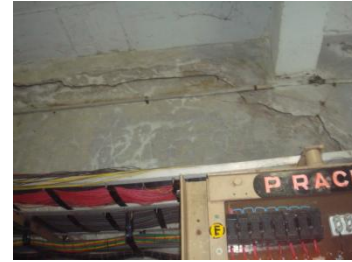
- a. Relay room ceiling & side walls are getting cracks very badly. Needs major repairs on priority.
