**BI-MONTHLY SAFETY AUDIT INSPECTION OF DHARMAVARAM
JUNCTION STATION OF GUNTAKAL DIVISION FOR THE PERIOD
JULY & AUGUST 2013**

**EXECUTIVE SUMMARY ON THE BI-MONTHLY INTERNAL SAFETY AUDIT OF
DHARMAVARAM JUNCTION STATION OF GUNTAKAL DIVISION FOR THE
PERIOD JULY & AUGUST 2013**

No. Safety. 195/Bi-MSA/4/2013/DMM

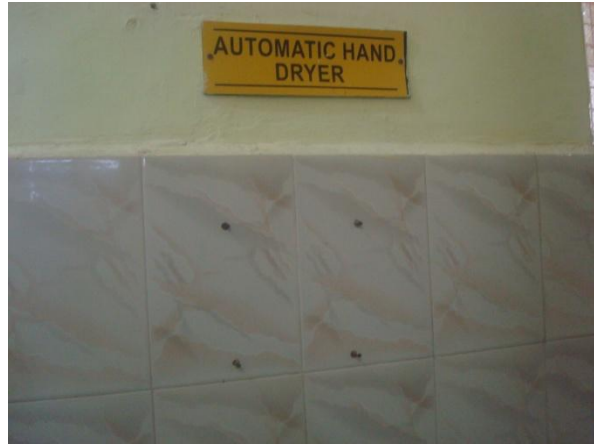
- e. **Shelter required from entrance gate to main door.**
- f. **Automatic hand drier not available, but board is available.**

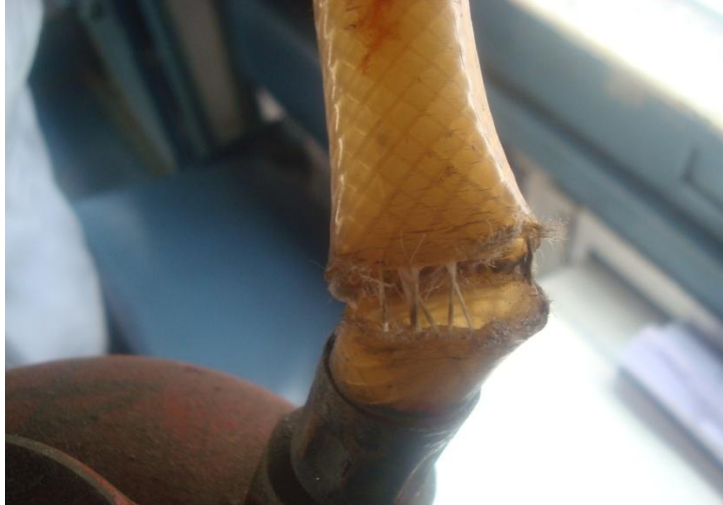
5.2 SLR No.91710 SWR of T. No. 56503 Passenger:

- a. **In EL box electrical bulbs broken condition.**
- b. **Stretcher fully dirty** condition.
- c. **PT box not working.**
- d. **Fire extinguisher delivery pipe line in damaged condition.**

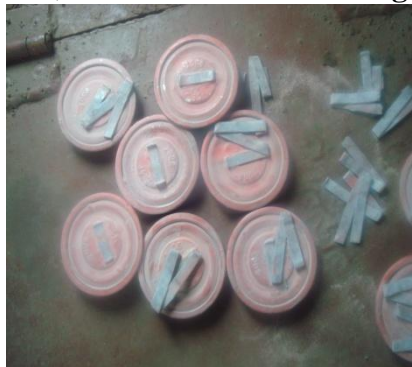
- 5.5 **Train No. BCCW/N, Guard Sri K. Bhaskar /GY**
- a. PT Phone available, but he doesn't know how to use it. He should be properly trained. PT Phone **cells also not available.**

- b. G&SR correction slips issued in the form of replacement pages upto no.7 are not replaced.
 - c. Ten detonators are available, of which 7 are **not having clasps.**

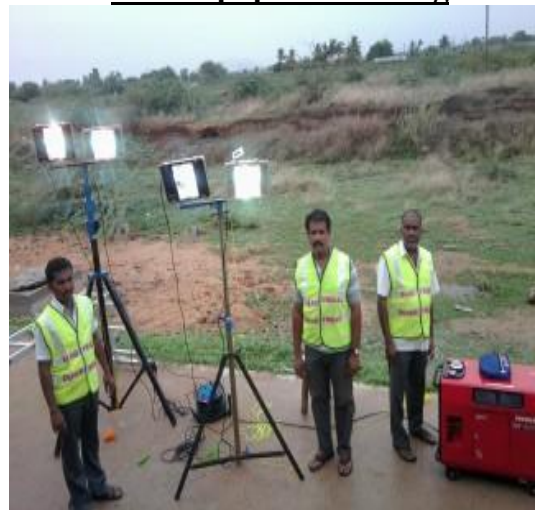
ART Equipment Testing

- a. 04 Nos. of telescopic stands of 2 m height and 2 Nos. of 6 m height are tested and found working satisfactory.
- b. Checked generator maintenance record found up-to-date.
- c. 02 Nos. of fire extinguishers are available and their due dates are 17.07.14.
- d. It is appreciated that the layout of ART & MRV provided with racks and stacking of materials in racks are very good. Item wise name boards are also provided on the racks for easy identification of materials. All the Sr.DEEs may follow the similar layout of ART and MRV as at DMM. Photos are shown below.

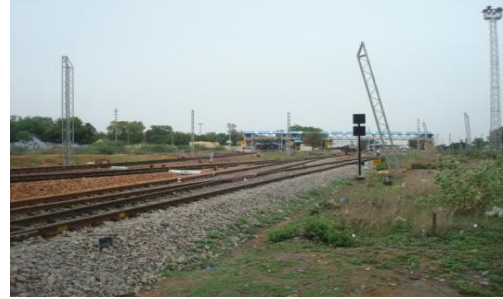
- 9.0** One OHE mast (RVNL construction organisation) is provided at KM 177/9 by the side of the track. The same was leaning towards track side. Needs corrected as leaning away from the track in view of safety.
