**BI-MONTHLY SAFETY AUDIT INSPECTION OF RENIGUNTA JUNCTION
STATION OF GUNTAKAL DIVISION FOR THE PERIOD MARCH & APRIL 2014**

**EXECUTIVE SUMMARY ON THE BI-MONTHLY INTERNAL SAFETY AUDIT OF
RENIGUNTA JUNCTION STATION OF GUNTAKAL DIVISION FOR THE PERIOD
MARCH & APRIL 2014**

No. Safety. 195/BI-MSA/2/2014/RU

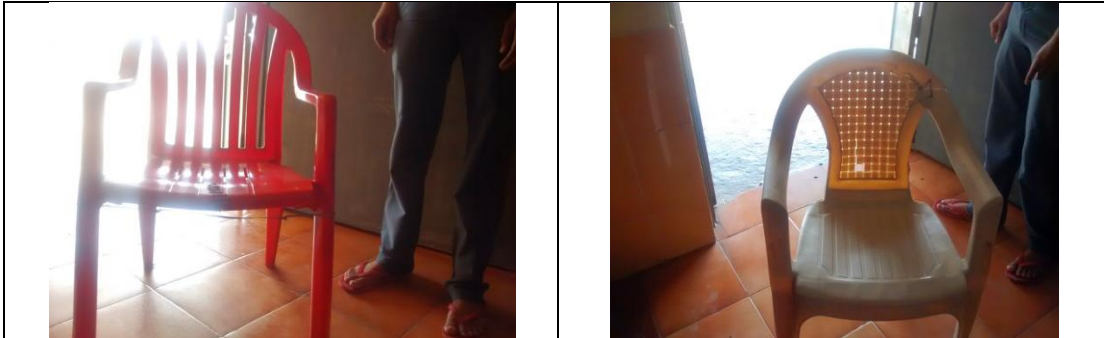
1.5	<p>There is no proper furniture at this Cabin. Following photographs speaks the truth. The available ones are in broken condition which is knitted with rope wire. Hence, the <u>Division may procure adequate furniture at the earliest.</u></p> <div style="text-align: center;">

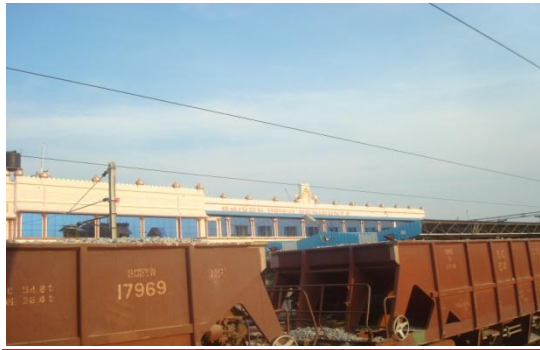
h. Train No. BT special on Road No 02:

Complete ballast train formation was kept on Road No.2 from 16.00 hours of 24.4.2014; and it was noticed that the loco was unmanned in cranked position for the last 26+ hours. Two BVs (BVZC) are in the formation one on either side of the formation but the handbrakes of them were not applied. Stabling entry was not made in the Stabled Load Register on the plea that it is not a stabled load.

A Control message was written in the Control Book of the station vide message no. CSO/SC/25/1 to DRM/GTL to take suitable action on the Officials who failed to ensure the stabling precautions is correctly taken. Allowing a loco in cranked condition for the last 26 hours in unmanned position is totally unsafe and undesired. Division shall sensitise the 'all-concerned' and enforce strict discipline in safe working of trains.
