**BI-MONTHLY SAFETY AUDIT INSPECTION OF GUNTUR JUNCTION STATION  
OF GUNTUR DIVISION FOR THE PERIOD MAY & JUNE 2014**

**EXECUTIVE SUMMARY ON THE BI-MONTHLY INTERNAL SAFETY AUDIT OF  
GUNTUR JUNCTION STATION OF GUNTUR DIVISION FOR THE PERIOD MAY &  
JUNE 2014**

**BI-MONTHLY SAFETY AUDIT INSPECTION OF GUNTUR JUNCTION OF GUNTUR**  
**DIVISION FOR THE PERIOD MAY & JUNE 2014**

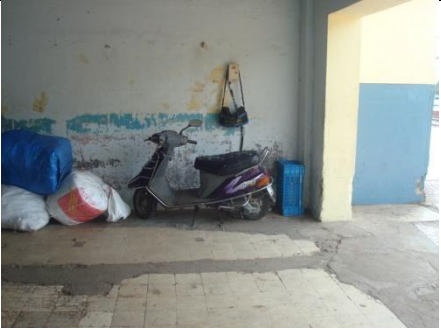
<b>5.15</b>	<b><u>Parcel Office:</u></b> a. <u>Register with the particulars of random check</u> made to check the Petrol residuals in the petrol tanks of Two-wheelers is <u>not maintained</u> at this office. b. <u>Only one Fire Extinguisher is available</u> in the Parcel Office. Commercial authorities may supply more FEs to the Parcel Office for emergency use.								
	At parcel office on PF No.4, one two wheeler is available which is not booked.

<b>5.16</b>	One two-wheeler Hero Honda Passion make bearing Registration No. WB 74 G 6792 booked vide RR No. 916120 from <b><u>Giddalur to Abu Road</u></b> of 18.6.2014 was found unloaded from Train No. 57305 on PF-6 around 12.40 hours <b><u>was found with residual fuel of 200 – 250 ml.</u></b> A Control Message vide message No. CSO/SC/19/1 was issued to take up the responsible staff who booked the vehicle without ensuring the petrol tank is emptied. SMR/GNT collected the bottle of fuel.

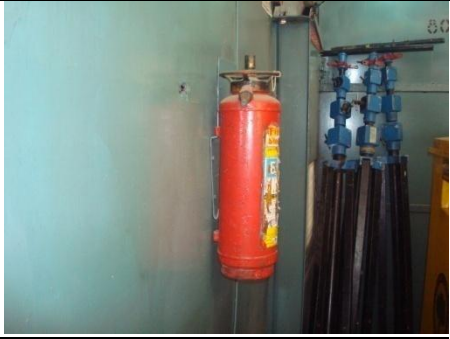
17.4	<p>In Electrical coach no.80273, fire extinguisher <u>only one available</u> that too over due for refilling from 9.5.12 and discharge pipe is not available.</p>

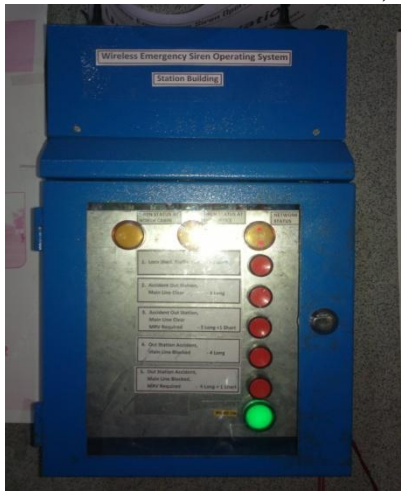
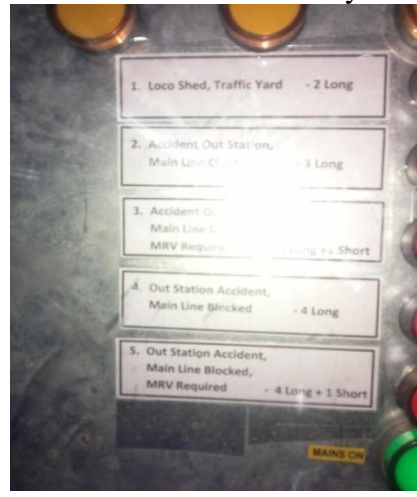
“Synchronisation of Breakdown Sirens” i.e., at DRM’s office, Guntur Railway Station & North Cabin/GNT was done, which works on GPS based system.

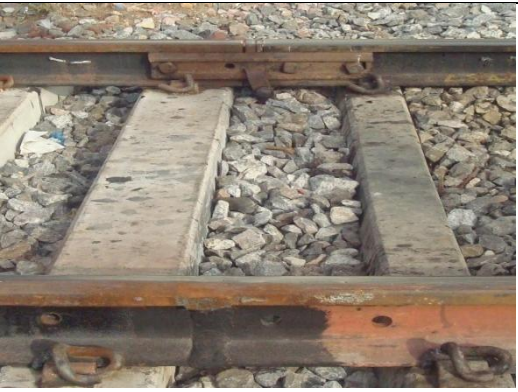
13.1	Rail closure pieces on main line & yard portion needs to be removed. (Point No.44B ahead of crossing joint, LH side SRJ of Point No.10A.
