**BI-MONTHLY SAFETY AUDIT INSPECTION OF MANUGURU &
CHADRACHALAM ROAD STATIONS OF SECUNDERABAD DIVISION FOR THE
PERIOD SEPTEMBER & OCTOBER 2014**

**EXECUTIVE SUMMARY ON THE BI-MONTHLY INTERNAL SAFETY AUDIT OF
MANUGURU & BHADRACHALAM ROAD STATIONS OF SECUNDERABAD
DIVISION FOR THE PERIOD SEPTEMBER & OCTOBER 2014**

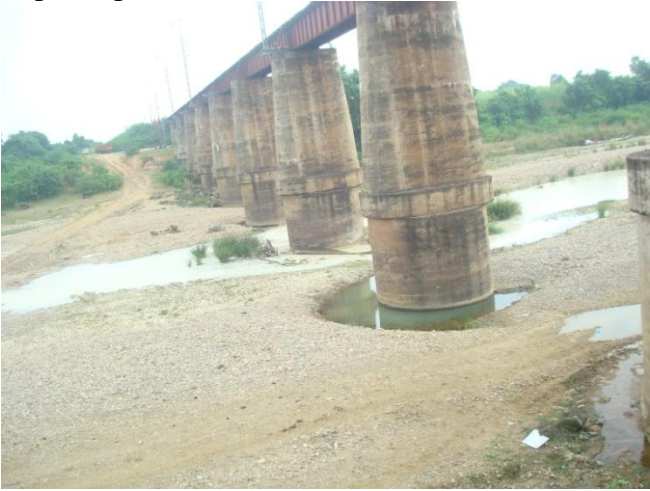
35.0	<p><u>Inspection of Bridge No.94 (11x18.30m) at kmbetween</u></p> <ul style="list-style-type: none"> c. Alignment on second span i.e., end of the first span needs to be attended. d. In centre of bridge, scour around the piers, suitable protection around the piers to be provided in view of safety. Also, stability check of well foundation may be done with well depth exposed condition.
