**BI-MONTHLY SAFETY AUDIT INSPECTION OF BOLARUM – MALKAJGIRI –
KACHEGUDA - FALAKNUMA STATIONS OF HYDERABAD DIVISION FOR THE
PERIOD JANUARY & FEBRUARY 2015 ON 20.02.2015**

**EXECUTIVE SUMMARY ON THE BI-MONTHLY INTERNAL SAFETY AUDIT OF
BOLARUM – MALKAJGIRI – KACHEGUAD – FALAKNUMA STATIONS OF
HYDERABAD DIVISION FOR THE PERIOD JANUARY & FEBRUARY 2015 ON
20.02.2015**

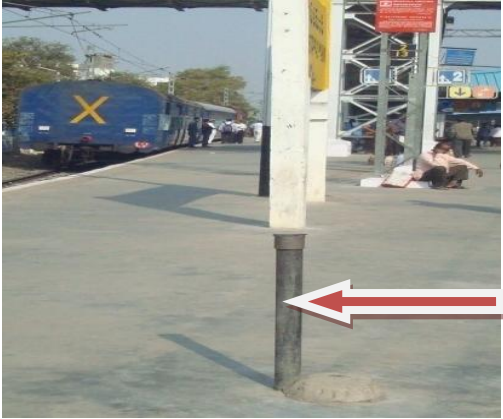
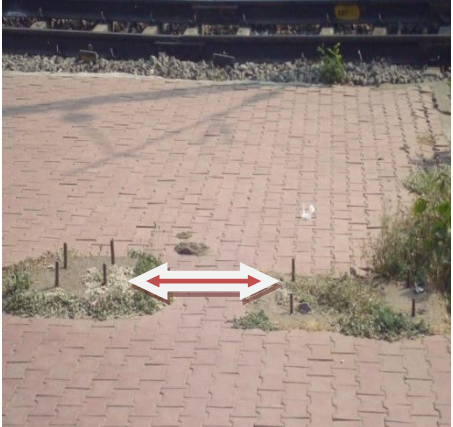
Para	Subject / Topic
<p>1.0</p>	<p><u>STPD station:</u></p> <p>c. On PF1 (KCG side) one vertical pipe protruding - spiking on the floor of platform was found which is dangerous for the safety of passengers. This should be removed immediately before it causes any injury to the passengers.</p> <p>d. On the pathway connecting PF 2 & 3 (island PF) towards KCG end, one removed pillar basement with vertical rods protruding & obstructing the free movement of passengers was noticed. This should be removed on priority.</p>
	<div style="display: flex; justify-content: space-around;">

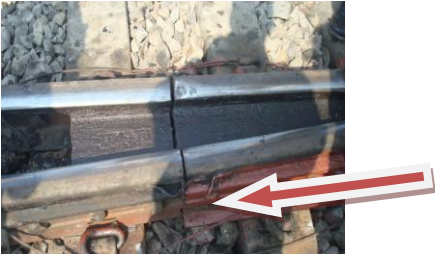
4.16	<p><u>Inspection of Point No.24B at KM 606/9-607/0 at BMO:</u></p> <ol style="list-style-type: none"> Vertical clearances of leading, 1st following & 2nd following stretcher bars are 3, 3 & 0 against 1.5mm-3.0mm. CMS crossing laid on 05/2006. Crossing joint gaps are 6, 12mm against 'zero'. GR pads have been very thin/missing, needs to be provided with new 10mm GR pads. S&T bond wires are connected to CMS crossing by Exo-thermic weld <u>which is not permitted</u>. On CMS crossings as a part of design, separate lugs along with pre-drilled holes are provided to facilitate connecting S&T bond wires. (Ref: CTE/SC Lr.No.W/509/TC/Zig-zag welding, of dated 9.3.12).

<ol style="list-style-type: none"> LH stock rail SRJ portion scabbed, need to be reconditioned / replaced. This point was last checked by ADEN/KCG on 05.1.15 & previously checked by SSE/P.Way/BMO on 07.11.14. <u>But all the readings i.e., Gauge, Cross levels & versines on main line & turn-out, stretcher bar lengths / clearances etc., do not tally with existing readings.</u> Gauge at station no.4 (+10mm), station no.5 (-8mm) & station no.11 (-8mm) on main line needs to be attended. Cross levels on turnout side also need to be attended. LH stock rail is scabbed, need to be reconditioned.

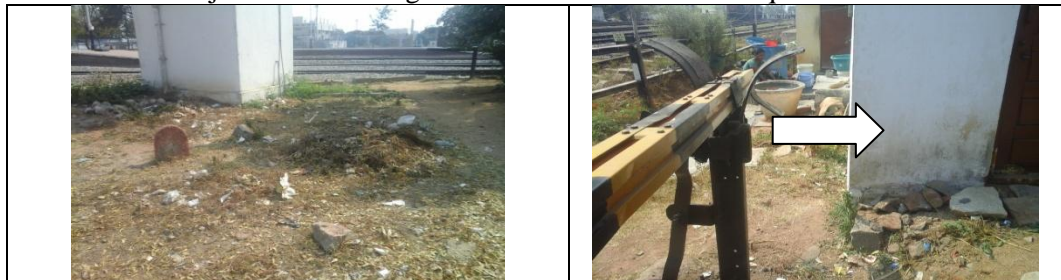
- TVUs 182852, RVU 2689, O&E 7.2.13.
- Sri G.Nanda Kishore, Gateman was on duty in uniform and possessing valid competency certificate **but PME certificate was not available.**
- On 13.02.15 the gate was non-interlocked due to failure at 13.00hrs and for closing the gate for T.No.17058 Exp the on duty APM Sri. Khajamia exchanged PN with on duty SM/BMO. It is noticed that the PN given by SM was 98 but written as 59 in PN exchange register. It is advised that SS/TI to counsel the Gateman for proper exchange of PNs and ensure correct entries. Even the train numbers are being recorded incorrectly.
- Over shoot of the 3rd loop line towards MJF end across this LC gate is badly maintained.
- Encroachment adjacent to the LC gate. Immediate attention is required.

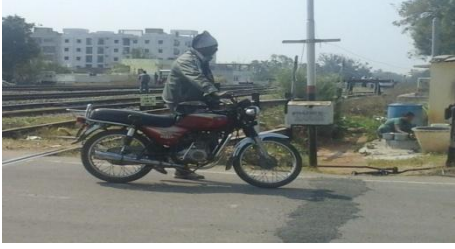
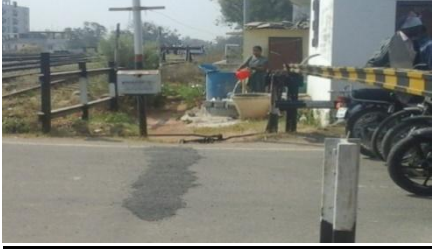
- When gate was in ‘closed’ condition two wheelers are crossing the road in spite of repeated warning by the Gatemen.

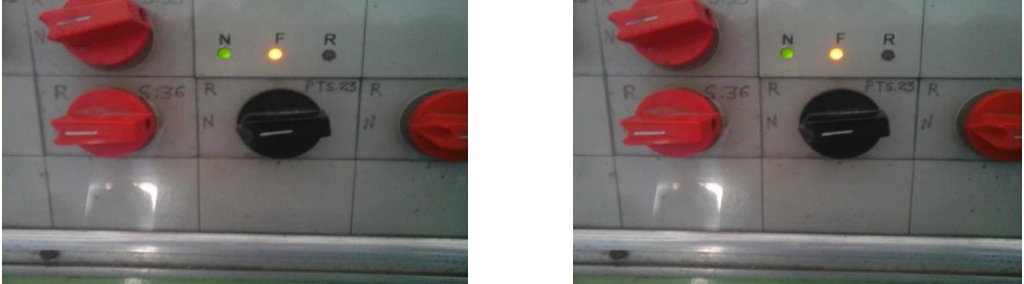
7.2	<p><u>Point / Signal / Gate Control switch positions on the panel are not matching with the indications exhibited on the panel. This needs to be rectified immediately.</u></p>
