**BI-MONTHLY SAFETY AUDIT INSPECTION OF KINWAT – ADILABAD STATIONS  
OF NANDED DIVISION FOR THE PERIOD MAY & JUNE 2015 ON 24.6.2015**

**EXECUTIVE SUMMARY ON THE BI-MONTHLY INTERNAL SAFETY AUDIT OF  
KINWAT – ADILABAD STATIONS OF NANDED DIVISION FOR THE PERIOD MAY  
& JUNE 2015 ON 24.6.2015**

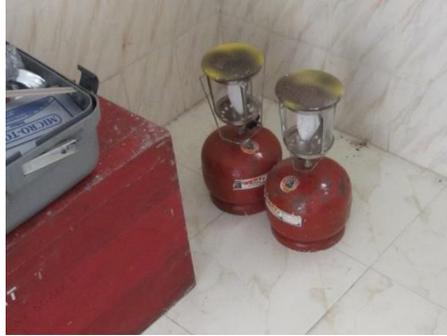
- g. As per Accident Manual Para 604.2, 604.6.2 & 605.2, KNVT station shall have ARME Scale II which is not provided; instead it was noticed that it is kept in the Health Unit. Secondly, the post of CMP is lying vacant. Thirdly, it was noticed that both the Oxygene cylinders in Health Unit were 'empty' which shall be replaced immediately. Also, noticed that the two petromax lights are available but not working. It is suggested to replace them with LED.

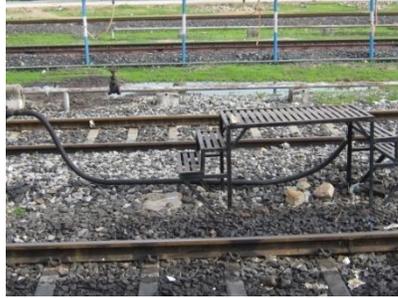
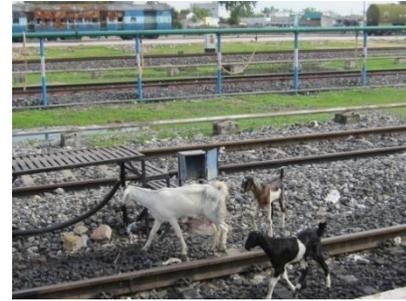
- j. **Fuelling of multi locos towards PMKT direction on 2<sup>nd</sup> & 3<sup>rd</sup> loop:** The available one fuelling point is able to cater the needs of fuelling of the front loco only. In order to fuel the second loco, the first loco needs to go beyond the Starter Signal. To overcome this problem, additional / extension of second fuelling point shall be studied by the Division.

It was seen at all fuelling points of the station in either direction that safety hazard warning boards are not available which is essential. Similarly, fire extinguishers, fire buckets are required to be made available at all fuelling points which is not provided.

Division to ensure that the same is installed at the earliest in the background of the fire incident in a stabled coach on PF-1 recently which may aggravate damages in case fuelling points happened to be closer to the fire location.

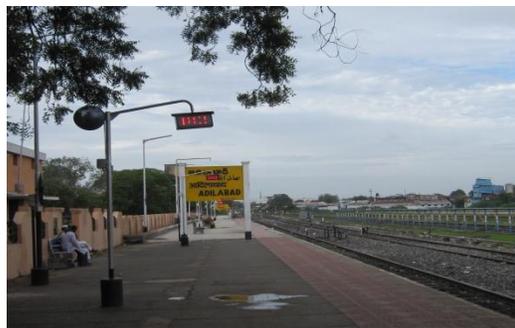
- k. **Water hydrants:** Though water hydrant facility exist on 2<sup>nd</sup> loop, 57552/53 Passenger is daily backed onto PF – 1 for watering. During this shunt movement, the rake needs to enter into the block section **which is not desirable on a routine-basis.** **The asset (water hydrant) was installed 5 years back and not commissioned till date.** This was also advised to the Division during GM's annual inspection on 9<sup>th</sup> January 2015 for which no action is taken till date.
- l. On PF-1, subsequent to the platform extension, the old station name board was not removed. The station name board was obstructing the Coach Indication Boards. Hence, the Divisional Engineering Officials were advised to remove the same which was removed.
