BI-MONTHLY SAFETY AUDIT INSPECTION OF GOOTY STATION OF GUNTAKAL DIVISION FOR THE PERIOD JULY & AUGUST 2015 ON 25.8.2015

**EXECUTIVE SUMMARY ON THE BI-MONTHLY INTERNAL SAFETY AUDIT OF
GY STATION OF GUNTAKAL DIVISION FOR THE PERIOD JULY & AUGUST 2015
ON 25.8.2015**

No. Safety. 195/Bi-MSA/4/2015/GY

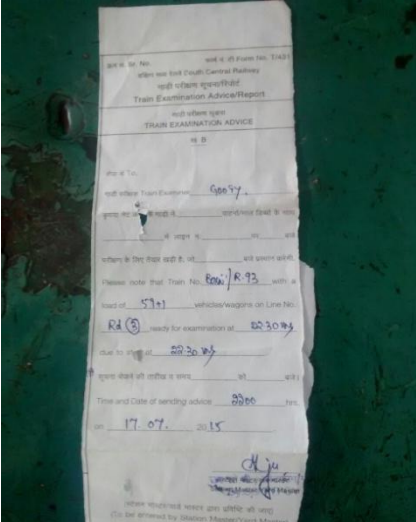
Thirdly, the incident of side collision at GY station involving coupled engines with JSWT Goods on 17th July 2015; It is brought out that once the locos are detached from the formation, the formation shall be treated as stabled load and entry to that effect should have been made in the Stabled Load Register. The claim made by the Staff that the formation is offered for TXR check. On further scrutiny of the record T.431 (Train Examination Advice), it was noticed that it was prepared with timing of 22.00 hours and taken over by TXR Staff under acknowledgement at 22.30 hours; All these timings are subsequent to the incident of side collision which happened at 21.51 hours.

The activity of offering the rake for train examination and till such time, the rake is accepted by TXR Staff, the formation shall be considered as stabled load and related instructions needs to be recorded and proper care / safety precautions should be taken. Divisional Authorities and Station Officials shall take a serious note of this for enforcement.

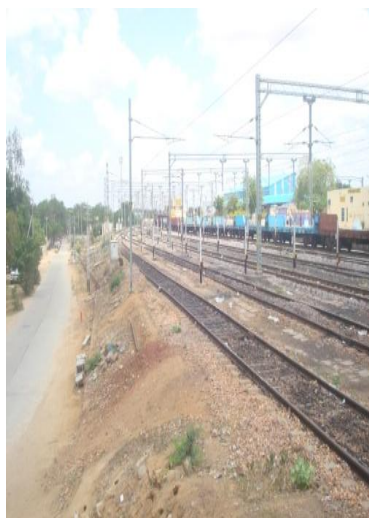
As per CCC / GY Rd no.1&2 towards north end when locos are stabled, the securing equipment such as wooden wedges is prone for theft. In order to minimize the cases of theft, it is suggested that the Division may launch a drive with Security Officials and take up two / three cases which may send warning signals.

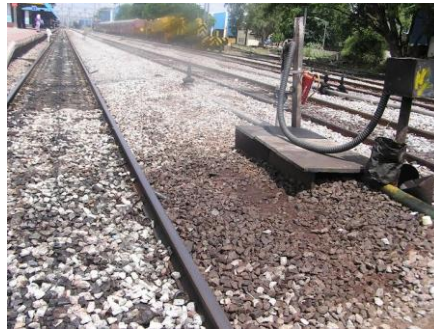
The surrounding area near fuelling points no S1, S2 on south end of GY PF no. 1 was checked,

- a. The area near the fuelling point is fully wet.
- b. Total 3 nos. fire Extinguishers are kept completely open to atmosphere. No shade is provided because of which the flexible hose pipes will become hard and likely to get damaged / cut.
- c. Fuelling point at KM 414/2 between Road No. 8 & 9 towards RU end was found to be having more leakages on track.
