**BI-MONTHLY SAFETY AUDIT INSPECTION OF NARSAPUR STATION OF
VIJAYAWADA DIVISION FOR THE PERIOD NOVEMBER & DECEMBER ON
28.12.2015**

**EXECUTIVE SUMMARY ON THE BI-MONTHLY INTERNAL SAFETY AUDIT OF NS
STATION OF VIJAYAWADA DIVISION FOR THE PERIOD NOVEMBER &
DECEMBER 2015 ON 28.12.2015**

BI-MONTHLY SAFETY AUDIT INSPECTION OF NARSAPURSTATION OF VIJAYAWADA DIVISION FOR THE PERIOD NOVEMBER & DECEMBER 2015 ON 28.12.2015

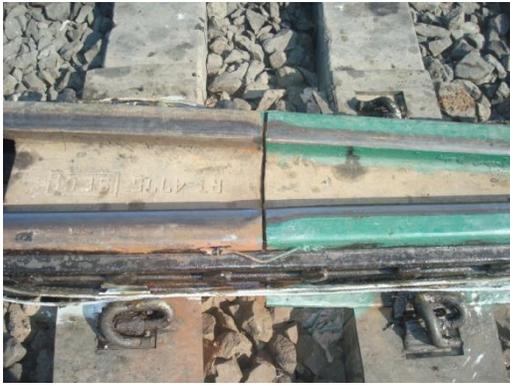
15	14.0	<p><u>Engineering observations at NS:</u></p> <ol style="list-style-type: none"> Point No.20B, 19B; CMS crossing portions S&T bond wires are connected to CMS crossing by Exo-thermic weld <u>which is not permitted</u>. On CMS crossings as a part of design, separate lugs along with pre-drilled holes are provided to facilitate connecting S&T bond wires. (Ref: CTE/SC Lr. No.W/509/TC/Zig-zag welding, of dated 9.3.12). <u>'J' type clips also not fixed properly & not holding.</u>

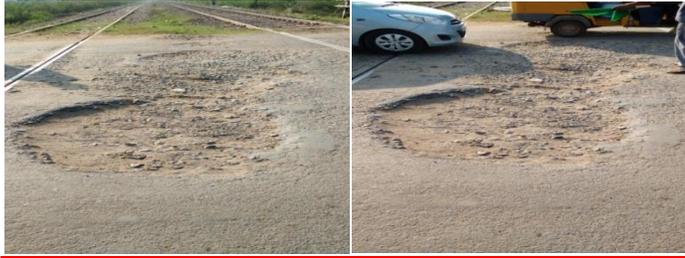
<ul style="list-style-type: none"> LC Gate No.52 is provided with sliding boom arrangement and it was observed that the SMs and TI were not aware of the procedure of exchanging PNs before introduction of sliding boom working and after introducing normal working eg., on 12.12.2015, LC Gate failure took place for which the above procedure was not followed. This is against the guidelines given in G&SR, Appendix-II. 	DRM/BZA COM
17	18.0	<p><u>Inspection of LC Gate no 52/T, special class at KM 44/2-3 between GDV-OTR stations:</u></p> <p>Road portion between tracks is completely damaged. Also noticed Pot Holes between speed breakers of the LC Gate which needs to be attended on priority since road traffic is heavy.</p>

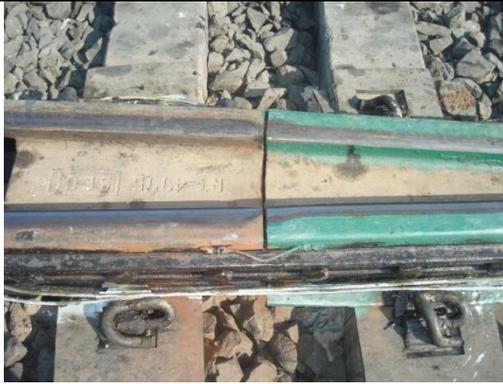
<p>14.0</p>	<p><u>Engineering observations:</u></p> <ul style="list-style-type: none"> d. Point No.20B, 19B; CMS crossing portions S&T bond wires are connected to CMS crossing by Exo-thermic weld <u>which is not permitted</u>. On CMS crossings as a part of design, separate lugs along with pre-drilled holes are provided to facilitate connecting S&T bond wires. (Ref: CTE/SC Lr. No.W/509/TC/Zig-zag welding, of dated 9.3.12). <u>‘J’ type clips also not fixed properly & not holding.</u>

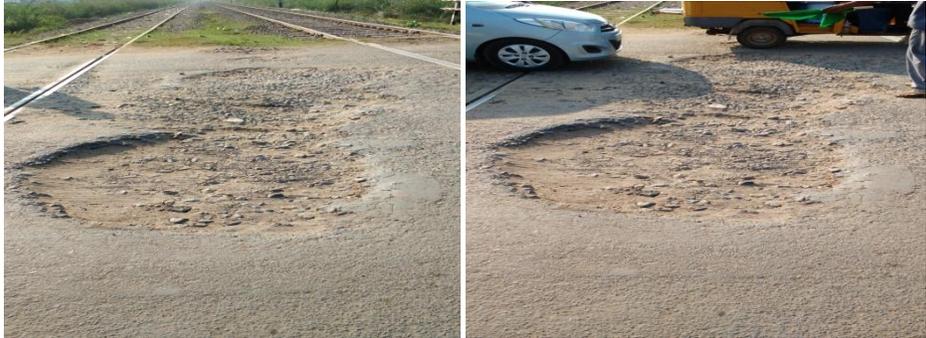
Inspection of LC Gate no 52/T, special class at KM 44/2-3 between GDV-OTR stations:

- a. Sri.K.Ravi Kumar was on duty in possession of valid competency certificate.
- b. TVUs – 224068; RVUs – 7228; Date of Census is 01.03.2015 to 07.03.2015. O&E was done on 9.12.15
- c. Duty Roster is not displayed on the gate lodge.
- d. Bio-data board should be clearly displayed with particulars of staff working at this gate.
- e. **Road Sign Boards are not fixed** on either side as per IRPWM.
- f. Road portion between tracks is completely damaged. Also noticed Pot Holes between speed breakers of the LC Gate which needs to be attended on priority since road traffic is heavy.
