## **South Central Railway**

# **Inspection of FOB at Lingampally Station**

**Preliminary Report  
September 2019**

**Name of the Project** : VISUAL INSPECTION OF FOB/ PF-1 - PF-6 AT LINGAMPALLY RAILWAY STATION

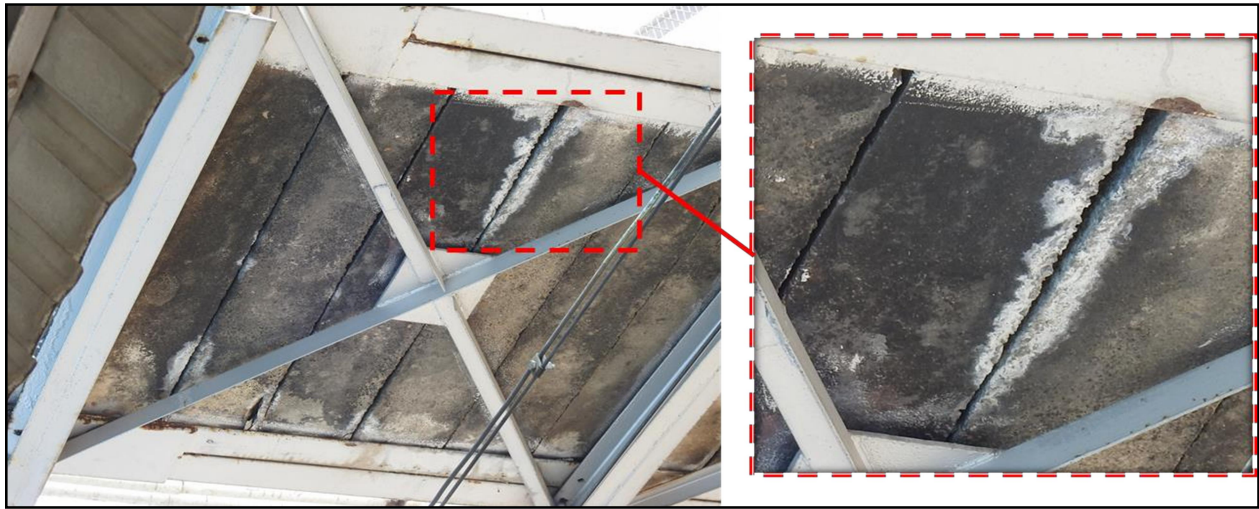
- ✓ Leaching effect is observed at bottom of slab panels along the length of 1<sup>st</sup> span
- ✓ Rusting is observed in truss bracing members and sacrificial plate along the length of FOB on both sides.

leaching effect observed at bottom of slab panels for 1<sup>st</sup> span of FOB

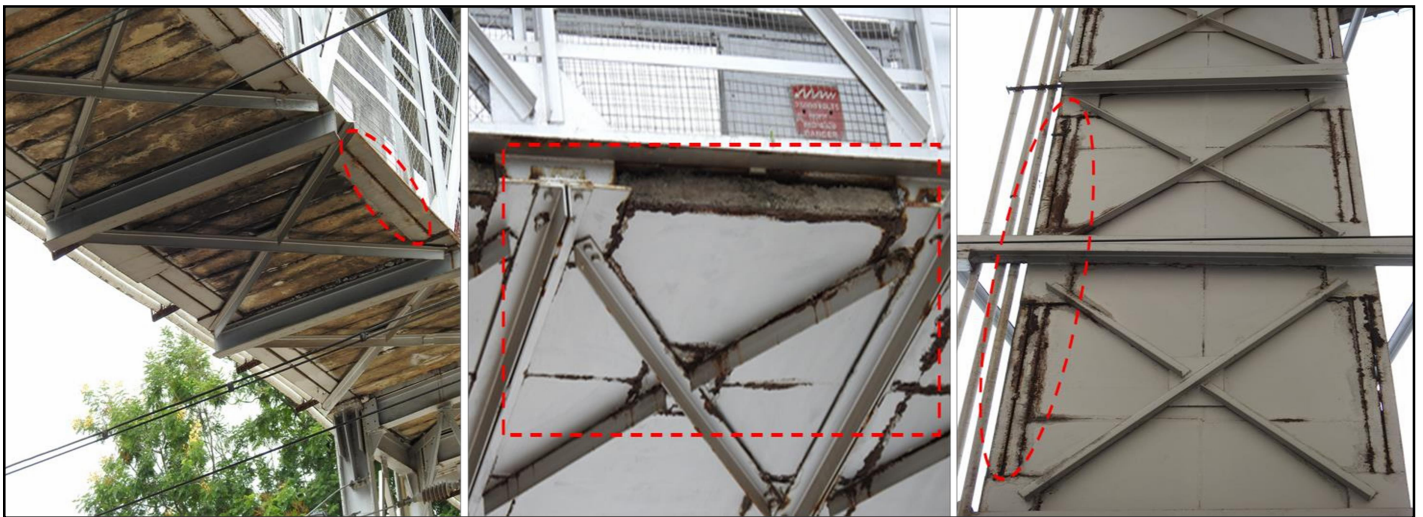
Rusting observed along the spans of FOB

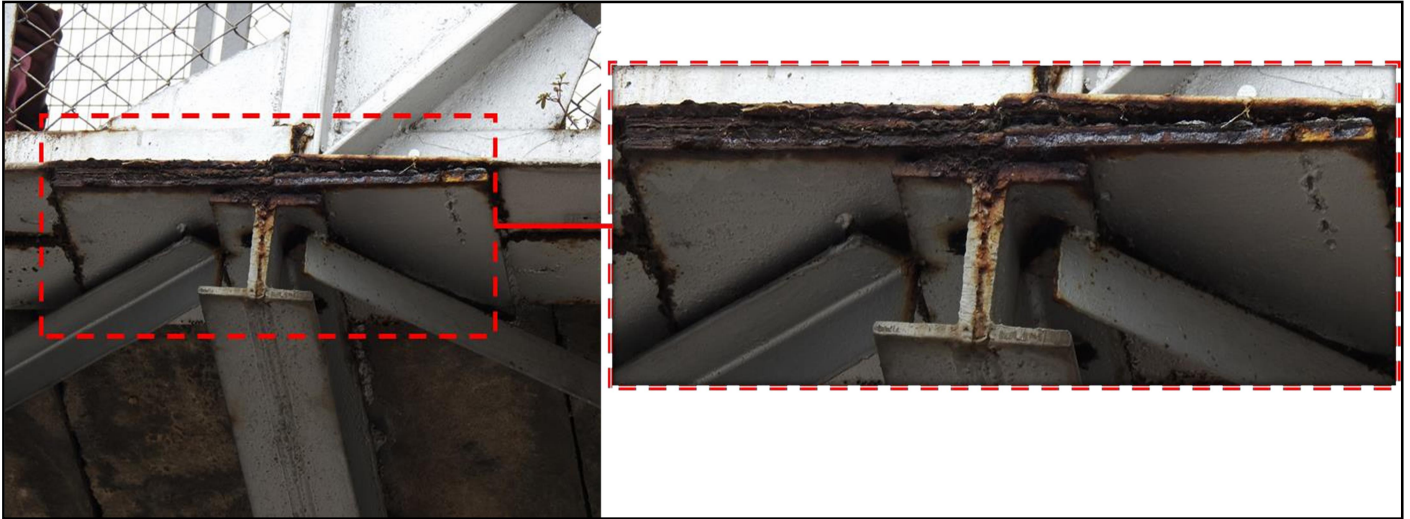
- ✓ Corrosion is observed in gusset plate connecting main girders and secondary girder in 1<sup>st</sup> span of FOB

Major Corrosion observed at gusset plate connecting girders

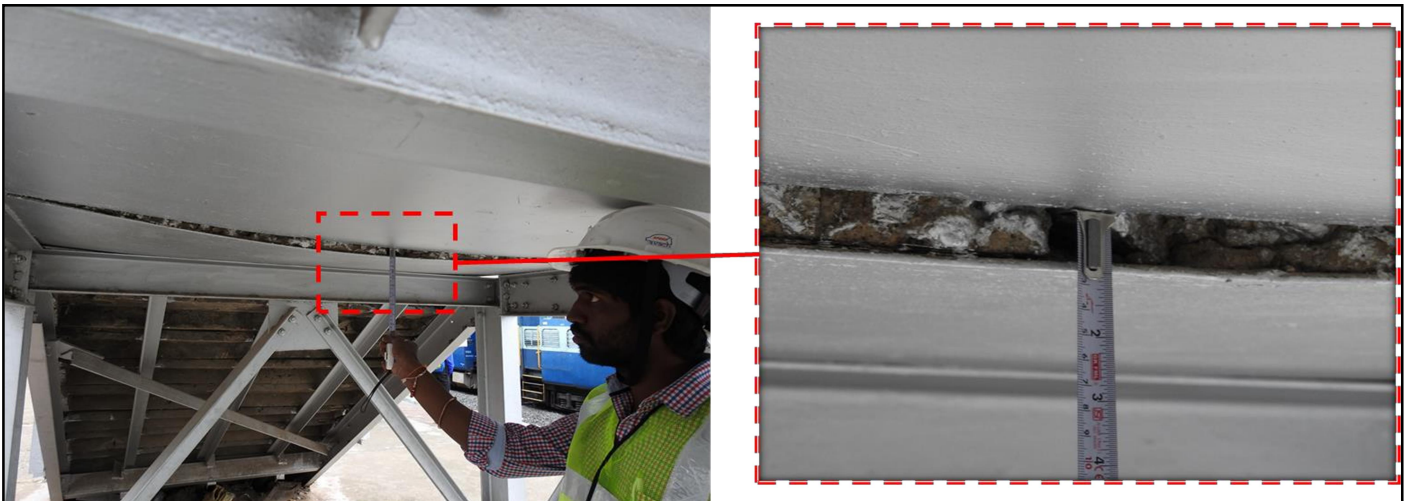
4.3 ✓ Deformation in cast in-situ sacrificial plate at staircase landing up to 20 mm.

Deformation in MS plate below slab

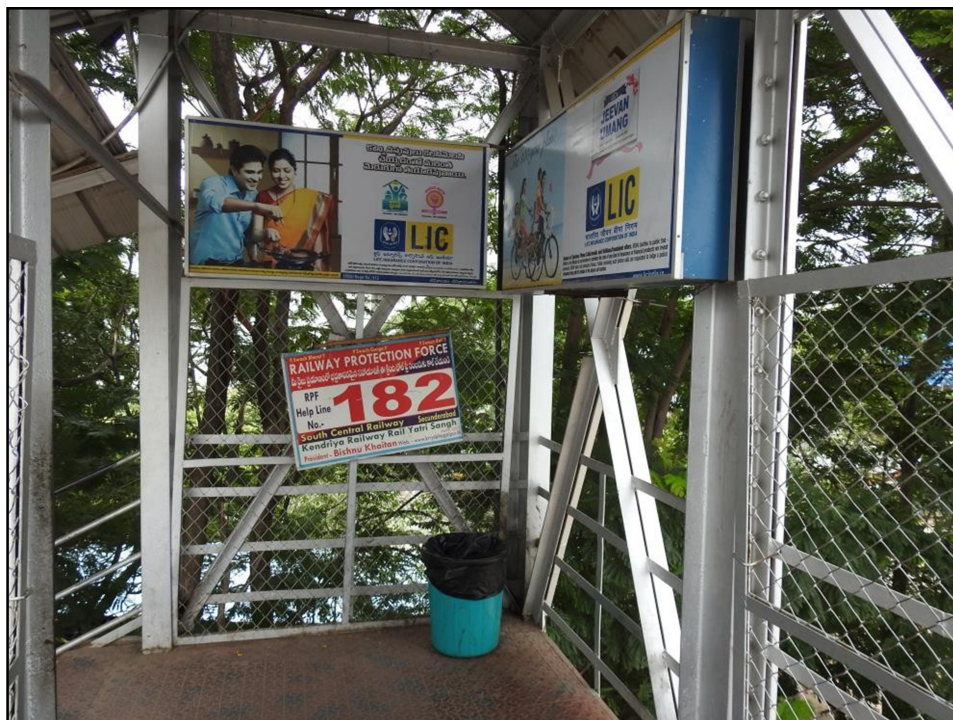
| PART 2 IDENTIFICATION OF LOADS ON BRIDGE | | | |
|---|---|---|---|
| | e) load of advertising hoarding | Yes | Advertising boards are provided. (Refer <b>fig :3</b> ) |

**Fig 3: load of advertising hoarding**

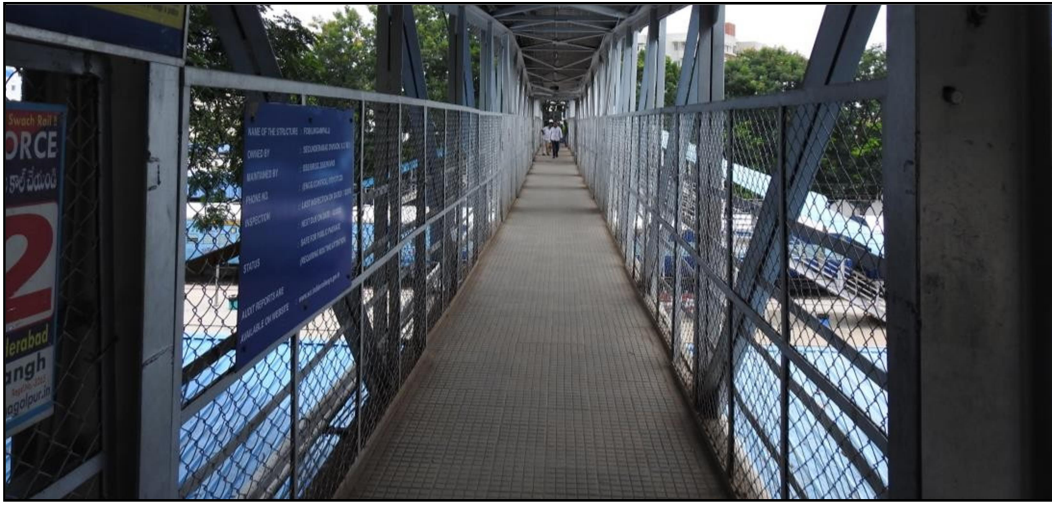
| PART 2 IDENTIFICATION OF LOADS ON BRIDGE | | | |
|---|---|---|---|
| | a) Additional wearing coat on Floor | No | Chequered tiles are used for flooring (Refer <b>fig :4</b> ) |

**Fig 4** Flooring and protective screen

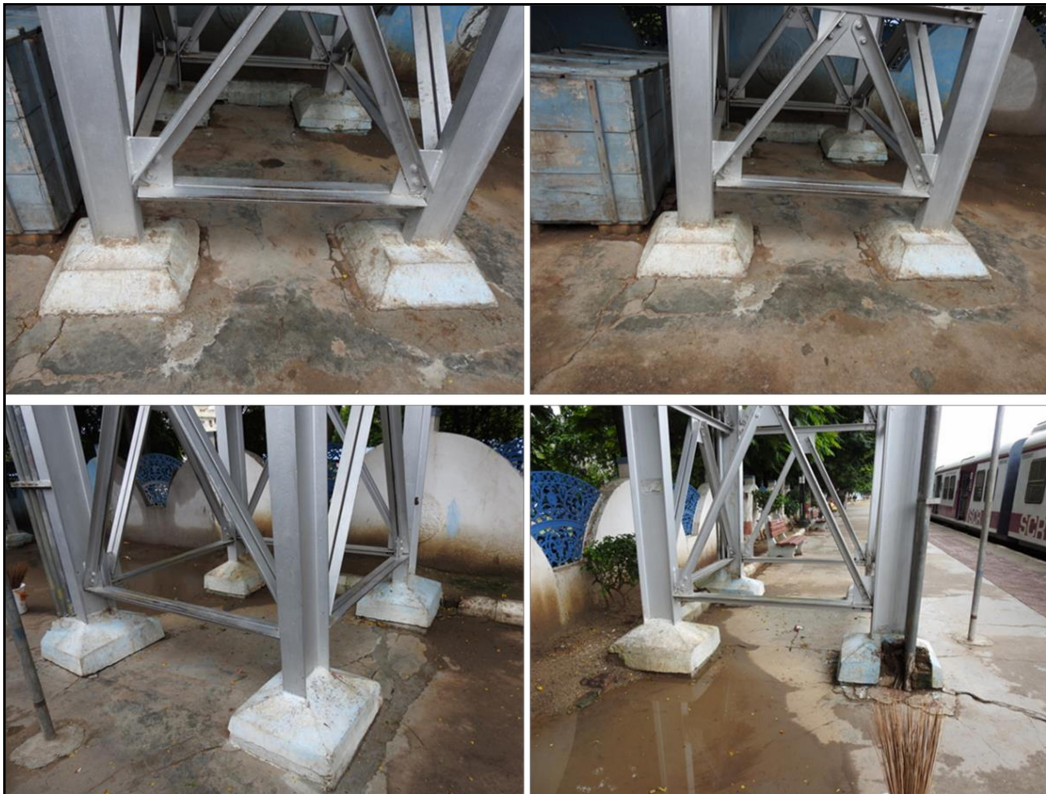
| PART 3 STRUCTURAL SYSTEM OF THE BRIDGE | | | |
|---|---|---|---|
| | Type of Trestles | Steel I – Section | Trapezoidal concrete encasement is observed in vertical supports (Refer <b>fig :5</b> ) |

| | Type/Shape of Column section | I – Section | FOB is supported on vertical column of Four - ISMB 300. (Refer <b>fig :5</b> ) |

**Fig 5:** Trestle details

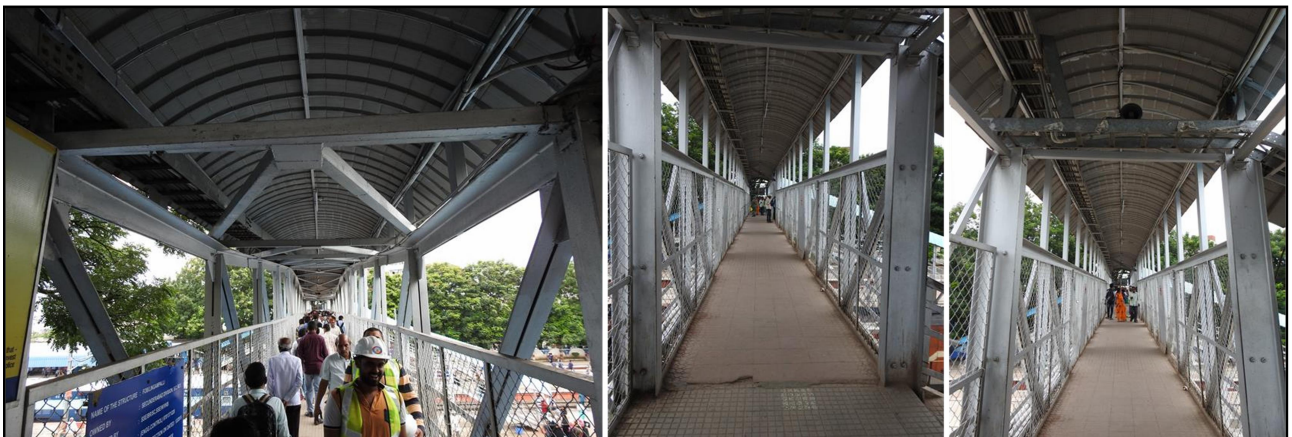
| PART 3 STRUCTURAL SYSTEM OF THE BRIDGE | | | |
|---|---|---|---|
| | Element of roof truss section | Angular sections | 1 <sup>st</sup> span of 27.80 m roof truss is supported with 30 x 30 x 4 mm angular and supported on 65 x 65 x 8 mm tie members. 2 <sup>nd</sup> and 3 <sup>rd</sup> span is supported with 30 x 30 x 4 mm angular trusses supported on tie members (Refer <b>fig :6</b> ) |

**Fig 6:** Roof truss and roof elements of three spans

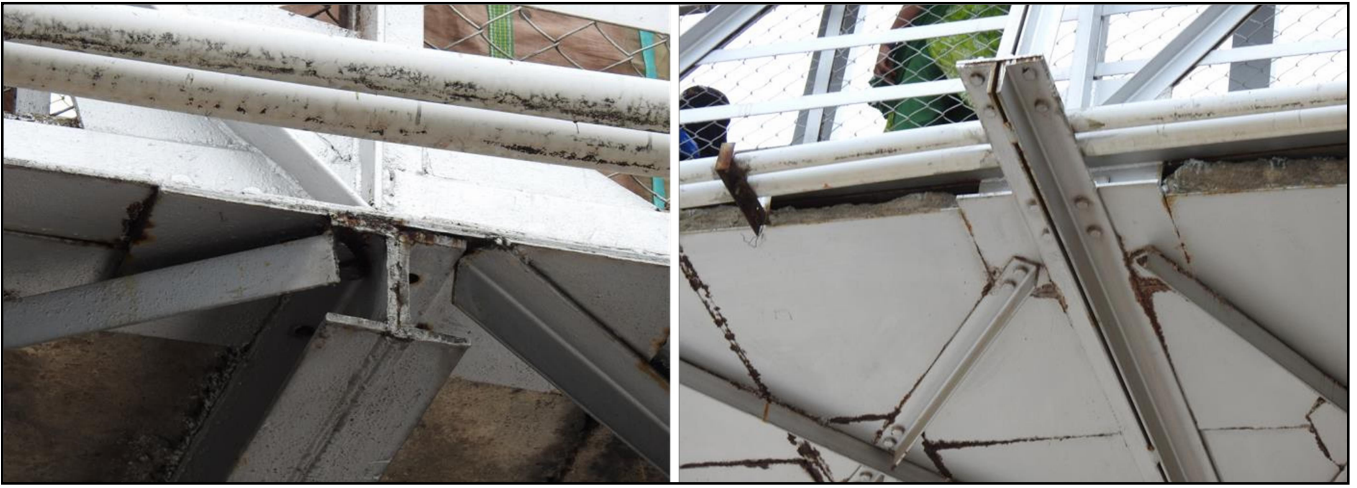
| | Type/Shape of Secondary Girder /Bracings | Double Channel sections,<br>Double angular section | a. For 1 <sup>st</sup> span ISMC 150 Double Channel are used as secondary girders supported with 65 x 65 x 8 mm angular section to transfer load from slab to roof truss.<br>b. For 2 <sup>nd</sup> and 3 <sup>rd</sup> span 100x100x12 mm Double angular section Secondary girders are connected with tie member using bolts and bracing are connected to tie members using welding (Refer <b>fig :7</b> ) |

**Fig 7:** Shape of Secondary girder section

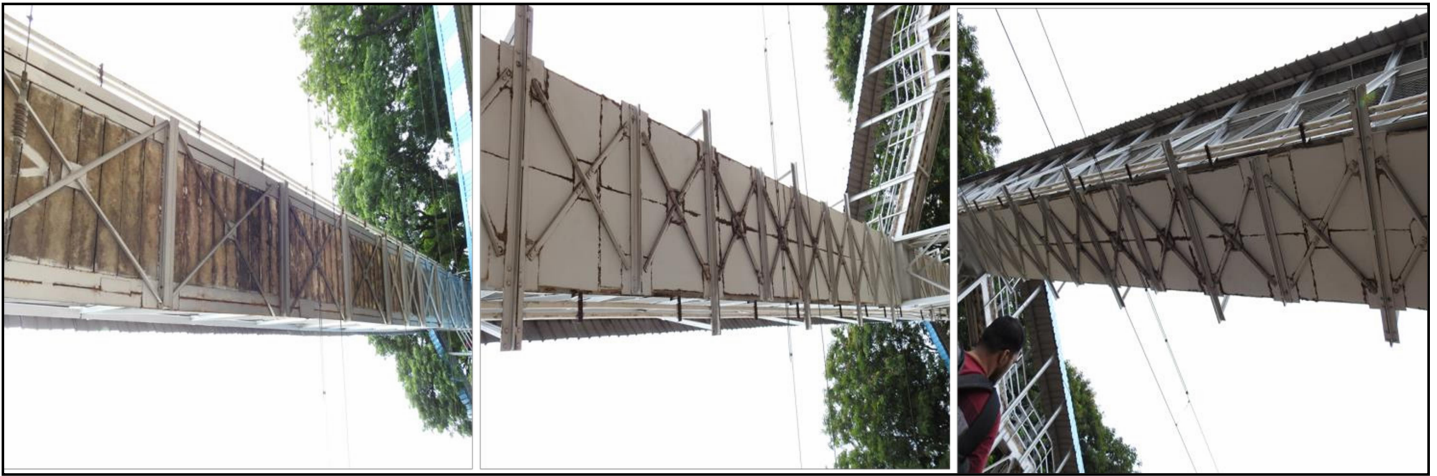
| | Material of Slab | RCC, Pre-cast panels | a. For 1 <sup>st</sup> span Pre-cast Reinforced concrete slab panels are used for floor slab of 100 mm thick, RCC slab panels are resting on angular tie members supported on secondary girder and bracing from bottom.<br>b. For 2 <sup>nd</sup> and 3 <sup>rd</sup> span cast-in-situ slab is used for floor slab of 100mm thick, with sacrificial plate which is supported on secondary girder and bracings from bottom<br>c. Chequered tile flooring is laid on the top of the slab panels (Refer <b>fig : 4 and 8</b> ) |

**Fig 8:** Bottom view of FOB
