| <b>Name of the Project</b> | <b>:</b> | <b>VISUAL INSPECTION OF FOB/ PF-1 - PF-6 AT SECUNDERABAD RAILWAY STATION</b> |
| <b>Location</b> | <b>:</b> | <b>SECUNDERABAD STATION<br/>17°26'00.3"N 78°30'08.5"E</b> |
| <b>Date of Inspection</b> | <b>:</b> | <b>2<sup>nd</sup>, 3<sup>rd</sup> AUGUST 2019</b> |

## VISUAL INSPECTION OF STEEL FOOT OVER BRIDGE

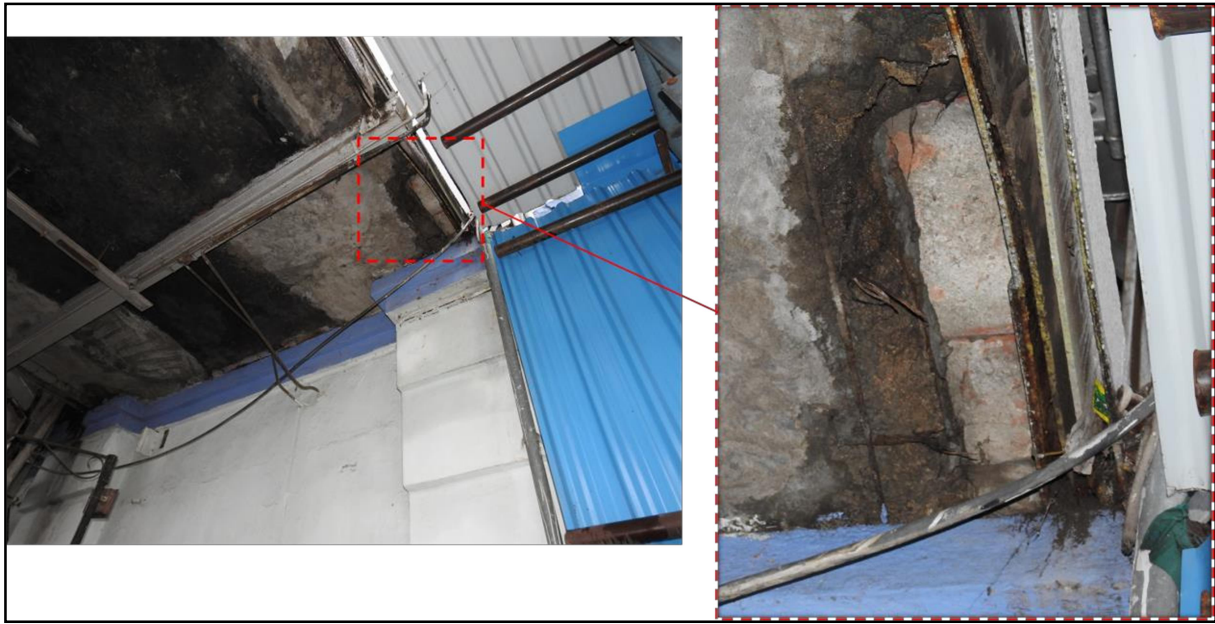
4.1

- ✓ Corrosion is observed in truss joints at bottom T sections -M.S flats steel – concrete joint on both sides of FOB

Corrosion is observed in Tie plates

| Defects | Location | |
|---|---|---|
| Extent of Corrosion | In Tie member | Distressing is observed in bottom Tie members along steel concrete joints (Refer <b>para:4.1</b> ) |

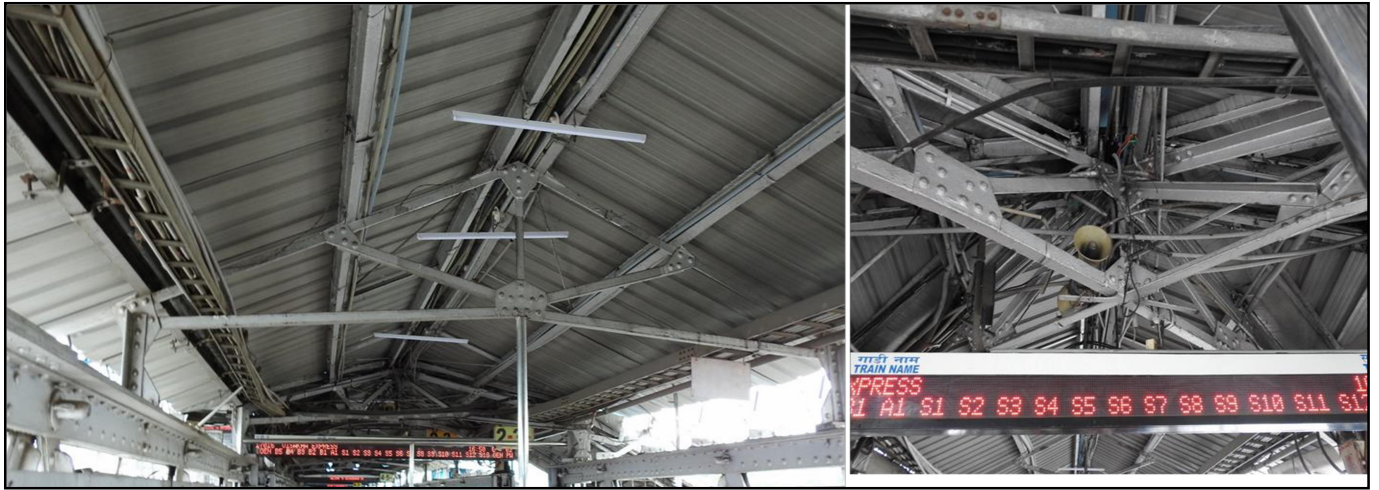
| PART 2 IDENTIFICATION OF LOADS ON BRIDGE | | | |
|---|---|---|---|
| | b) Cables | Yes | Cables are protected with 1-inch dia HDPE pipe (Refer <i>fig :1</i> ) |
| | d) Roof Sheet | Yes | Steel Metal Sheet is used for Roof (Refer <i>fig :1</i> ) |

| PART 3 STRUCTURAL SYSTEM OF THE BRIDGE | | | |
|---|---|---|---|
| | Element of roof truss section | King post angular section | King post angular truss with 65x65x8 mm section is used. Supported on Main tie members using welded joints (Refer <i>fig:1</i> ). |

**Fig 1:** Electrical Cables, Roof truss and Roof sheet

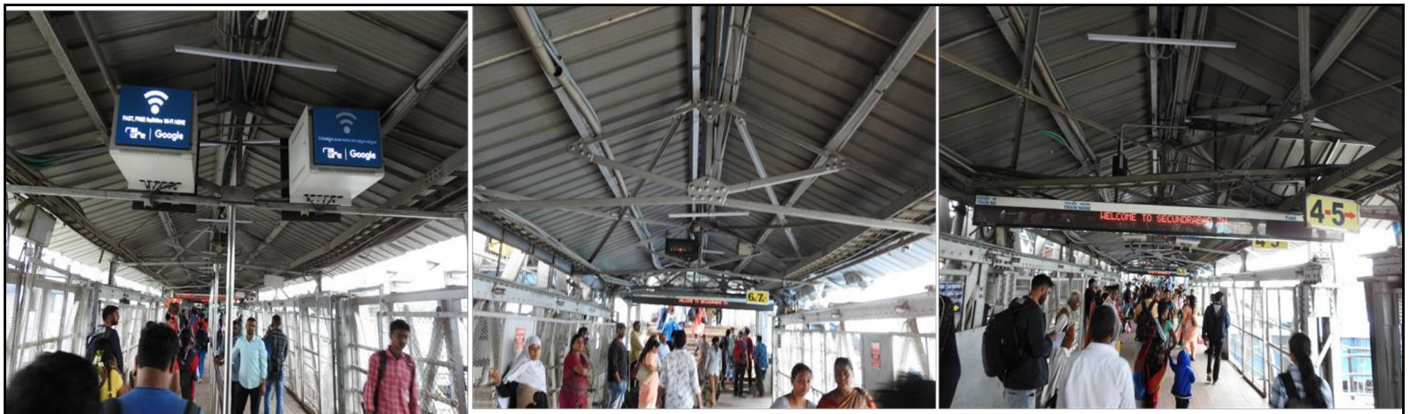
| PART 2 IDENTIFICATION OF LOADS ON BRIDGE | | | |
|---|---|---|---|
| | e) load of advertising hoarding | Yes | Advertising boards are provided (Refer <i>fig :2</i> ) |
| | f) load of train/coach display boards | Yes | Train coach display boards are provided (Refer <i>fig :2</i> ) |

**Fig 2:** Advertising hoarding (Rail wi-fi), coach display boards

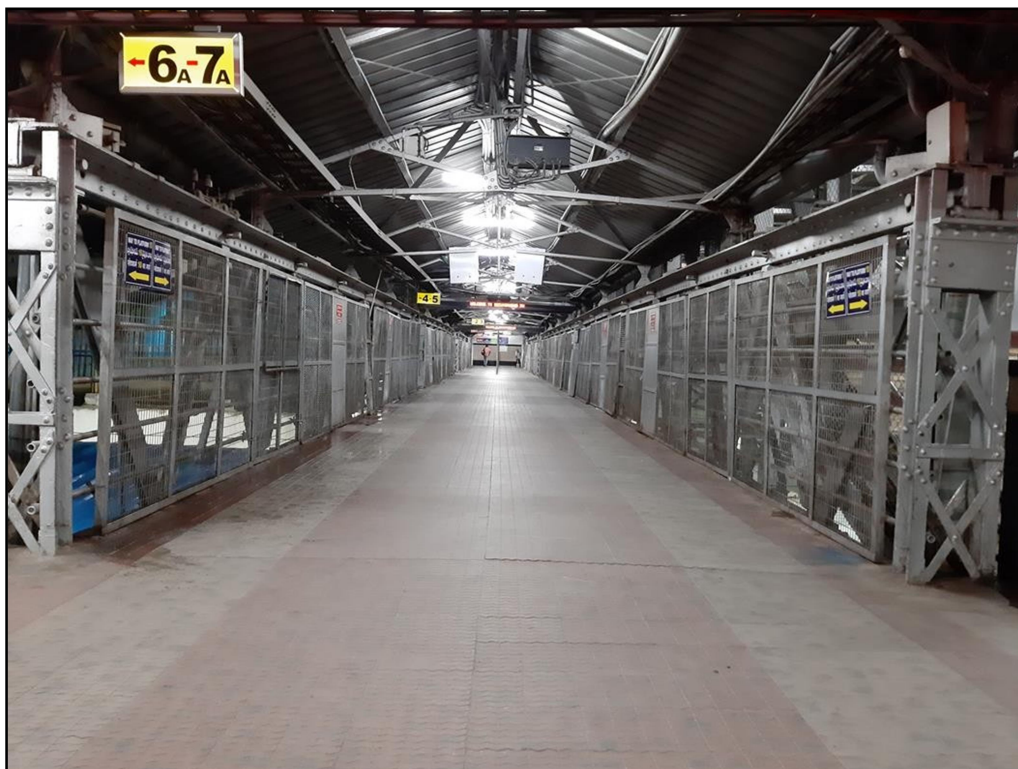
| PART 2 IDENTIFICATION OF LOADS ON BRIDGE | | | |
|---|---|---|---|
| | b) Provision of protective screen for passengers | Yes | Chain link fence made of Galvanized wire of 2 mm gauge and 2 mm Galvanized sheet is used above OHE Line on both side of pathway is used for Protection. Mesh frame is supported with angular and MS flats. (Refer <i>fig :3</i> ) |

**Fig 3:** Protective screen provided on both sides and details of Flooring

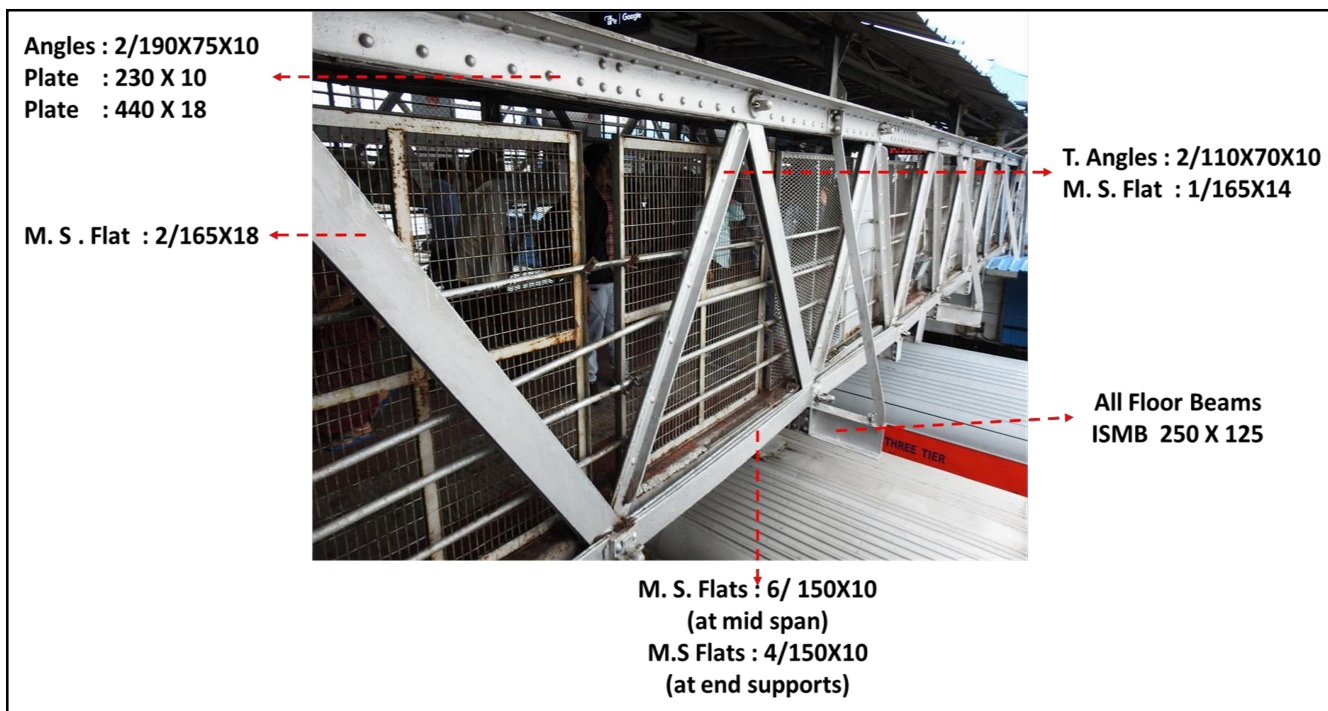
| | | | c. 10 mm thick gusset plate is used for welded joint (Refer <b>fig:4 and 8</b> ) |

**Fig 4:** Section properties of Truss

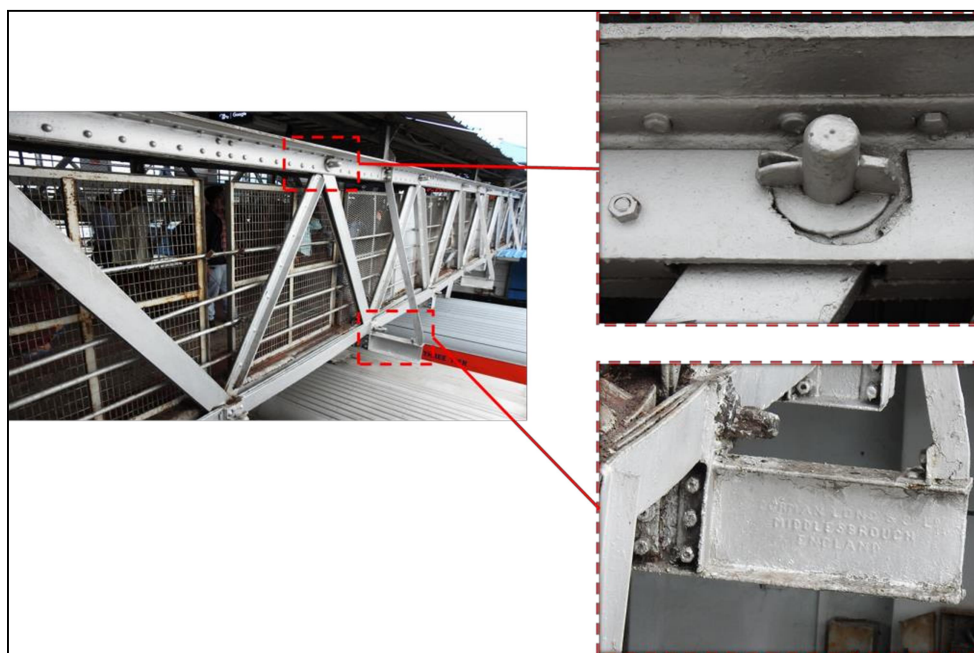
| | Type/Shape of Secondary Girder /Bracings | I-Section | ISMB 250x125 are used as secondary girders to transfer load from slab to truss. Secondary girders are connected with tie member using pin joints and bracing are connected to Secondary girder to transfer load to main tie members using bolted joint (Refer <b>fig :5</b> ) |

**Fig 5:** Pinned joints and secondary beam supported with angular bracings

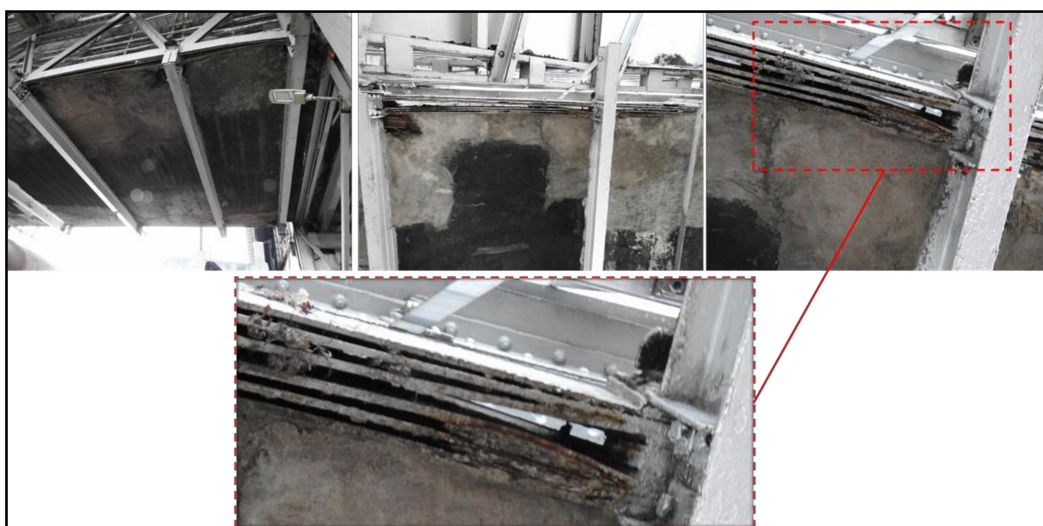
| | Material of Slab | RCC | a. Chequered tiles of 25 mm thick are observed on FOB.<br>b. RCC slab casted in site is supported by secondary girders of ISMB 250 (Refer <b>fig :6</b> ) |

- ✓ Condition of slab from bottom and corrosion of M.S flats (Refer **fig:6**)

| Defects | Location | |
|---|---|---|
| Spalling | | Spalling is observed in some portion of slab at end near support (Refer <b>fig:6</b> ) |
| Corrosion at steel-Concrete joint | | Major corrosion is observed at steel concrete joint. (Refer <b>fig:6</b> ) |

**Fig 6:** Condition of slab from bottom and corrosion of M.S flats

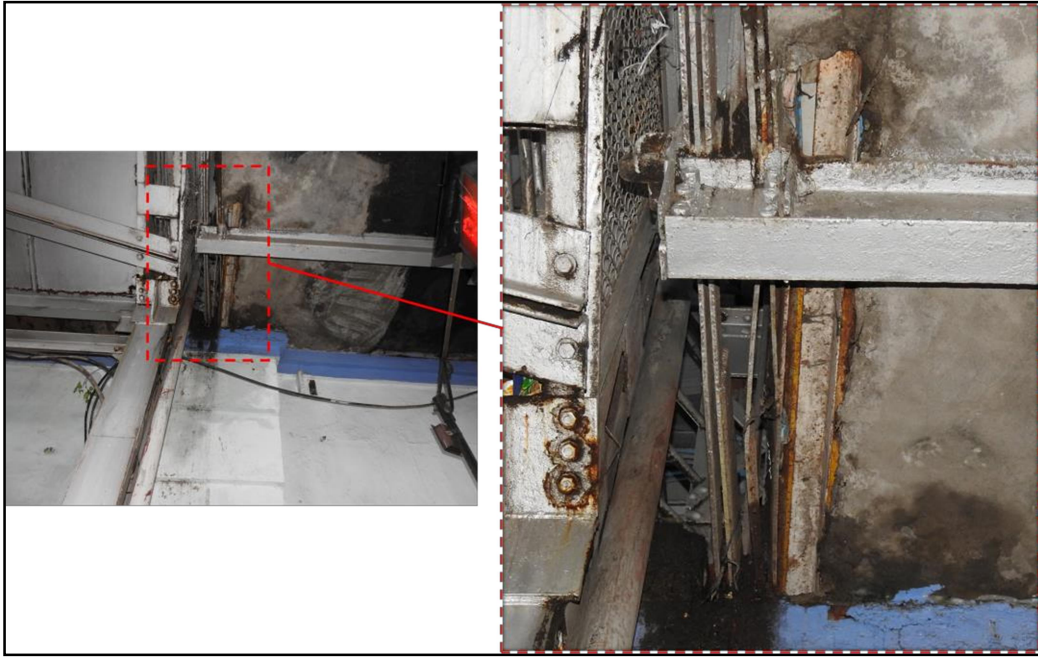
| Defects | Location | |
|---|---|---|
| Corrosion in welded structures | Truss | Corrosion is observed (Refer <b>fig:7</b> ) |

***Fig 7:*** Corrosion of M.S flats near end support

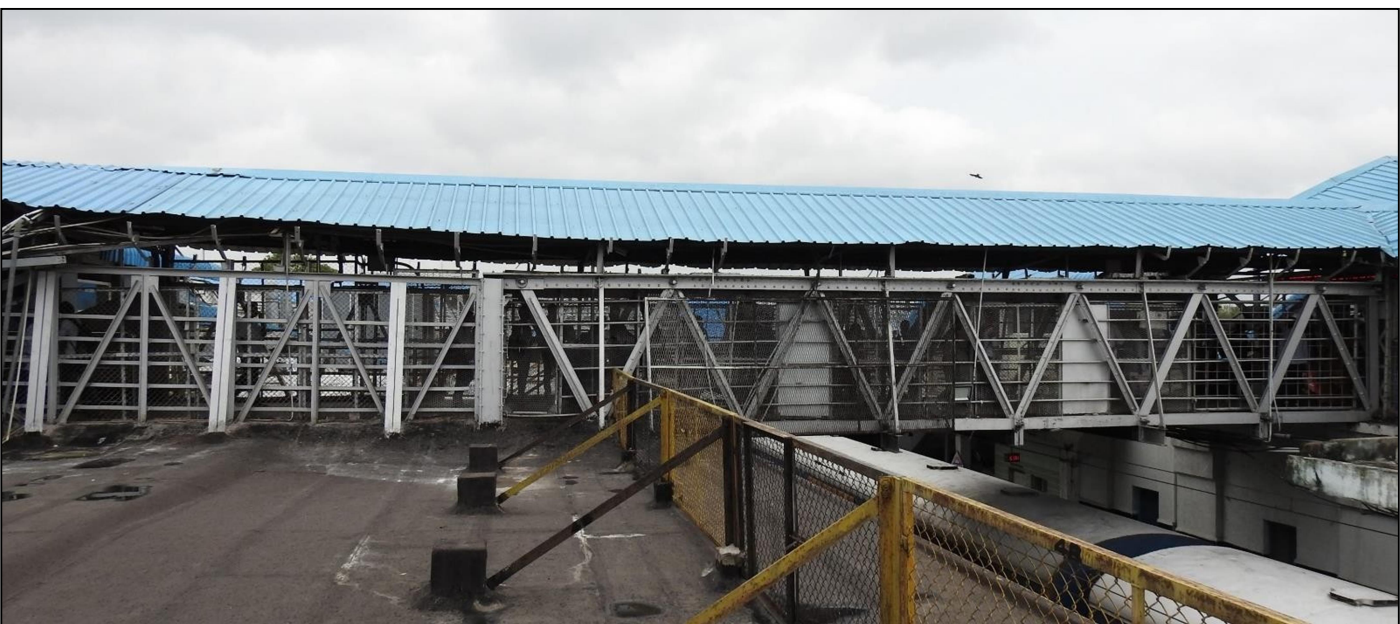
***Fig 8:*** Arrangement of truss
