## South Central Railway

### Inspection of ROB No. 7A at Lakdikapul

**Preliminary Report  
September 2019**

| <b>Name of the Project</b> | <b>: VISUAL INSPECTION OF ROB (7A) NEAR LAKDIKAPUL</b> |

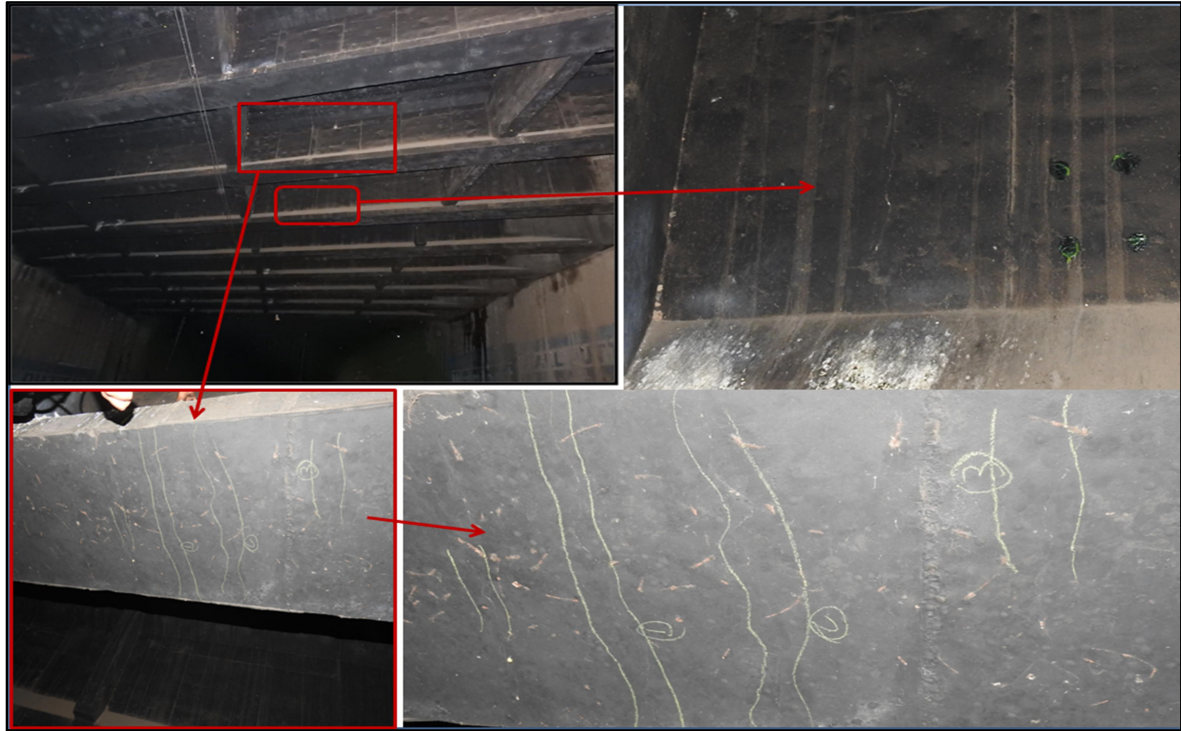
Fig.1

| | Condition of Girder | | Structural cracks have been observed in mid span of the girders (Refer Fig-1) |

- ✓ Structural Cracks have been observed in the Mid spans of Longitudinal Girders.

| PART 4 SURVEY OF SIGNS OF DISTRESS, DEFORMATION IN BRIDGES | | | |
|---|---|---|---|
| | Cracking in RCC components | Main Girders,<br>Secondary<br>Girders | cracks are observed in Main and<br>secondary girders |

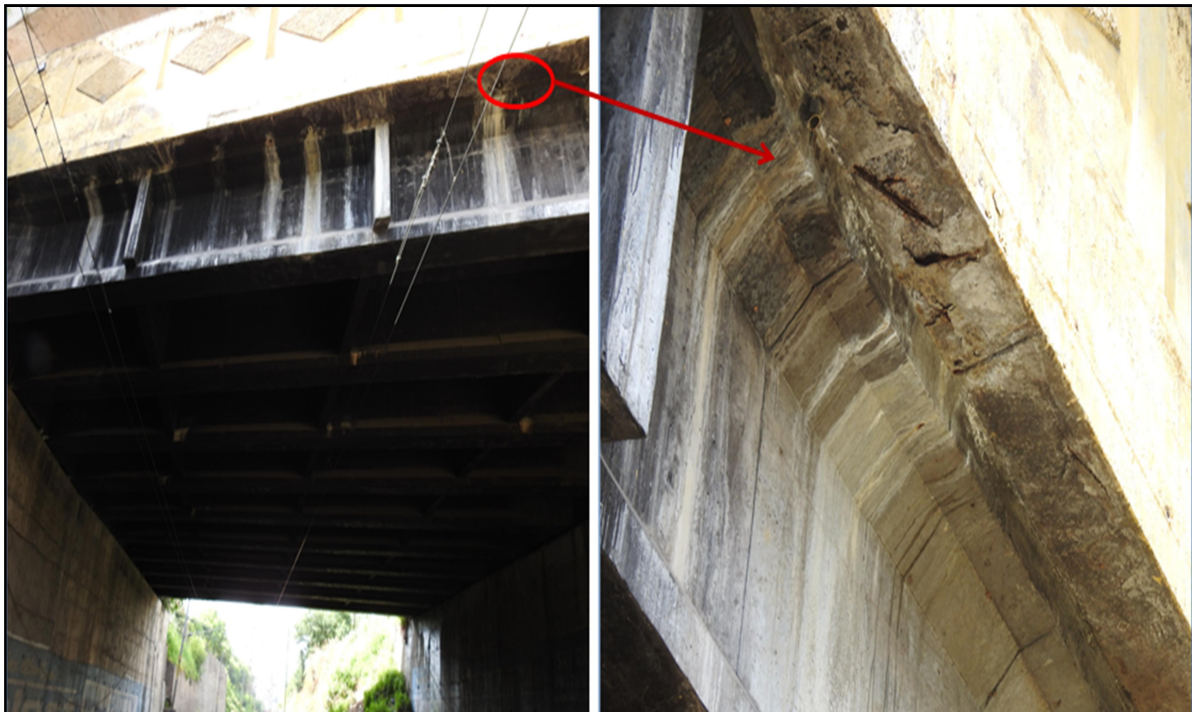
Fig.2

| | Condition of Slab from Bottom | | Spalling & Reinforcement exposure has been observed. (Refer Fig-2) |

- ✓ Spalling and Reinforcement exposure is observed at the bottom of slab.

| PART 4 SURVEY OF SIGNS OF DISTRESS, DEFORMATION IN BRIDGES | | | |
|---|---|---|---|
| | Reinforcement Exposure | Slab | Reinforcement Exposure is observed in<br>Slab |

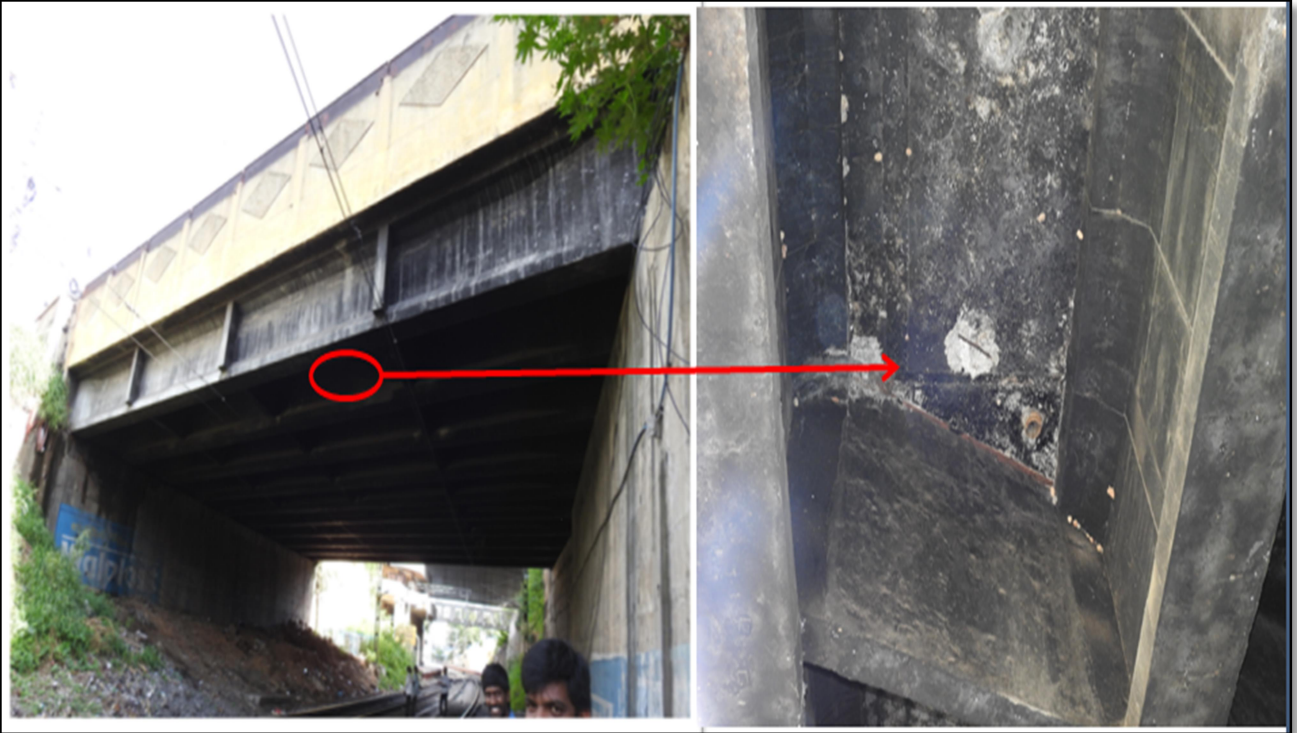
Fig.3

- ✓ Corrosion and Spalling observed near Drainage Spout

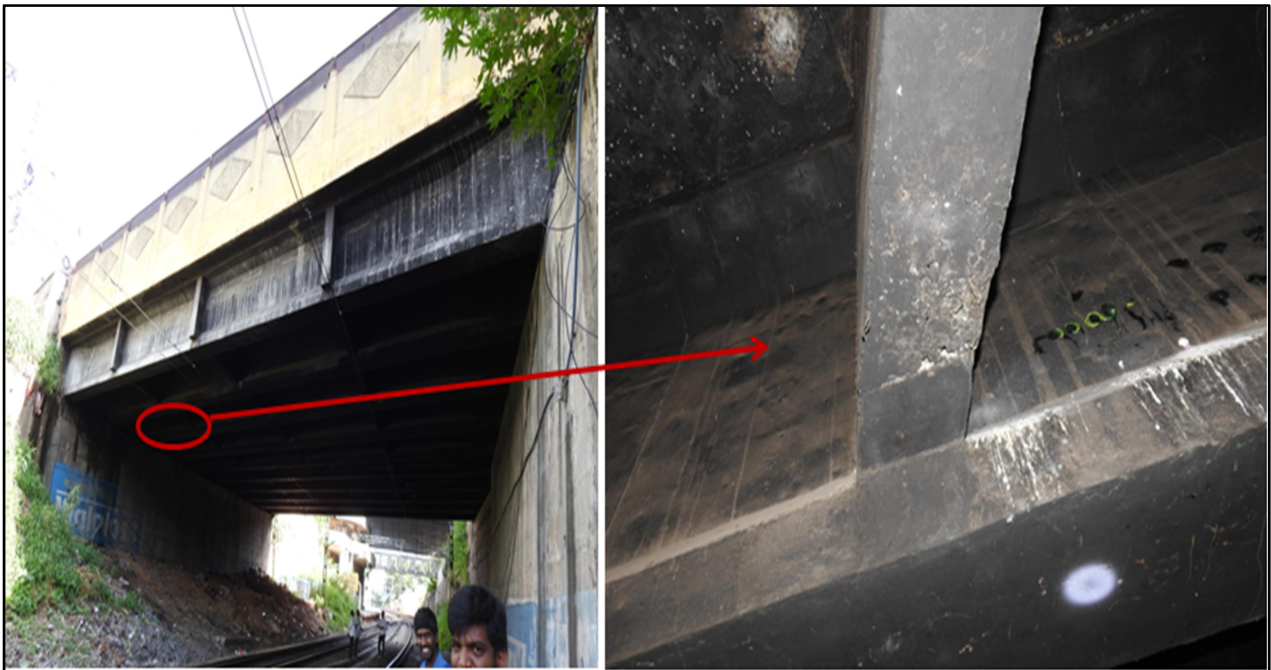
Fig.4

| | Condition of Secondary Girder | | Distresses are observed near main & secondary Girder junctions(Refer Fig-4) |

- 4.4 ✓ Cracks are observed in the secondary girders.

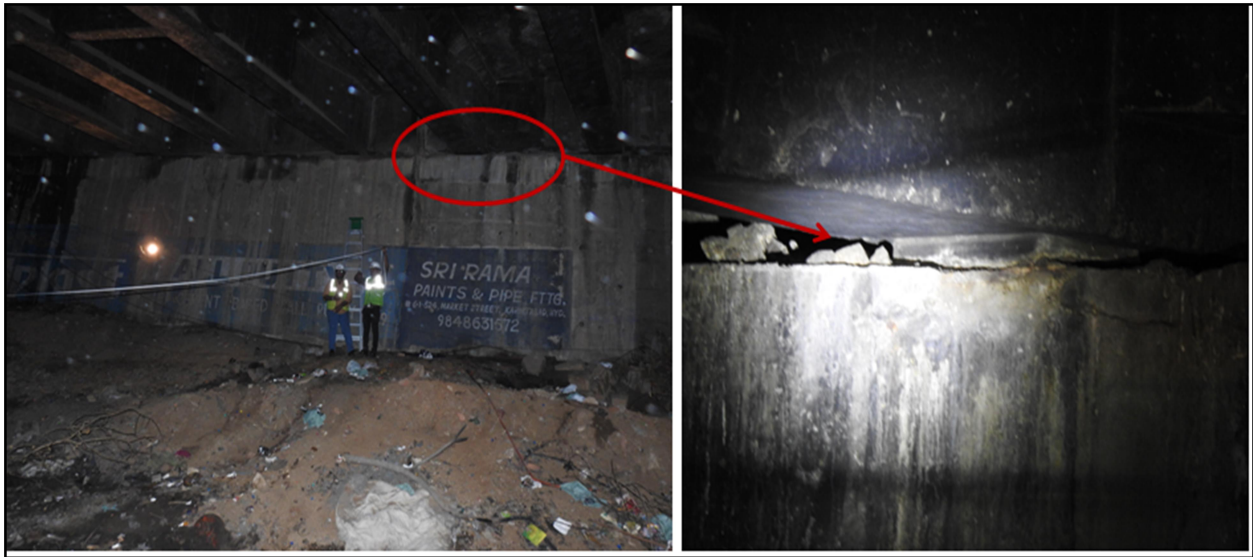
Fig.5

| | General condition<br>(Check Corrosion, cleanliness, seizing of plates silting, accumulations of dirt in case of submersible bridges) | | All the bearings are in distressed condition |

- 4.5 ✓ Distresses are found in the Elastomeric Pad bearings.

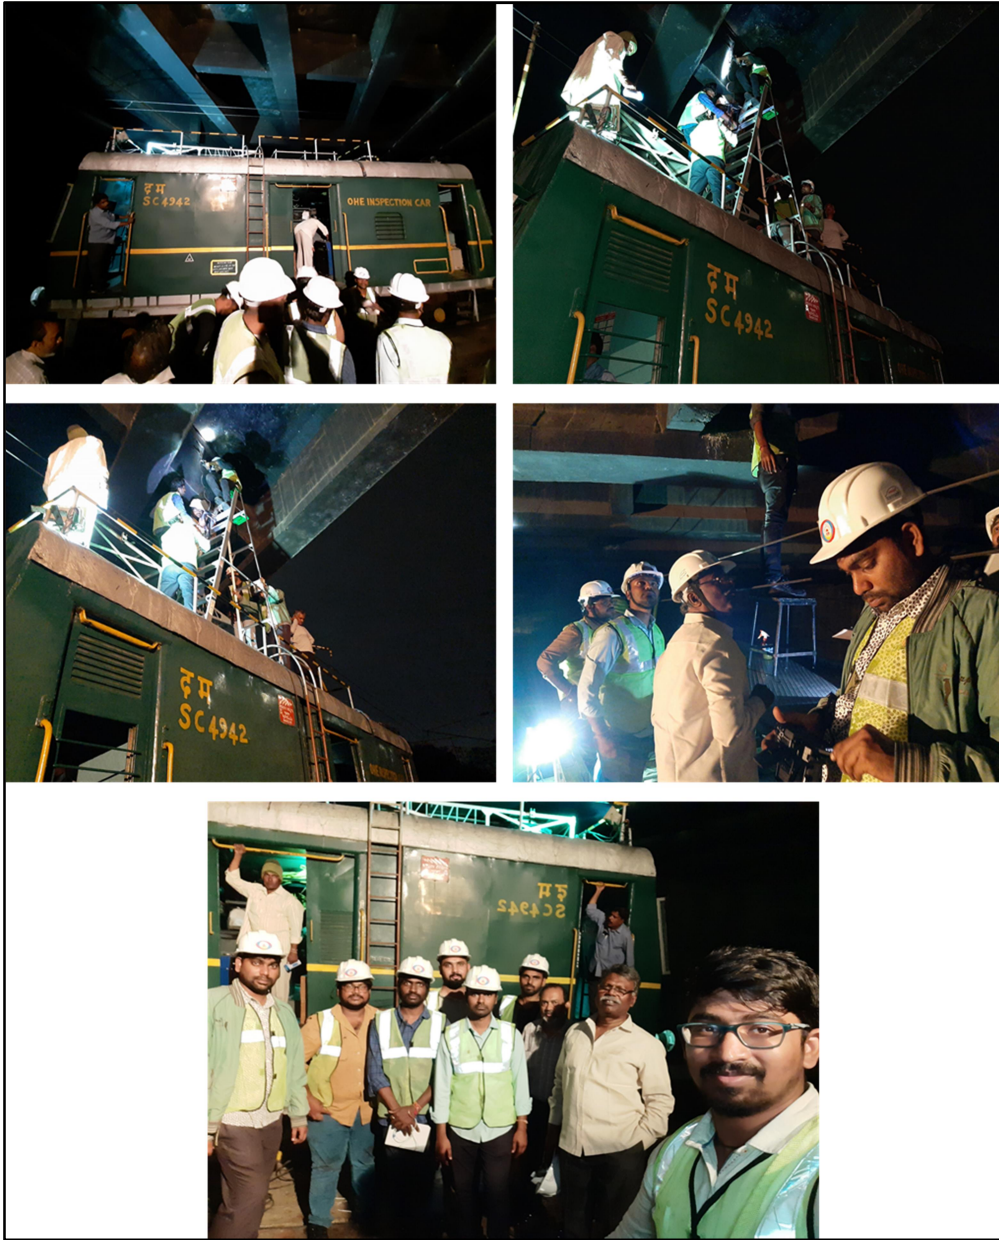
Few snapshots taken during visual inspection using a traction car on 22<sup>nd</sup> Aug 2019. Minor cracks are observed during this inspection.
