| <b>Name of the Project</b> | : | VISUAL INSPECTION OF FOB/ PF-1 - PF-2 AT WIRUR RAILWAY STATION |
| <b>Location</b> | : | WIRUR RAILWAY STATION |
| <b>Date of Inspection</b> | : | 23 <sup>rd</sup> September 2019 |

## FORMAT FOR VISUAL INSPECTION OF STEEL FOOT OVER BRIDGE

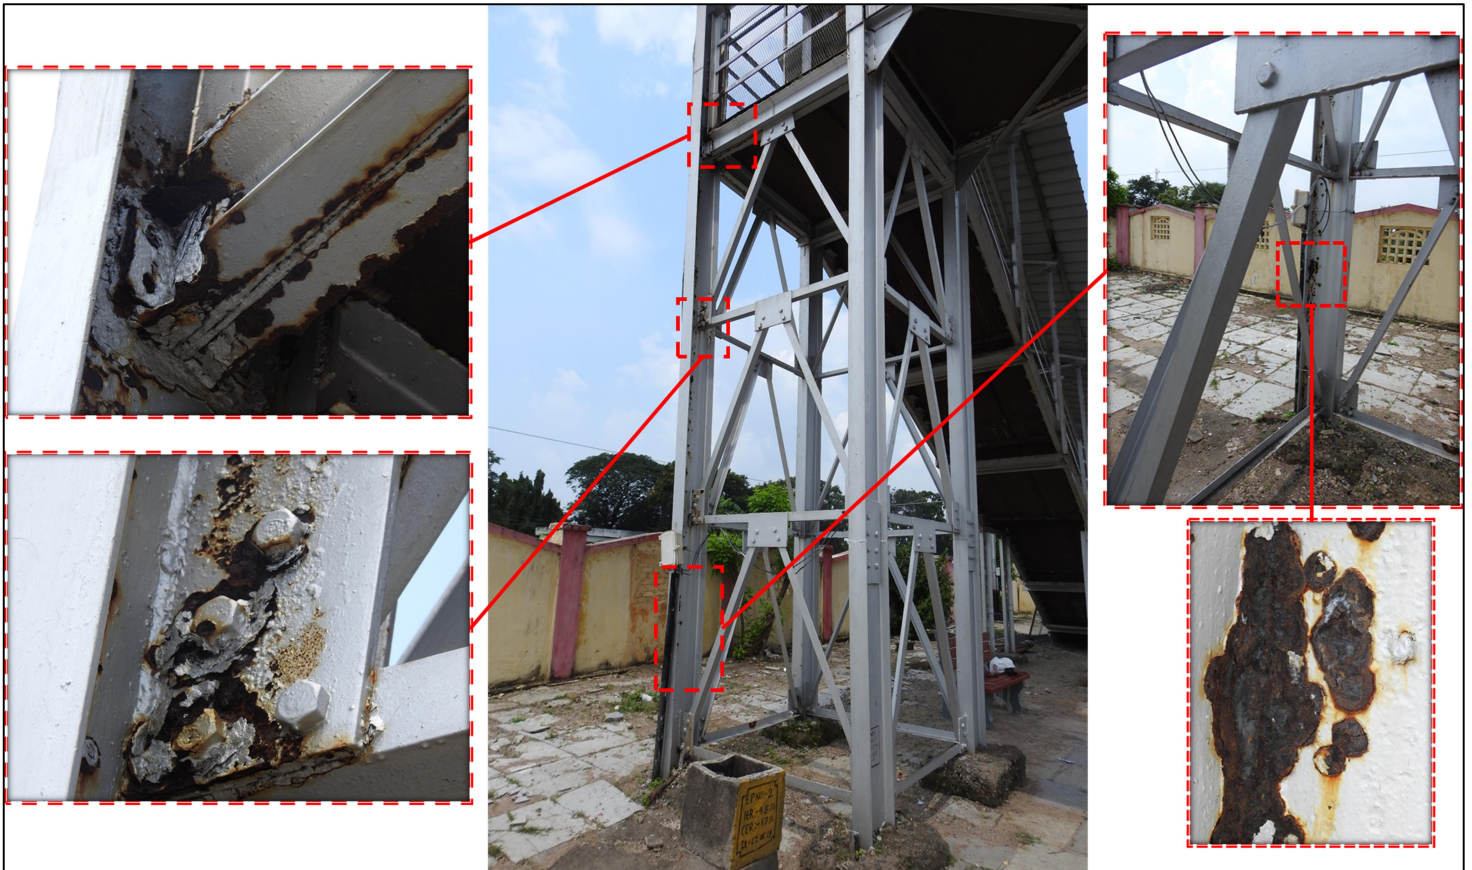
4.1

✓ Major corrosion observed in stanchions, gusset plate and in Trestles at PF-2.

Major corrosion observed

| PART 4 SURVEY OF SIGNS OF DISTRESS, DEFORMATION IN BRIDGES | | | |
|---|---|---|---|
| | Corrosion in Gusset plate | Trestles bracings | Rusting is observed in Gusset plates.<br>(Refer <b>Part 4 - 4.1</b> ) |

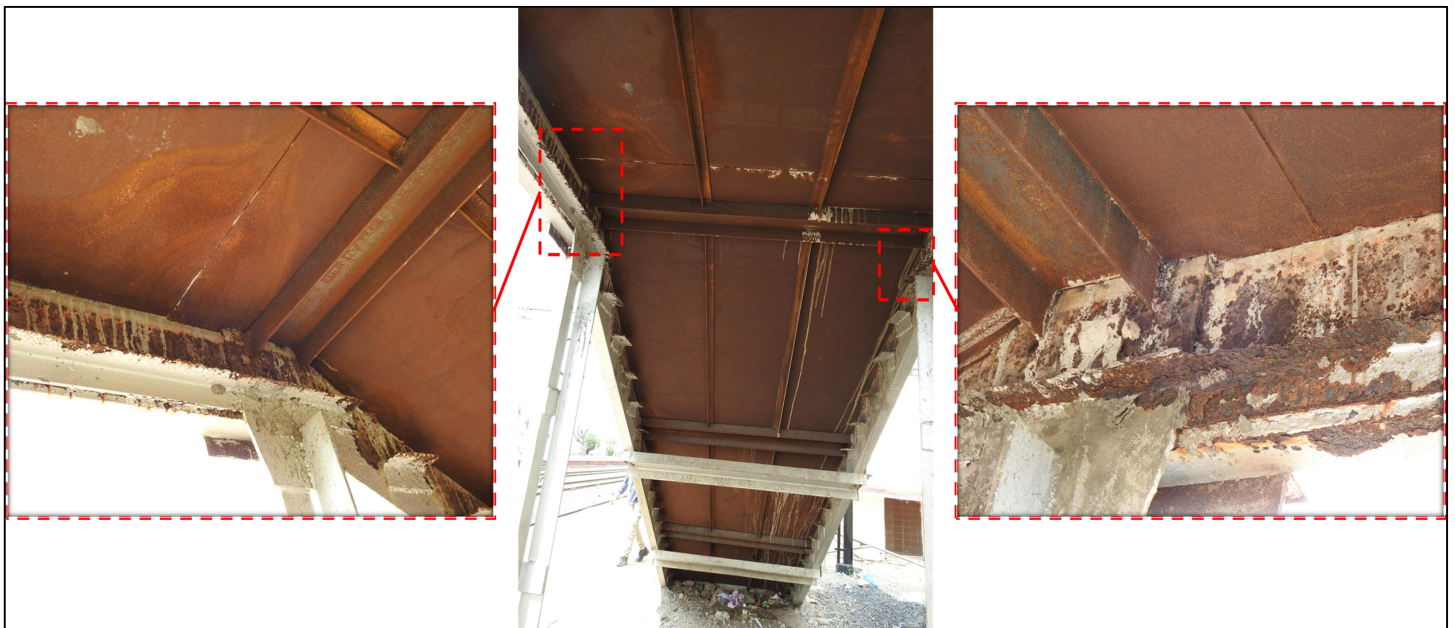
4.2

✓ Corrosion is observed in staircase landing which is supported on channel section at PF-1

Major Corrosion observed in channel section staircase landing at PF-1

| PART 4 SURVEY OF SIGNS OF DISTRESS, DEFORMATION IN BRIDGES | | | |
|---|---|---|---|
| | Extent Of Corrosion | Floor beam, stringer beam and channel section | a. Spacers in between floor beam channels are distressed. (Refer <b>Part 4 - 4.4</b> )<br>b. Major corrosion is observed at Double channel support of landing slab (Loss of effective thickness).<br>c. Corrosion is observed in staircase landing which is supported on channel section at PF-1. (Refer <b>Part 4 - 4.1 and 4.2</b> ) |

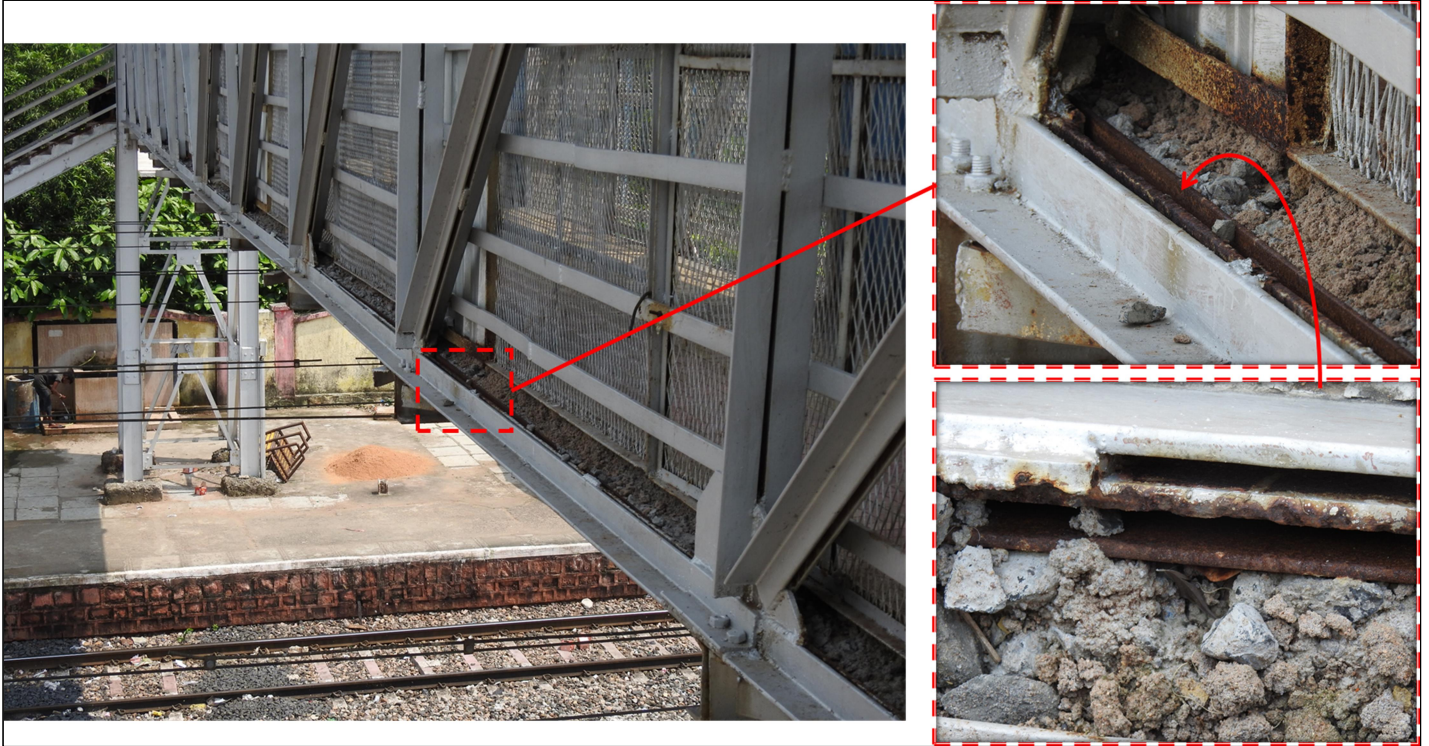
4.3

✓ Corrosion is observed in bottom chord member (Double angular section) near steel concrete joint

Corrosion is observed at steel concrete joint

| PART 4 SURVEY OF SIGNS OF DISTRESS, DEFORMATION IN BRIDGES | | | |
|---|---|---|---|
| | Corrosion at steel-Concrete joint | Bottom main chord member | Corrosion is observed at steel concrete joint.<br>(Refer <b>Part 4 - 4.3</b> ) |

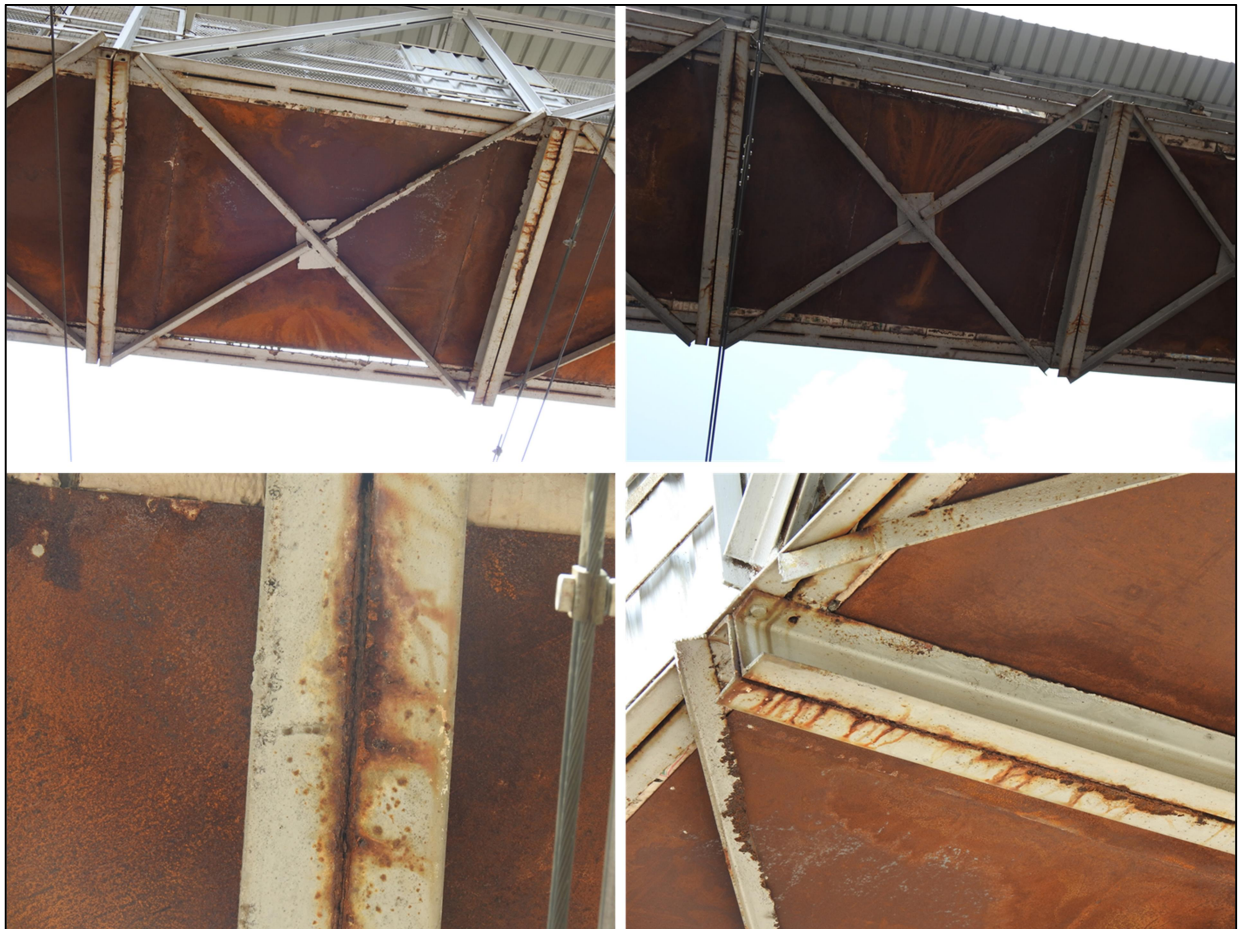
4.4

✓ Rusting of sacrificial plates is observed at slab bottom and corrosion observed in floor beams.

Rusting and corrosion is observed

| PART 4 SURVEY OF SIGNS OF DISTRESS, DEFORMATION IN BRIDGES | | | |
|---|---|---|---|
| | Rust straining | Sacrificial plate | Rusting is observed below slab and bottom of staircase of FOB.<br>(Refer <b>Part 4 - 4.4</b> ) |

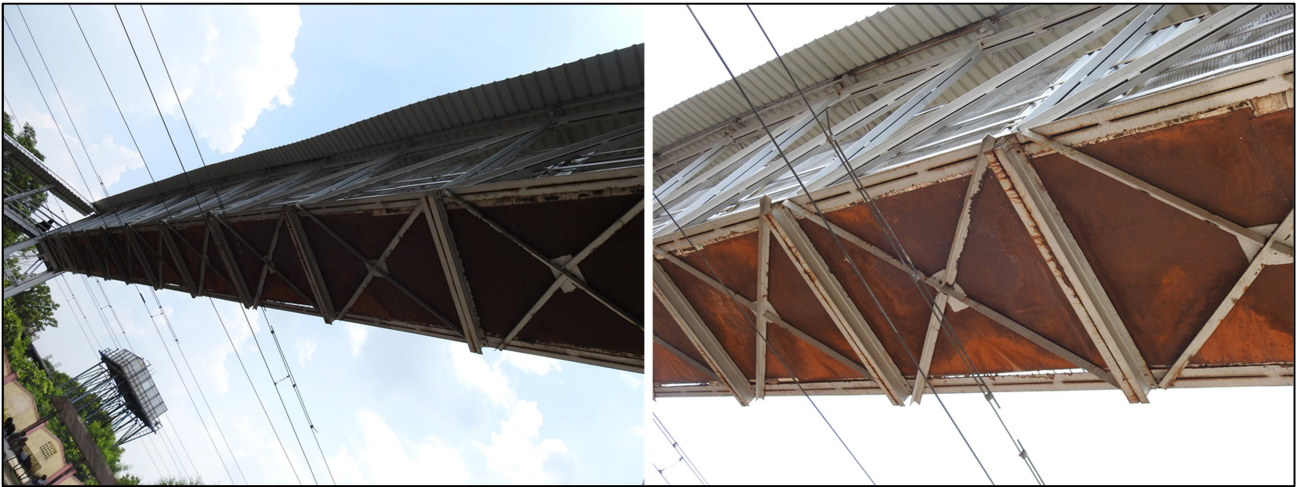
**Fig 4:** Bottom view of FOB

| | Condition of sheeting- MS. Sheet at bottom | Rusting is observed at the joints connecting MS sheet plate | |
