| <b>Name of the Project</b> | <b>:</b> | <b>VISUAL INSPECTION OF FOB/ PF-1 - PF-2 AT<br/>POTKAPALLI RAILWAY STATION</b> |
| <b>Location</b> | <b>:</b> | <b>POTKAPALLI RAILWAY STATION</b> |
| <b>Date of Inspection</b> | <b>:</b> | <b>22<sup>nd</sup> September 2019</b> |

## FORMAT FOR VISUAL INSPECTION OF STEEL FOOT OVER BRIDGE

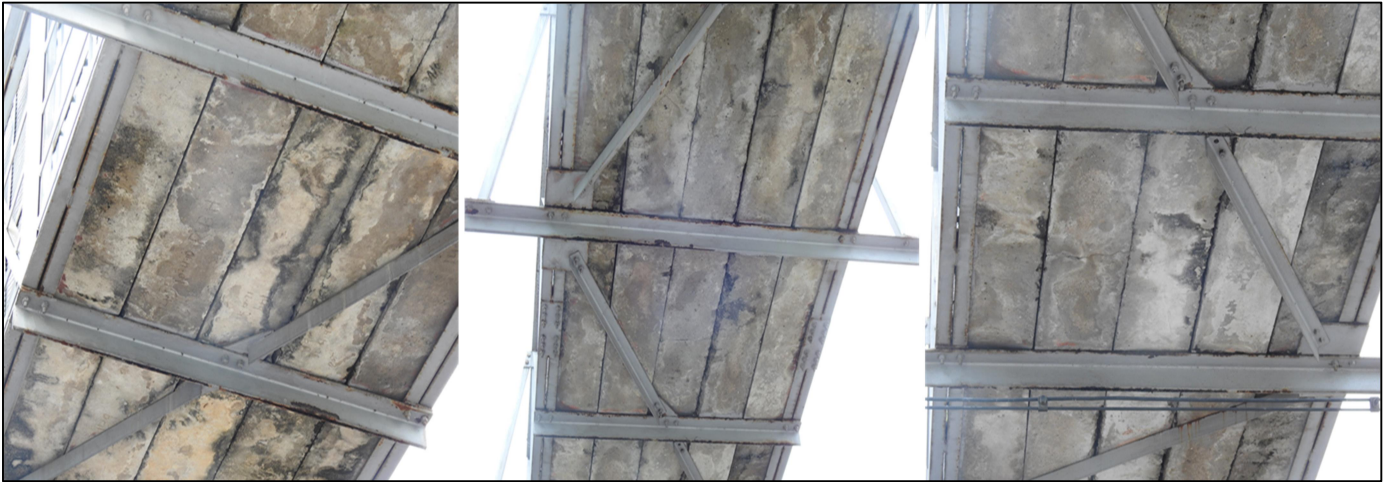
4.1

| | Condition of Slab from Bottom | Leaching effect is observed | |

- ✓ Leaching effect is observed at bottom of slab panels and near joints

leaching effect observed at bottom of slab panels of FOB

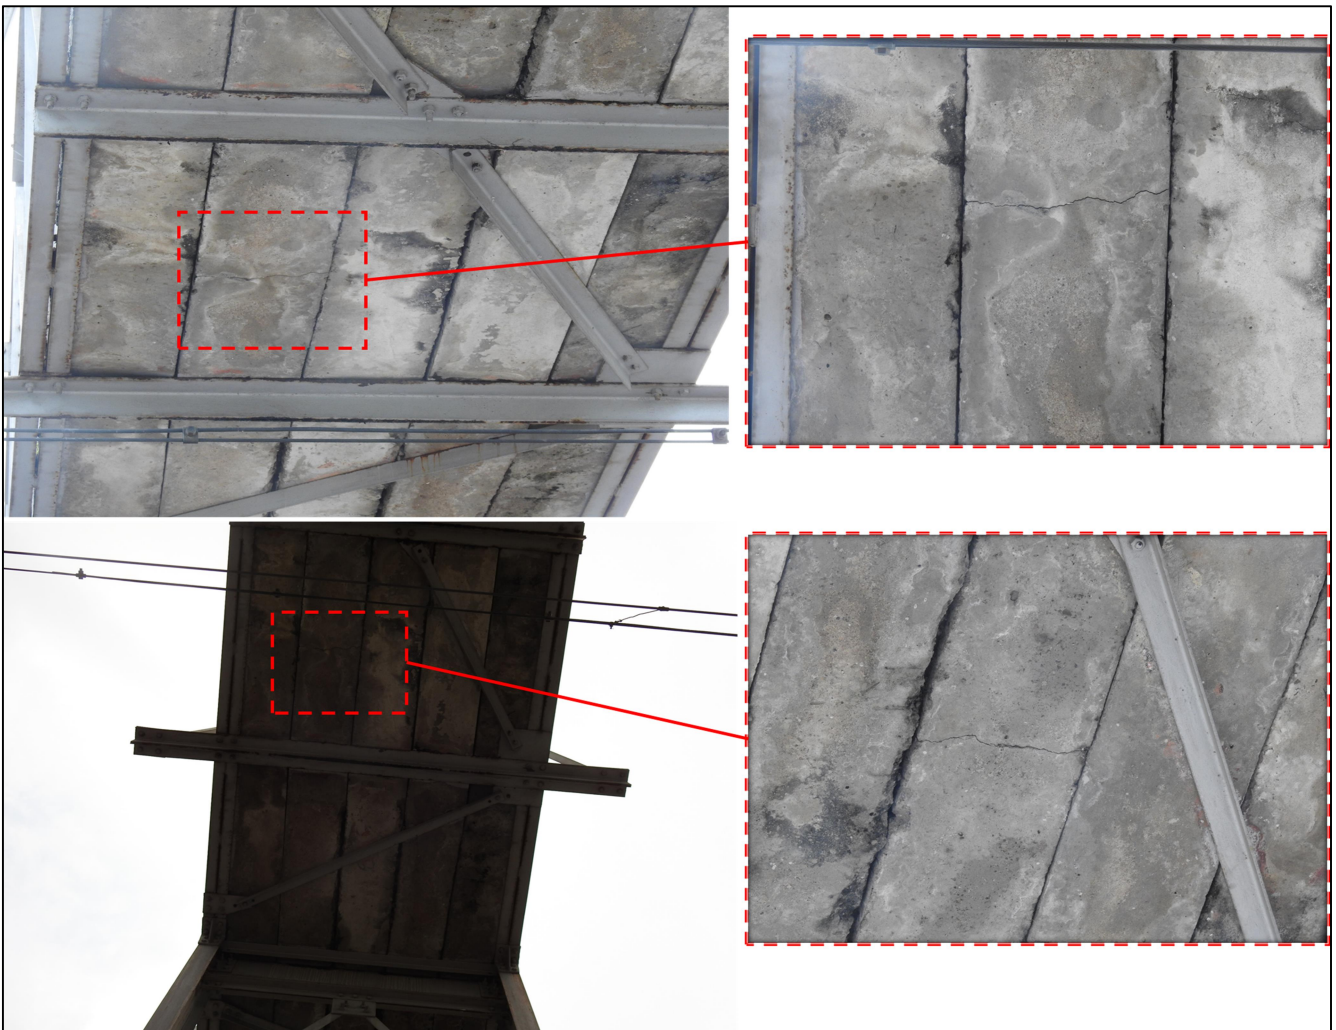
4.2

- ✓ Cracks are observed in Pre cast slab panels in 2<sup>nd</sup> span of FOB

Cracks observed in slab panels

| PART 4 SURVEY OF SIGNS OF DISTRESS, DEFORMATION IN BRIDGES | | | |
|---|---|---|---|
| | Cracking in RCC components | Slab Panels | cracks are observed in Pre-casted RCC slab panels (Refer <i>Part 4- 4.2</i> ) |

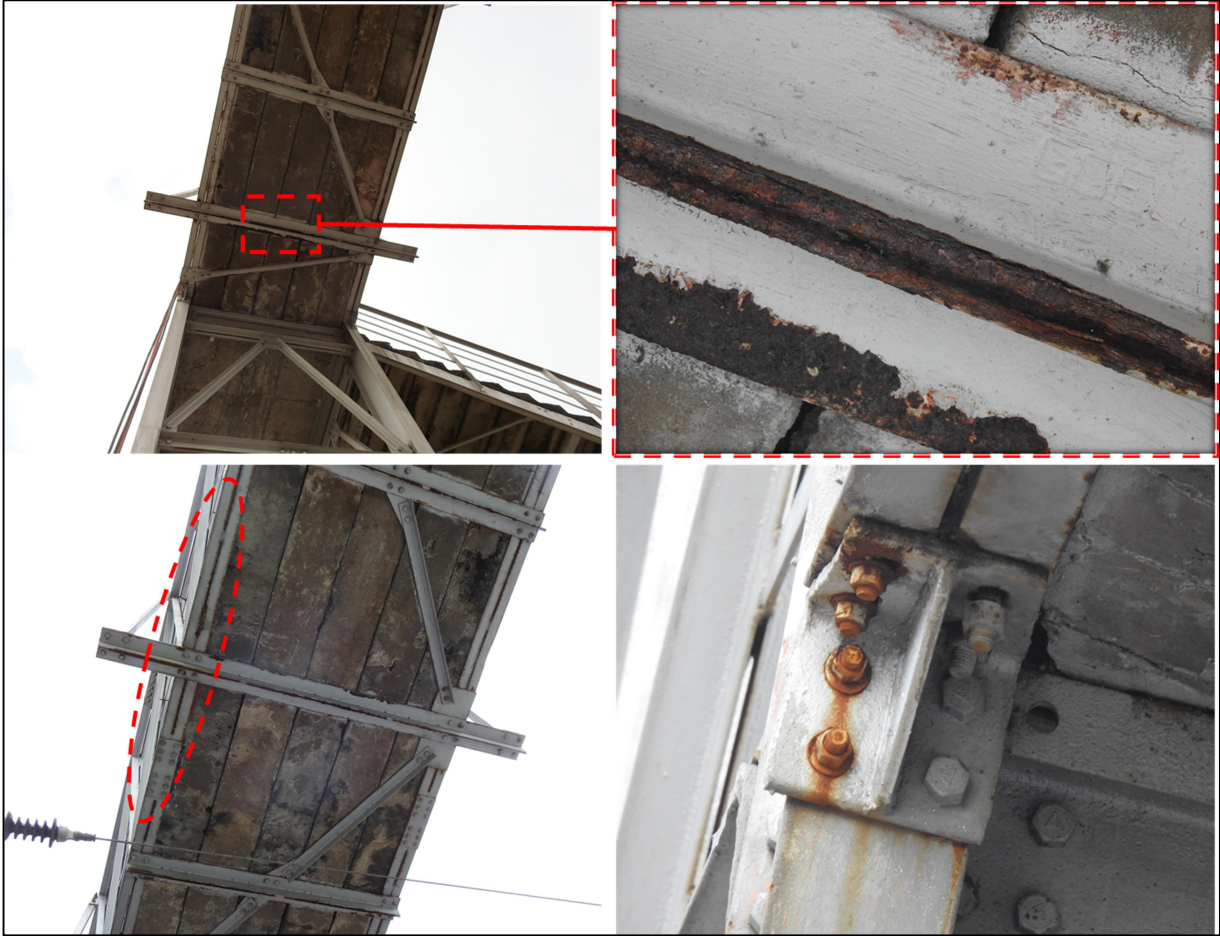
4.3

- ✓ Corrosion is observed in floor beam at 1<sup>st</sup> span of FOB in some locations and Rusting is observed in Double Angular sections and cleat angle at beam column joint.

Corrosion and rusting is observed

| PART 4 SURVEY OF SIGNS OF DISTRESS, DEFORMATION IN BRIDGES | | | |
|---|---|---|---|
| | Rust straining | Double angular sections and cleat angle | Rusting is observed at all the joints of FOB at floor level (Refer <i>Part 4- 4.3</i> ) |
| | Extent Of Corrosion | Secondary girder | Corrosion is observed in floor beam in 1 <sup>st</sup> span of FOB (Refer <i>Part 4- 4.3</i> ) |

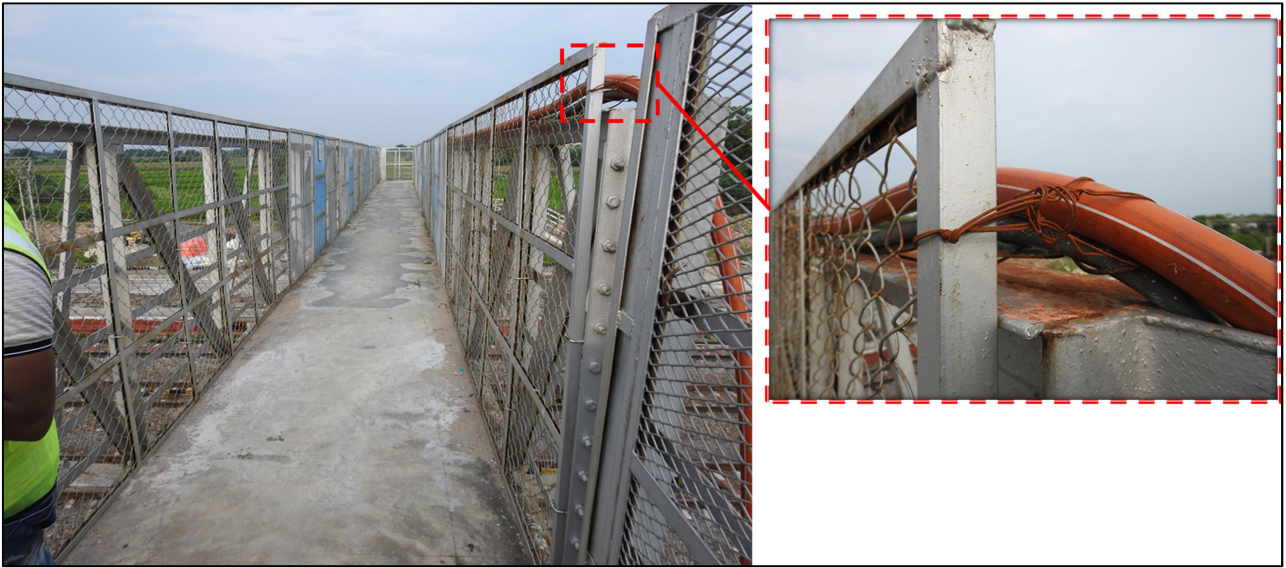
***Fig 1:*** Cables and protective screen

| PART 2 IDENTIFICATION OF LOADS ON BRIDGE | | | |
|---|---|---|---|
| | b) Cables | Yes | Cables are protected with 2-inch and 1-inch HDPE pipe. (Refer <i>fig :1</i> ) |
| | b) Provision of protective screen for passengers | Yes | Chain link fence made of galvanized wire of 2 mm gauge and 2mm galvanized sheet is used above OHE line on both side of gangway is used for protection (Refer <i>fig :1</i> ). |

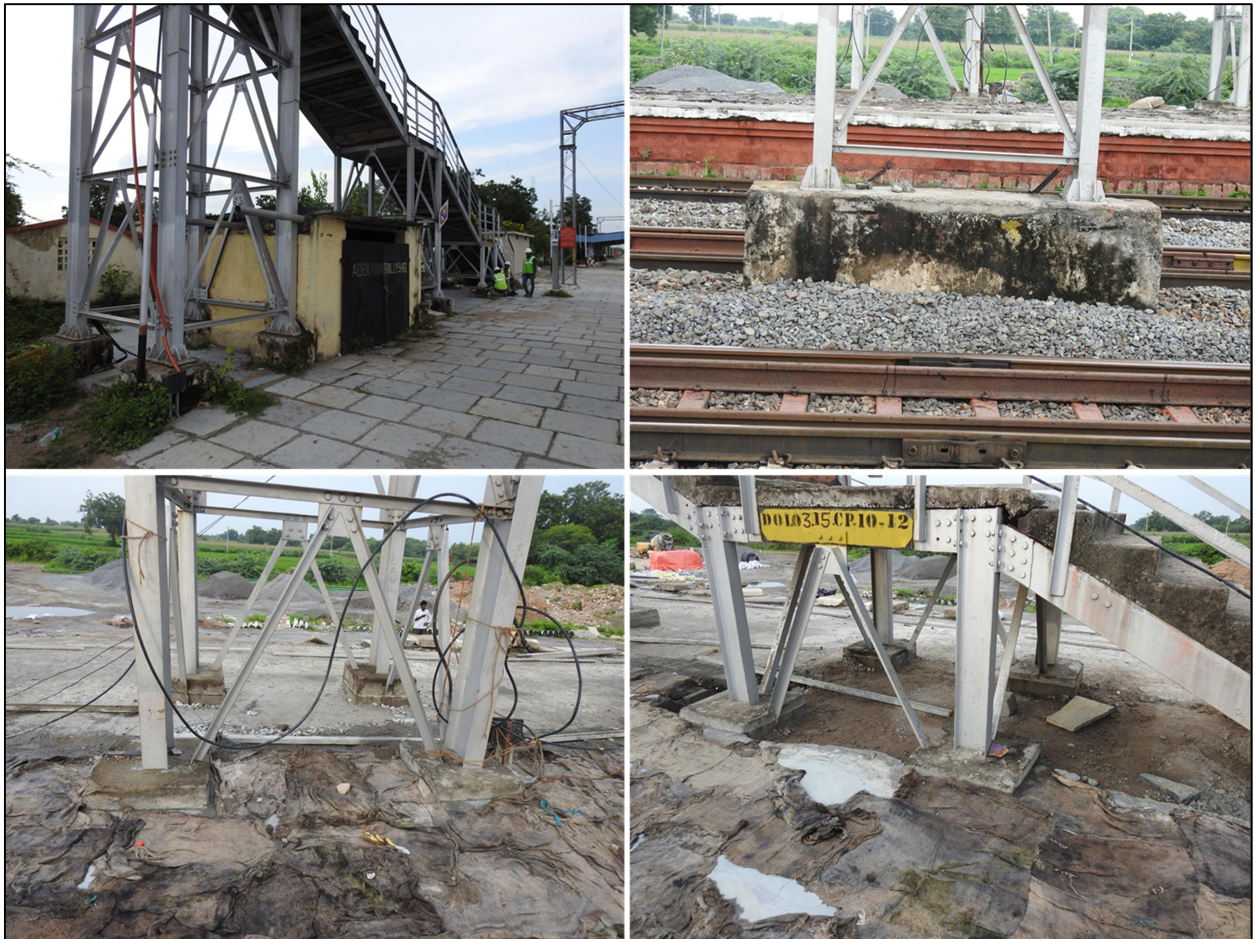
***Fig 2:*** Trestles and Stanchions

| PART 3 STRUCTURAL SYSTEM OF THE BRIDGE | | | |
|---|---|---|---|
| | Type | RCC | a) Column base plate is observed at PF-1 and stanchion in between tracks.<br>b) Concrete encasement is observed below vertical supports only at PF-2. (Refer <i>fig :2 and 3</i> ) |

| | Type/Shape of Column section | I – Section | FOB is supported on vertical column of Four - ISMB 300. (Refer <b>fig :2</b> ) |

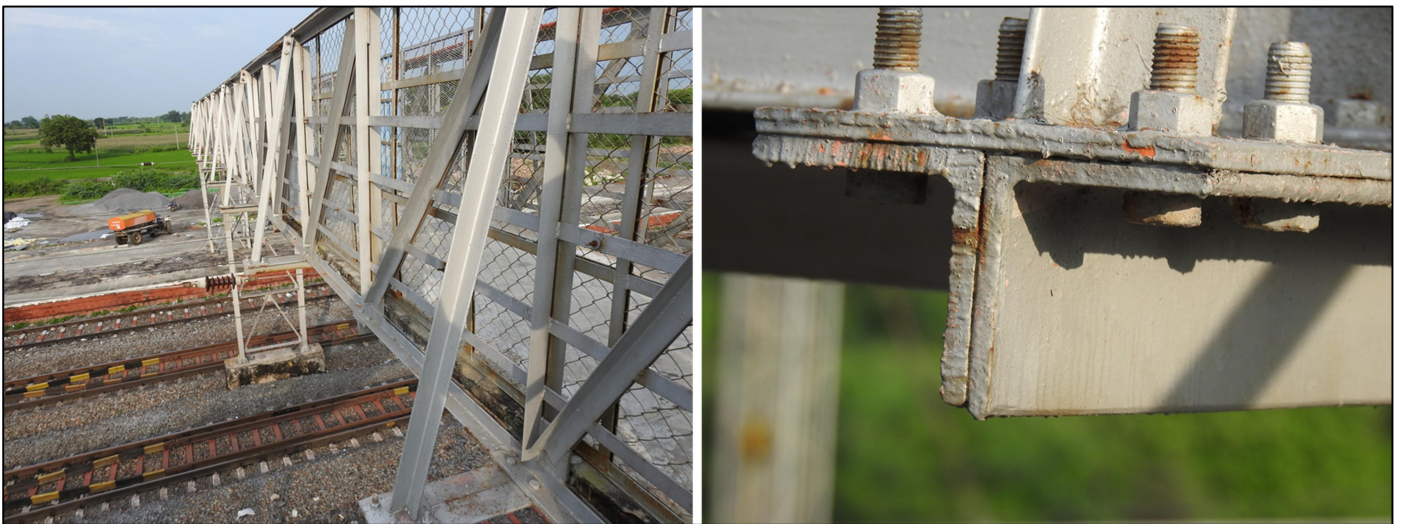
**Fig 4:** Top and bottom main chord, vertical, diagonal and Shape of floor beams

| PART 3 STRUCTURAL SYSTEM OF THE BRIDGE | | | |
|---|---|---|---|
| | Type/Shape of Girder Section | Double angular sections | a. Top and bottom main chord members 75x75x8 mm Double angular section<br>b. 65 x 65 x 8 mm double angular are used as bracing members<br>c. 10 mm thick gusset plate is used for welded joint.<br>d. For 1 <sup>st</sup> and 2 <sup>nd</sup> span 100x100x10 mm Double angular section are connected with |

| | No of Floor beam/bracings for span | 1 <sup>st</sup> span :9 no's<br>2 <sup>nd</sup> span: 7 no's | main chord member using bolts and bracing are connected to tie members using welding (Refer <b>fig :4</b> ) |

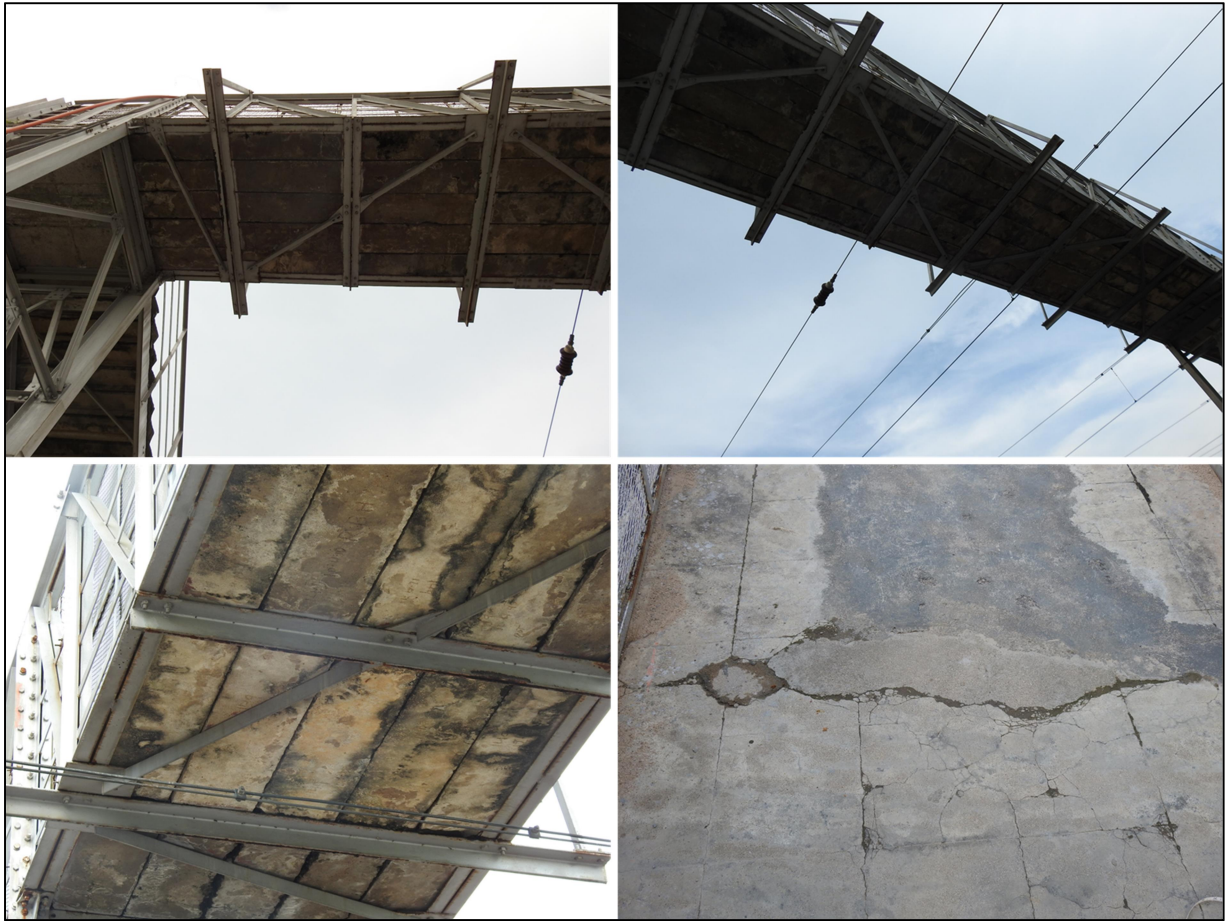
***Fig 5:*** Bottom and top view of FOB

| | Material of Slab | Pre-cast panels | For 1 <sup>st</sup> and 2 <sup>nd</sup> span Pre-cast Reinforced concrete slab panels are used for floor slab of 100 mm thick, RCC slab panels are resting on floor beams. Flooring coat is laid on the top of the slab panels (Refer <b>fig :5</b> ) |
| | Condition of Slab from Top | Patch work is done and cracks are observed on flooring | |

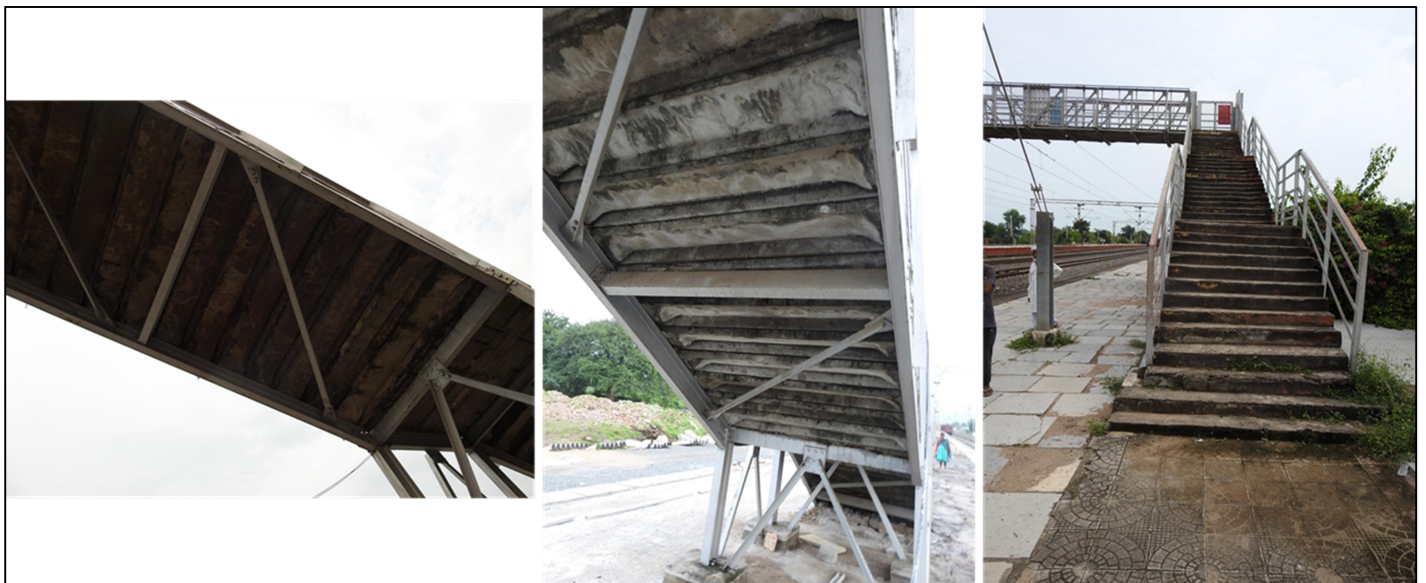
***Fig 6:*** Staircase details

| | Number of staircases | 2 No's | Staircase steps are observed as Precast RCC slab panels of size 300 x 100 mm used. Steps are supported on ISMC 200 channel Stringer beam using cleat angles. Staircase landing of 2.02 m wide is supported on vertical and horizontal channels members. (Refer <b>fig :6</b> ) |
| | Type of Parapet Railing | Steel railing | Staircase is provided with railing on both sides of one-meter height using 65 x 65 x 6 mm angular and 50 x 6 mm M.S flats are used. (Refer <b>fig :6</b> ) |
