| <b>Name of the Project</b> | <b>:</b> | VISUAL INSPECTION OF FOB/ PF-1 - PF-2 AT LAKDIKAPUL RAILWAY STATION |
| <b>Location</b> | <b>:</b> | LAKDIKAPUL RAILWAY STATION |
| <b>Date of Inspection</b> | <b>:</b> | 18 <sup>th</sup> September 2019 |

## FORMAT FOR VISUAL INSPECTION OF STEEL FOOT OVER BRIDGE

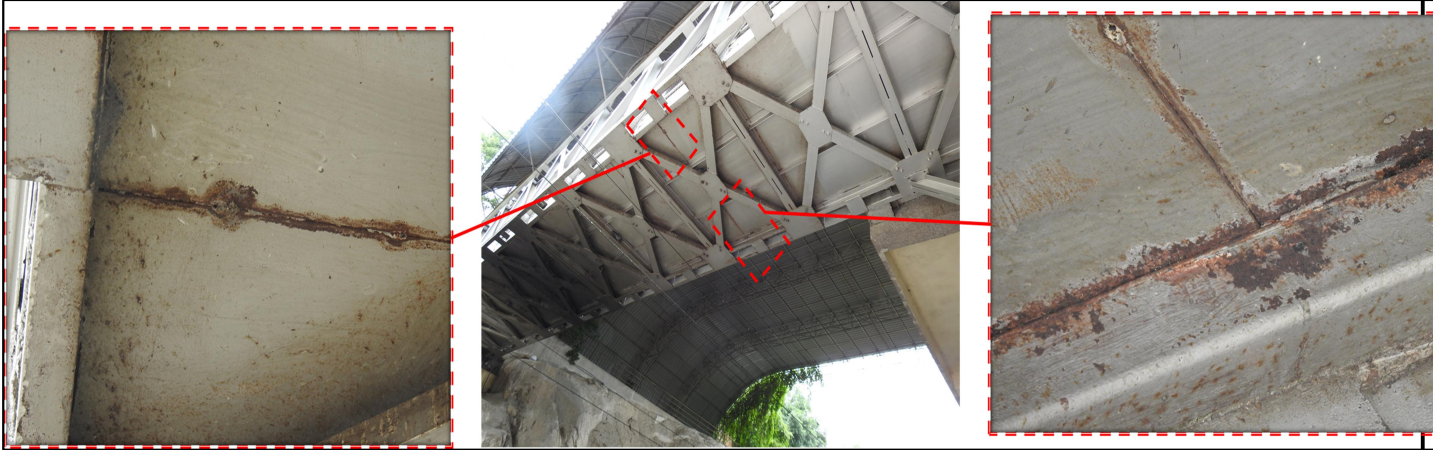
4.1

- a) From visual inspection, slight rusting is observed at bottom of sacrificial plate.
- b) Mild Corrosion is observed at Trestles (Double channel section) on PF-2.

- ✓ Slight corrosion is observed between two sacrificial plate joints

Corrosion observed at sacrificial plates

| PART 4 SURVEY OF SIGNS OF DISTRESS, DEFORMATION IN BRIDGES | | | |
|---|---|---|---|
| | Rust straining | Sacrificial plate | Rusting is observed at bottom of FOB (Refer <b>Part 4- 4.1</b> ) |

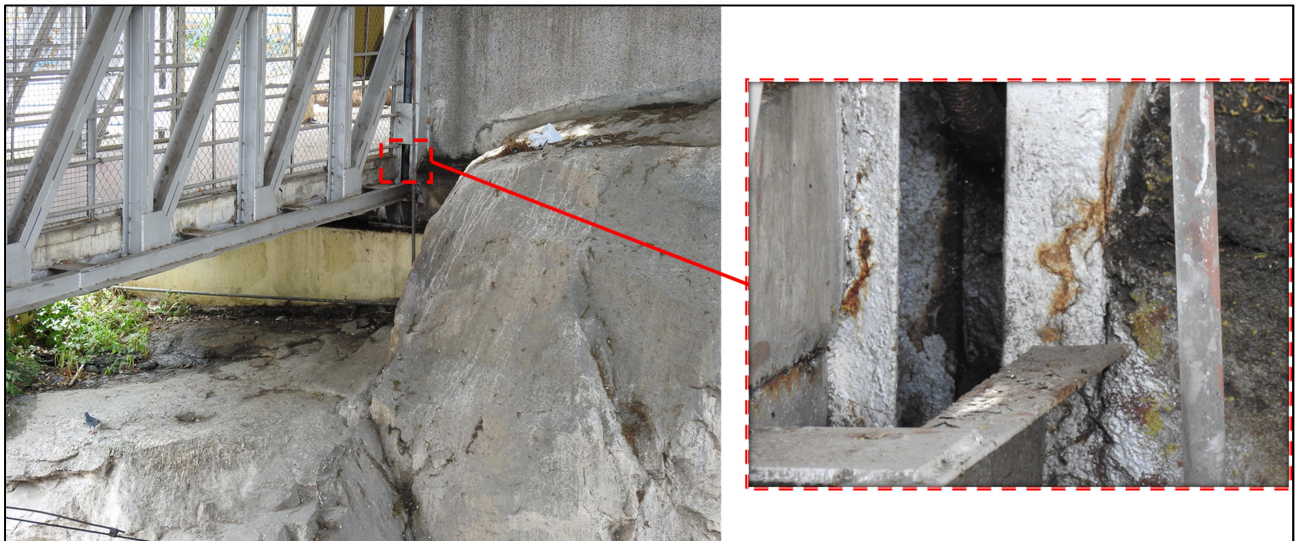
4.2

- ✓ Mild Corrosion is observed at Trestles (Double channel section) at PF-2

Corrosion observed in Double channel section

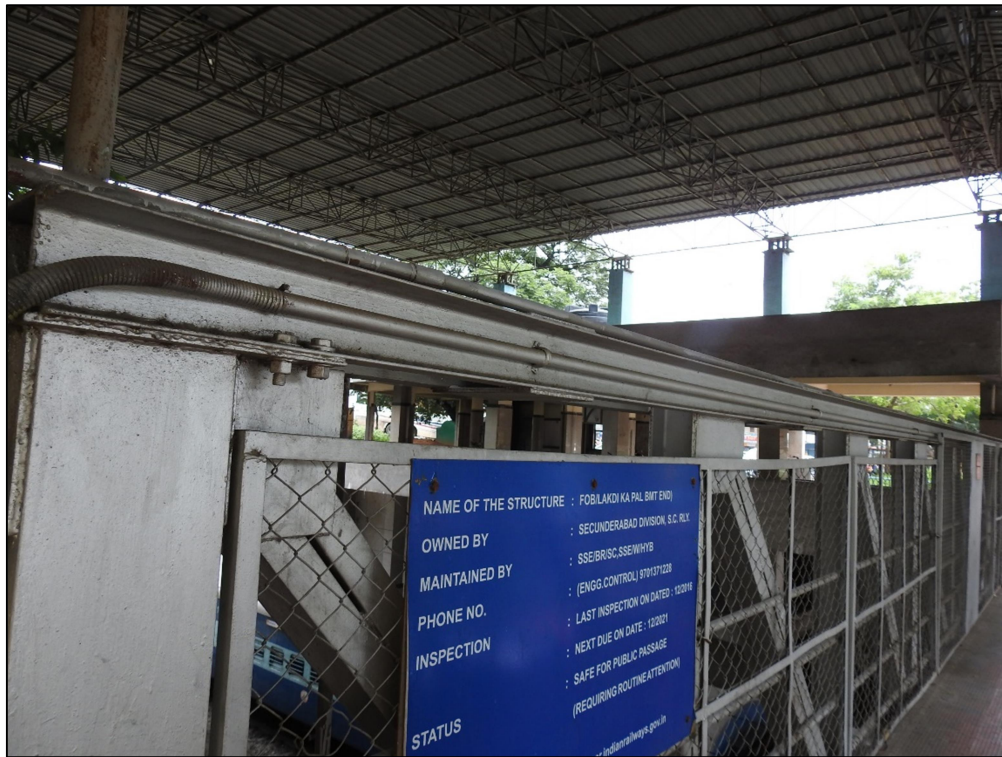
| PART 2 IDENTIFICATION OF LOADS ON BRIDGE | | | |
|---|---|---|---|
| | b) Provision of protective screen for passengers | Yes | Chain link fence made of Galvanized wire of 2 mm gauge and 2 mm Galvanized sheet is used above OHE Line on both side of pathway is used for Protection. Mesh frame is supported with angular and MS flats. (Refer <i>fig :1</i> ) |

**Fig 1:** Electrical Cables and Protective screening mesh for passengers

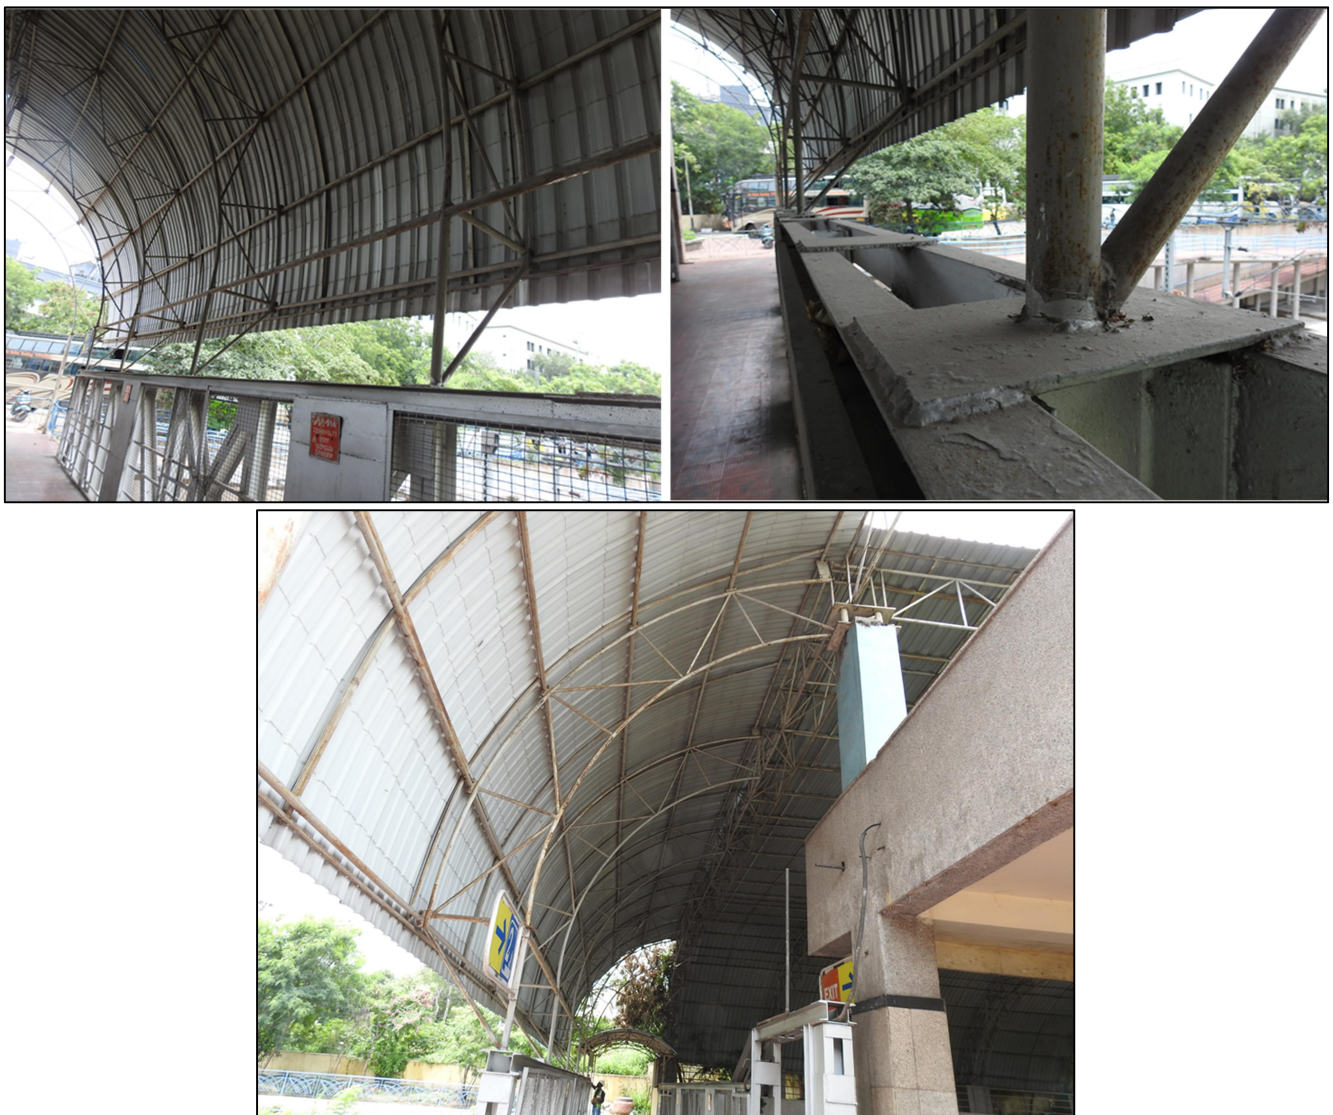
| PART 2 IDENTIFICATION OF LOADS ON BRIDGE | | | |
|---|---|---|---|
| | d) Roof Sheet | Yes | Steel Metal Sheet is used for Roof (Refer <i>fig :2</i> ) |

| PART 3 STRUCTURAL SYSTEM OF THE BRIDGE | | | |
|---|---|---|---|
| | Element of roof truss section | circular truss supported with hollow pipes | 2-inch tubular truss with plate welded to top chord members on one side. (Refer <i>fig :2</i> ) |

**Fig 2:** Roof Sheet and Roof truss

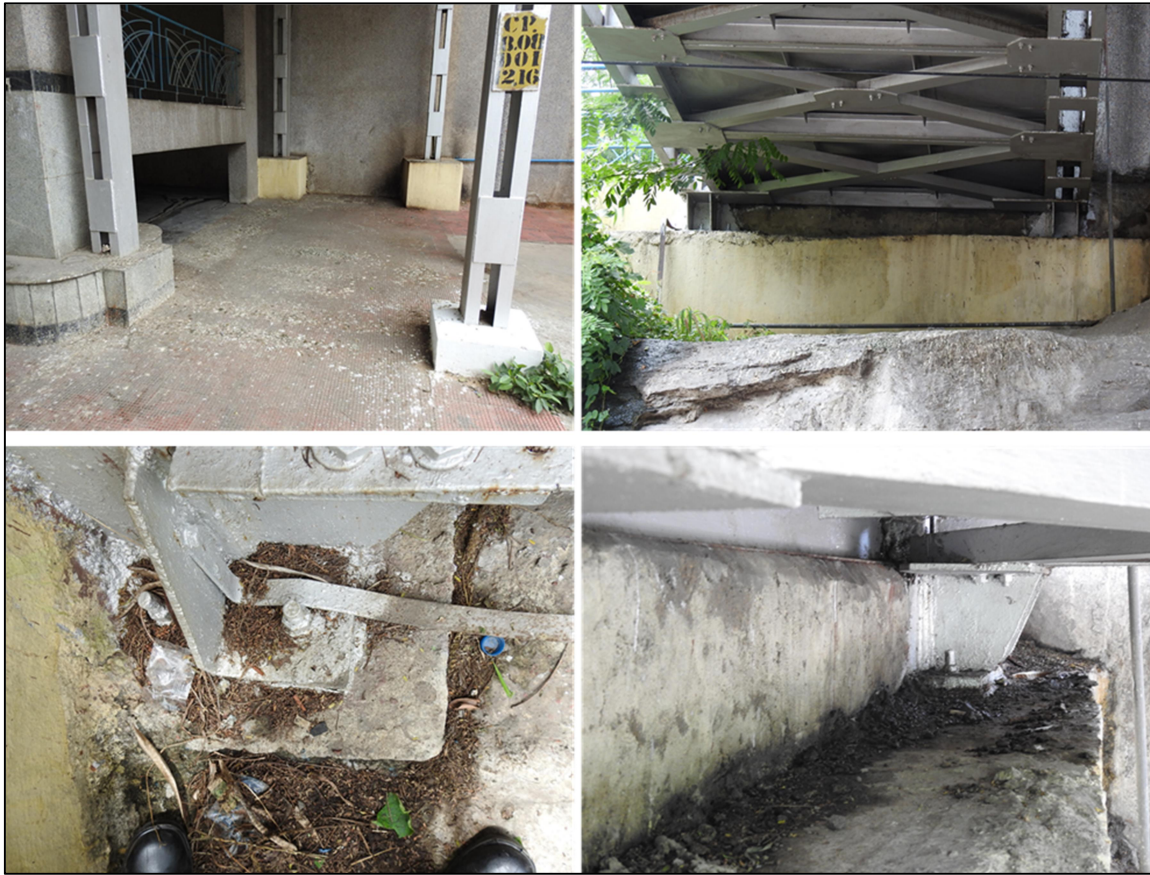
| PART 3 STRUCTURAL SYSTEM OF THE BRIDGE | | | |
|---|---|---|---|
| | Type of Pedestal | Concrete | Concrete encasement is observed below vertical supports (Refer <i>fig :3</i> ) |

| | Type/Shape of Column section | Channel Section | a. Truss supported on ISMC 250 double channel section<br>b. Supported with angular bracings of 90x 90 x 8 mm<br>c. 10 mm thick gusset plate is used.<br>(Refer <b>fig :3</b> ) |

**Fig 3:** Trestles and their protection with concrete encasement

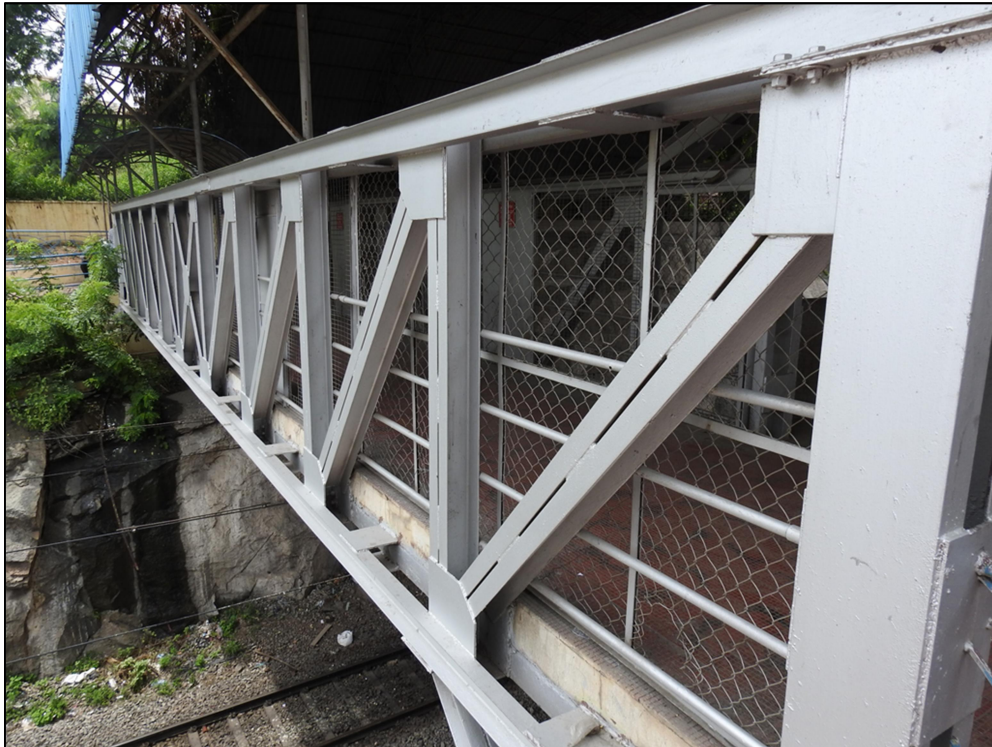
| PART 3 STRUCTURAL SYSTEM OF THE BRIDGE | | | |
|---|---|---|---|
| | Shape of Truss Section | N- type truss, Double Channel sections | a. Top and bottom Chord members are ISMC 150 double channel section back to back |
| | Height of Truss (H) | 1.85 m | b. Diagonal bracings and vertical bracings of ISMC 150 Double channel section. |

| | Girder/Truss Support Condition | Ridged connection | c. Secondary Girders are ISMC 150 Double channel section.<br>(Refer <b>fig :4</b> ) |

**Fig 4:** Top and bottom main chord members with vertical and diagonal bracings

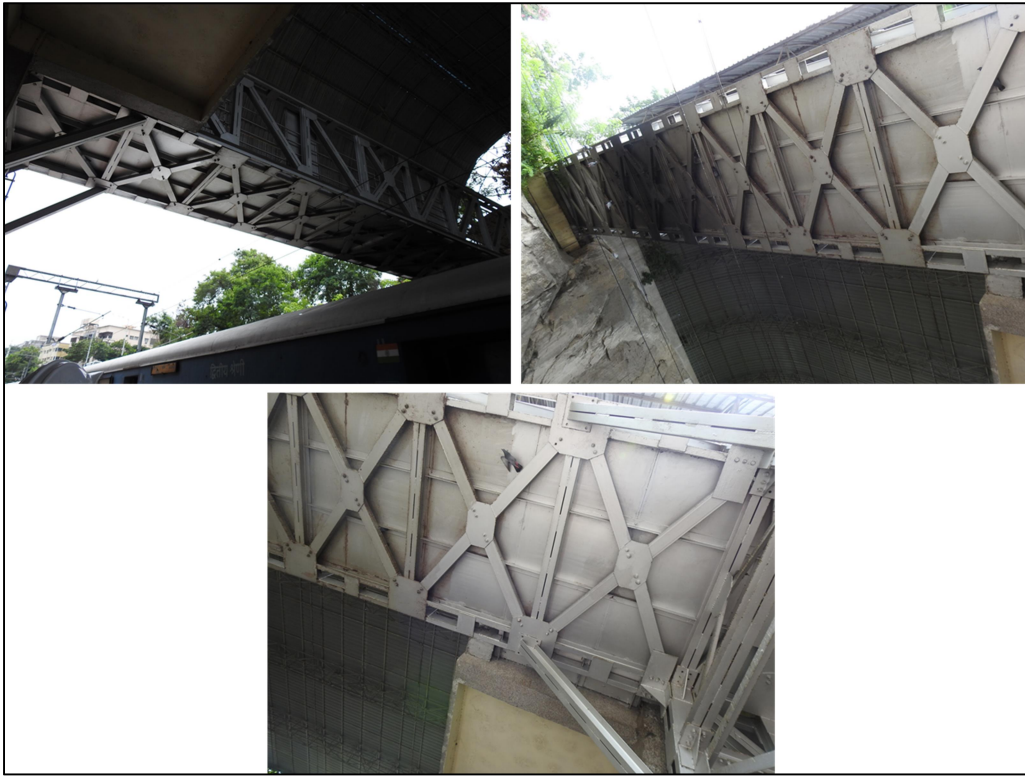
| | Material of Slab | RCC | a. RCC slab casted in site supported on sacrificial plate.<br>b. Chequered tiles of 25 mm thick are observed on FOB.<br>c. RCC slab is supported by secondary girders of ISMC150<br>(Refer <b>fig :5</b> ) |

**Fig 5:** Slab is supported with sacrificial plate

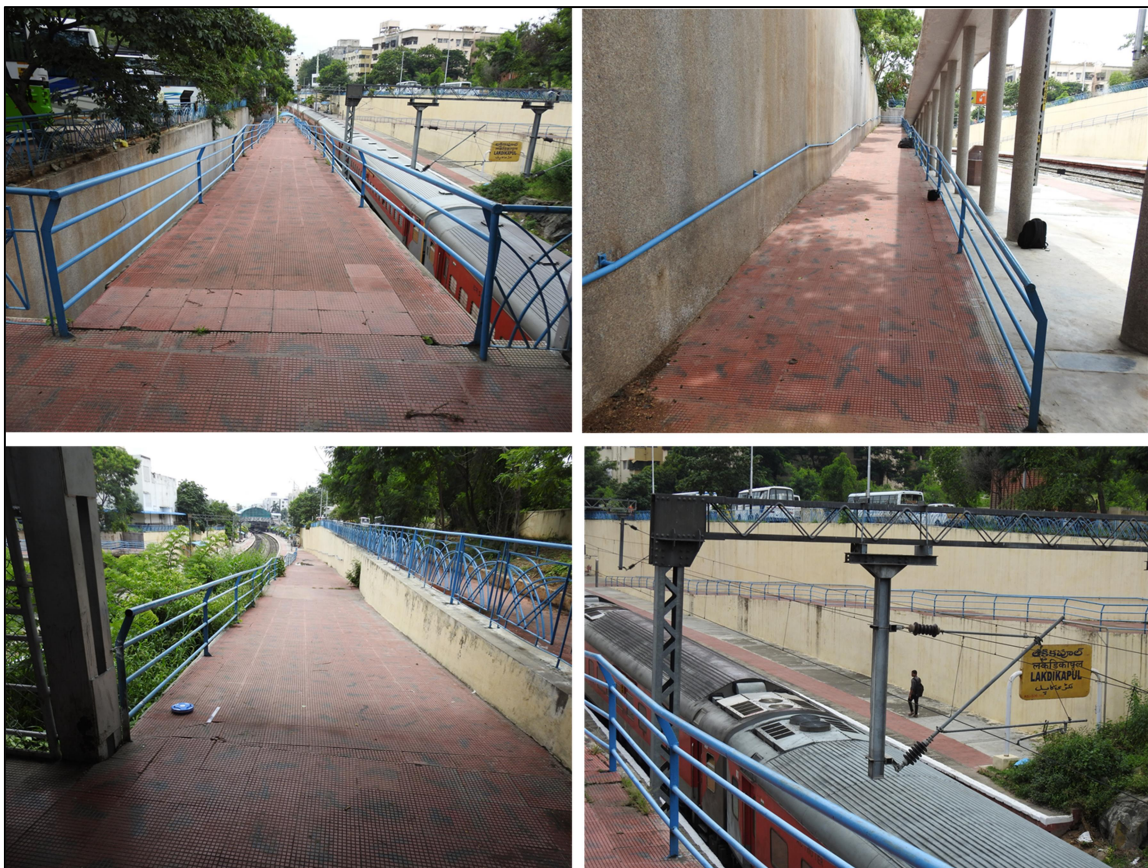
| | Width of ramp | 2.3 m | Ramp is supported on RCC columns for a length of 49.54 m at PF-1 and 60 m on rock at PF-2 (Refer <b>fig :6</b> ) |
| | Type of Parapet Railing | Steel railing | Stair case is provided with Railing on both sides of one-meter height using Hollow Circular sections. (Refer <b>fig :6</b> ) |

**Fig 6:** Ramp on PF-1 and PF-2
