| <b>Name of the Project</b> | <b>:</b> | VISUAL INSPECTION OF FOB/ PF-1 - PF-2 AT SIRPUR TOWN RAILWAY STATION |
| <b>Location</b> | <b>:</b> | SIRPUR TOWN RAILWAY STATION |
| <b>Date of Inspection</b> | <b>:</b> | 23 <sup>rd</sup> September 2019 |

## FORMAT FOR VISUAL INSPECTION (VI) OF STEEL FOOT OVER BRIDGE

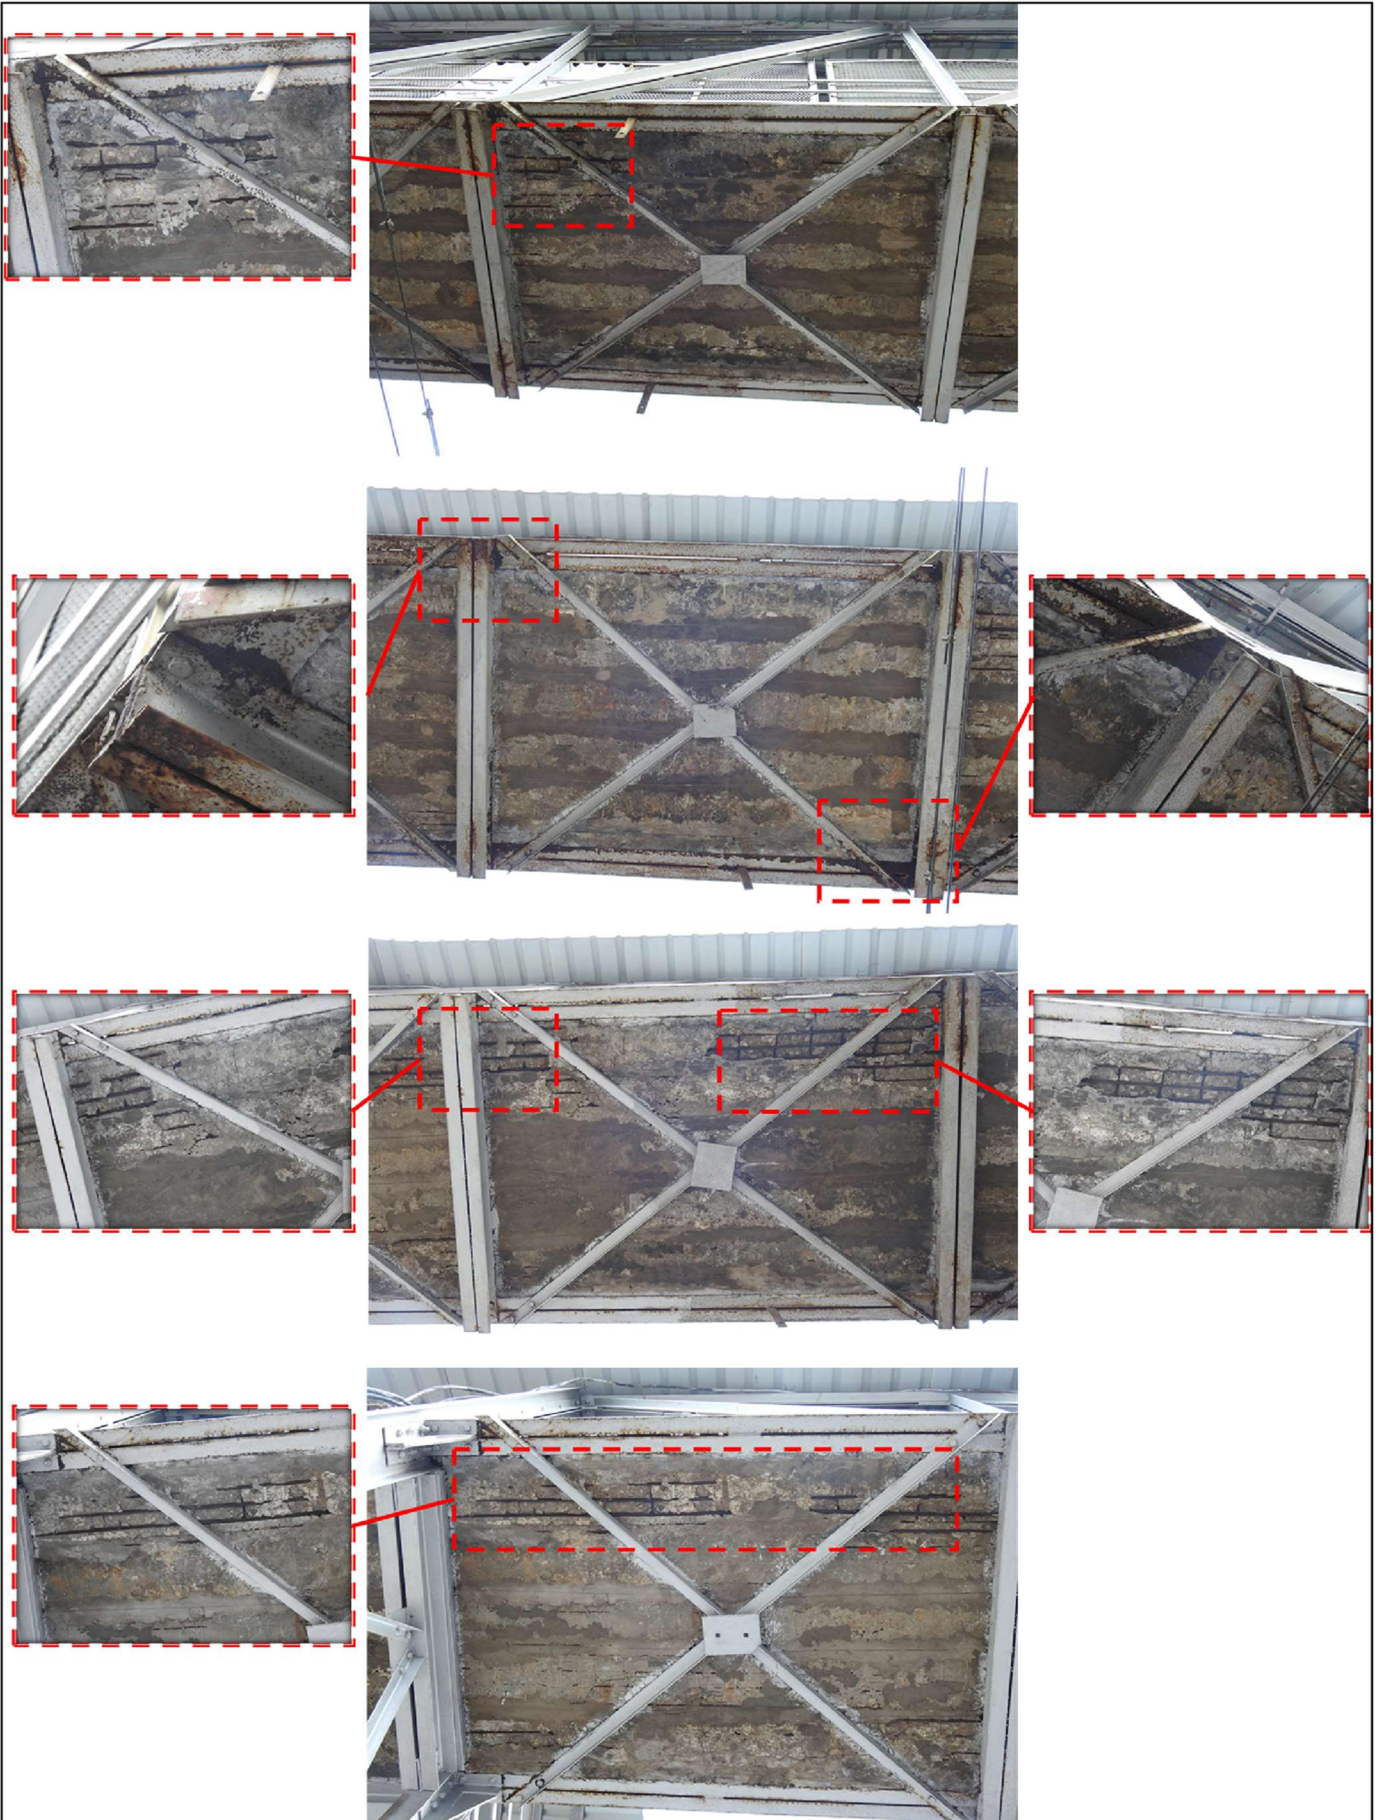
4.1 ✓ Reinforcement exposure of RCC slab panels and corrosion observed along the span of FOB

## Reinforcement exposure and corrosion

| PART 4 SURVEY OF SIGNS OF DISTRESS, DEFORMATION IN BRIDGES | | | |
|---|---|---|---|
| | Spalling | Bottom of RCC slab panels and bottom slab panels of staircase | Major spalling and exposed reinforcement is observed at the bottom of slab panels of staircase and pathway. (Refer <b>Part 4 - 4.1 and fig: 4</b> ) |

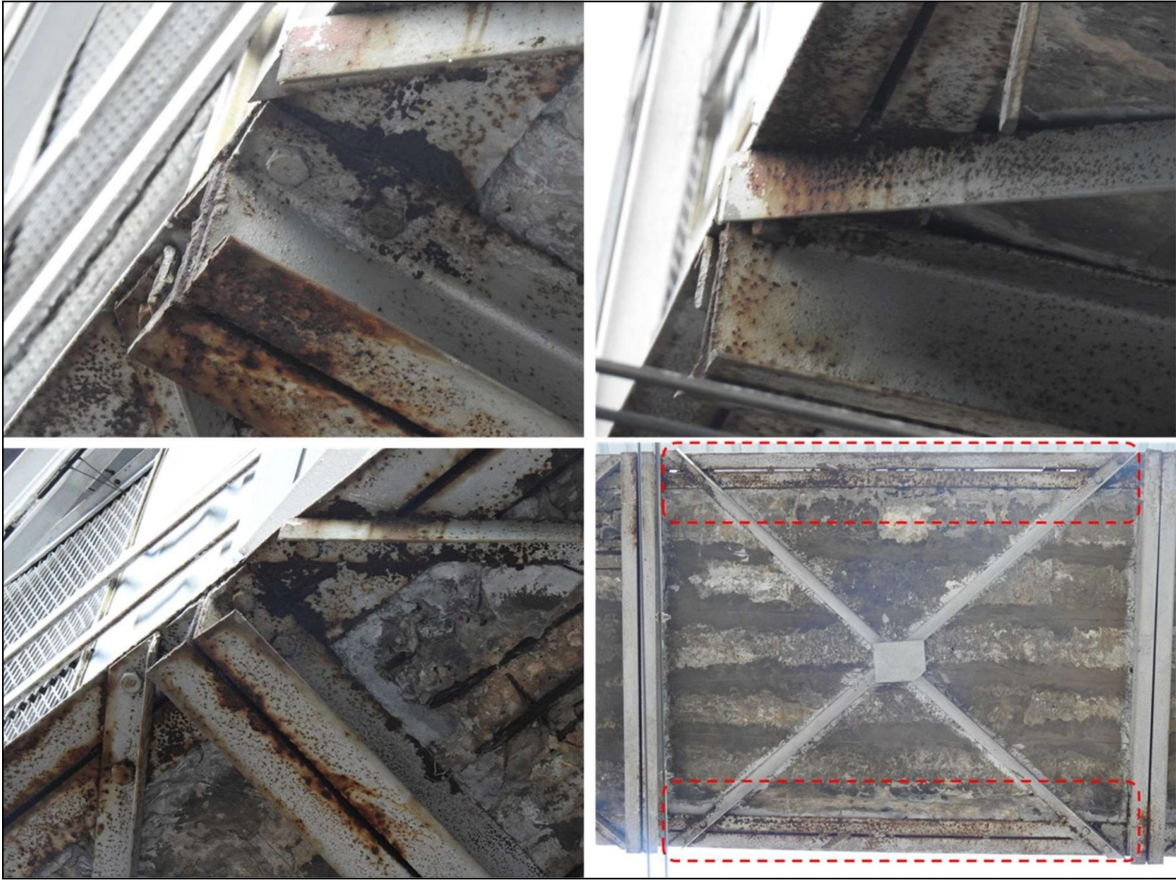
4.2

- ✓ Corrosion is observed in joints of Floor beams and bottom main chord member and slight rusting is observed at bottom of main bottom double angle sections along the length of FOB

Corrosion observed in Floor beams joints

| PART 4 SURVEY OF SIGNS OF DISTRESS, DEFORMATION IN BRIDGES | | | |
|---|---|---|---|
| | Rust straining | Bottom main chord members | Rusting is observed at all over the bottom chord members of FOB. (Refer <b>Part 4 - 4.2</b> ) |
| | Extent Of Corrosion | Gusset plate connecting Floor beams and bottom main chord member | a. Spacers in between Floor beams are distressed.<br>b. Major corrosion is observed at gusset plate connecting Floor beams and bottom chord (Refer <b>Part 4 - 4.2</b> ) |

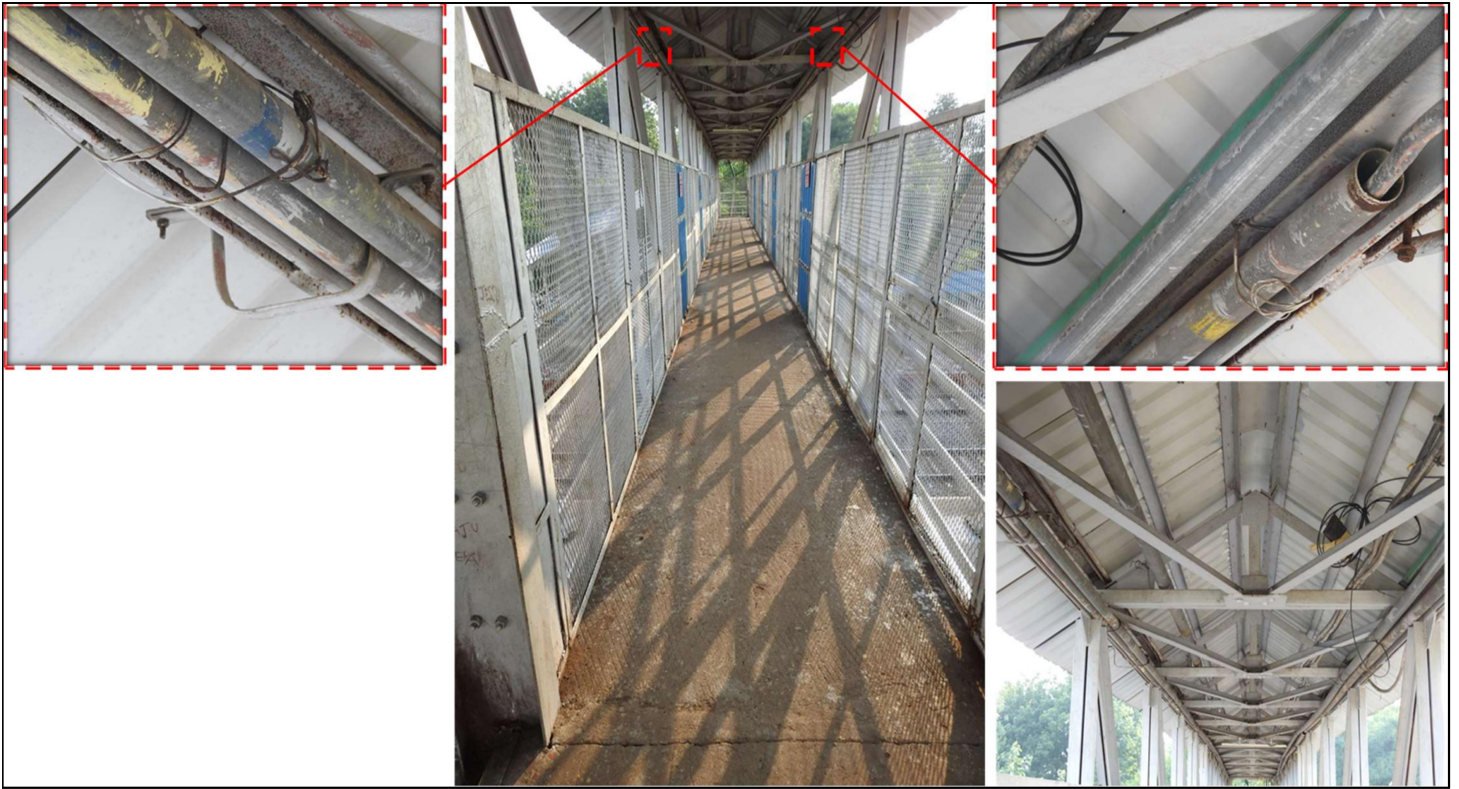
| PART 2 IDENTIFICATION OF LOADS ON BRIDGE | | | |
|---|---|---|---|
| | b) Cables | Yes | Cables are protected with 1-inch HDPE pipe and five 2-inch Galvanized pipes (Refer <i>fig :1</i> ) |
| | c) Roof Truss | Yes | King post truss with 65 x 65 x 6 mm angles are used (Refer <i>fig: 1</i> ). |
| | d) Roof Sheet | Yes | Metal sheet is used for roof (Refer <i>fig: 1</i> ). |
| | b) Provision of protective screen for passengers | Yes | Chain link fence made of galvanized wire of 2 mm gauge and 2mm galvanized sheet is used above OHE line on both side of gangway is used for protection. (Refer <i>fig :1</i> ) |

| PART 3 STRUCTURAL SYSTEM OF THE BRIDGE | | | |
|---|---|---|---|
| 3.3 | Element of roof truss section | Angle sections | Roof truss is made with 65 x 65 x 6 mm angles and supported on 80 x 80 x 8 mm main top chord members. (Refer <i>fig :1</i> ) |

**Fig 1:** Cables, Roof truss, Flooring and Protective screen

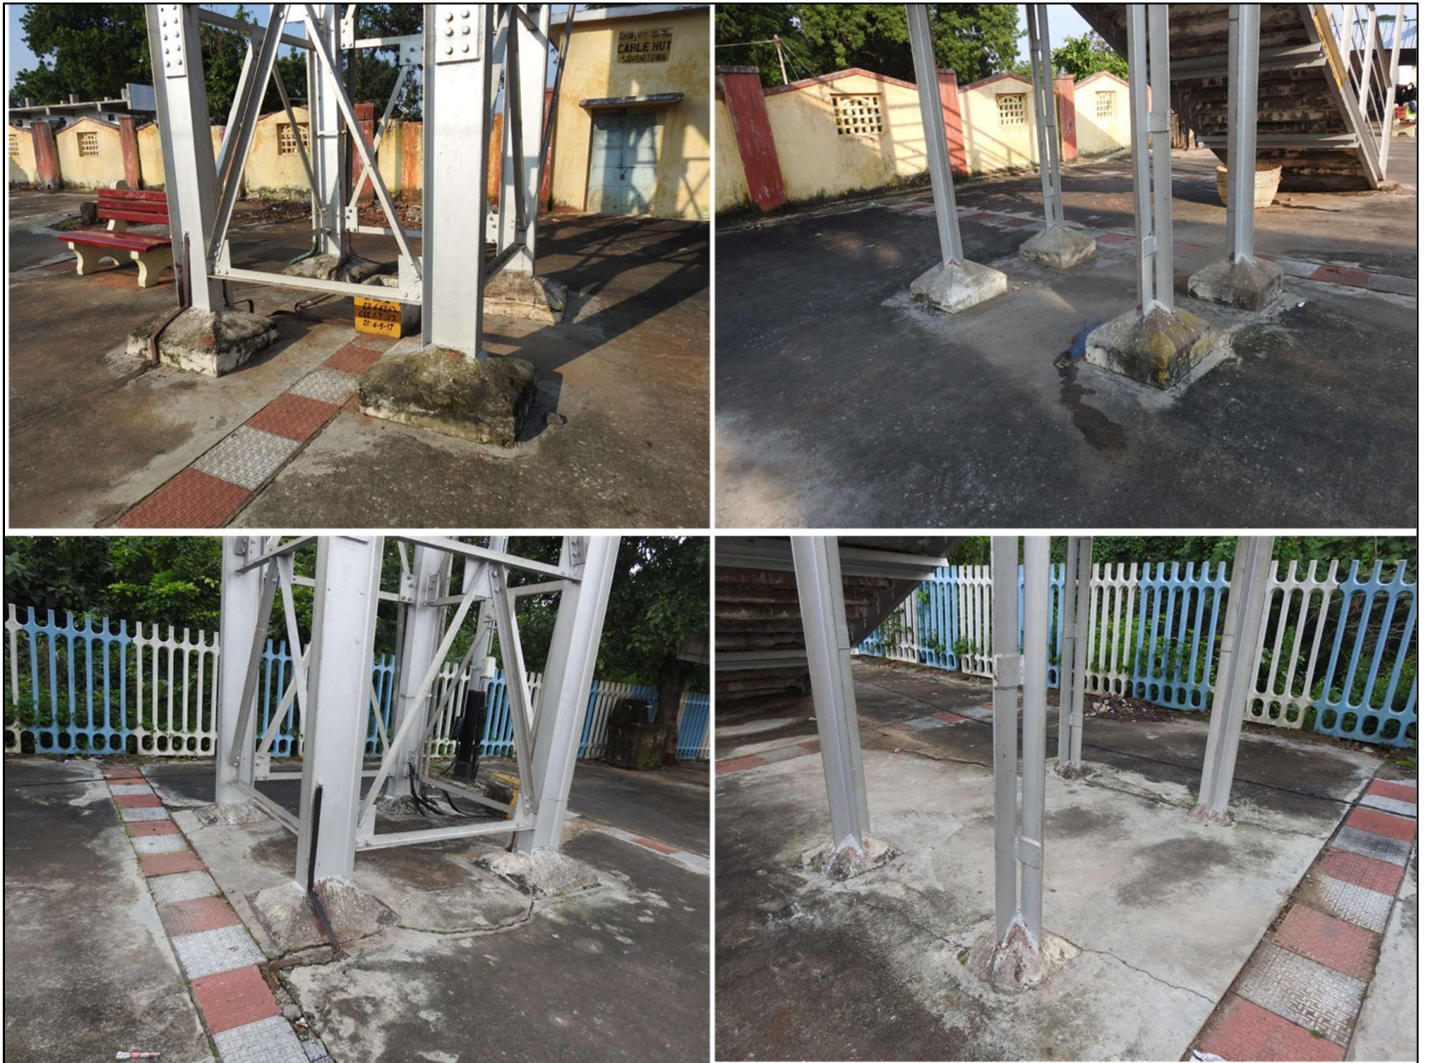
| PART 3 STRUCTURAL SYSTEM OF THE BRIDGE | | | |
|---|---|---|---|
| | No of Bolts and size | Not visible, filled with concrete | Trapezoidal Concrete encasement is observed at vertical supports bottom (Refer <i>fig :2</i> ) |

| | BEAM-Column joint (bolted, welded, riveted) | Bolted | FOB is supported on vertical column of Four - ISMB 300. (Refer <b>fig :2</b> ) |

**Fig 2:** Trestles details

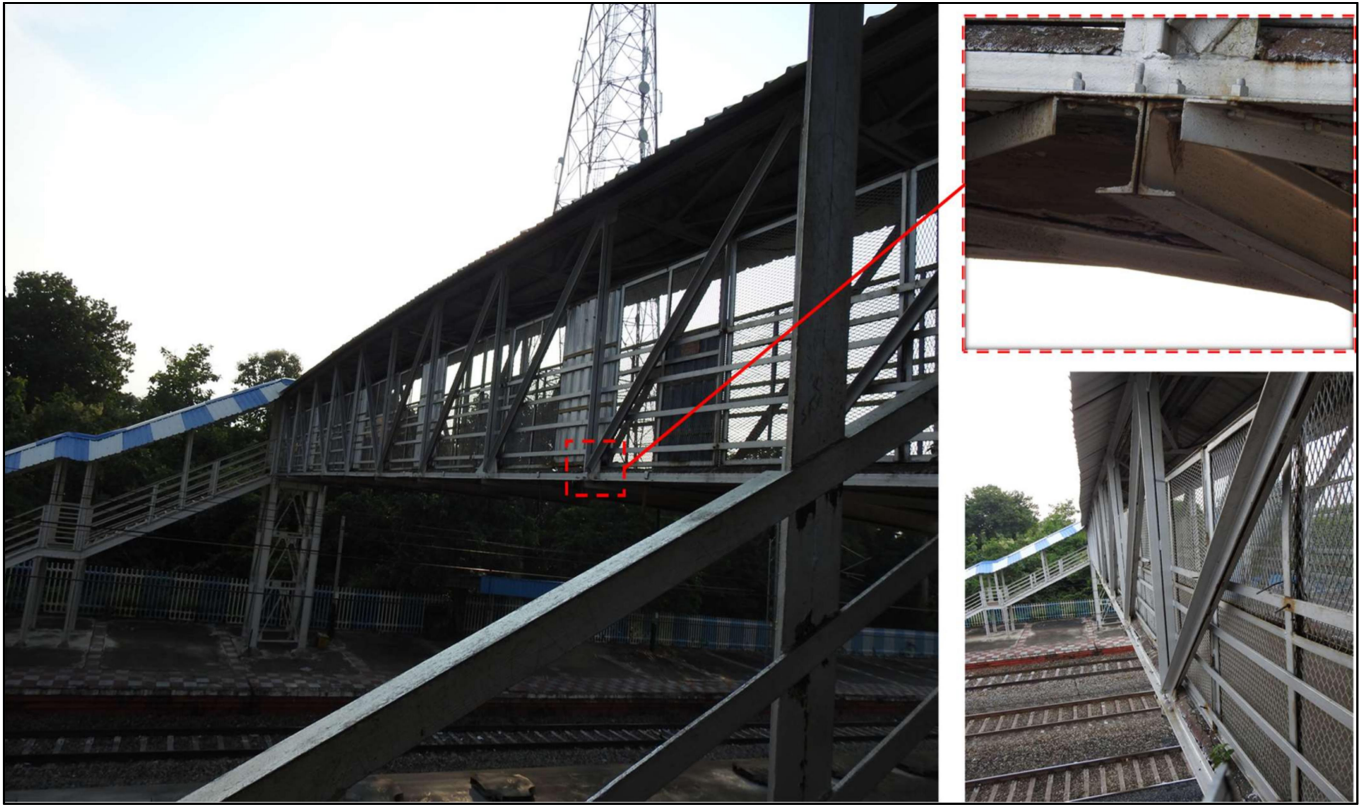
| | Type/Shape of Floor beams /Bracings | Double Channel sections and angle sections | c. 10 mm thick gusset plate is used for welded joint.<br>d. Two ISMC 150 Channels are used as Floor beams<br><br>(Refer <b>fig :3</b> ) |

**Fig 3:** Top and bottom chord members, bracings and Floor beams

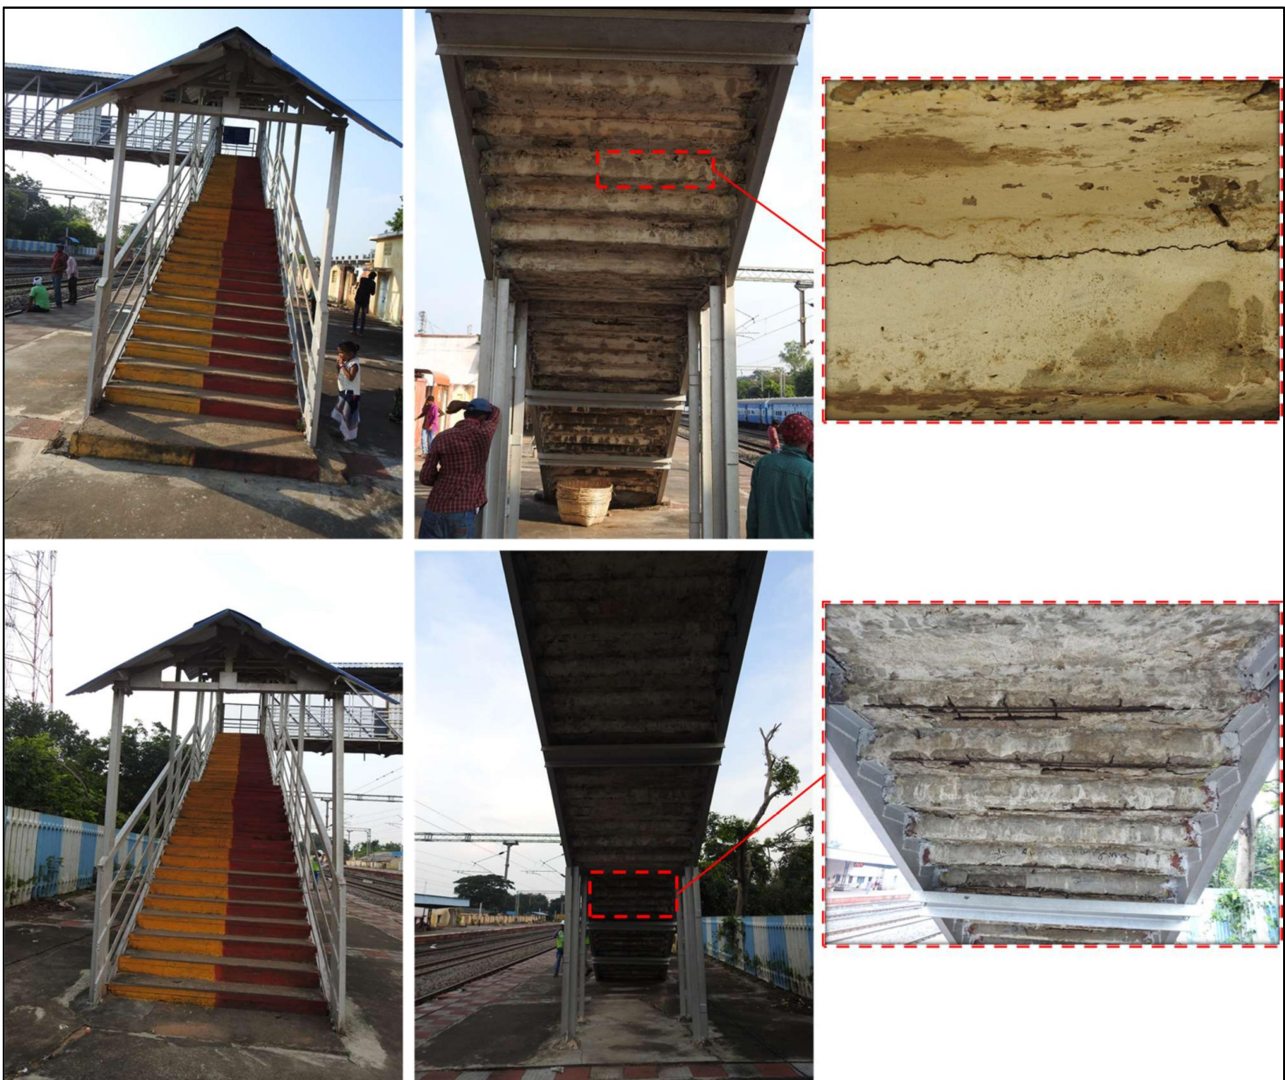
| | Material used for steps | RCC slab panels | Staircase steps are observed as RCC slab panels of size 300 x 100 mm used. Steps are on ISMC 250 channel Stringer beam using cleat angle. Staircase landing of 1.8 m wide is supported on vertical and horizontal channels members. Roof of staircase is made with 75 x 75x 6 mm double angle sections.<br>(Refer <b>fig :4</b> ) |
| | Height of Railing | 1 m | Staircase is provided with railing on both sides of one-meter height using 65 x 65 x 6 mm angle sections and 50 x 6 mm M.S flats are used.<br>(Refer <b>fig :4</b> ) |

| PART 4 SURVEY OF SIGNS OF DISTRESS, DEFORMATION IN BRIDGES | | | |
|---|---|---|---|
| | Cracking in RCC components | | cracks are observed in bottom of staircase slabs (Refer <b>fig: 4</b> ) |

**Fig 4:** Staircase details, cracks and reinforcement exposure
