| Name of the Project | : | VISUAL INSPECTION OF FOB/ PF-1 - PF-2 AT MAHABUBABAD RAILWAY STATION |
| Location | : | MAHABUBABAD RAILWAY STATION |
| Date of Inspection | : | 24 <sup>th</sup> SEPTEMBER, 2019 |

## FORMAT FOR VISUAL INSPECTION OF STEEL FOOT OVER BRIDGE

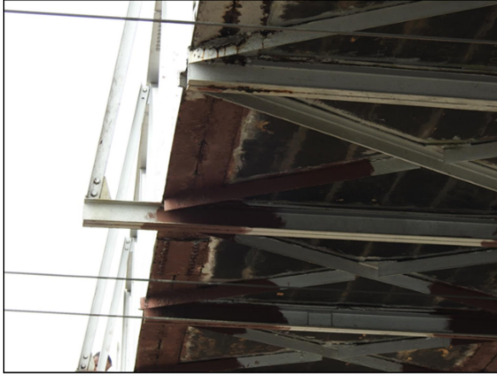
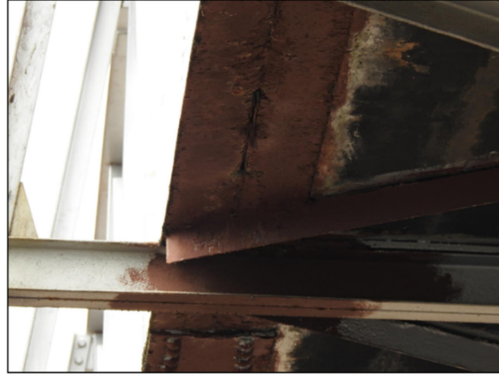
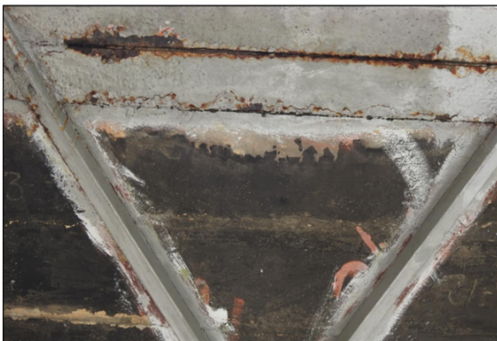
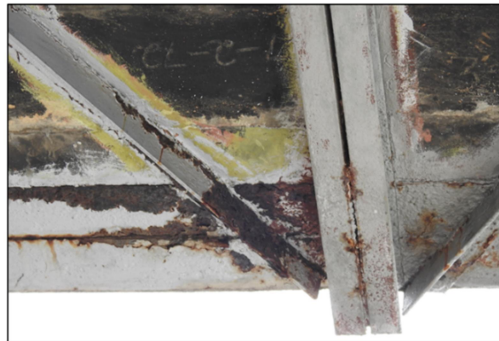
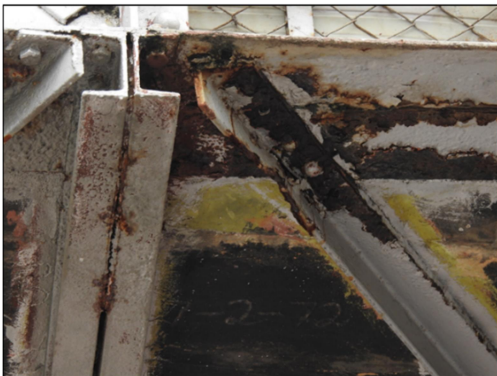
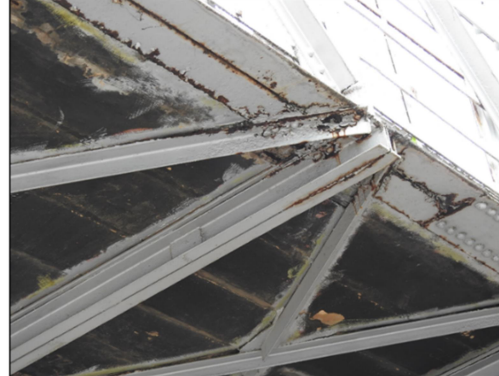
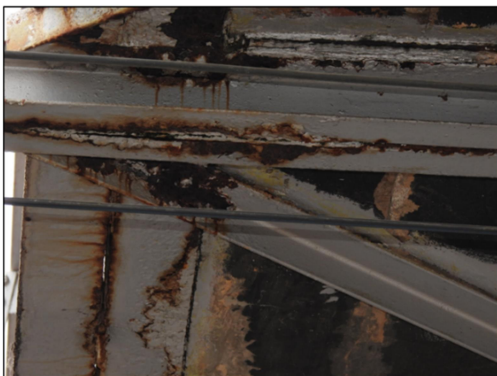
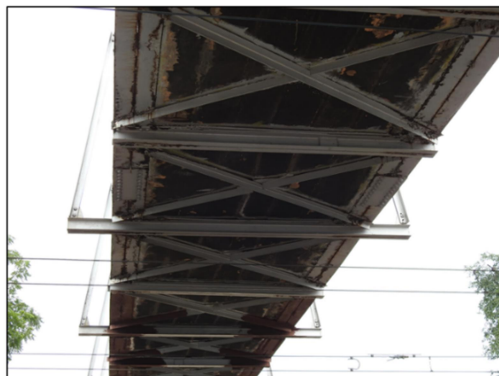
- ✓ Severe corrosion is observed at joints below slab (Gusset plate, Angle sections)

| PART 4 SURVEY OF SIGNS OF DISTRESS, DEFORMATION IN BRIDGES | | | |
|---|---|---|---|
| | Corrosion in Gusset plate | Floor level | corrosion is observed in Gusset plates |
| | Corrosion at steel-Concrete joint | | Major corrosion is observed at steel concrete joint along length of FOB |

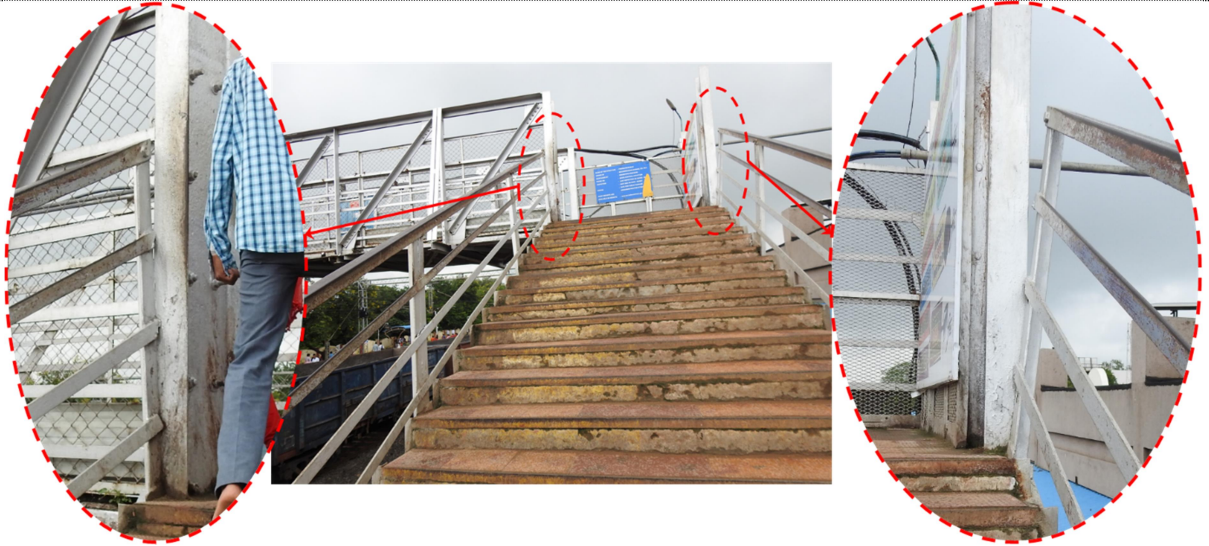
| | Type of Parapet Railing | Steel Railing | a) Stair case is provided with Railing on both sides of one-meter height using one Angle section of 65 x 65 x 8 mm and three Flats 50 x 12 mm.<br>b) On Platform 1 Staircase Railing connection with column member has been lost and bent outward of the column member. |

- ✓ On Platform 1 Staircase Railing connection is missing on 2<sup>nd</sup> Flight tilting is observed towards outside on both sides of staircase Railing as shown in figure.

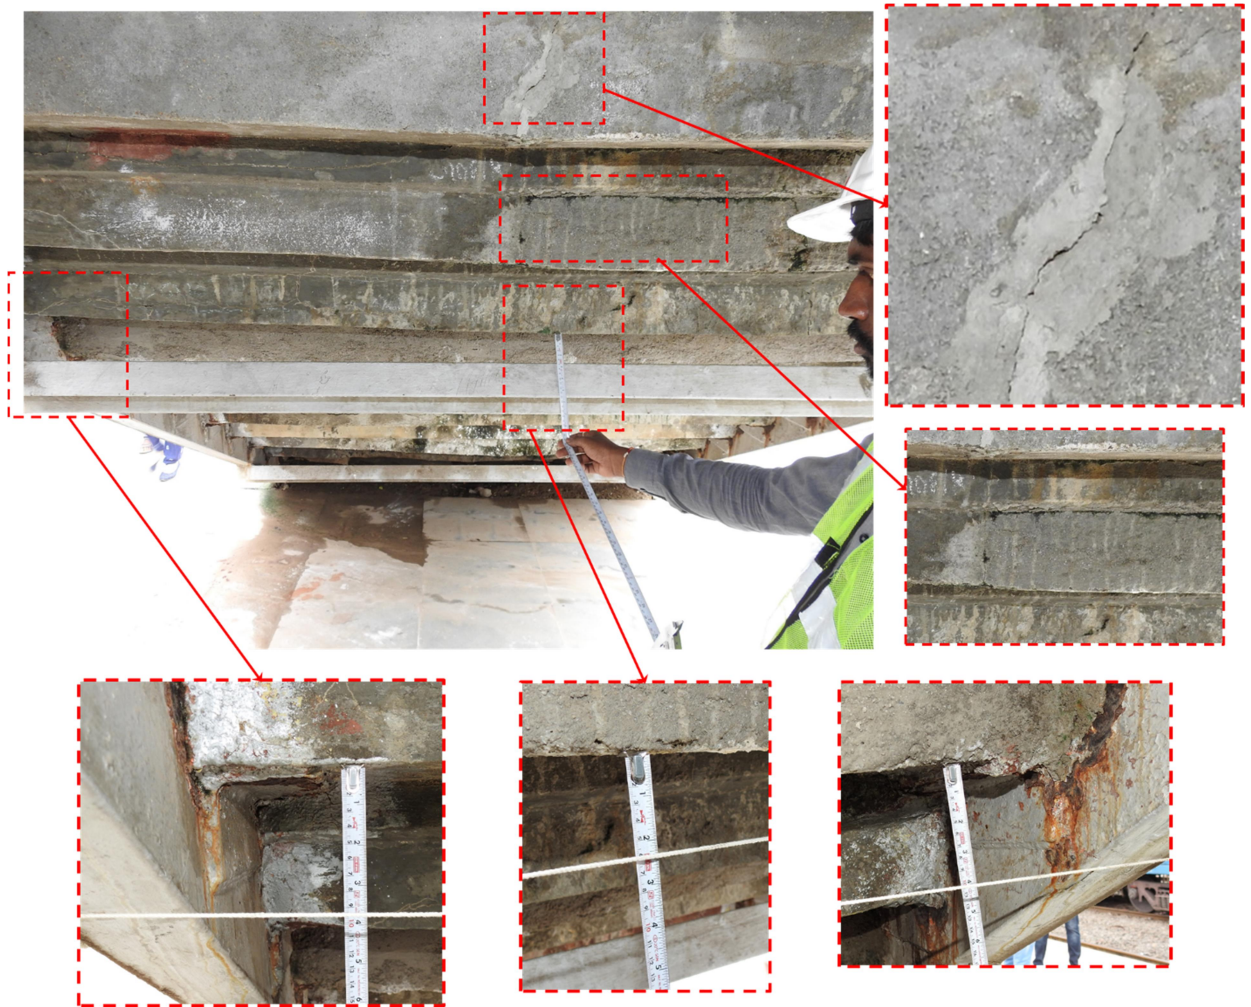
| | Number of Staircase | 2 No's | a) Staircase steps are observed as Pre-cast RCC slab panels of size 300 x 100mm are used. Steps are supported on ISMC 250 Channel stringer beam using cleat Angles. Staircase Landing of 1.50 m wide is supported on 2/100 x 100 x 12 mm Vertical Angle and Horizontal Channels Members.<br>b) Two staircase steps on Platform 1 are deflected by 40-50 mm and cracked at the center of Pre-cast slab panel.<br>c) In Step number 11 and 12 on Platform 1 from bottom cracks and deflection are observed at site as shown in part 4. |

- ✓ Some staircase steps on Platform 1 are deflected by 40-50 mm and cracked at the center as shown in the figure.

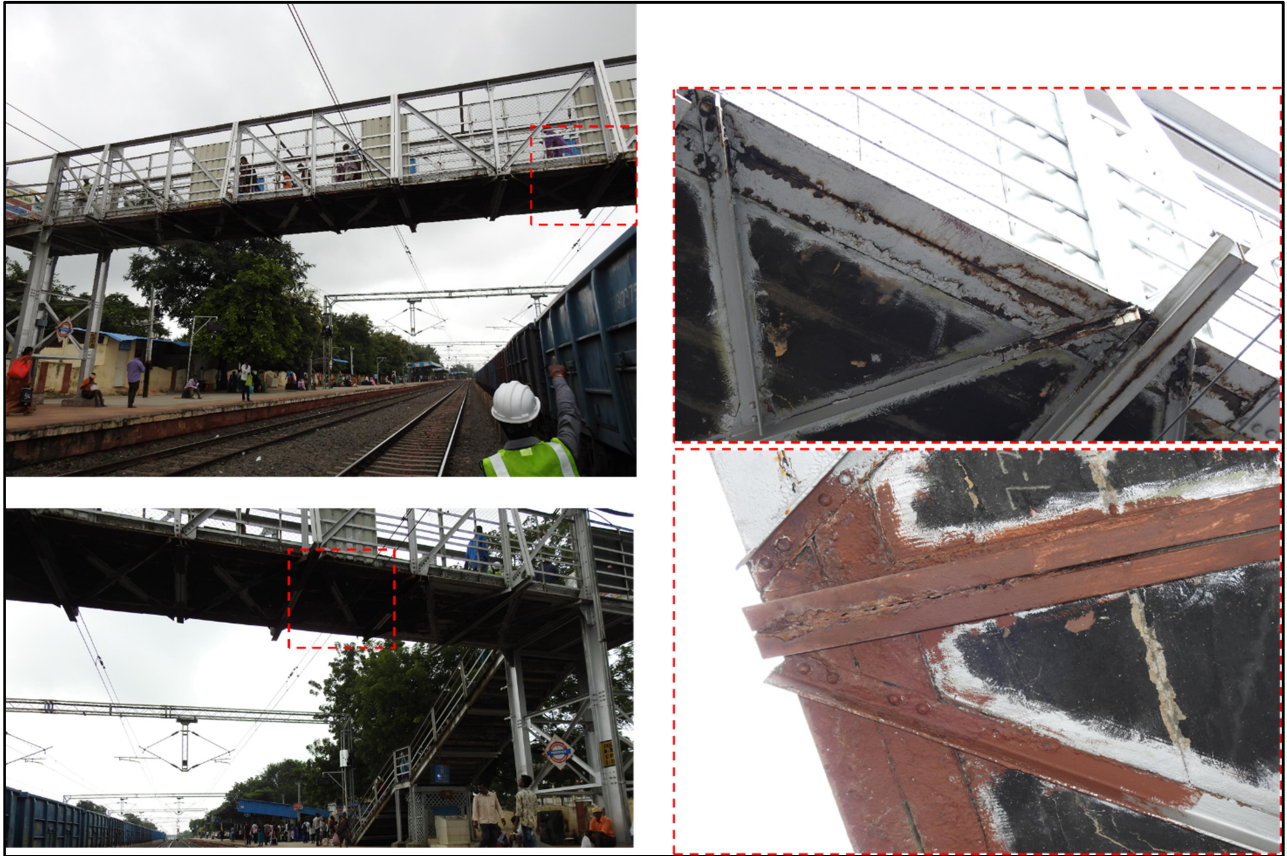
**Fig 6:** Redoxide paint applied at corroded joints and member

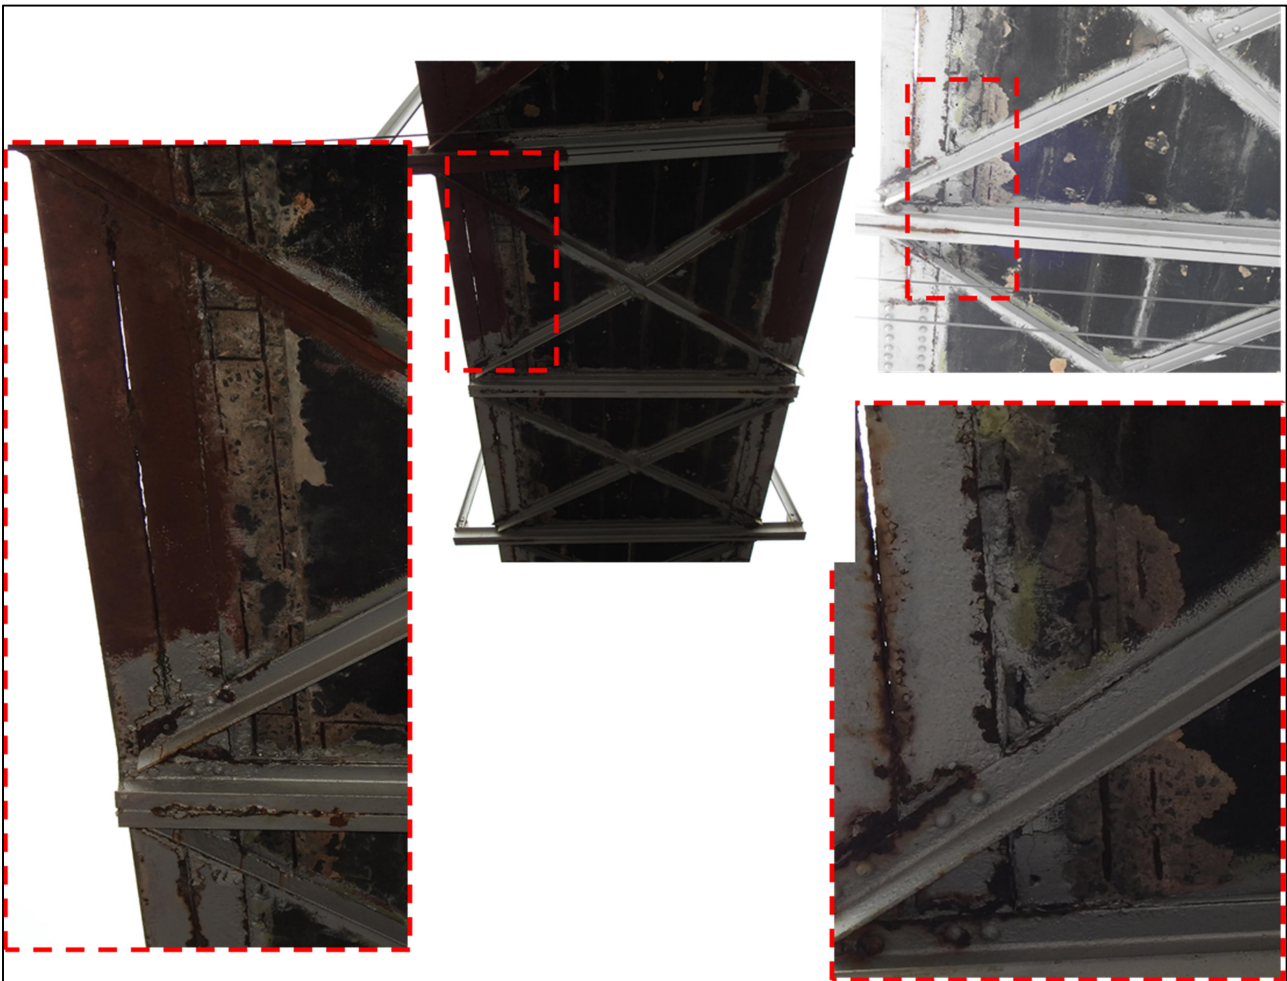
| PART 4 SURVEY OF SIGNS OF DISTRESS, DEFORMATION IN BRIDGES | | | |
|---|---|---|---|
| | Spalling | | Spalling is observed in Slab panels and in staircase-pre-cast panels. |

**Fig 7:** Spalling is observed in Floor slab from bottom

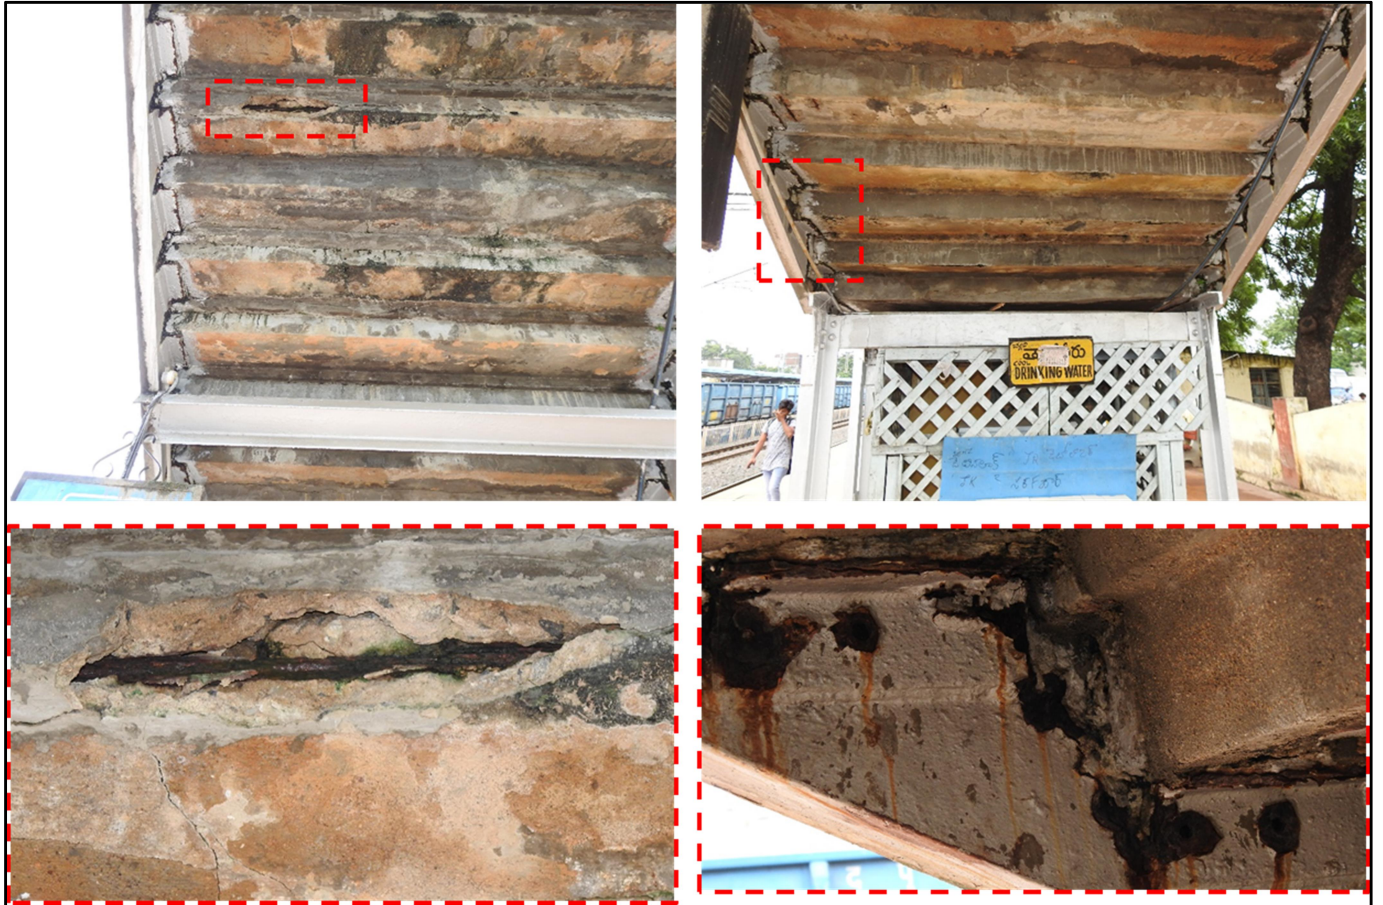
**Fig 8:** Spalling in staircase slabs

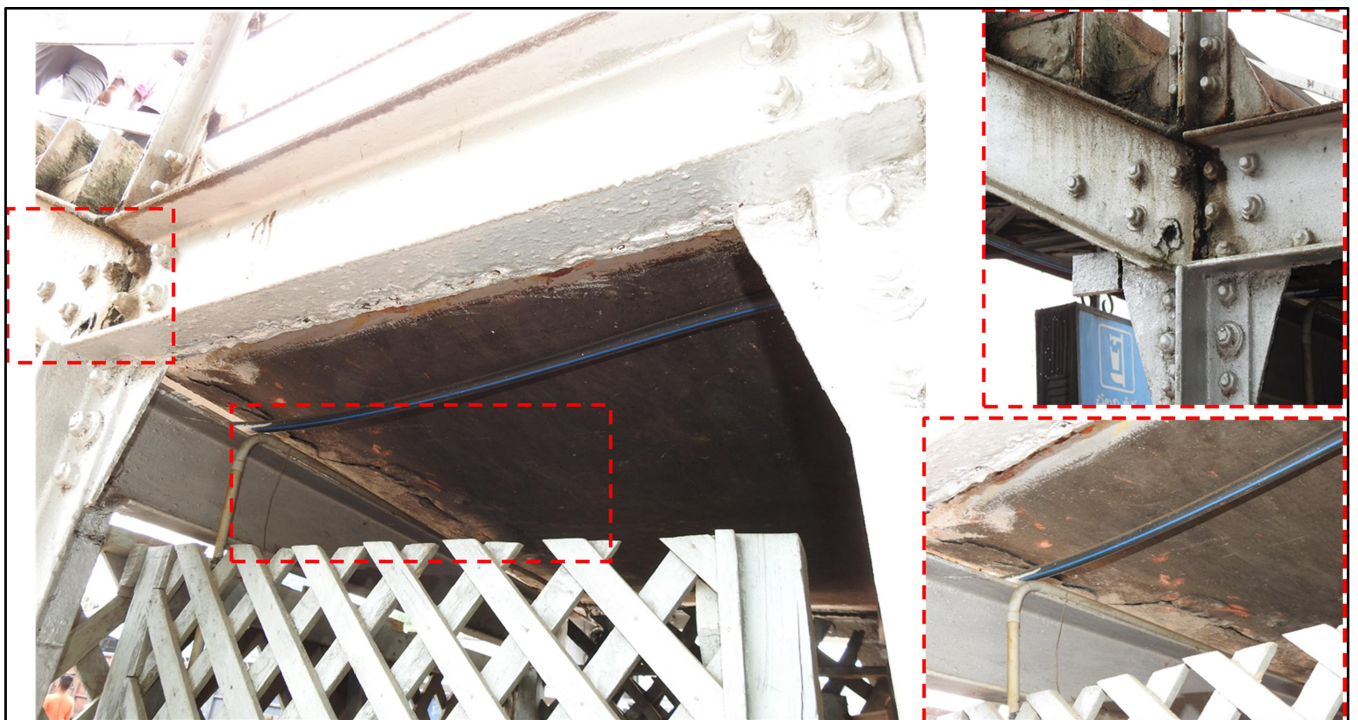
| PART 4 SURVEY OF SIGNS OF DISTRESS, DEFORMATION IN BRIDGES | | | |
|---|---|---|---|
| | Cracking in RCC components | Slab panels | Cracks are observed in Staircase and floor slab Pre-cast RCC slab panels |

**Fig 9:** cracks are observed on landing floor slab from bottom

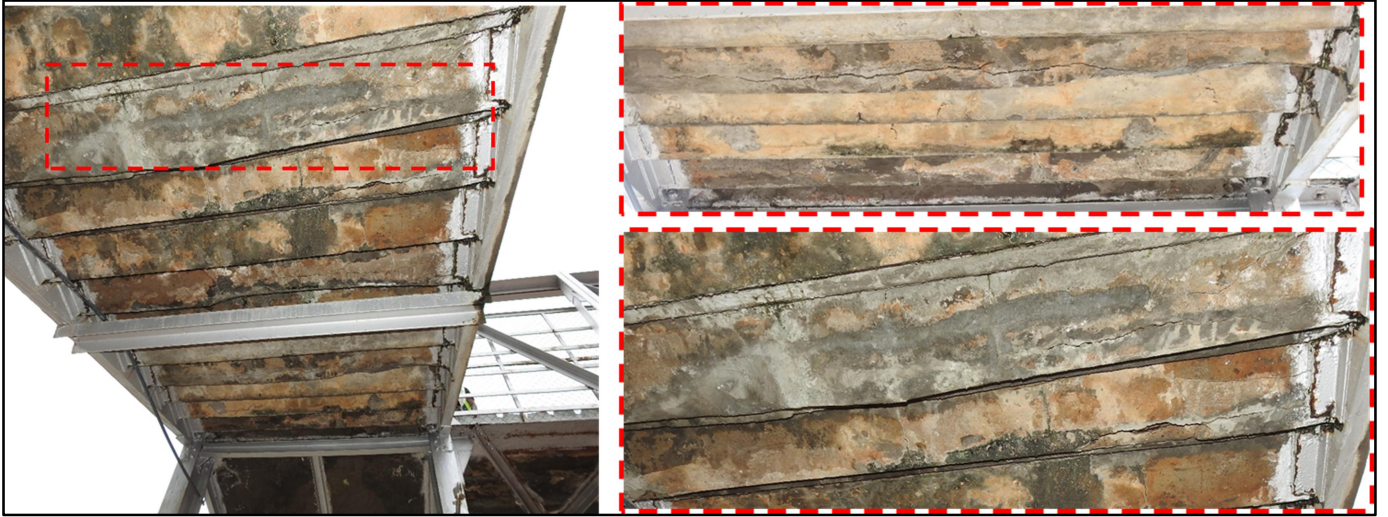
***Fig 10:*** cracks are observed in staircase slabs
