| <b>Name of the Project</b> | <b>:</b> | <b>VISUAL INSPECTION OF FOB/ PF-1 – CIRCULATING AREA AT MANCHIRYAL RAILWAY STATION</b> |
| <b>Location</b> | <b>:</b> | <b>MANCHIRYAL RAILWAY STATION</b> |
| <b>Date of Inspection</b> | <b>:</b> | <b>24<sup>th</sup> September 2019</b> |

## FORMAT FOR VISUAL INSPECTION OF STEEL FOOT OVER BRIDGE

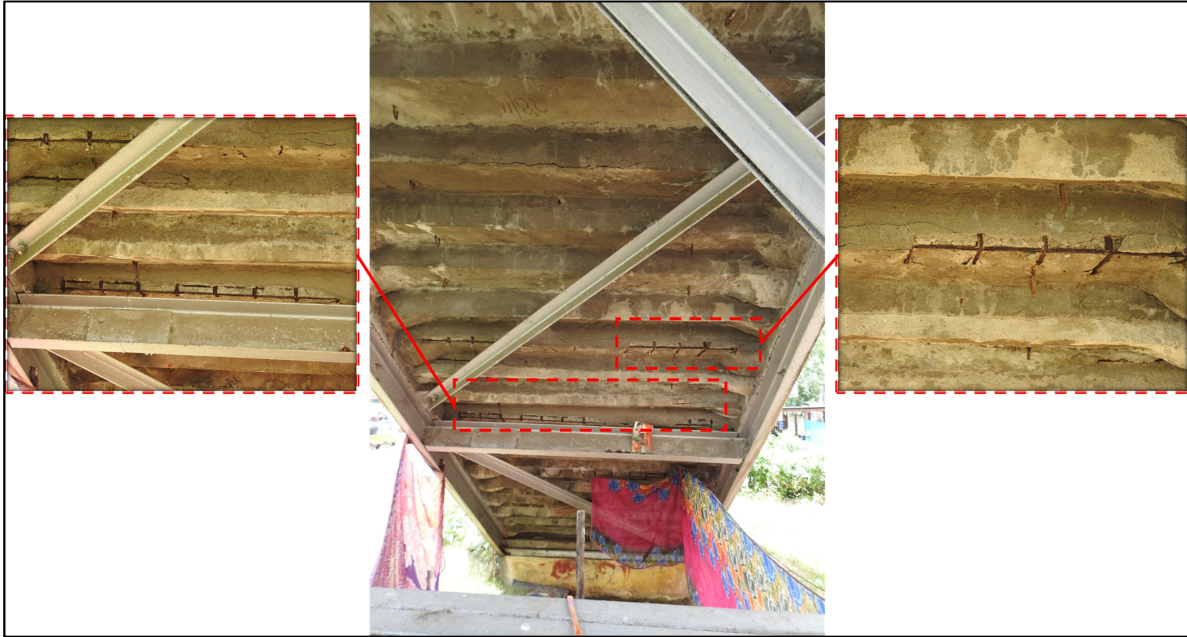
4.1

- ✓ Exposed reinforcement is observed on Pre-cast RCC slab panels of staircase at bottom at Circulating area.

Reinforcement exposed slab panels

| PART 4 SURVEY OF SIGNS OF DISTRESS, DEFORMATION IN BRIDGES | | | |
|---|---|---|---|
| | Spalling | Stair case | Spalling and reinforcement exposure is observed in some precast RCC panels connecting circulating area to PF-1 staircase. (Refer <i>Part 4 - 4.1</i> ) |

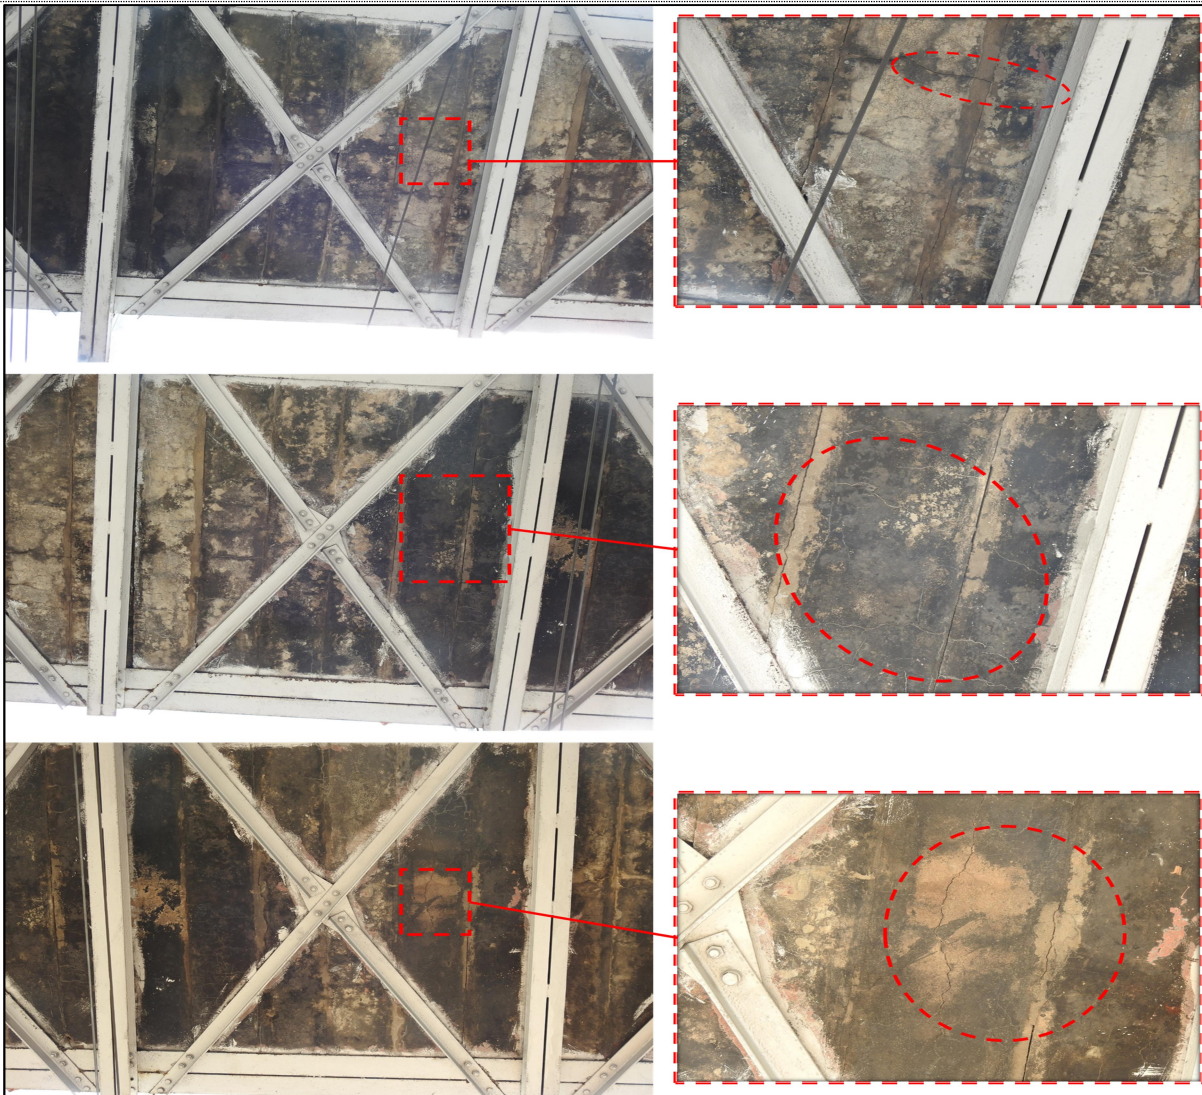
4.2

- ✓ Leaching effect and Cracks are observed on Pre-cast slab panels on 1<sup>st</sup> span of FOB (PF-1 – PF-2).

Leaching and Cracks in Pre-cast panels of 1<sup>st</sup> span

| PART 4 SURVEY OF SIGNS OF DISTRESS, DEFORMATION IN BRIDGES | | | |
|---|---|---|---|
| | Cracking in RCC components | Slab Panels | cracks are observed in Pre-cast RCC slab panels (Refer <i>Part 4 - 4.2</i> ) |

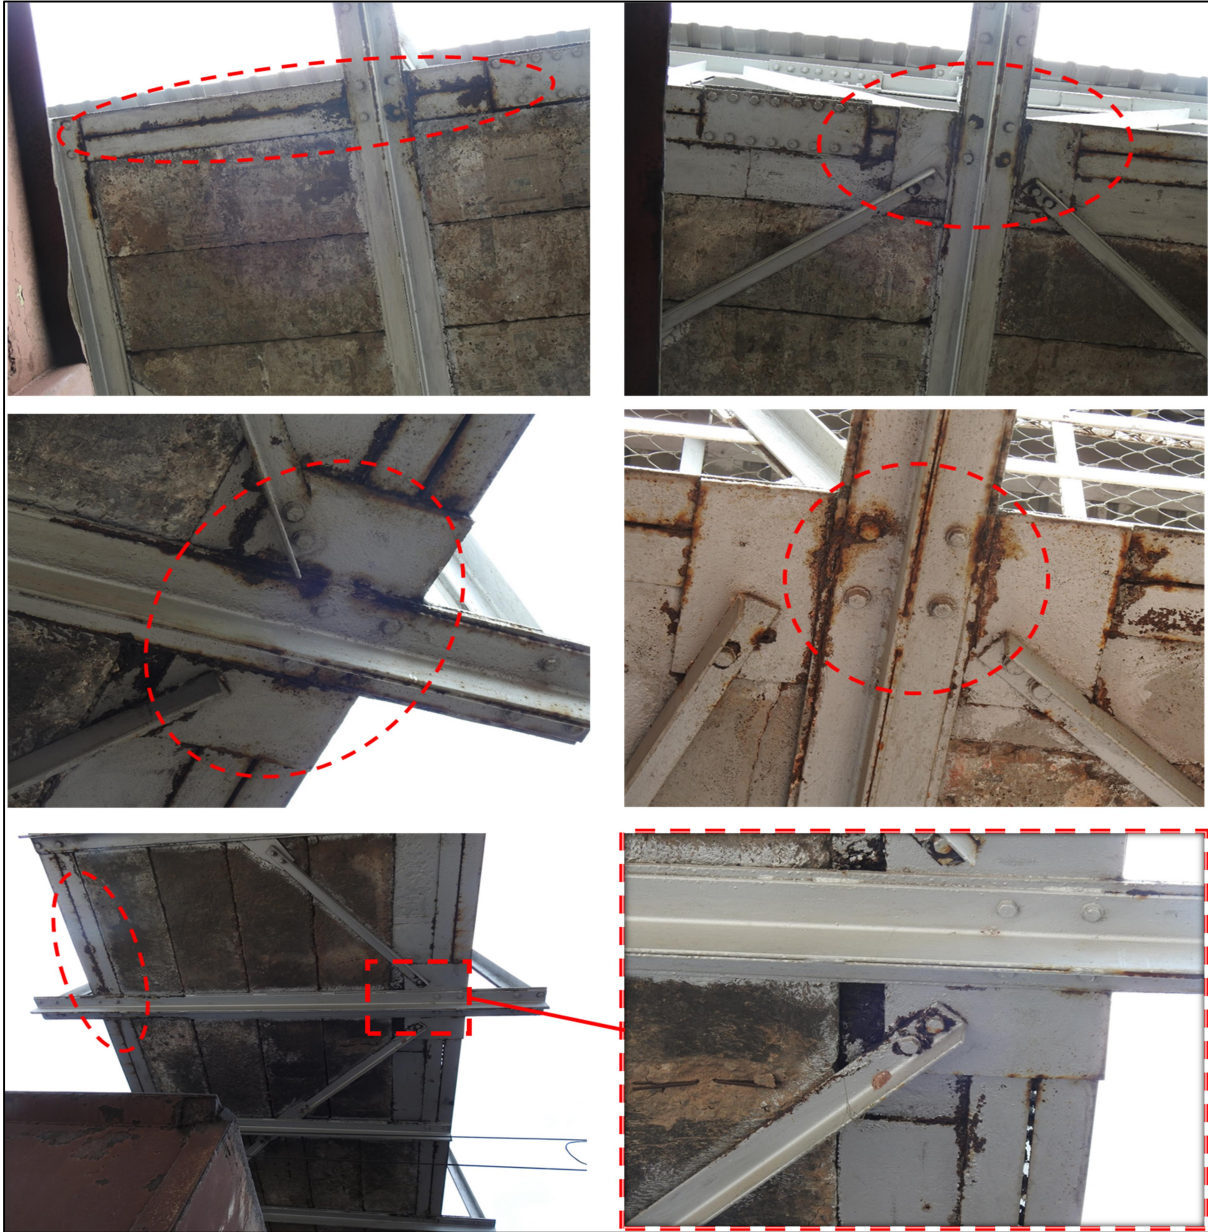
- 4.3 ✓ Corrosion is observed at gusset plate joints and bottom chord double angle section of 2<sup>nd</sup> span of FOB and vegetation is also observed.

(a) Corrosion in gusset plate joints and bottom chord double angle section

| PART 4 SURVEY OF SIGNS OF DISTRESS, DEFORMATION IN BRIDGES | | | |
|---|---|---|---|
| | Corrosion in Gusset plate | Bottom of the slab | Rusting is observed on Gusset plates (Refer <i>Part 4 - 4.3</i> ) |

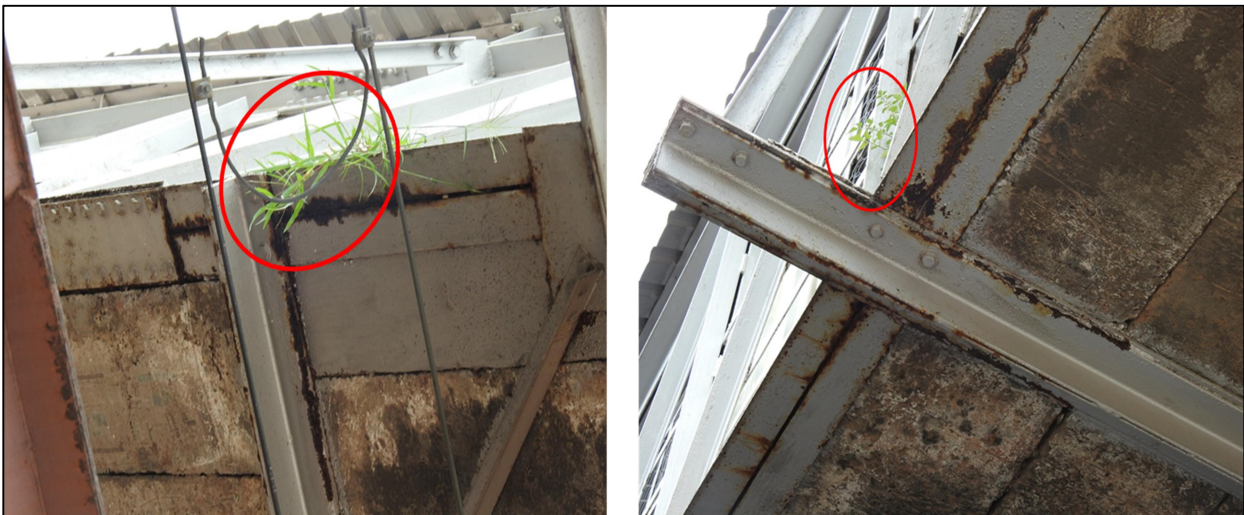
(b) Vegetation

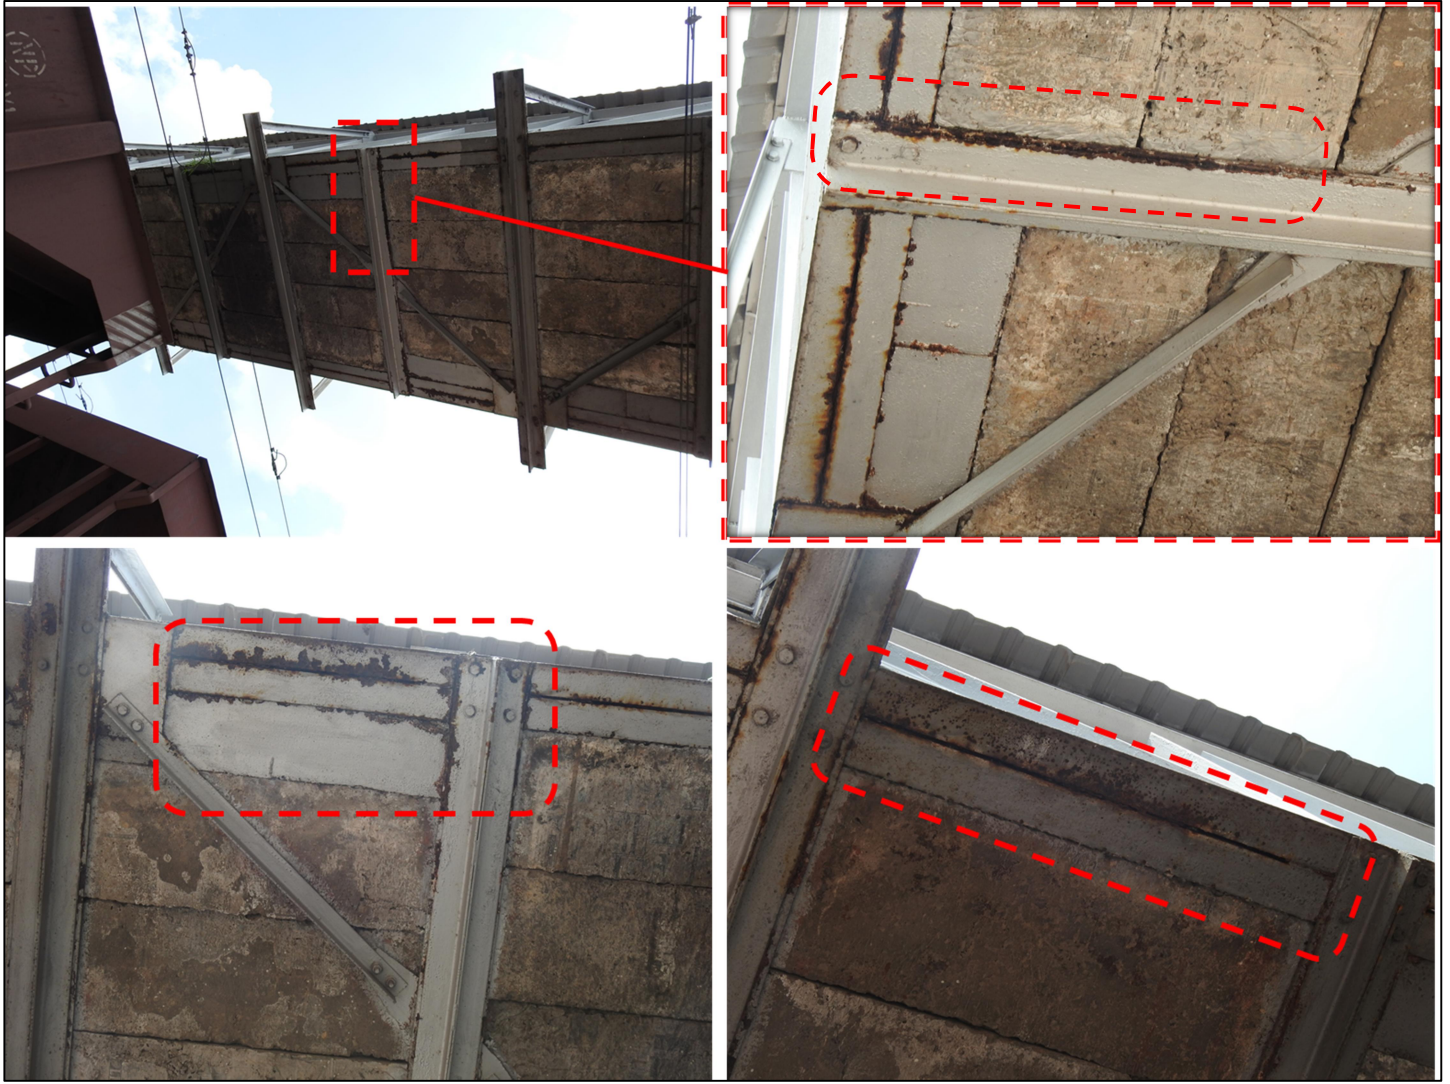
4.4

✓ Corrosion of Floor beam is observed in 2<sup>nd</sup> span and Slight rusting of bottom chord angle section

Corrosion of Floor beam and rusting of bottom chord members

| PART 4 SURVEY OF SIGNS OF DISTRESS, DEFORMATION IN BRIDGES | | | |
|---|---|---|---|
| | Extent Of Corrosion | In Floor beam | Corrosion of floor beam is observed in 2 <sup>nd</sup> span of FOB. (Refer <i>Part 4 - 4.4</i> ) |

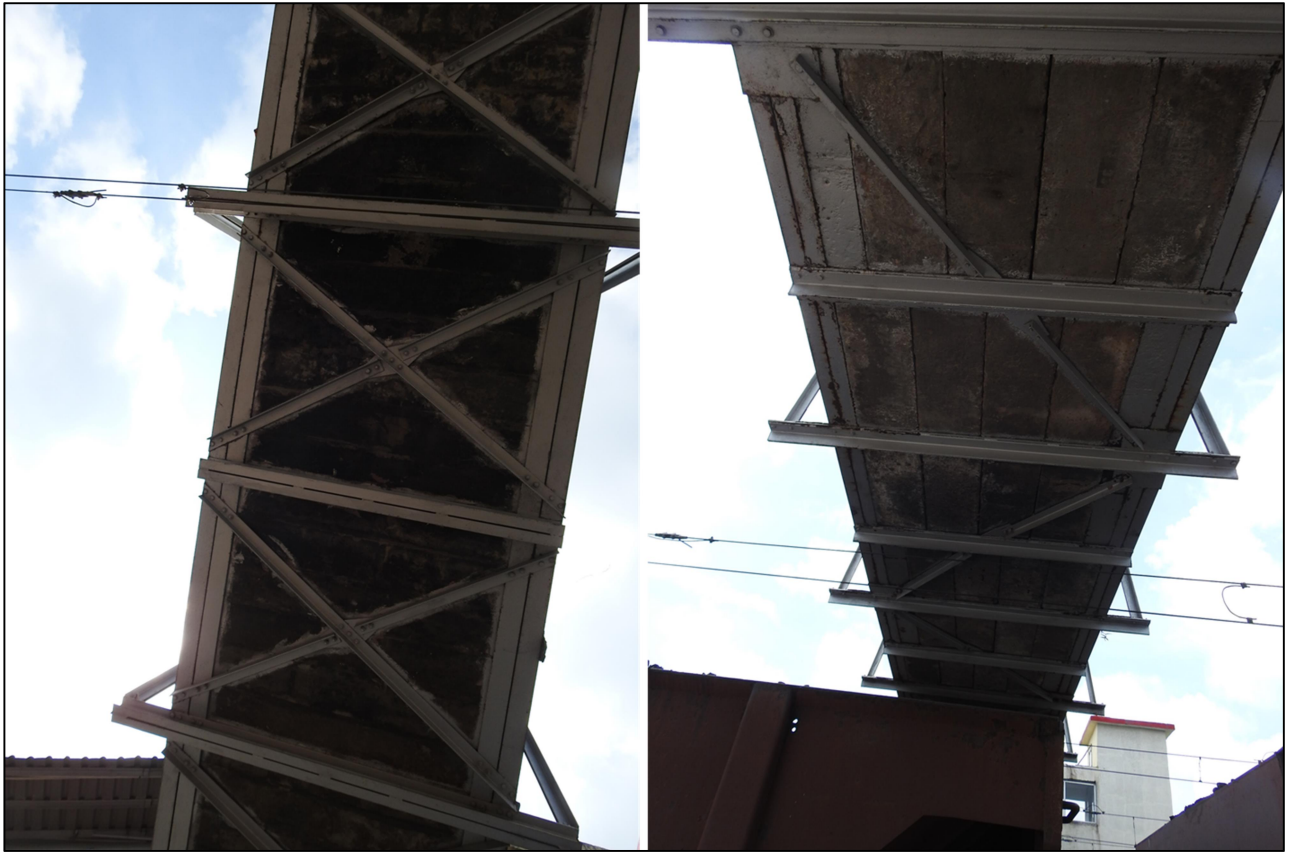
| | Condition of Slab from Bottom | Leaching effect near 1 <sup>st</sup> span and for 2 <sup>nd</sup> span | |

**Fig 5:** Bottom view of 1<sup>st</sup> and 2<sup>nd</sup> span of FOB

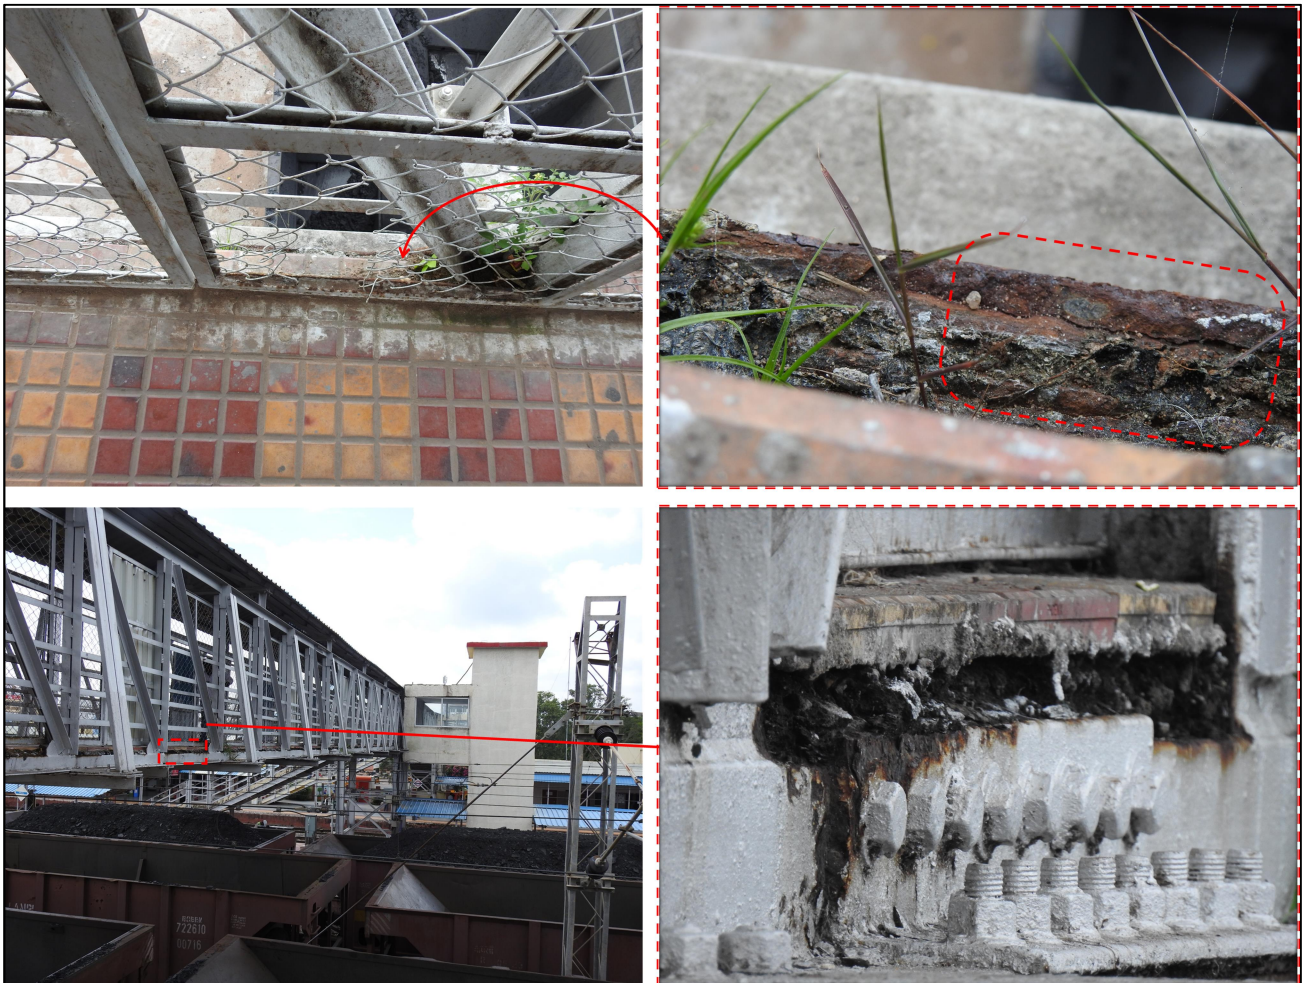
| PART 4 SURVEY OF SIGNS OF DISTRESS, DEFORMATION IN BRIDGES | | | |
|---|---|---|---|
| | Corrosion at steel-Concrete joint | | Corrosion is observed at steel concrete joint. (Refer <i>fig : 6</i> ) |

**Fig 6:** Corrosion is also observed at steel concrete joint
