| <b>Name of the Project</b> | <b>:</b> | <b>VISUAL INSPECTION OF FOB/ PF-1 – CIRCULATING AREA AT RAGHAVAPURAM RAILWAY STATION</b> |
| <b>Location</b> | <b>:</b> | <b>RAGHAVAPURAM RAILWAY STATION</b> |
| <b>Date of Inspection</b> | <b>:</b> | <b>26<sup>th</sup> September 2019</b> |

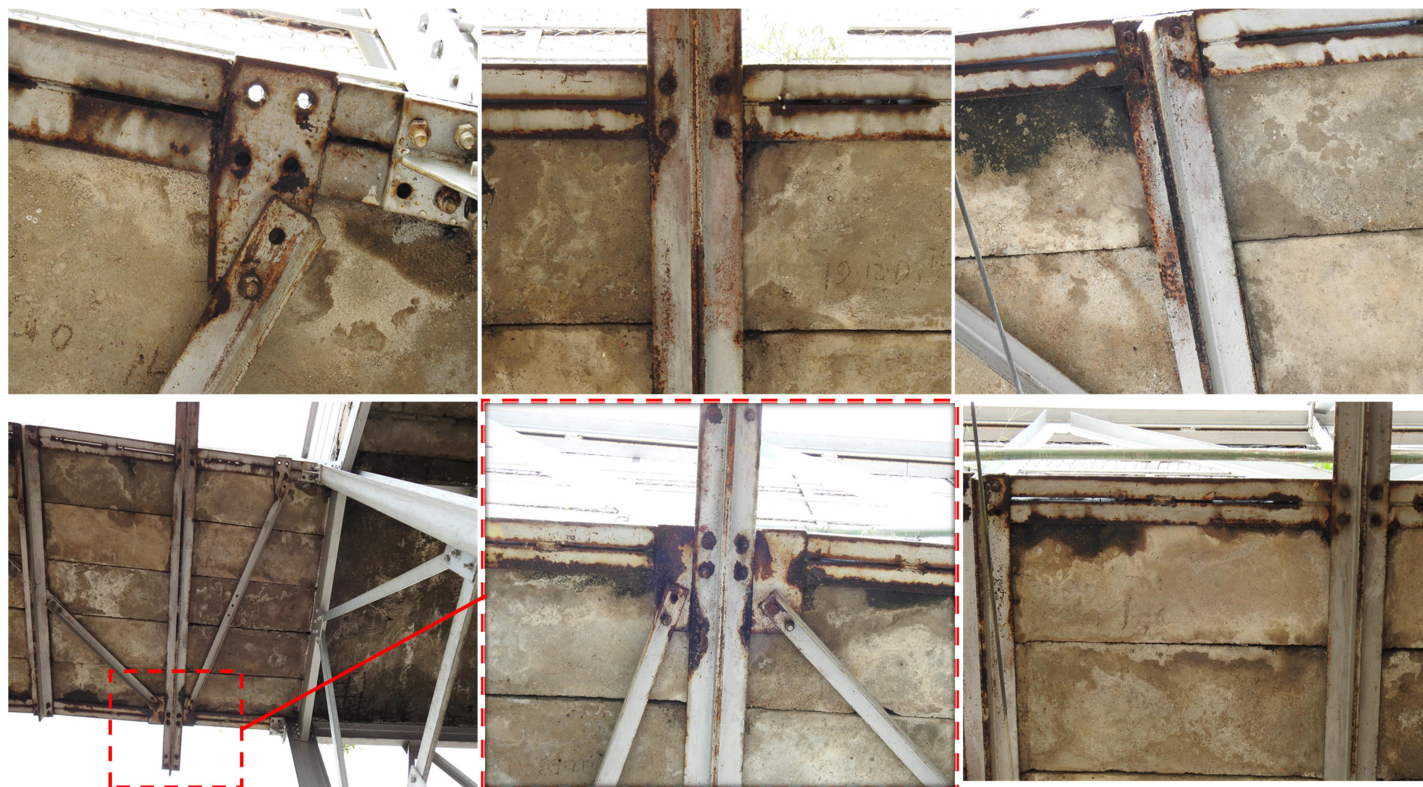
- 4.1 ✓ Corrosion is observed in bottom chord member ( Double angle section), gusset plate joints connecting floor beam

| PART 4 SURVEY OF SIGNS OF DISTRESS, DEFORMATION IN BRIDGES | | | |
|---|---|---|---|
| | Rust straining | Bottom Chord members and floor beams joints | Rusting and corrosion is observed at joints of floor beam gusset plate connecting bottom chord is observed. (Refer <b>Part 4 - 4.1 and 4.2</b> ) |

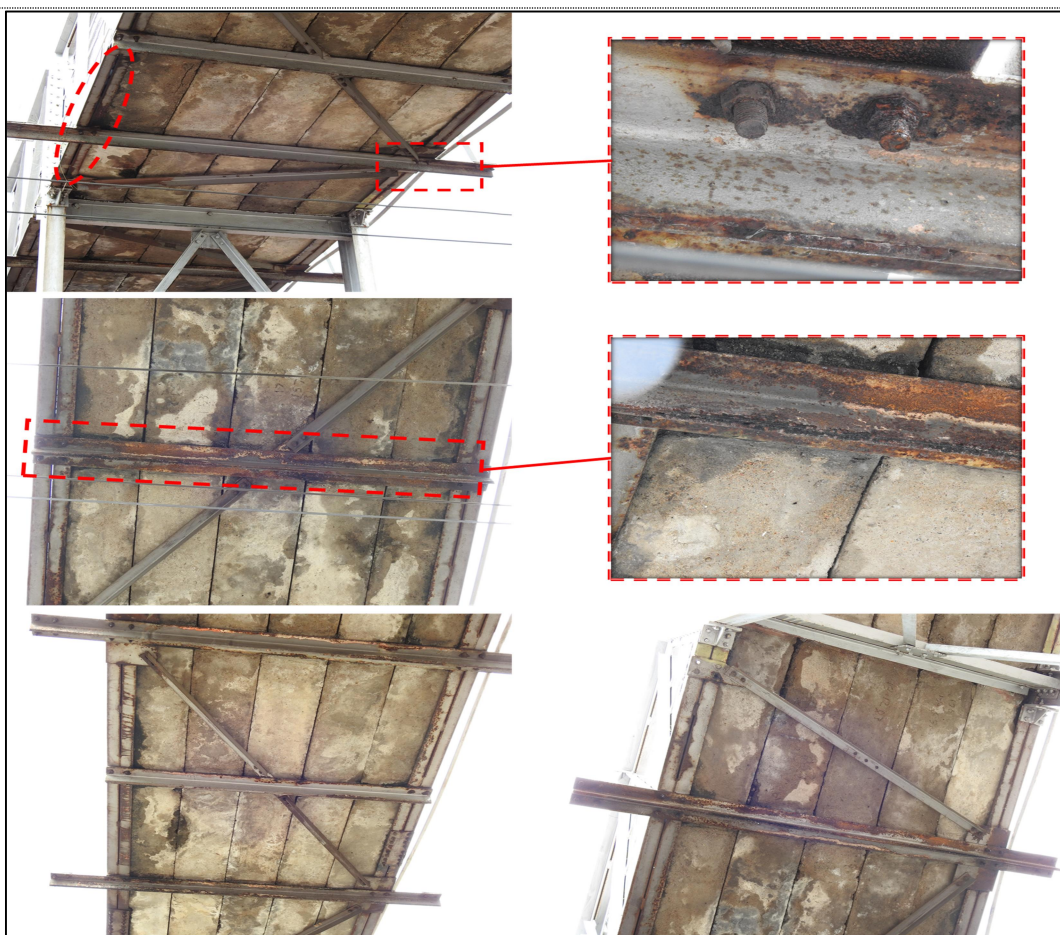
- 4.2 ✓ corrosion observed in floor beams and bottom chord members at 3<sup>rd</sup>, and 5<sup>th</sup> span of FOB

| PART 4 SURVEY OF SIGNS OF DISTRESS, DEFORMATION IN BRIDGES | | | |
|---|---|---|---|
| | Rusting in Gusset plate | | Rusting is observed in Gusset plates (Refer <b>Part 4 - 4.2</b> ) |

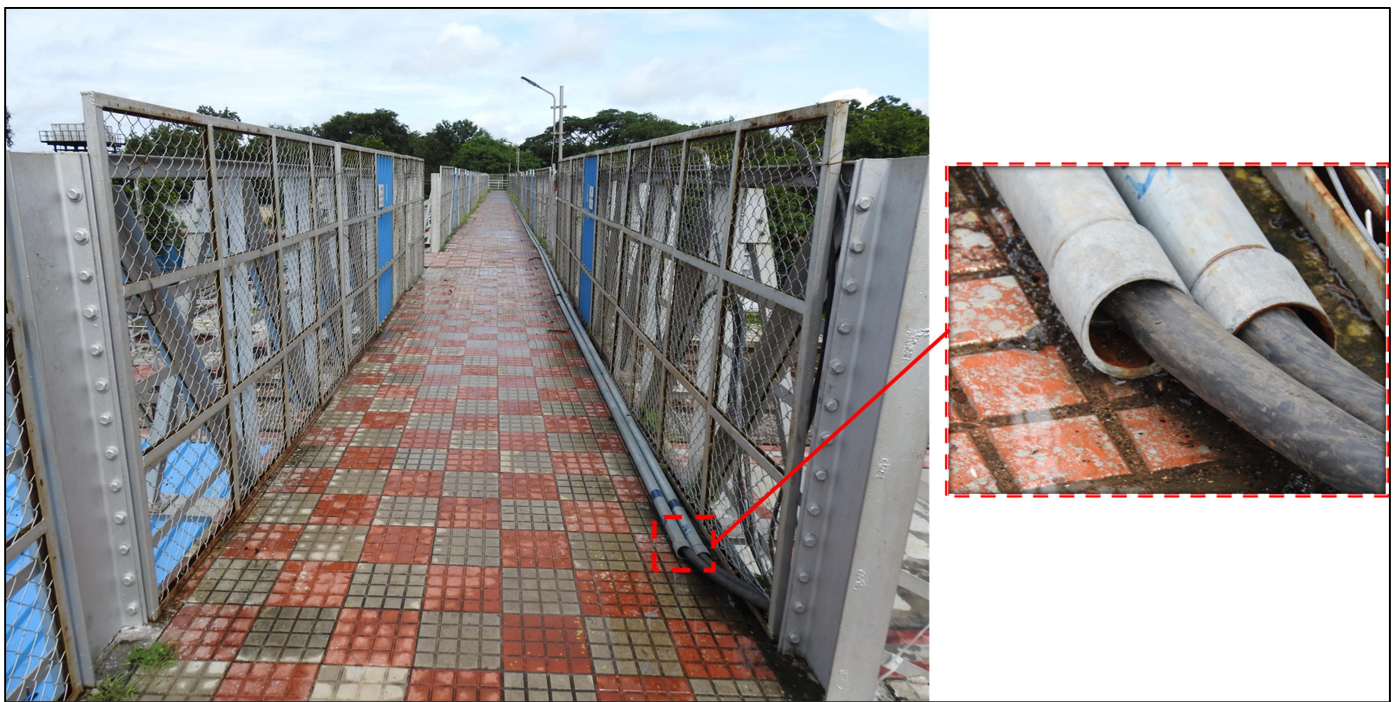
***Fig 1:*** Cables, Flooring and protective screen

| PART 2 IDENTIFICATION OF LOADS ON BRIDGE | | | |
|---|---|---|---|
| | a) Pipeline - Utilities | No | No pipe lines are observed at roof level. Two GI pipes of 2 inch dia with cables running on the floor.<br><br>a. Cables are protected with 2-inch GI pipe.<br>b. No advertising boards are provided. (Refer <b>fig :1</b> ) |
| | a) Additional wearing coat on Floor | No | Chequered tiles are used for flooring (Refer <b>fig :1</b> )<br><br>Chain link fence made of galvanized wire of 2 mm gauge and 2 mm galvanized sheet is used above OHE line on both side of gangway is used for protection (Refer <b>fig :1</b> ) |

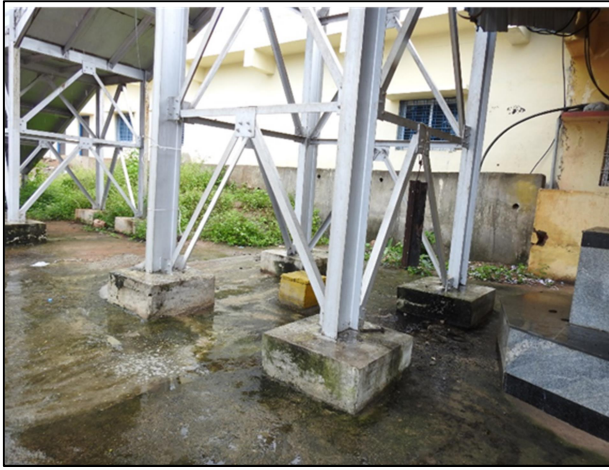
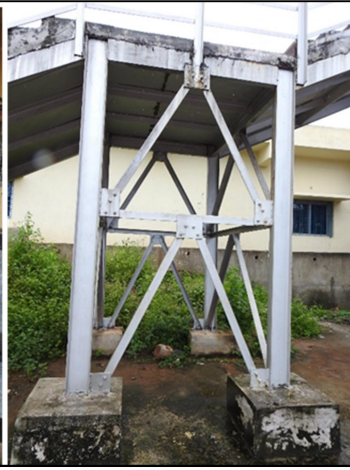
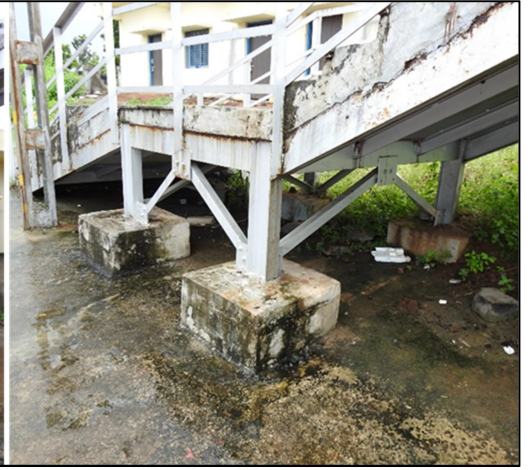
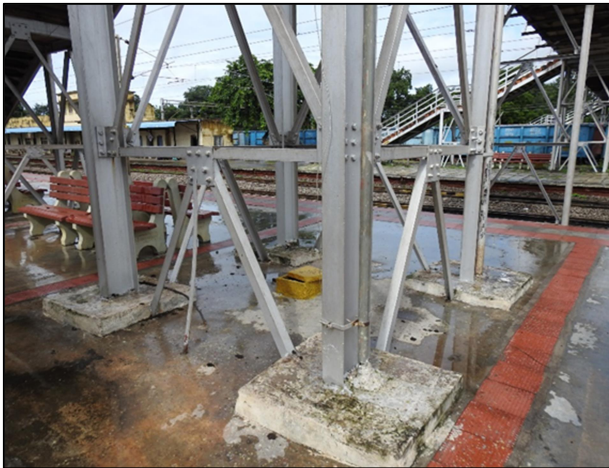
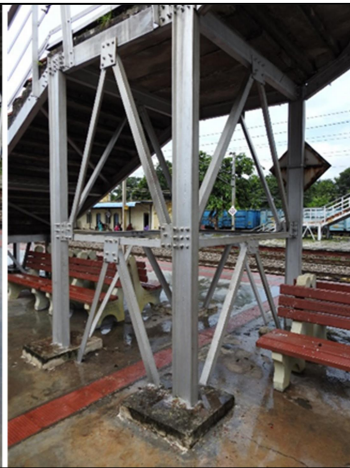
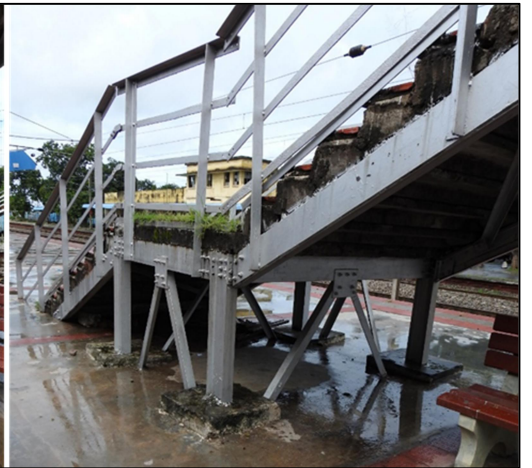
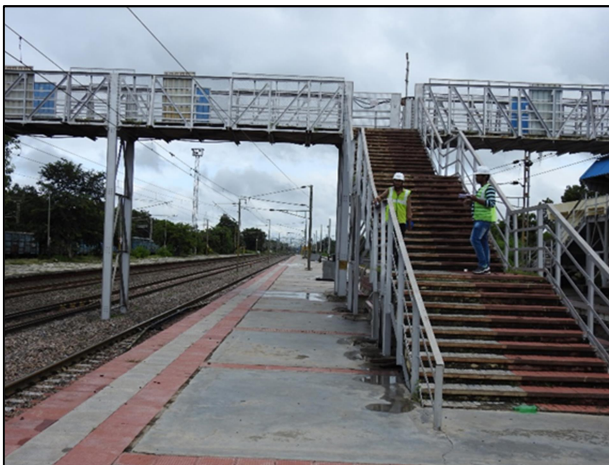
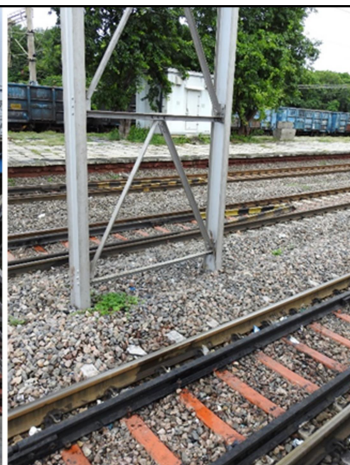
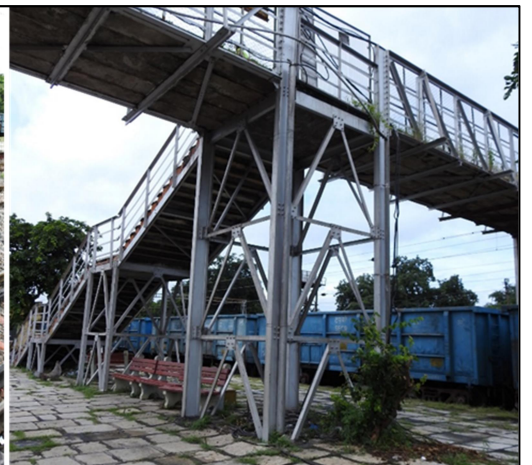
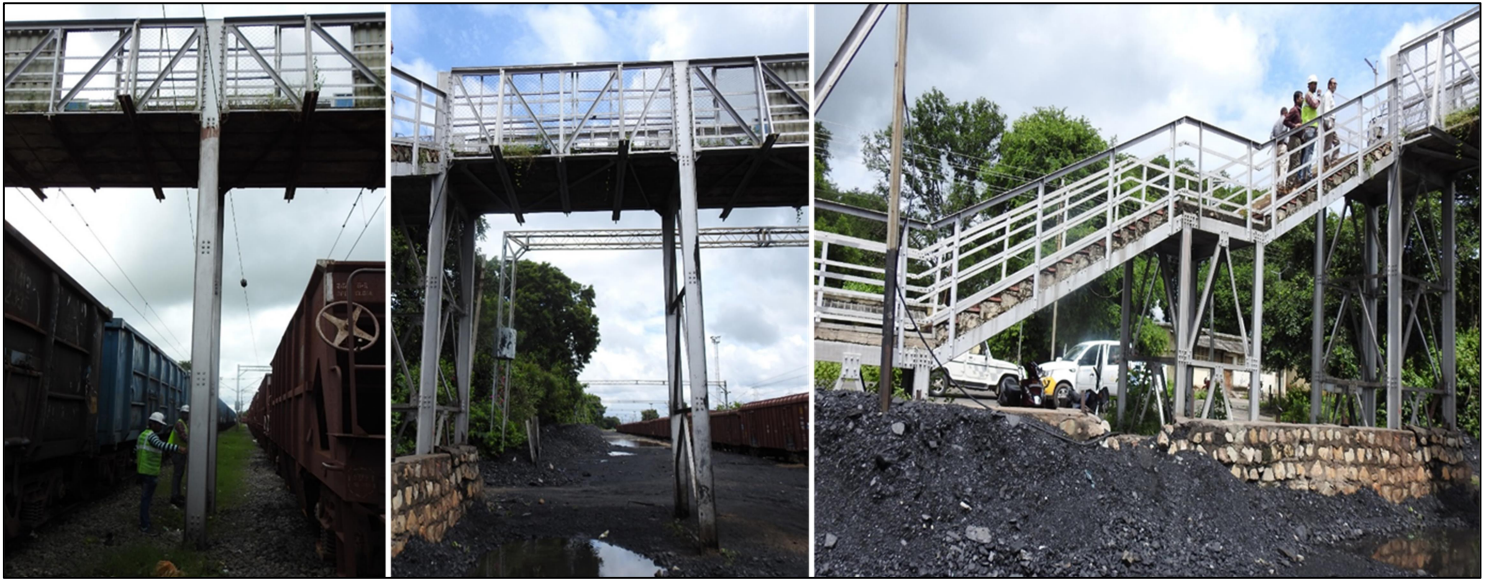
**Fig 2:** Trestles details

| PART 3 STRUCTURAL SYSTEM OF THE BRIDGE | | | |
|---|---|---|---|
| | Column – Trestles Connection Details | | Concrete encasement is observed on vertical supports at platform level. (Refer <b>fig :2</b> ) |

| | Type/Shape of Column section | I – Section | a. FOB is supported on vertical column of Four - ISMB 300 with bracings of IAS 75 x 75 x 8 mm angle section.<br>b. Staircase landing is supported on ISMB 200. (Refer <b>fig :2</b> ) |

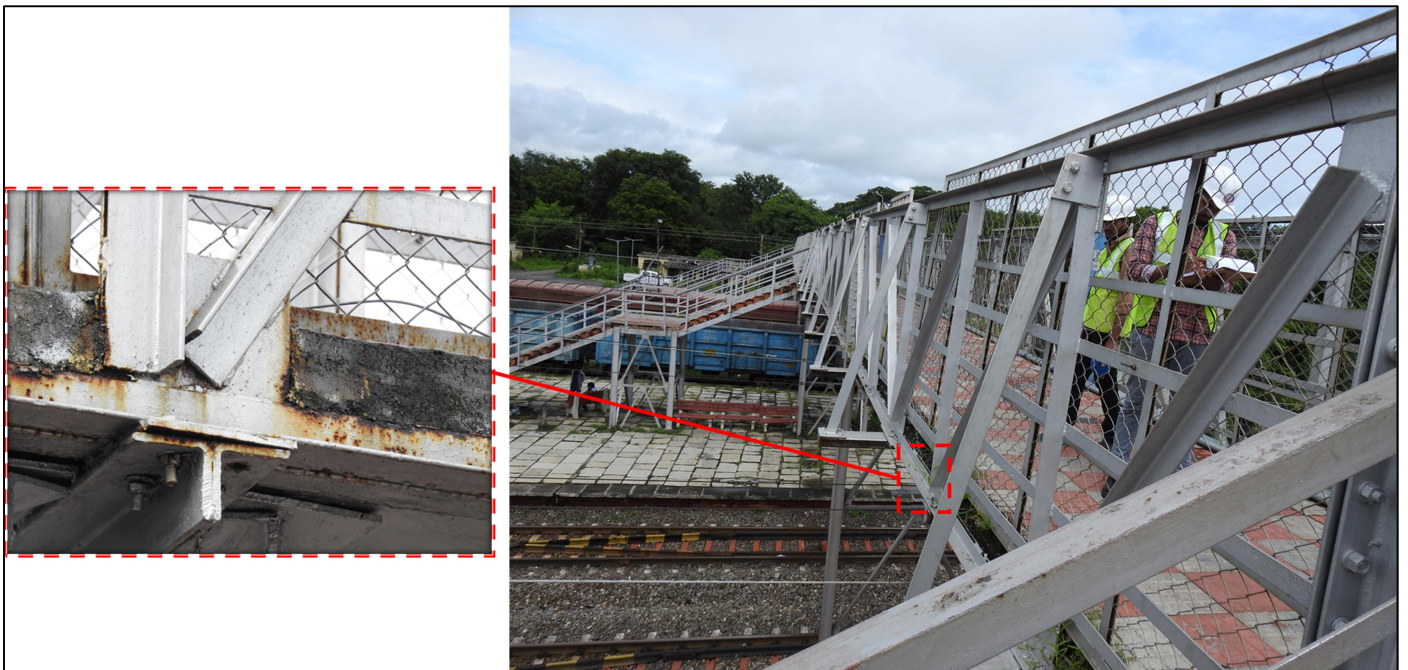
**Fig 3:** Chord members, Floor beams, vertical and diagonal bracings

| | Type/Shape of Girder Section | Double angle sections | a. Top and bottom Chord members are ISA 75 x 75 x 8 mm Double angle section.<br>b. ISA 75 x 75 x 8 mm double angle section are used as vertical members and ISA 75 x 75 x 8 mm diagonal bracing members.<br>c. 12 mm thick gusset plate is used for welded joint.<br>d. ISA 100 x 100 x 10 mm are used as Floor beams supported with ISA 75 x 75 x 8 mm bracing connected by gusset plate. (Refer <b>fig :3</b> ) |

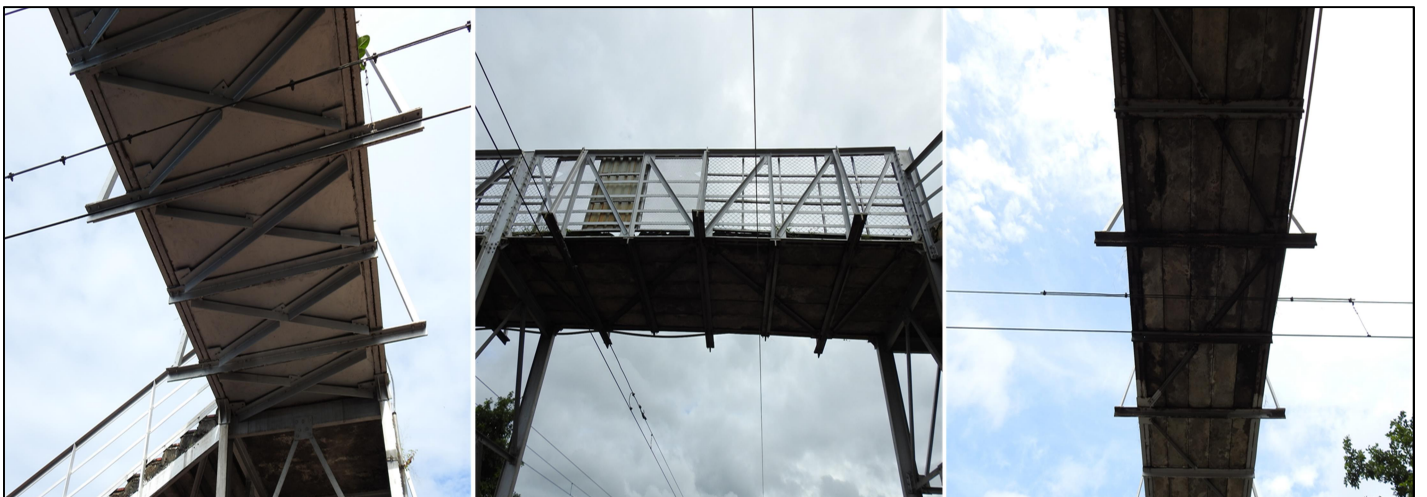
**Fig 4:** Bottom view Slab panels

| | Material of Slab | Pre-cast panels and cast in situ slab | a. For 1 <sup>st</sup> span RCC slab cast in situ supported on sacrificial plate.<br>b. For 2 <sup>nd</sup> to 6 <sup>th</sup> span Pre-cast Reinforced concrete slab panels are used for floor slab of 100 mm thick, RCC slab panels are resting on floor beams.<br>c. Chequered tile flooring is laid on the top of the slab panels (Refer <b>fig : 1 and 4</b> ) |
| | Condition of Slab from Bottom | Leaching effect | |

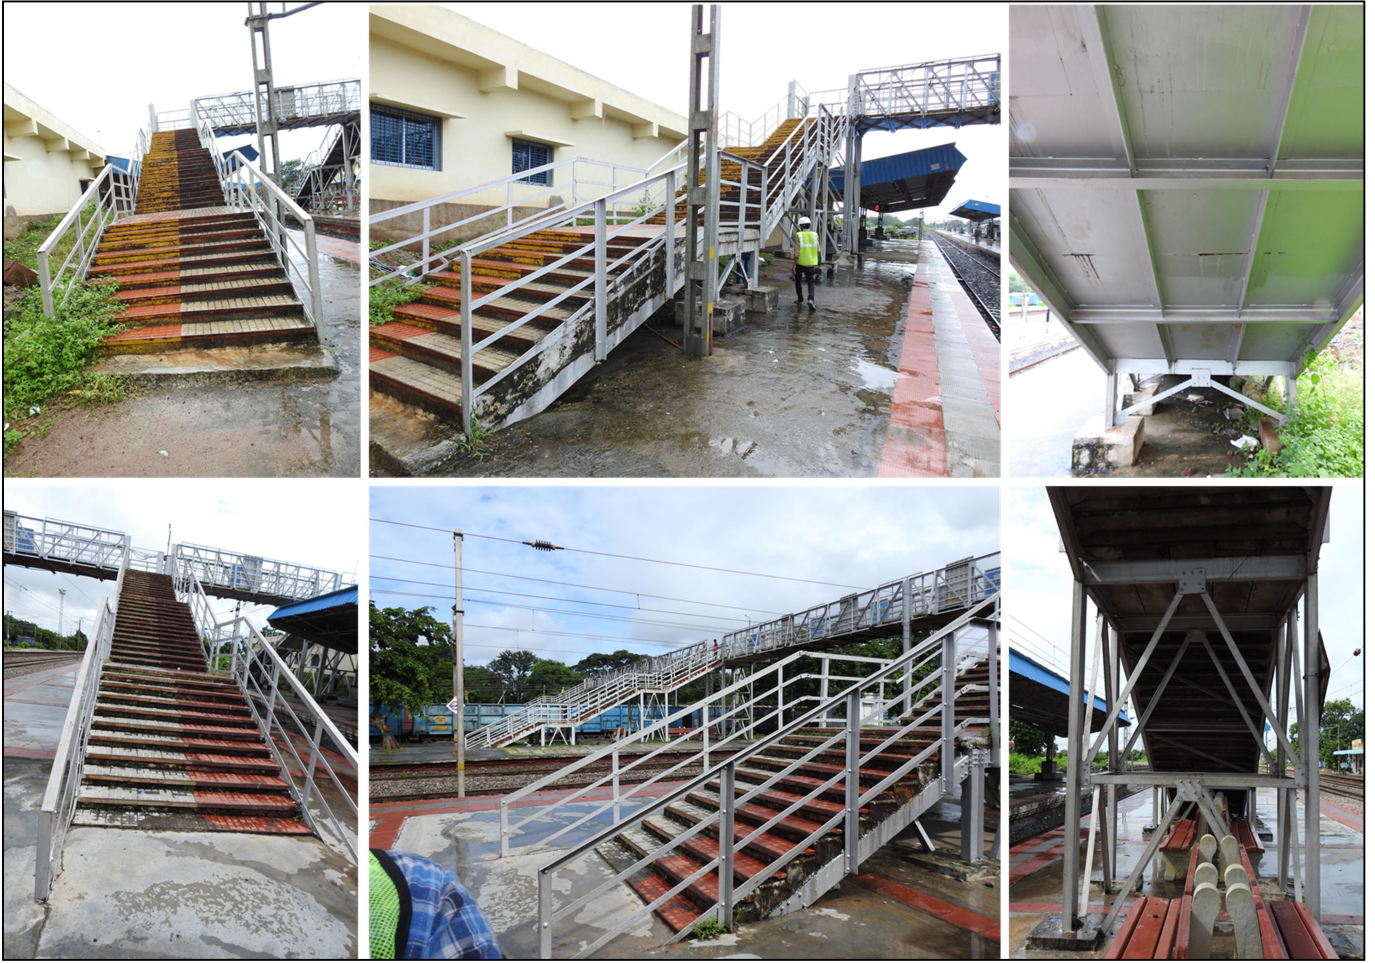
**Fig 5:** Staircase details

| | Material used for steps | Pre cast slab panels and cast in situ slab | slab panels. Steps size of 300 x 100 mm are supported on ISMC 200 channel. Staircase landing of 2.54 m wide is supported on ISMC 250. (Refer <b>fig :5</b> ) |
| | Type of Parapet Railing | Steel railing | a. Staircase is provided with railing on both sides of one-meter height using ISA 75 x 75 x 10 mm angle section and 50 x 6 mm M.S flats are used. (Refer <b>fig :5</b> ) |

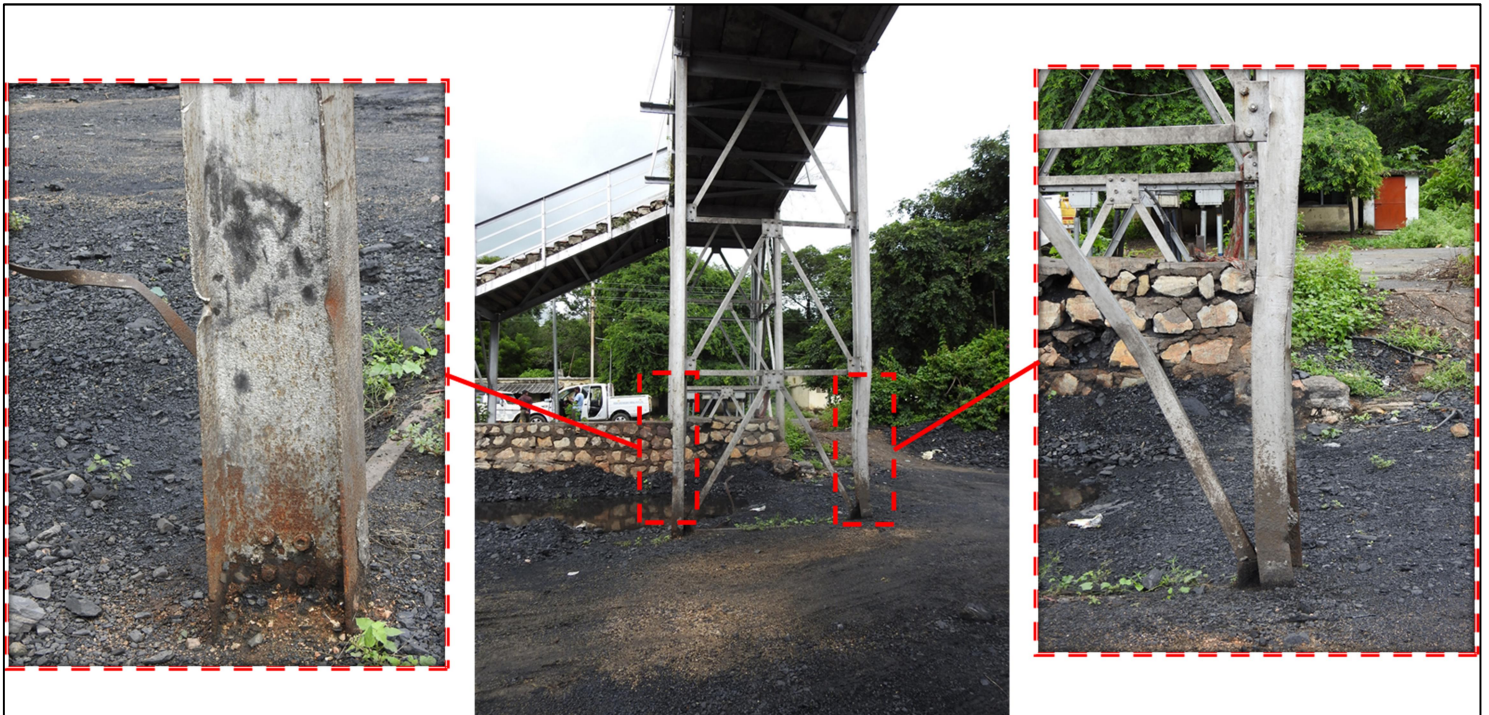
| PART 1 GENERAL INFORMATION AND OBSERVATION | | | |
|---|---|---|---|
| 1.13 | Damages due to accidental hitting, Grazing Marks | Yes (due to hitting by road vehicles at coal siding)<br>(Refer <i>fig :6</i> ) | |

**Fig 6:** Accidental damage observed at stanchion in coal yard

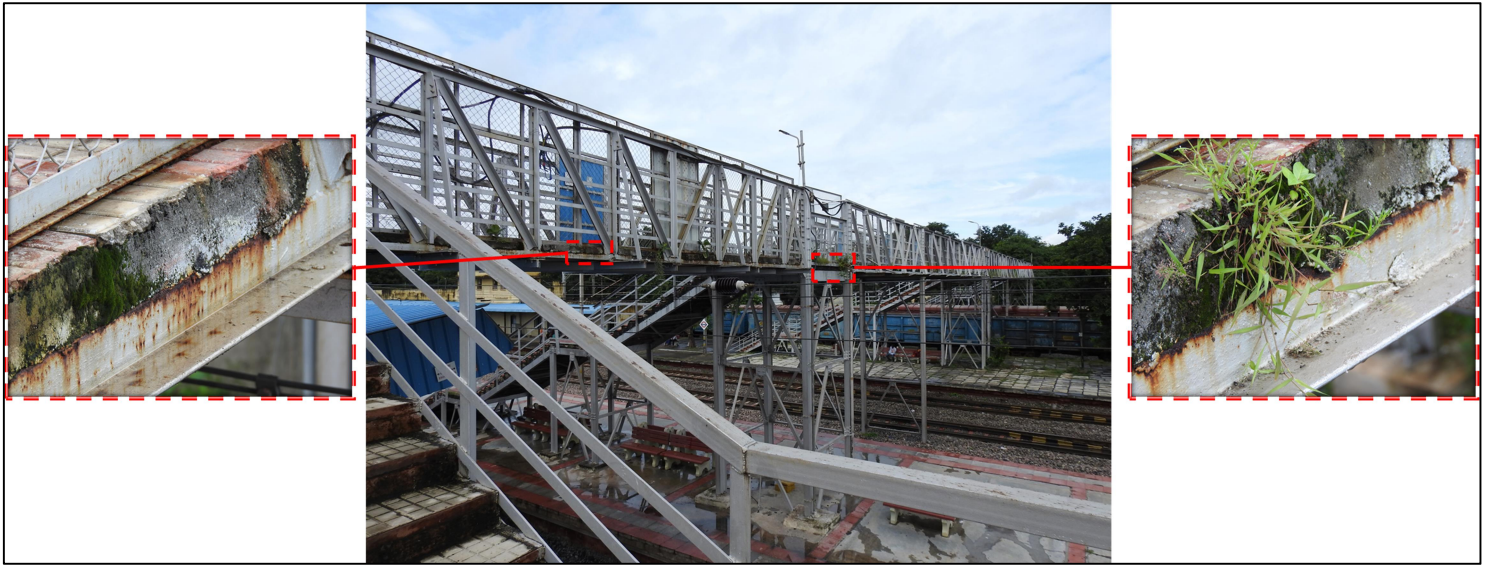
| PART 4 SURVEY OF SIGNS OF DISTRESS, DEFORMATION IN BRIDGES | | | |
|---|---|---|---|
| | Corrosion at steel-Concrete joint | | Corrosion is observed at steel concrete joint. (Refer <b>fig :7</b> ) |

***Fig 7: Corrosion and vegetation***
