| <b>Name of the Project</b> | : | VISUAL INSPECTION OF FOB/ PF-1 – CIRCULATING AREA AT BELLAMPALLI RAILWAY STATION |
| <b>Location</b> | : | BELLAMPALLI RAILWAY STATION |
| <b>Date of Inspection</b> | : | 25 <sup>th</sup> September 2019 |

## FORMAT FOR VISUAL INSPECTION OF STEEL FOOT OVER BRIDGE

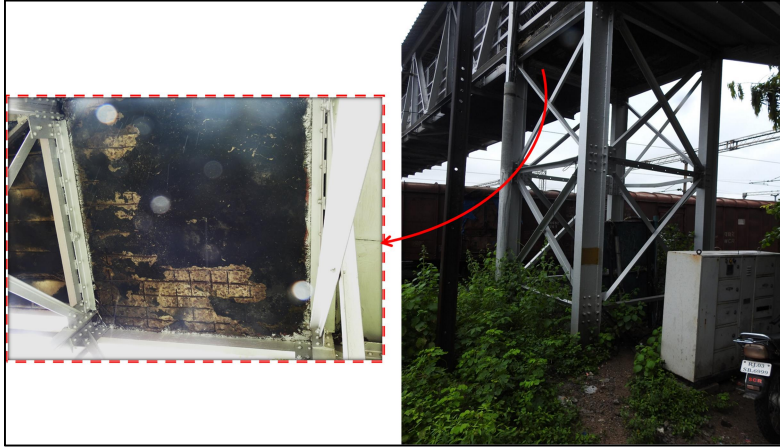
(a) Circulating area (Yard) landing

4.1 ✓ Exposed reinforcement and leaching is observed at Pre-cast RCC slab panels at slab bottom of FOB.

| PART 4 SURVEY OF SIGNS OF DISTRESS, DEFORMATION IN BRIDGES | | | |
|---|---|---|---|
| | Cracking in RCC components | Slab Panels | Cracks are observed in Pre-cast RCC slab panels in deck(Refer <b>Part 4 - 4.1</b> ) |
| | Spalling | Spalling and reinforcement exposure | Spalling and reinforcement exposed in slab panels at 1 <sup>st</sup> , 2 <sup>nd</sup> and 3 <sup>rd</sup> span of FOB and 4 <sup>th</sup> span end circulating area landing. (Refer <b>Part 4 - 4.1</b> ) |

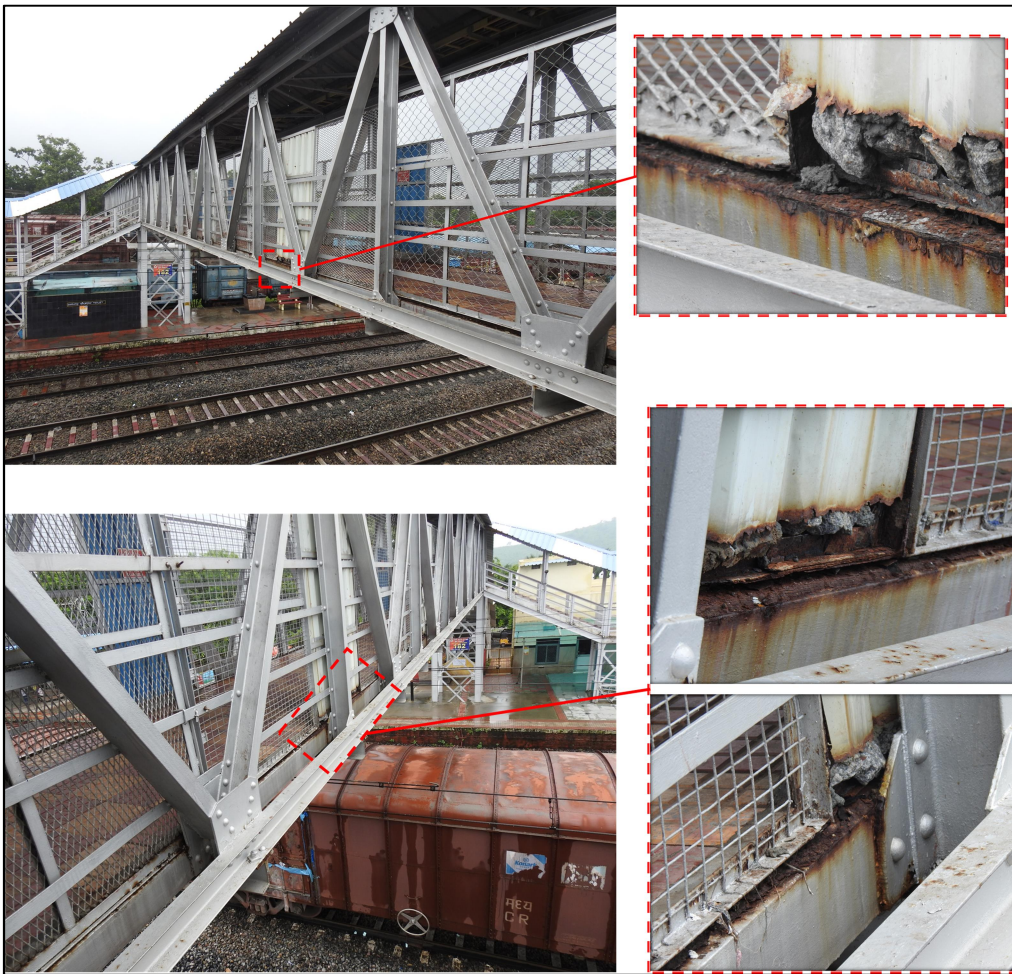
- 4.2 ✓ Corrosion observed in bottom chord member (ISMC 150 Double channel section) near concrete steel joint of FOB.

Leaching and Cracks in Pre-cast panels of 1<sup>st</sup> span

| PART 4 SURVEY OF SIGNS OF DISTRESS, DEFORMATION IN BRIDGES | | | |
|---|---|---|---|
| | Corrosion at steel-Concrete joint | | Corrosion is observed at steel concrete joint. (Refer <b>Part 4 - 4.3</b> ) |

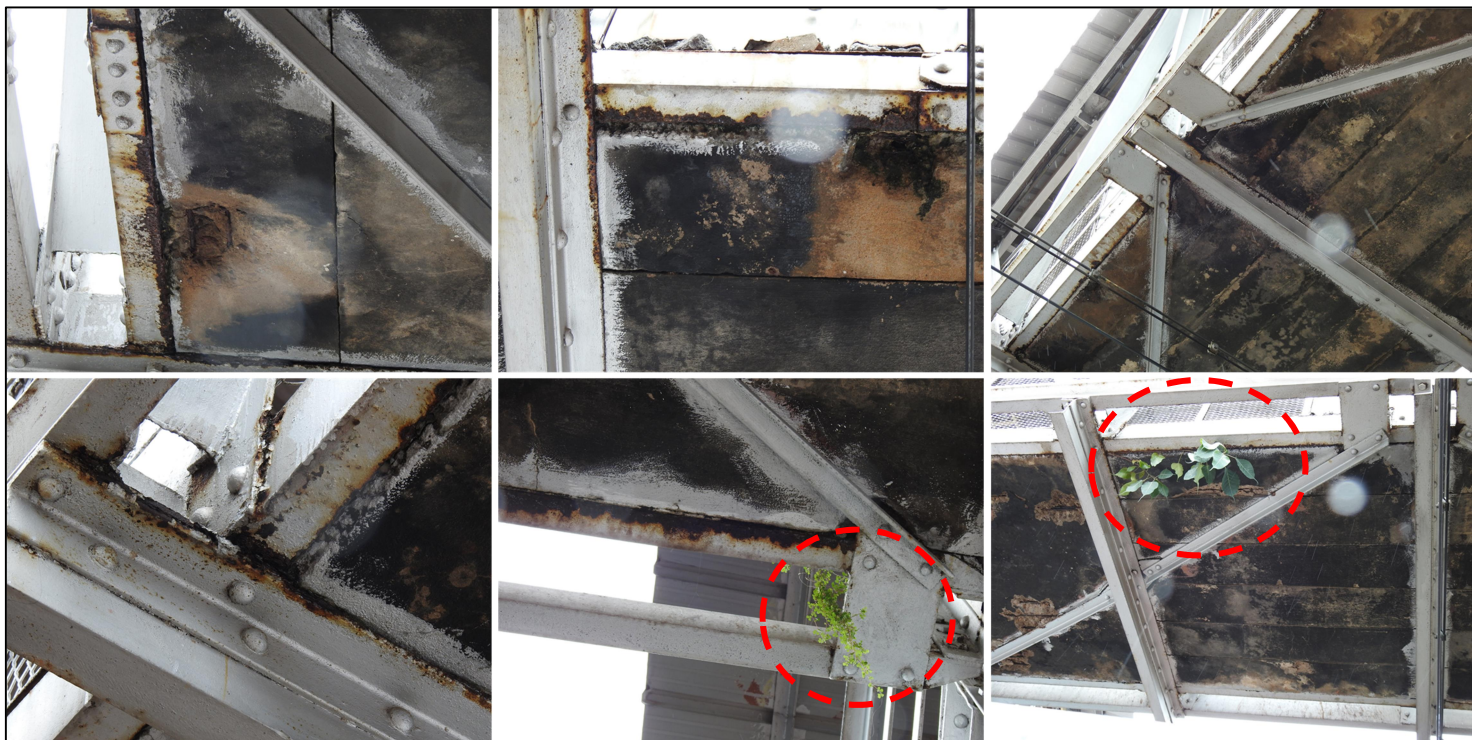
- 4.3 ✓ Corrosion is observed at gusset plate joints and bottom chord double channel section and vegetation is also observed.

Corrosion and vegetation

| PART 4 SURVEY OF SIGNS OF DISTRESS, DEFORMATION IN BRIDGES | | | |
|---|---|---|---|
| | Rust straining | Bottom chord members and floor beams joints | Rusting and corrosion is observed at joints of floor beam gusset plate connecting bottom chord is observed. (Refer <b>Part 4 - 4.3</b> ) |
| | Rusting in Gusset plate | | Rusting is observed in Gusset plates (Refer <b>Part 4 - 4.3</b> ) |

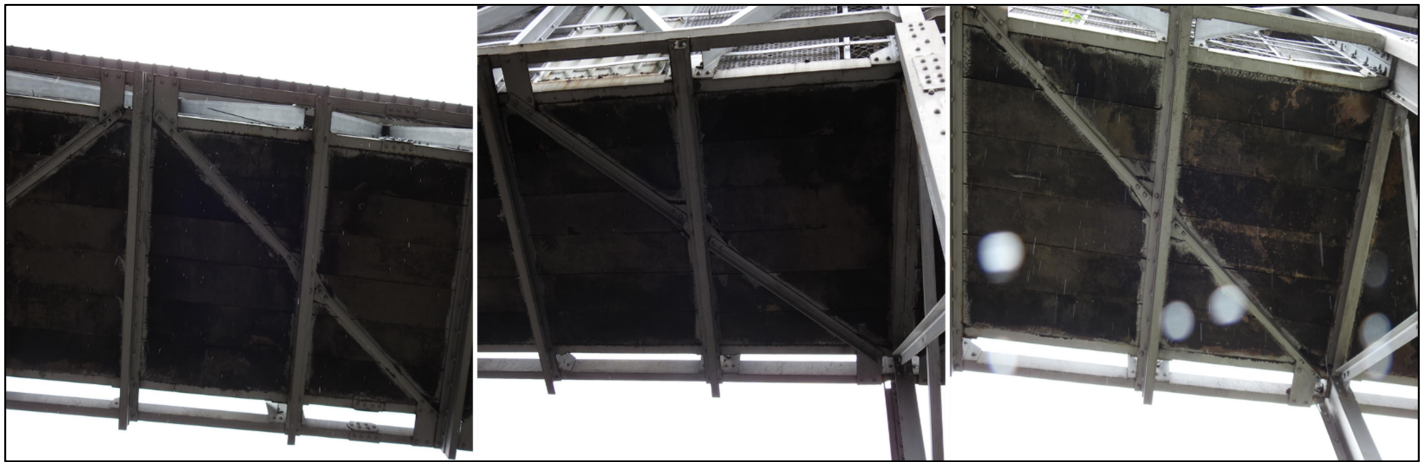
| | Condition of Slab from Bottom | Leaching and spalling | |

**Fig 4:** Bottom view Slab panels

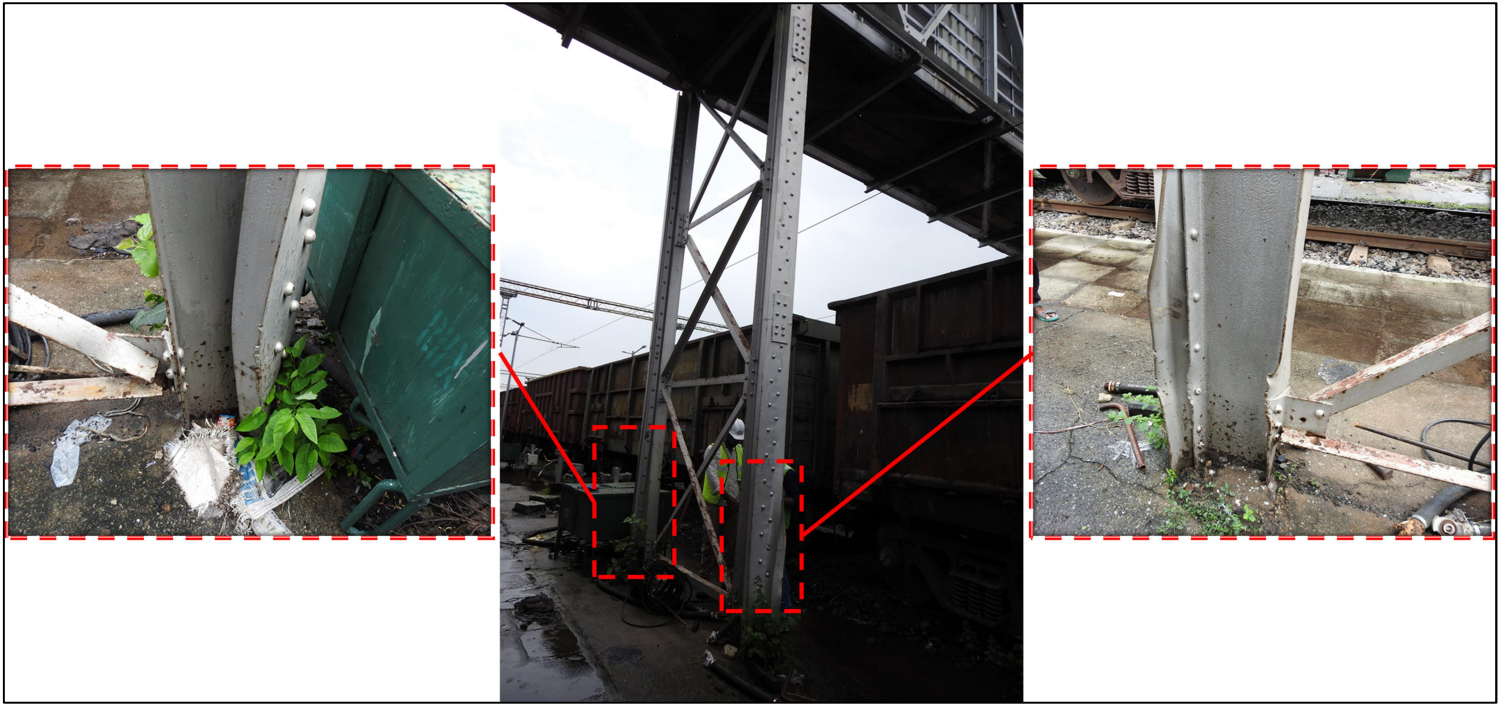
| 1.13 | Damages due to accidental hitting, Grazing Marks | Yes (Damage due to accidental hitting )<br>(Refer <b>fig :6</b> ) |

***Fig 6:*** Accidental damage observed at stanchion 1
