| <b>Name of the Project</b> | <b>:</b> | <b>VISUAL INSPECTION OF FOB/ PF-1 - PF-2 AT MADHIRA RAILWAY STATION</b> |
| <b>Location</b> | <b>:</b> | <b>MADHIRA RAILWAY STATION</b> |
| <b>Date of Inspection</b> | <b>:</b> | <b>23<sup>rd</sup> SEPTEMBER, 2019</b> |

**FORMAT FOR VISUAL INSPECTION OF STEEL FOOT OVER BRIDGE**

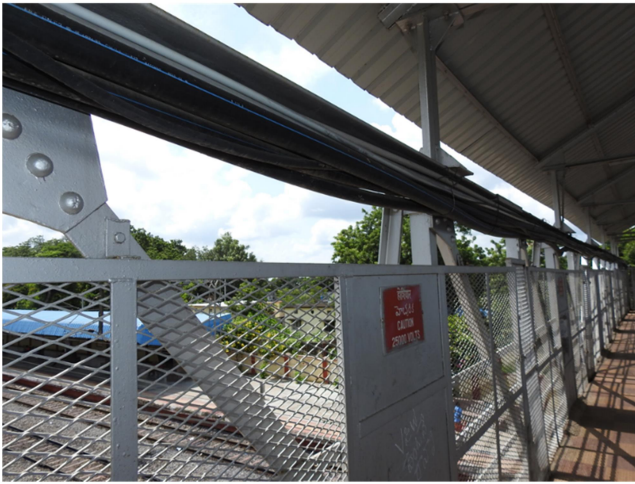
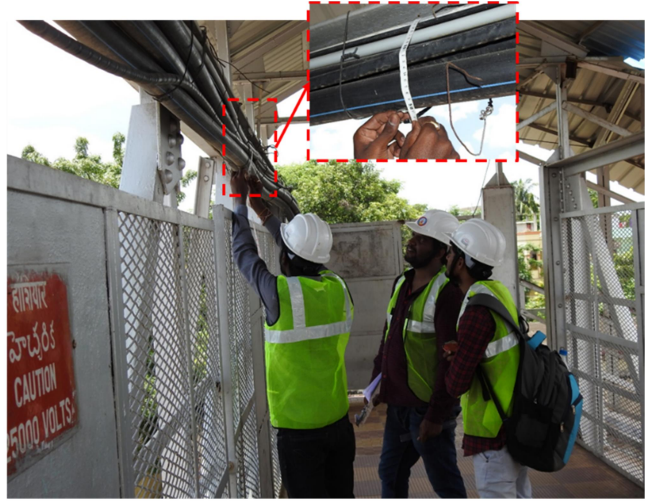
| | | Yes/No | Notes |
|---|---|---|---|
| | b) Cables | Yes | Set of Cables are running along the length of FOB, Approximate circumference of cables is 500 mm (Refer <b>fig : 3</b> ) |

**Fig 3:** Bunch of Cables running along the length of FOB, Approximate circumference is 500 mm

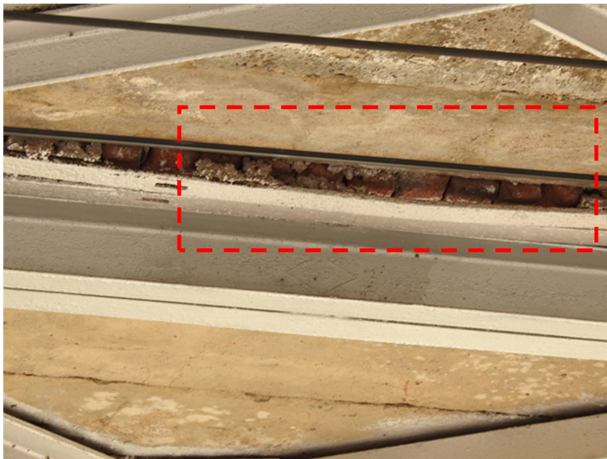
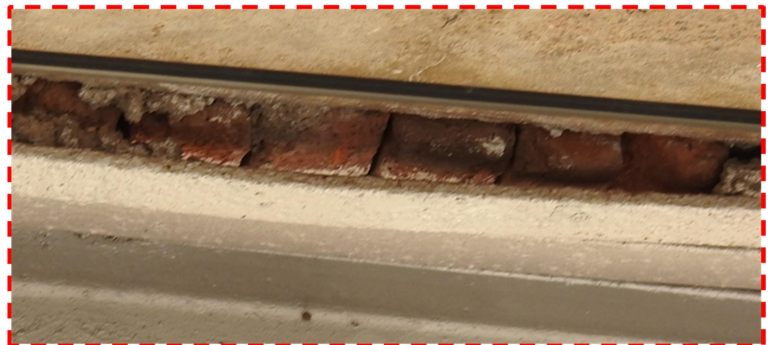
**Fig 6:** Gap above floor beam

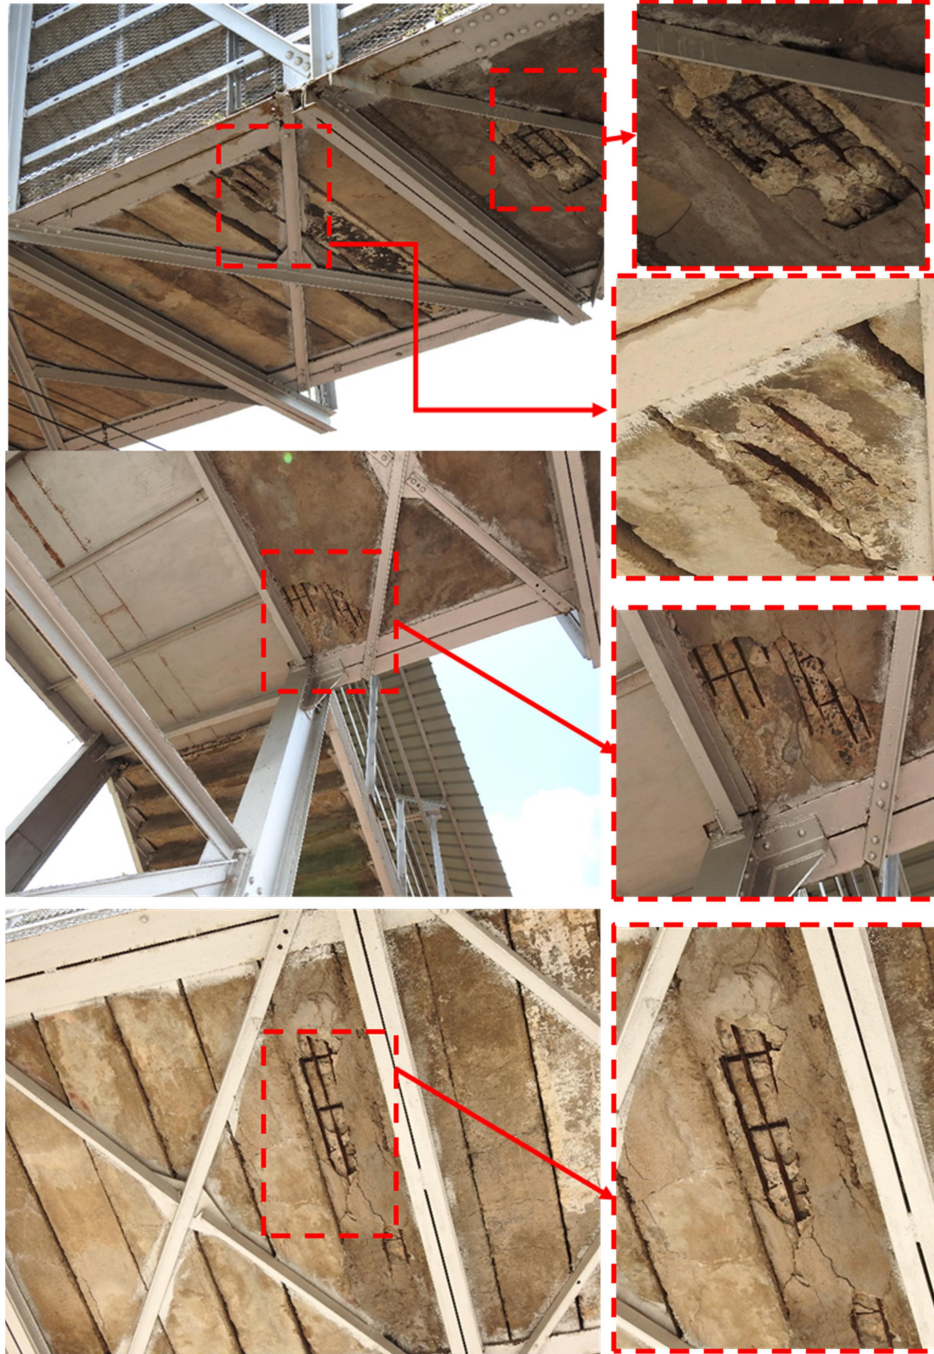
| | Material of Slab | Pre-cast slabs | a) Pre-cast Reinforced Concrete Slab panels<br>are used for floor slab of 100 mm thick,<br>Pre-cast RCC slab panels are resting on<br>bottom chord members. Chequered tile (25<br>mm thick) flooring is laid on the top of the<br>Pre-cast slab panels. (Refer <b>fig : 7</b> )<br>b) Almost all the panels are having minor<br>cracks and some of the slab panels are<br>repaired.<br>c) Slab panels near to the platform 2 are<br>distressed, spalling observed at the bottom of<br>the slabs and reinforcement is exposed and<br>corroded. (Refer <b>fig :7</b> )<br>d) Bricks are used to fill the gap above floor<br>beam<br>e) Landing of Platform 1 is repaired with |
| | Condition of Slab from<br>Bottom | Spalling and Cracks<br>observed | |

| PART 4 SURVEY OF SIGNS OF DISTRESS, DEFORMATION IN BRIDGES | | | |
|---|---|---|---|
| | Spalling | | Spalling is observed in Slab panels |

**Fig 7:** Spalling observed in deck slab

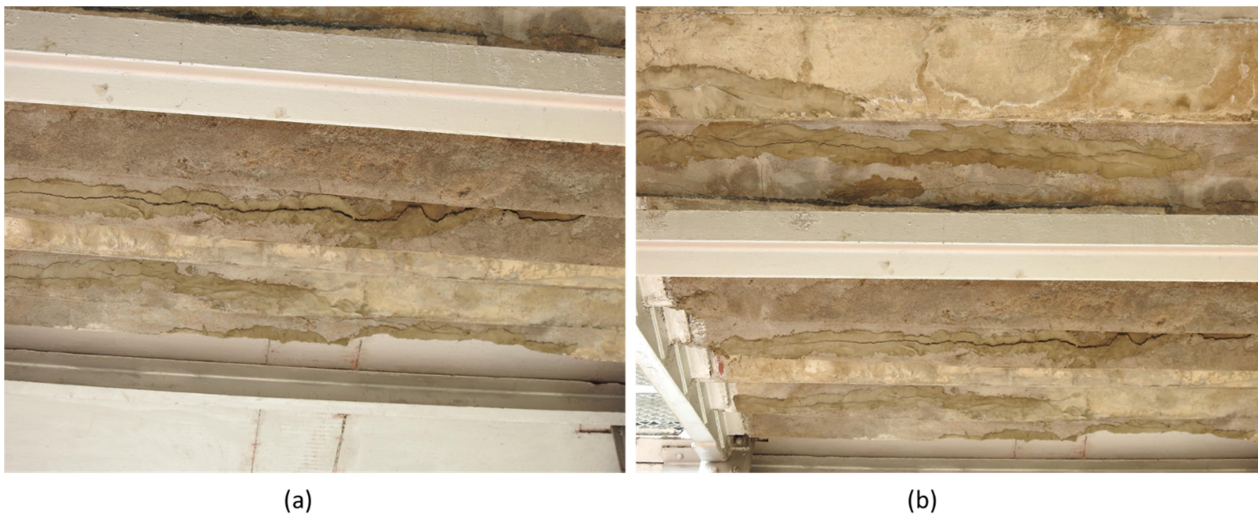
| | Number of Staircase | 2 No's | a) Staircase steps are observed as Pre-cast RCC slab panels of size 300 x 100. Steps are supported on ISMC 250 Channel using cleat Angles. Staircase Landing of 1.56 m wide is supported on Vertical Angle and Horizontal Channel Members. (Refer <b>fig :8</b> )<br>b) Steps are repaired at bottom with cement motor. (Refer <b>fig :8</b> )<br>c) Reinforcement is exposed and corroded. (Refer <b>fig : 7</b> )<br>d) At platform 2, under the staircase, room is constructed, full of debris. (Refer <b>fig :9</b> ) |

| PART 4 SURVEY OF SIGNS OF DISTRESS, DEFORMATION IN BRIDGES | | | |
|---|---|---|---|
| | Cracking in RCC components | Slab panels | Cracks are observed in Staircase and Pre-cast deck slab panels |

**Fig 8:** Cracks are observed in staircase steps

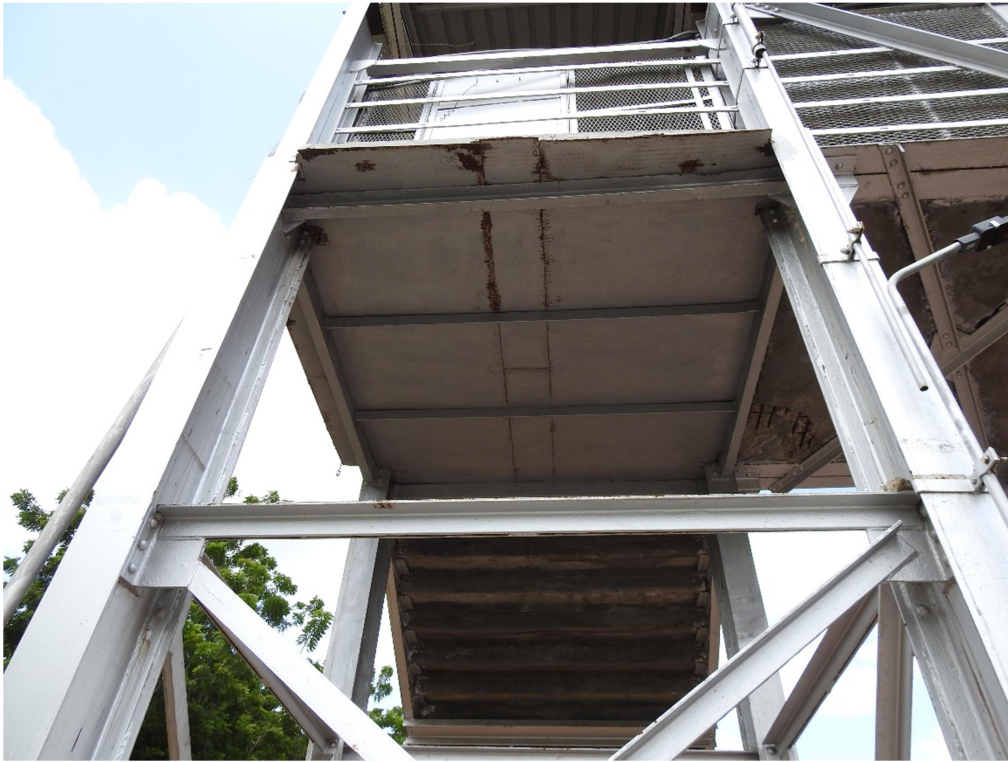
| | | | cement motor<br>Platform 2 staircase slab is having sacrificial plate. (Refer <b>fig :9</b> ) |

***Fig 9:*** Landing on platform 2.
