| <b>Name of the Project</b> | <b>:</b> | <b>VISUAL INSPECTION OF FOB/ HYD CIRCULATING AREA TO PUBLIC GARDEN CIRCULATING AREA</b> |
| <b>Location</b> | <b>:</b> | <b>HYD CIRCULATING AREA TO CIRCULATING AREA</b> |
| <b>Date of Inspection</b> | <b>:</b> | <b>16<sup>th</sup> September 2019</b> |

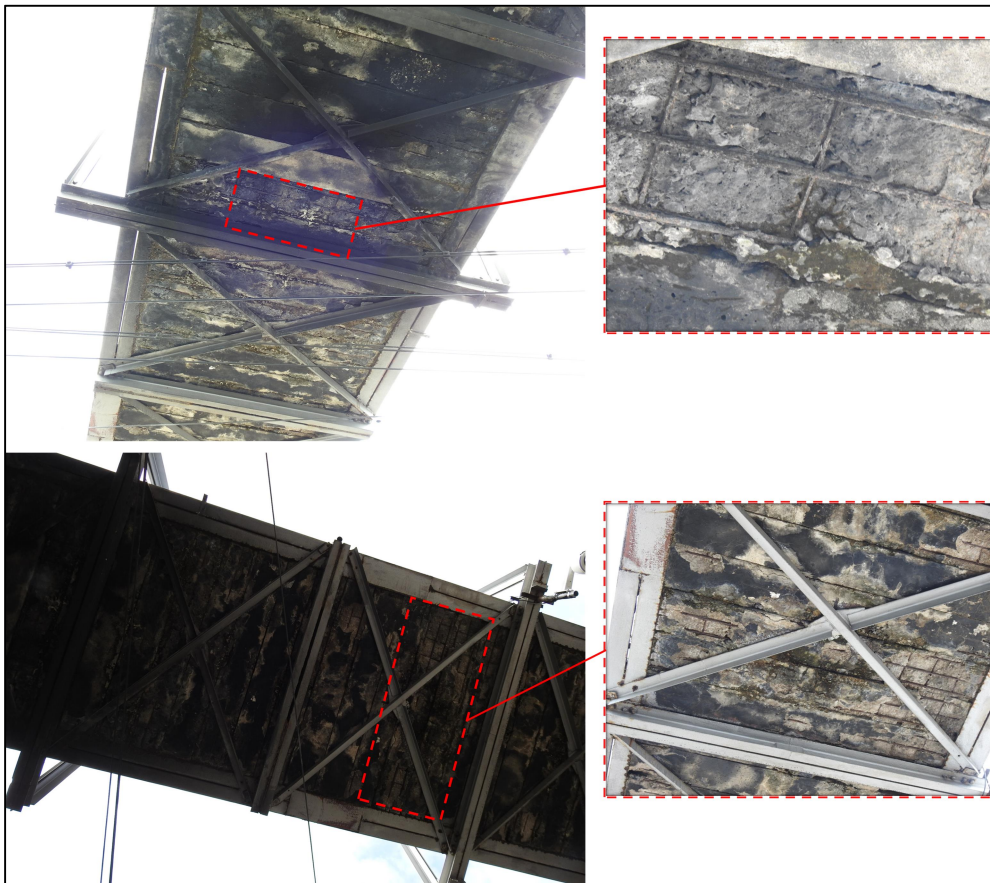
| | Condition of Slab from Bottom | Leaching effect, spalling and exposed reinforcement in observed | |

4.1 | ✓ Reinforcement exposed in slab, formation of algae, leaching of slab is observed.

Spalling and Reinforcement exposed

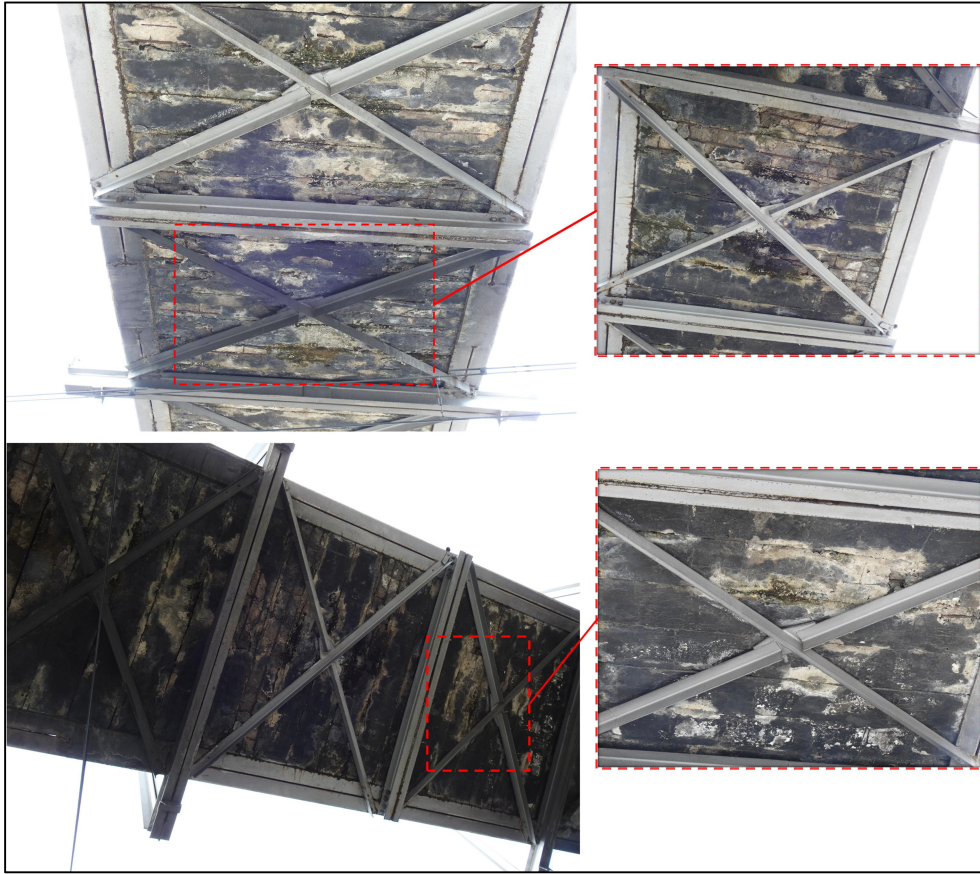
Leaching effect and algae

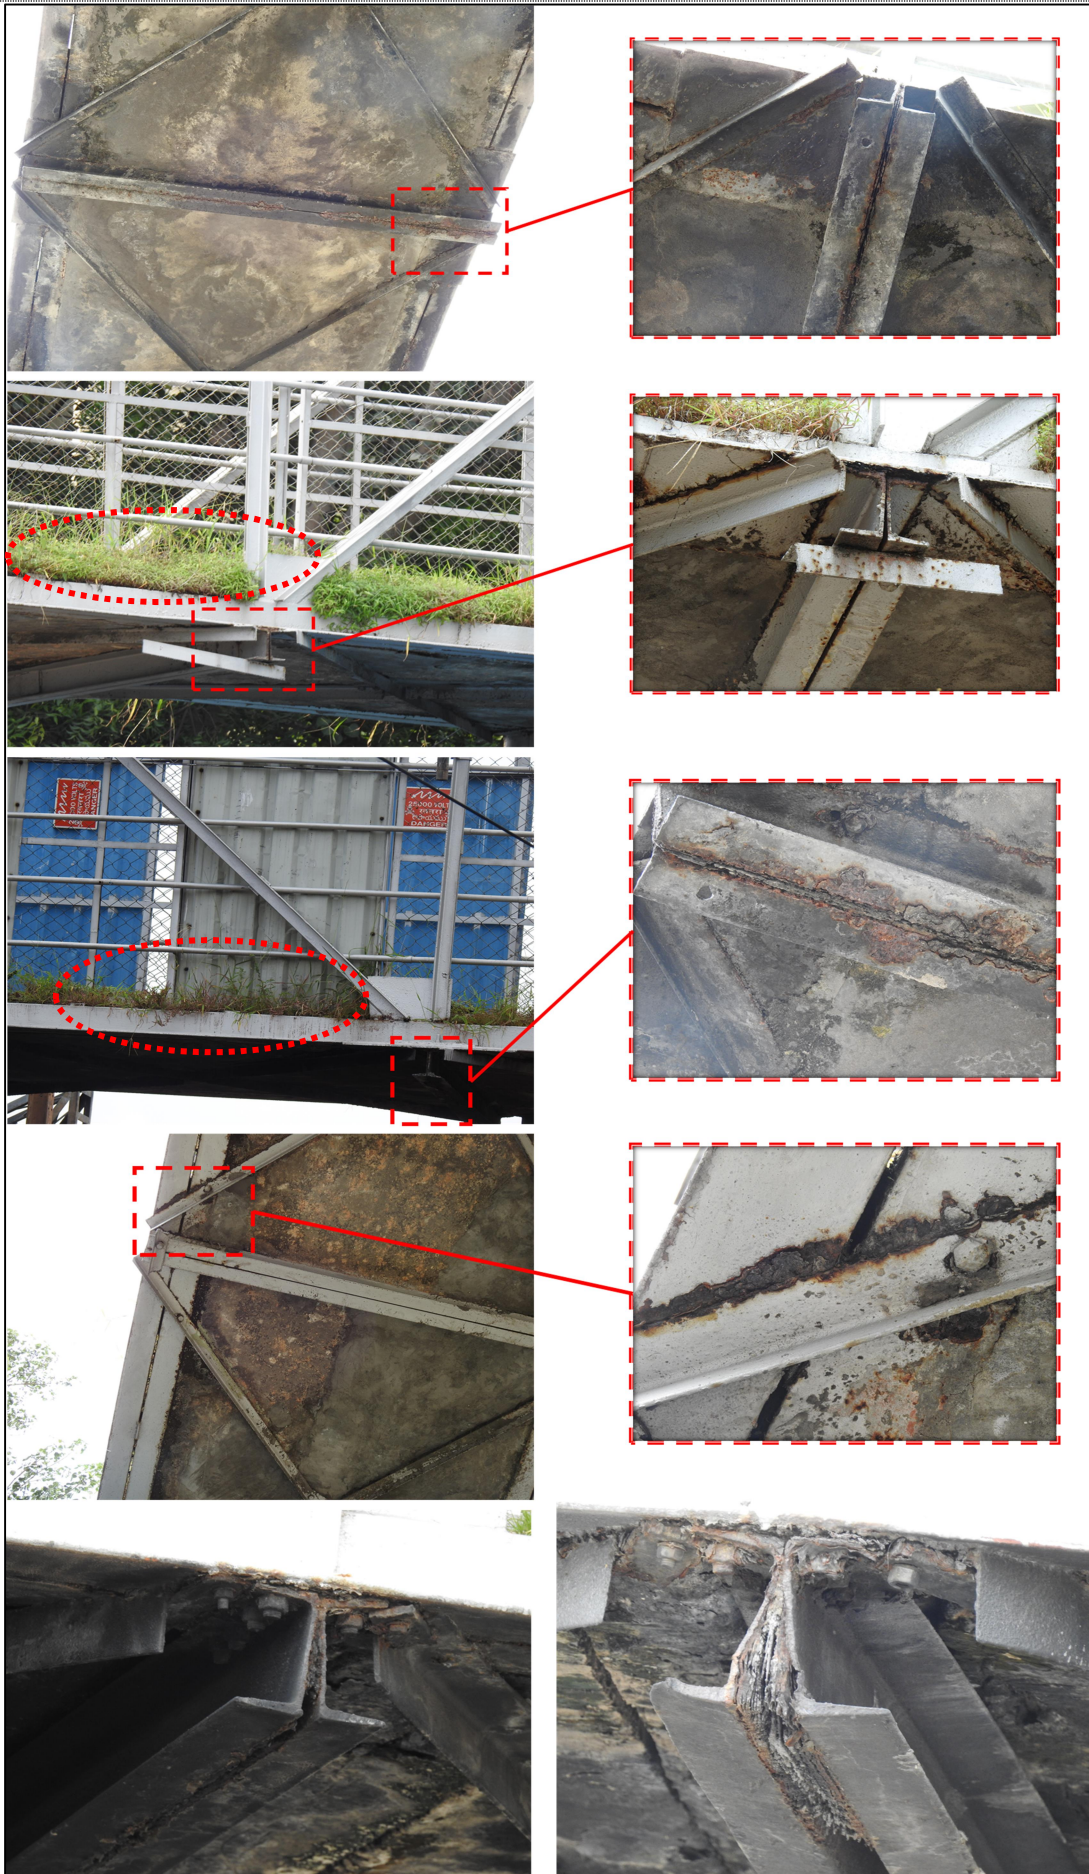
| 4.2 | ✓ Corrosion and vegetation observed in floor beams and bottom Chord members at span of FOB |

Corrosion and deformation of floor beam

| PART 4 SURVEY OF SIGNS OF DISTRESS, DEFORMATION IN BRIDGES | | | |
|---|---|---|---|
| | Rust straining | Bottom Chord members and floor beams joints | Rusting and corrosion is observed at joints of floor beam gusset plate connecting bottom Chord is observed. (Refer <b>Part 4 - 4.2</b> ) |
| | Rusting in Gusset plate | | Rusting is observed in Gusset plates (Refer <b>Part 4 - 4.2</b> ) |

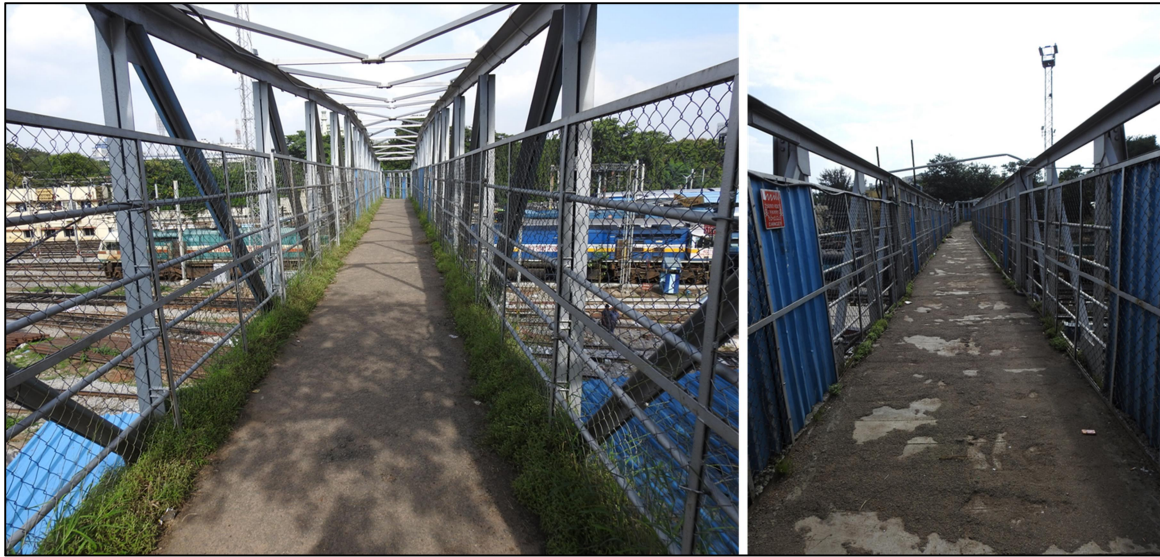
**Fig 1:** Cables, Flooring, vegetation and protective screen

| PART 2 IDENTIFICATION OF LOADS ON BRIDGE | | | |
|---|---|---|---|
| | a) Additional wearing coat on Floor | Yes | Plain concrete flooring (Refer <b>fig :1</b> ) |

| | Element of roof truss section | No roof truss | ISA 65 x 65 x 6 mm angle section as top bracings in span 1.<br>(Refer <b>fig :1</b> ) |

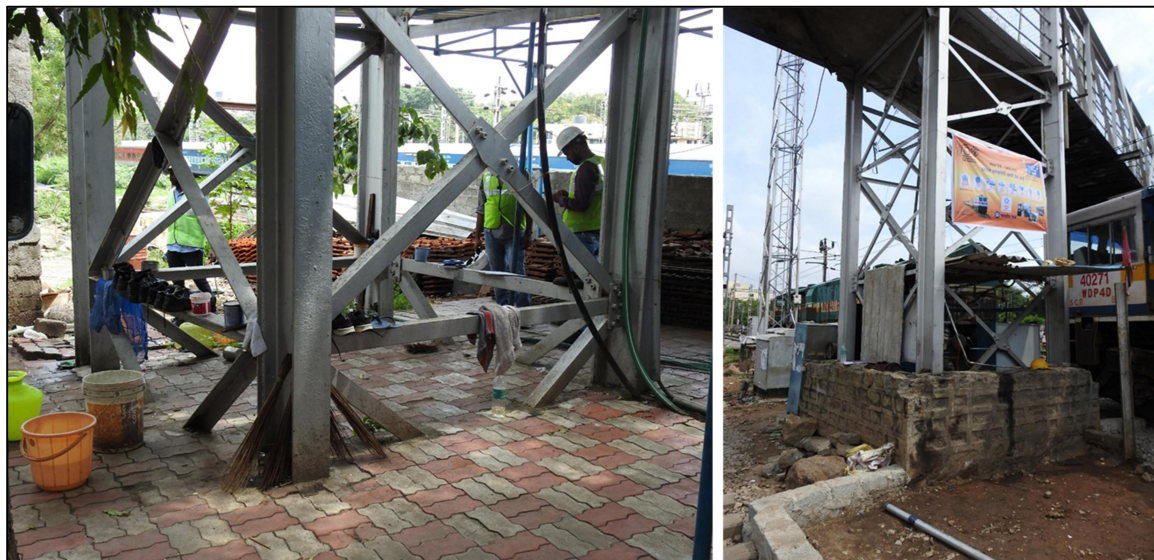
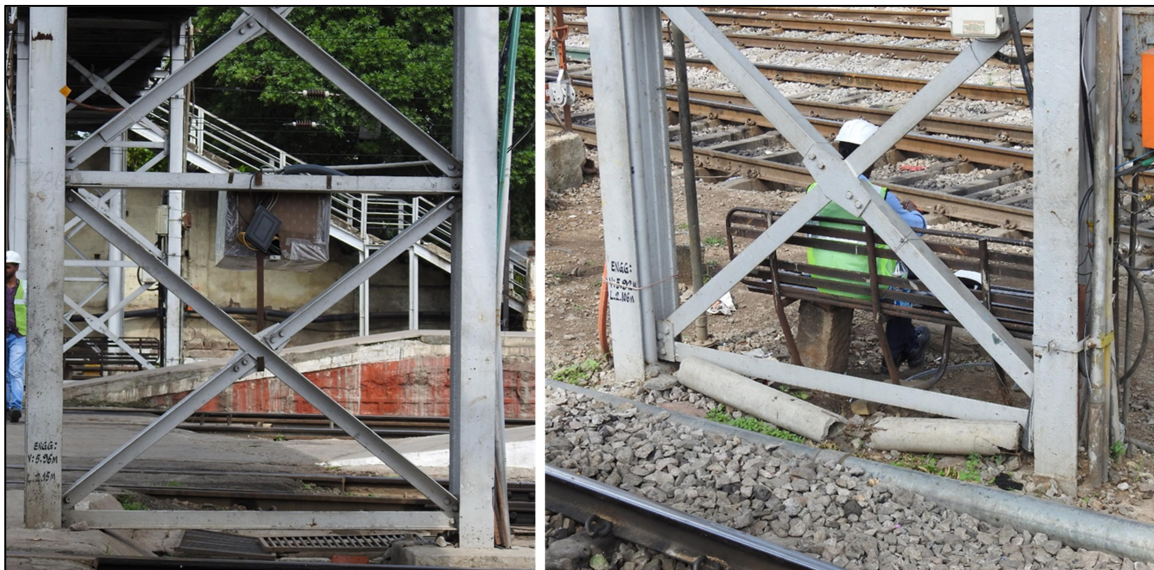
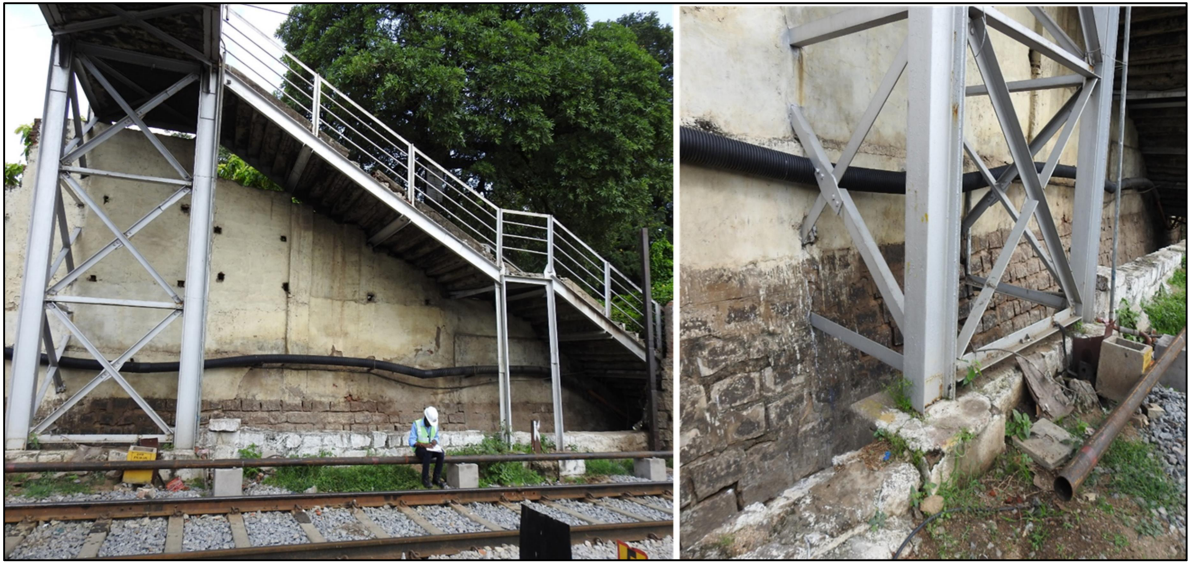
**Fig 2:** Trestles details

| PART 3 STRUCTURAL SYSTEM OF THE BRIDGE | | | |
|---|---|---|---|
| | Column – Trestles Connection Details | | Concrete encasement is observed at platform level for vertical supports. (Refer <b>fig :2</b> ) |

| | Type/Shape of Column section | Built up section (ISMB 300 and MS plate 300 ) | FOB is supported on vertical column of Four - Built up section (ISMB 300 and MS plate 300 ) with bracings of ISA 65 x 65 x 6 mm double angle section.(Refer <b>fig :2</b> ) |

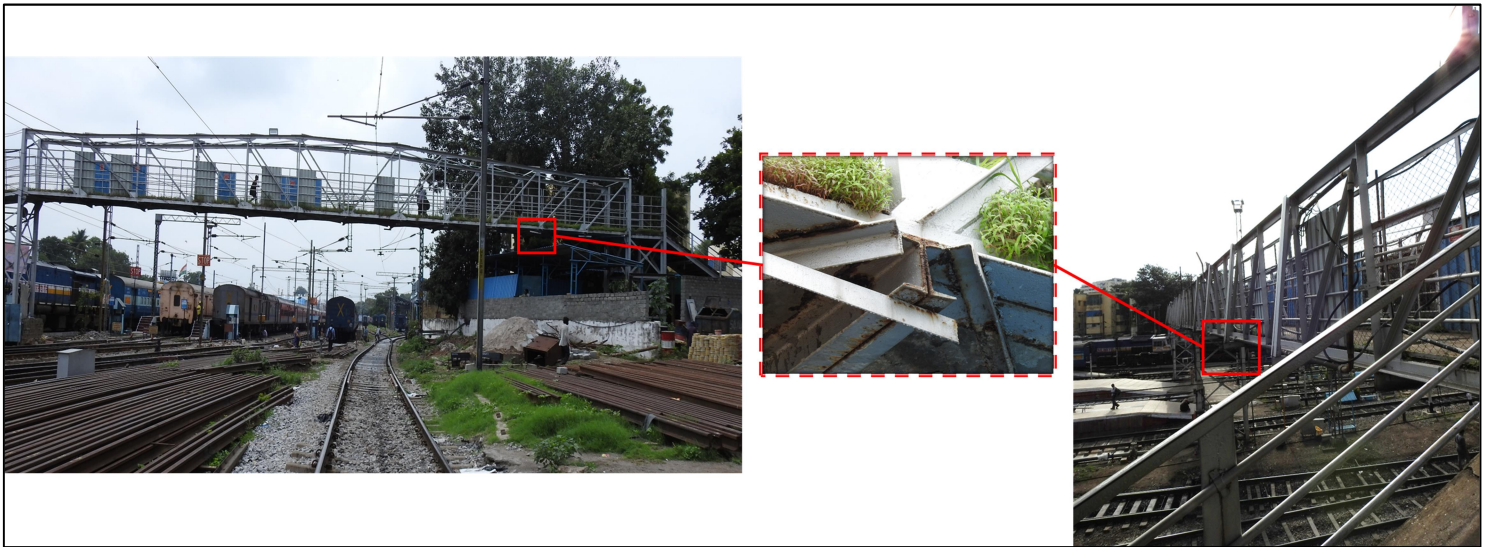
**Fig 3:** Chord members, Floor beams, vertical and diagonal bracings

| | Type/Shape of Girder Section | Double angle sections | a. For 1 <sup>st</sup> span top and bottom Chord members are ISA 150 x 150 x 10mm double angle section and ISA 75 x 75x 10 mm double angle is used for verticals and bracings.<br>b. For 2 <sup>nd</sup> to 4 <sup>th</sup> span top and bottom Chord members are ISA 100 x 100 x 10 mm double angle section are used and ISA 100 x 100 x 10 mm angle section are used for vertical members and ISA 80 x 80 x 8 mm used for diagonal bracing members.<br>c. ISMC 150 double channel section used as Floor beams supported with ISA 80 x 80 x 8 mm bracing connected through gusset plate. (Refer <b>fig :3</b> ) |

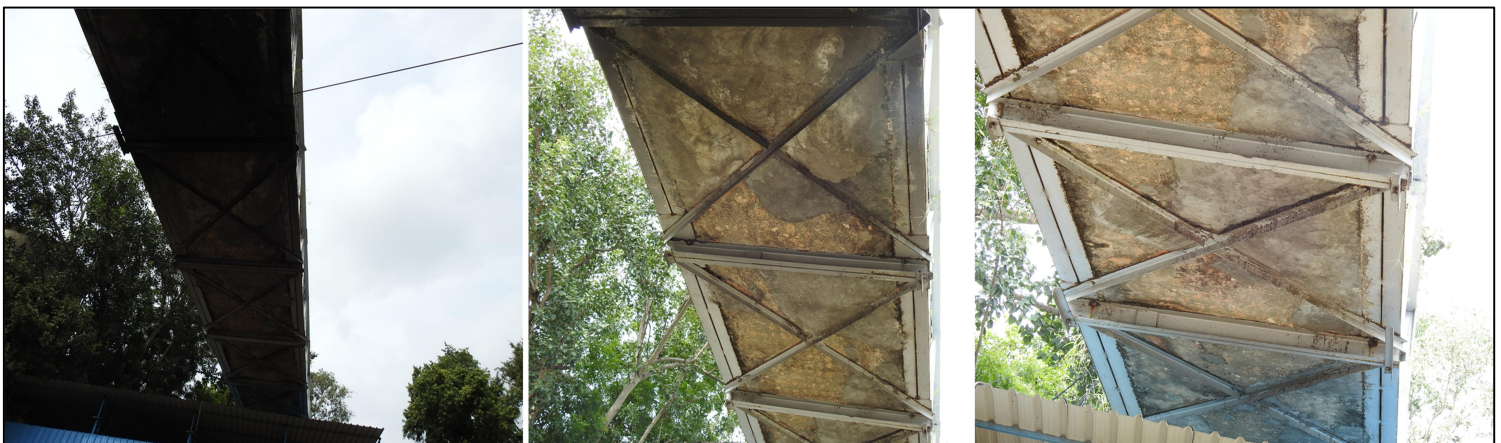
**Fig 4:** Bottom view Slab and Repair work

| | Material of Slab | RCC slab | RCC slab, 125 mm thick is resting on bottom chord. (Refer <b>fig :4 and fig:1</b> ) |

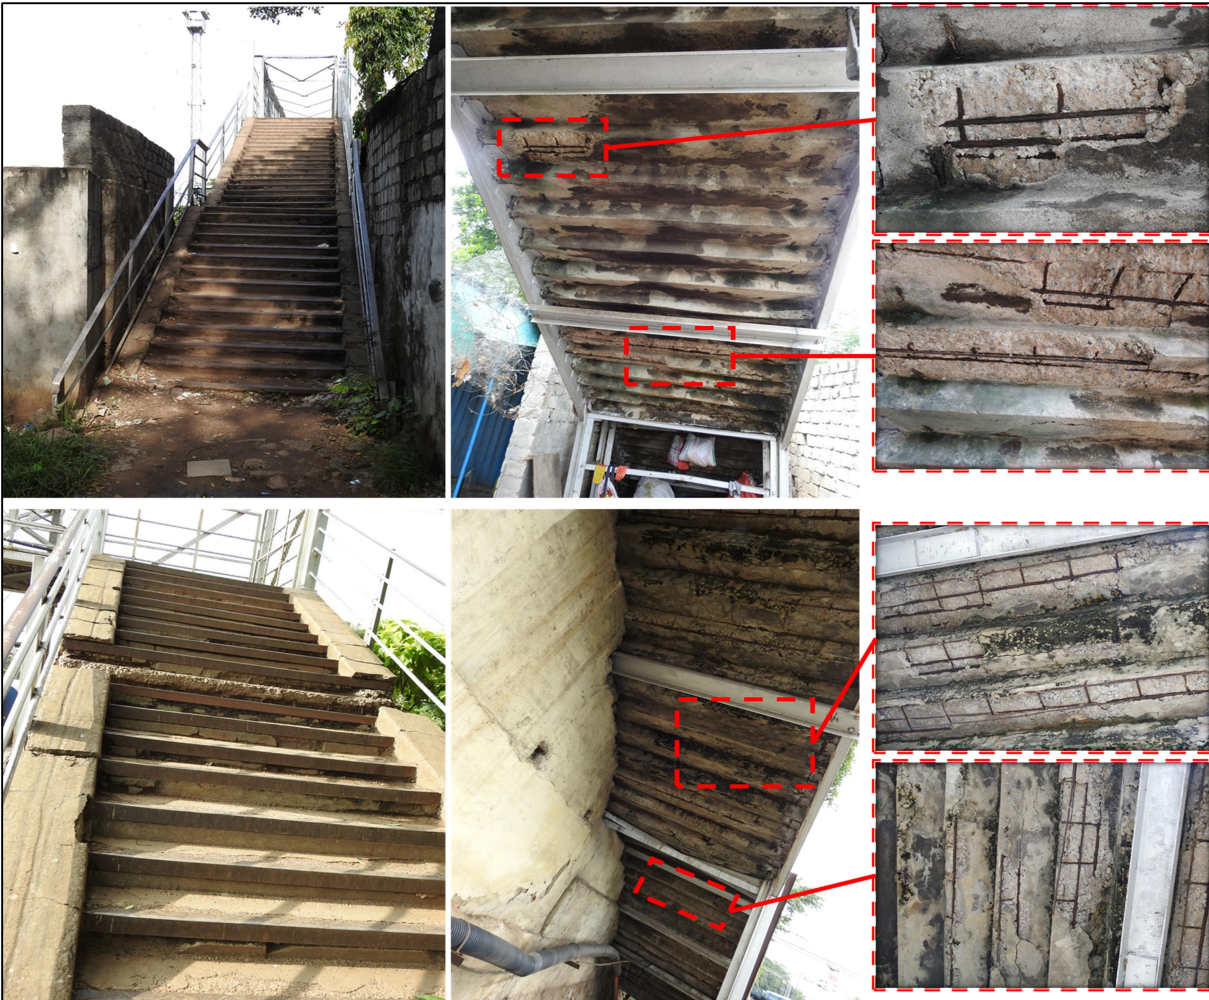
***Fig 5:*** Staircase details, Spalling & exposure of reinforcement

| | Number of staircases | 2 No's | Staircase steps are observed as Pre-cast slab panels. Steps size of 300 x 100 mm are supported on ISMC 250 channel Stringer beam. Bracings ISA 65 x 65 x 6 mm angle section connected to ISMC 200. Staircase landing of 2.12 m wide is supported on ISMC 250. (Refer <b>fig :5</b> ) |

| | Type of Parapet Railing | Steel railing | Staircase is provided with railing on both sides of one-meter height using ISA 65 x 65 x 8 mm angle section and 50 x 6 mm M.S flats are used.(Refer <i>fig :5</i> ) |

| PART 4 SURVEY OF SIGNS OF DISTRESS, DEFORMATION IN BRIDGES | | | |
|---|---|---|---|
| | Spalling | Slab and staircase precast panels | Spalling and reinforcement exposed is observed (Refer <b>Part 4 - 4.1</b> ) and (Refer <b>fig :5</b> ) |
