| <b>Name of the Project</b> | <b>:</b> | <b>VISUAL INSPECTION OF FOB/ PF-1 - PF-2 AT KHAMMAM RAILWAY STATION</b> |
| <b>Location</b> | <b>:</b> | <b>KHAMMAM RAILWAY STATION</b> |
| <b>Date of Inspection</b> | <b>:</b> | <b>22<sup>th</sup> SEPTEMBER, 2019</b> |

## **FORMAT FOR VISUAL INSPECTION OF STEEL FOOT OVER BRIDGE**

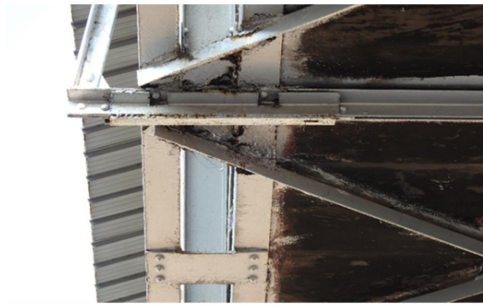
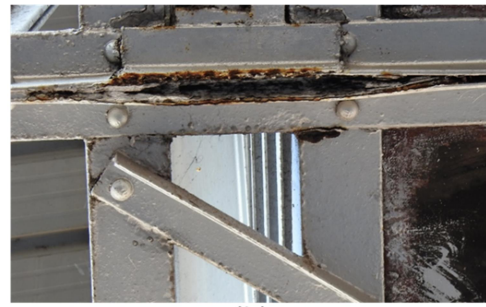
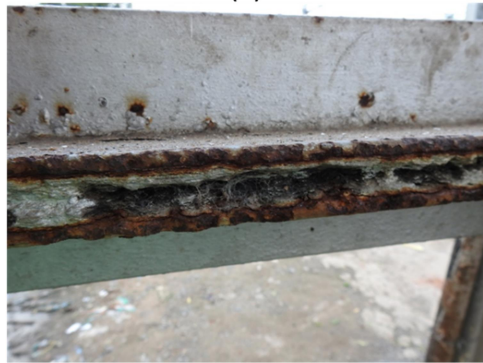
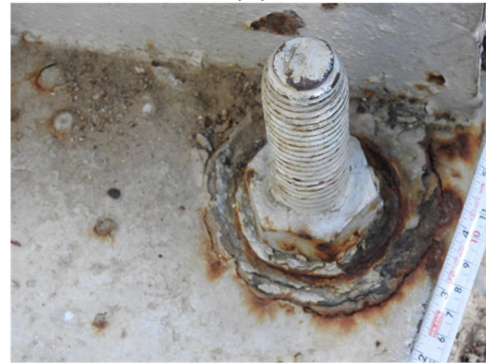
- ✓ Heavy corrosion is observed at bottom slab joint (Gusset plate, Angle sections)

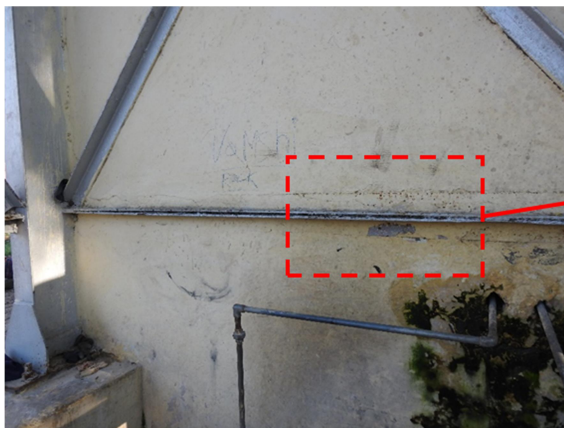
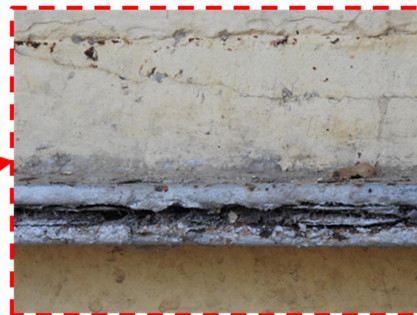
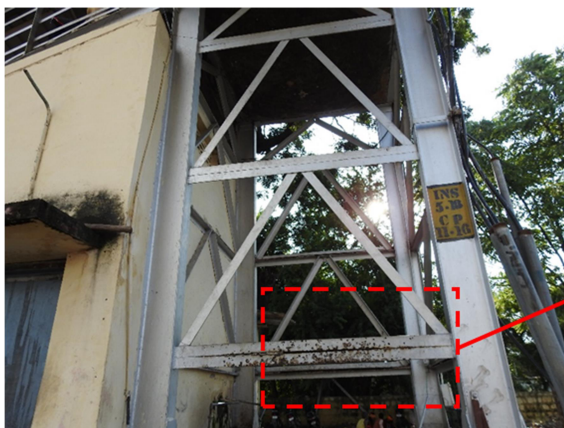
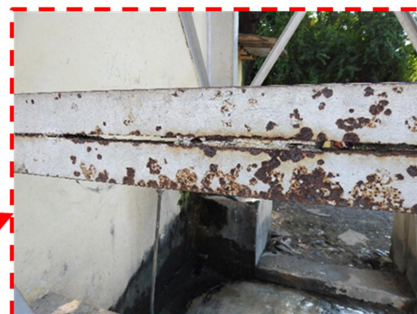
- ✓ Heavy corrosion is observed at Column bracings

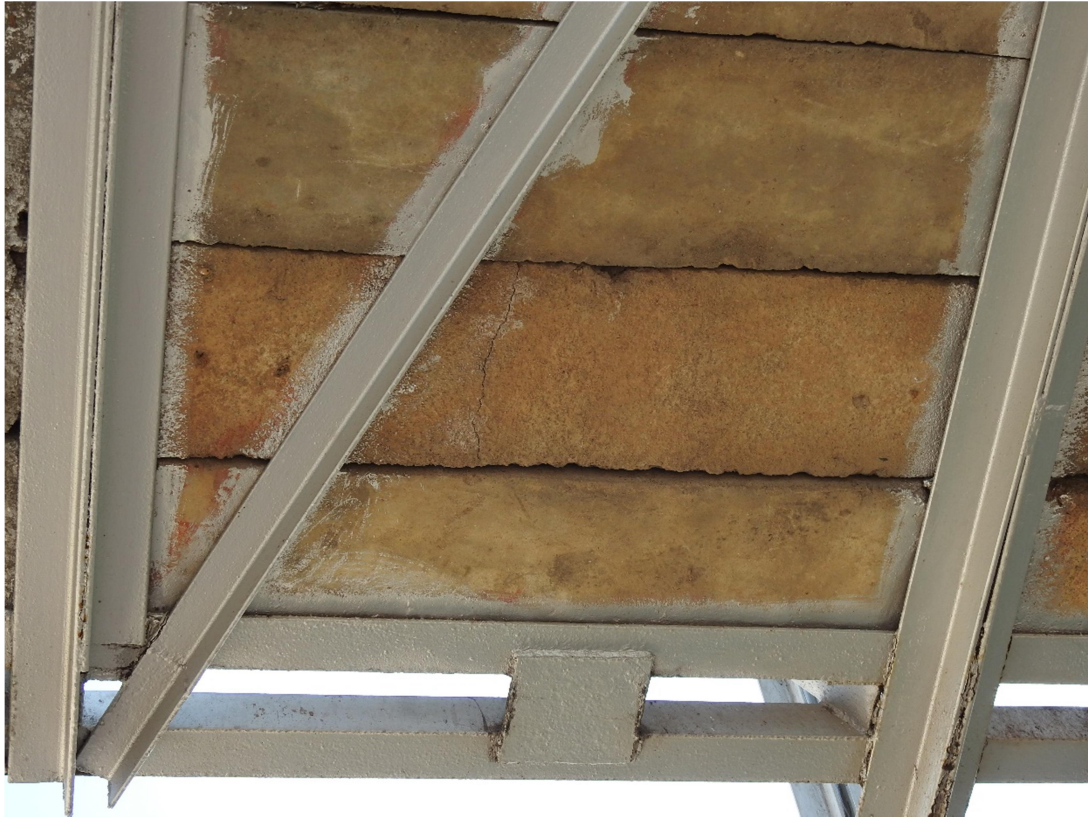
| | Condition of Slab from Bottom | Cracks observed | |

| PART 4 SURVEY OF SIGNS OF DISTRESS, DEFORMATION IN BRIDGES | | | |
|---|---|---|---|
| | Cracking in RCC components | Slab panels | Cracks are observed in Pre-cast RCC slab panels |

**Fig 4:** Cracks are observed in Pre-cast RCC slab panels (bottom view)

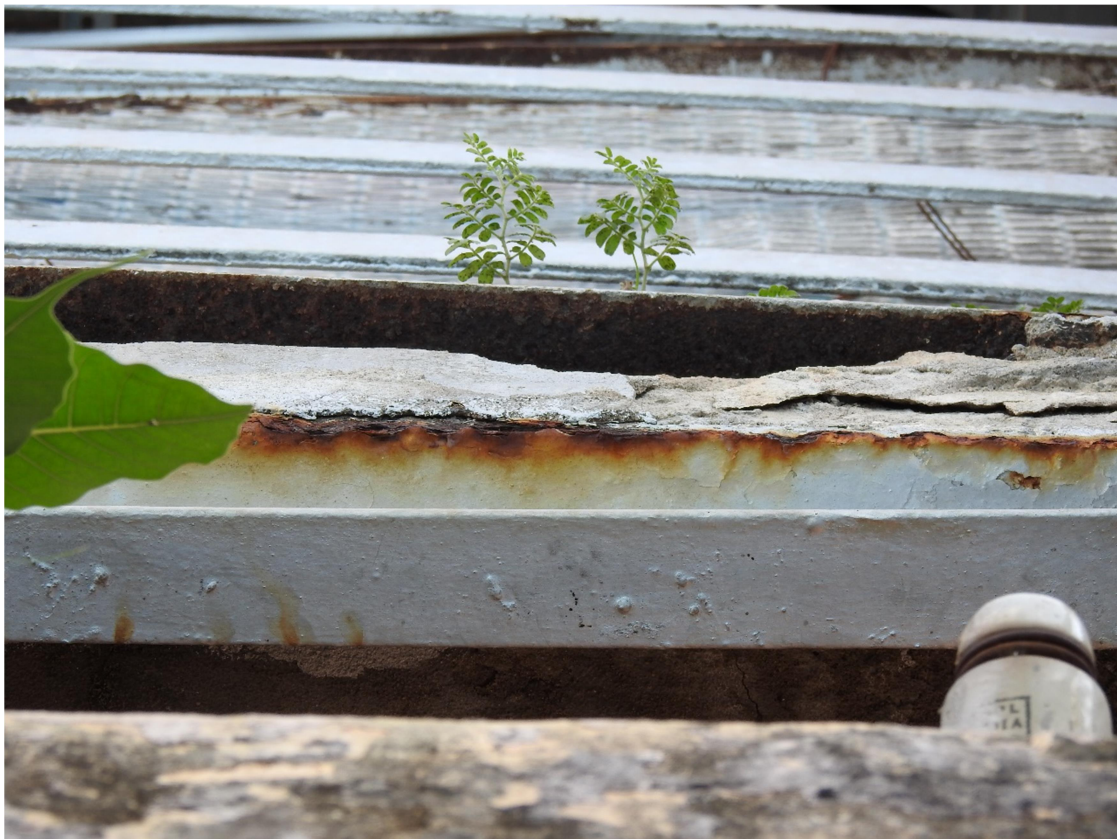
| PART 4 SURVEY OF SIGNS OF DISTRESS, DEFORMATION IN BRIDGES | | | |
|---|---|---|---|
| | Water seepage | | Vegetation is observed along the length of FOB |

**Fig 5:** Vegetation is observed along the length of FOB
