| <b>Name of the Project</b> | <b>:</b> | <b>VISUAL INSPECTION OF FOB/ PF-1 - PF-4 AT WARANGAL RAILWAY STATION</b> |
| <b>Location</b> | <b>:</b> | <b>WARANGAL RAILWAY STATION</b> |
| <b>Date of Inspection</b> | <b>:</b> | <b>25<sup>th</sup> SEPTEMBER, 2019</b> |

## **FORMAT FOR VISUAL INSPECTION OF STEEL FOOT OVER BRIDGE**

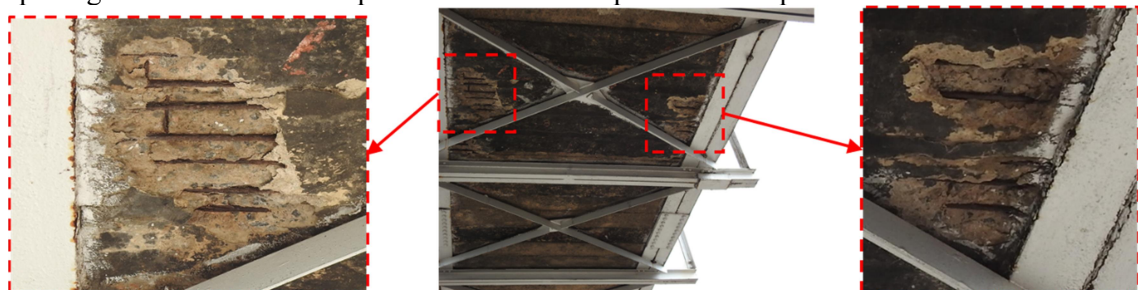
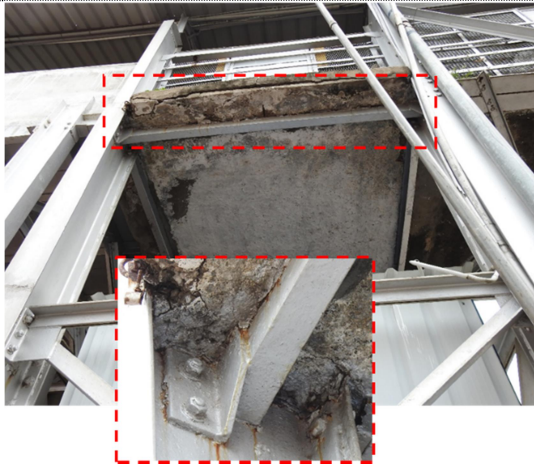
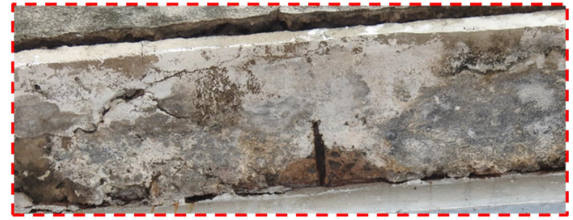
- ✓ Spalling and reinforcement exposure is observed in pre-cast RCC panels

| PART 4 SURVEY OF SIGNS OF DISTRESS, DEFORMATION IN BRIDGES | | | |
|---|---|---|---|
| | Spalling | | Spalling is observed in Slab panels |

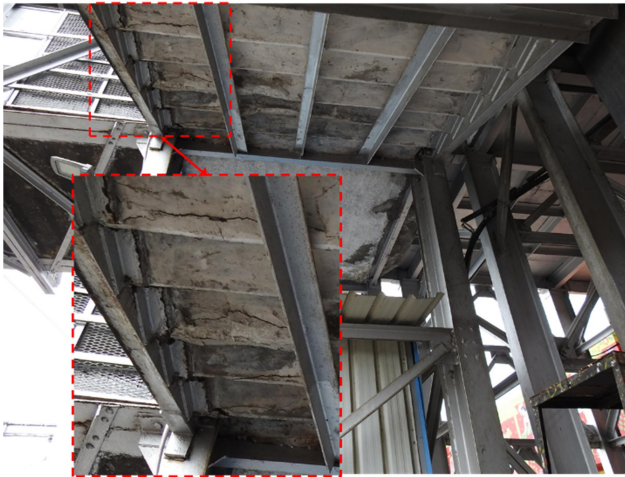
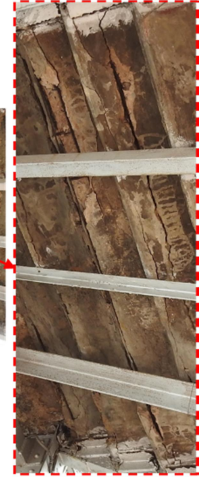
| | Number of Staircase | 3 No's | Staircase steps are observed as Pre-cast RCC slab panels of size 300 x 100 are used. Steps are supported on ISMC 250 Channel stringer beam using cleat Angles. Staircase Landing of 2 m wide is supported on Vertical and Horizontal 100 x 100 x 12 mm Angle Members. Cracks are observed in almost all the steps from bottom in three staircases. |

- ✓ Spalling and Cracks are observed in staircase 1 and 2 steps from bottom

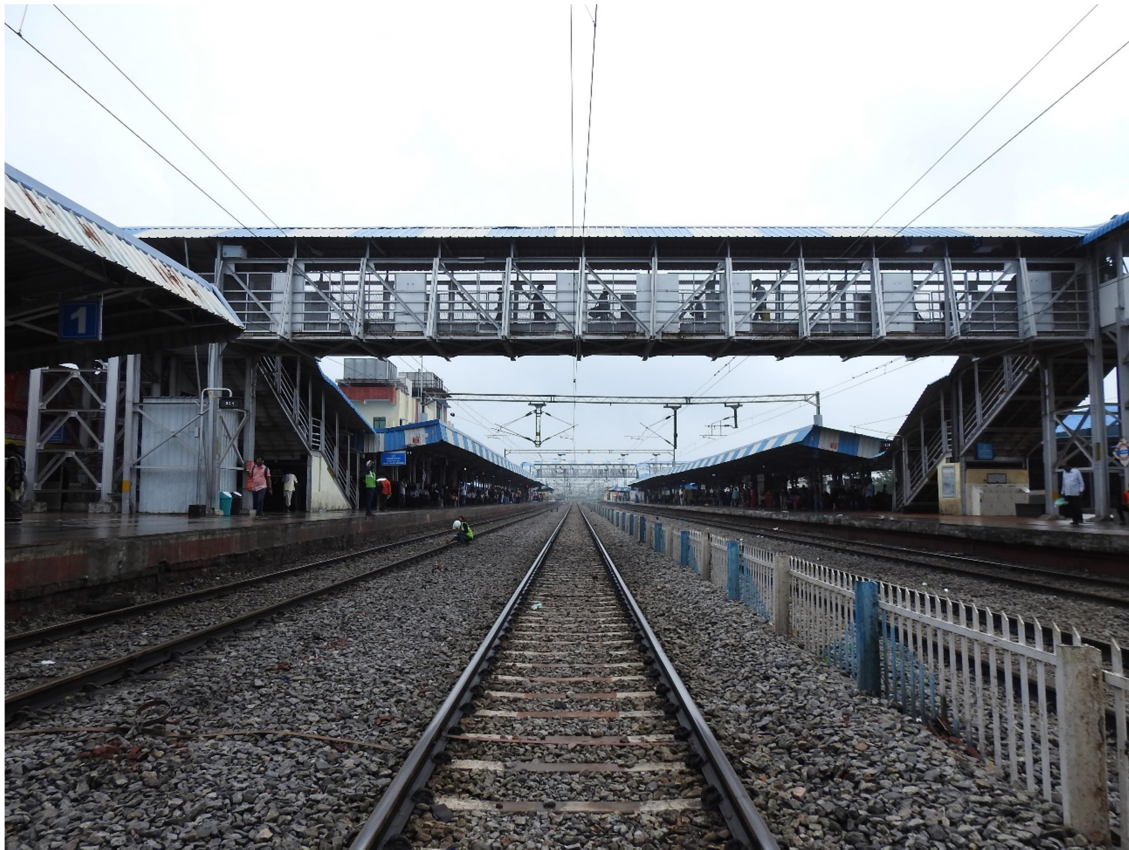
***Fig 1(a):*** Span 1 Front view of FOB towards Khammam

| PART 3 STRUCTURAL SYSTEM OF THE BRIDGE | | | |
|---|---|---|---|
| | Type /Shape of Truss Section | Pratt truss, N- type, Double Angle | <b>Span 1:</b><br>a) Main Chord members 2/150 x 150 x 12 mm Double Angle section.<br>b) 100 x 100 x 12 mm angles are used as Vertical and inclined bracing Members<br>c) 10 mm thick, gusset plate used for welded joint. (Refer <b>fig :1(a)</b> ) |

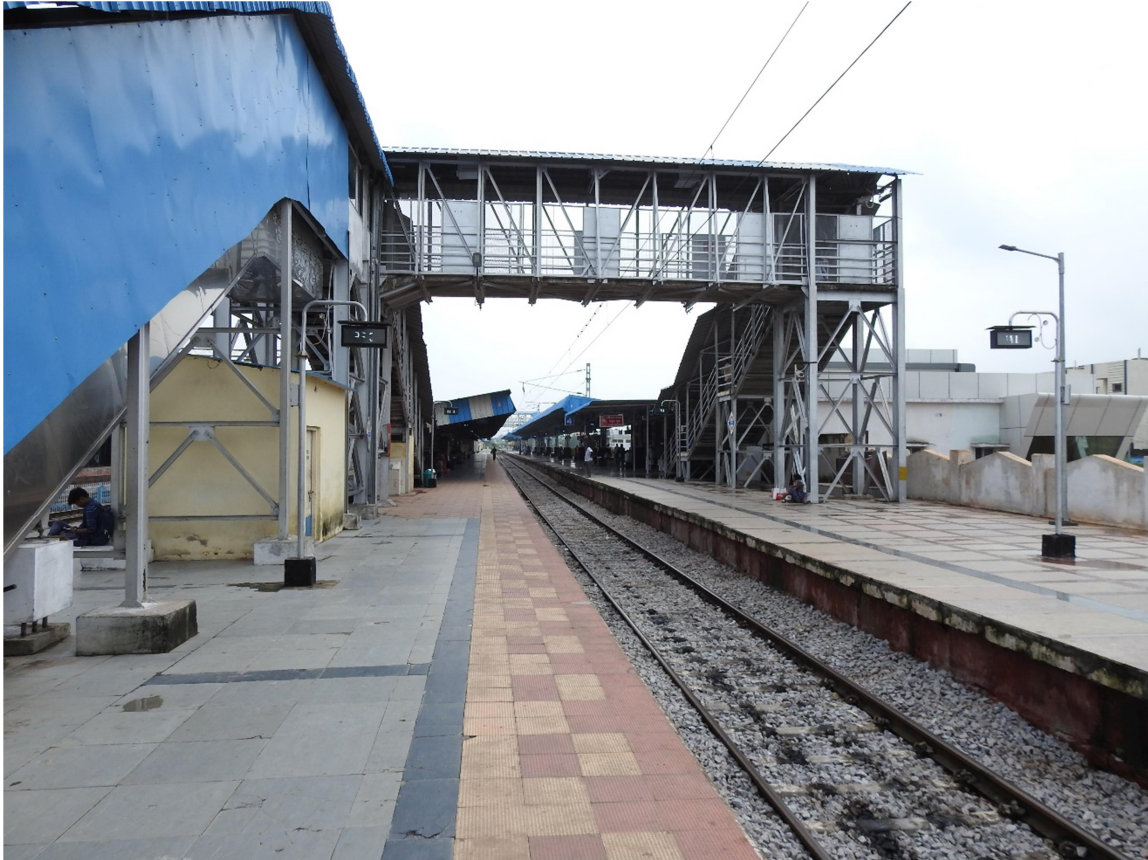
**Fig 1(b):** Span 2 Front view of FOB towards Khammam

| PART 3 STRUCTURAL SYSTEM OF THE BRIDGE | | | |
|---|---|---|---|
| | Boundary Condition | Rigid connection | <b>Span 2:</b><br>a) Main Chord members 2/65 x 65 x 8 mm Double Angle section.<br>b) 65 x 65 x 8 mm angles are used as Vertical posts and bracing Members<br>c) 10 mm thick, gusset plate used for welded joint. (Refer <b>fig :1(b)</b> ) |

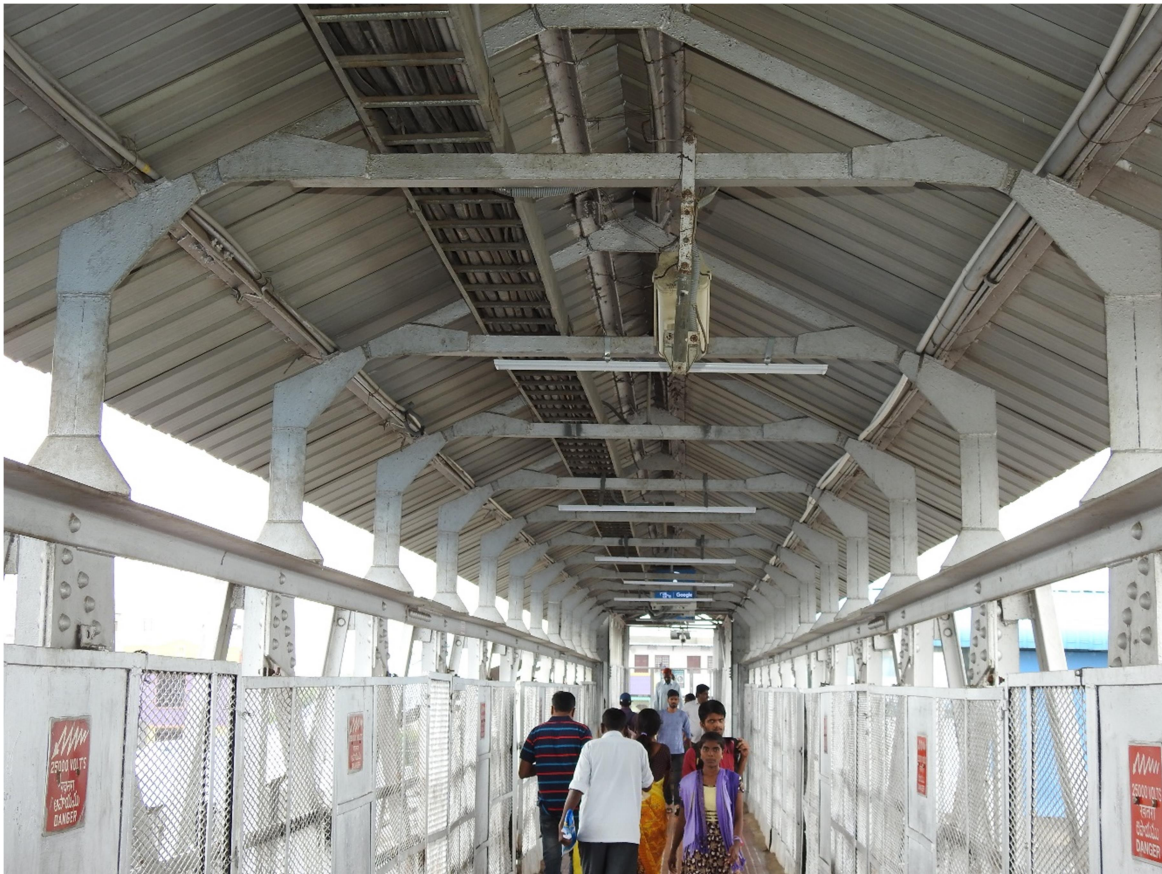
**Fig 2:** Set of cables running along the length of FOB

| | | Yes/<br>No | Notes |
|---|---|---|---|
| | b) Cables | Yes | Set of Cables are running along the length of the FOB (Refer <b>fig : 2</b> ) |

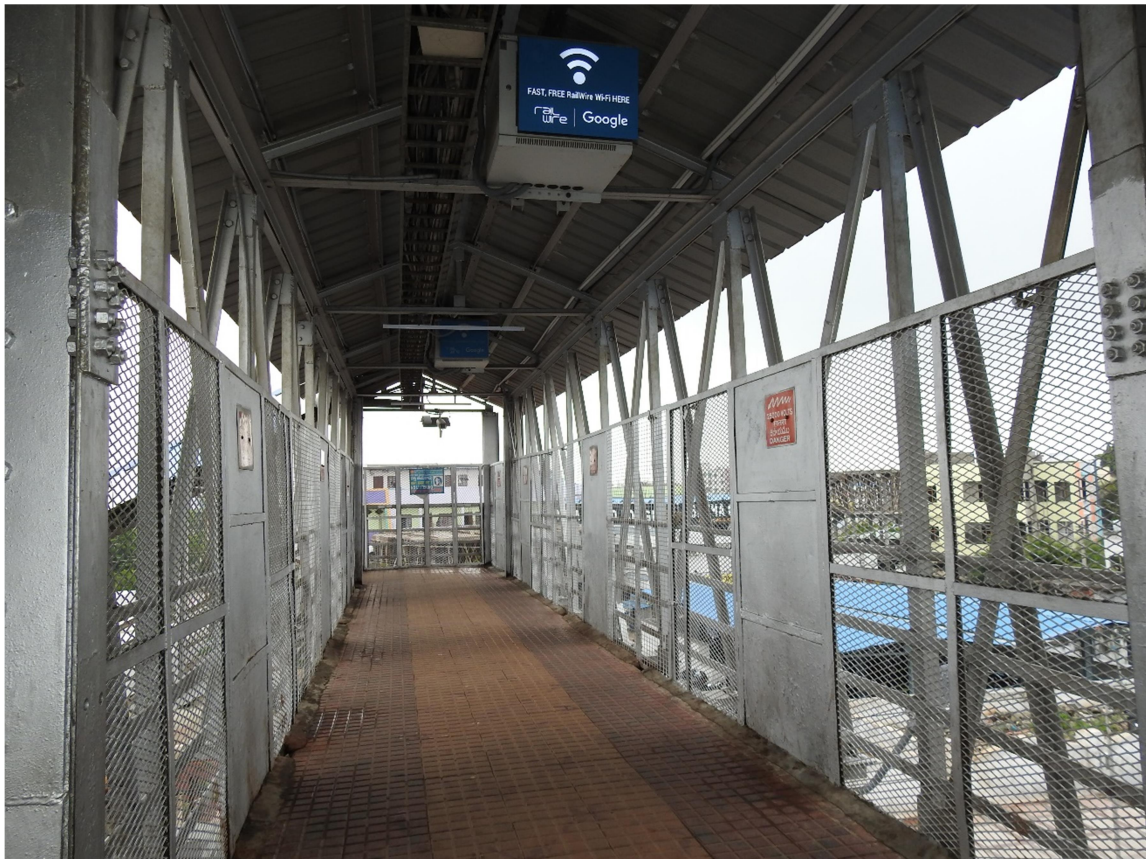
**Fig 3:** Rail Wi-Fi units are supported on roof truss

| | | Yes/<br>No | Notes |
|---|---|---|---|
| | e) load of advertising hoarding | Yes | No Advertising boards are provided.<br>Rail Wi-Fi units are supported on roof truss.(Refer <b>fig :3</b> ) |

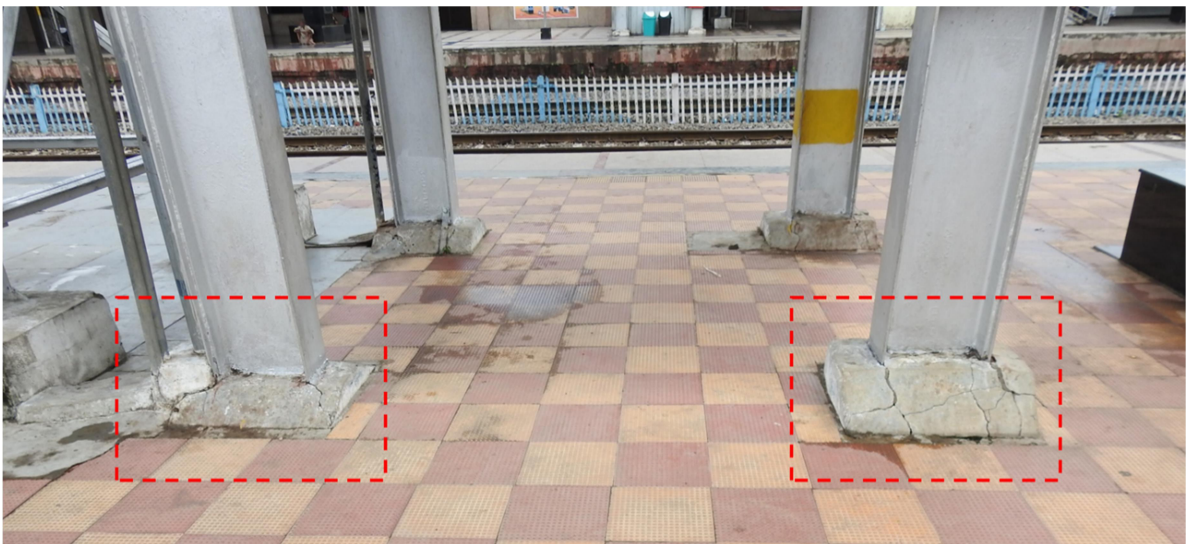
**Fig 6:** Concrete Encasement for vertical trestles on platform 2 are damaged

| PART 3 STRUCTURAL SYSTEM OF THE BRIDGE | | | |
|---|---|---|---|
| | Type of Material for Bottom Encasement | Concrete | Concrete encasement is used for protecting trestles from the corrosion on the platform (Refer <b>fig : 6</b> ) |
