| <b>Name of the Project</b> | <b>:</b> | <b>VISUAL INSPECTION OF FOB/ PF-1 - PF-2 AT TANDUR RAILWAY STATION</b> |
| <b>Location</b> | <b>:</b> | <b>TANDUR RAILWAY STATION</b> |
| <b>Date of Inspection</b> | <b>:</b> | <b>20<sup>th</sup> SEPTEMBER, 2019</b> |

## **FORMAT FOR VISUAL INSPECTION OF STEEL FOOT OVER BRIDGE**

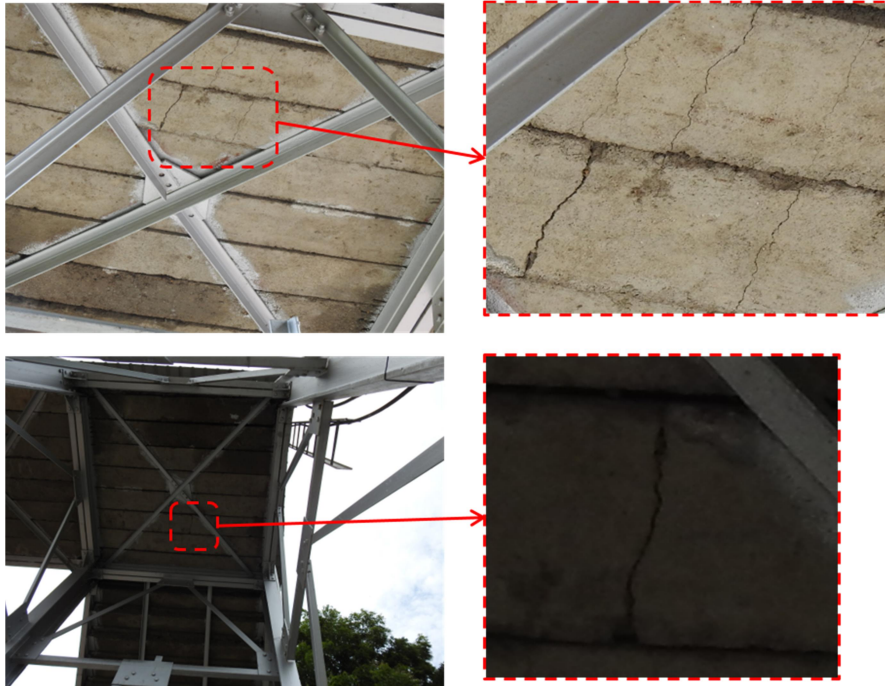
- ✓ Cracks are observed in Pre-cast RCC Slab panels, staircase panels (landing & steps).

**(a) Pathway from bottom**

| PART 4 SURVEY OF SIGNS OF DISTRESS, DEFORMATION IN BRIDGES | | | |
|---|---|---|---|
| | Cracking in RCC components | Slab panels | Cracks are observed in more than 50% of Pre-casted RCC slab panels |

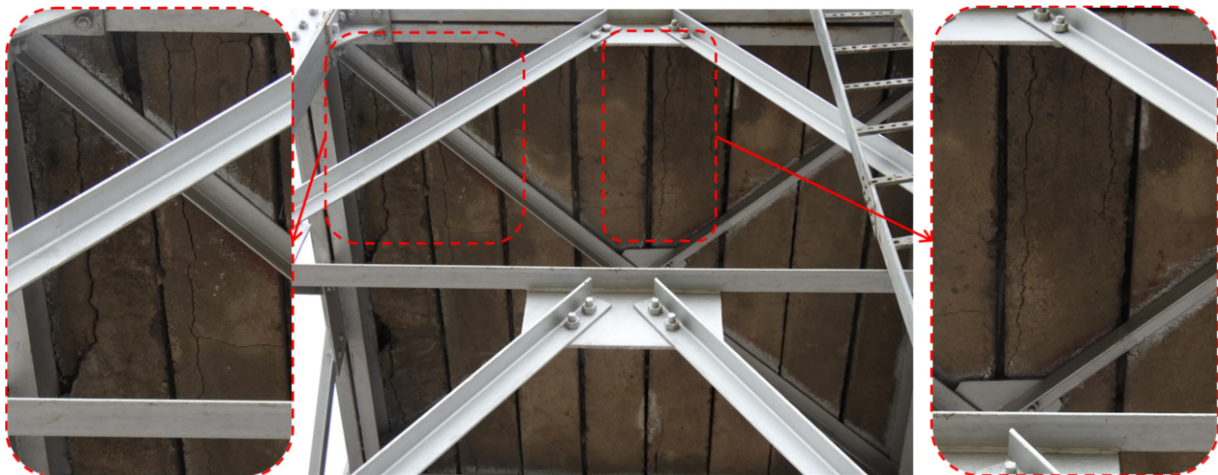
**(b) Pathway from the bottom**

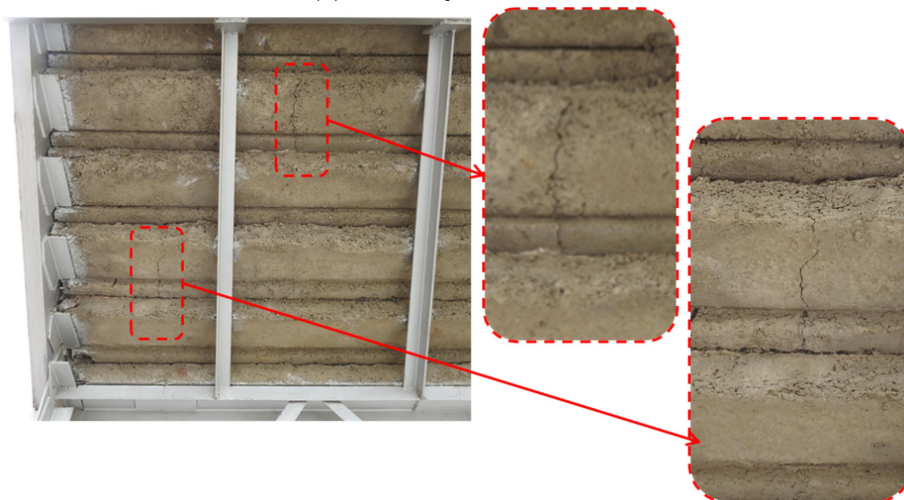
**(c) Staircase from the bottom**

| PART 4 SURVEY OF SIGNS OF DISTRESS, DEFORMATION IN BRIDGES | | | |
|---|---|---|---|
| | Spalling | | Spalling is observed in Slab panels near chord members and at staircase landing. |

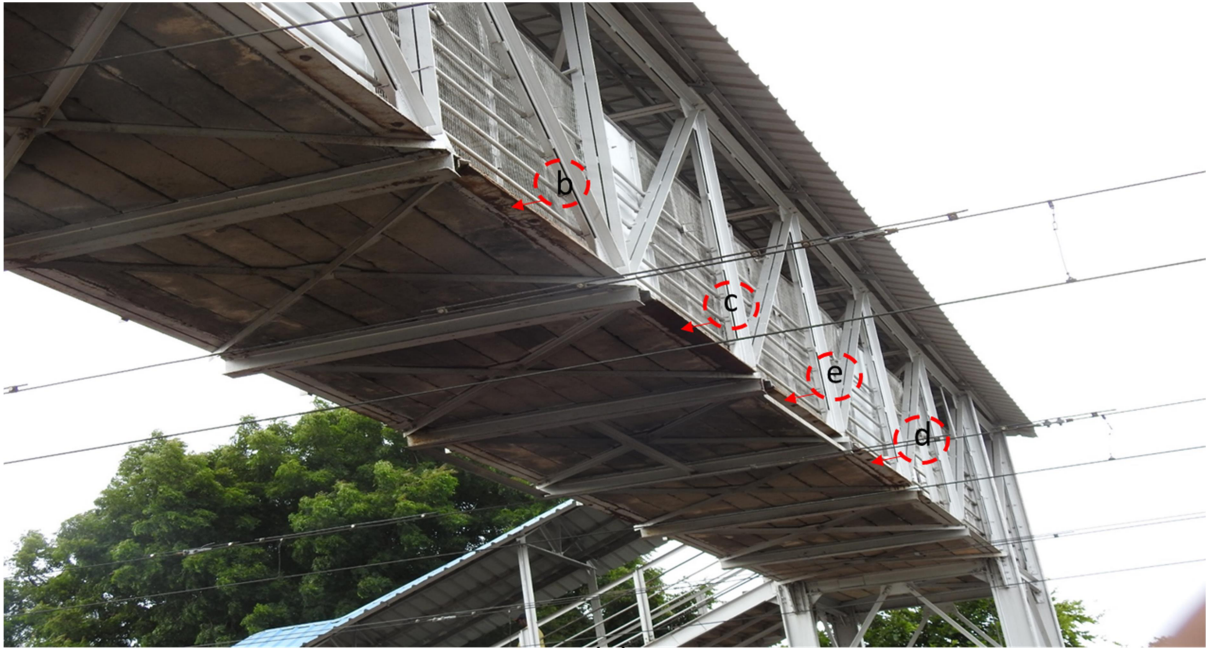
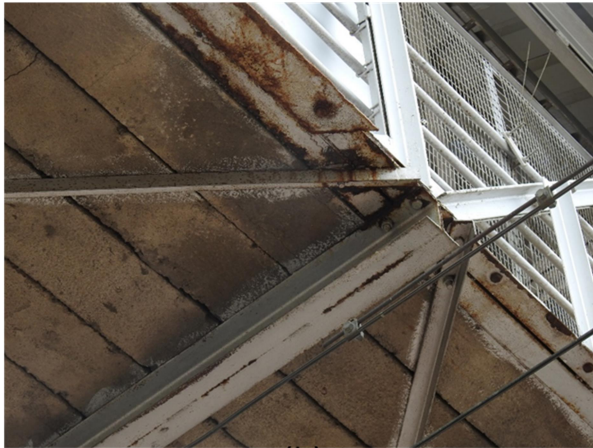
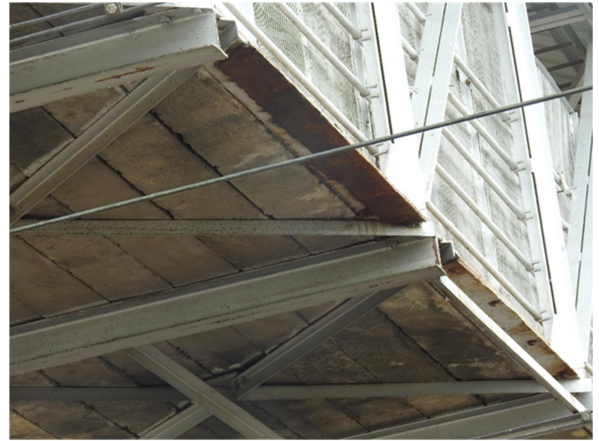
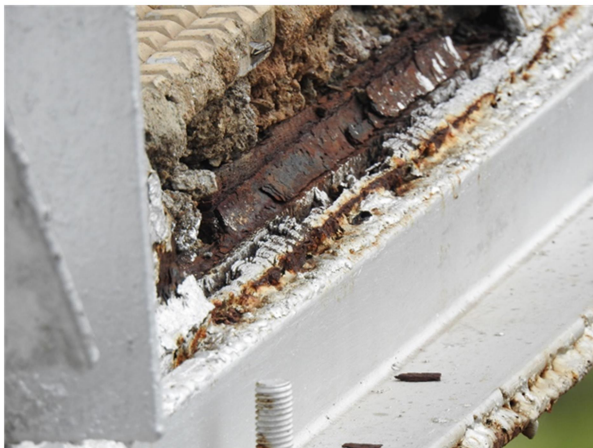
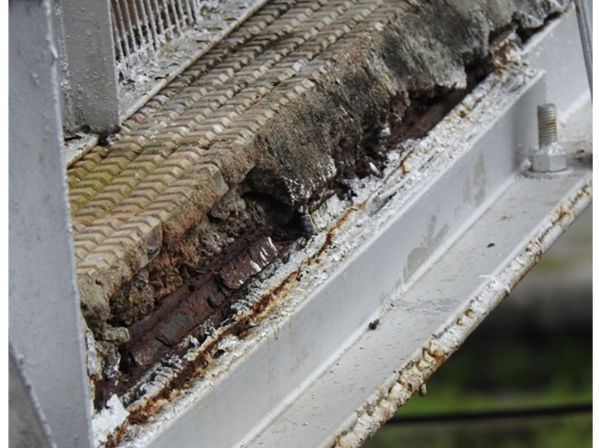
- ✓ Major corrosion is observed along the length of steel concrete on both sides

| PART 4 SURVEY OF SIGNS OF DISTRESS, DEFORMATION IN BRIDGES | | | |
|---|---|---|---|
| | Corrosion at steel-Concrete joint | | Major corrosion is observed at steel concrete joint along length of FOB |

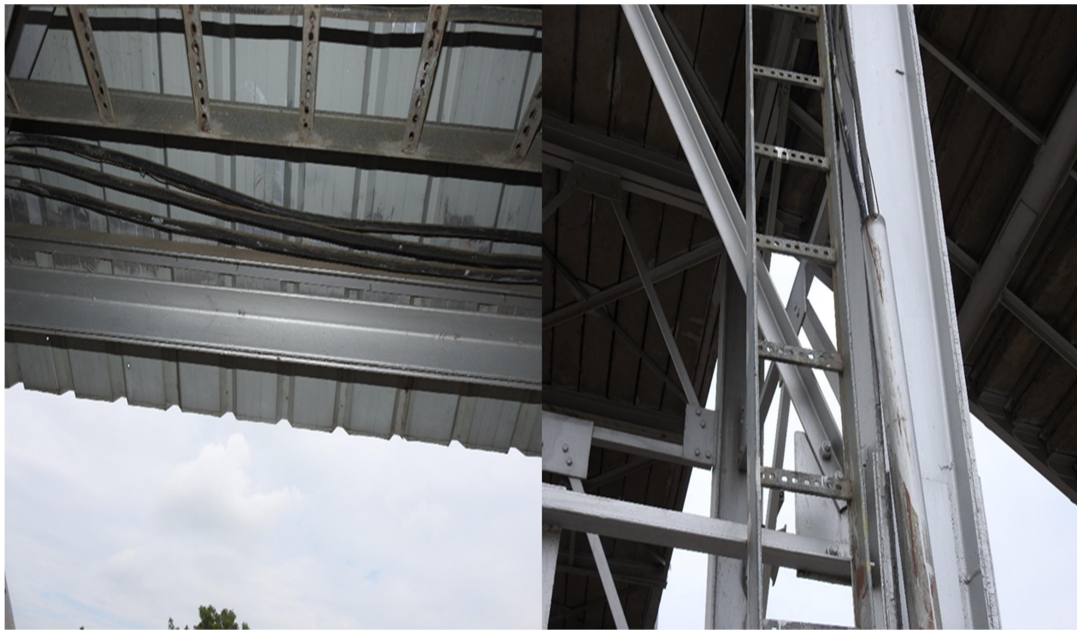
| PART 2 IDENTIFICATION OF LOADS ON BRIDGE | | | |
|---|---|---|---|
| | b) Cables | Yes | Cables are protected (Refer <b>fig : 2</b> ) |

***Fig 2:*** Electrical Cables observed on FOB

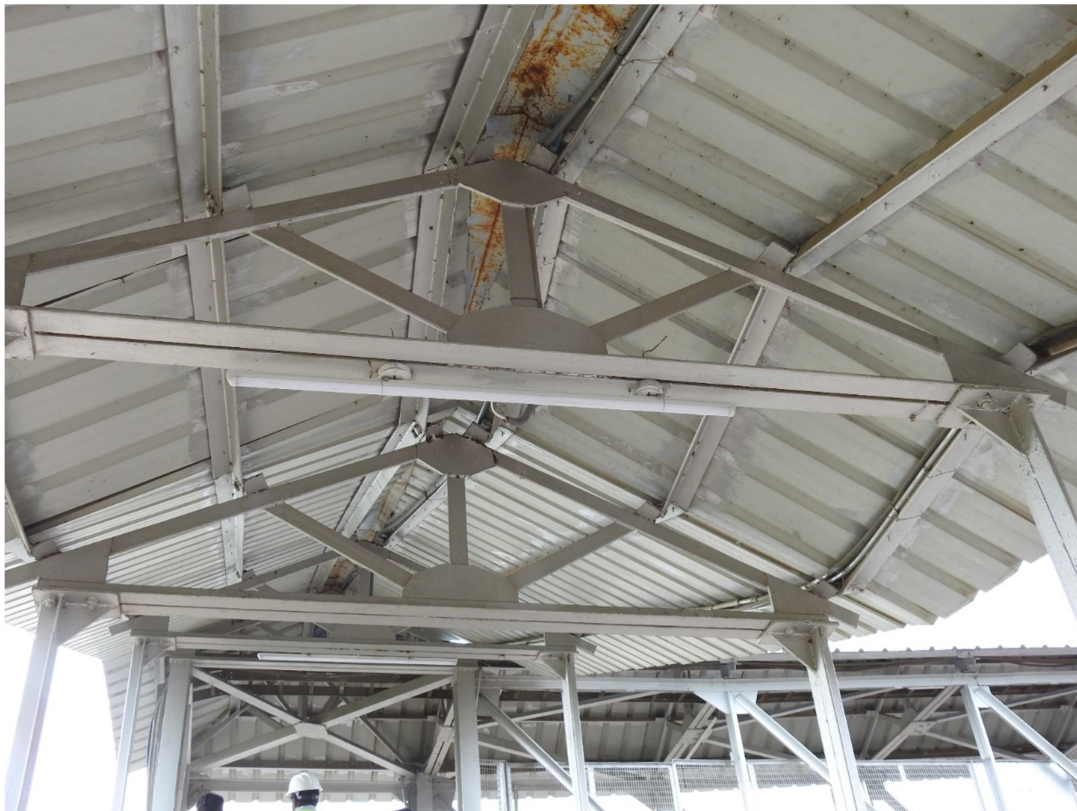
| PART 2 IDENTIFICATION OF LOADS ON BRIDGE | | | |
|---|---|---|---|
| | c) Roof Truss | Yes | 65 x 65 x 4 mm Angles are used (Refer <b>fig :3</b> ) |

| | Element of roof truss section | King post truss | 65 x 65 x 6 mm King post Angle section are used for roof truss supported on 90 x 90 x 10mm Top Chord Members using welded joints. (Refer <b>fig : 3</b> ) |

***Fig 3:*** King post roof truss with metal sheet roofing

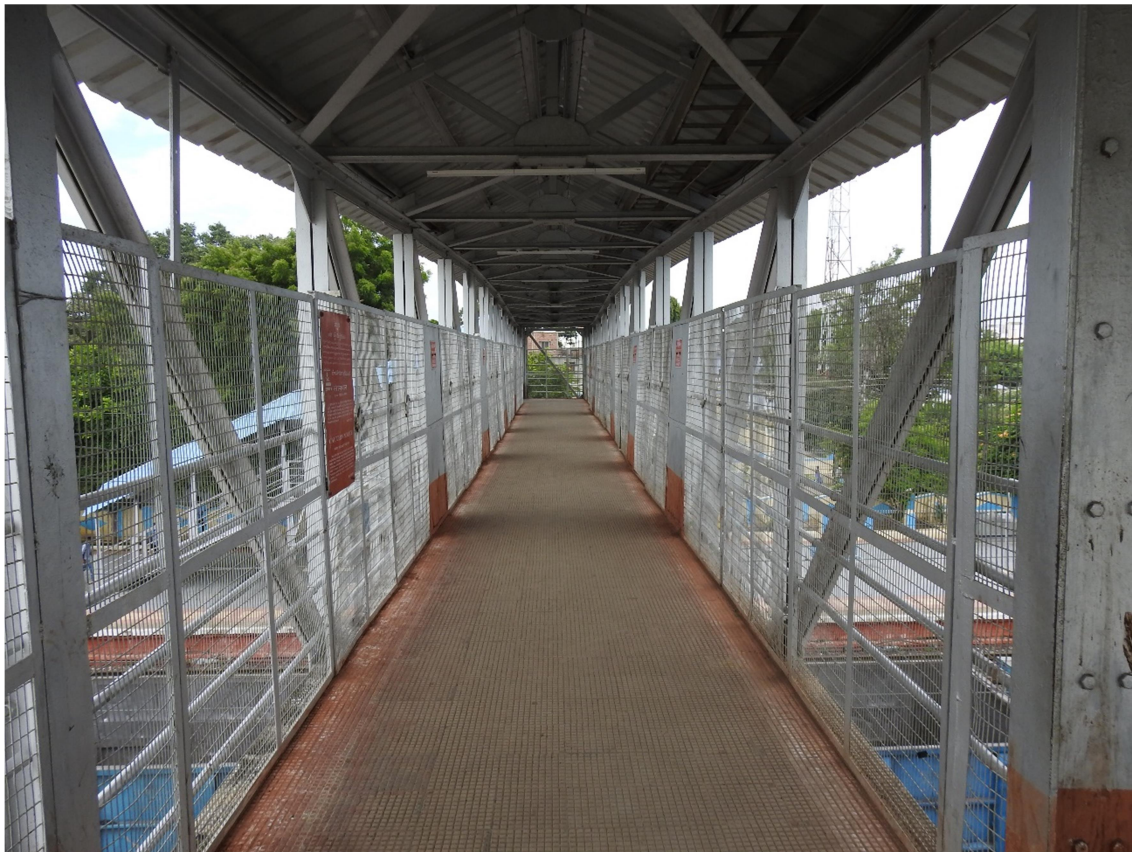
| PART 2 IDENTIFICATION OF LOADS ON BRIDGE | | | |
|---|---|---|---|
| | b) Provision of protective screen for passengers | Yes | Galvanized wire of 2 mm gauge rectangle mesh and 2 mm Galvanized sheet is provided near OHE Line on both side of pathway for passenger Protection. (Refer <b>fig :4</b> ) |

| | Material of Slab | Pre-cast slabs | Pre-cast Reinforced Concrete Slab panels are used for floor slab of 100 mm thick, Pre-cast RCC slab panels are resting on Angle tie members supported on Floor beams and Bracings from bottom. Chequered tile (25 mm thick) flooring is laid on the top of the Pre-cast slab panels. (Refer <b>fig : 4</b> ) |

**Fig 4:** GI 2 mm thick wire rectangle mesh and sheet is provided for passenger protection

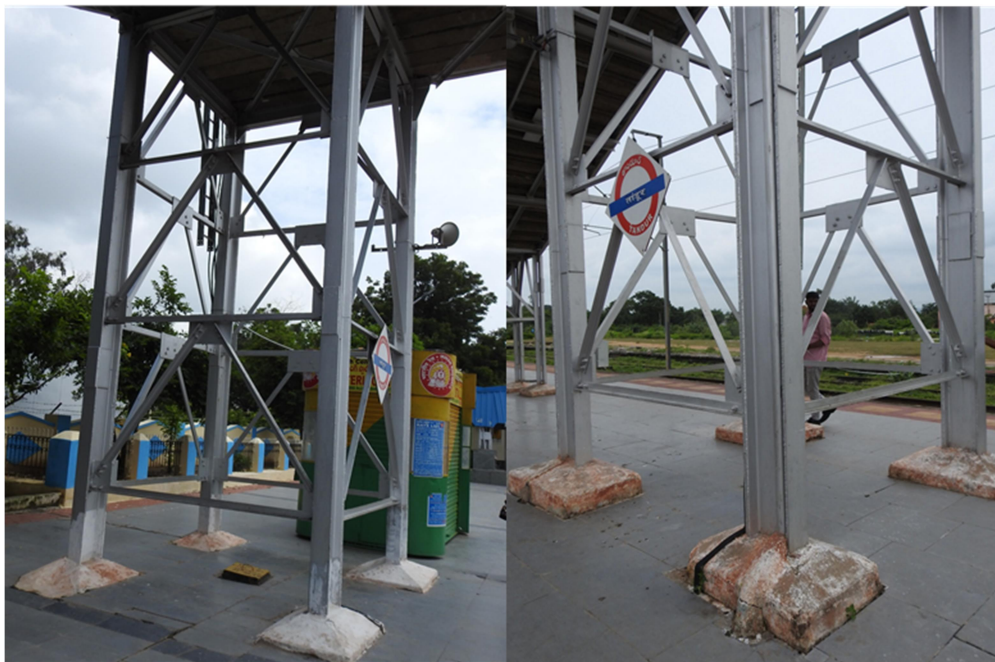
| PART 3 STRUCTURAL SYSTEM OF THE BRIDGE | | | |
|---|---|---|---|
| | Type of Material | | *To protect the column from corrosion, it is protected with concrete encasement on PF level (Refer <b>fig :5</b> ) |

| | Shape of Column section | I – Section | FOB is Supported on Vertical Column of 4 - ISMB 300 with 65 x 65 x 8 mm Angle Lacing members connected using Gusset plates and bolts. (Refer <b>fig : 5</b> ) |

**Fig 5:** Concrete encasement is provide for ISMB columns

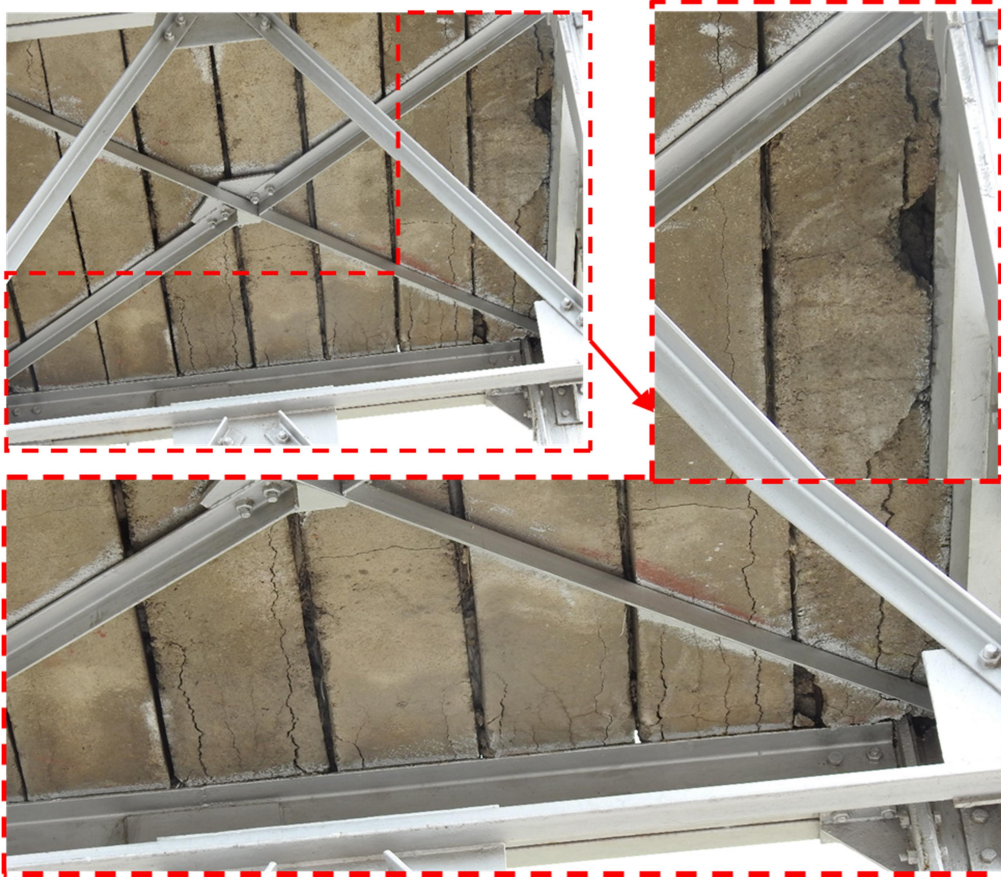
**Fig 6:** Cracks observed in slab panels above column Support

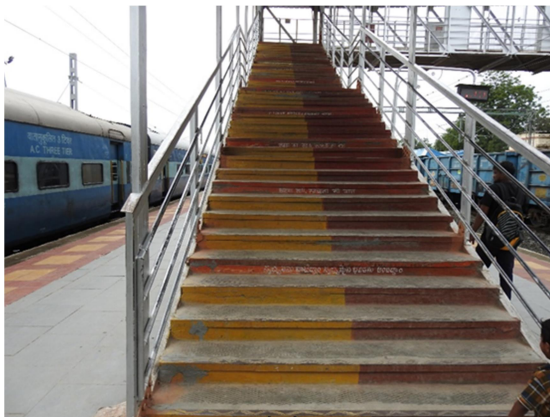
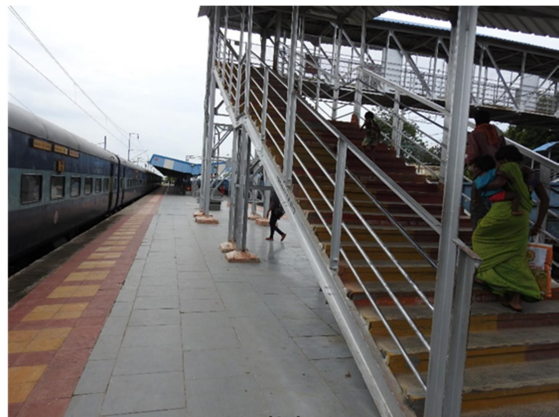
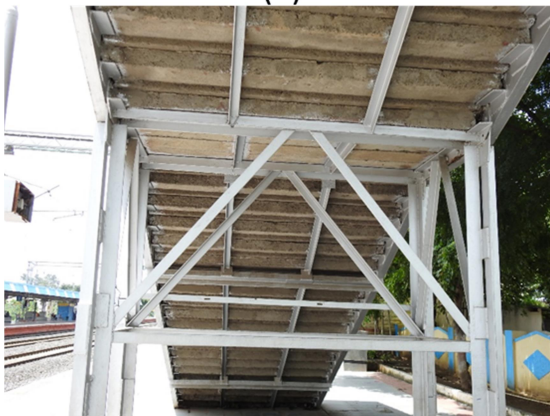
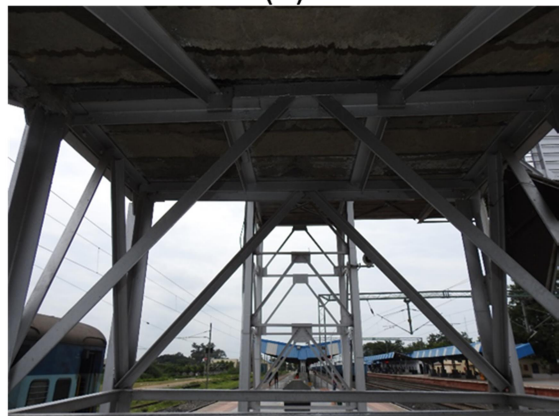
**Fig 7:** Snap shots of Staircase from different views

| | Number of Staircase | 2 No's | Staircase steps Pre-cast RCC slab panels of size 300 x 100 are used. Steps are supported on ISMC 300 Stringer using cleat Angles. Staircase Landing of 2 m wide is supported on Vertical and Horizontal Angle Members. (Refer <b>fig : 7</b> ) |

| | Type of Parapet Railing | Steel Railing | Stair case is provided with Railing on both sides of one-meter height using Angle 65 x 65 x 8 mm and Hollow Circular sections (Refer <b>fig :7</b> ) |

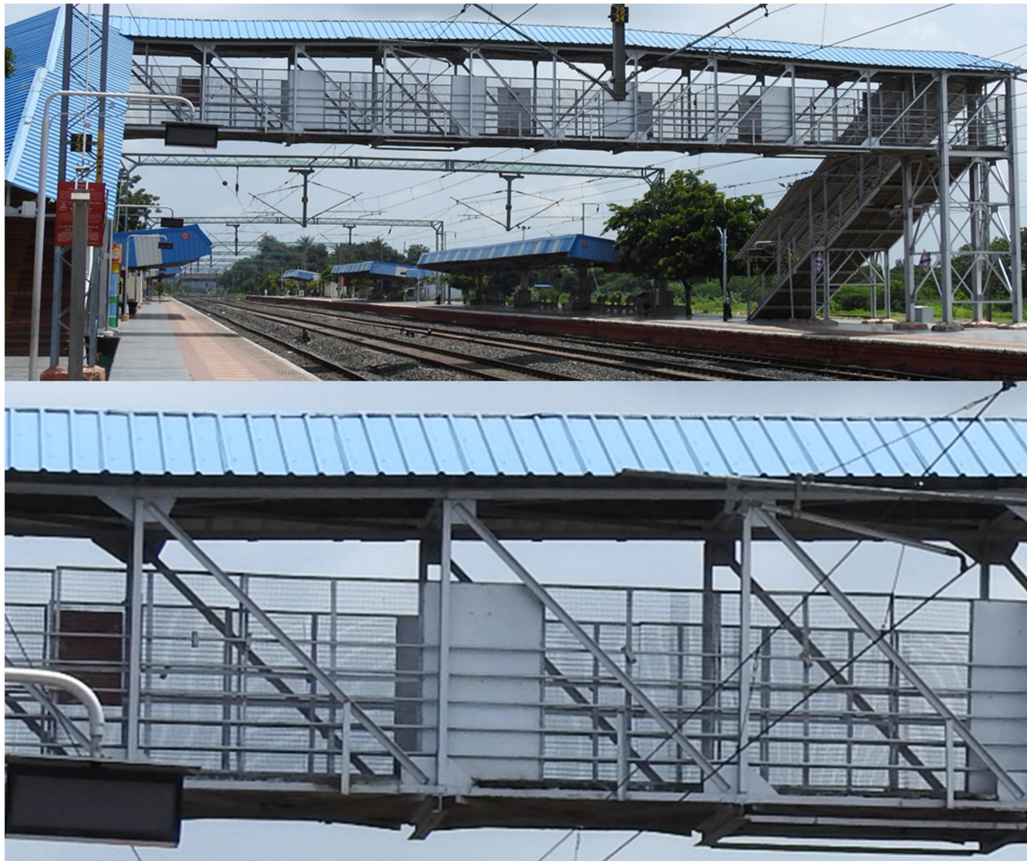
| | Type /Shape of Truss Section | N- type, Camel back | a) Main Chord members 90 x 90 x 10 mm Double Angle section<br>b) 80 x 80 x 10 mm Double angle are used as bracing Members<br>c) 10 mm thick, gusset plate used for welded joint. (Refer <b>fig : 8</b> ) |
| | Shape of Floor beam /Bracings | Double Channels angle section | 150 x 75 x 6 mm Double Channel Sections are used as Floor beams, supported with 75 x 75 x 10 mm bottom bracings and 65 x 65 x 8 mm angle sections to main trusses. Floor beams ISMC 150 are connected to bottom chord Member using Bolts and Bracings are connected by welding. (Refer <b>fig : 8</b> ) |

***Fig 8:*** View of Steel Truss
