| <b>Name of the Project</b> | <b>:</b> | <b>VISUAL INSPECTION OF FOB AT CHIRALA RAILWAY STATION</b> |
| <b>Location</b> | <b>:</b> | <b>CHIRALA RAILWAY STATION</b> |
| <b>Date of Inspection</b> | <b>:</b> | <b>25<sup>th</sup> OCTOBER, 2019</b> |

### **VISUAL INSPECTION OF STEEL FOOT OVER BRIDGE**

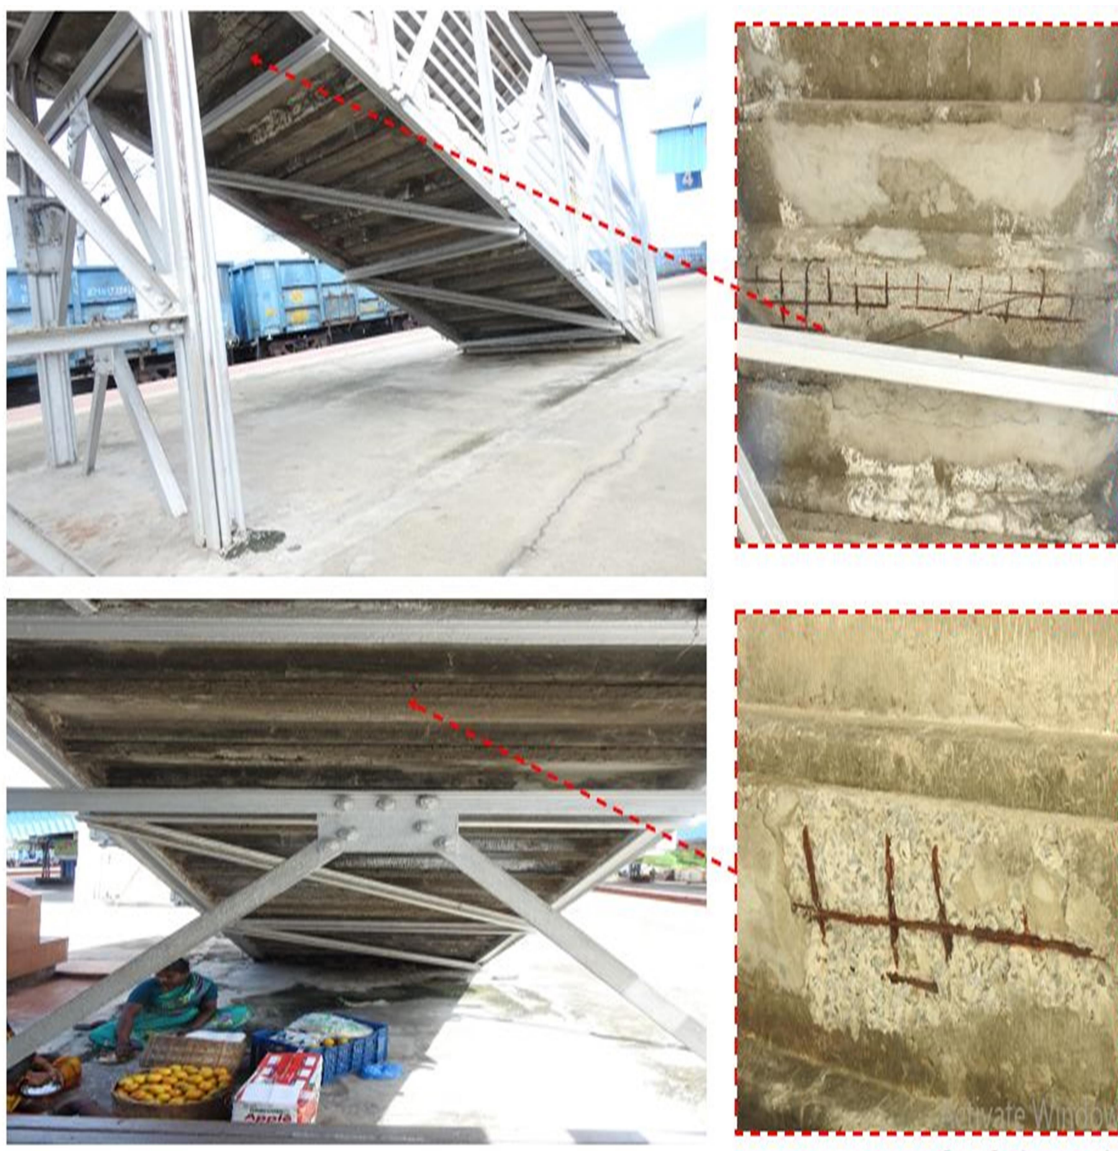
4.1 ✓ Exposed reinforcement is observed on Pre-cast RCC steps.

a) Reinforcement exposed in slab panels

| PART 4 SURVEY OF SIGNS OF DISTRESS, DEFORMATION IN BRIDGES | | | |
|---|---|---|---|
| | Cracking in RCC components | Slab panels | Cracks are observed in Pre-cast RCC slab panels of stair cases ( <i>Refer Part 4.1</i> ) |

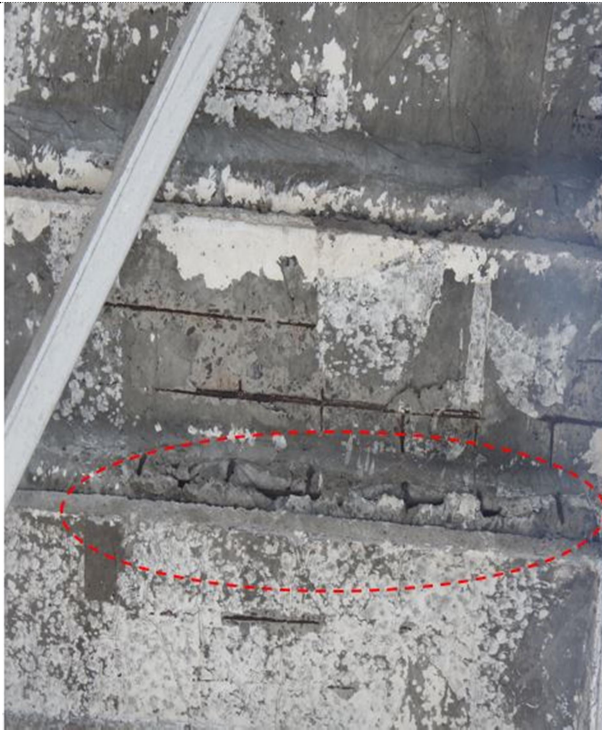
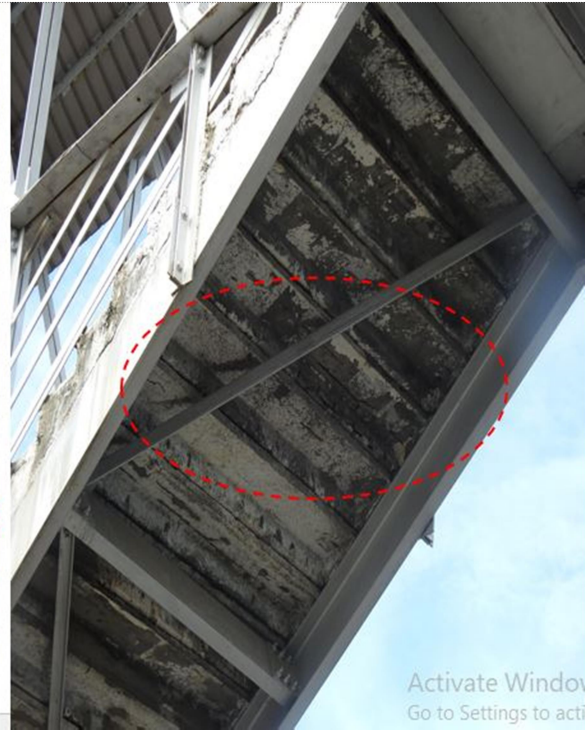
b) Spalling and cracks on staircase steps

| PART 4 SURVEY OF SIGNS OF DISTRESS, DEFORMATION IN BRIDGES | | | |
|---|---|---|---|
| | Spalling | | Spalling is observed in staircase-pre-cast panels. ( <i>Refer Part 4.1</i> ) |

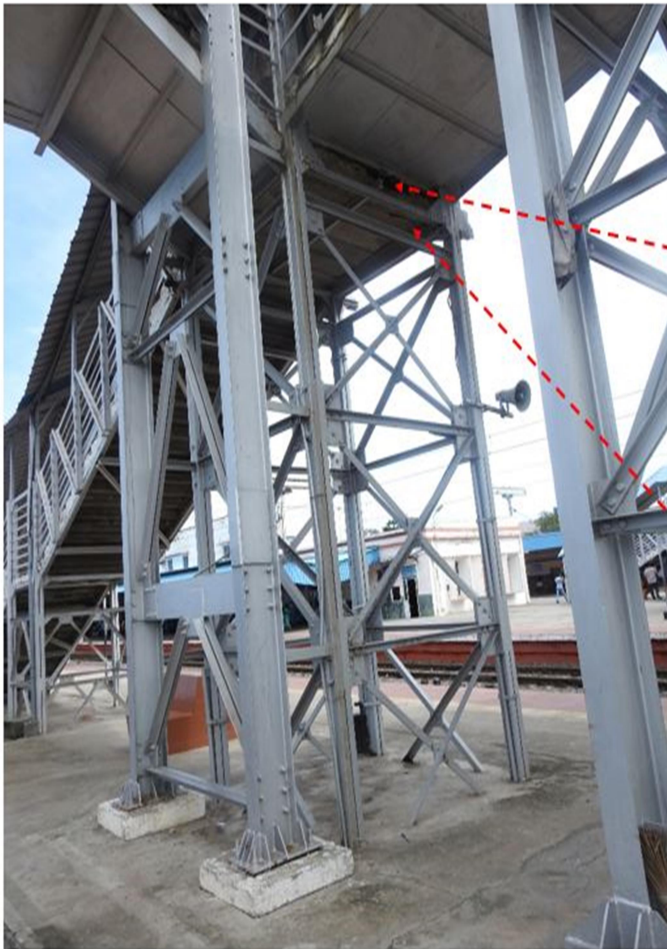
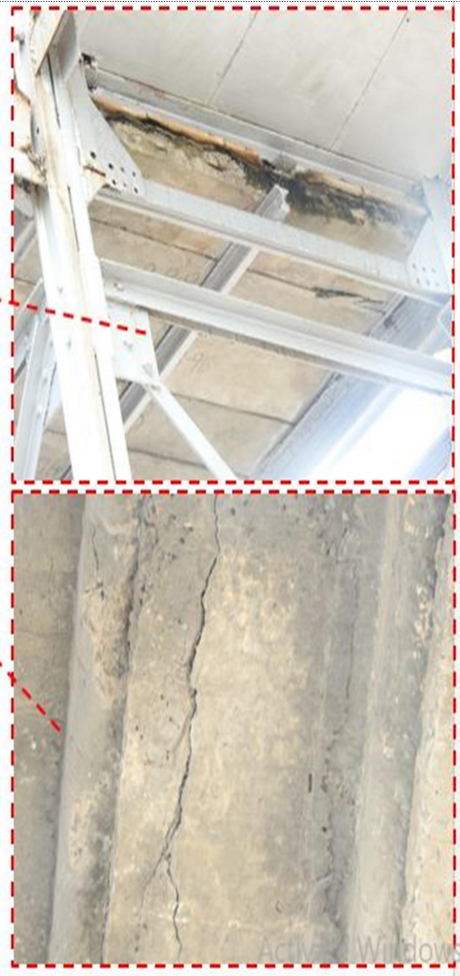
4.2

✓ Leaching effect and Cracks are observed on Pre-cast slab panels.

a) Cracks are observed on Pre-cast steps

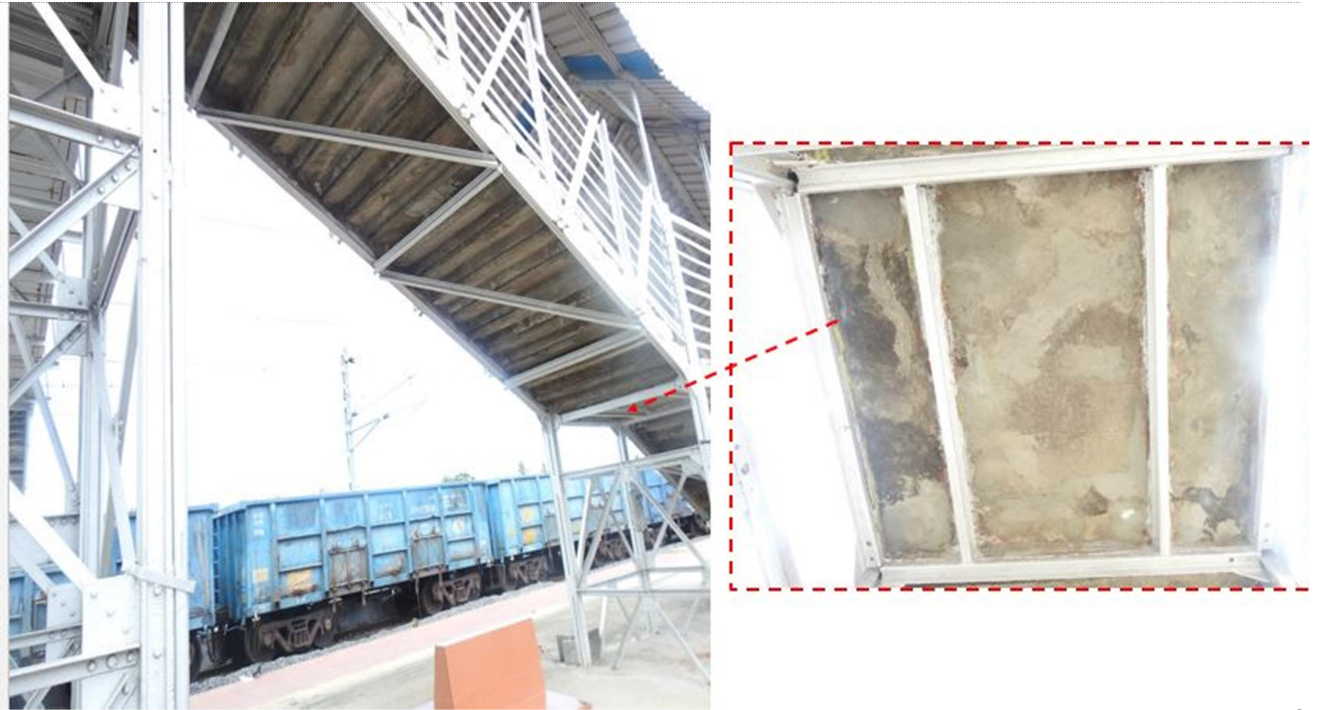
b) Leaching effect on staircase pre cast slab panels

| PART 4 SURVEY OF SIGNS OF DISTRESS, DEFORMATION IN BRIDGES | | | |
|---|---|---|---|
| | Water seepage | | Seepage observed in the slab panels of stair cases |

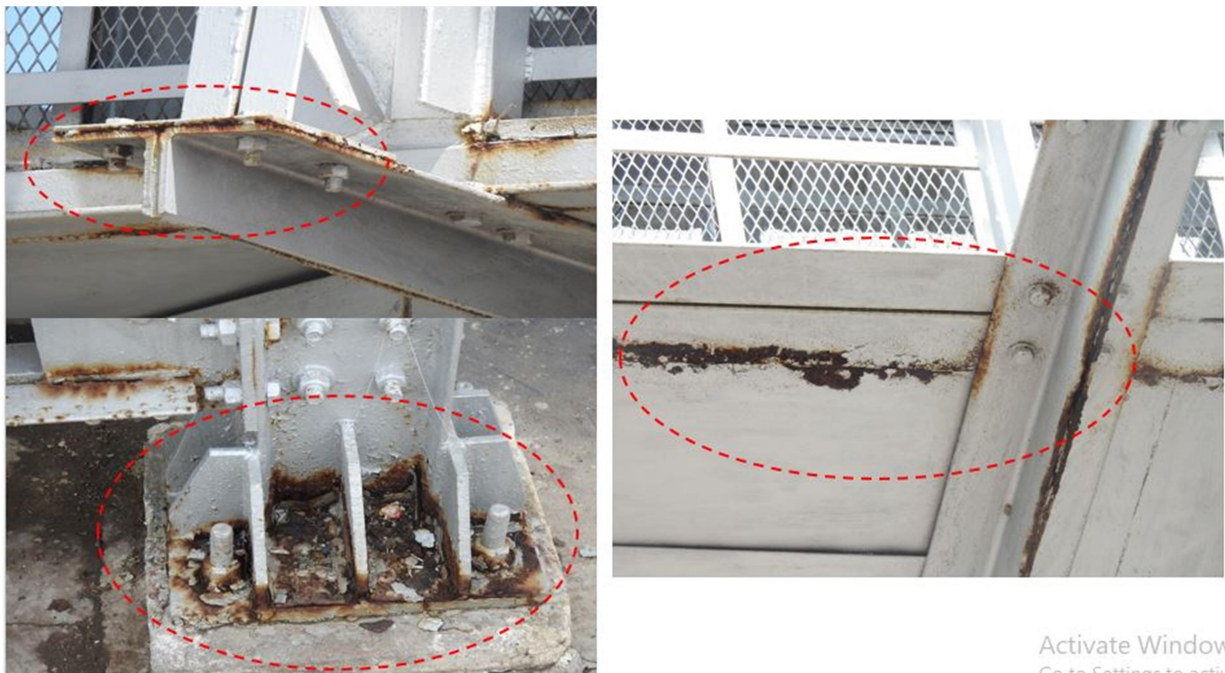
4.3 ✓ Corrosion observed at floor beams, base plates and sacrificial plates.

(a) Corrosion observed at floor beams, base plates & sacrificial plates

| PART 4 SURVEY OF SIGNS OF DISTRESS, DEFORMATION IN BRIDGES | | | |
|---|---|---|---|
| | Corrosion in Gusset plate | Floor level | corrosion is observed in Sacrificial Plates |

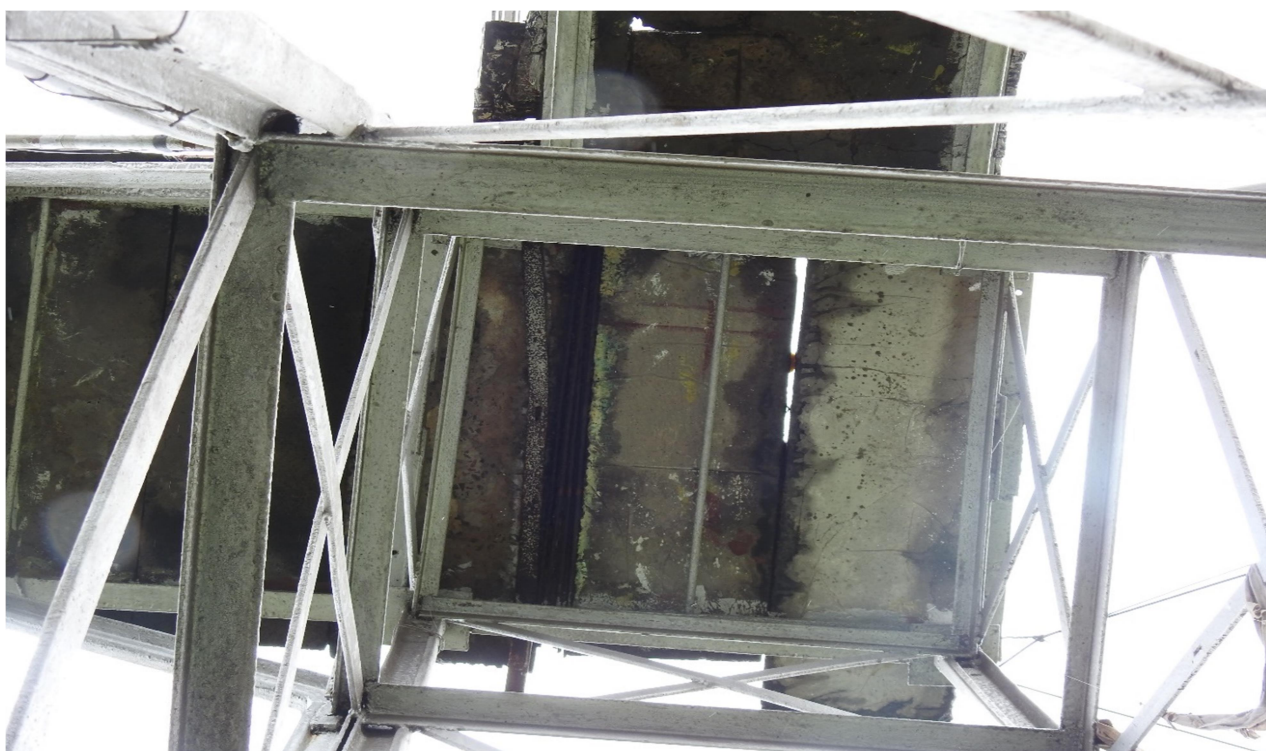
| PART 1 GENERAL INFORMATION AND OBSERVATION | | |
|---|---|---|
| 1.14 | History of Repair/ Maintenance | Patch work observed in the staircase-2 Landing |

**Fig 6:** Patch work is observed at slab panels of stair case landing
