| <b>Name of the Project</b> | <b>:</b> | <b>VISUAL INSPECTION OF FOB/ PF-1 - PF-2 AT ELURU RAILWAY STATION</b> |
| <b>Location</b> | <b>:</b> | <b>ELURU RAILWAY STATION</b> |
| <b>Date of Inspection</b> | <b>:</b> | <b>19<sup>th</sup> OCTOBER, 2019</b> |

### **VISUAL INSPECTION OF STEEL FOOT OVER BRIDGE**

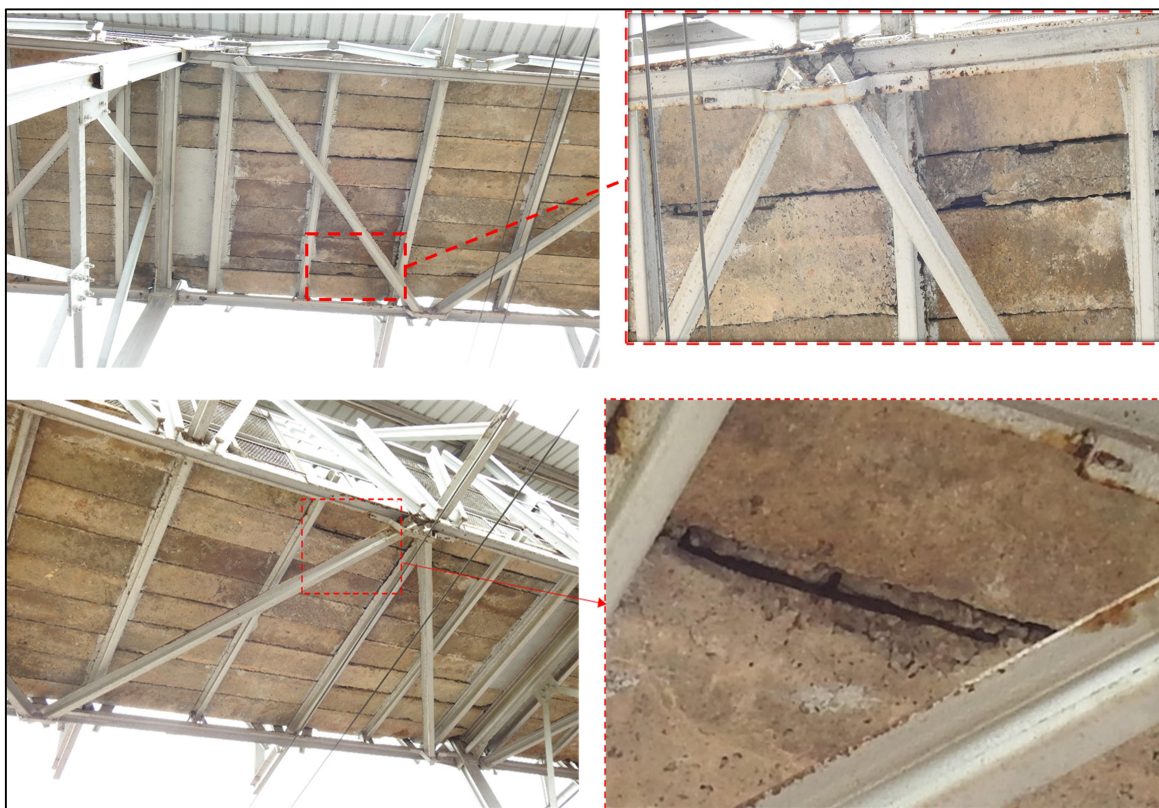
4.1 ✓ Exposed reinforcement is observed on Pre-cast RCC slab panels of Span 1, Span 2 and staircase panels.

(a) Exposed reinforcement, concrete spalling

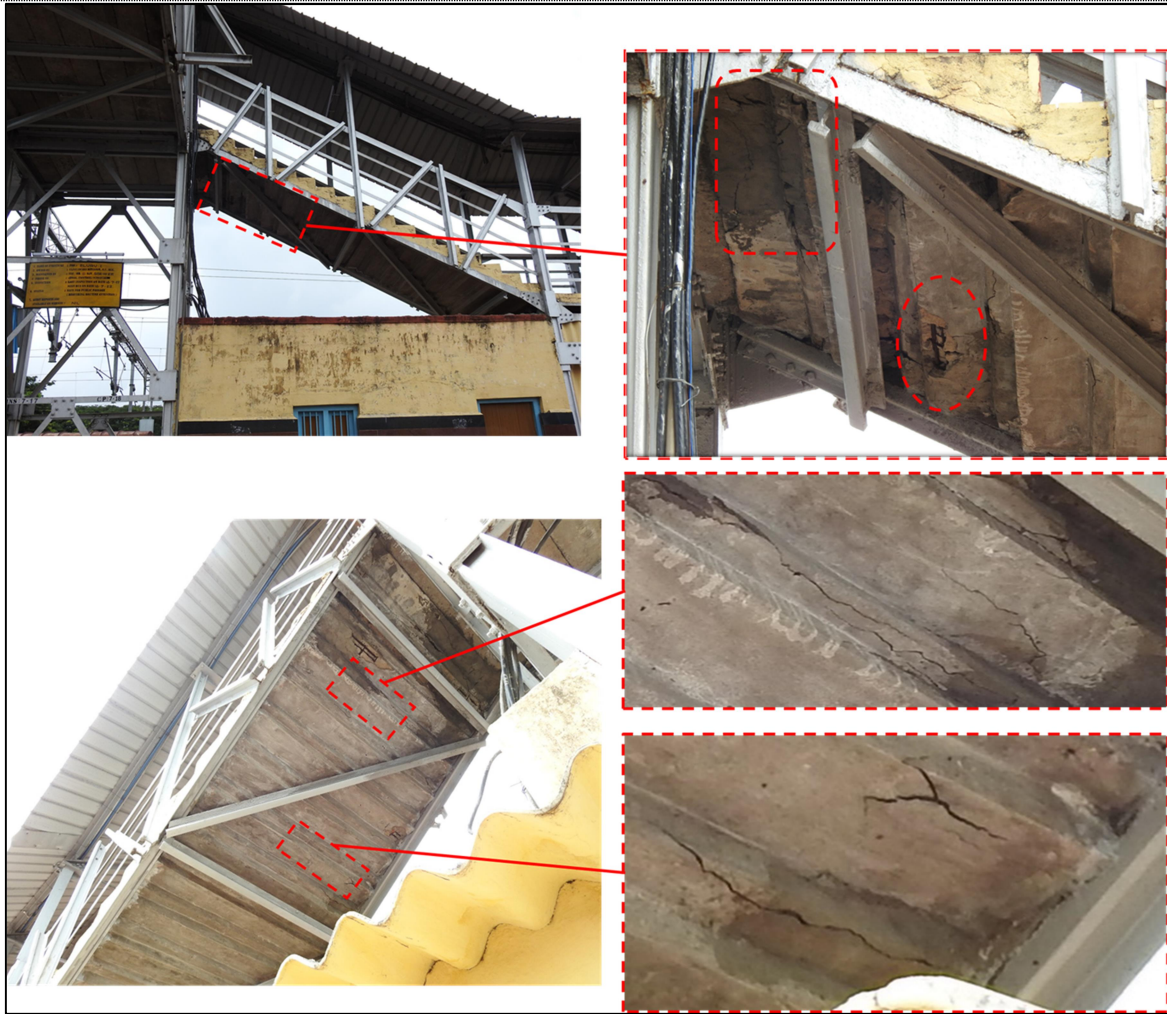
(b) Exposed reinforcement and cracks in steps

| PART 4 SURVEY OF SIGNS OF DISTRESS, DEFORMATION IN BRIDGES | | | |
|---|---|---|---|
| | Cracking in RCC components | Staircase and bottom slab panels | Cracks are observed in Pre-cast RCC slab panels of stair case. |
| | Spalling | Staircase | Spalling is observed in Slab panels and in staircase-pre-cast panels. |

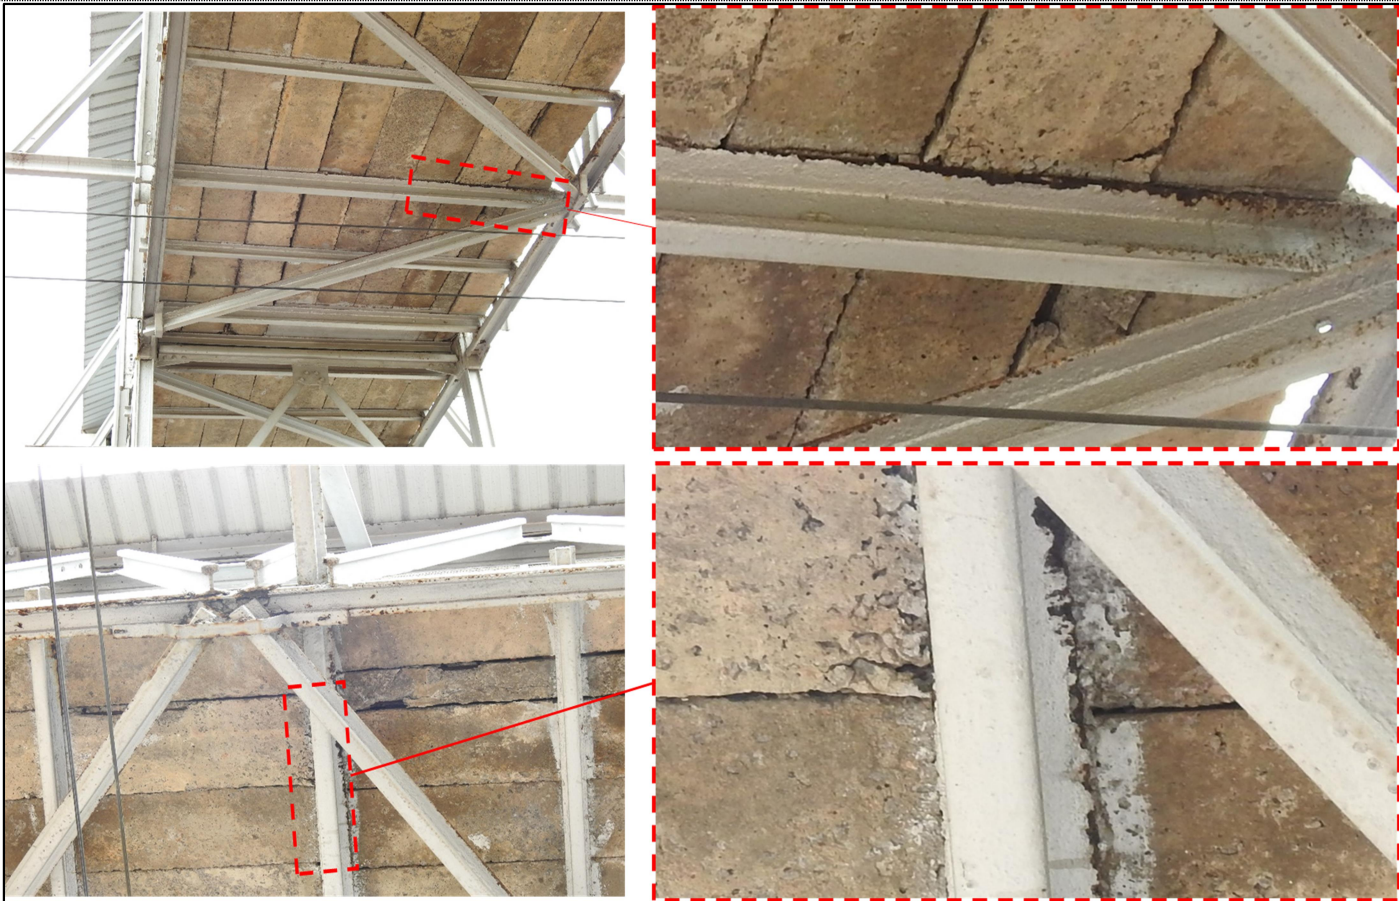
| 4.2 | ✓ Loss of Effective thickness is observed in floor beams, bottom bracings joints due to corrosion. |

(a) Corrosion observed at floor beams

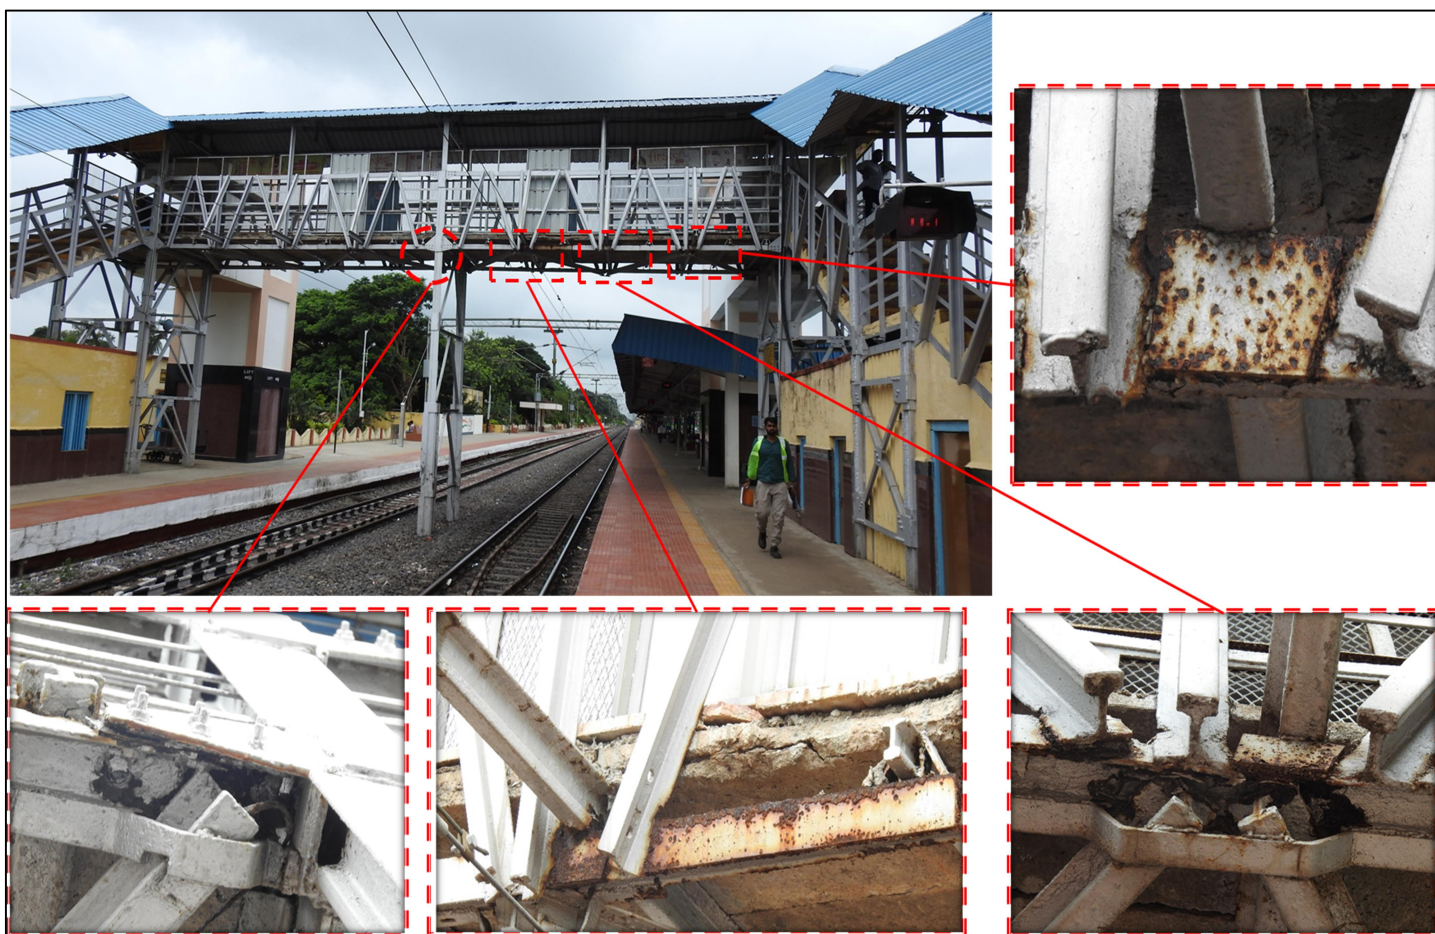
(b) Corrosion observed at Bottom chord and bracings joints.

| PART 4 SURVEY OF SIGNS OF DISTRESS, DEFORMATION IN BRIDGES | | | |
|---|---|---|---|
| | Corrosion in Gusset plate | Floor level | corrosion is observed in Gusset plates |

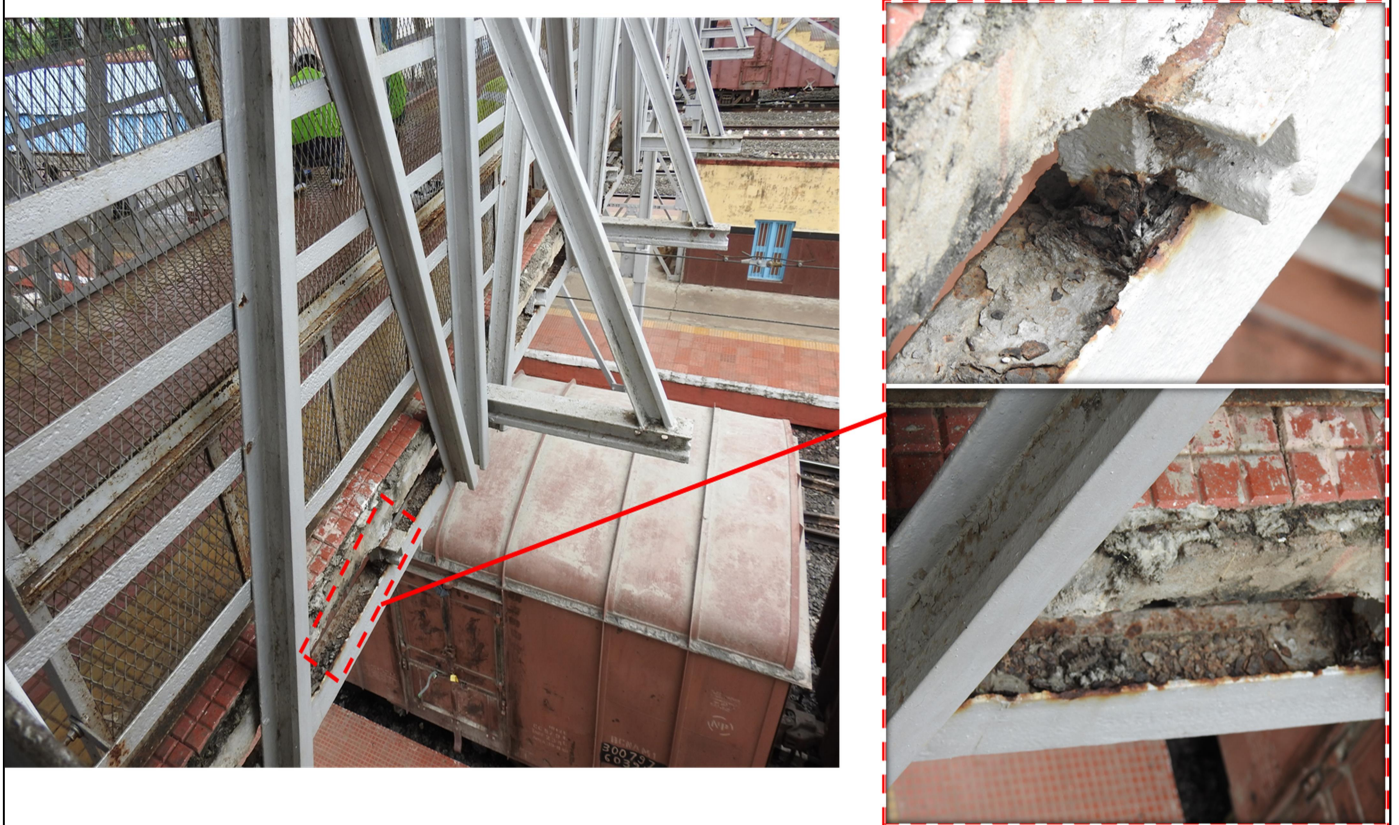
(c) Rusting and corrosion at Bottom chord

| PART 4 SURVEY OF SIGNS OF DISTRESS, DEFORMATION IN BRIDGES | | | |
|---|---|---|---|
| | Rust straining | Top and bottom chord | Slight rusting is observed at all the joints of FOB at floor level |

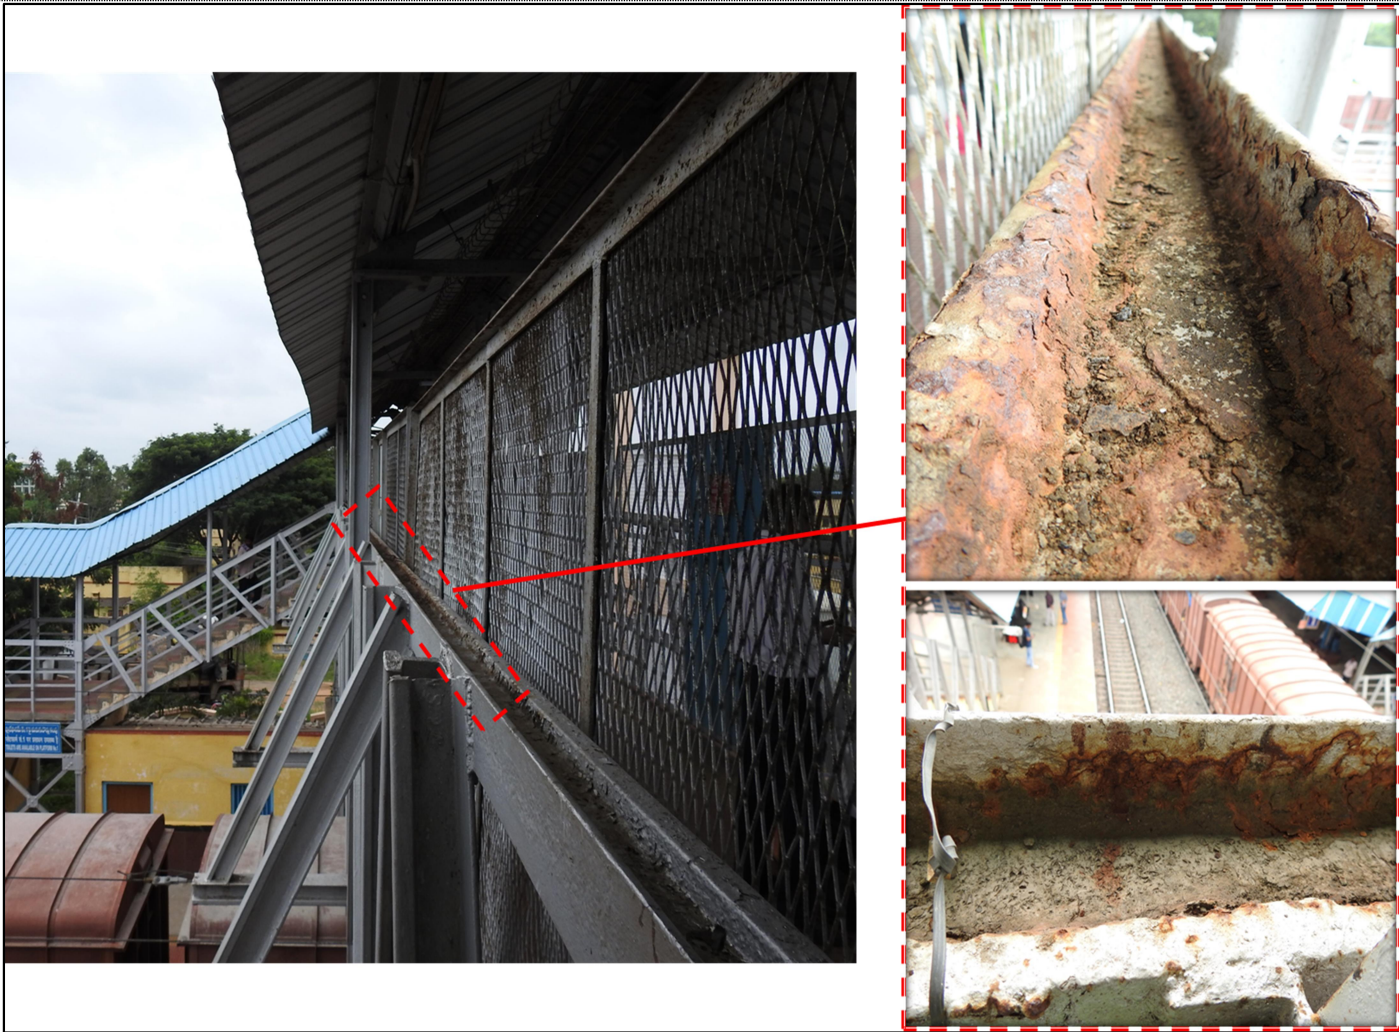
(d) Rusting and corrosion at top chord

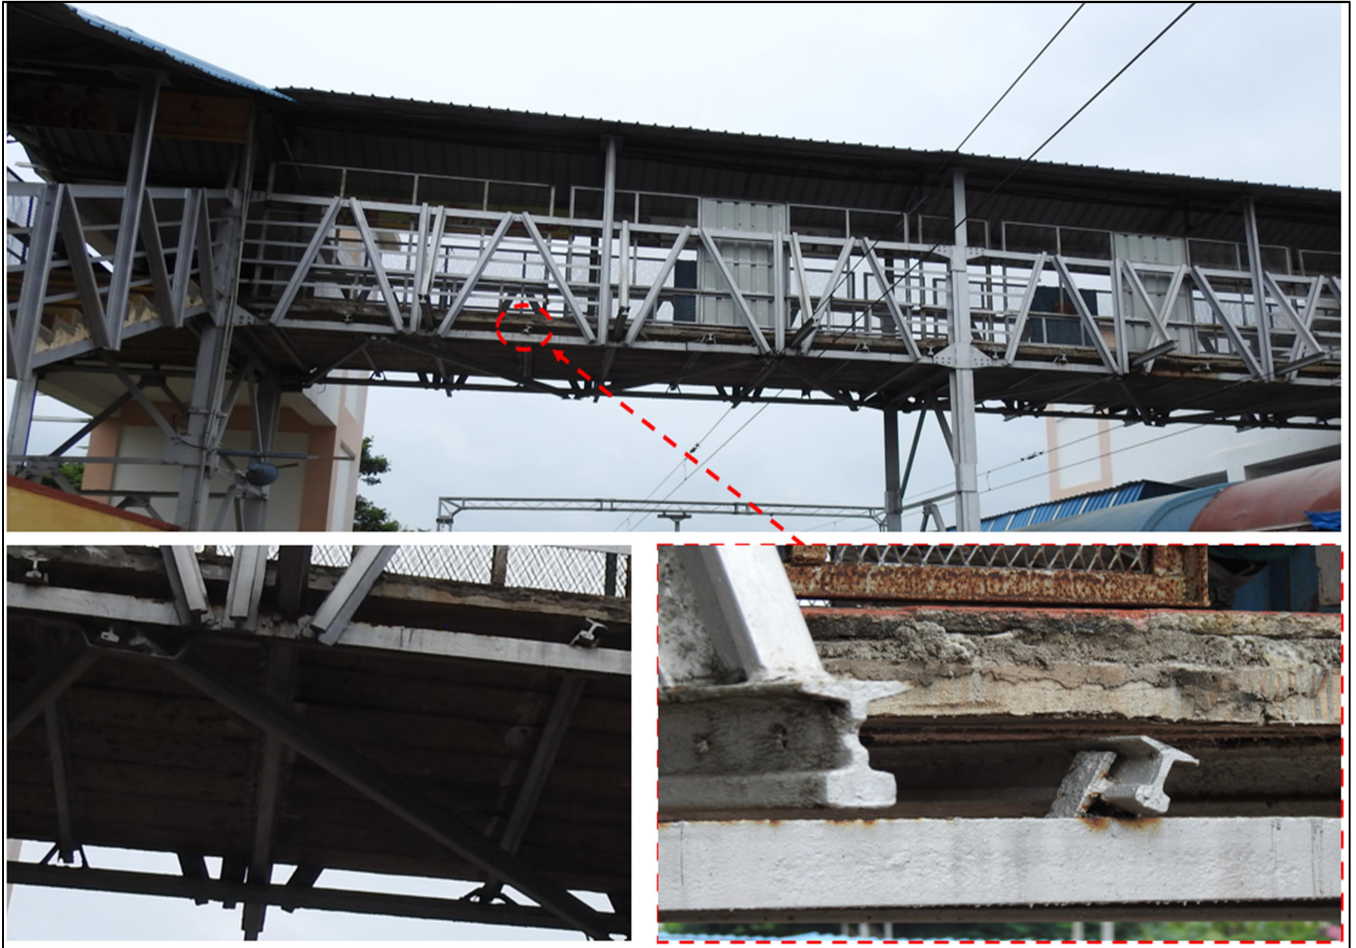
| 4.3 | ✓ Deformation is observed at floor beam of span 1 and Trestle column in span 1. |

(a) Deformations in floor beam of span 1

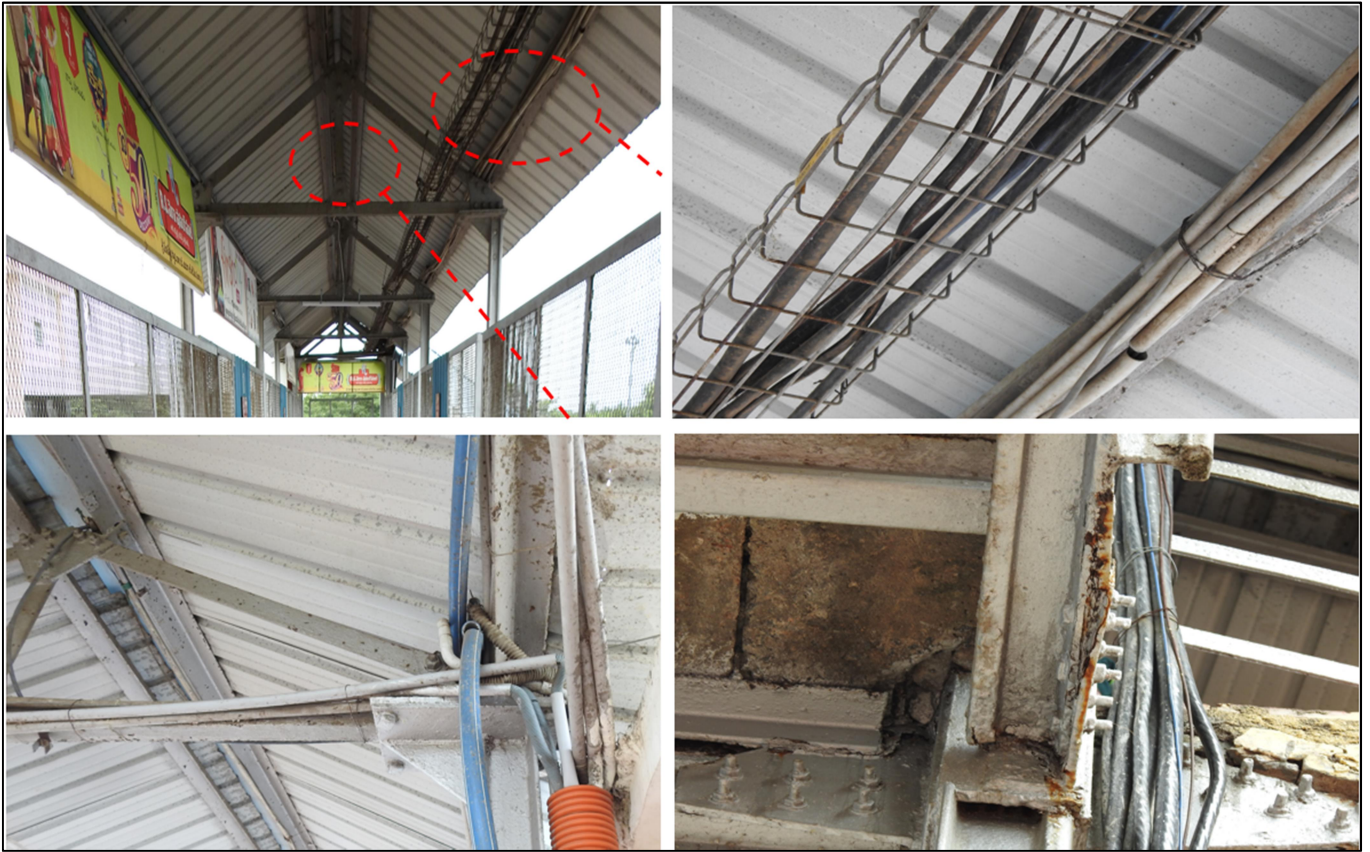
| | | Yes/No | Notes |
|---|---|---|---|
| | b) Cables | Yes | a. Cables in 1-inch HDPE pipe of 2 No's, 1.5-inch HDPE pipe of 1 No's, 1-inch PVC pipe of 9 No's and 1-inch GI pipe of 2 No's supported on Roof Truss. (Refer <b>fig :3</b> )<br>b. King post of 65 x 65 x 10 mm Angles are used as Roof truss (Refer <b>fig :2</b> )<br>c. Corrugated Metal Sheet is used for Roof (Refer <b>fig : 2</b> )<br>d. Advertising boards are provided (Refer <b>fig : 3</b> ) |

**Fig 3:** Additional loads of HDPE, PVC pipes

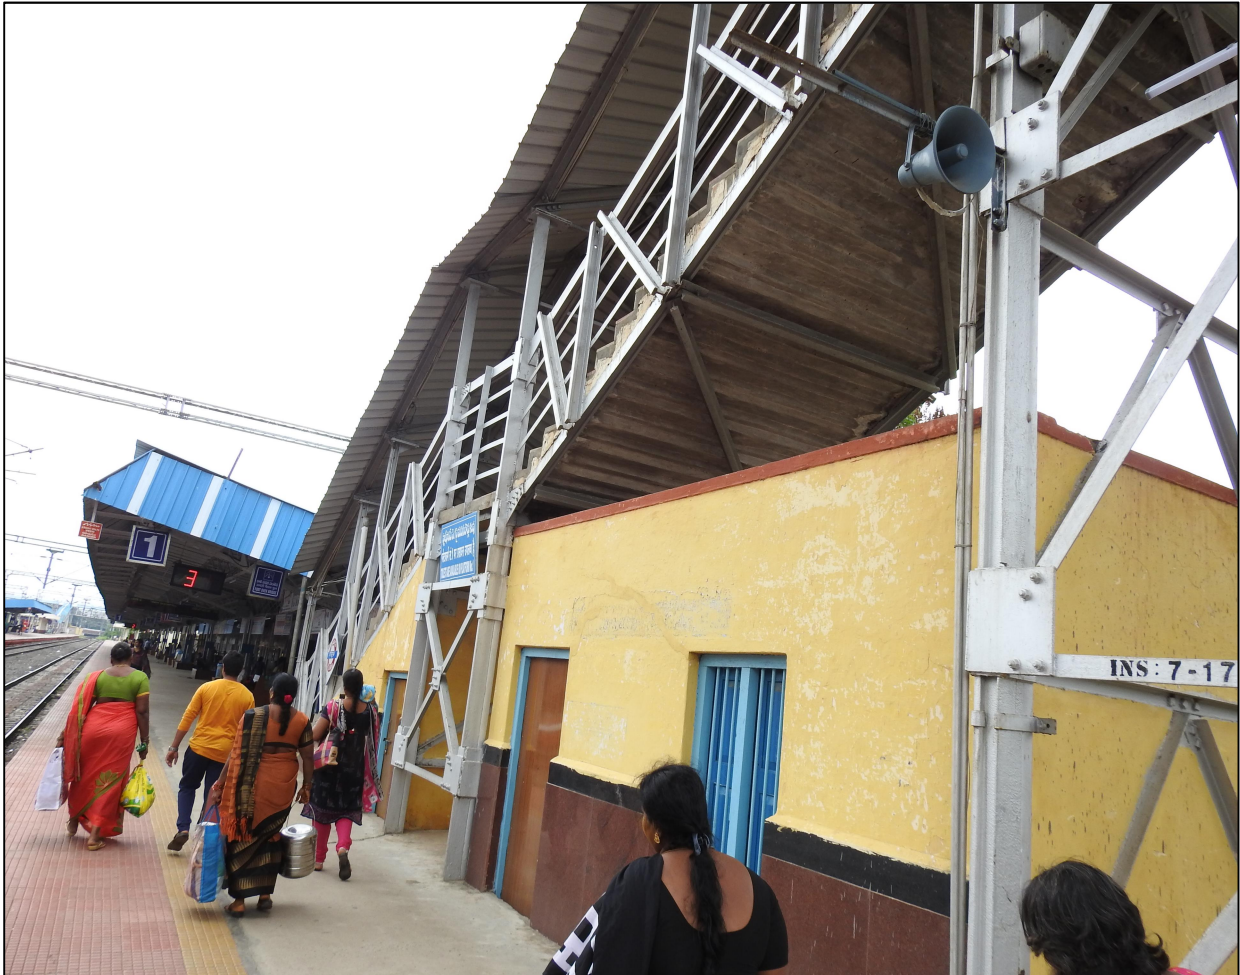
**Fig 6:** Unable to inspect under stair case due to existing rooms below Stair case flight,

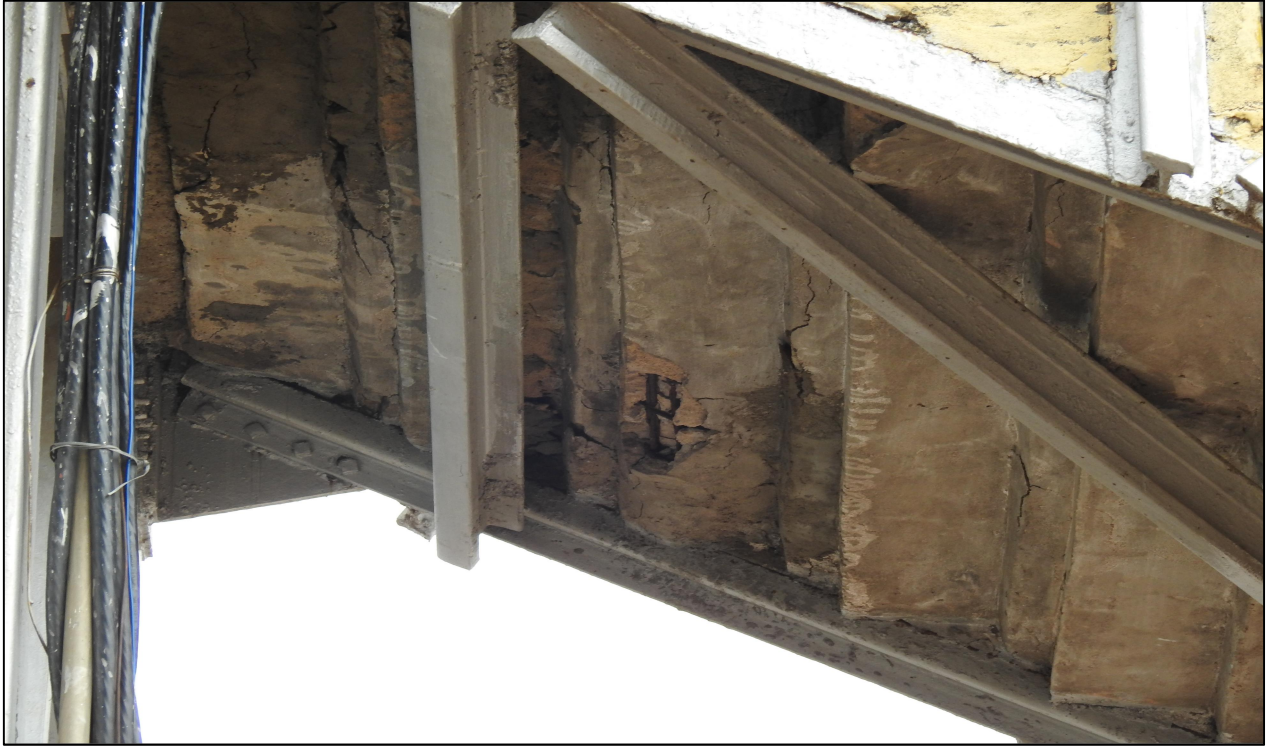
**Fig 8:** Patch work is observed at PF-2 stair case flight slab panels

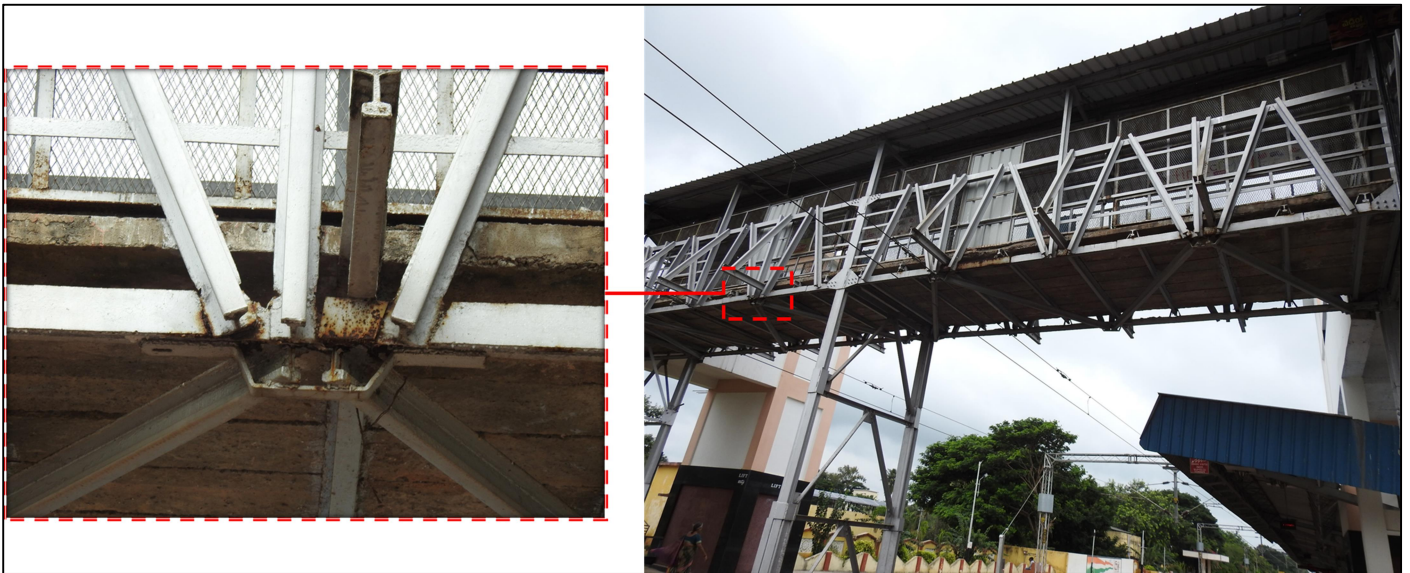
| | Material of Slab | Pre-cast slab panels | a. Pre-cast Reinforced concrete slab panels are used for floor slab of 80 mm thick, RCC slab panels are resting on Floor beams, which are supported on Bottom chord member and bottom lateral bracings. (Refer <b>fig :9</b> ) |
| | Condition of Slab from Bottom | Spalling is observed | |

**Fig 9:** Bottom view of FOB and details of floor slab
