| <b>Name of the Project</b> | <b>:</b> VISUAL INSPECTION OF FOB/ PF-1 - PF-4 AT KRISHNA CANAL RAILWAY STATION |
| <b>Location</b> | <b>:</b> KRISHNA CANAL RAILWAY STATION |
| <b>Date of Inspection</b> | <b>:</b> 21 <sup>st</sup> OCTOBER, 2019 |

### **VISUAL INSPECTION OF STEEL FOOT OVER BRIDGE**

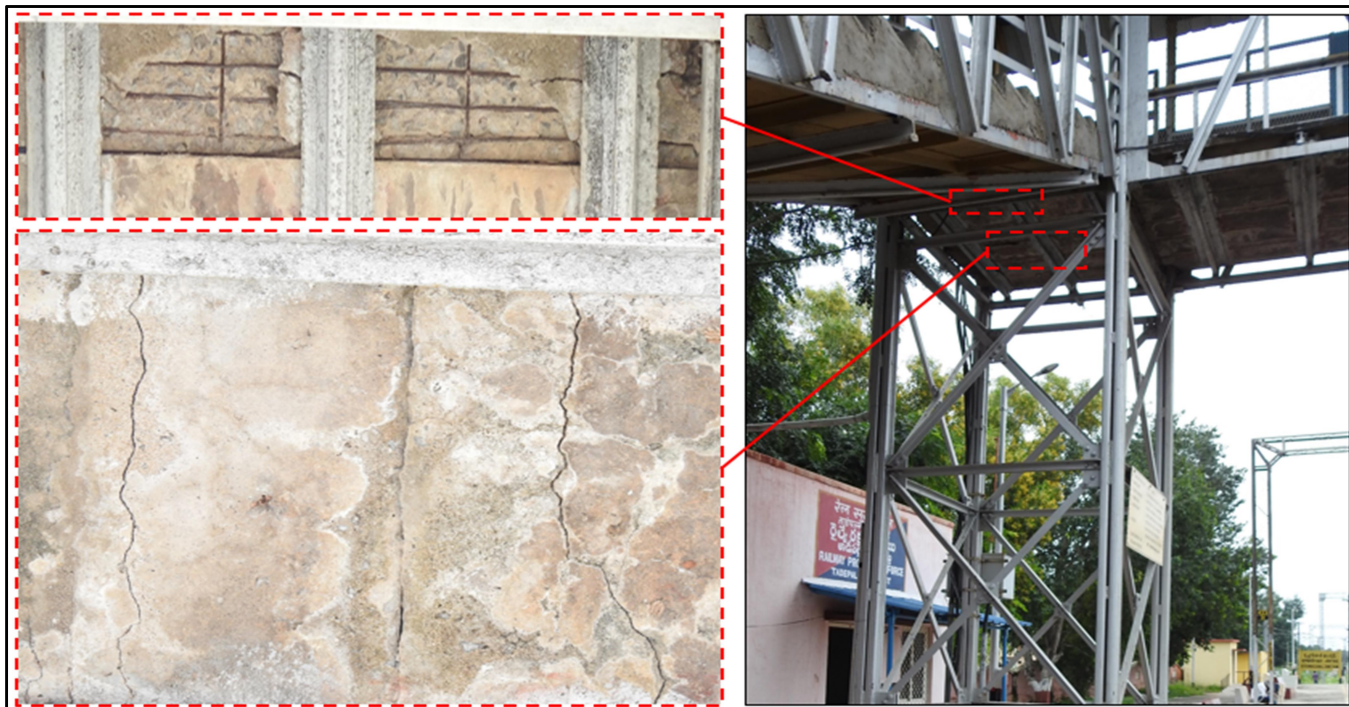
- ✓ Exposed reinforcement is observed on Pre-cast RCC slab panels of staircase Landing at platform 1 2 & 3.

a) Exposed reinforcement and cracks on bottom of slab panels (Staircase 1 Main landing)

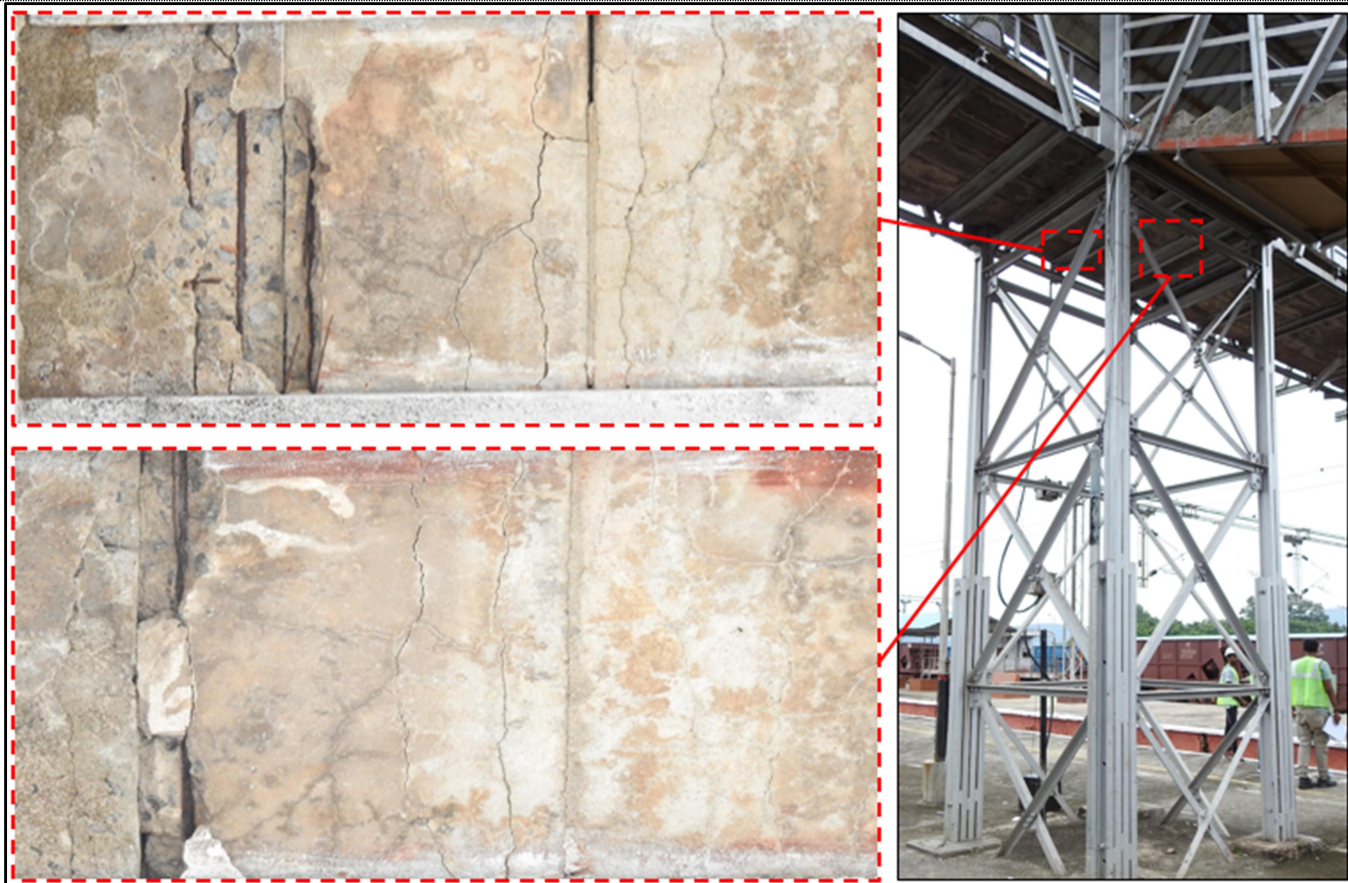
b) Exposed reinforcement and cracks on bottom of slab panels (Staircase 2 - Main landing)

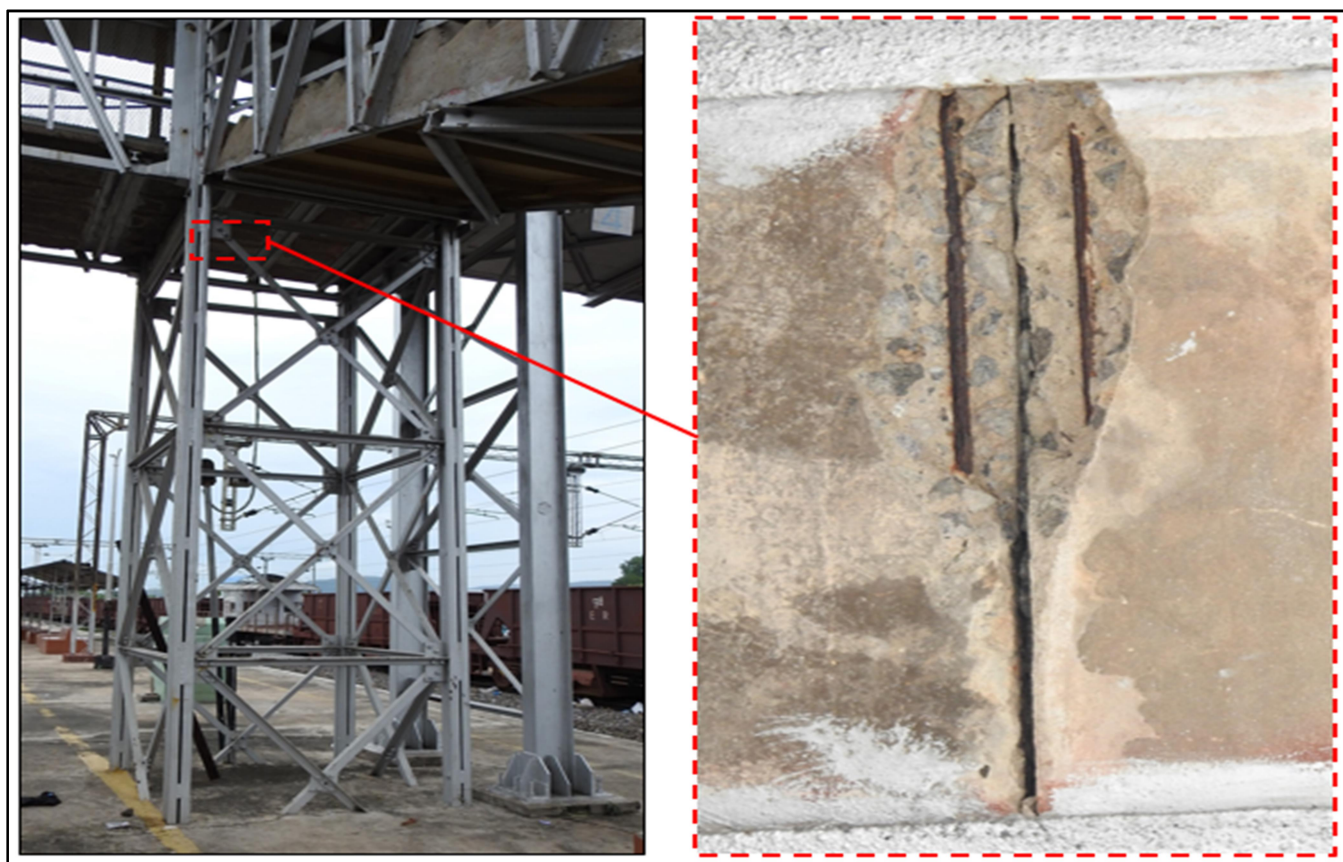
c) Exposed reinforcement on bottom of slab panels (Staircase 3 - Main landing)

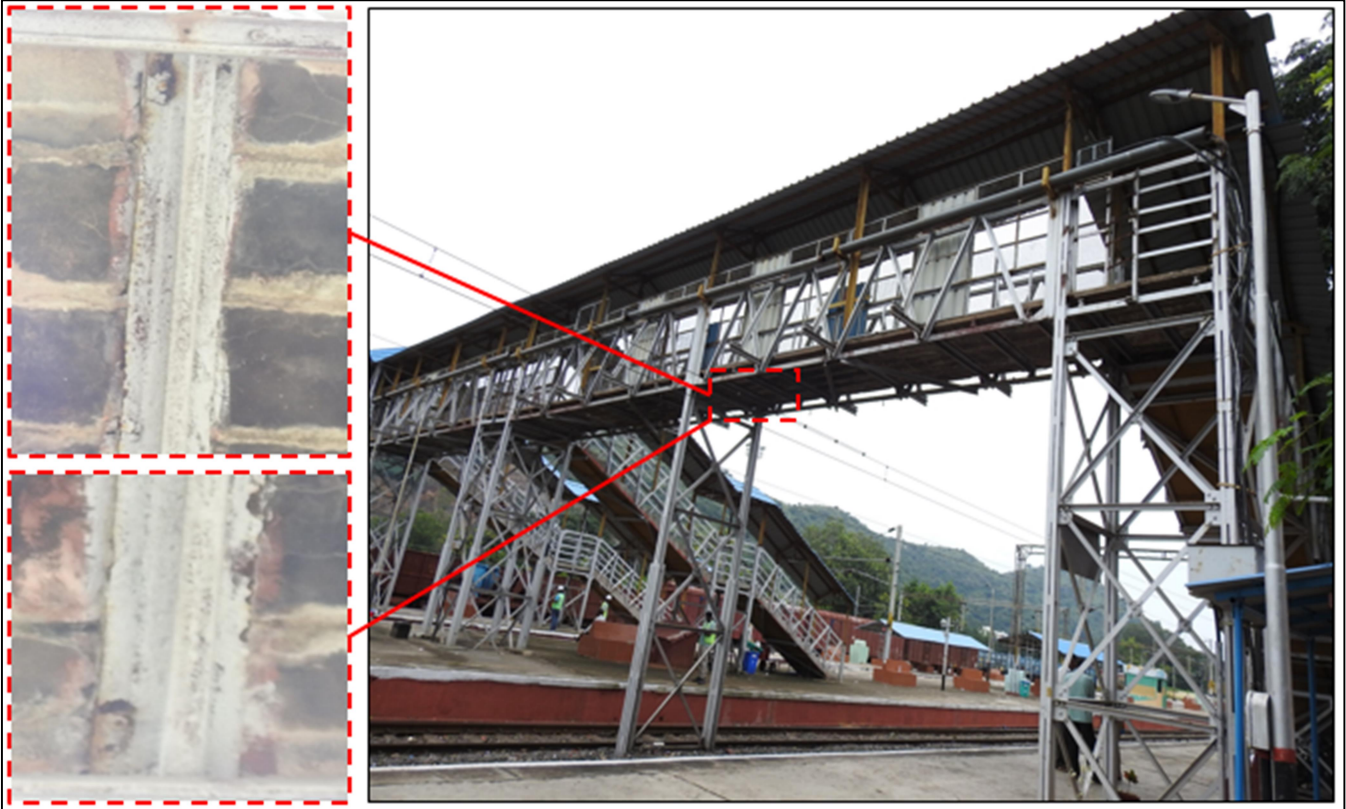
a) Corrosion observed at floor beams on Span-1

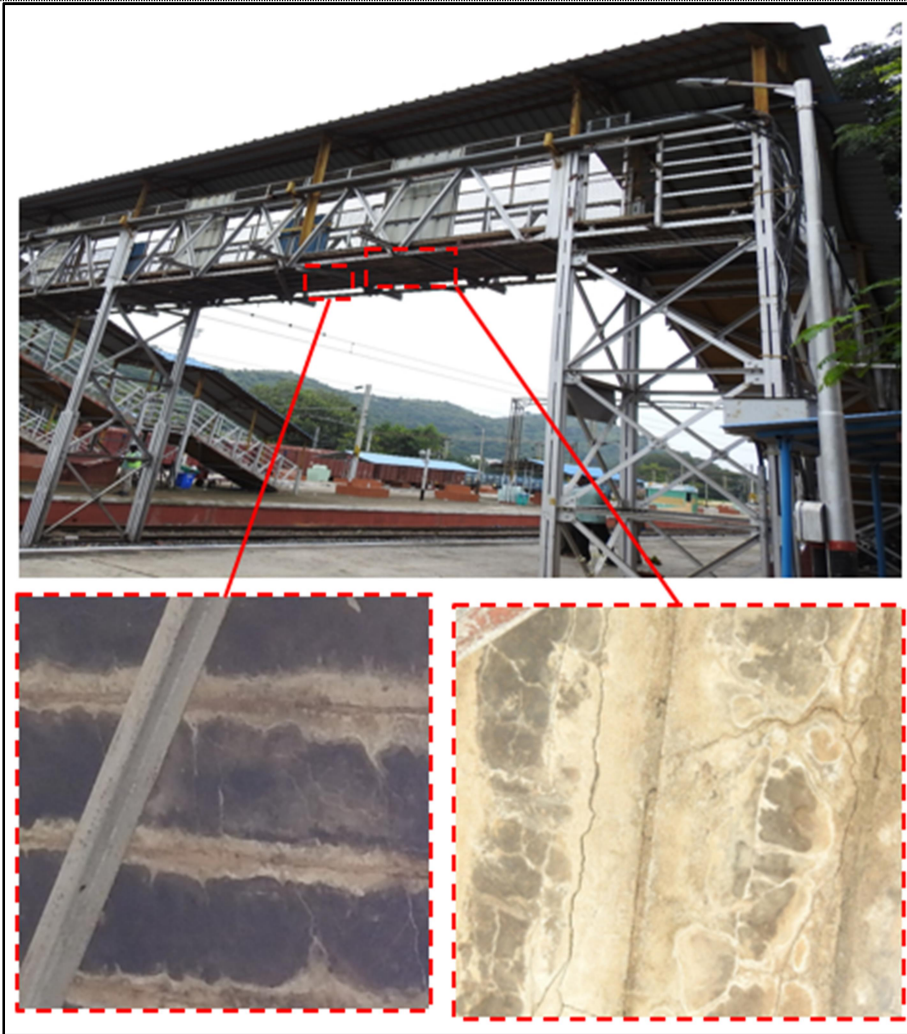
b) Cracks and Leaching on slab panels on Span-1

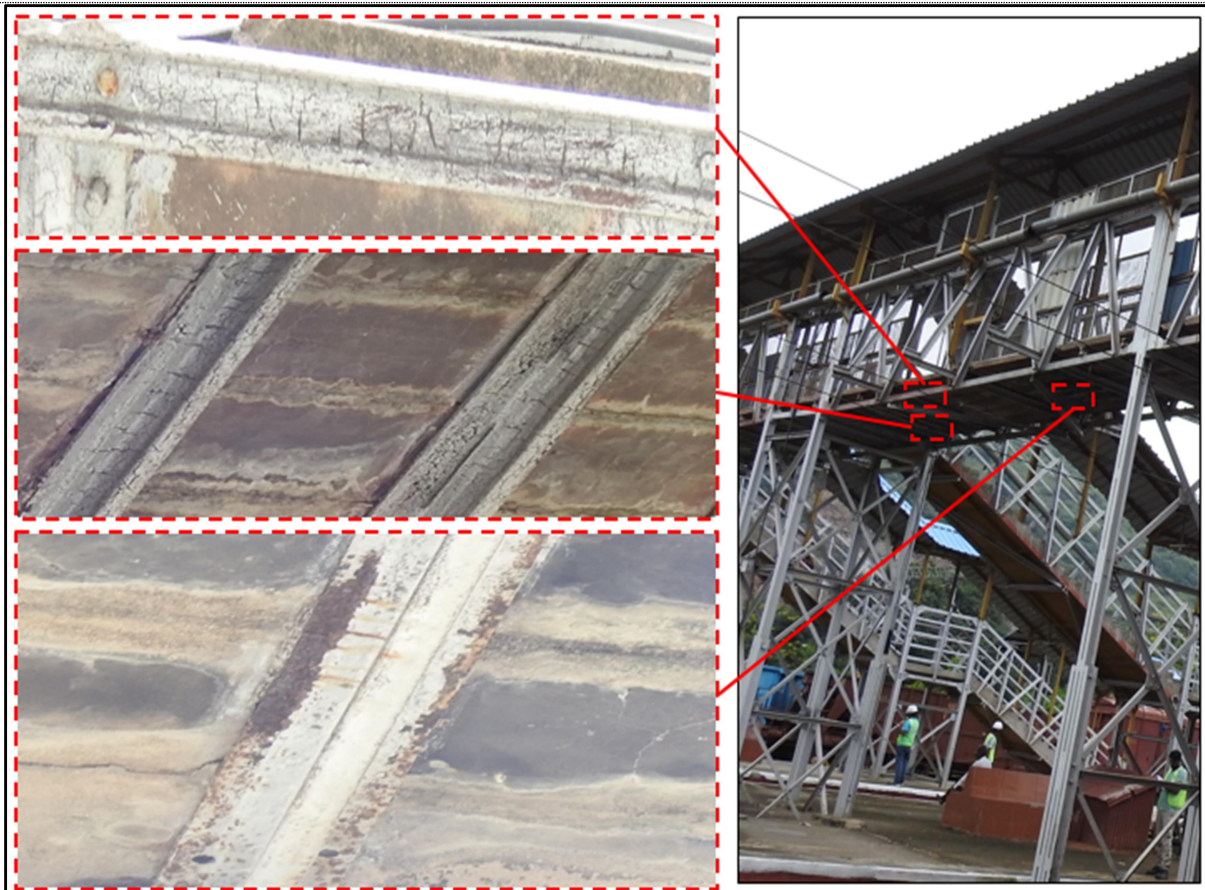
c) Corrosion observed at floor beams and bottom chord on Span-2

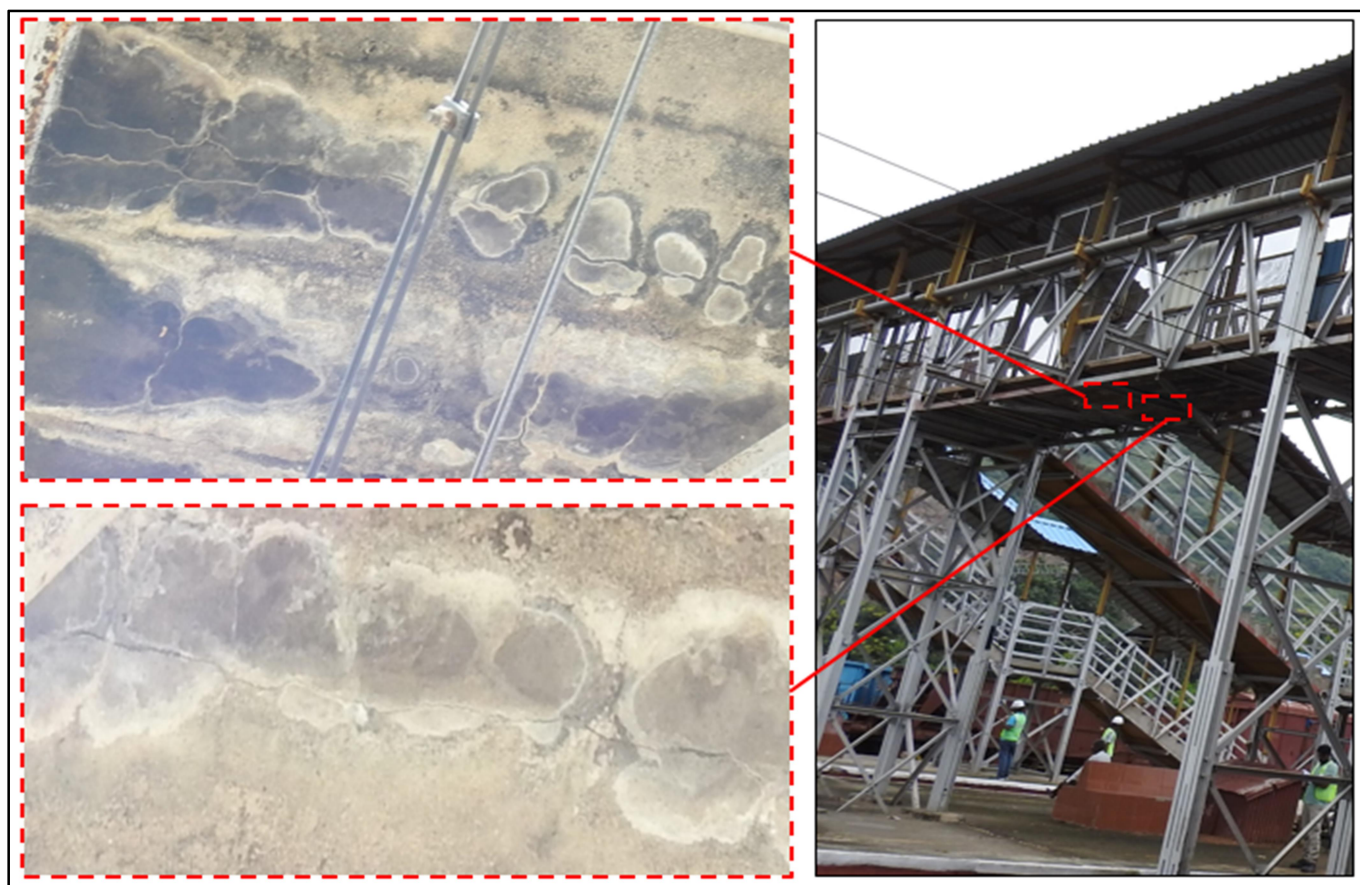
d) Cracks and Leaching in slab panels on Span-2

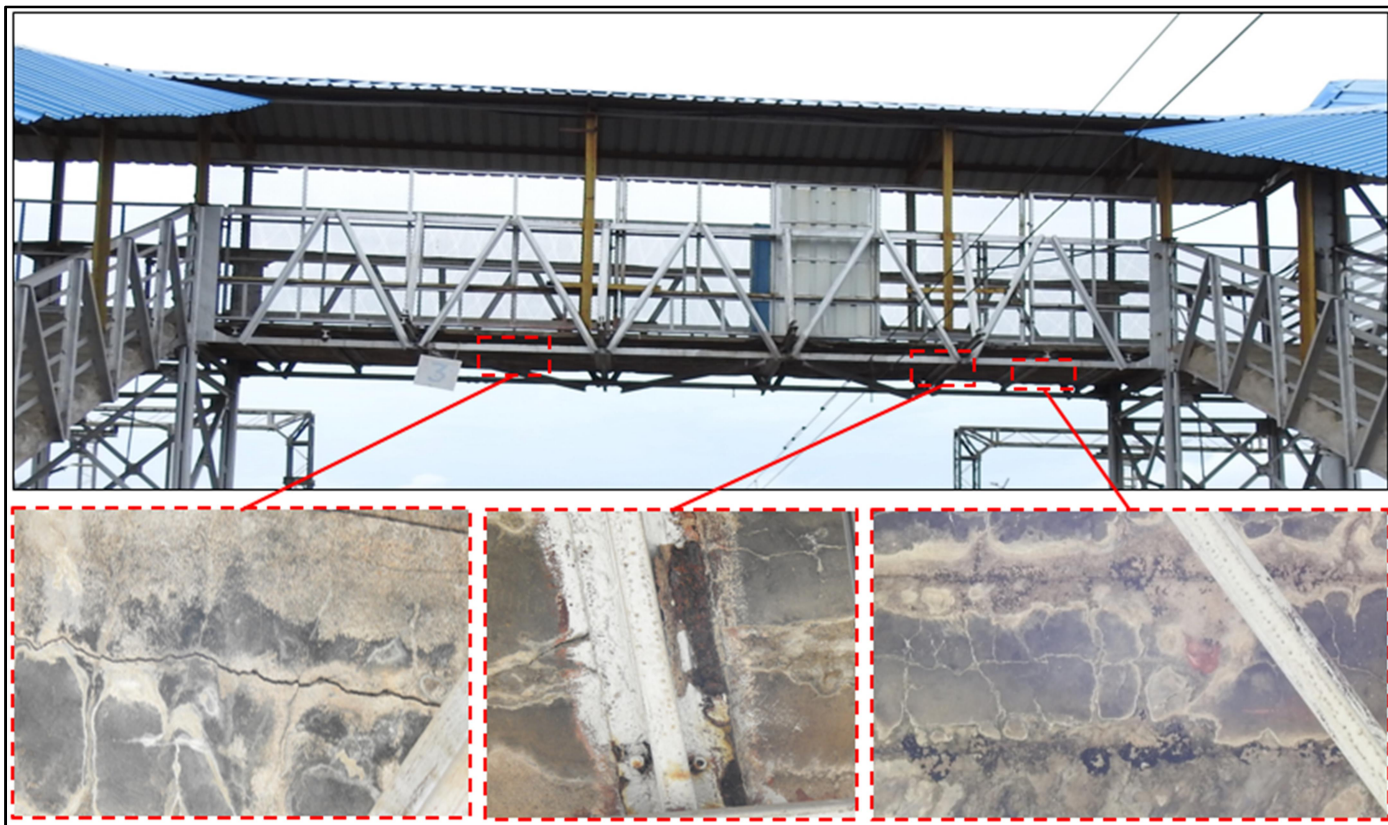
e) Cracks , Corrosion and Leaching in slab panels on Span-3

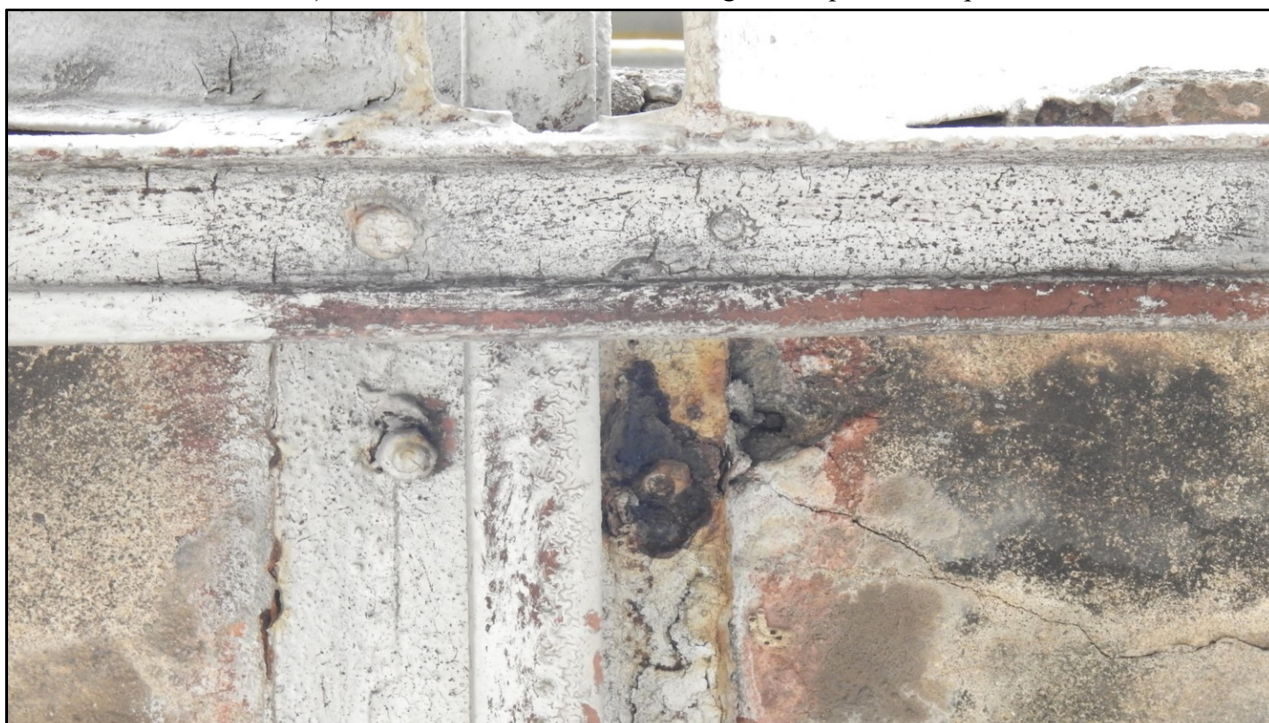
f) Corrosion and rusting observed in Floor beam and bottom chord bolt connection

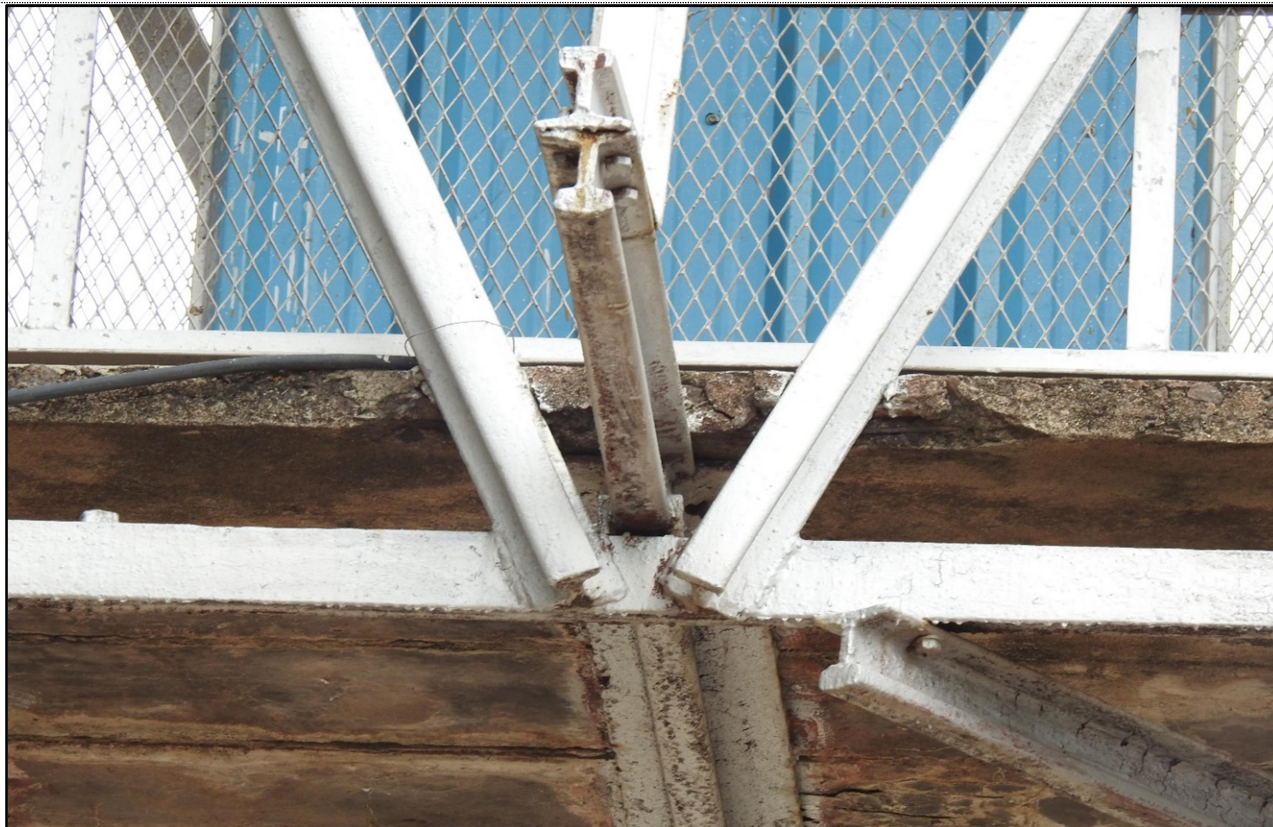
g) Rusting observed at Floor beam and bottom chord

| PART 4 SURVEY OF SIGNS OF DISTRESS, DEFORMATION IN BRIDGES | | | |
|---|---|---|---|
| | Rust straining | | Slight rusting is observed at all the joints of FOB at floor level (Refer <i>part 4.2 g</i> ) |
| | Corrosion at steel-Concrete joint | | Rusting is observed at steel concrete joint along length of FOB(Refer <i>part 4.2 g</i> ) |
