| <b>Name of the Project</b> | <b>:</b> | <b>VISUAL INSPECTION OF FOB AT TENALI RAILWAY STATION</b> |
| <b>Location</b> | <b>:</b> | <b>TENALI RAILWAY STATION</b> |
| <b>Date of Inspection</b> | <b>:</b> | <b>23<sup>rd</sup> OCTOBER, 2019</b> |

### **VISUAL INSPECTION OF STEEL FOOT OVER BRIDGE**

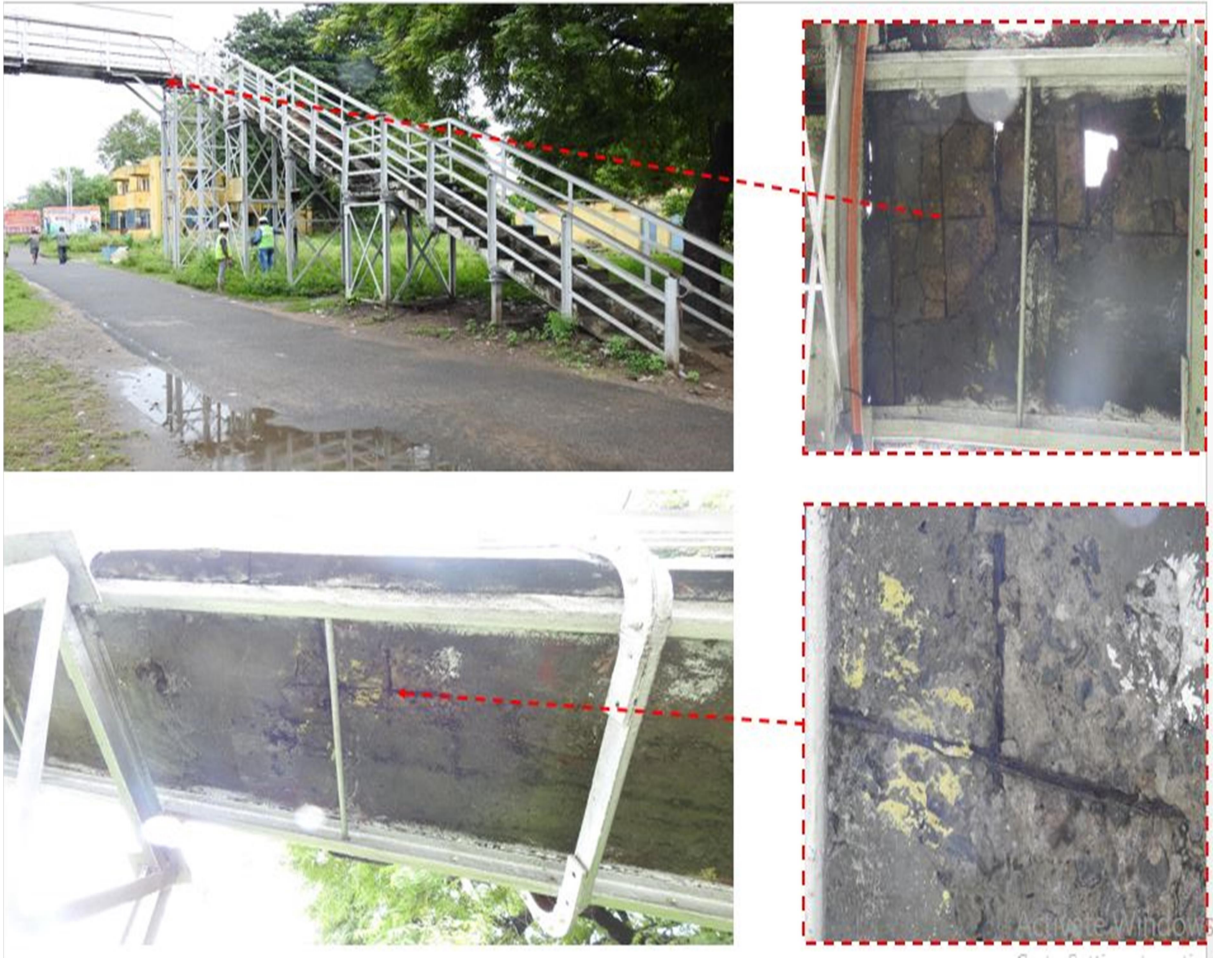
- ✓ Exposed reinforcement is observed on Pre-cast RCC slab panels of Span 11 and staircase panels

a) Reinforcement exposed & broken slab panels

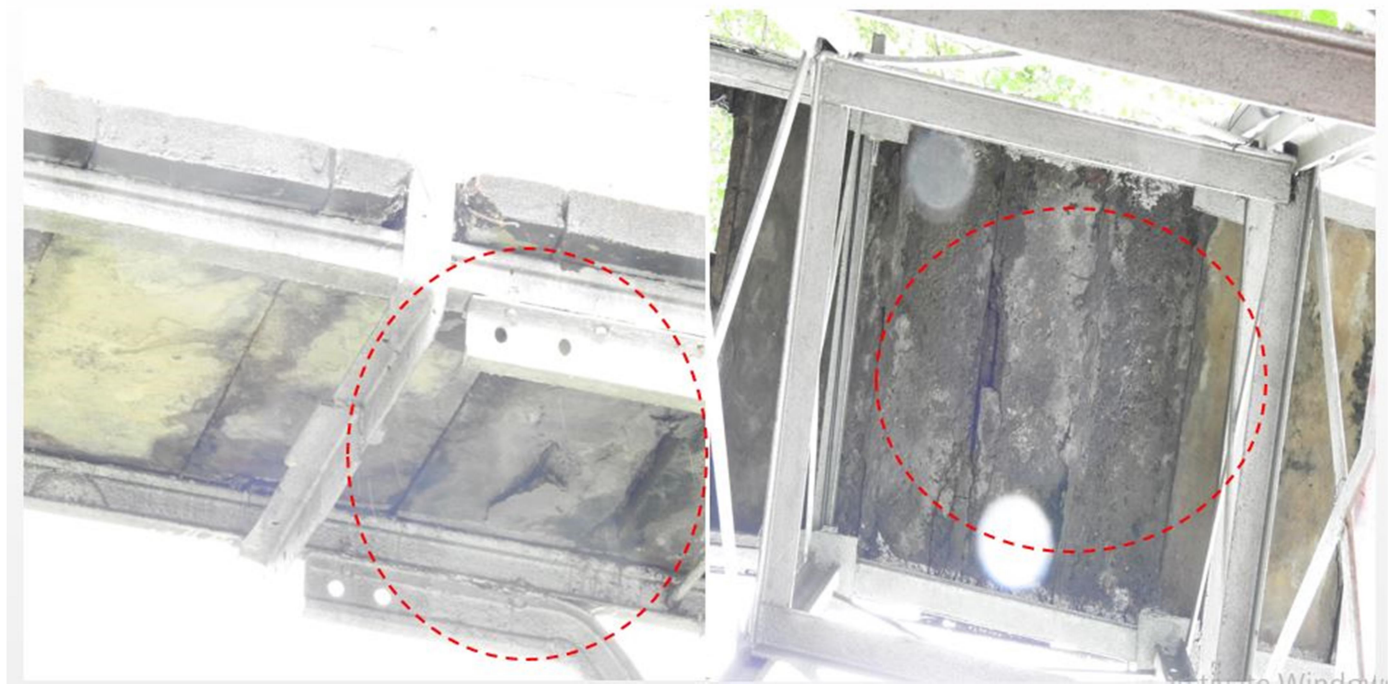
b) Spalling and cracks at Main Slab & stair case pre cast slab panels

| PART 4 SURVEY OF SIGNS OF DISTRESS, DEFORMATION IN BRIDGES | | | |
|---|---|---|---|
| | Spalling | | Spalling is observed in Slab panels and in staircase-pre-cast panels. |

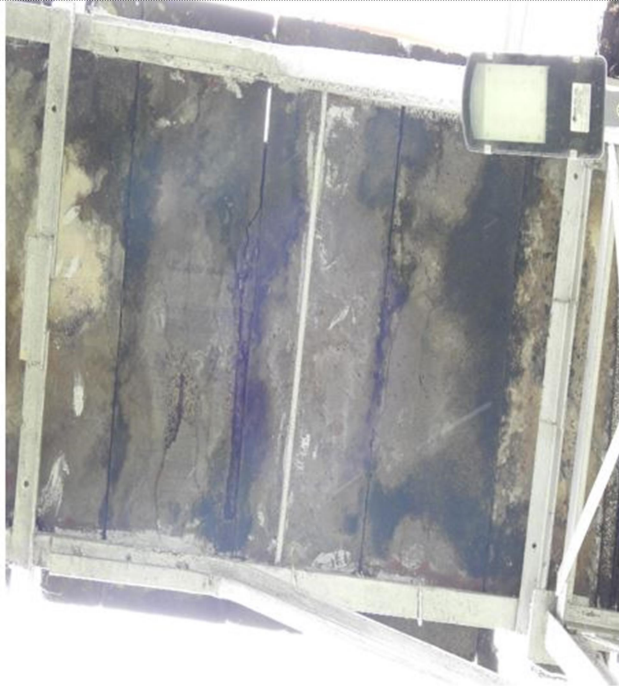
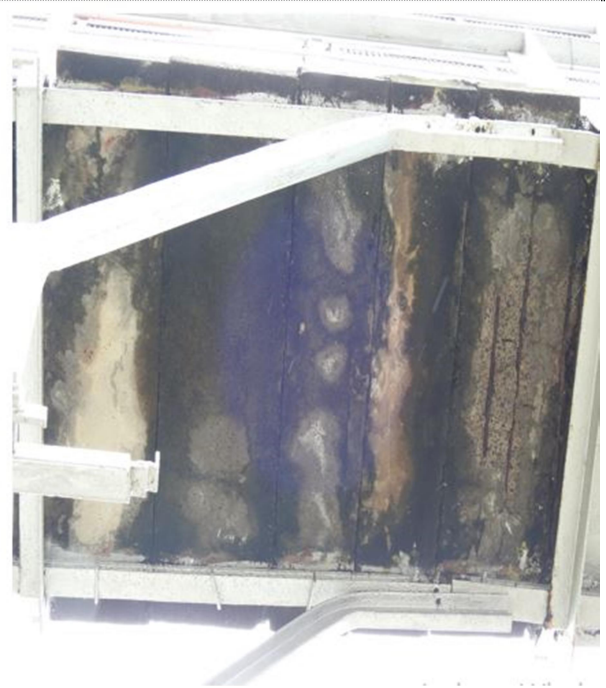
| 4.2 | ✓ Leaching effect and Cracks are observed on Pre-cast slab panels on 2 <sup>nd</sup> & 11 <sup>th</sup> span of FOB. |

a) Leaching effect and Cracks are observed on Pre-cast slab panels

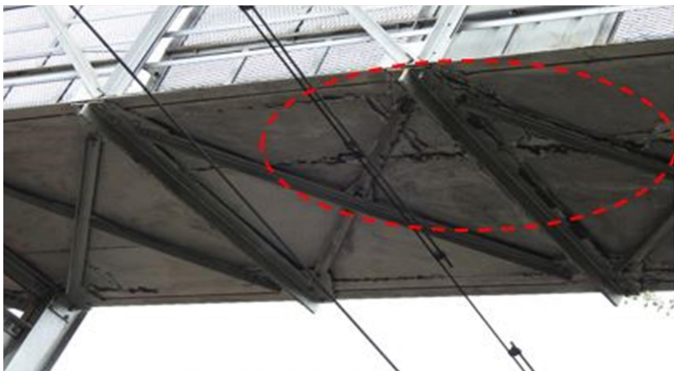
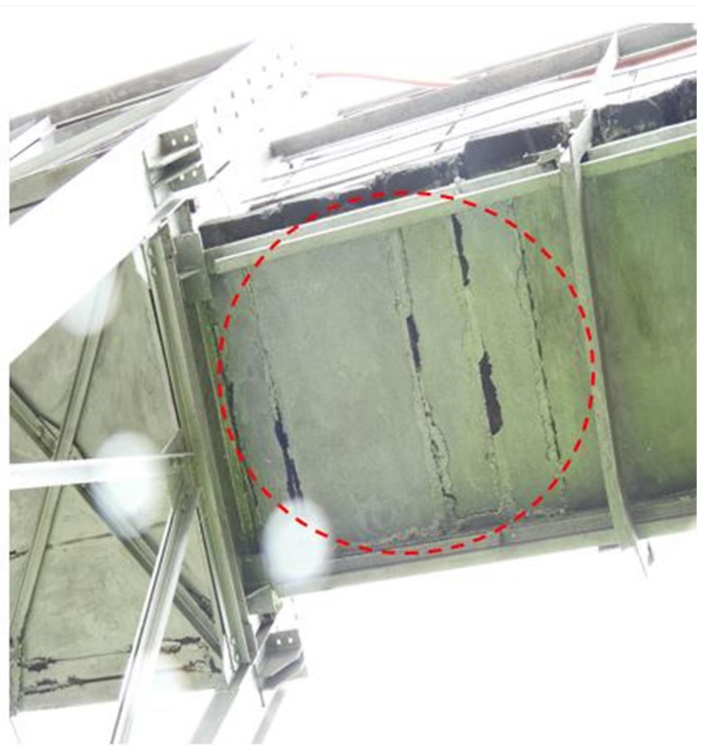
b) Corrosion observed at floor beams & Sacrificial Plates

| PART 4 SURVEY OF SIGNS OF DISTRESS, DEFORMATION IN BRIDGES | | | |
|---|---|---|---|
| | Corrosion in Gusset plate | Floor level | corrosion is observed in Sacrificial Plates |

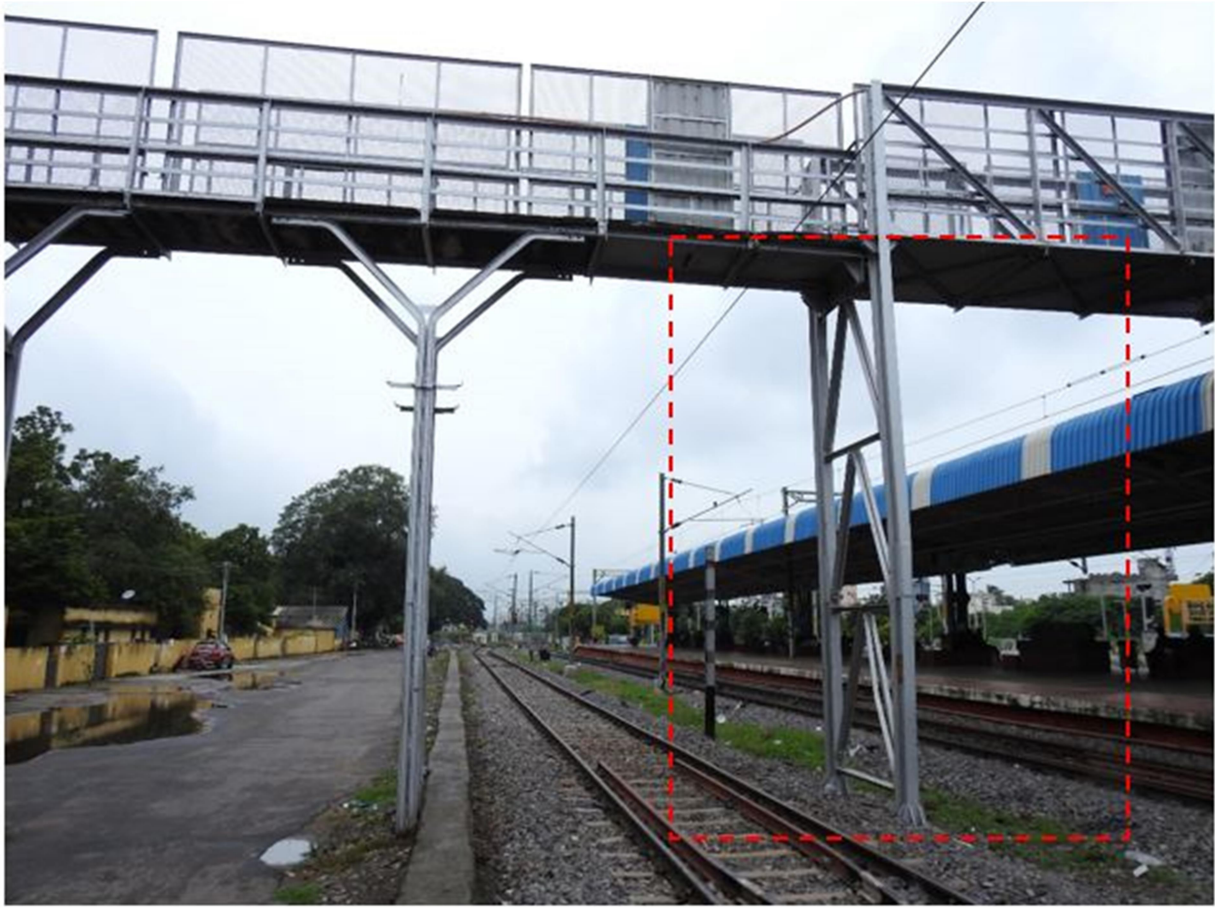
| 4.3 | ✓ Deformation is observed at Stanchion-7. |

(a) Deformation observed in Stanchion-7 column and bracing

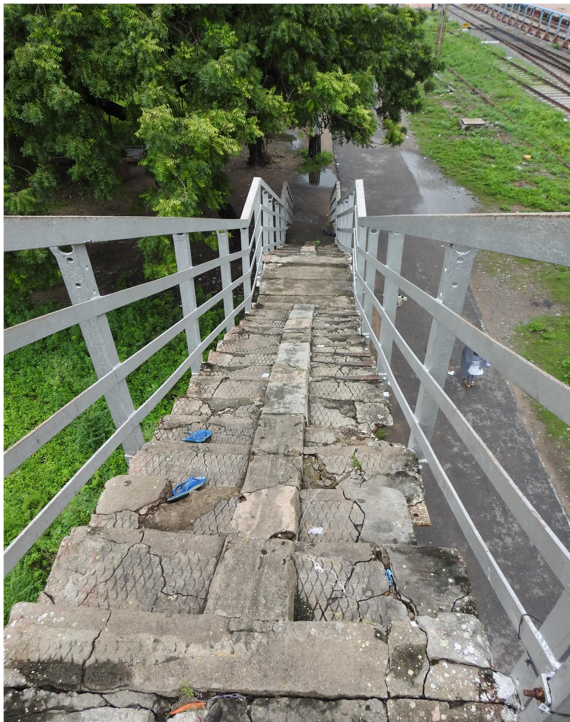
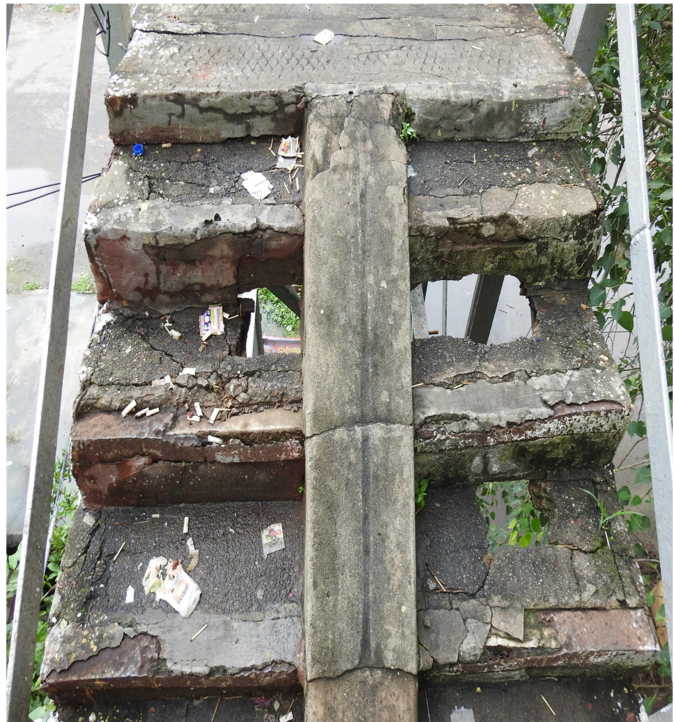
✓ Critically damaged staircase

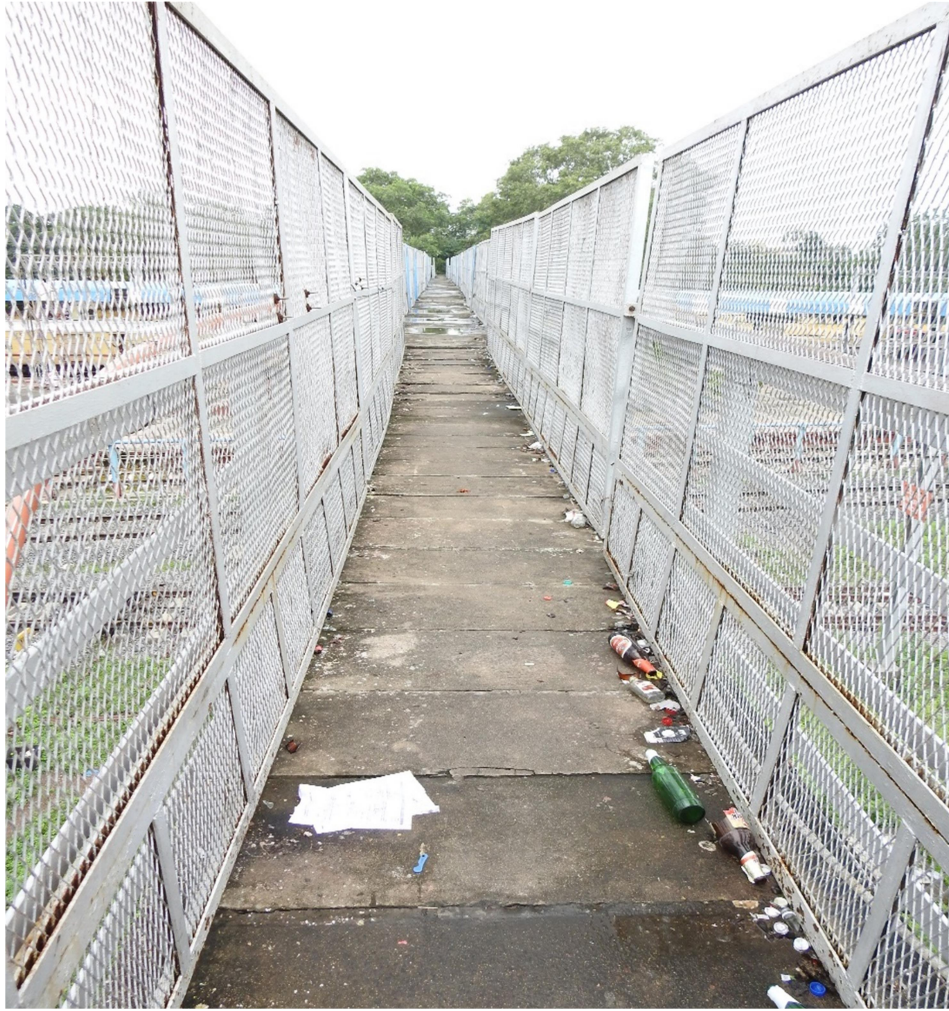
| | a) Additional wearing coat on Floor | No | No wearing coat on RCC precast Slabs (Refer <i>fig :2</i> ) |
| | b) Provision of protective screen for passengers | Yes | Fence made of galvanized wire of 2 mm gauge and 2 mm galvanized sheet is used above OHE Line on both side of pathway is used for passengers Protection. (Refer <i>fig :2</i> ) |

**Fig 2:** FOB pathway, protective screen

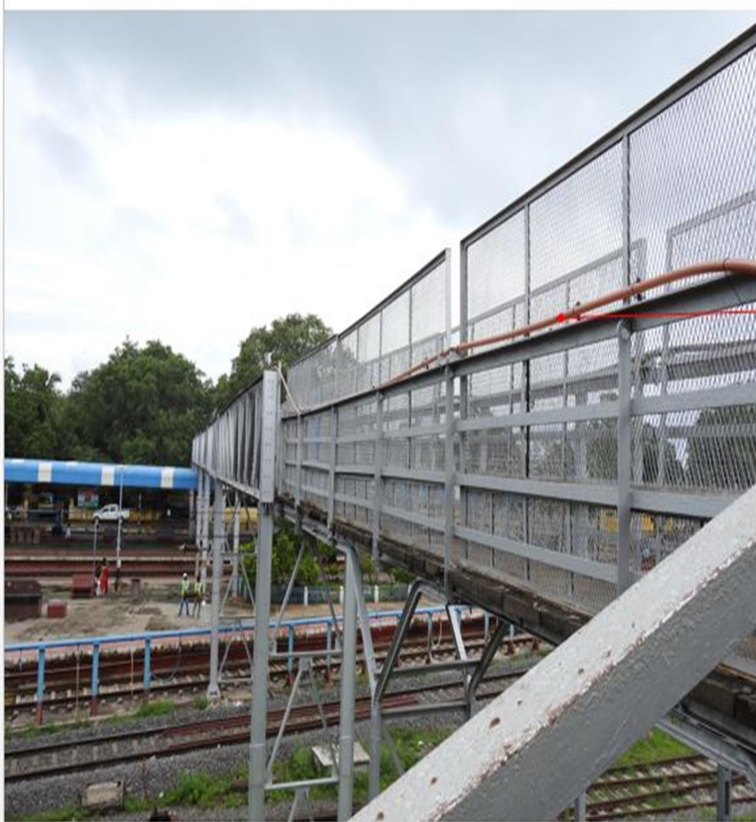
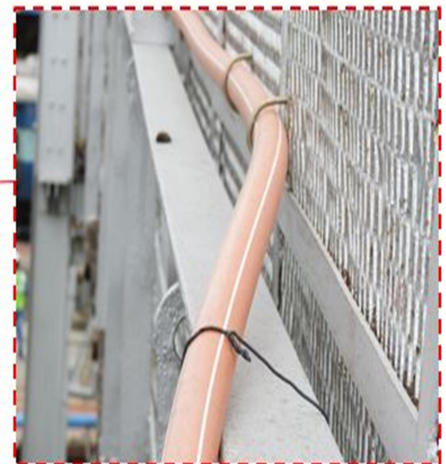
| 2.1 | a) Pipeline - Utilities | No | a. Cables in 1-inch HDPE pipe, 1.5-inch HDPE pipe. & 2-inch PVC pipe are supported on Truss. (Refer <i>fig :3</i> )<br>b. GI Pipes of Dia-60mm at Trestle-1 is observed<br>c. No Roof Truss is provided. |

**Fig 3:** Additional loads of PVC pipes

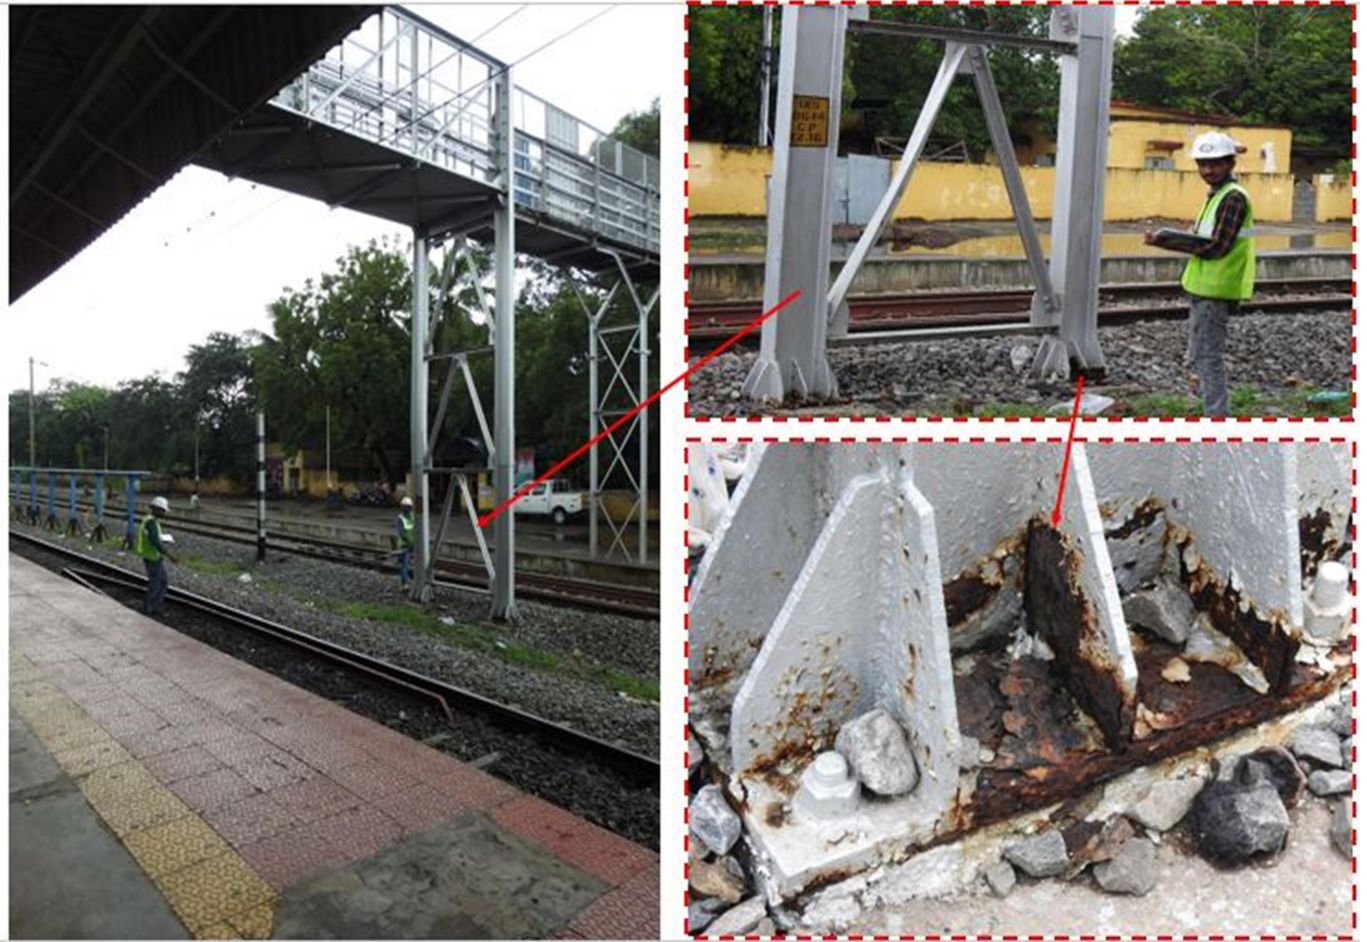
| | Dimensions of Column | | c. Stanchion-1,8,9&10 column has built up section of 2 rail sections of size 55 x 100 x 100mm (Head x Height x Base) (Refer <b>fig : 4</b> ) |

**Fig 4:** Stanchion column sections details

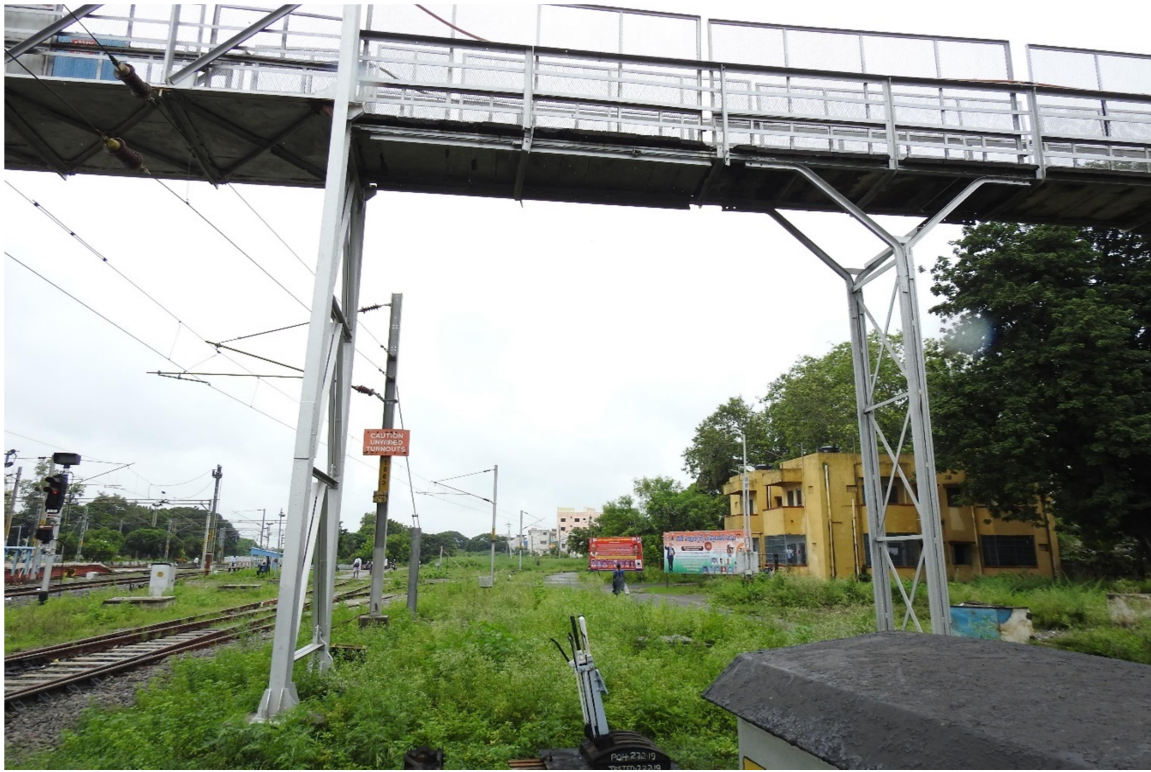
| PART 3 STRUCTURAL SYSTEM OF THE BRIDGE | | | |
|---|---|---|---|
| | Type /Shape of Truss Section | Pratt truss with Double Angles & Rail sections | <p><b>Span 1,2,8,9,10&amp;11:</b></p> <p>a) Top Angle is 75 x 75 x 10 mm sections and bottom NG Rail section is 45 x 90 x 90 (Head x Height x Base) (Refer <b>fig : 5</b>)</p> <p>b) 75 x 75 x 10 mm Angle sections are used as vertical members.</p> <p>c) 75 x 75 x 10 mm Angle sections are used as Floor beams</p> <p><b>Span 3,4,5,6&amp;7</b></p> <p>a) Top and bottom Chord members are 75 x 75 x 10 mm Angle sections (Refer <b>fig : 5</b>)</p> <p>b) 75 x 75 x 10 mm Angle sections are used as vertical and diagonal bracing members.</p> <p>c) 75 x 75 x 10 mm double Angle sections are used as Floor beams.</p> <p>d) Bottom Lateral Bracings 75 x 75 x 10 mm Angle sections in Cross pattern are used to support Floor beams.</p> |

**Fig 5:** Bottom view of FOB

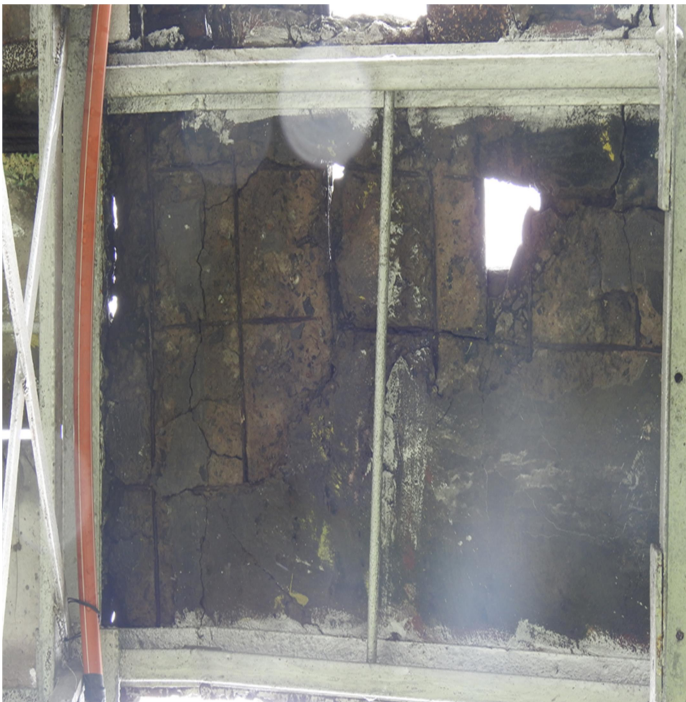
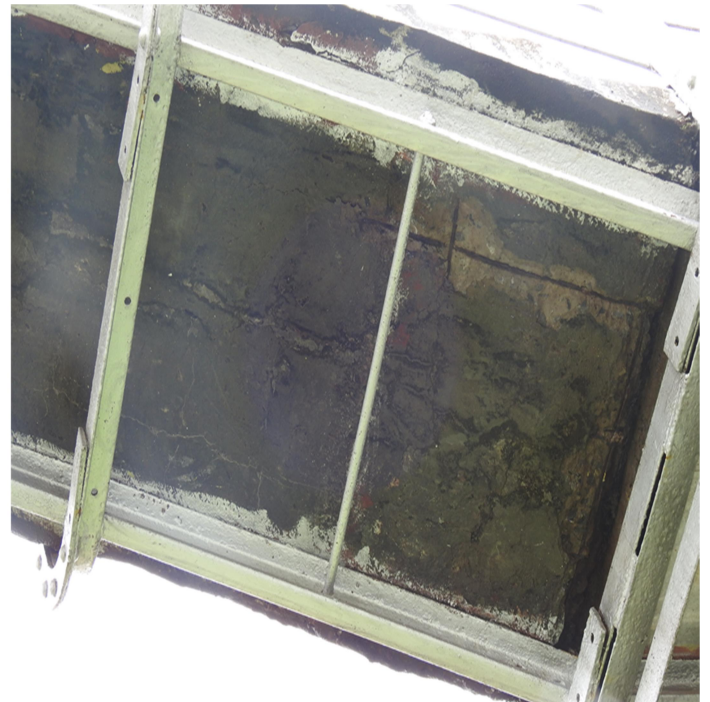
| PART 1 GENERAL INFORMATION AND OBSERVATION | | |
|---|---|---|
| 1.14 | History of Repair/ Maintenance | Patch work observed in the staircase-2 Landing |

**Fig 6:** Patch work is observed at slab panels of stair case landing
