| <b>Name of the Project</b> | <b>: VISUAL INSPECTION OF FOB/ PF-1 – PF-2 AT TSUNDURU RAILWAY STATION+</b> |
| <b>Location</b> | <b>: TSUNDURU RAILWAY STATION</b> |
| <b>Date of Inspection</b> | <b>: 24<sup>th</sup> October 2019</b> |

## VISUAL INSPECTION OF STEEL FOOT OVER BRIDGE

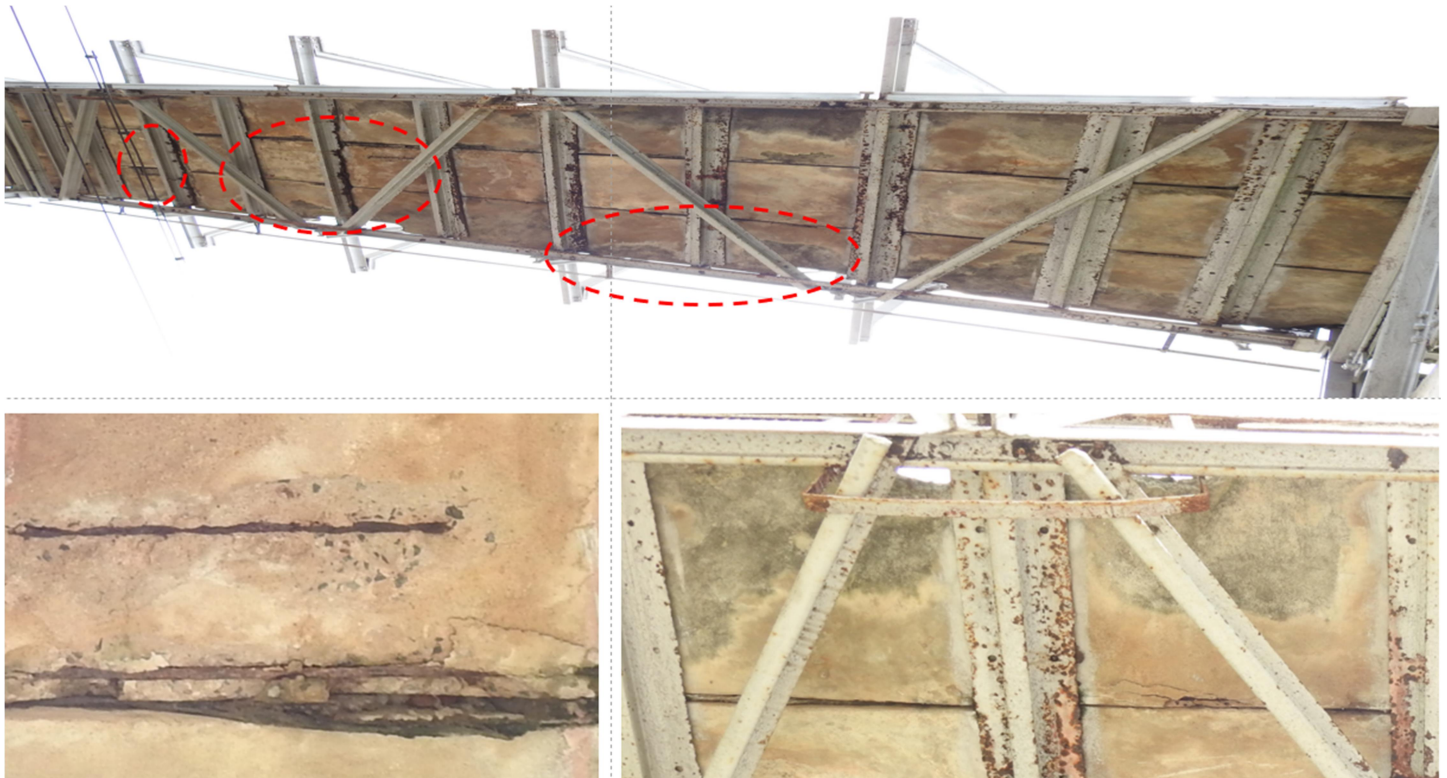
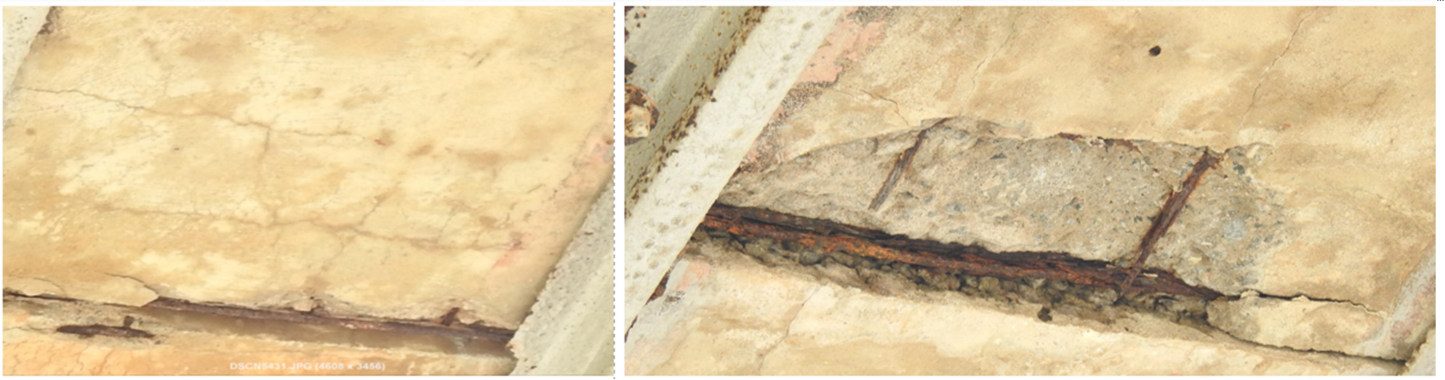
- 4.1 ✓ Exposed reinforcement is observed on Pre-cast RCC slab panels of FOB.

a) Reinforcement exposed at slab panels of 1<sup>st</sup> span

| | Cracking in RCC components | Slab Panels | cracks are observed in Pre-cast RCC slab panels ( <i>Refer part4 - 4.1 a,b</i> ) |

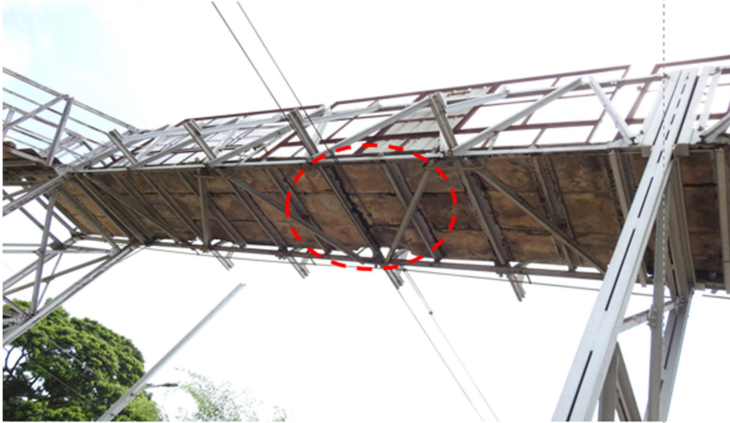
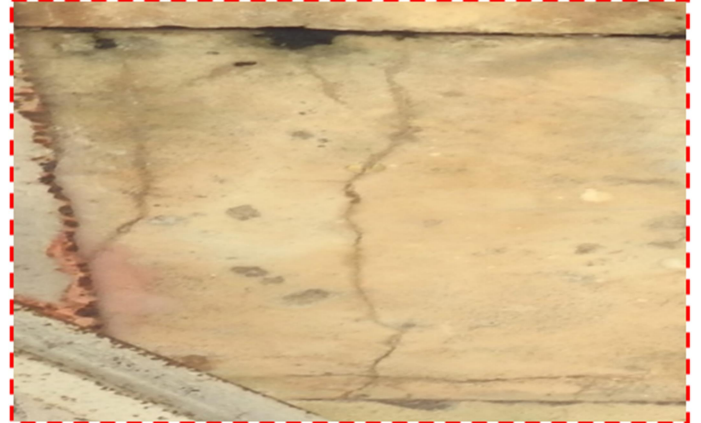
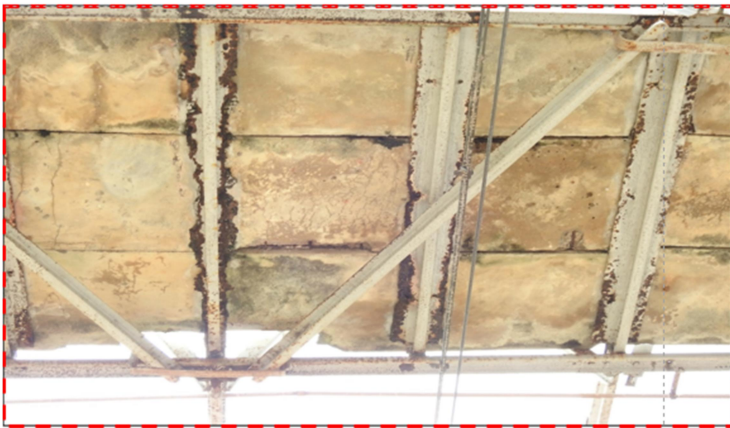
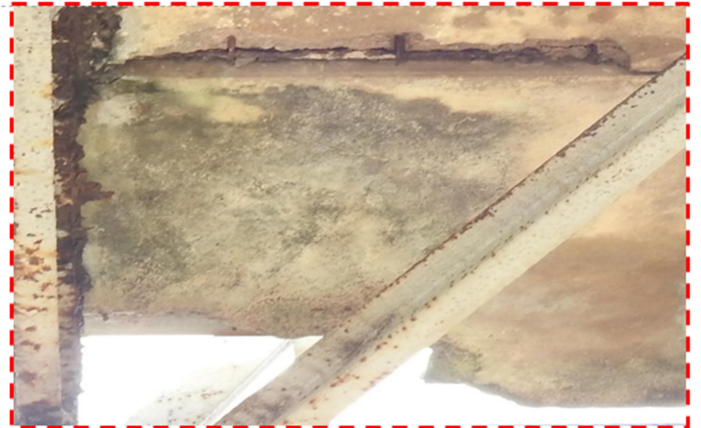
b) Reinforcement exposed at slab panels of 2<sup>nd</sup> span

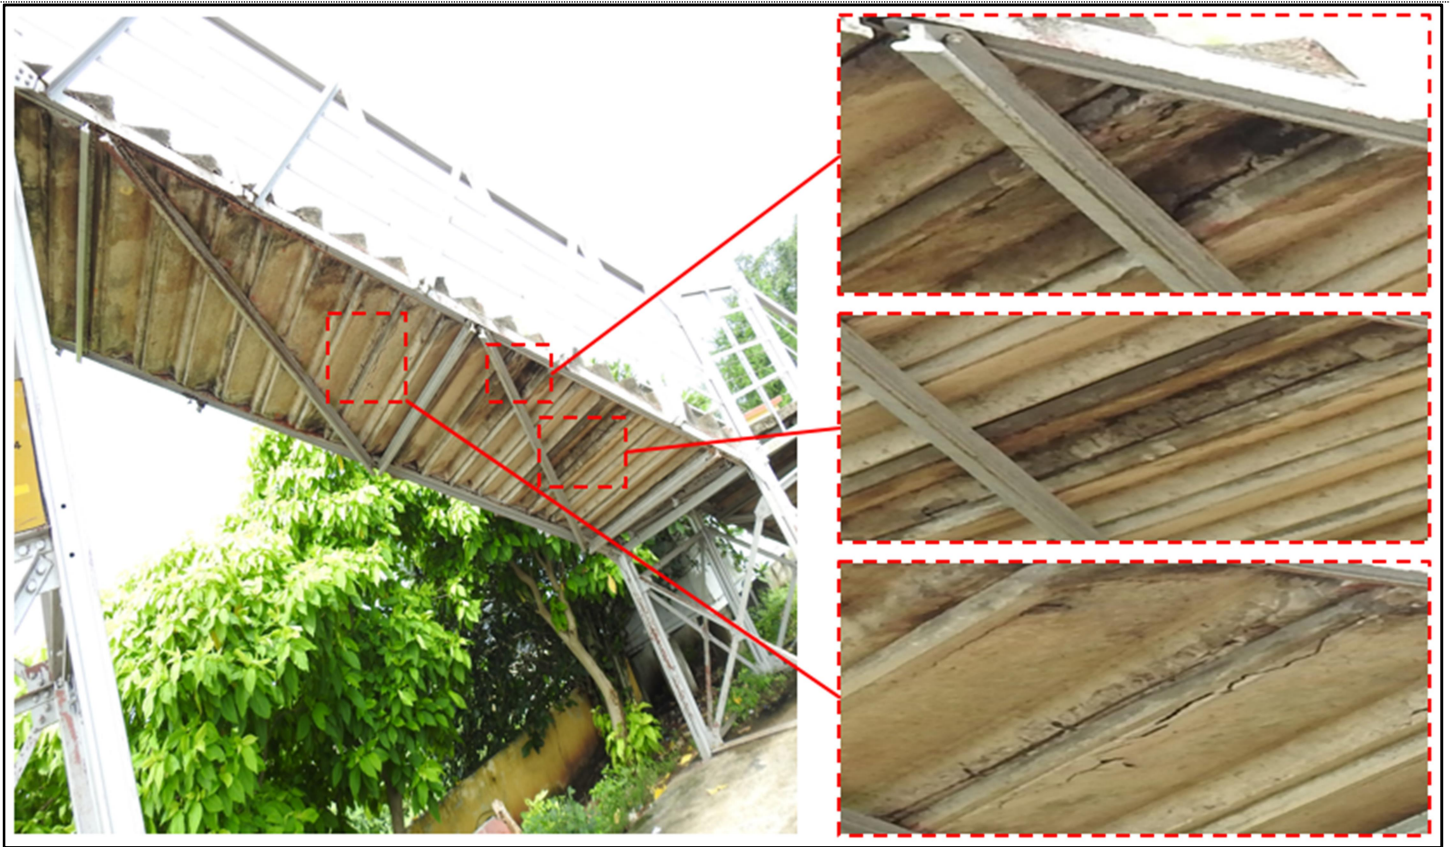
c) Reinforcement exposed slab panels on bottom of staircase-1

| | Spalling | Stair case | Spalling and reinforcement exposure is observed in some precast RCC panels of span1, 2 and landings of staircase. ( <i>Refer Part 4 - 4.1</i> ) |

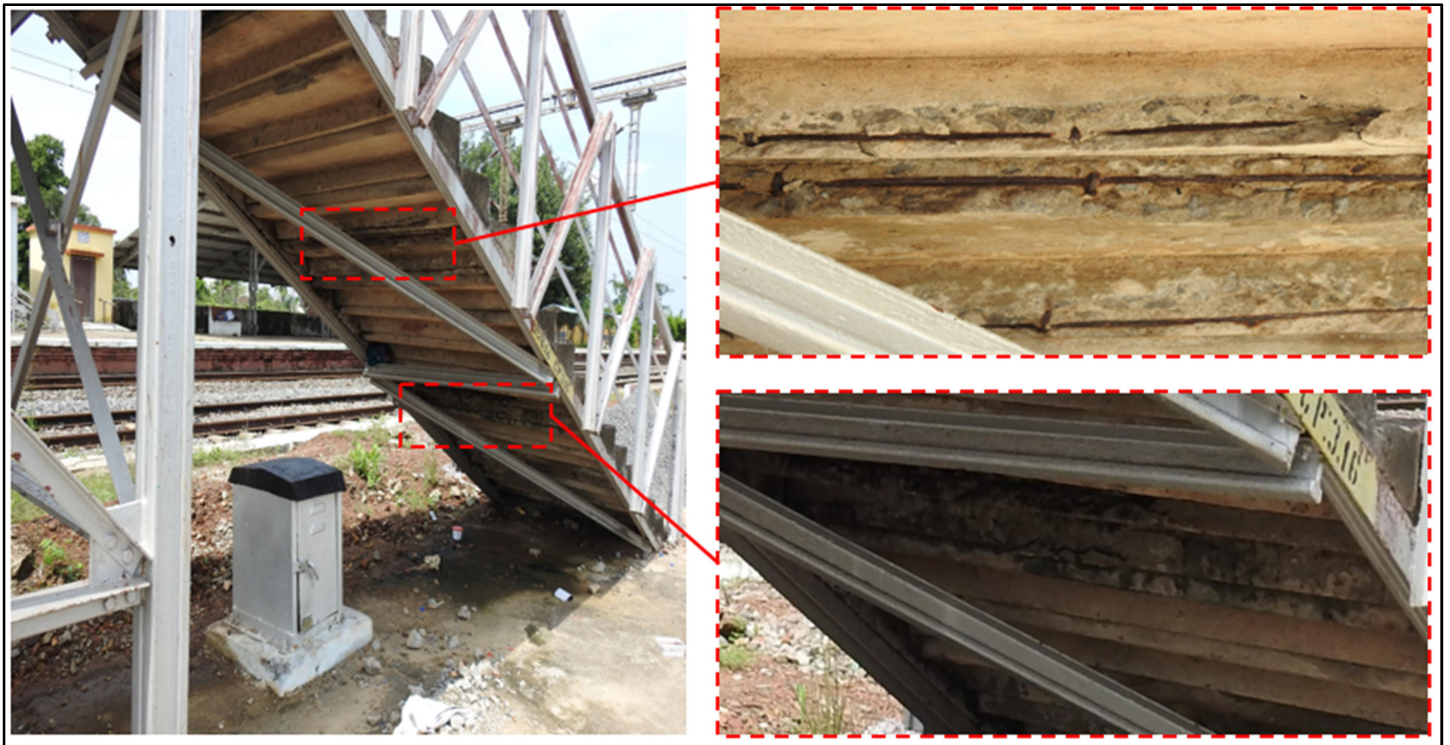
d) Reinforcement exposed slab panels on bottom of staircase-2

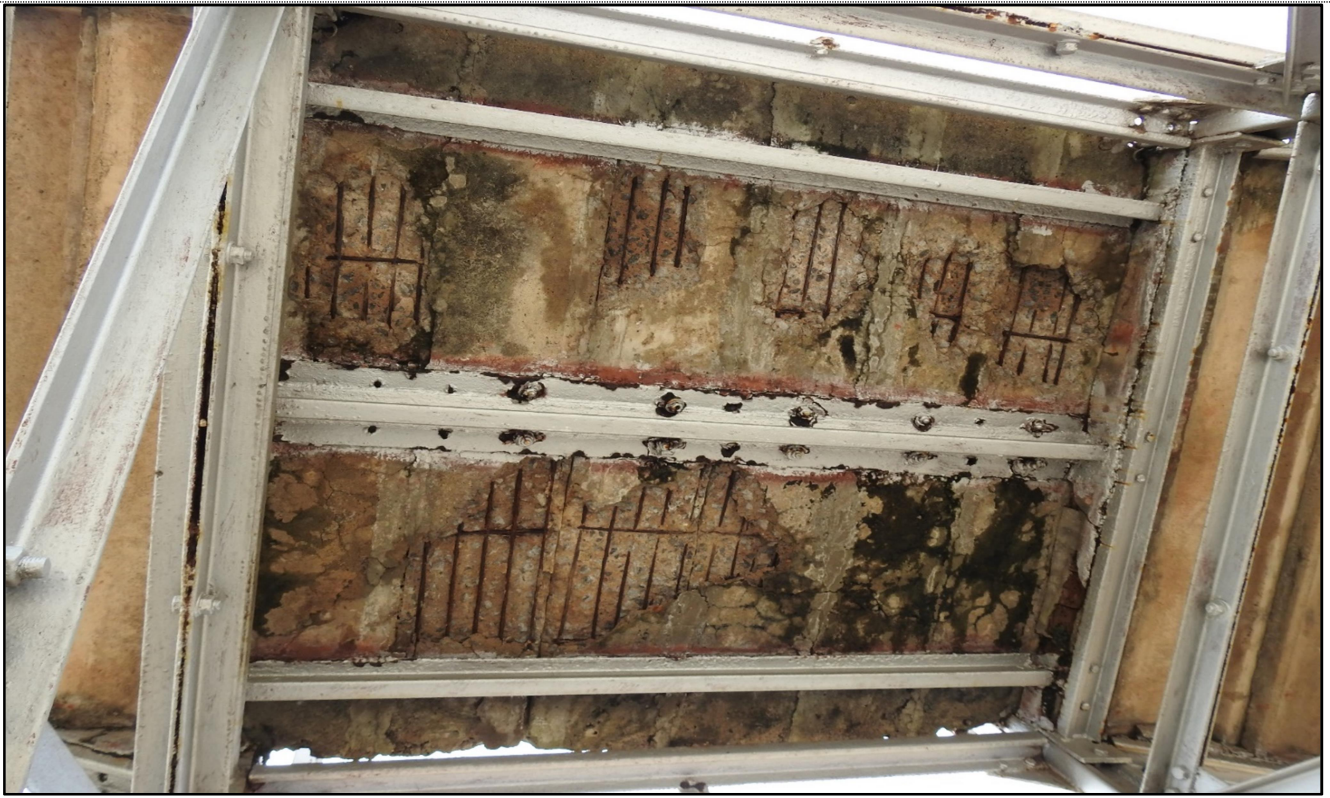
e) Severe Spalling, Reinforcement visible in staircase 2 (Mid landing)

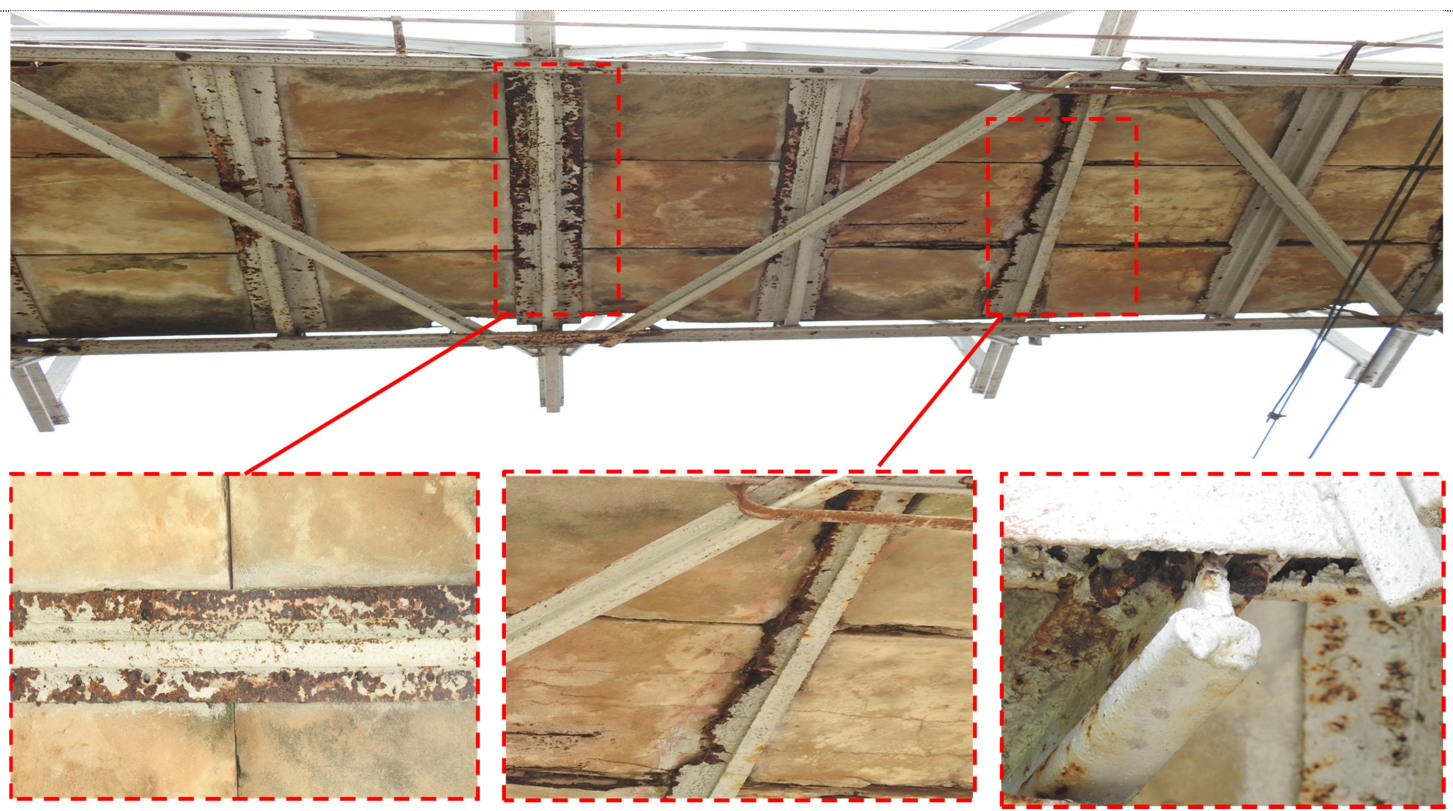
| 4.2 | ✓ Corrosion and rusting of Floor beams and Bottom chord, bottom bracings & Stringer beam of FOB |

a) Corrosion of Floor beams is observed in 1<sup>st</sup> span

| | Extent Of Corrosion | In Floor beam | Corrosion of floor beams is observed in 1 <sup>st</sup> and 2 <sup>nd</sup> span of FOB. ( <i>Refer Part 4 - 4.2</i> ) |

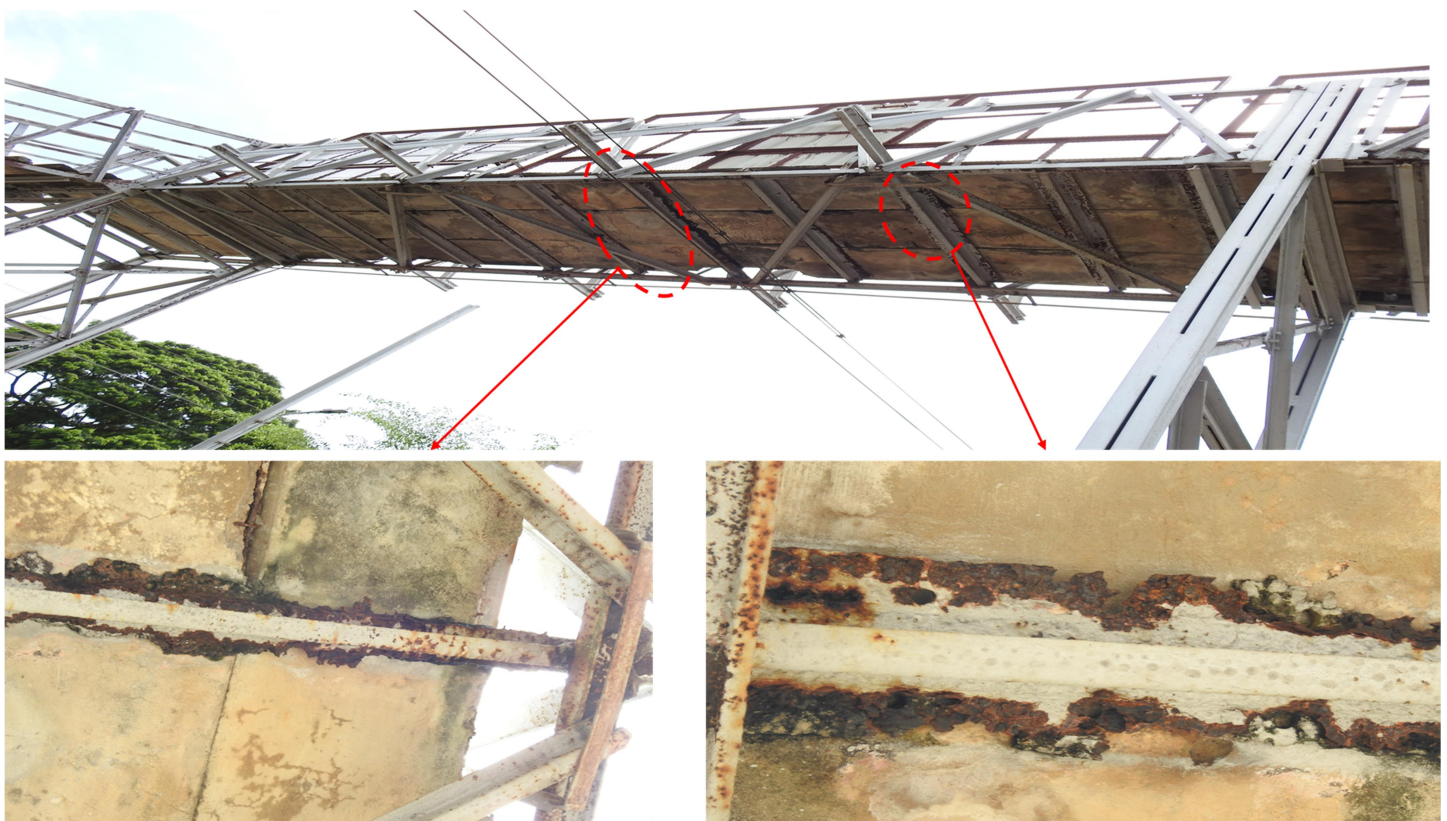
b) Corrosion of Floor beams is observed in 2<sup>nd</sup> span

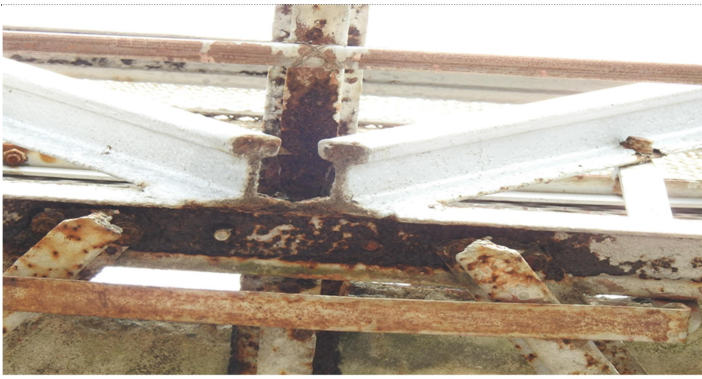
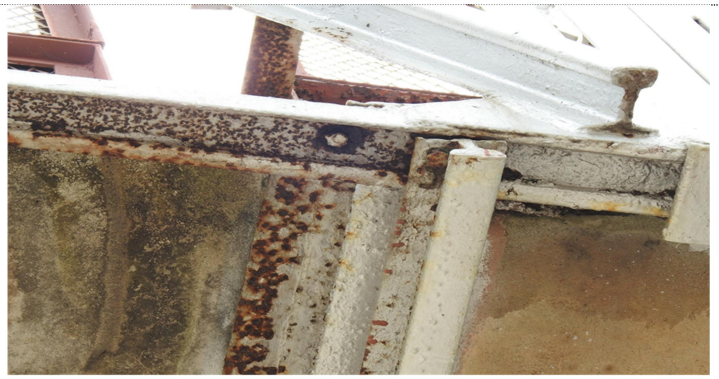
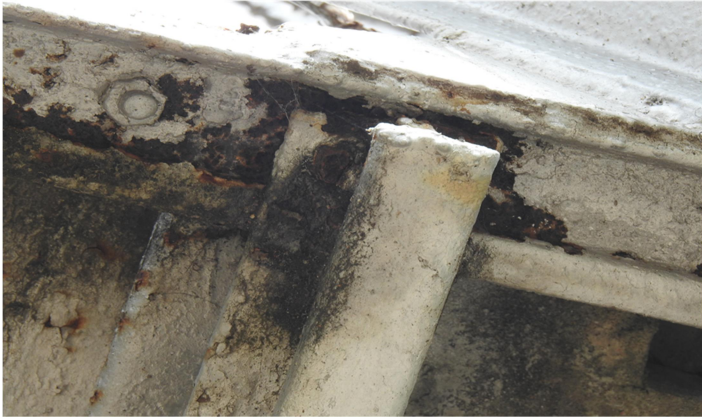
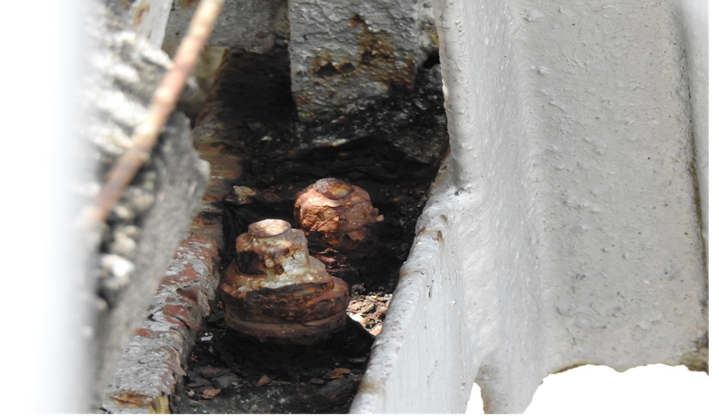
c) Rusting and Corrosion of bottom chord

| | Rust straining | Bottom main Chord members | Rusting is observed at all the joints of FOB ( <i>Refer Part 4 - 4.2</i> ) |

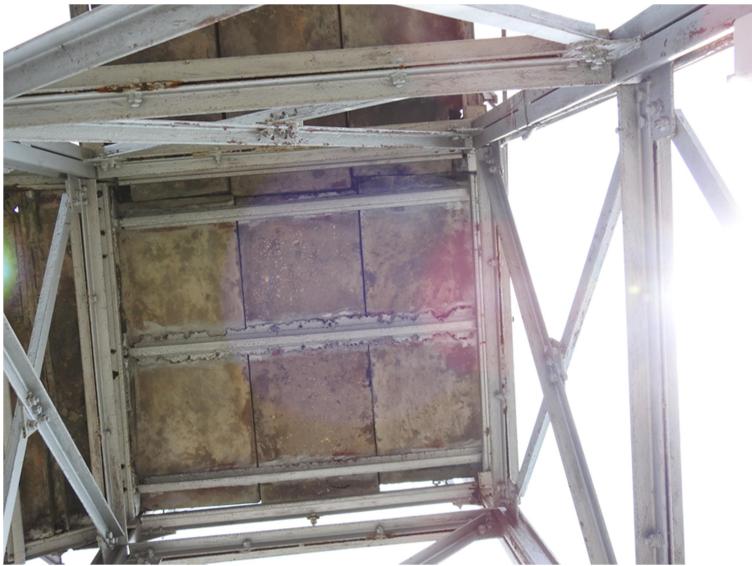
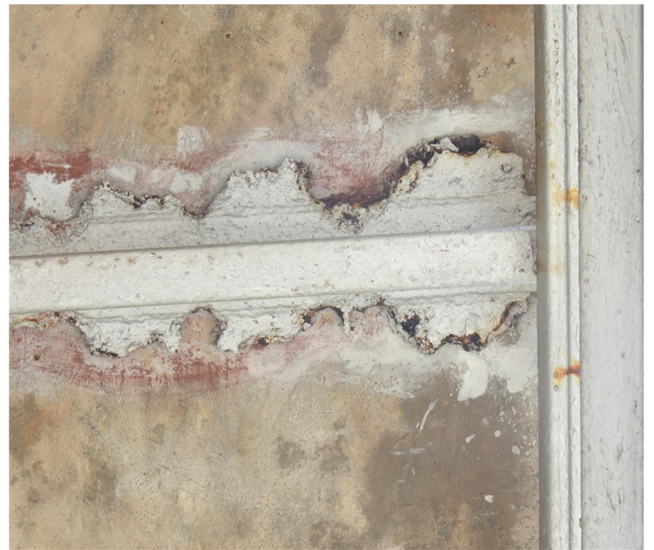
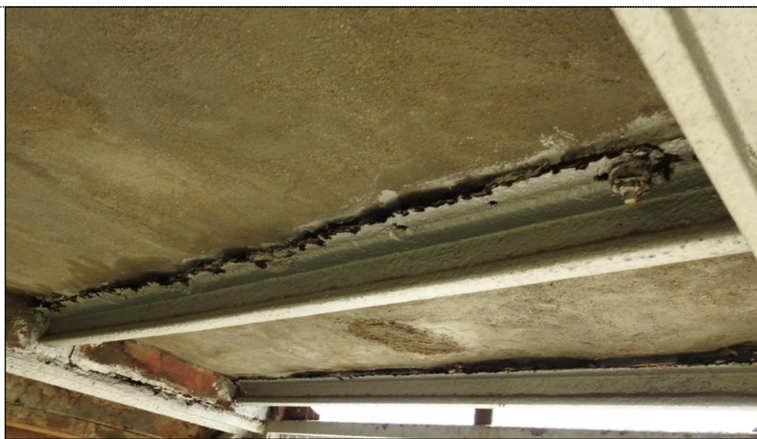
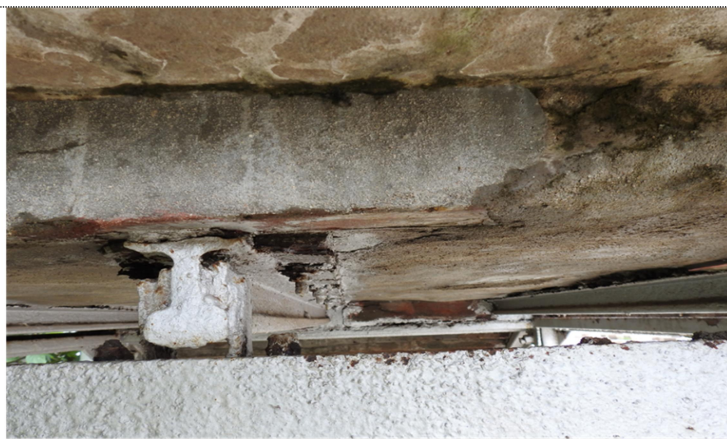
d) Corrosion of floor beam and Patch work observed at landing

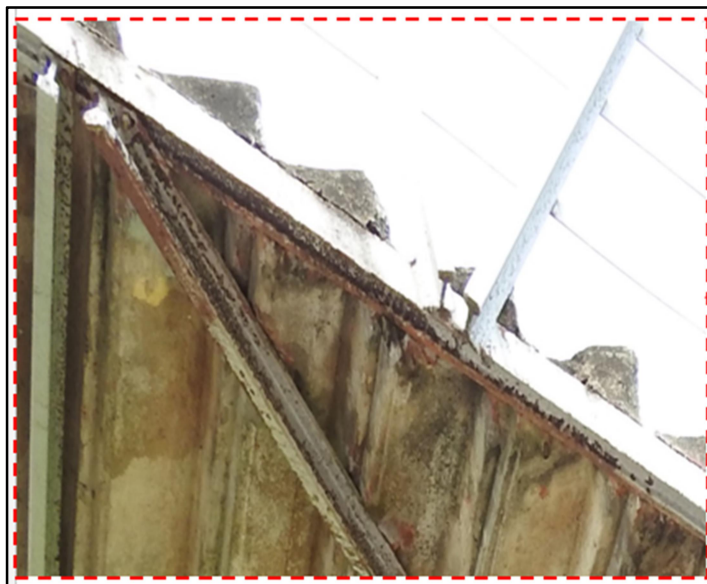
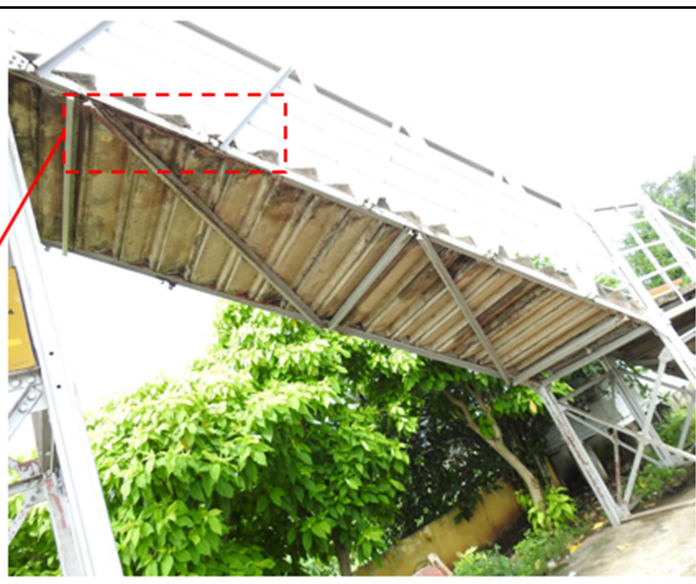
e) Rusting and corrosion observed at Stringer beams

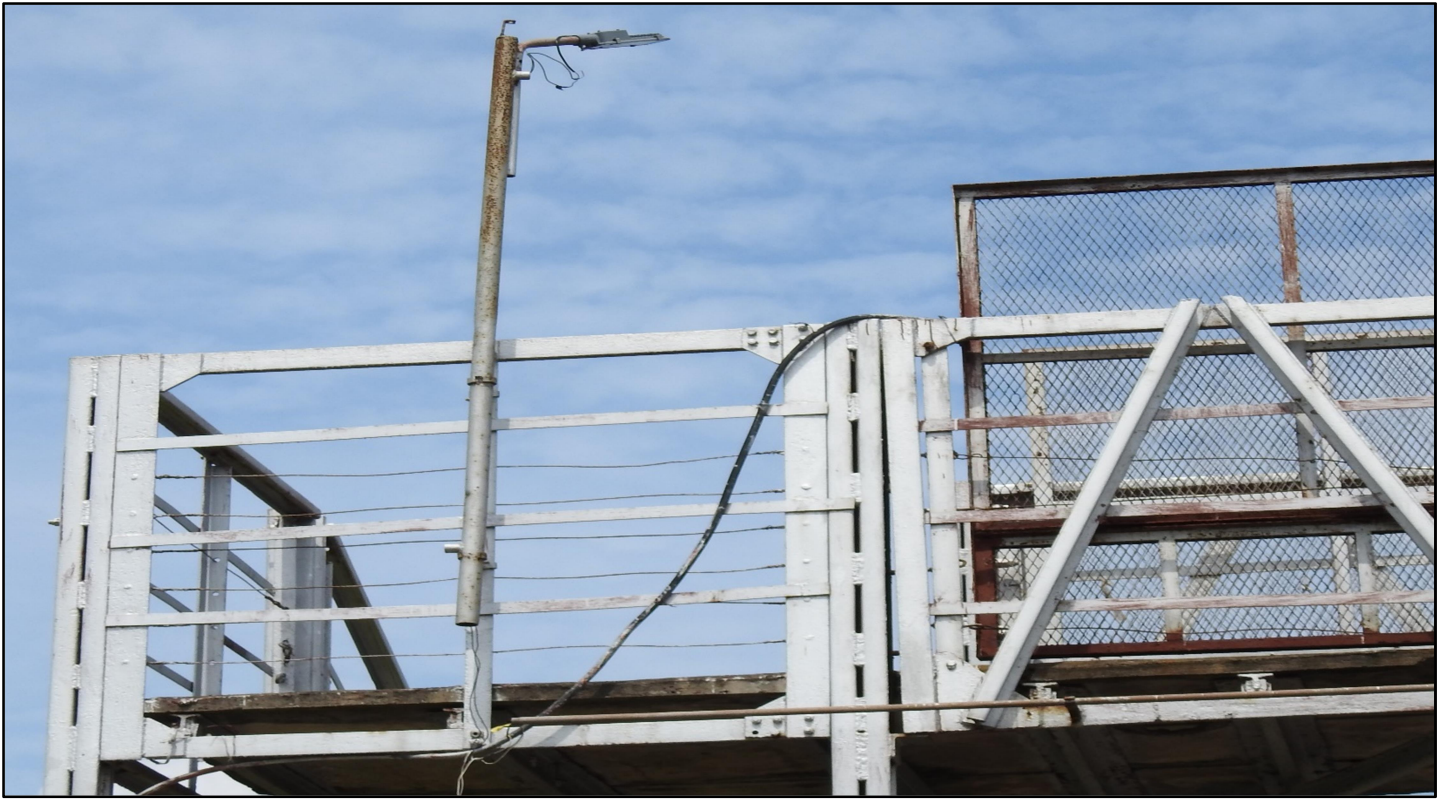
| | | Yes/No | Photo ID |
|---|---|---|---|
| | e) load of advertising hoarding, Light post | Yes | Light post with 60 mm dia. GI pipe is supported on Trestle railing at both corners of FOB. (Ref <b>Fig. 1</b> ) |

***Fig 1:*** Cables, Electric post and protective screen

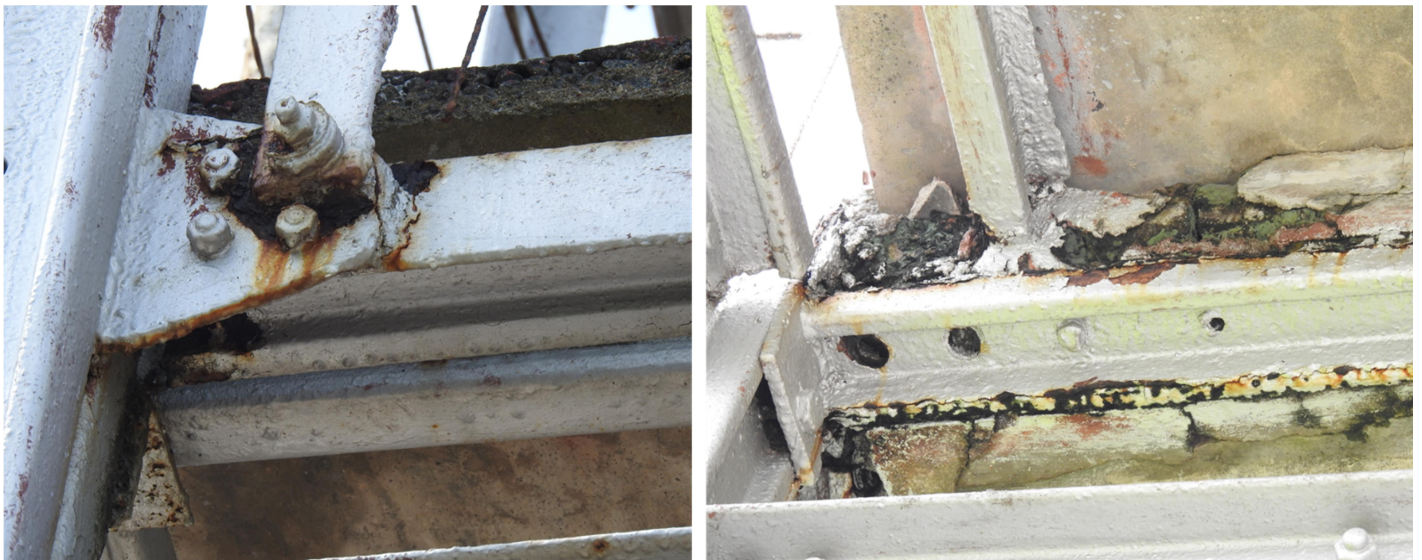
| | Corrosion in Gusset plate | Bottom of the slab | Rusting is observed on Gusset plates ( <i>Refer Fig 7</i> ) |
| | Corrosion at steel-Concrete joint | | Corrosion is observed at steel concrete joint. ( <i>Refer Fig 7</i> ) |

**Fig 7:** Corrosion is also observed at steel concrete joint gusset plate
