| <b>Name of the Project</b> | <b>:</b> | <b>VISUAL INSPECTION OF FOB AT MUSTABADA RAILWAY STATION</b> |
| <b>Location</b> | <b>:</b> | <b>MUSTABADA RAILWAY STATION</b> |
| <b>Date of Inspection</b> | <b>:</b> | <b>20<sup>th</sup> OCTOBER, 2019</b> |

### **VISUAL INSPECTION OF STEEL FOOT OVER BRIDGE**

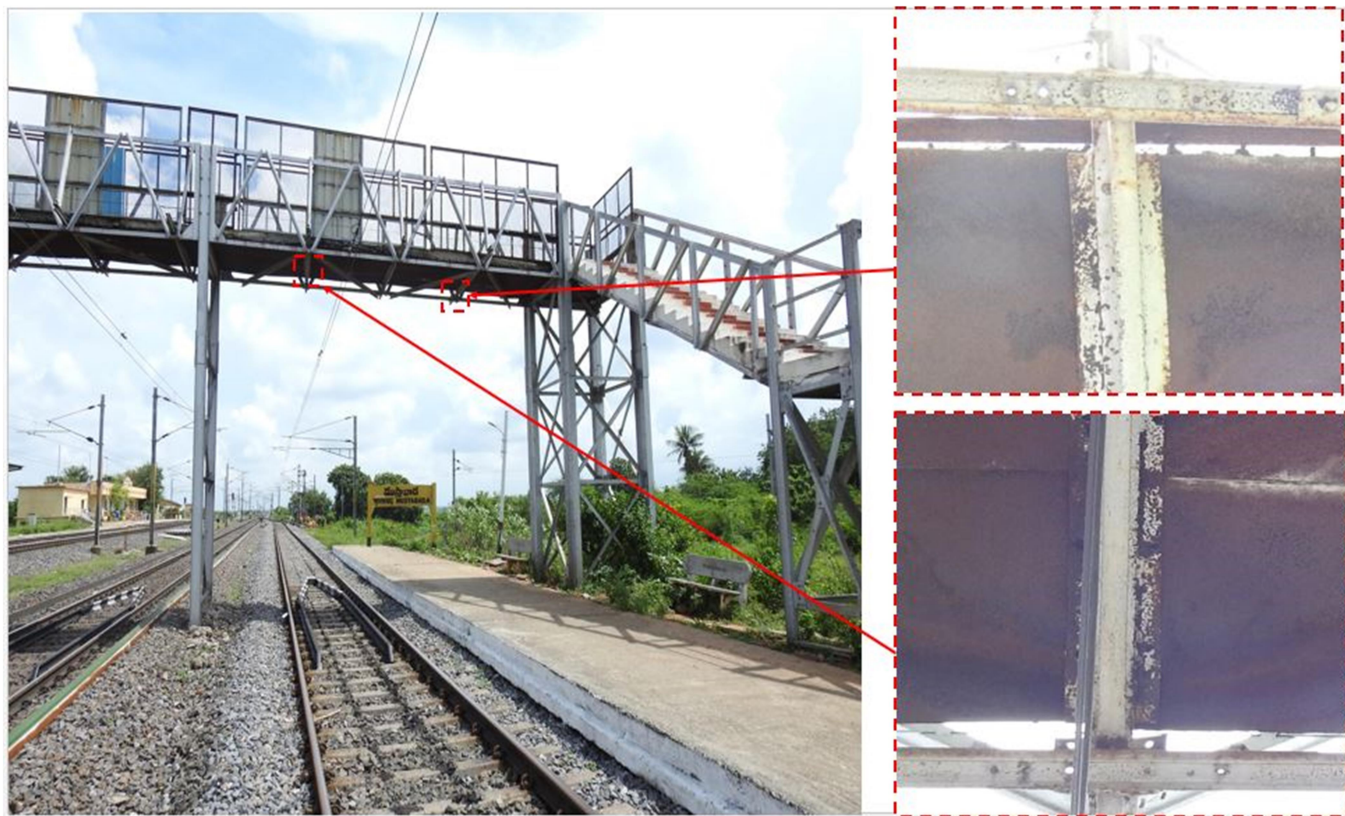
✓ Rusting is observed at all the Spans of FOB & Corrosion is observed in floor Beams

a) Rusting and Corrosion At Span-1

| PART 4 SURVEY OF SIGNS OF DISTRESS, DEFORMATION IN BRIDGES | | | |
|---|---|---|---|
| | Corrosion | Floor level | Corrosion is observed at floor beams of all the Spans of FOB (Refer <b>Part 4.1</b> ) |

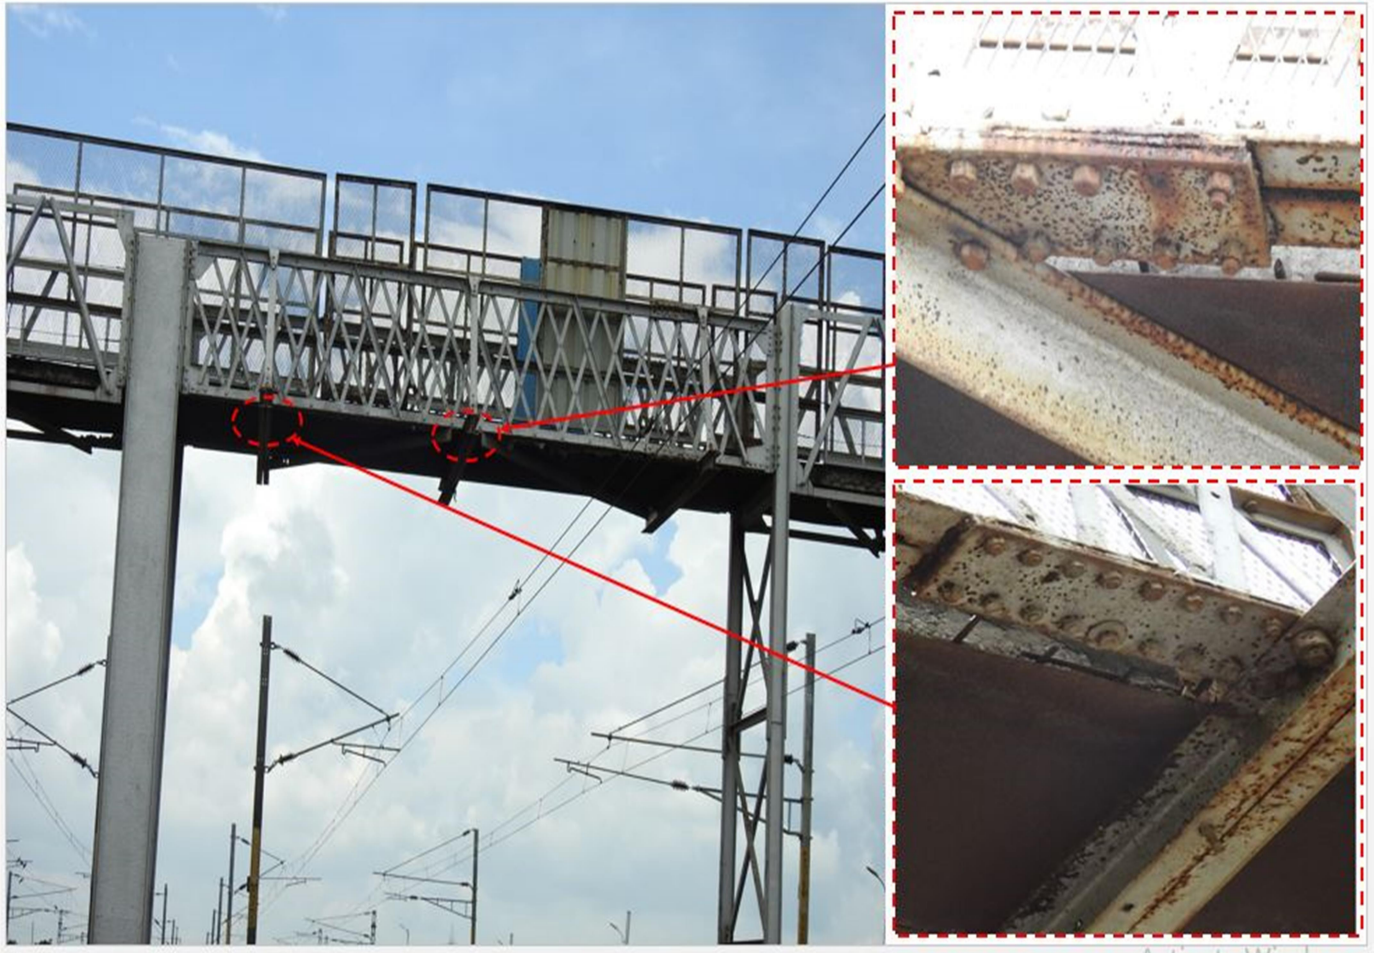
b) Rusting And corrosion At Span-2

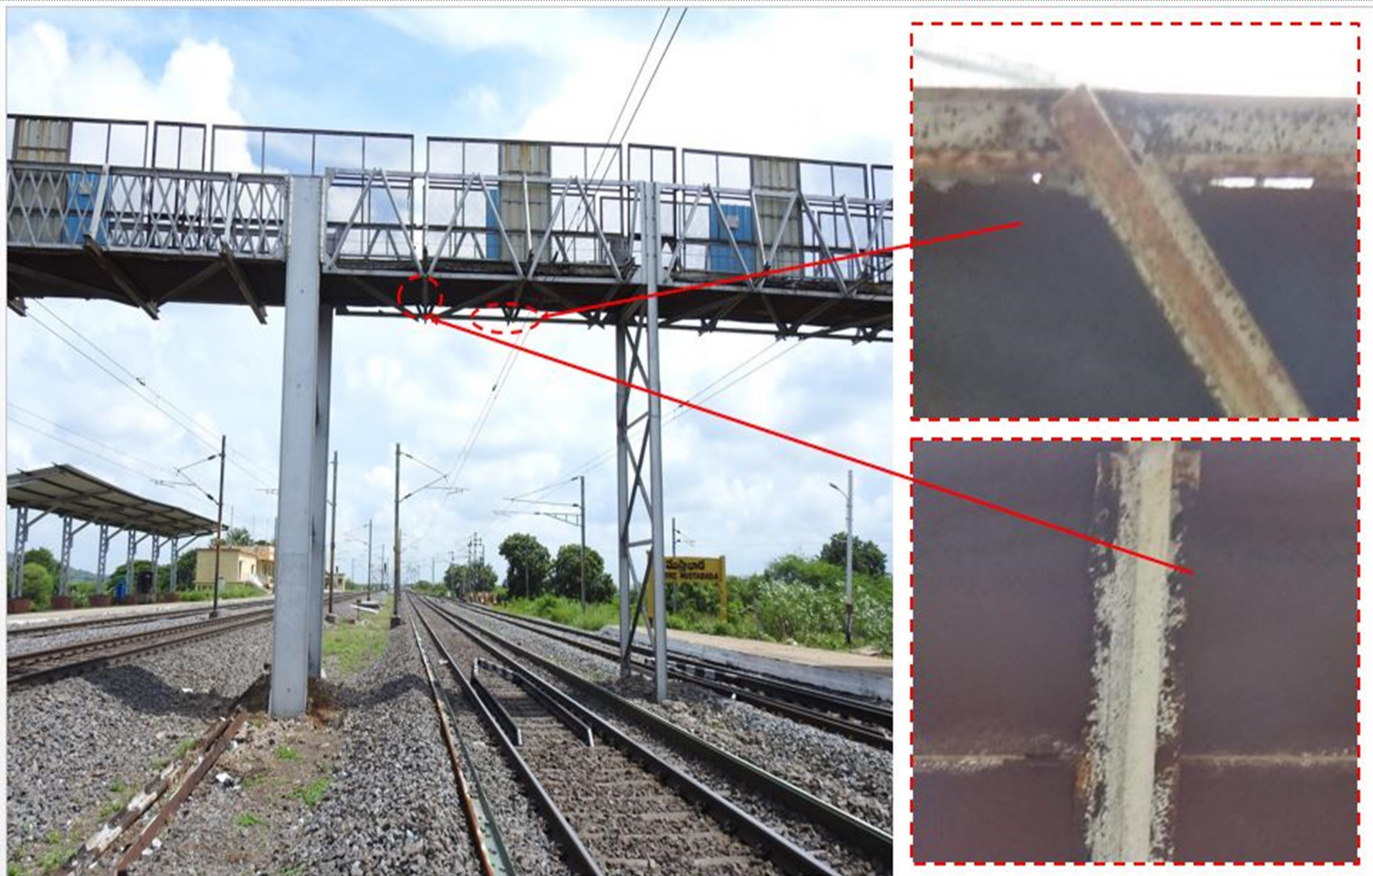
c) Rusting and Corrosion At Span-3

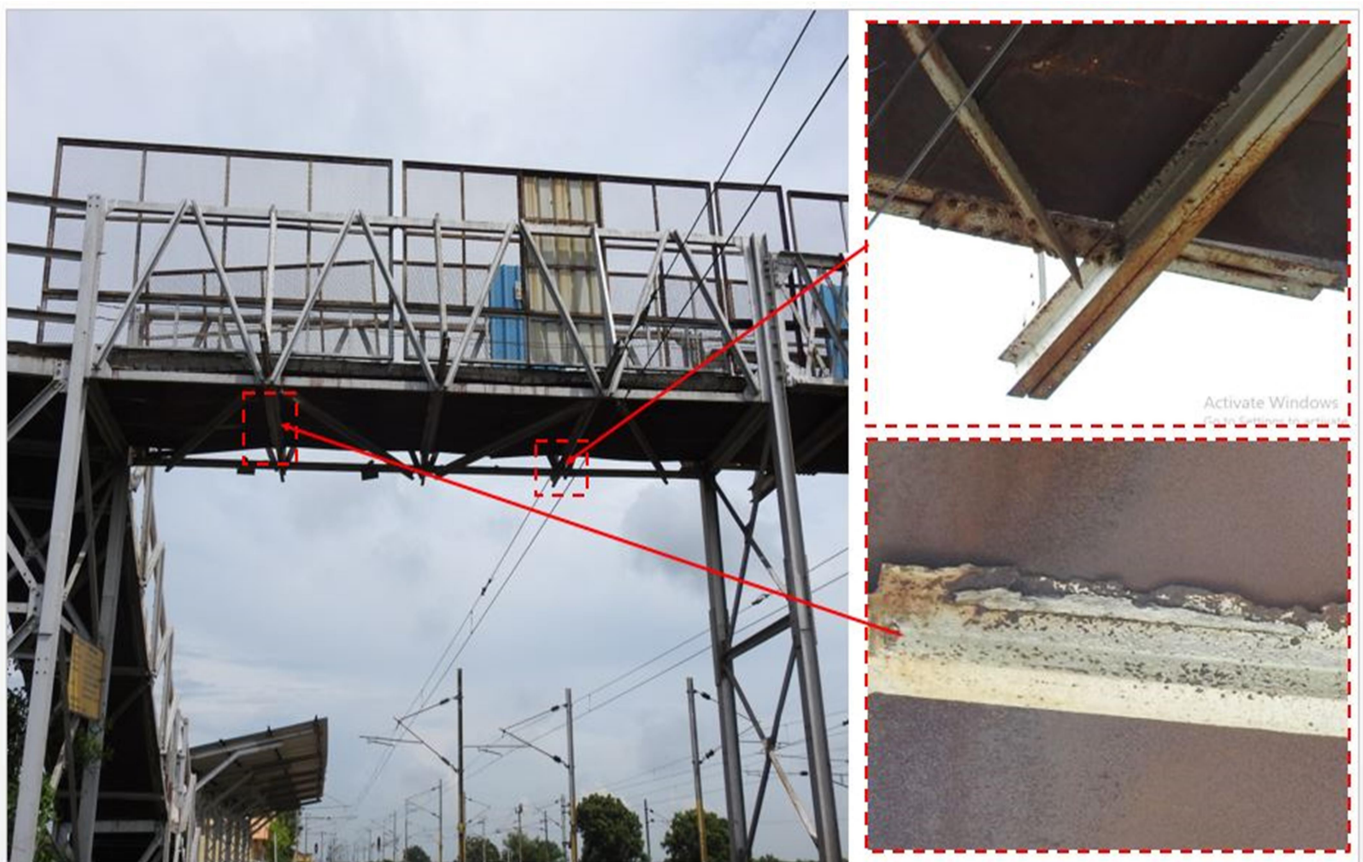
d) Rusting and Corrosion at Span-4

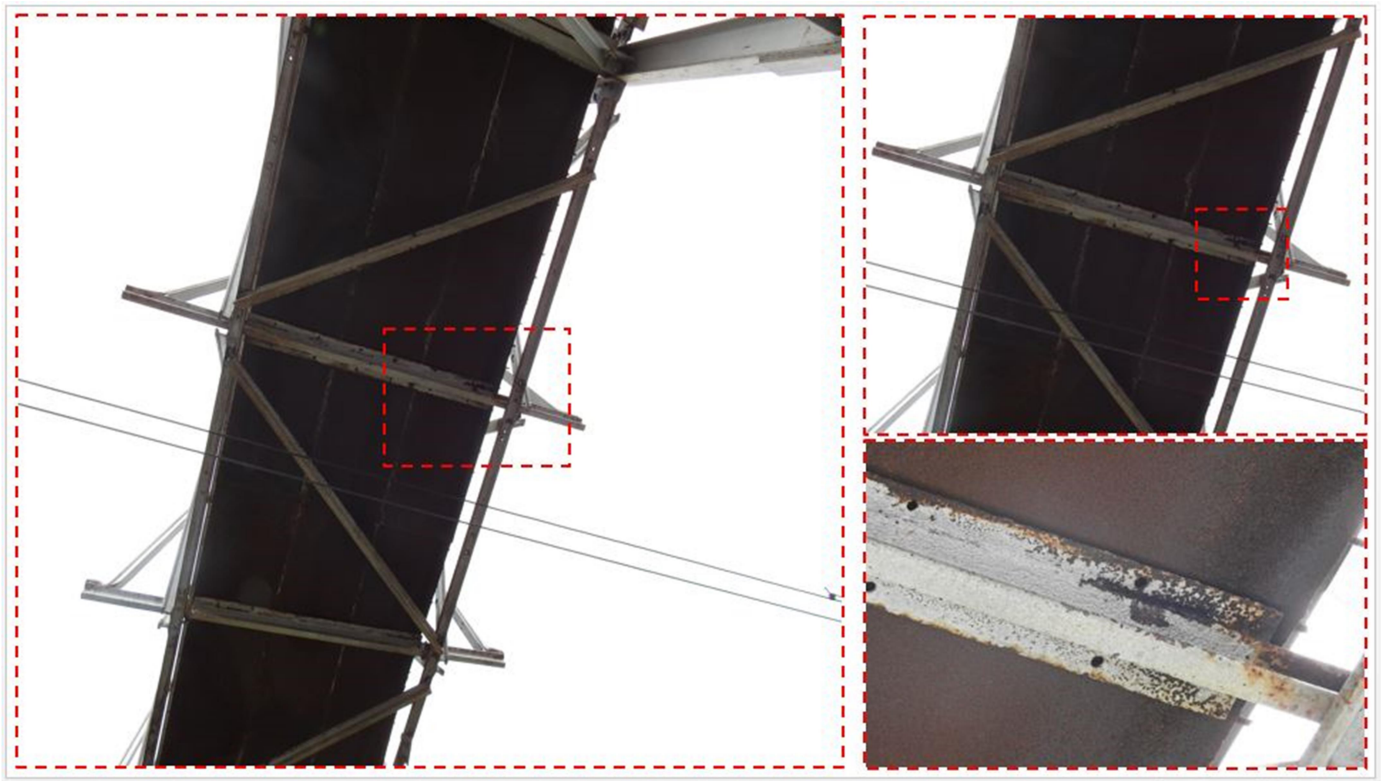
e) Corrosion Observed at Joints

| PART 4 SURVEY OF SIGNS OF DISTRESS, DEFORMATION IN BRIDGES | | | |
|---|---|---|---|
| | Corrosion at steel-Concrete joint | | Slight Rusting is observed at steel-concrete joint. (Refer <b>Part 4.1</b> ) |

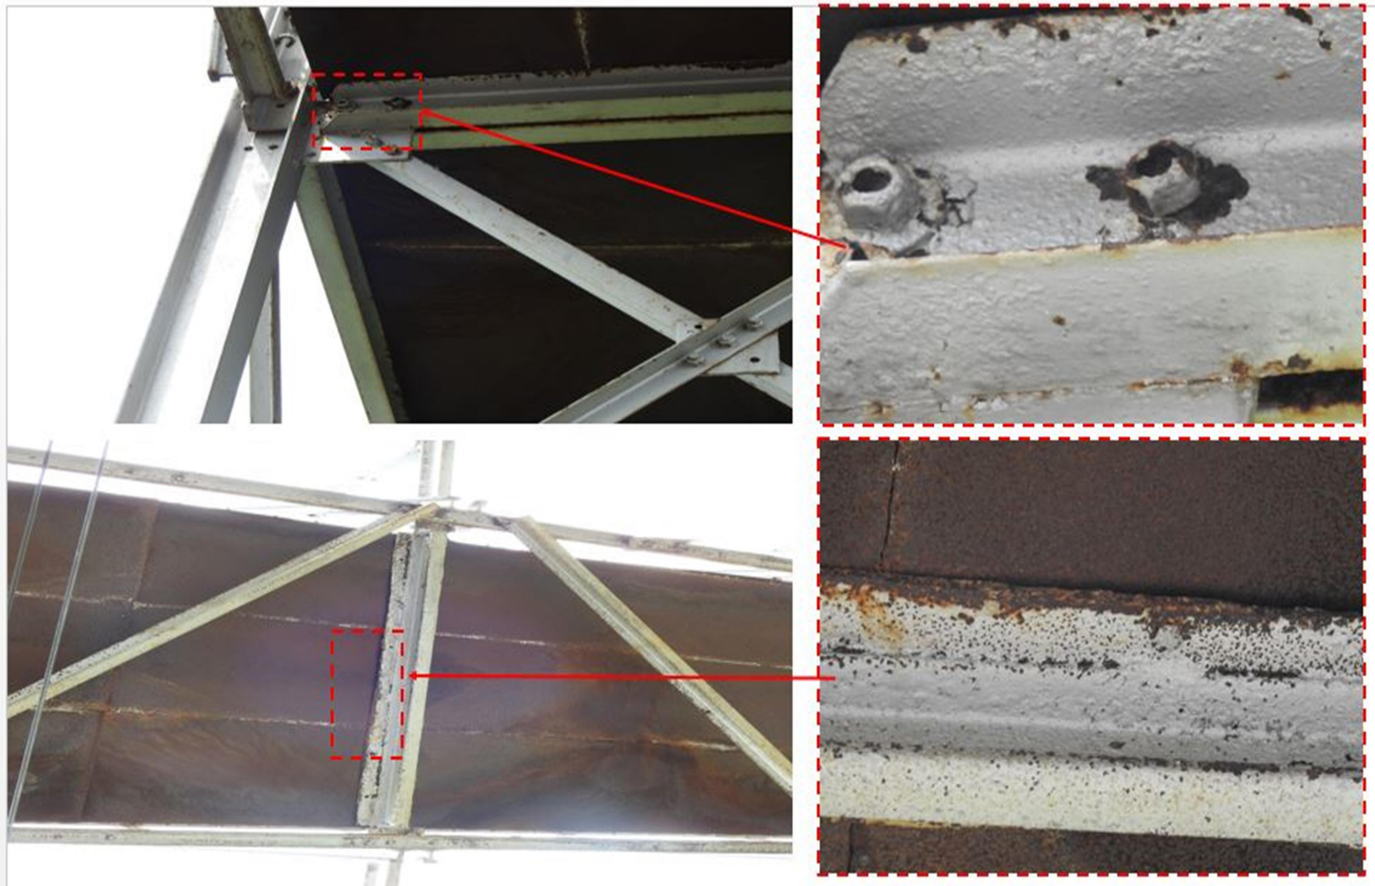
f) Corrosion at connections and Floor Beam

| PART 4 SURVEY OF SIGNS OF DISTRESS, DEFORMATION IN BRIDGES | | | |
|---|---|---|---|
| | Rust straining | | Rusting is observed in Gusset plates (Refer <b>Part 4.1</b> ) |

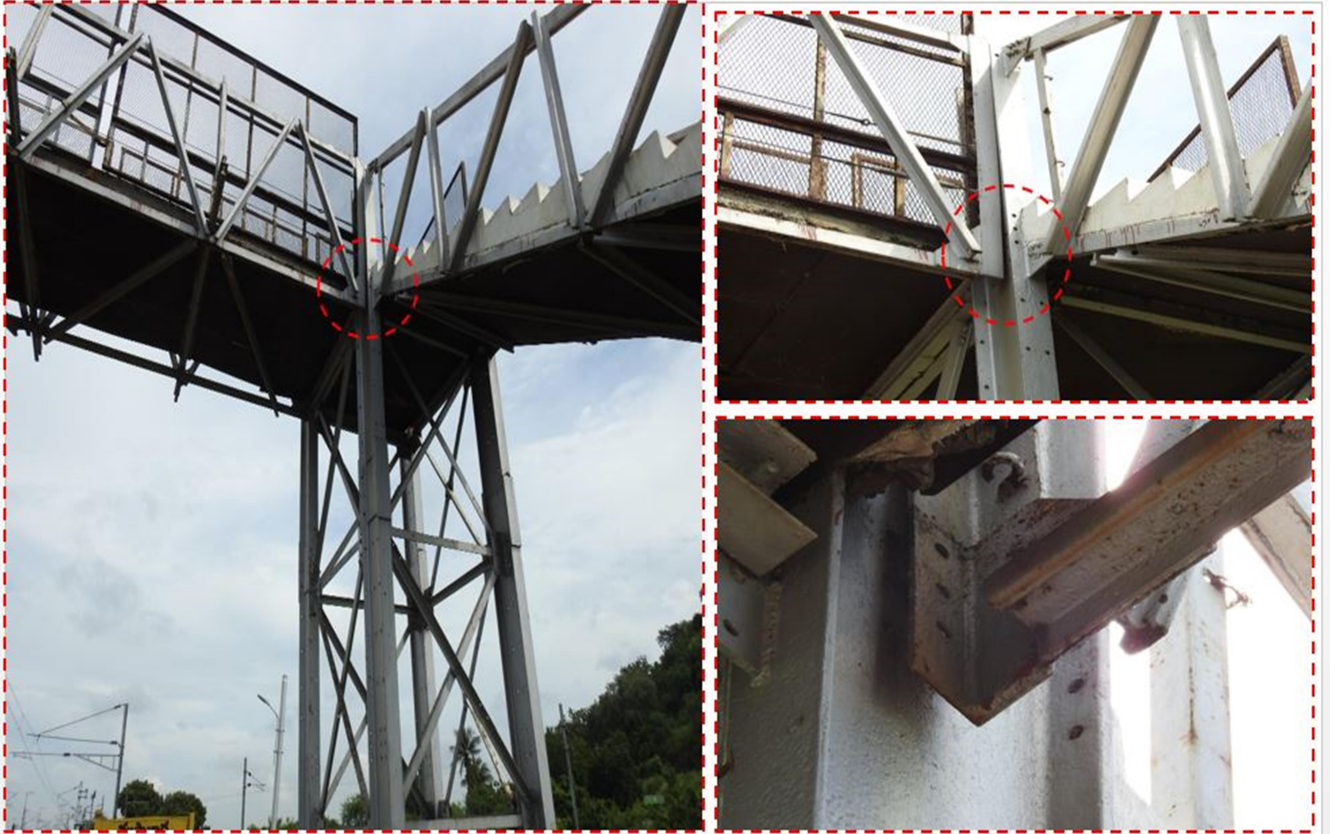
| 4.2 | ✓ Truss, Column joint connection failure is observed at span 4. |

3 Bolts missing and gap of 2" formed in connection between Truss and Trestle-2

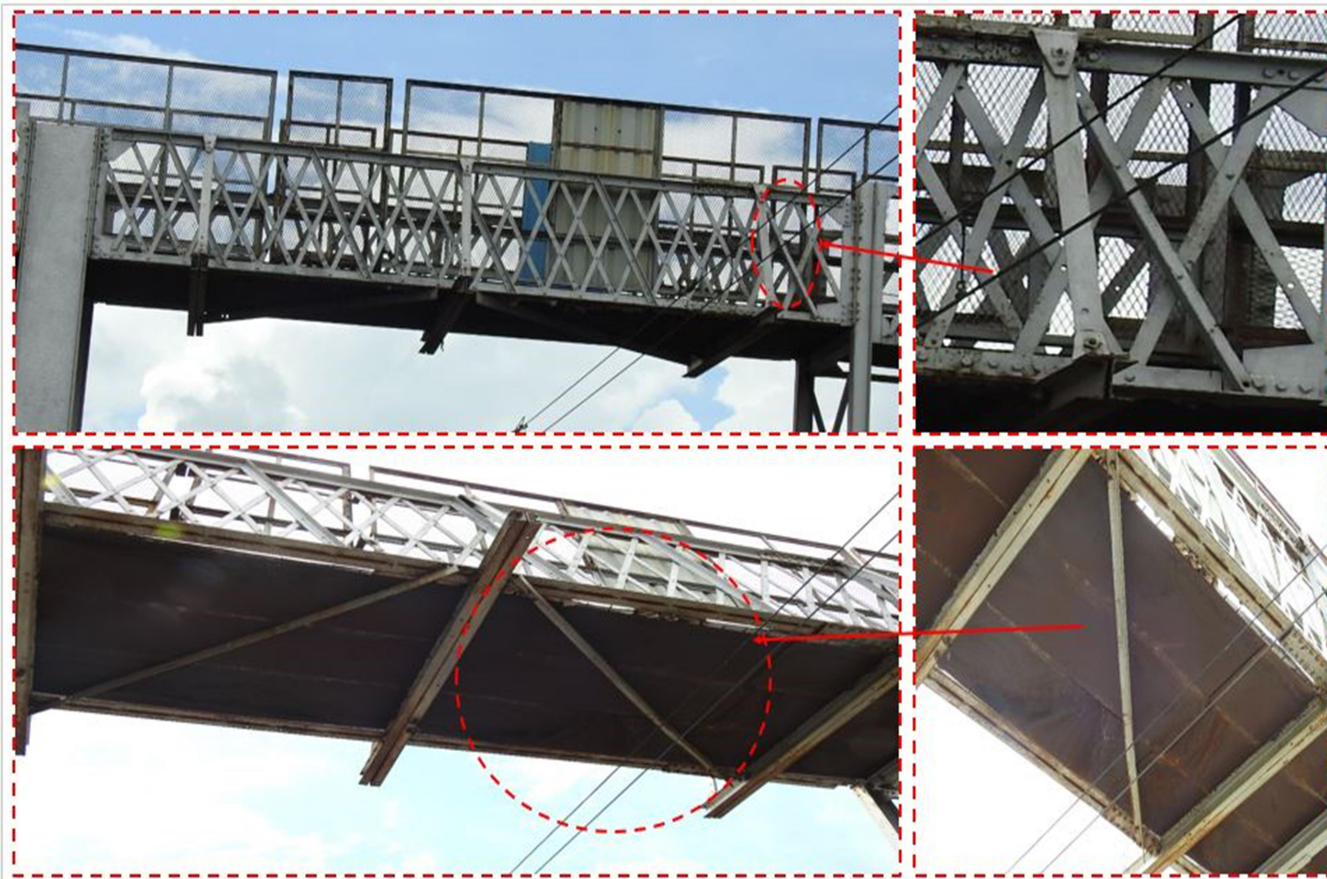
| 4.3 | ✓ Deformation observed at Diagonal member and Bottom bracing. |

Deformation in Diagonal members and Bottom bracing
