| <b>Name of the Project</b> | <b>:</b> | <b>VISUAL INSPECTION OF FOB/ PF-1 - PF-2 AT CHINNAGANJAM RAILWAY STATION</b> |
| <b>Location</b> | <b>:</b> | <b>CHINNAGANJAM RAILWAY STATION</b> |
| <b>Date of Inspection</b> | <b>:</b> | <b>03<sup>rd</sup> NOVEMBER, 2019</b> |

## **VISUAL INSPECTION OF FOOT OVER BRIDGE**

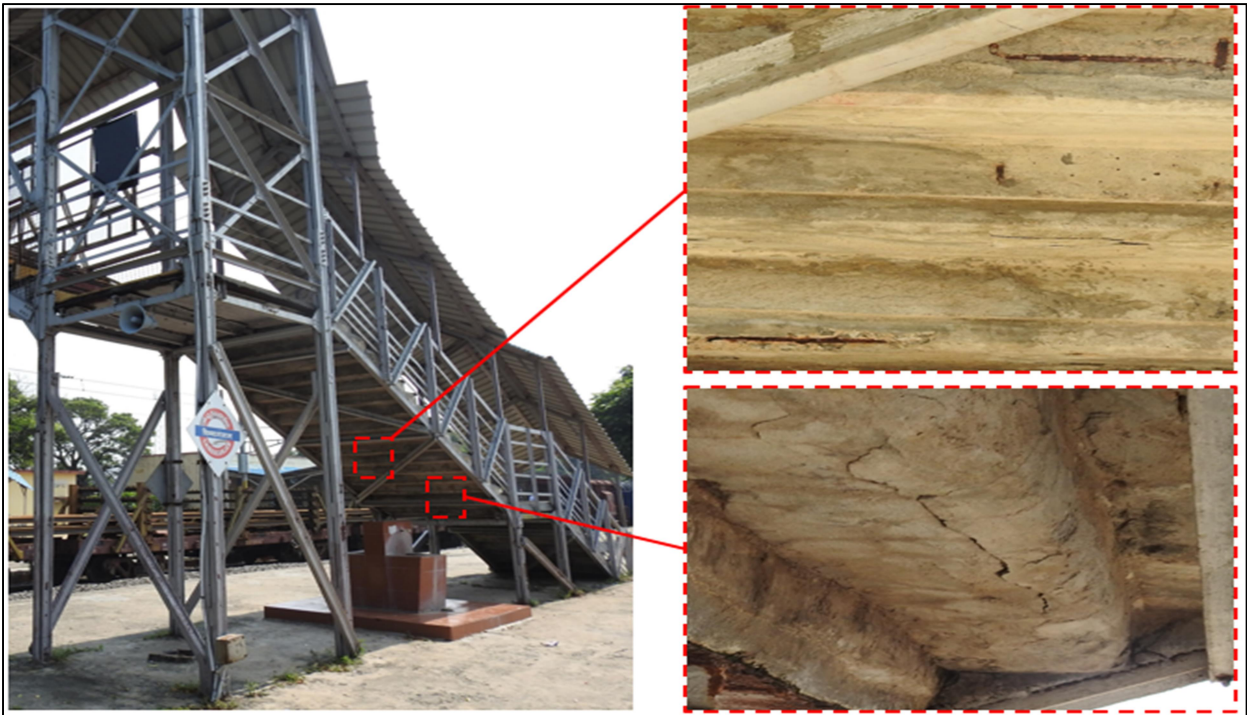
a) Cracks and exposed reinforcement observed in Staircase 2 slabs

| PART 4 SURVEY OF SIGNS OF DISTRESS, DEFORMATION IN BRIDGES | | | |
|---|---|---|---|
| | Cracking in RCC components | Slab panels | Cracks are observed in Pre-cast RCC slab panels of stair case. (Refer <b>Part 4.1 a, b</b> ) |
| | Spalling | | Spalling is observed in -pre-cast steps of staircase. (Refer <b>Part 4.1 a, c</b> ) |

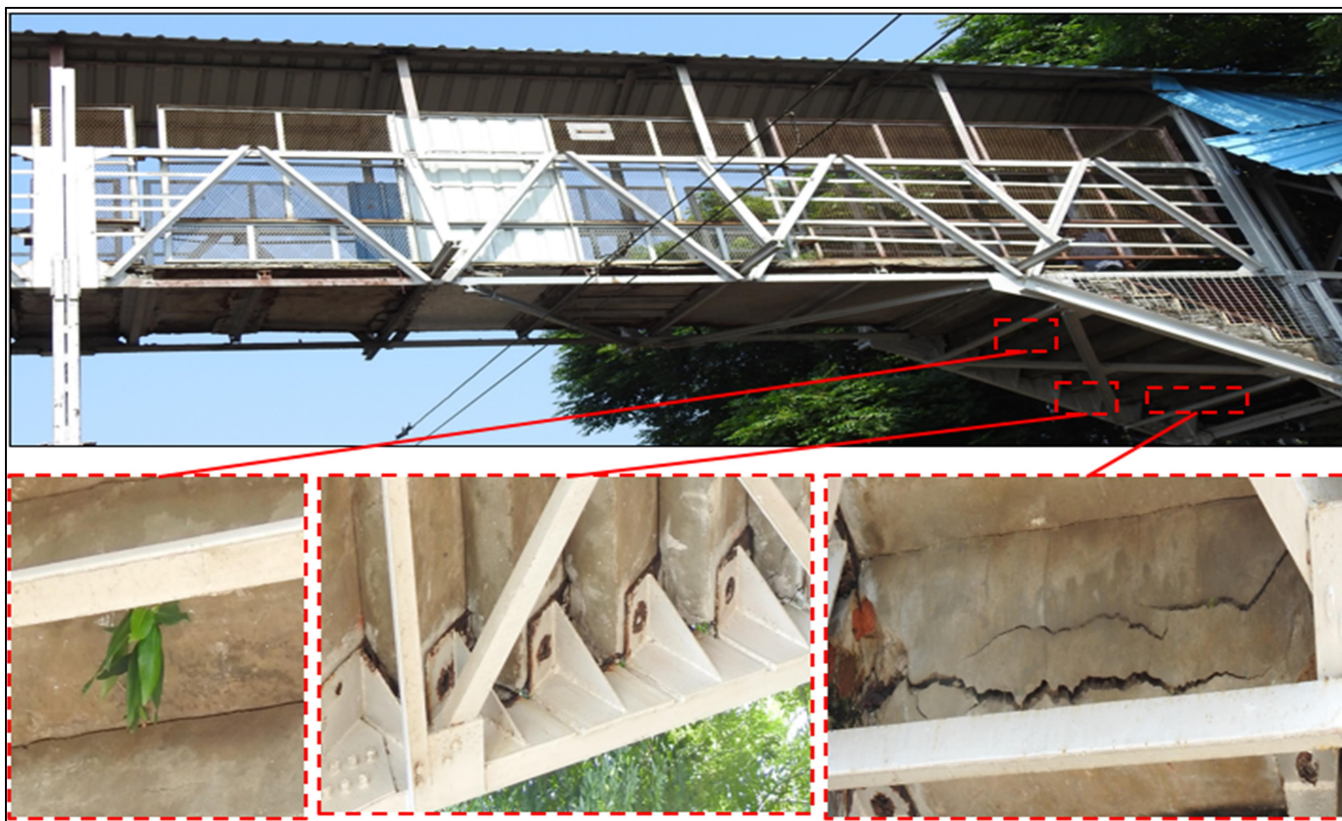
b) Vegetation, corrosion at cleat angles and cracks observed at staircase Span 1

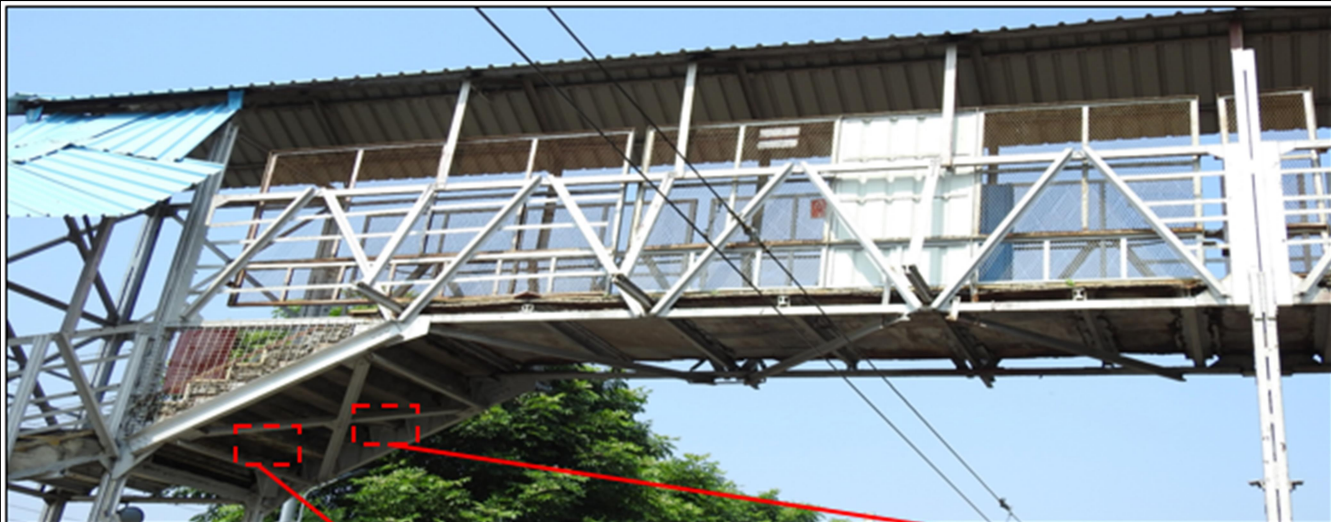
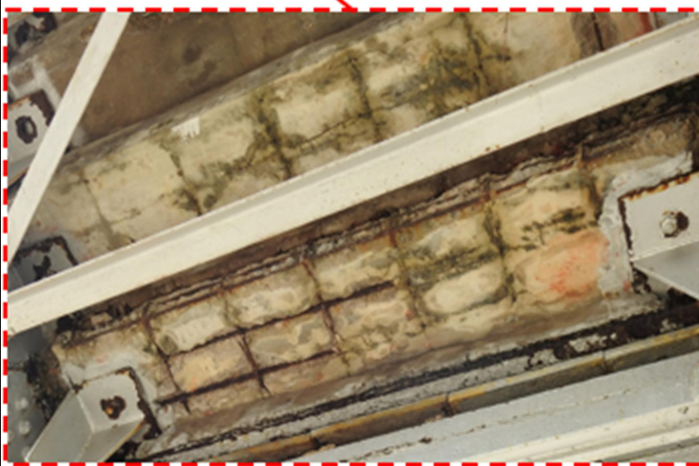
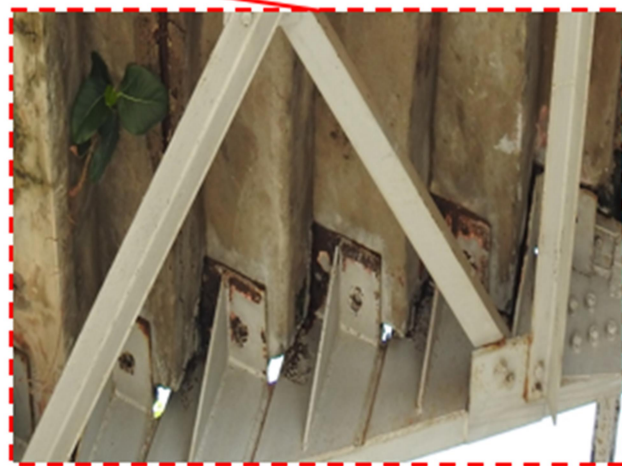
c) Exposed Reinforcement, vegetation and corrosion at cleat angles observed at staircase Span 2

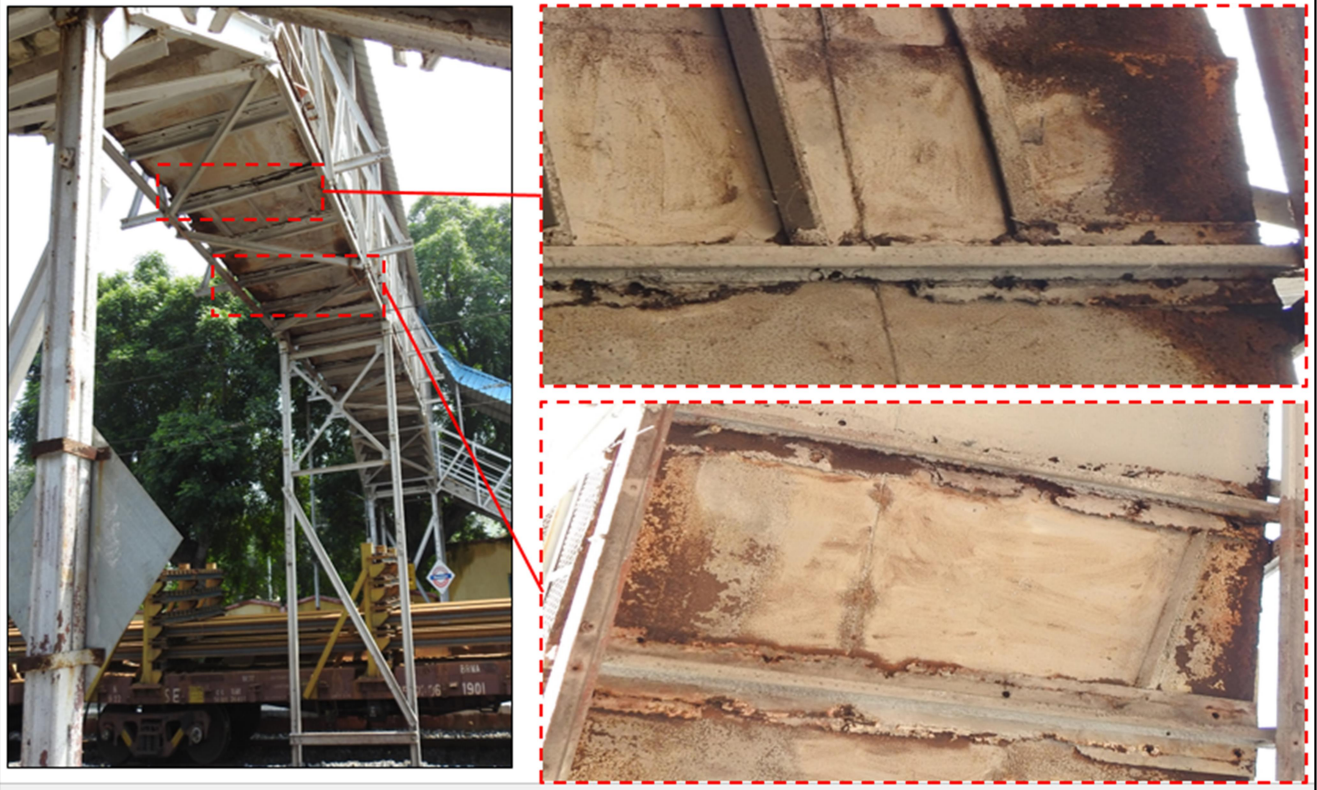
a) Corrosion observed at floor beams on Span-2

| PART 4 SURVEY OF SIGNS OF DISTRESS, DEFORMATION IN BRIDGES | | | |
|---|---|---|---|
| | Corrosion | Floor level | Major Corrosion is observed at all the Floor Beams of FOB. (Refer <b>Part 4.2</b> ) |

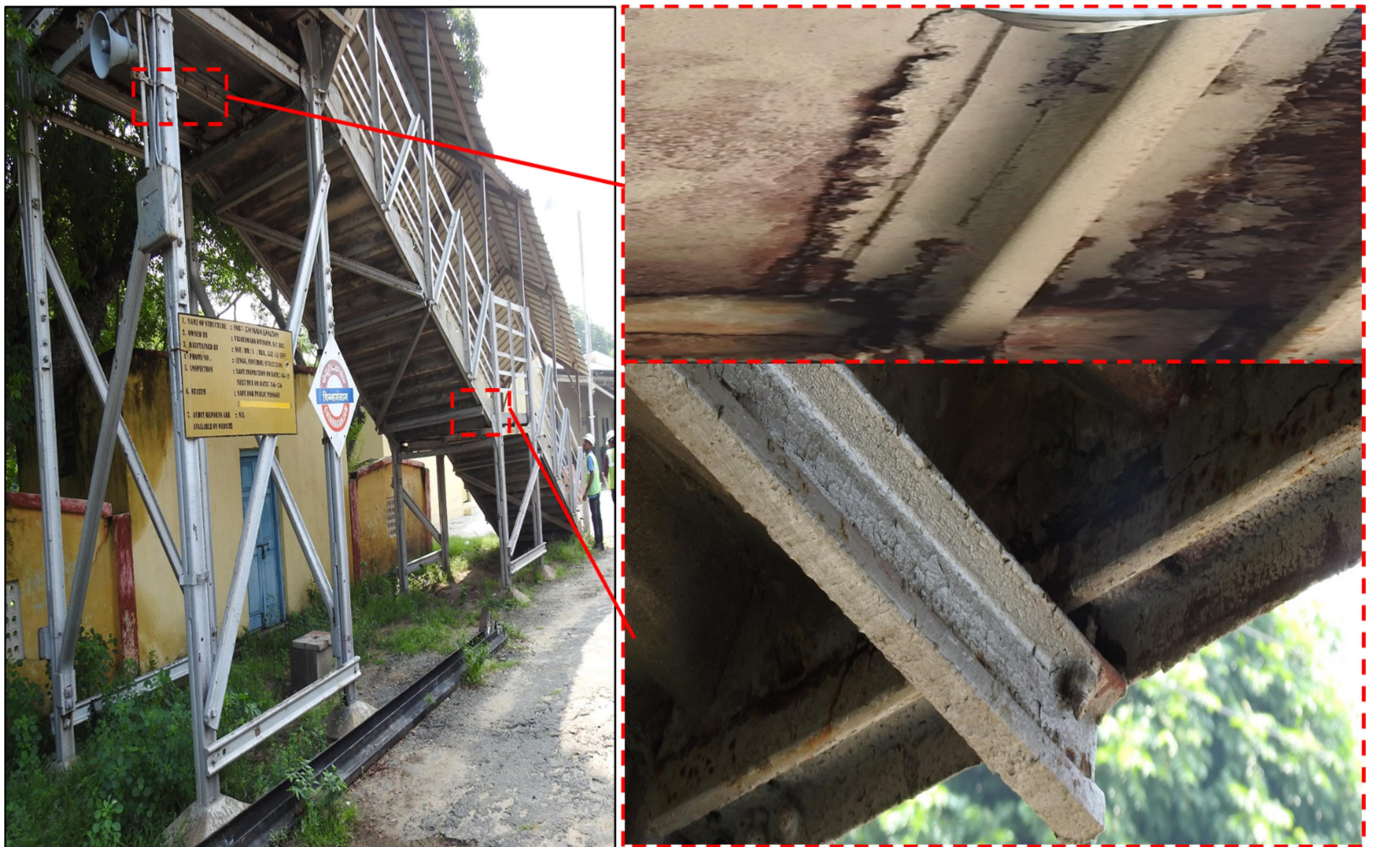
b) Corrosion observed at floor beams in landing and Stringer beams in Staircase 1

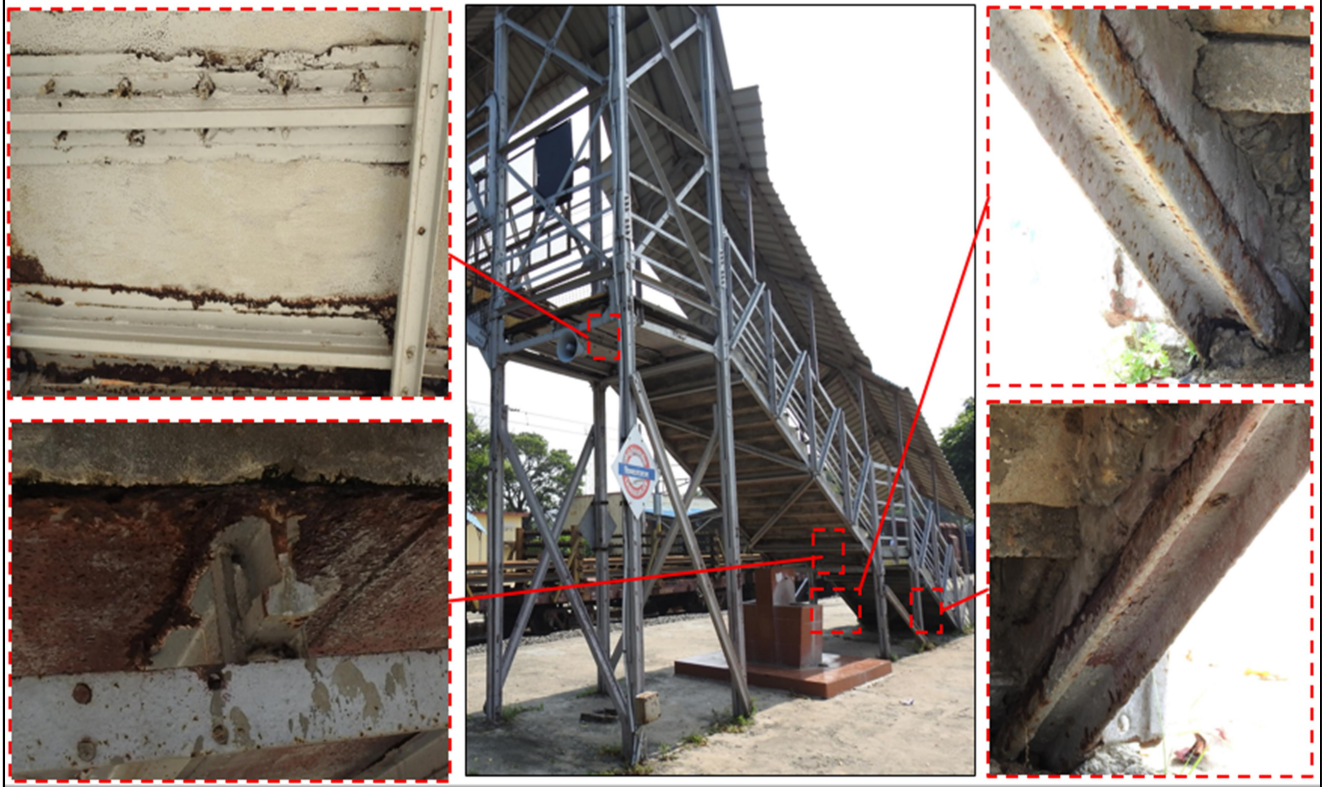
c) Corrosion observed at floor beams in landing and Stringer beams in Staircase 2

| | Corrosion at steel-Concrete joint | | corrosion is observed at steel concrete joint along length of FOB (Refer <i>Part 4.2 c</i> ) |

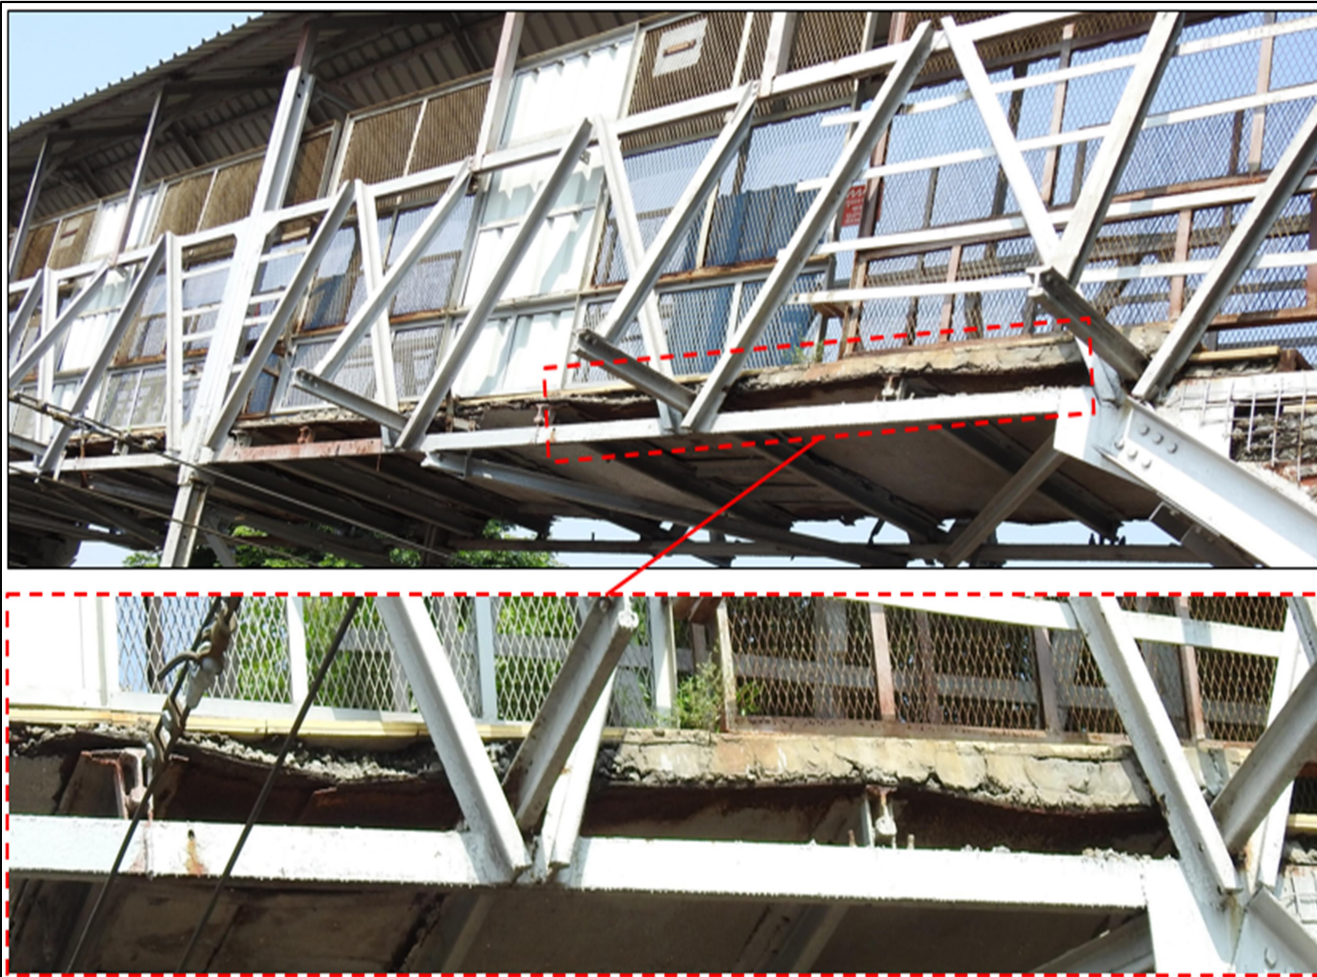
d) Deformation at slab panels on Span-1

| PART 4 SURVEY OF SIGNS OF DISTRESS, DEFORMATION IN BRIDGES | | | |
|---|---|---|---|
| | Deformation | Floor Slab, Staircase (PF-2) | Deformation is observed at Tie beam of Mid Landing and Floor Slab between floor beams. (Refer <b>Part 4.2, fig:d</b> ) |

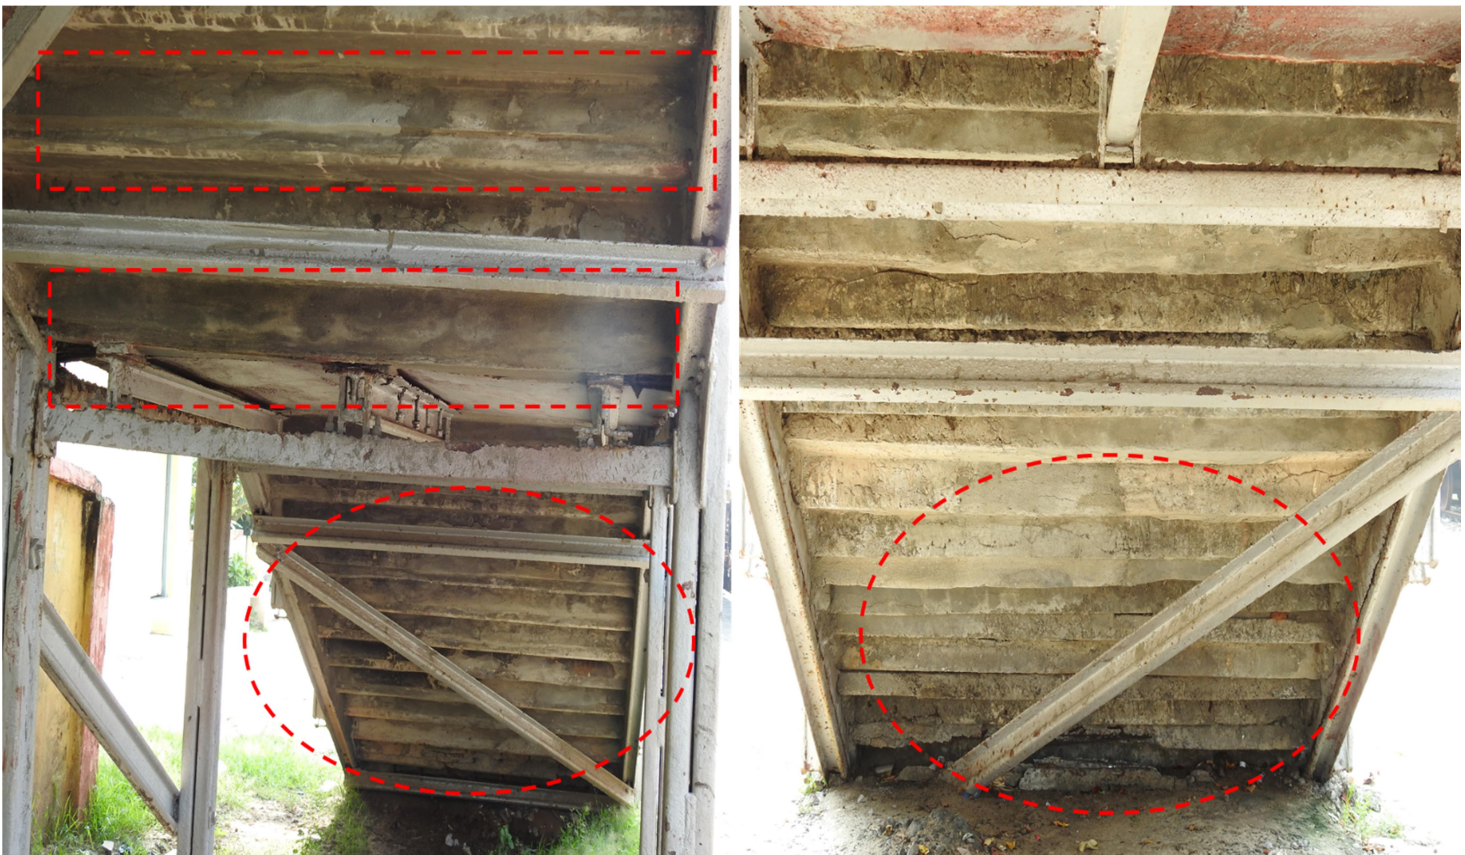
**Fig 5:** Patch work is observed at PF- 2 stair case steps
