| <b>Name of the Project</b> | <b>:</b> | <b>VISUAL INSPECTION OF FOB AT KONDAPALLI RAILWAY STATION</b> |
| <b>Location</b> | <b>:</b> | <b>KONDAPALLI RAILWAY STATION</b> |
| <b>Date of Inspection</b> | <b>:</b> | <b>10<sup>th</sup> NOVEMBER, 2019</b> |

## VISUAL INSPECTION OF STEEL FOOT OVER BRIDGE

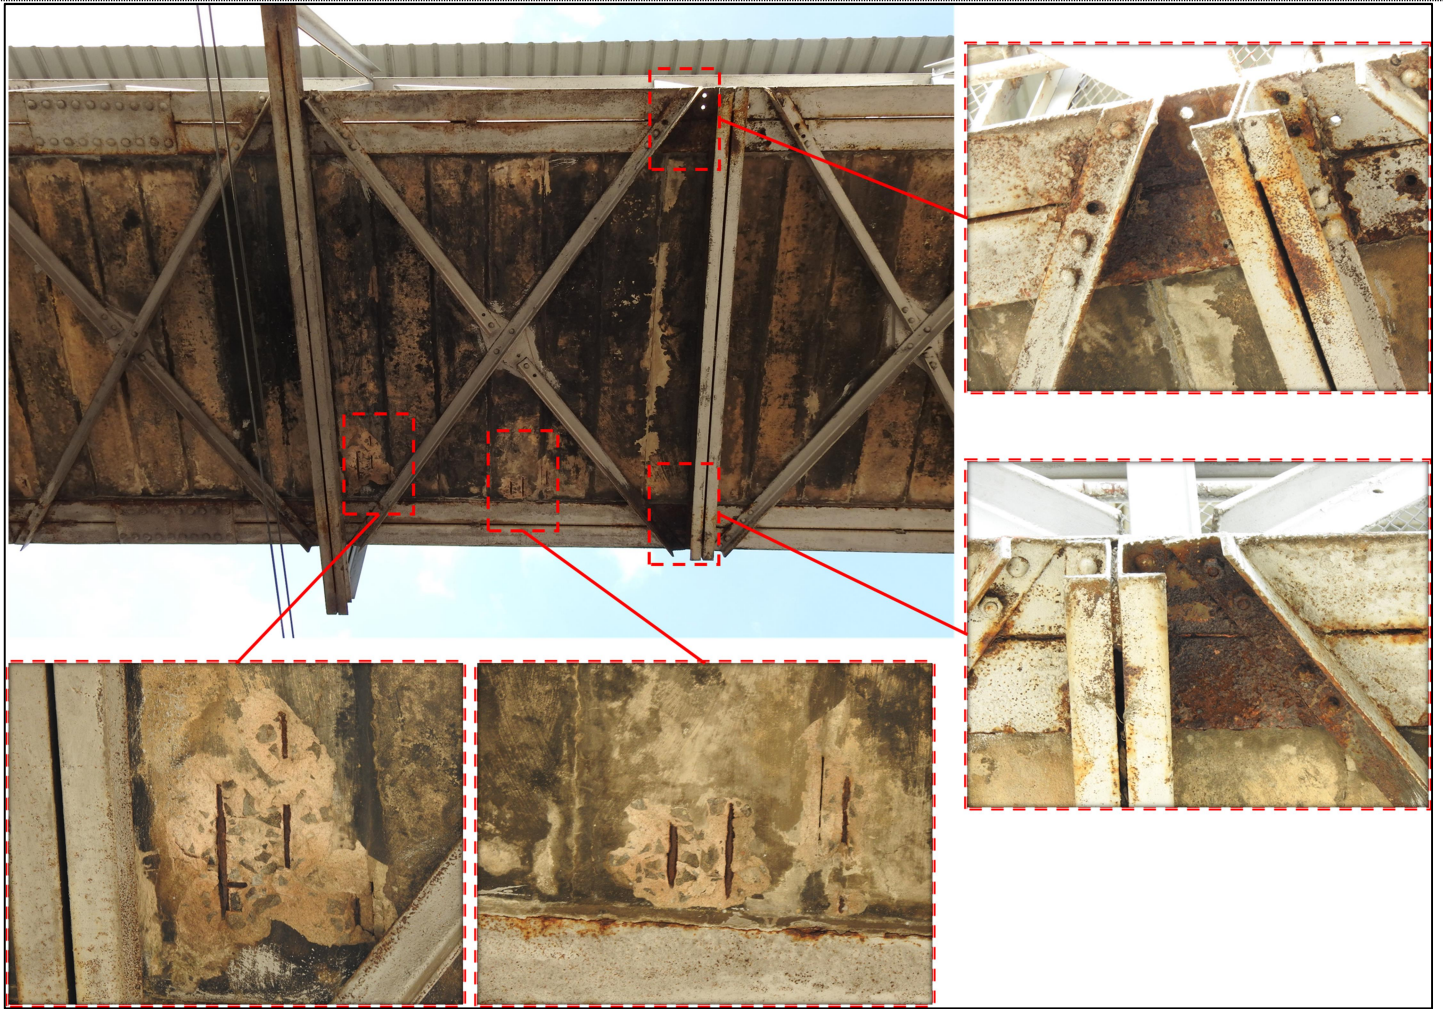
a) Reinforcement exposed slab and corrosion in 3<sup>rd</sup> span of FOB

| PART 4 SURVEY OF SIGNS OF DISTRESS, DEFORMATION IN BRIDGES | | | |
|---|---|---|---|
| | Spalling | Slab | Spalling is observed in cast in situ slab ( <i>Refer: Part 4.1, Fig- a, b, c, d, e, f, g</i> ) |

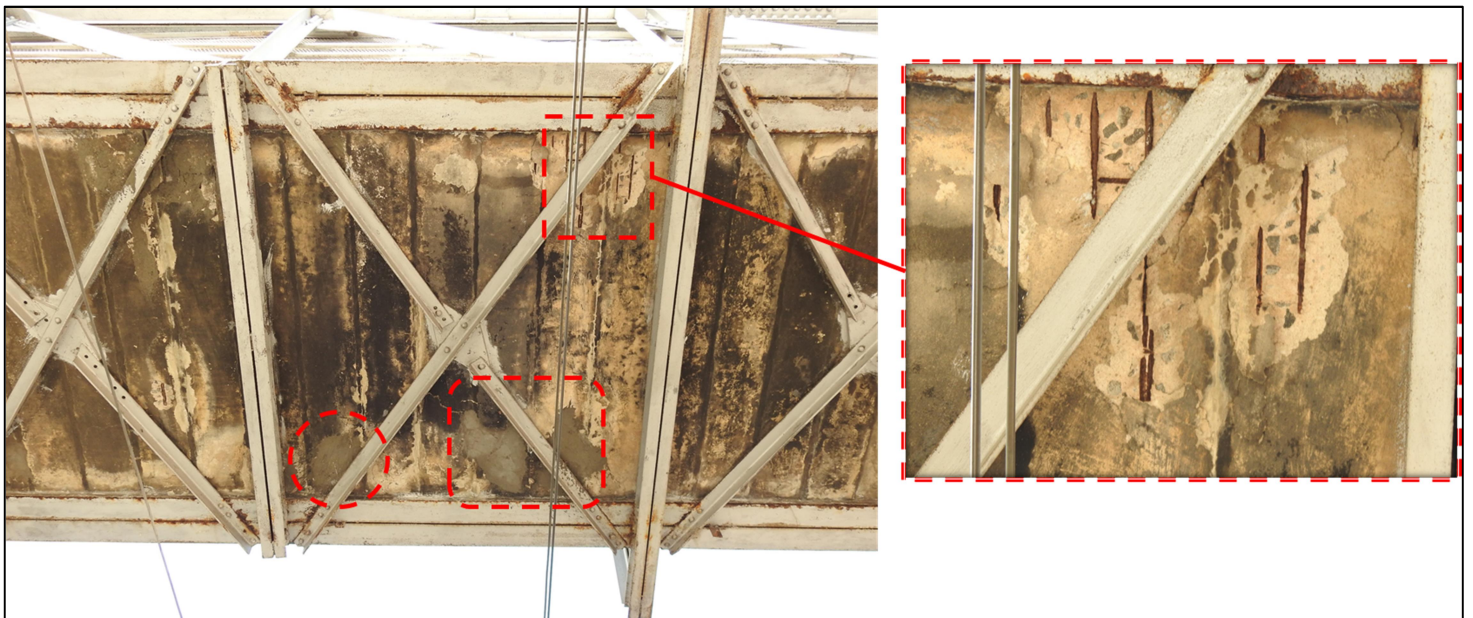
b) Reinforcement exposed slab and patch work 3<sup>rd</sup> span of FOB

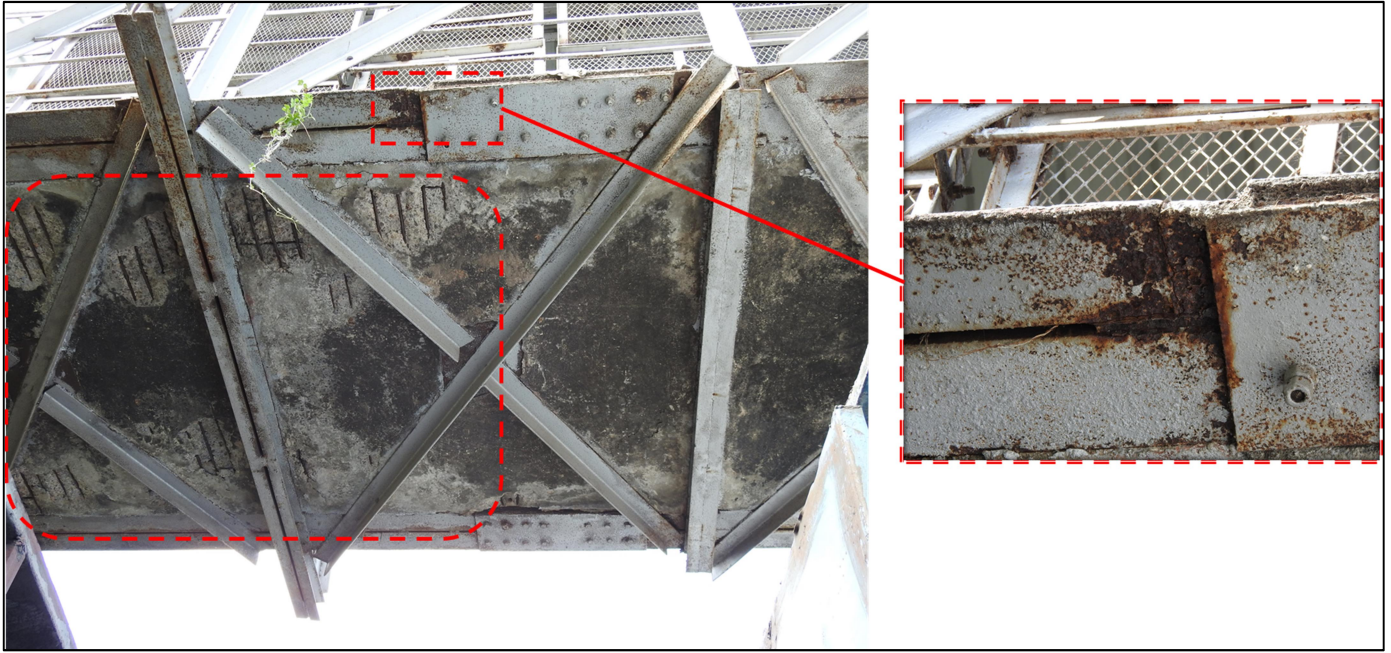
c) Reinforcement exposed slab and corrosion in 1<sup>st</sup> span of FOB

| PART 4 SURVEY OF SIGNS OF DISTRESS, DEFORMATION IN BRIDGES | | | |
|---|---|---|---|
| | Corrosion in Gusset plate | Floor level | corrosion is observed in Gusset Plates ( <i>Refer: Part 4.1, Fig- c, h</i> ) |

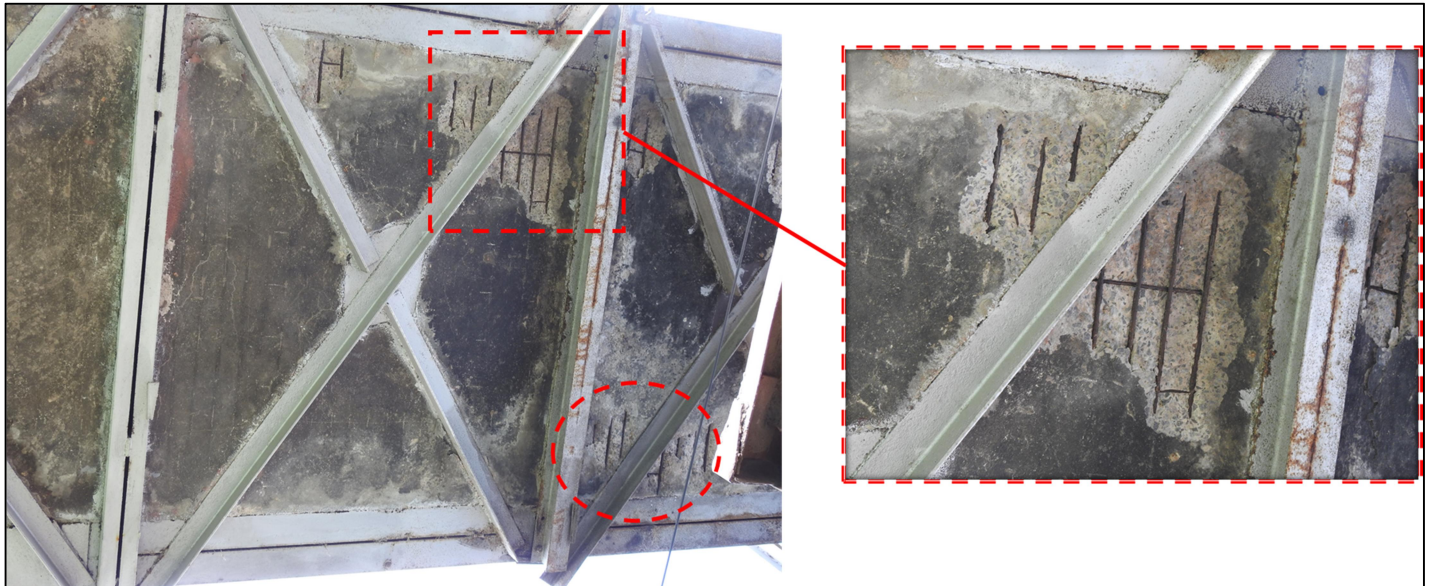
d) Reinforcement exposed slab in 1<sup>st</sup> span of FOB

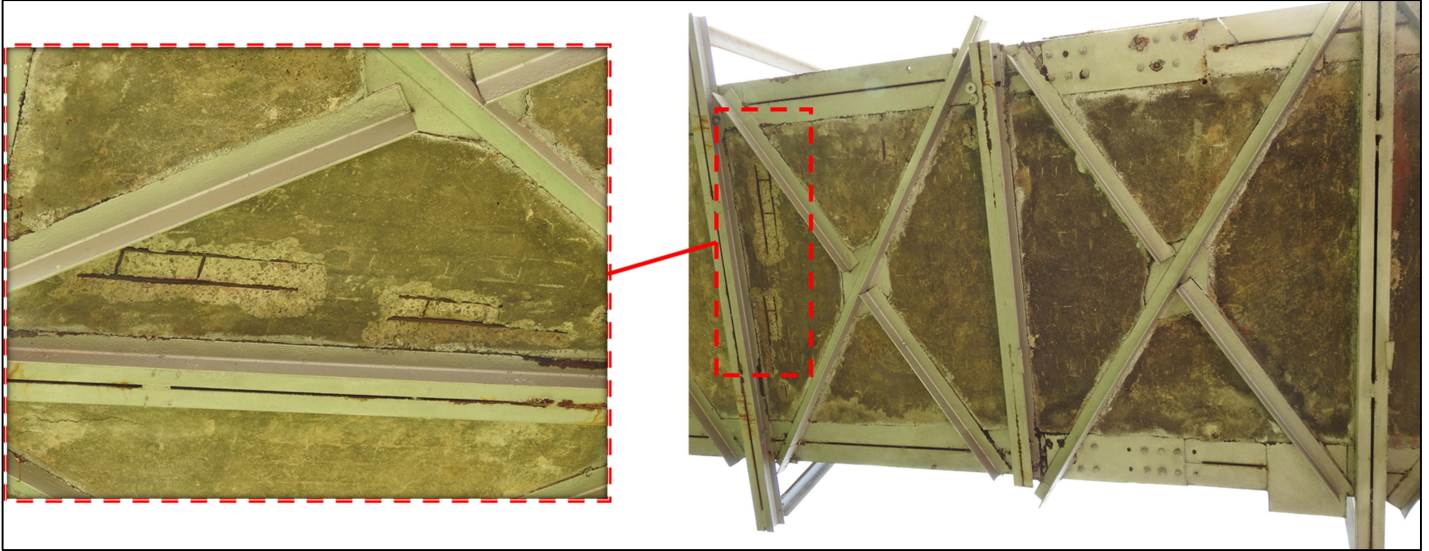
e) Reinforcement exposed slab in 1<sup>st</sup> span of FOB

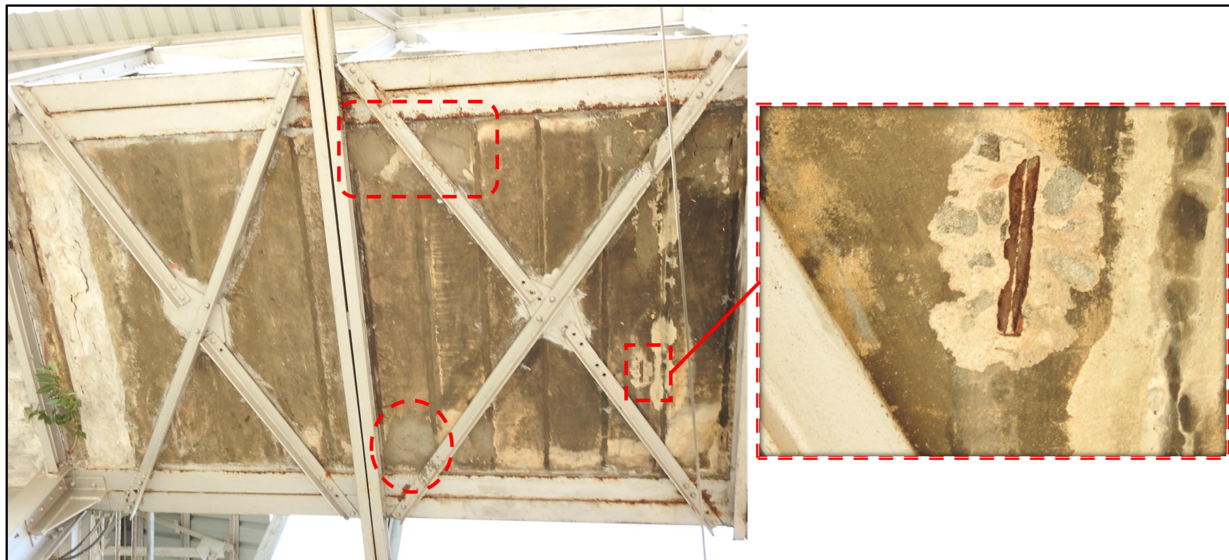
f) Reinforcement exposed slab and patch work 3<sup>rd</sup> span of FOB

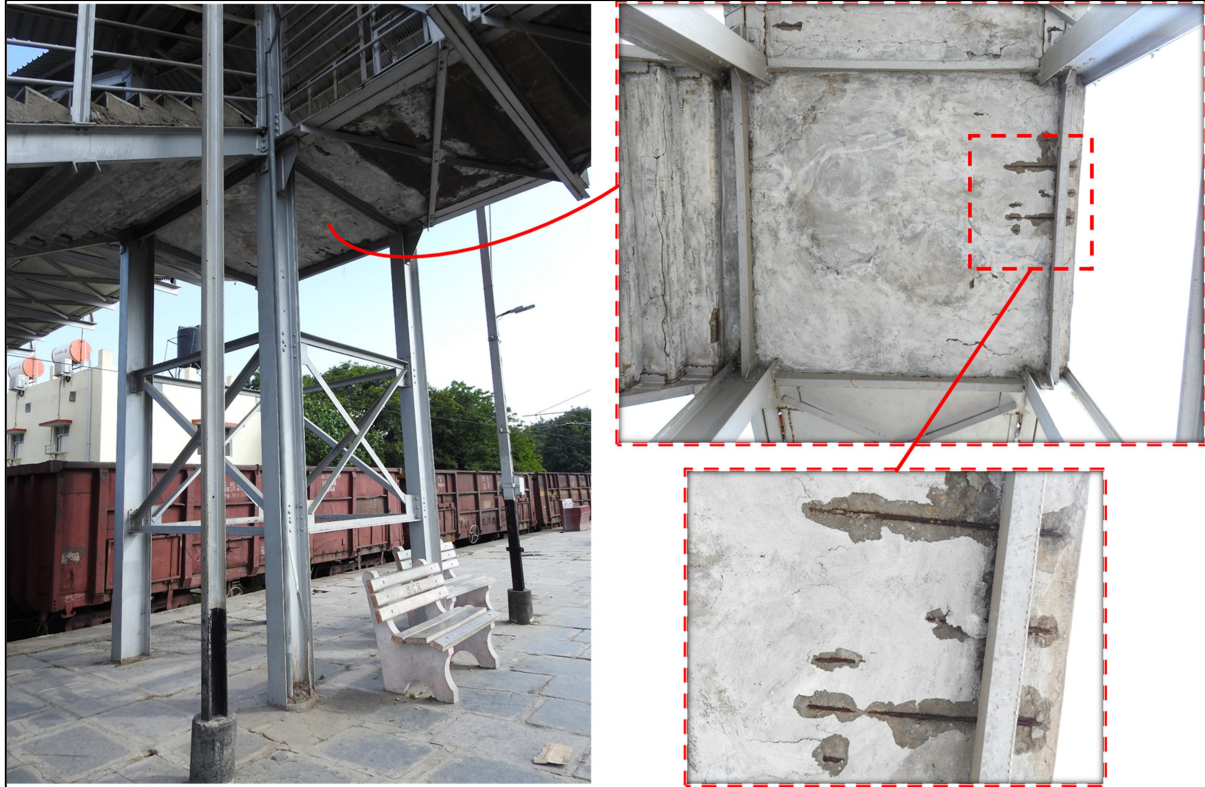
g) Reinforcement exposed slab in landing in 3<sup>rd</sup> span of FOB

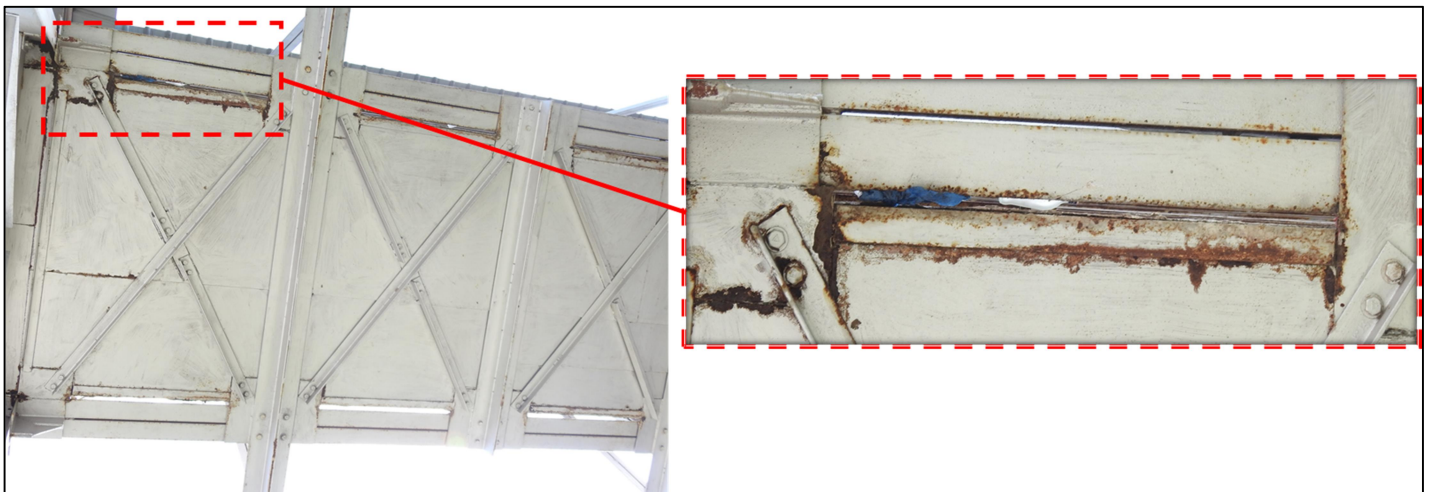
h) Corrosion of gusset plate connected bottom bracing angle in 4<sup>th</sup> span of FOB

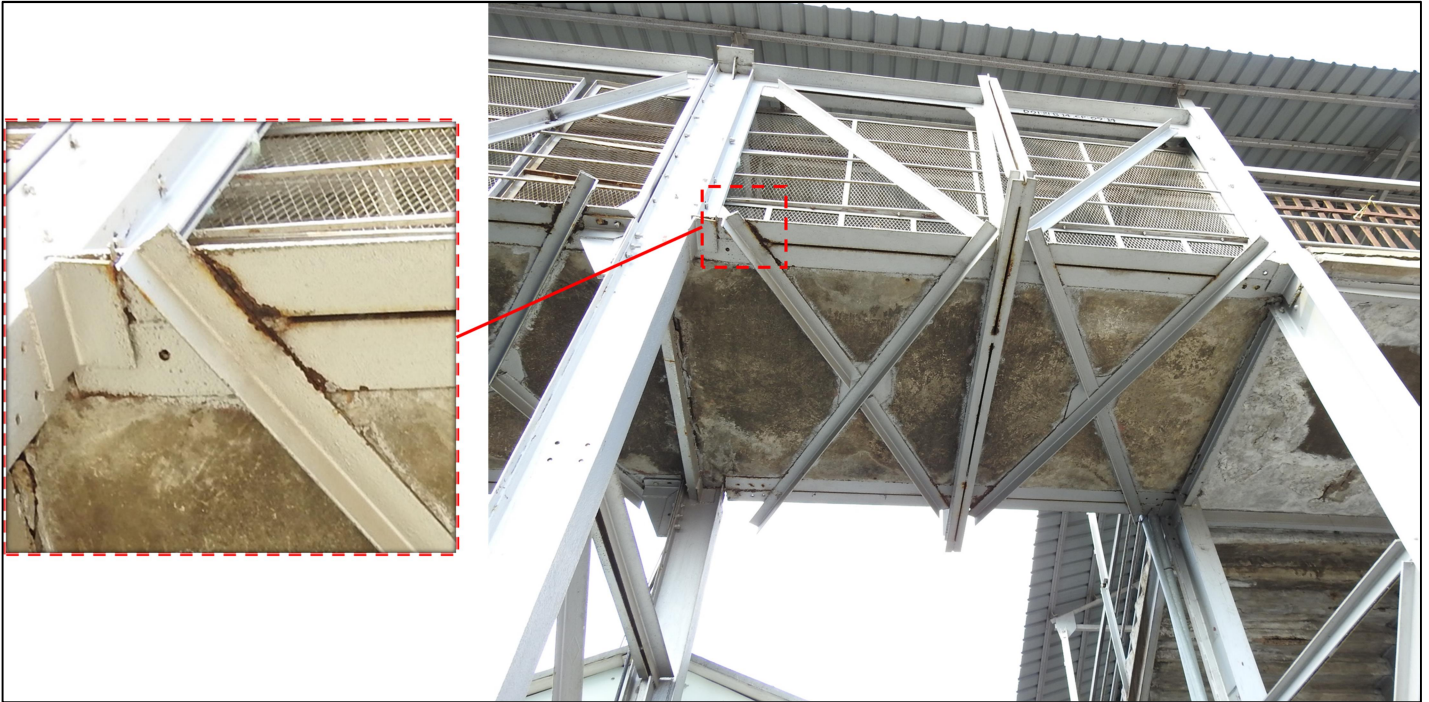
i) Corrosion of gusset plate connected bottom bracing in 2<sup>nd</sup> span of FOB

| PART 4 SURVEY OF SIGNS OF DISTRESS, DEFORMATION IN BRIDGES | | | |
|---|---|---|---|
| | Rust straining | 2 <sup>nd</sup> span-<br>bottom<br>bracing<br>connecting<br>bottom chord | Slight rusting is observed at the joint connecting bottom bracing and bottom chord. ( <i>Refer: Part 4.1, Fig- i</i> ) |

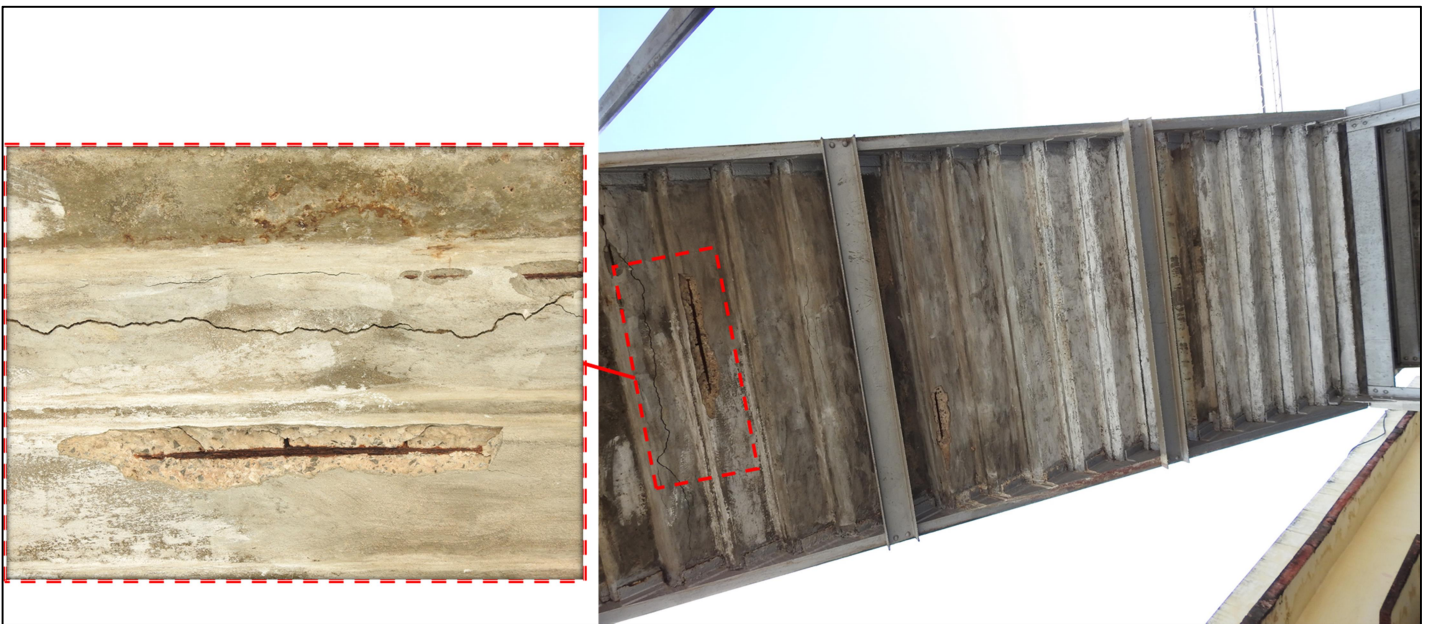
j) Cracks and reinforcement exposed in staircase slab panels in staircase -2

| PART 4 SURVEY OF SIGNS OF DISTRESS, DEFORMATION IN BRIDGES | | | |
|---|---|---|---|
| | Cracking in RCC components | staircase slab panels | Cracks are observed in Pre-cast RCC slab panels of Spans & stair cases ( <i>Refer: Part 4.1, Fig- j, k, l</i> ). |

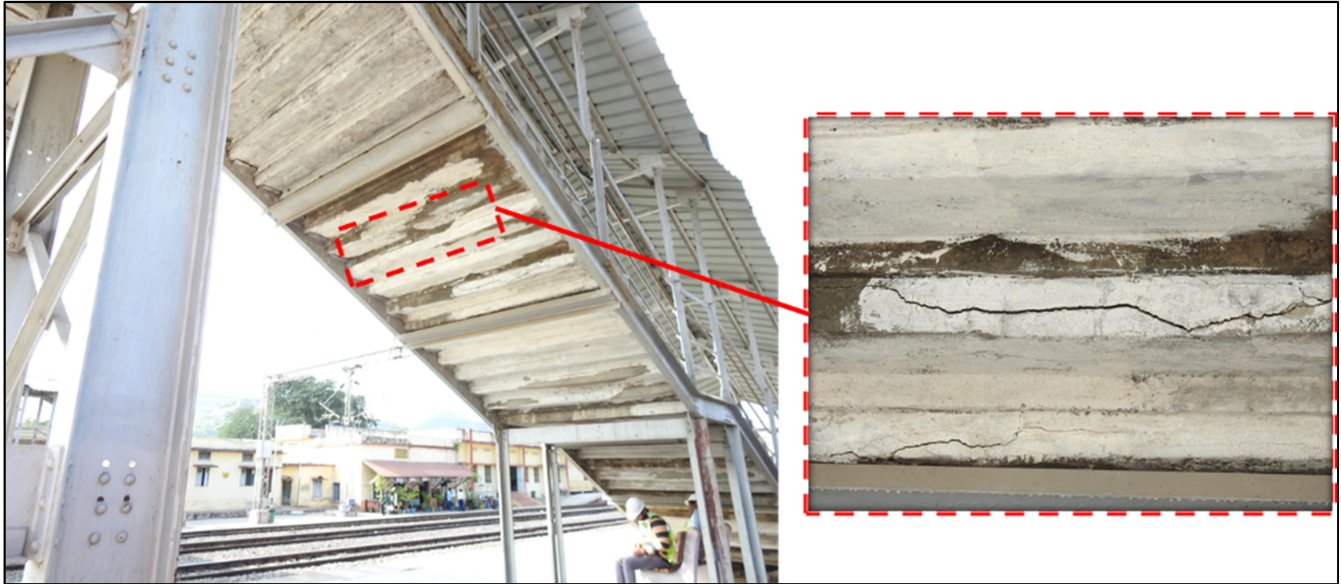
k) Cracks observed in staircase slab panels in staircase-3

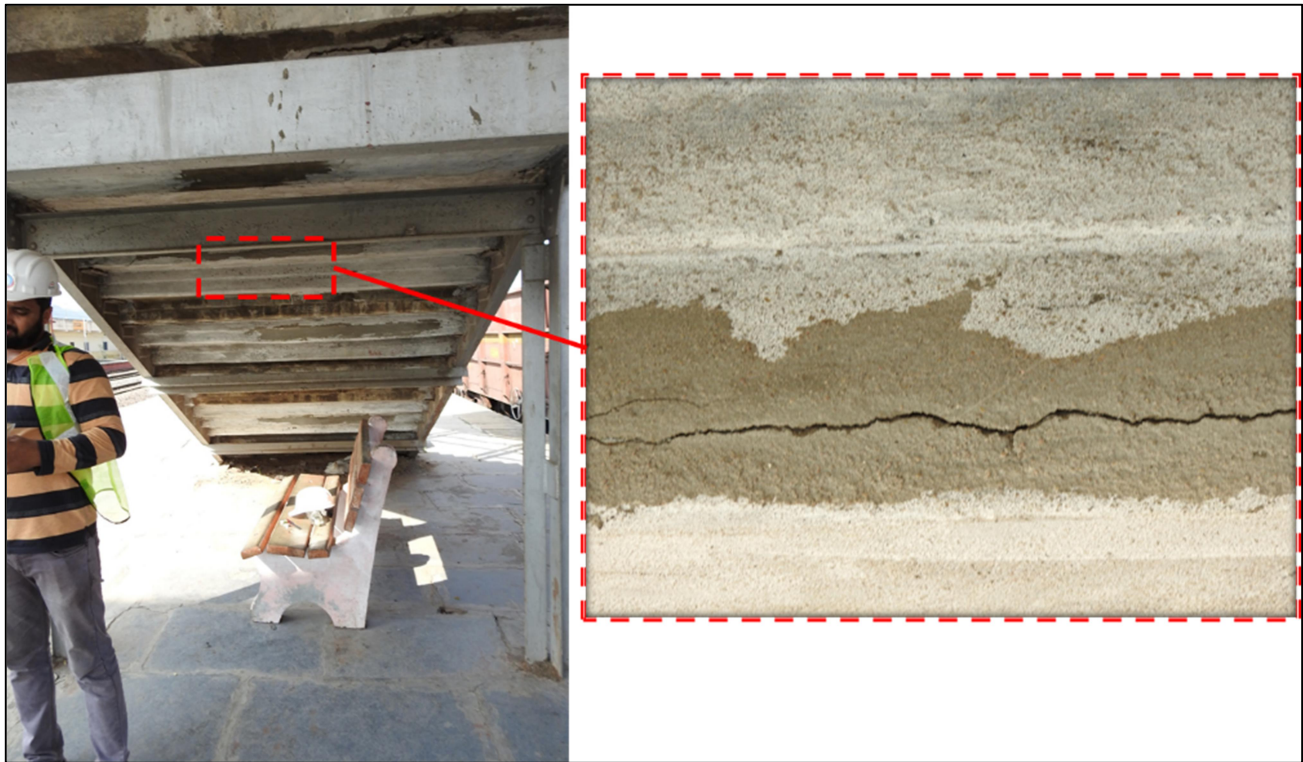
l) Cracks observed in staircase slab panels in staircase-3

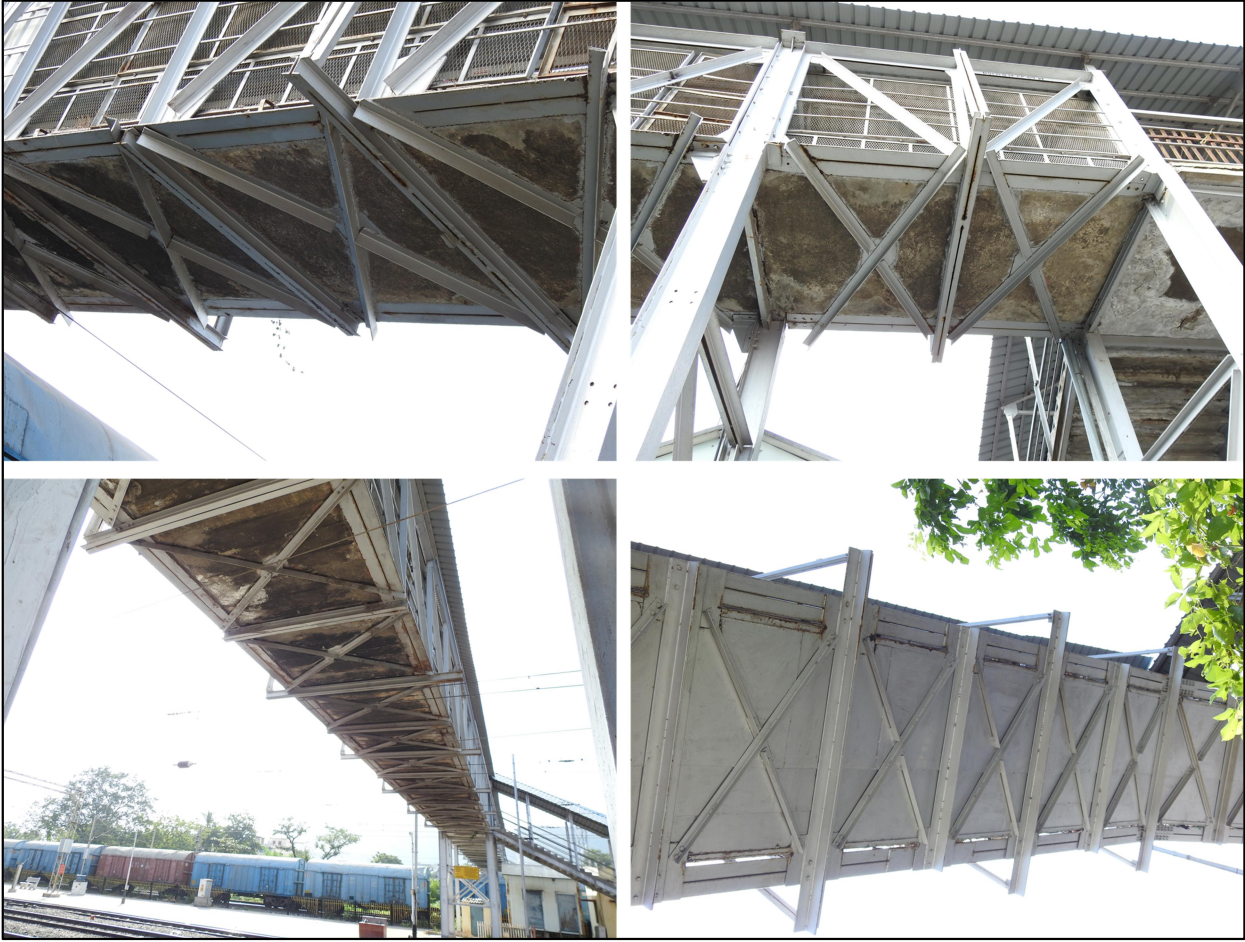
**Fig 4:** Bottom view of 1<sup>st</sup>, 2<sup>nd</sup>, 3<sup>rd</sup> span and sacrificial plate for 4<sup>th</sup> span of FOB

| | Condition of Slab from Bottom | Spalling Observed | is resting on bottom chord. <i>(Refer fig : 2, 2(a),2(c)) and (Refer fig : 4)</i> |

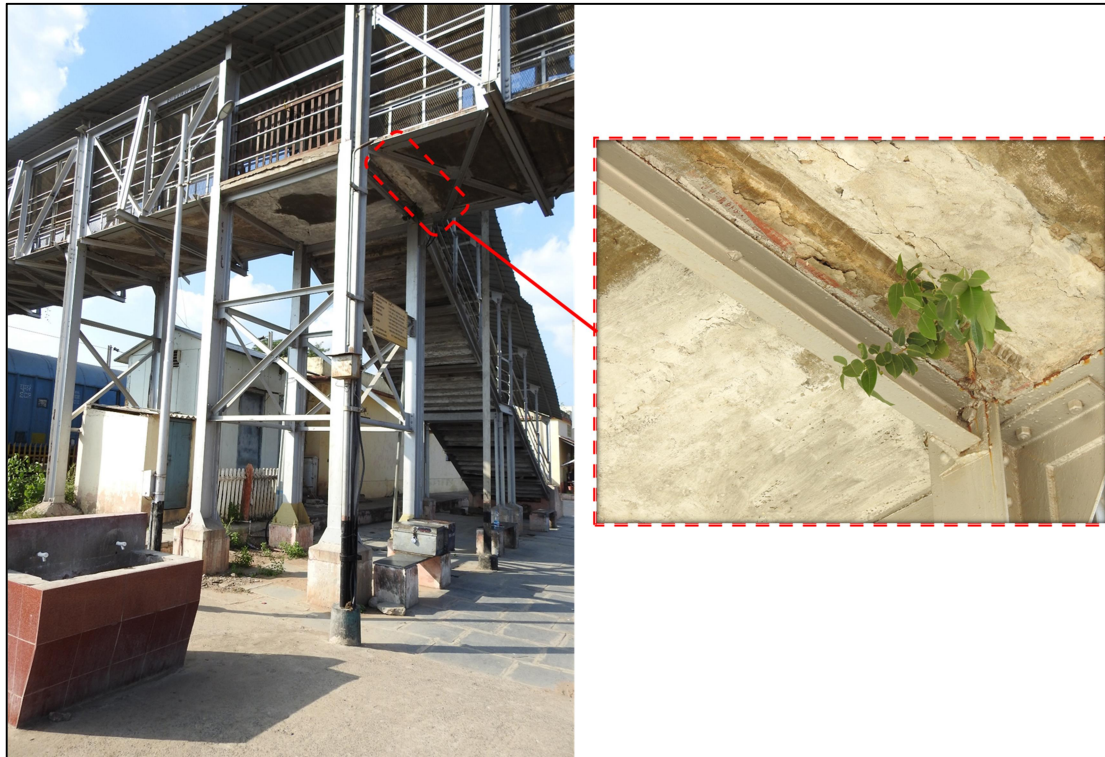
**Fig 6:** Cracks in slab and vegetation in staircase -2 of FOB
