| <b>Name of the Project</b> | <b>:</b> | <b>VISUAL INSPECTION OF FOB AT ANAKAPALLE RAILWAY STATION</b> |
| <b>Location</b> | <b>:</b> | <b>ANAKAPALLE RAILWAY STATION</b> |
| <b>Date of Inspection</b> | <b>:</b> | <b>7<sup>th</sup> NOVEMBER, 2019</b> |

### **VISUAL INSPECTION OF STEEL FOOT OVER BRIDGE**

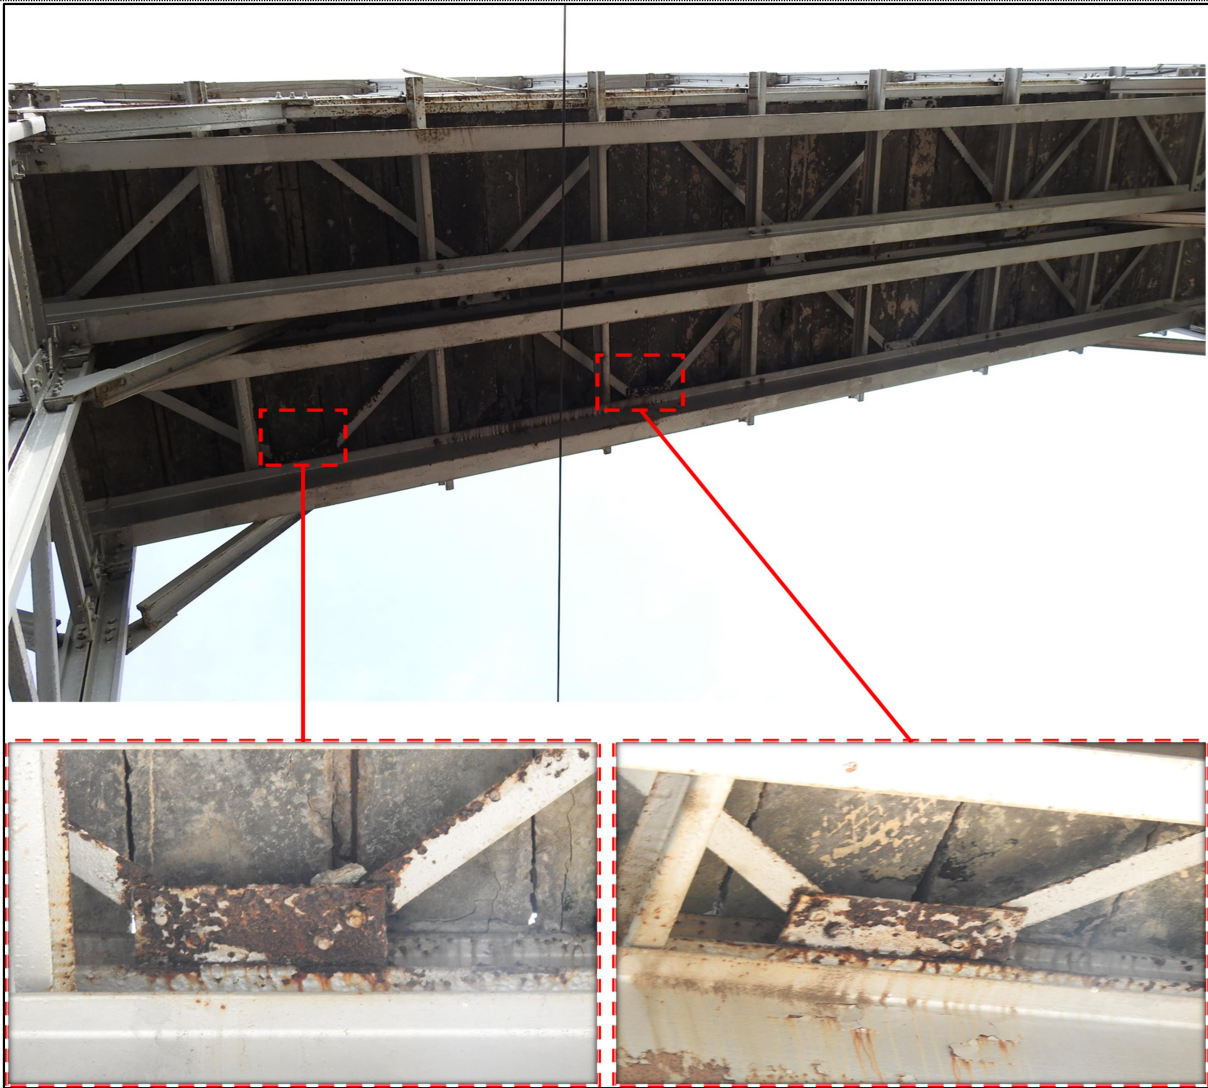
a) Corrosion of Gusset plate in 2<sup>nd</sup> Span of FOB

| PART 4 SURVEY OF SIGNS OF DISTRESS, DEFORMATION IN BRIDGES | | | |
|---|---|---|---|
| | Corrosion in Gusset plate | Span-2 <sup>nd</sup> , 4 <sup>th</sup> and 5 <sup>th</sup> | Corrosion is observed in gusset plate connecting bottom bracings (Refer: <b>Part 4.2, Fig- a, b and d</b> ). |

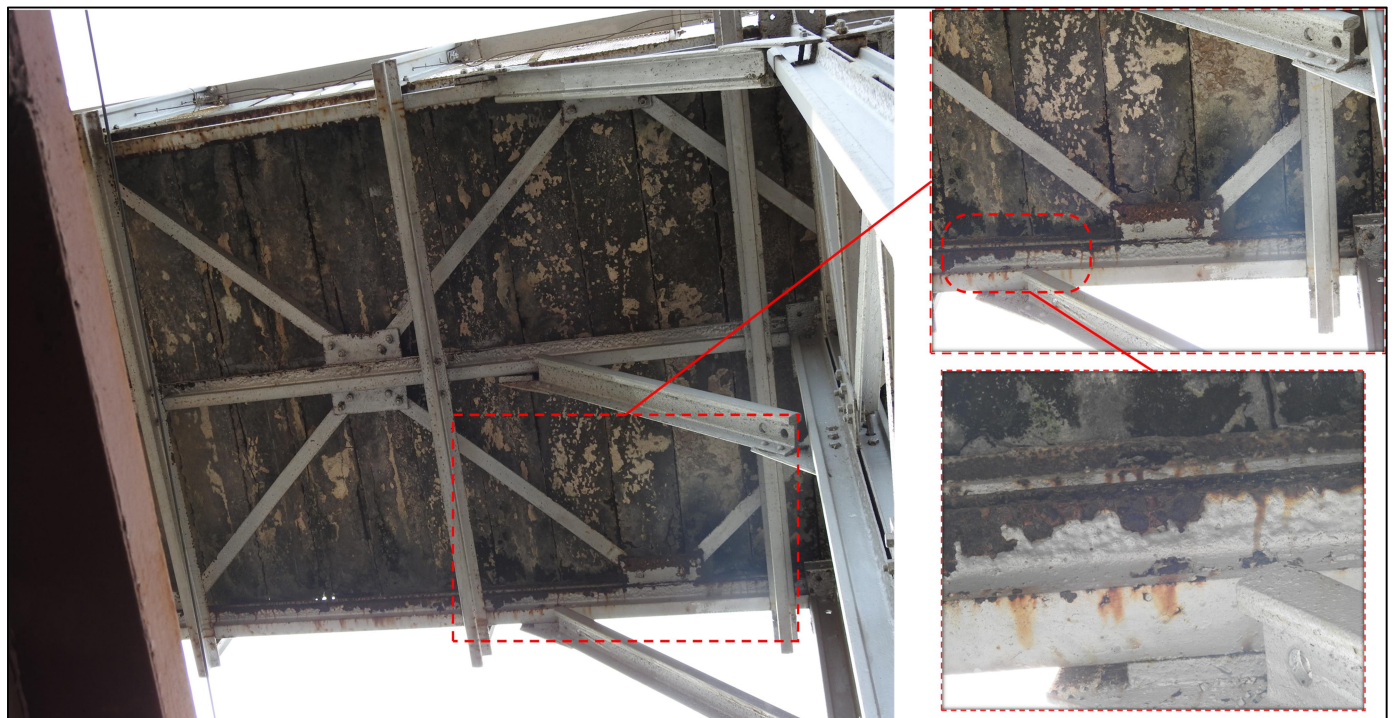
b) Corrosion of Gusset plate and bottom chord member in 3<sup>rd</sup> span of FOB

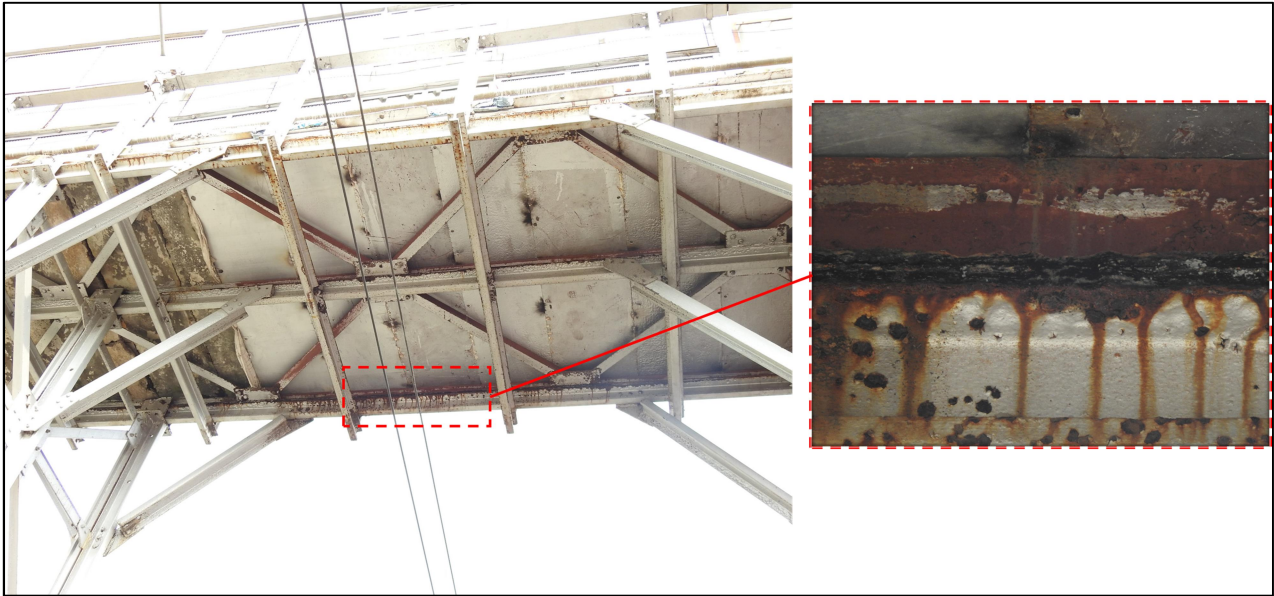
c) Corrosion of bottom chord member in 5<sup>th</sup> span of FOB

| PART 4 SURVEY OF SIGNS OF DISTRESS, DEFORMATION IN BRIDGES | | | |
|---|---|---|---|
| | Rust straining | Bottom chord | Slight rusting is observed at all the joints of FOB at floor level (Refer: <b>Part 4.2, Fig- c</b> ). |

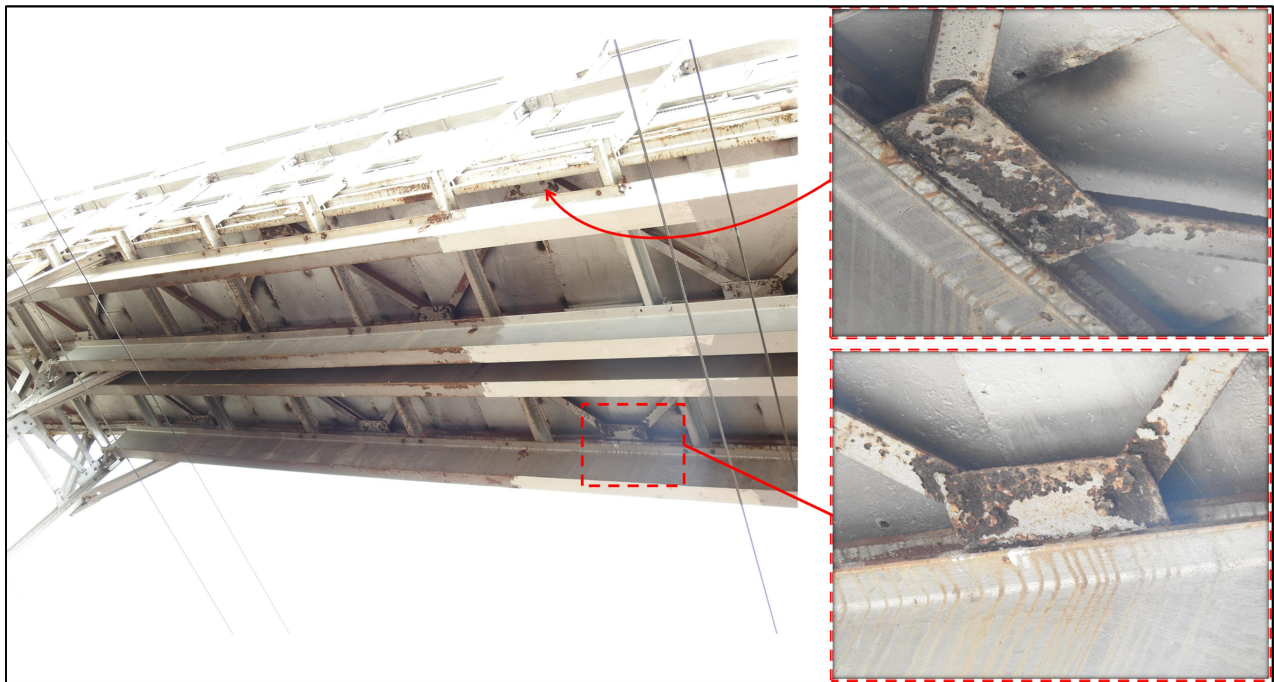
d) Corrosion of gusset plate connecting bottom bracings in 4<sup>th</sup> span of FOB

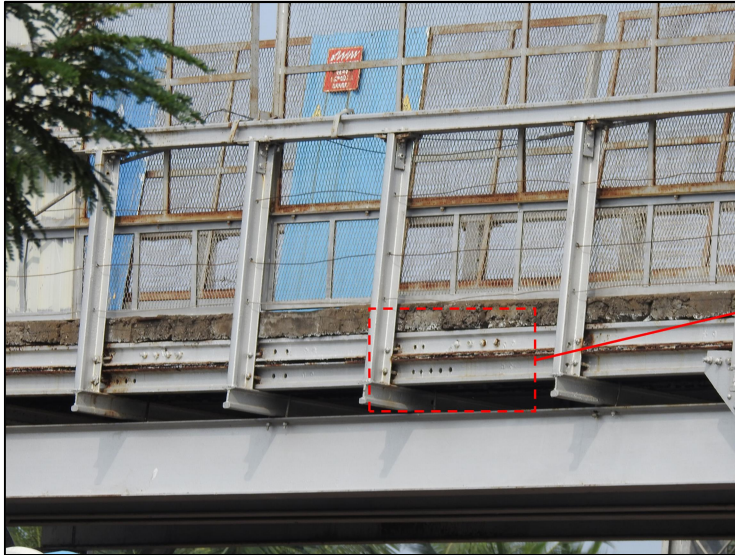
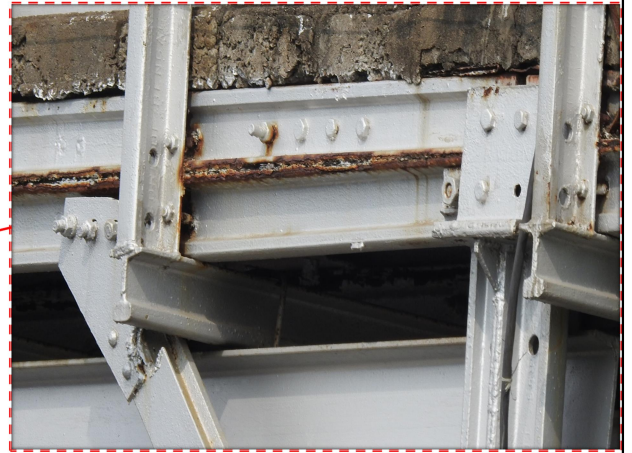
e) Corrosion observed in bottom rail

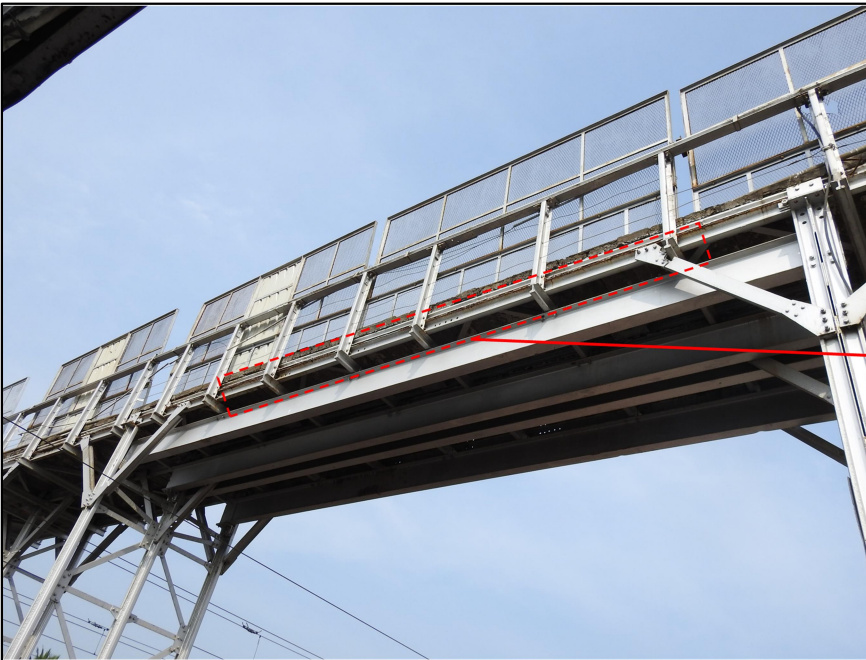
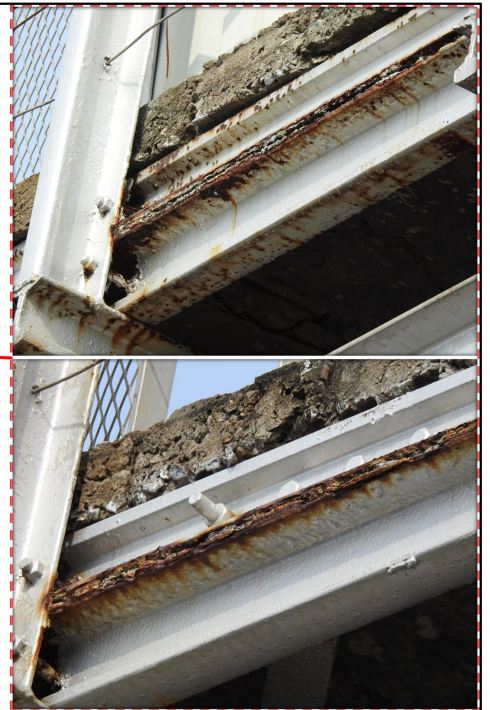
f) Corrosion observed in bottom rail

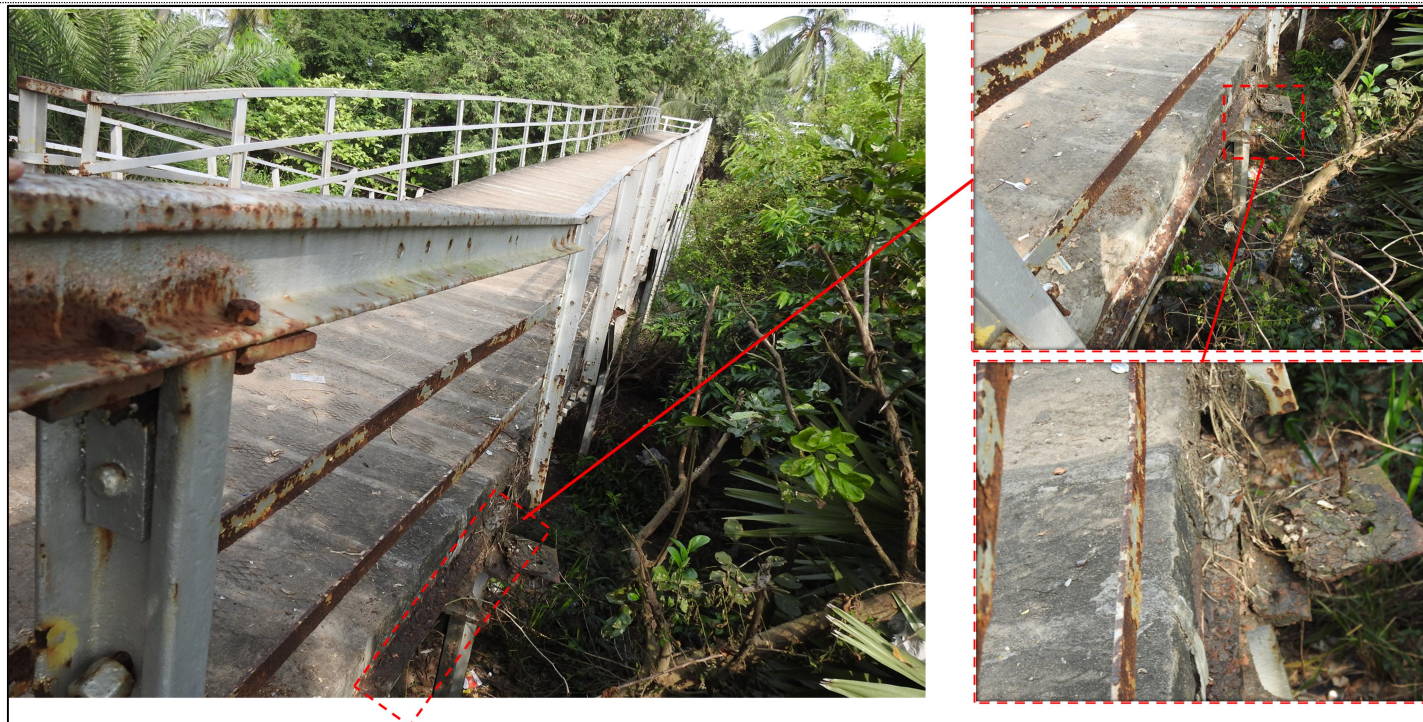
g) Corrosion of ramp landing beam

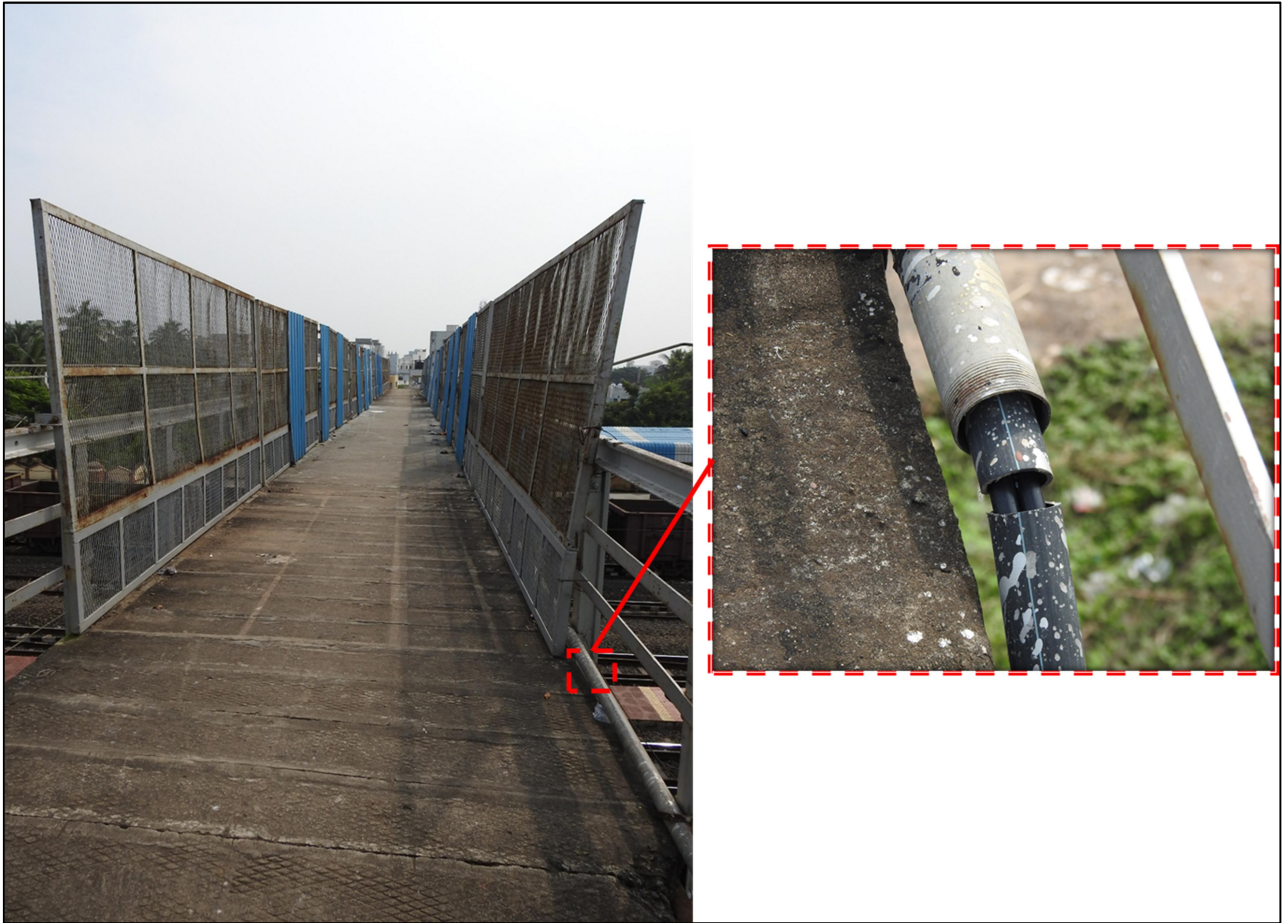
| | | Yes/No | Notes |
|---|---|---|---|
| | b) Cables | Yes | a. Cables are protected with 1.5-inch HDPE pipe.<br>(Refer <b>fig :2</b> )<br>b. GI Pipes of Dia-60mm is observed<br>c. No Roof Truss is provided. |
| | a) Additional wearing coat on Floor | No | No wearing coat observed (Refer <b>fig :2</b> ) |
| | b) Provision of protective screen for passengers | Yes | Fence made of galvanized wire of 2 mm gauge and 2 mm galvanized sheet is used above OHE Line on both side of pathway is used for passengers Protection.<br>(Refer <b>fig :2</b> ) |

**Fig 2:** FOB pathway, protective screen and cables on floor of pathway

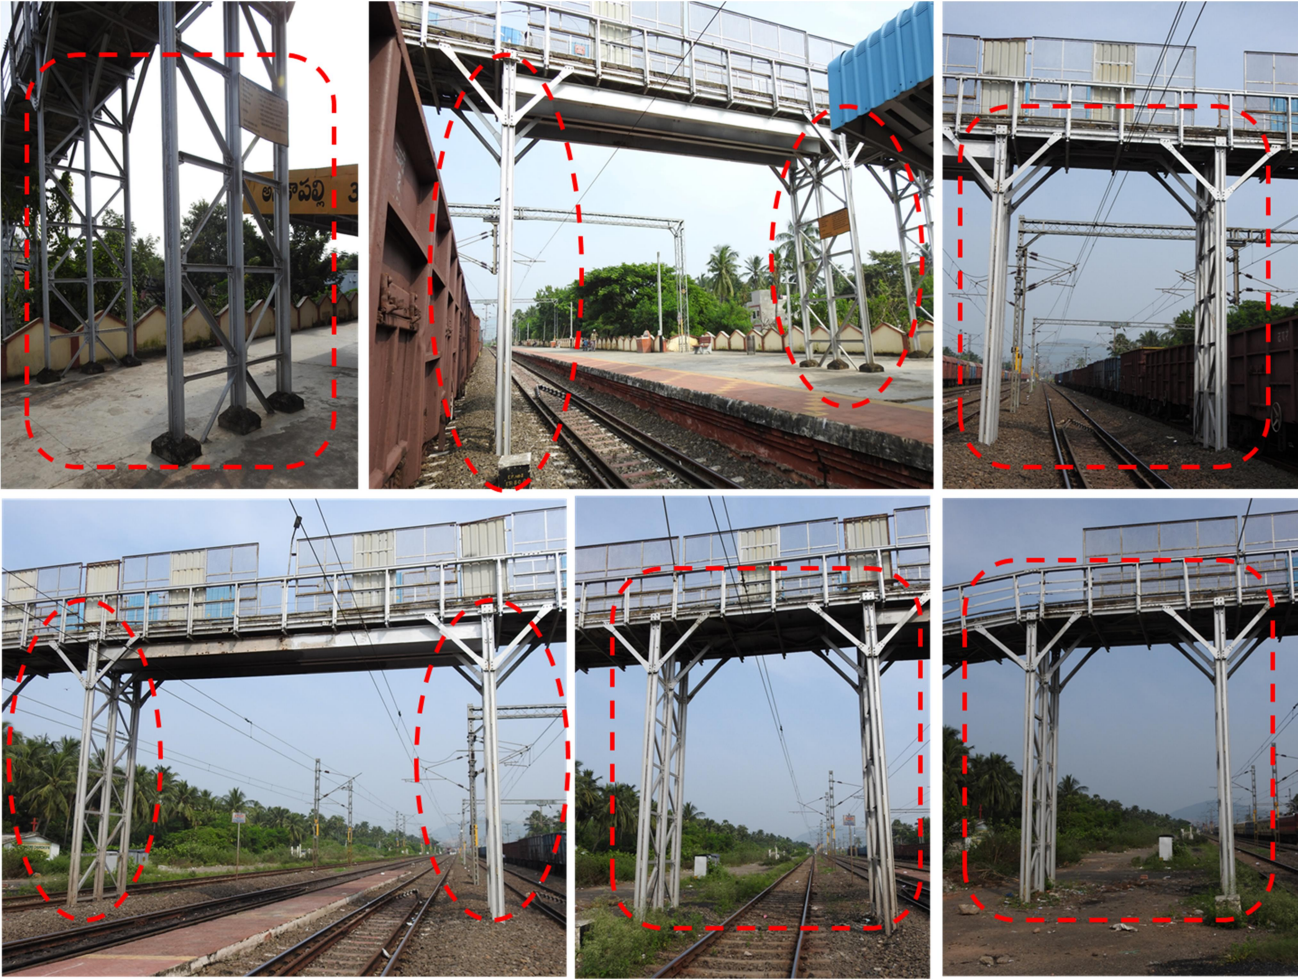
| | Type/Shape of Column section | Built up Section with Bull headed Rail | a. Stanchion Columns are 60 x 120 x 120 (Head x Height x Base) Rail sections.<br>b. Cross Bracings in Stanchions are 75 x 75 x 8 mm Angles are used. (Refer <b>fig :3</b> ) |

***Fig 3: Stanchion column details***

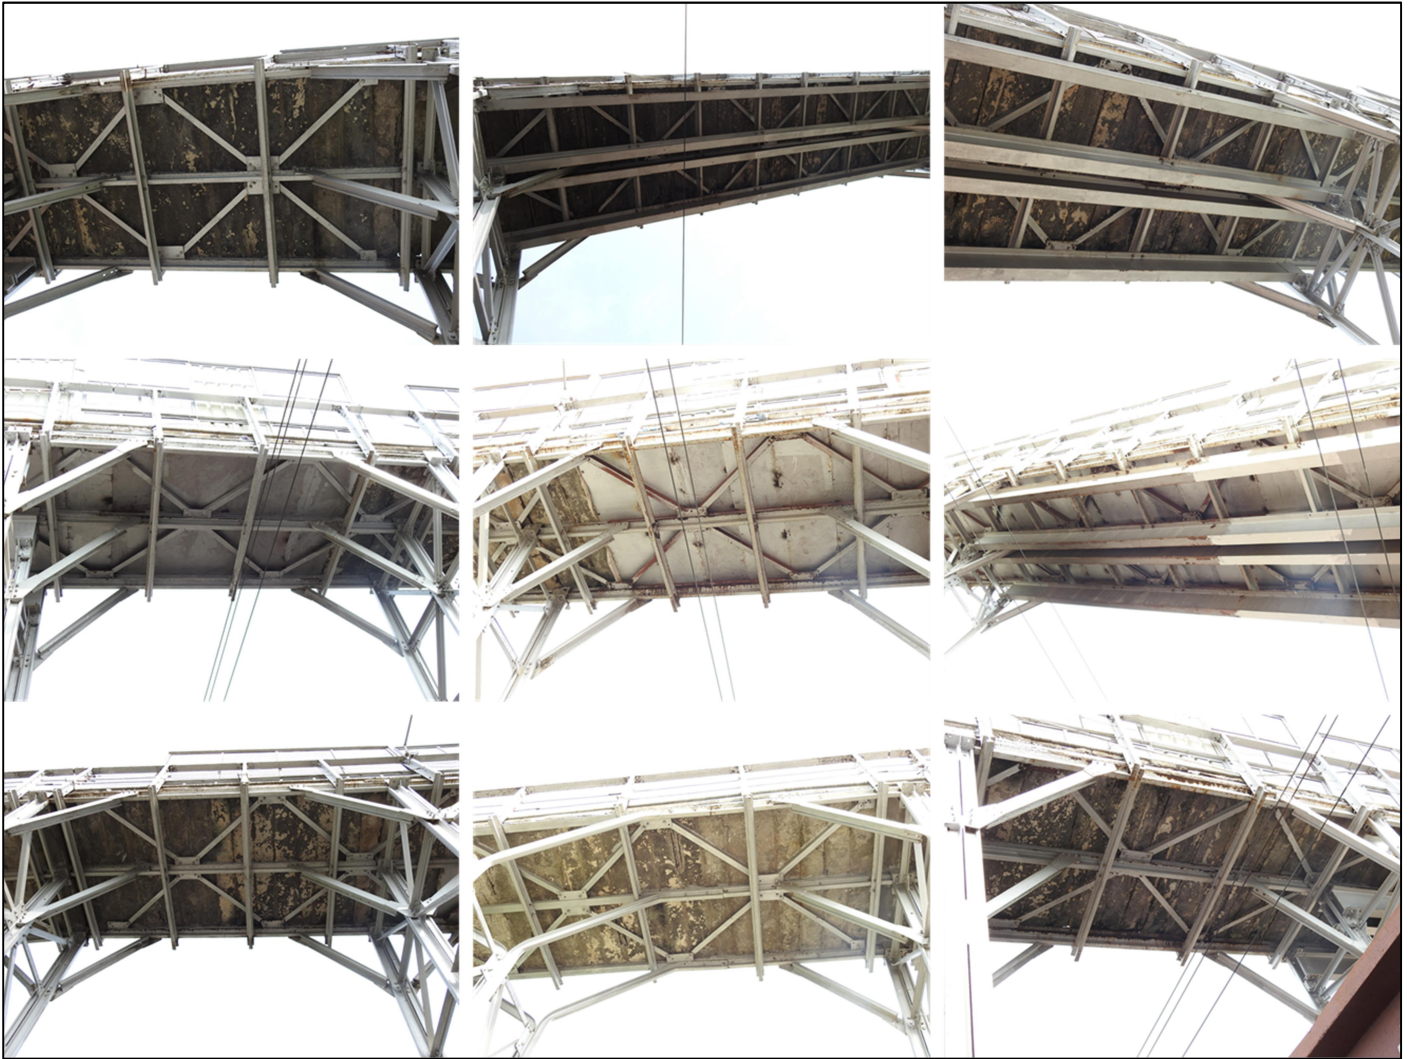
| | Type /Shape of Truss Section | Rail sections | a) Top Chord members are 60 x 120 x 120 (Head x Height x Base) Rail sections (Refer <b>fig :4</b> )<br>b) There are 3 nos. of Bottom Chords Bottom Chord members are back to back connected 60 x 120 x 120 (Head x Height x Base) Rail sections (Refer <b>fig :4</b> )<br>c) Addition 4 nos. of ISMB 400 Members are used as longitudinal girders in the spans 2&5.<br>d) 60 x 120 x 120 (Head x Height x Base) Rail sections are used as vertical members.<br>e) 45 x 90 x 90 (Head x Height x Base) Rail sections are used as Floor beams.<br>f) 45 x 90 x 90 (Head x Height x Base) Rail sections are used as Bracings. |

***Fig 4: Bottom view of FOB***

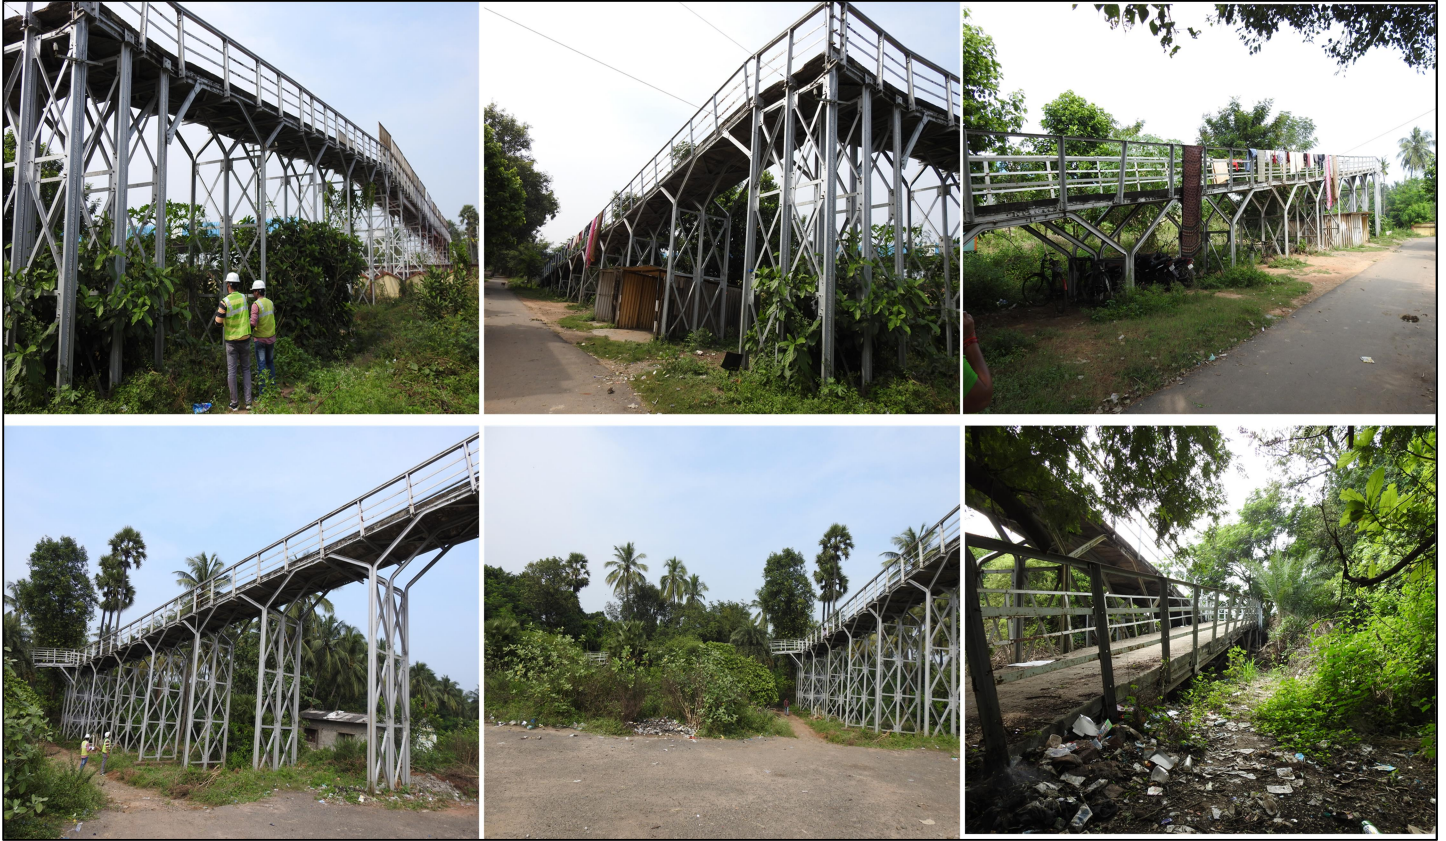
| | Number of Ramps | 2 No's | Ramp is observed as Pre cast RCC Slab panels supported on 55 x 110 x 110 (Head x Height x Base) Bottom chords on both sides and middle of the ramp. (Refer <b>fig :5</b> ) |

**Fig 5:** Ramp details both ends of FOB

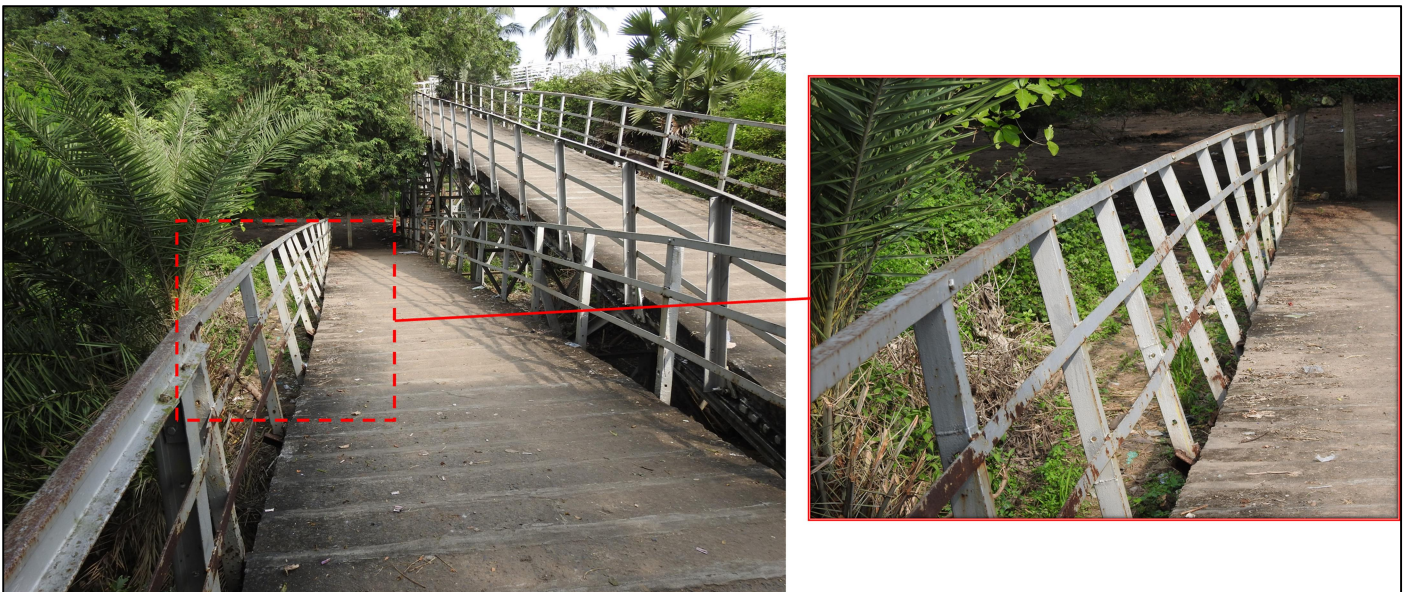
| | Type of Parapet Railing | Steel Railing | Ramps are provided with railing on both sides using 60 x 120 x 120 (Head x Height x Base) Angle sections and 65 x 65 x 8 mm Angles are used. (Refer <b>fig :6</b> ) |

**Fig 6:** Damaged ramp railing
