| <b>Name of the Project</b> | <b>:</b> | <b>VISUAL INSPECTION OF FOB AT ELAMANCHILI RAILWAY STATION</b> |
| <b>Location</b> | <b>:</b> | <b>ELAMANCHILI RAILWAY STATION</b> |
| <b>Date of Inspection</b> | <b>:</b> | <b>8<sup>th</sup> NOVEMBER, 2019</b> |

### **VISUAL INSPECTION OF STEEL FOOT OVER BRIDGE**

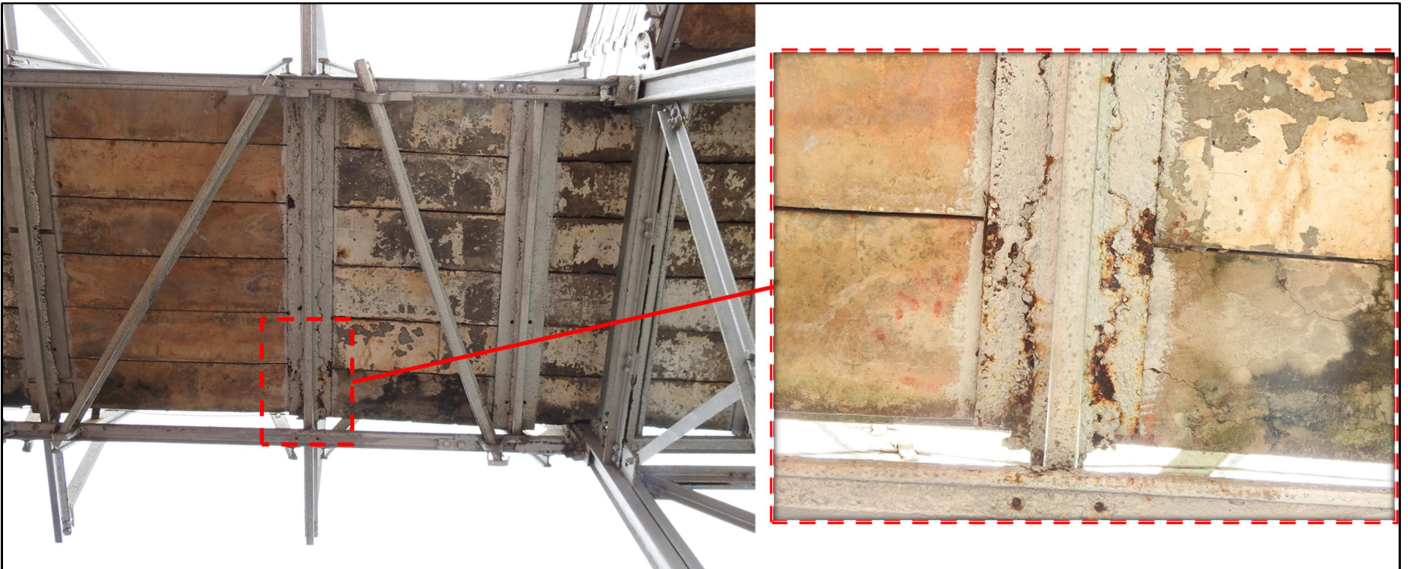
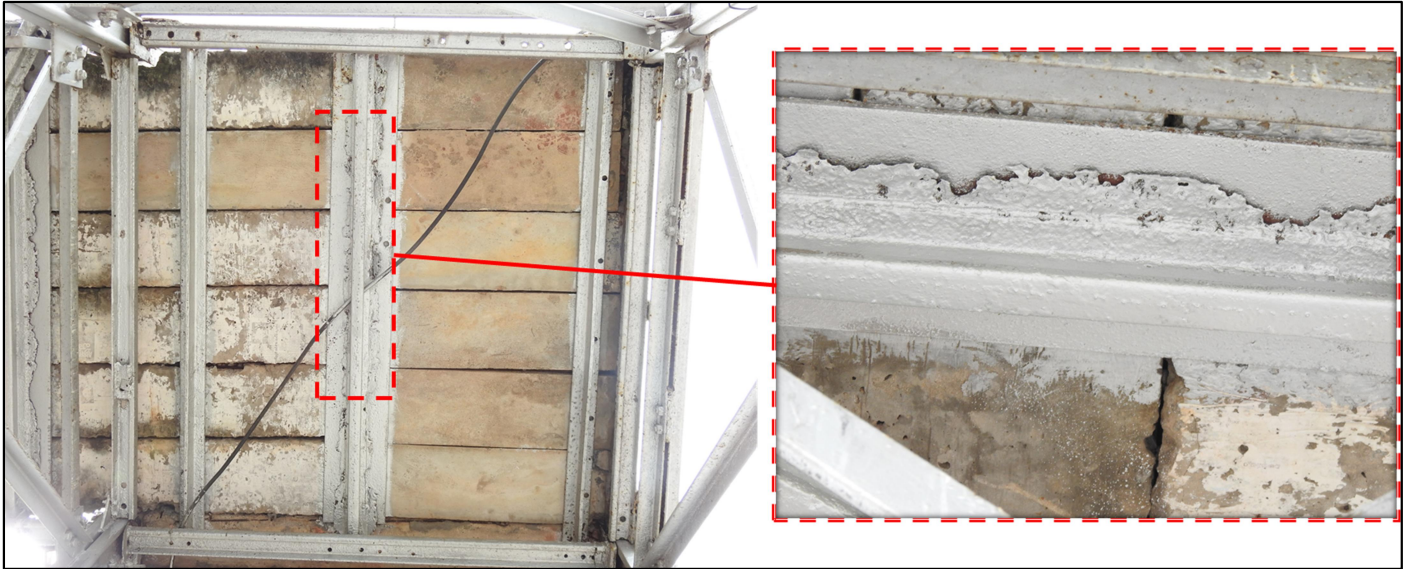
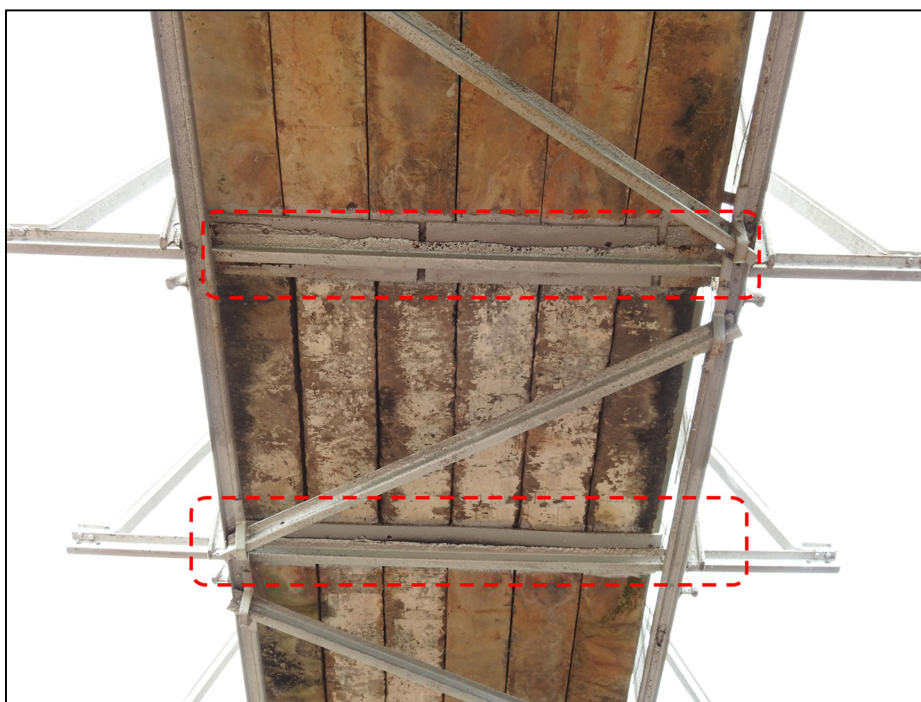
- 4.1 ✓ Corrosion of floor beams along the span of FOB, coated with Al paint.

Corrosion of Floor beam coated with silver oxide paint

| PART 4 SURVEY OF SIGNS OF DISTRESS, DEFORMATION IN BRIDGES | | | |
|---|---|---|---|
| | Rust straining/ corrosion | Floor Beams and staircase landing beam | Corrosion is observed at all the joints & floor beams of FOB and staircase landing beam. (Refer: <b>Part 4.1 and 4.2, Fig- a, b, c</b> ). |

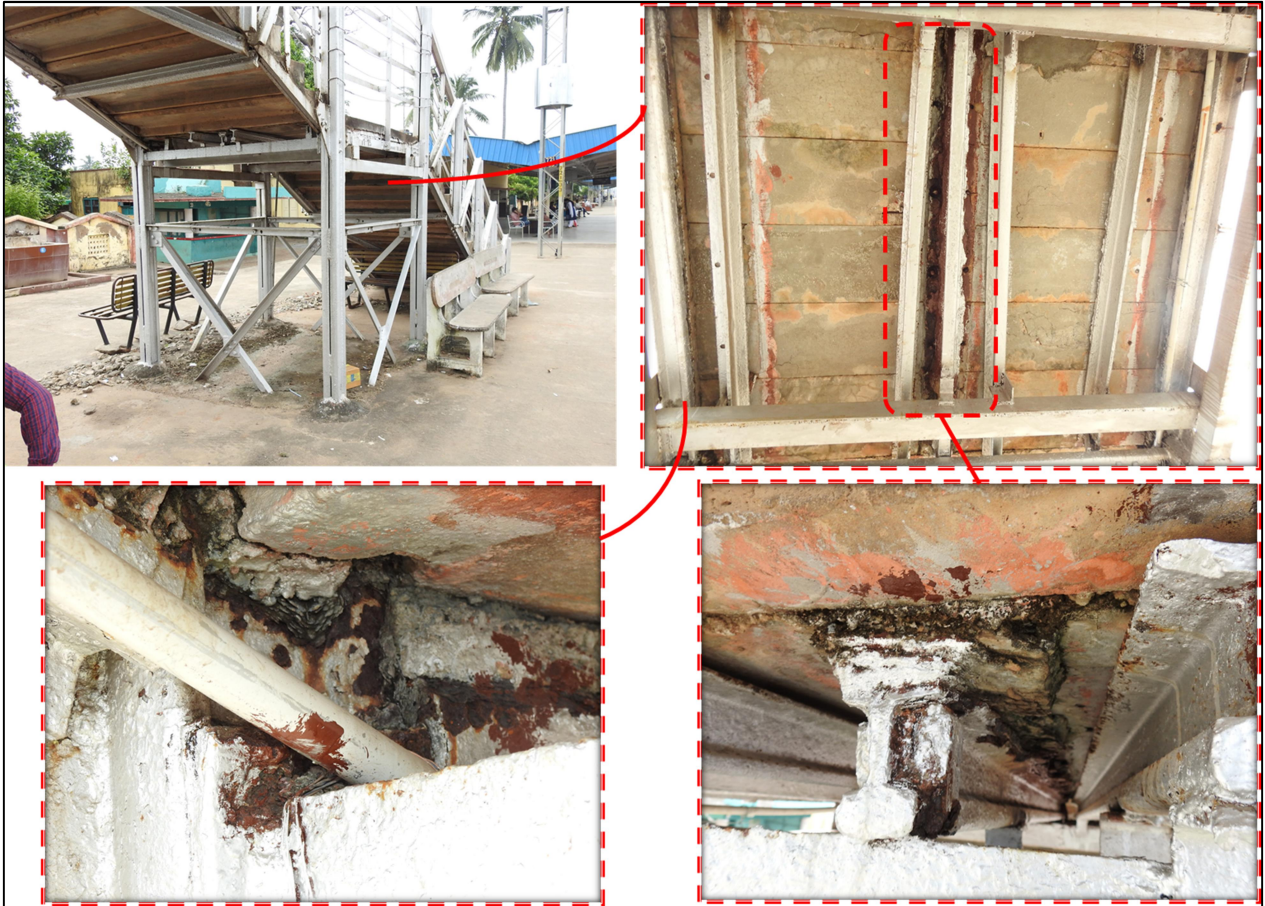
| 4.2 | ✓ Corrosion of floor beam in staircase landing and stringer beam of FOB |

(a) Corrosion of floor beam and stringer beam in staircase-1

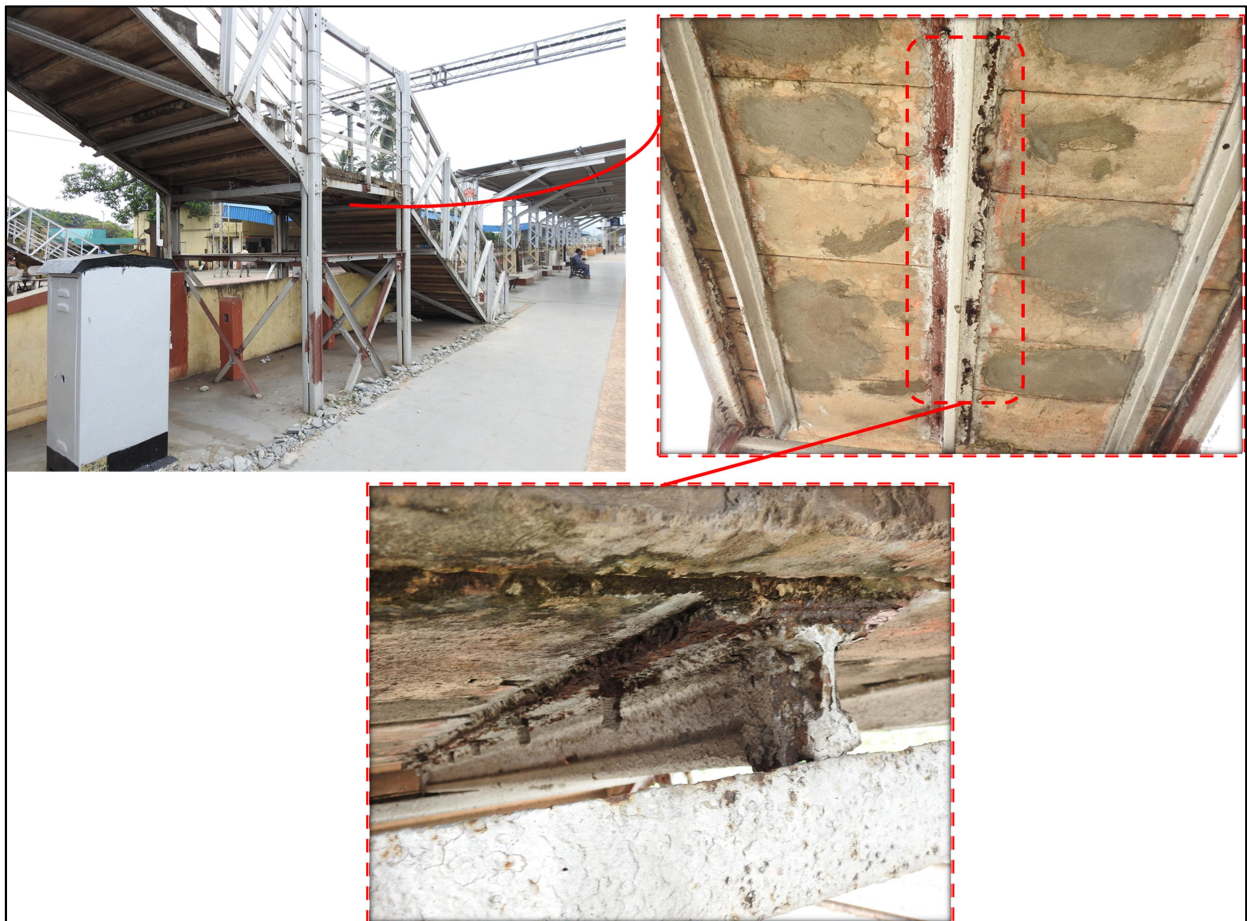
(b) Corrosion of floor beam in staircase-2

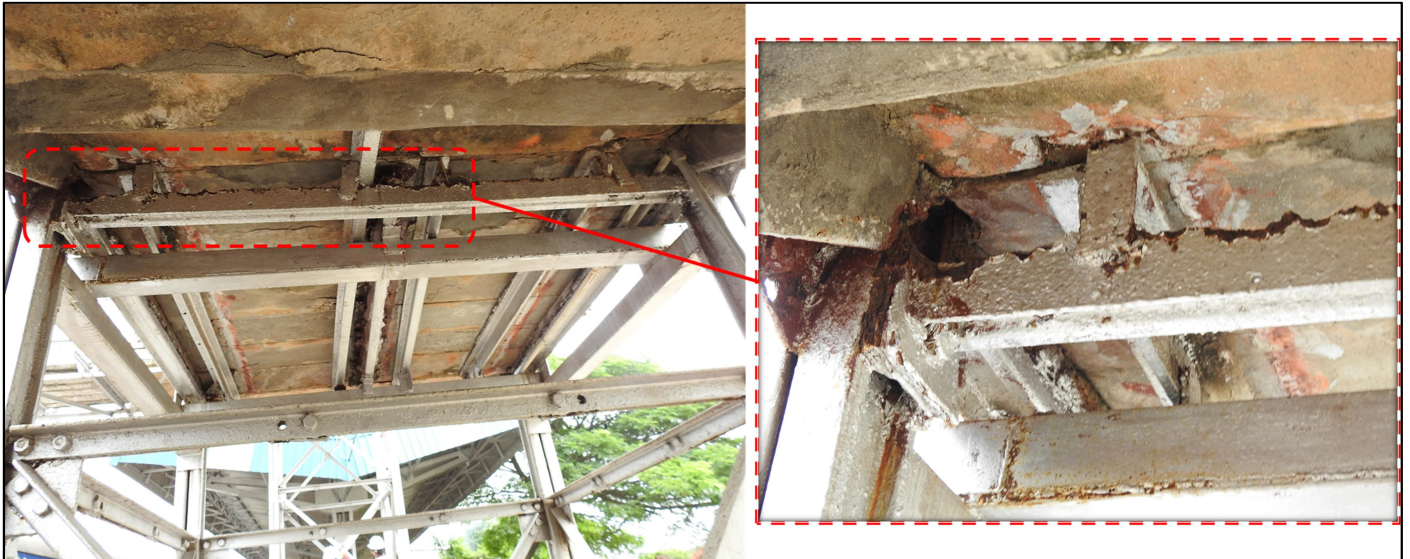
(c) Corroded angle section in staircase -1

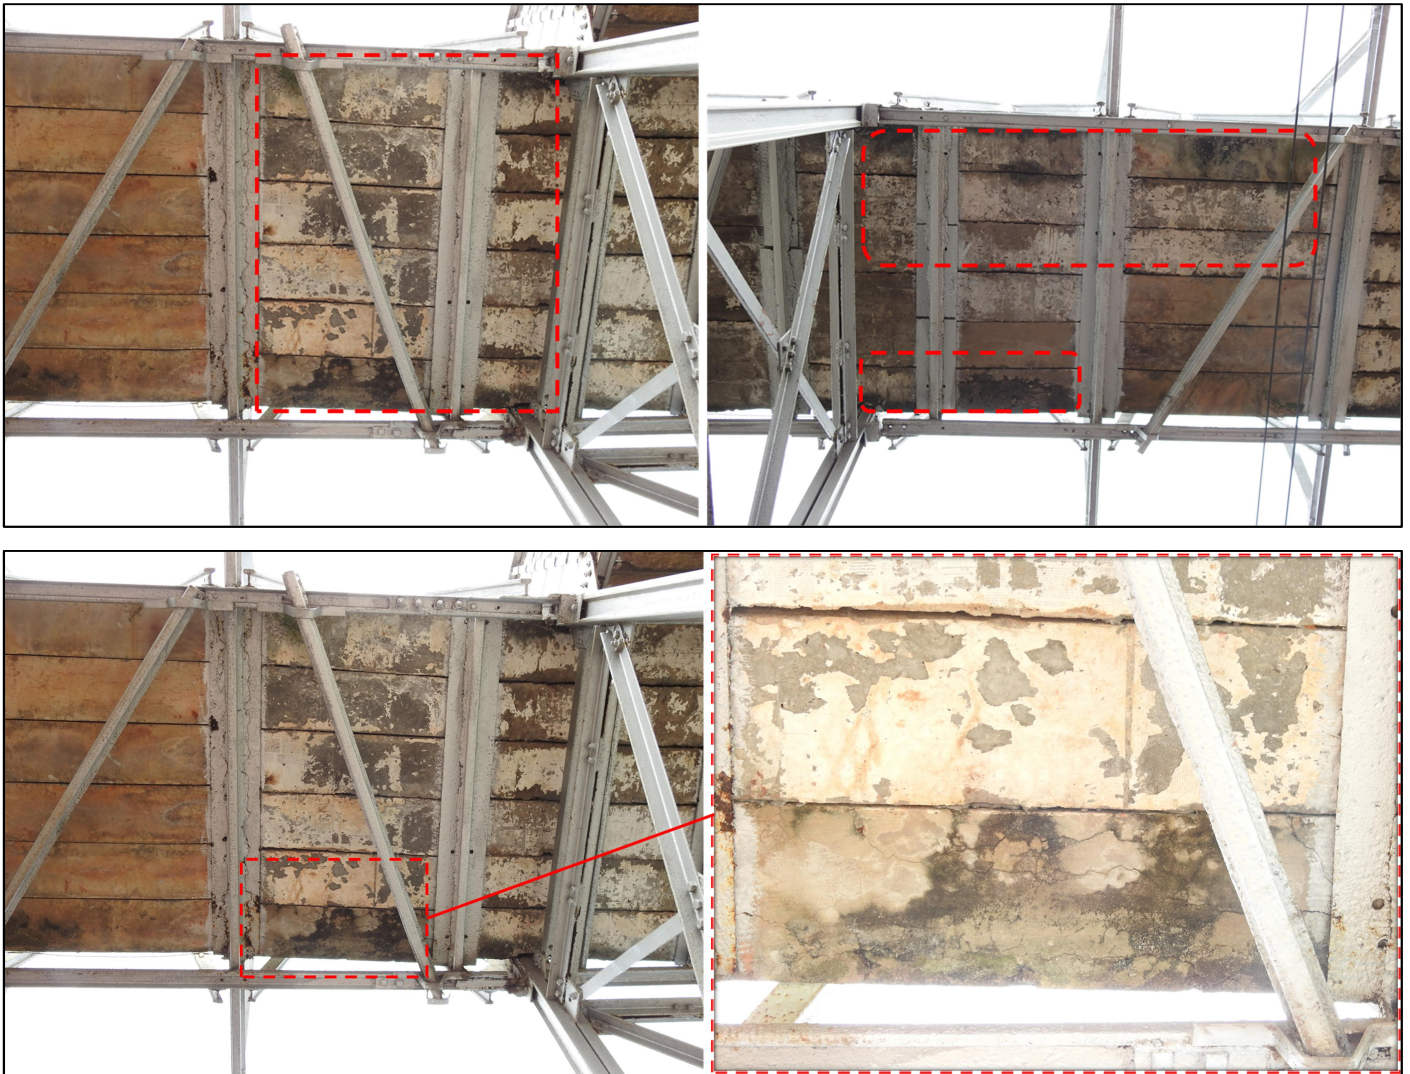
4.3 | ✓ Leaching and cracks observed in slab panels

(a) Leaching and cracks in slab panels

| PART 4 SURVEY OF SIGNS OF DISTRESS, DEFORMATION IN BRIDGES | | | |
|---|---|---|---|
| | Cracking in RCC components | Slab panels | Cracks are observed in Pre-cast RCC slab panels of Staircase & Main Slab. (Refer: <b>Part 4.3, Fig- a</b> ). |

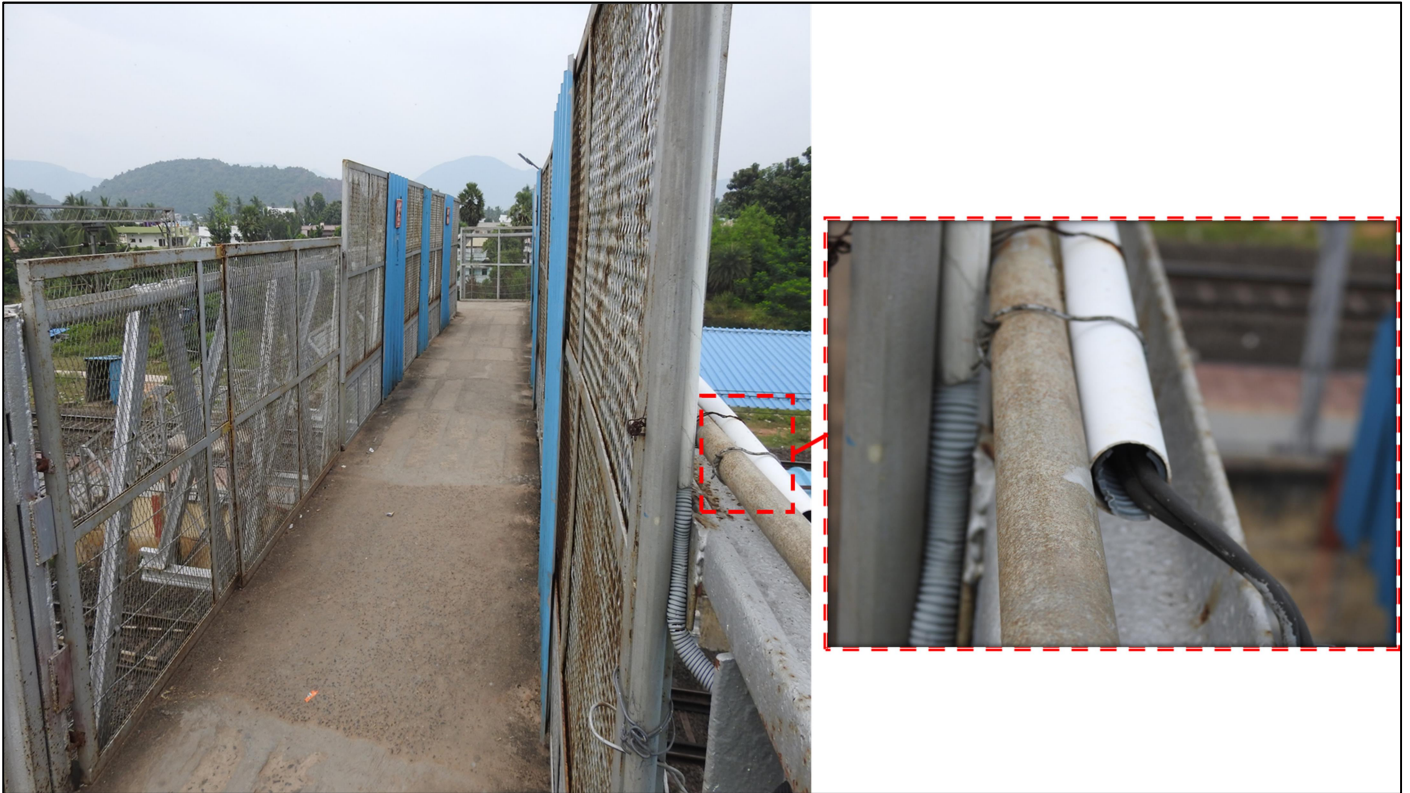
**Fig 2:** FOB pathway, protective screen and Additional loads of PVC pipes

| | | Yes/No | Notes |
|---|---|---|---|
| | b) Cables | Yes | a. Cables are protected with 2-inch HDPE pipe. |
| | a) Additional wearing coat on Floor | No | No wearing coat (Refer <b>fig :2</b> ) |
| | b) Provision of protective screen for passengers | Yes | Fence made of galvanized wire of 2 mm gauge and 2 mm galvanized sheet is used above OHE Line on both side of pathway is used for passengers Protection. |

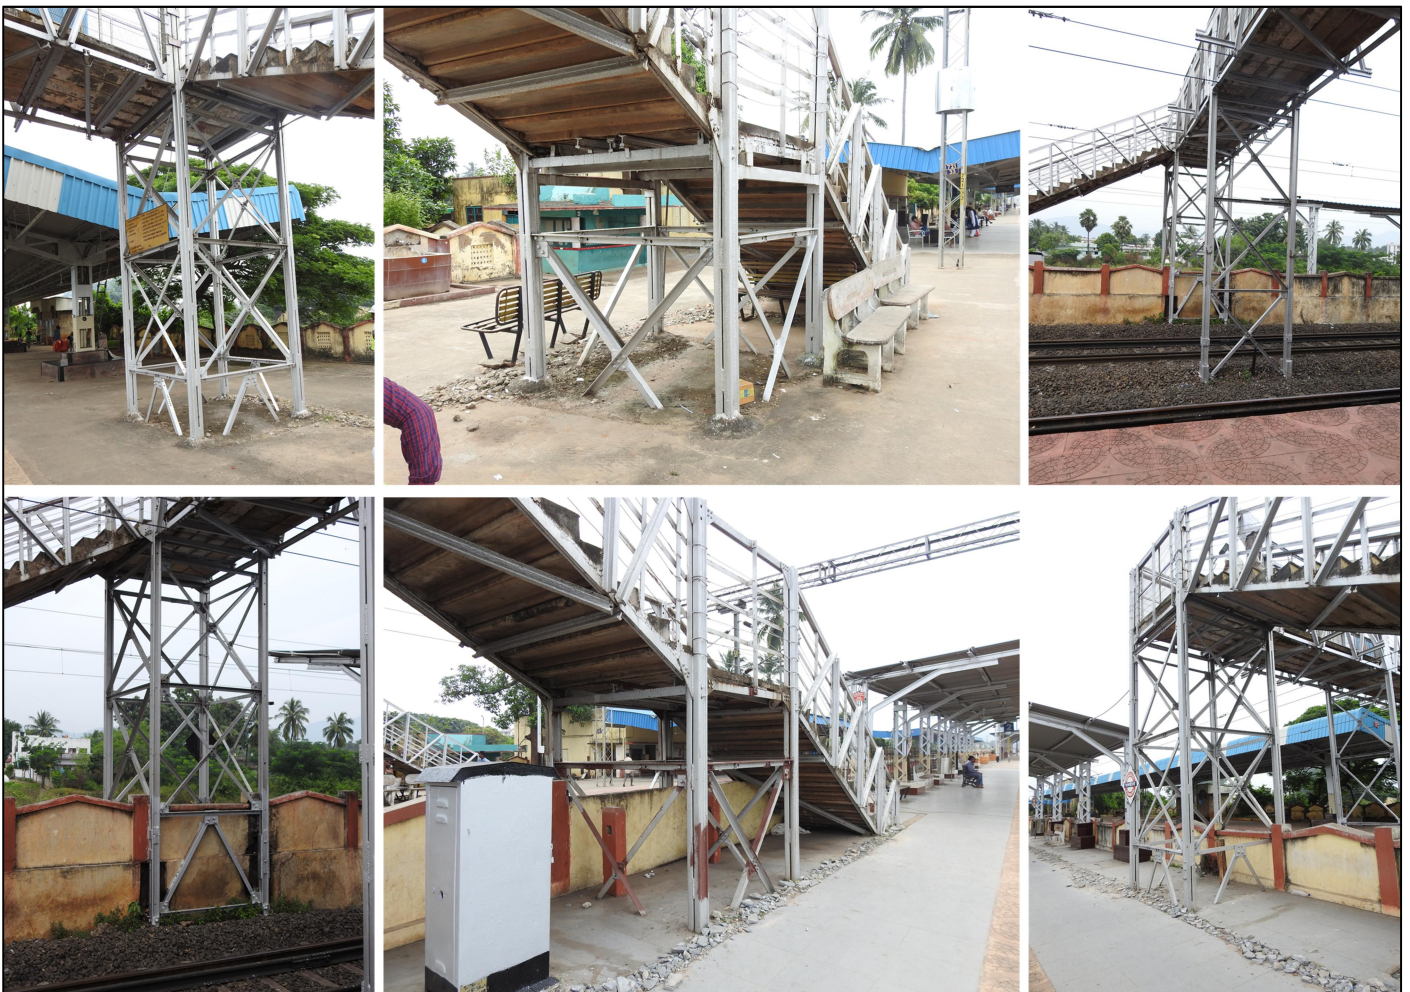
**Fig 3:** Trestles and Stanchion column details

| | Type/Shape of Column section | Bull headed Rail Sections | a. Trestles & Stanchion Columns are 65 x 135 x 135 (Head x Height x Base) bull headed Rail sections.<br>b. Cross Bracings in Stanchions are 65 x 65 x 8 mm Angles are used. (Refer <b>fig :3</b> ) |

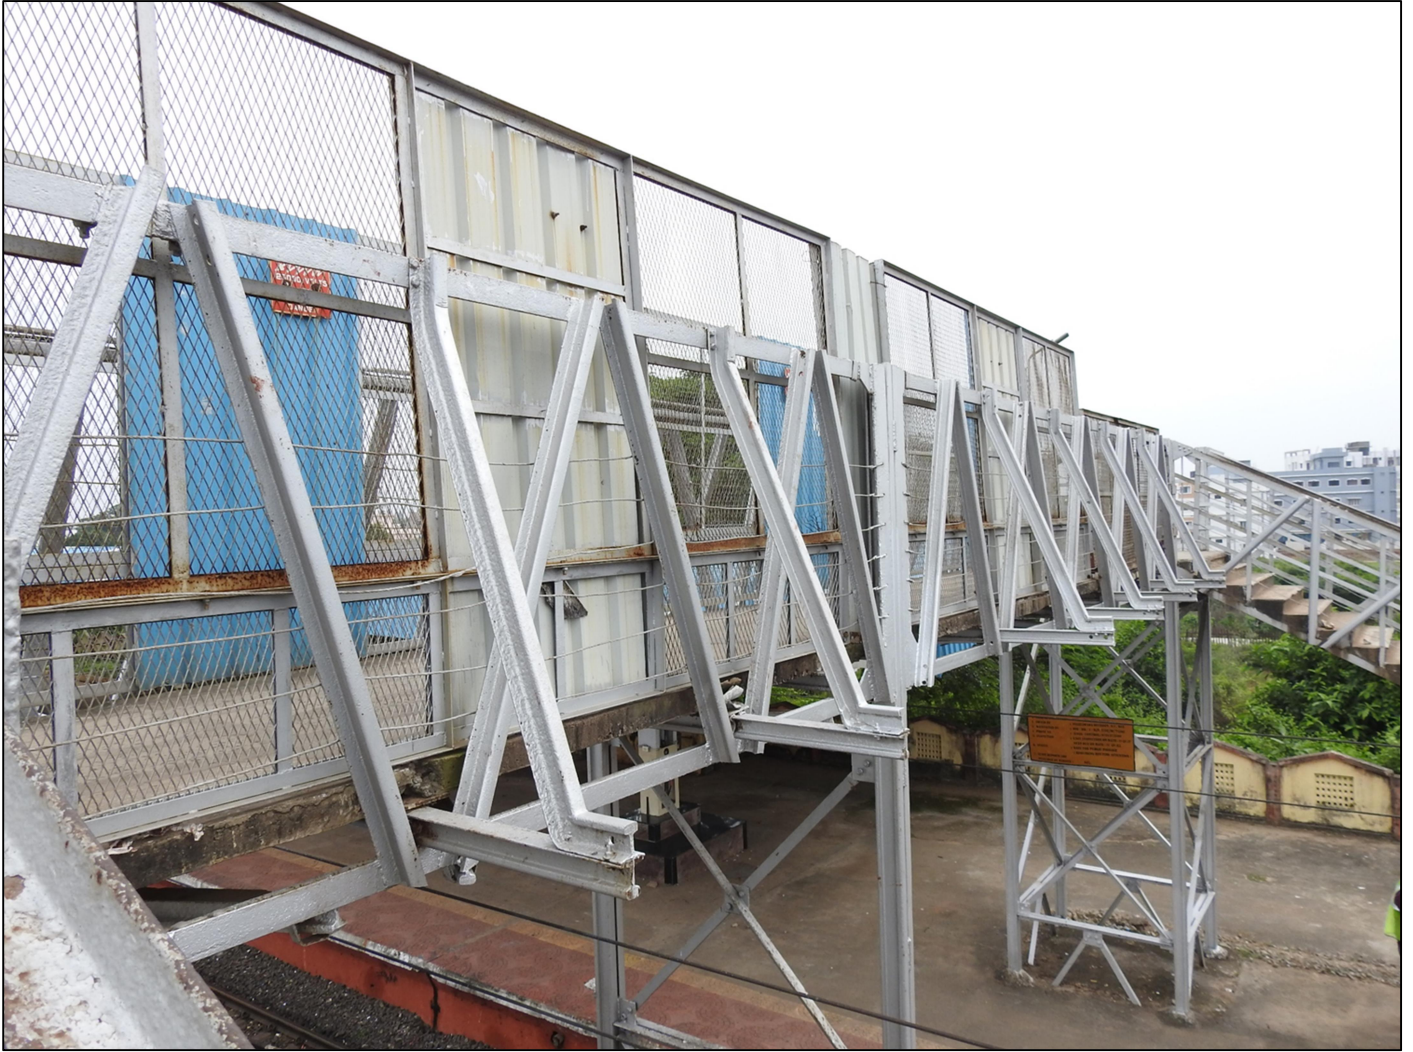
***Fig 4: Arrangement of truss***

| | Type /Shape of Truss Section | NG Rail sections | a) Top Chord & Bottom Chord members are 45 x 80 x 80 (Head x Height x Base) Rail sections<br>b) 45 x 80 x 80 (Head x Height x Base) Rail sections are used as vertical members.<br>c) 45 x 80 x 80 (Head x Height x Base) Rail sections are used as Floor beams.<br>d) 45 x 80 x 80 (Head x Height x Base) Rail sections are used as Bracings.<br>(Refer <b>fig :4</b> ) |

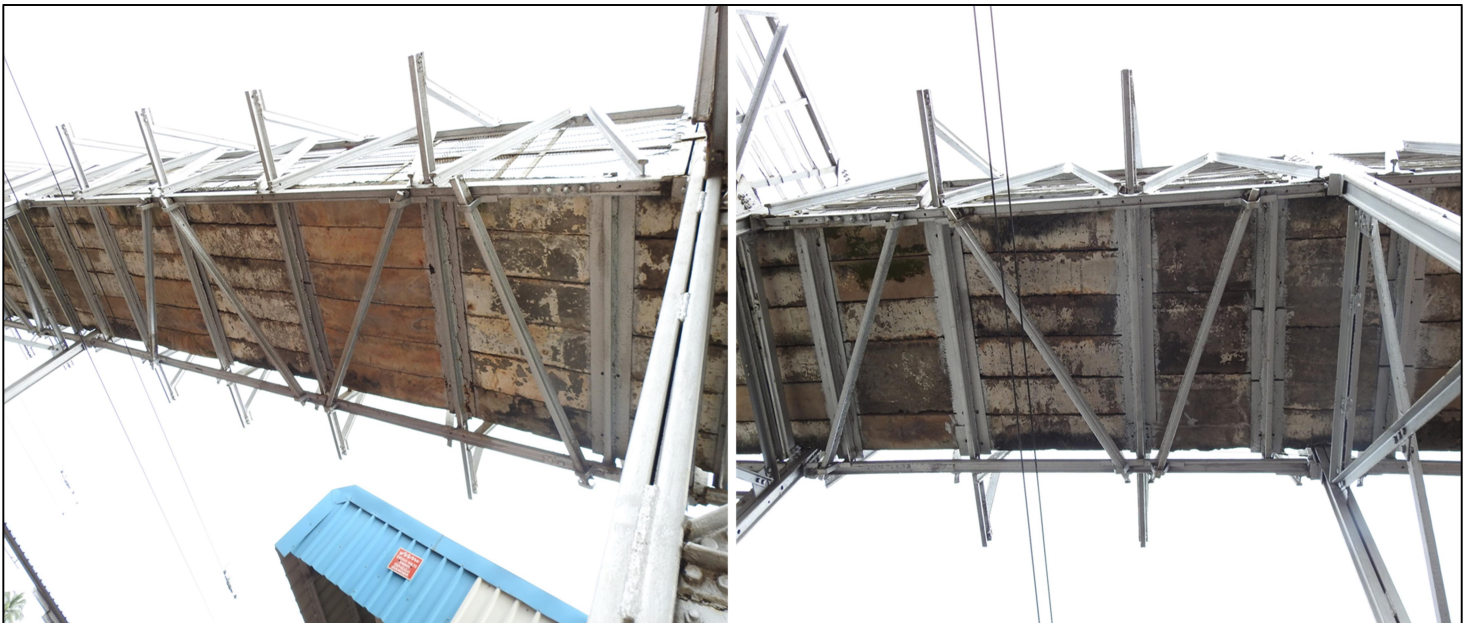
***Fig 5: Bottom view of FOB***

| | Material of Slab | Pre-cast slab panels for Spans | a. Pre-cast Reinforced concrete slab panels are used for floor slab of 100 mm thick, RCC slab panels are resting on Floor Beam members. (Refer <b>fig :5</b> ) |
| | Condition of Slab from Bottom | Deflection Observed<br>Spalling is observed | |

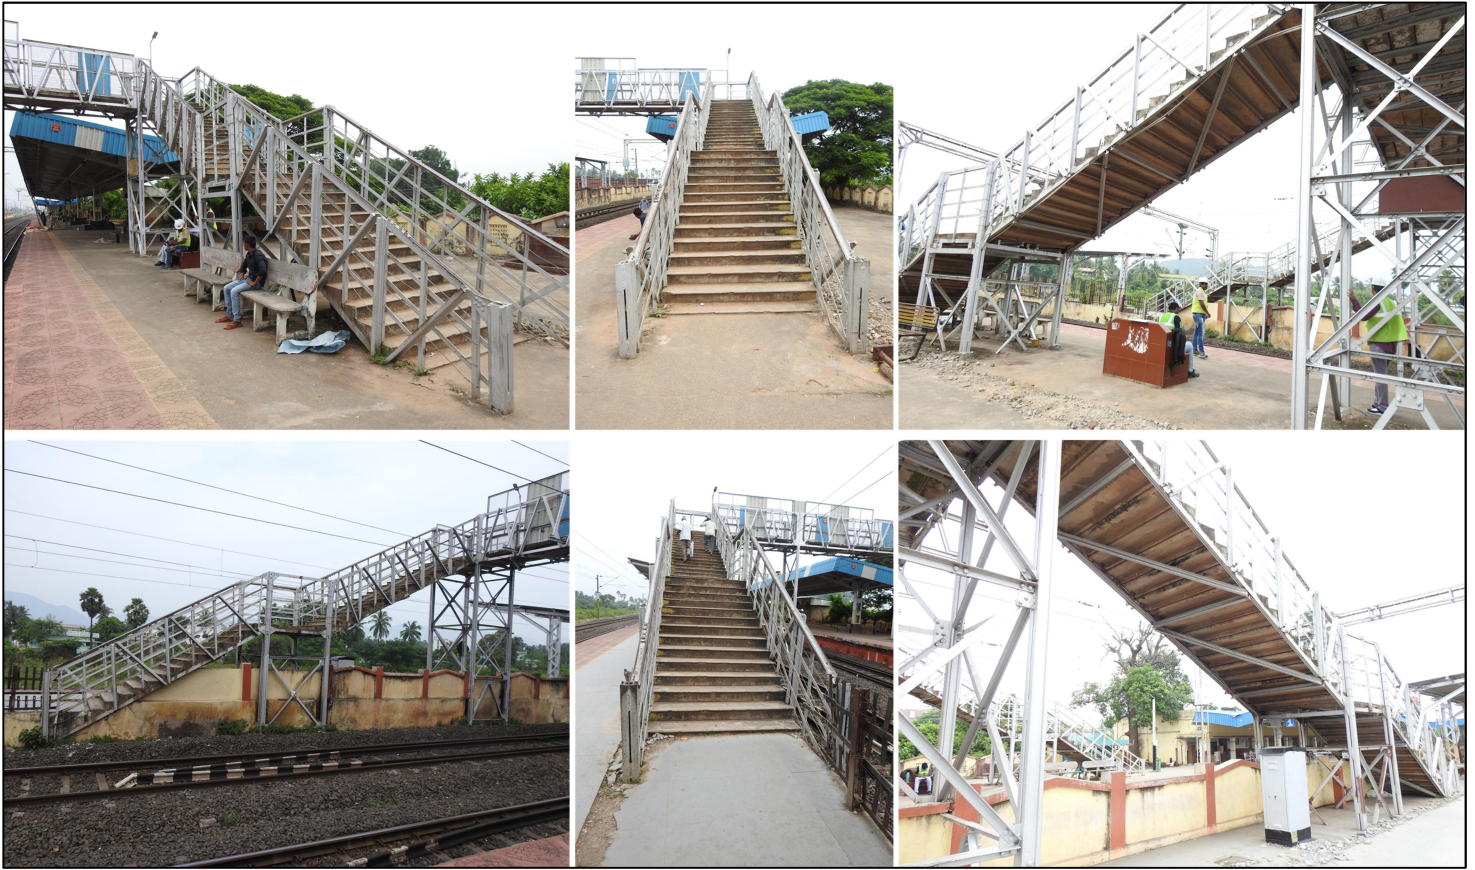
**Fig 6:** Staircase details

| | Number of Staircase | 2 No's | Staircase is observed as Pre cast RCC Slab panels supported on 45 x 45 x 80 (Head x Height x Base) Rail Stringers on both sides. (Refer <b>fig :6</b> ) |

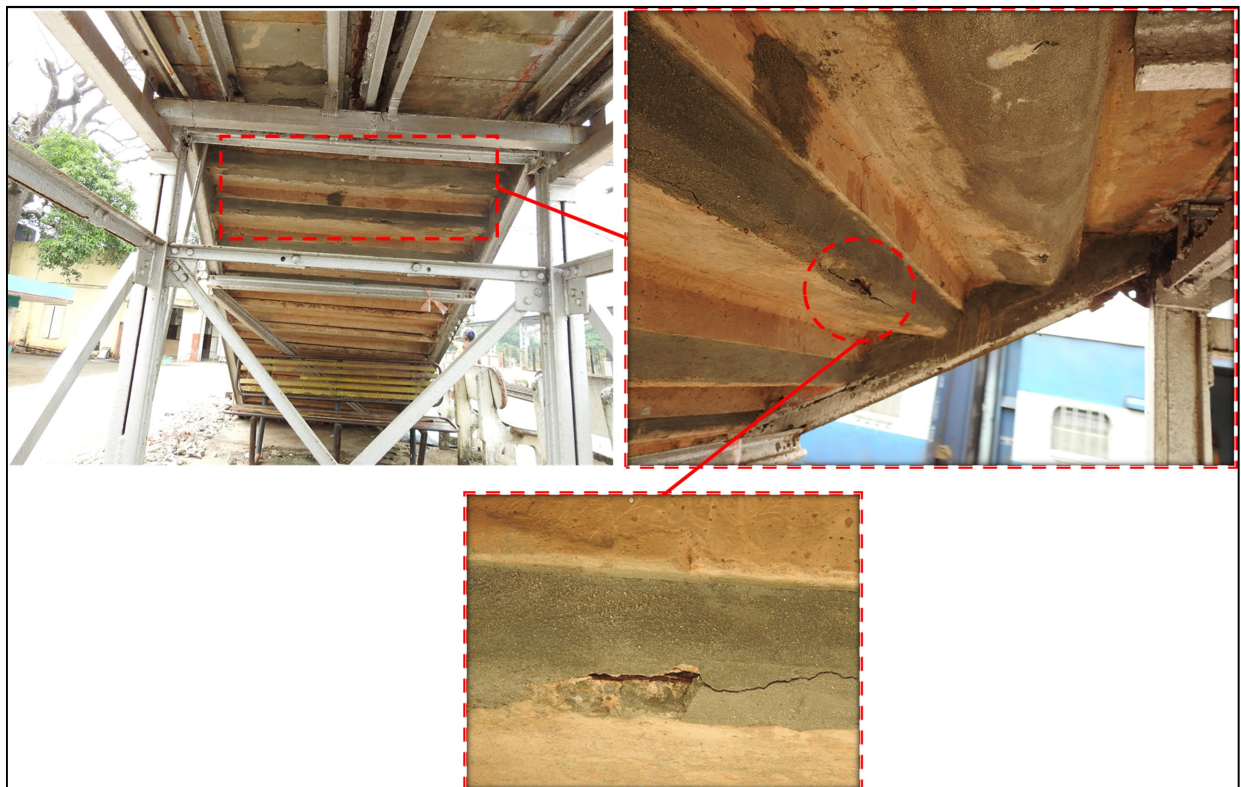
| 1.14 | History of Repair/ Maintenance | Patch work Observed at Slab Panels of Staircases |

**Fig 7:** Patch work and reinforcement exposed in staircase -1
