| <b>Name of the Project</b> | <b>:</b> | <b>VISUAL INSPECTION OF FOB AT PASIVEDALA RAILWAY STATION</b> |
| <b>Location</b> | <b>:</b> | <b>PASIVEDALA RAILWAY STATION</b> |
| <b>Date of Inspection</b> | <b>:</b> | <b>9<sup>th</sup> NOVEMBER, 2019</b> |

### **VISUAL INSPECTION OF STEEL FOOT OVER BRIDGE**

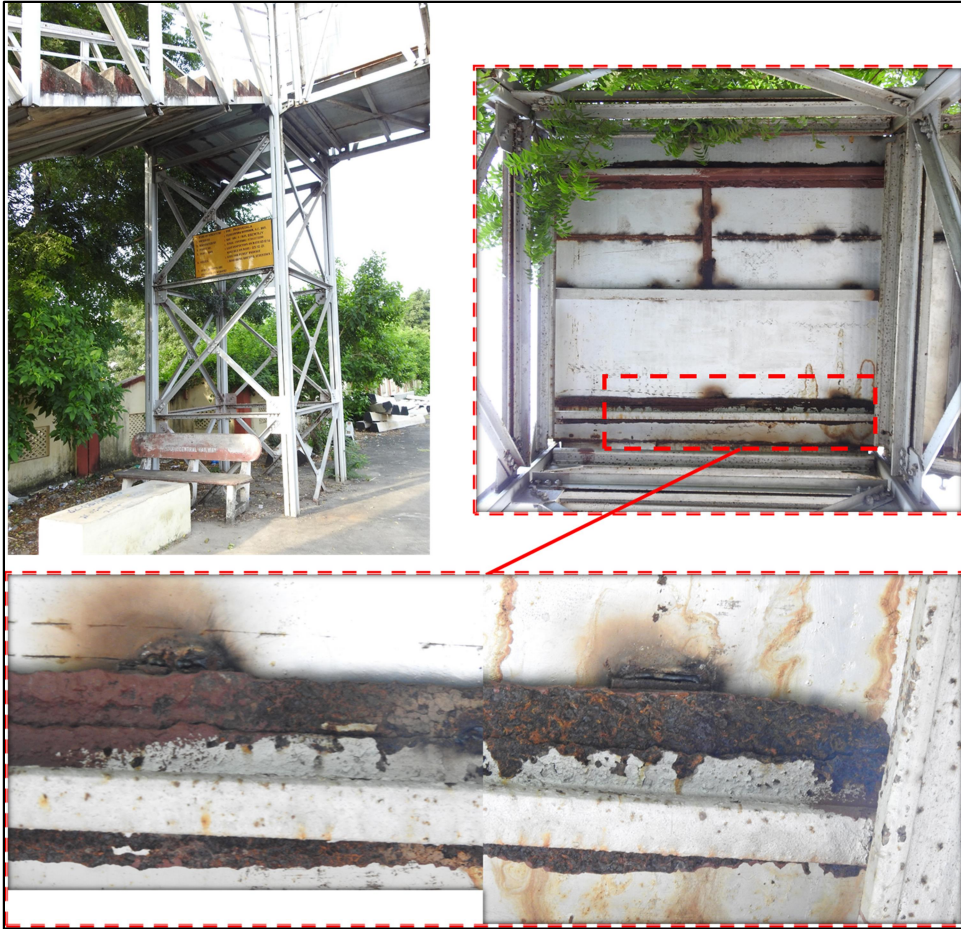
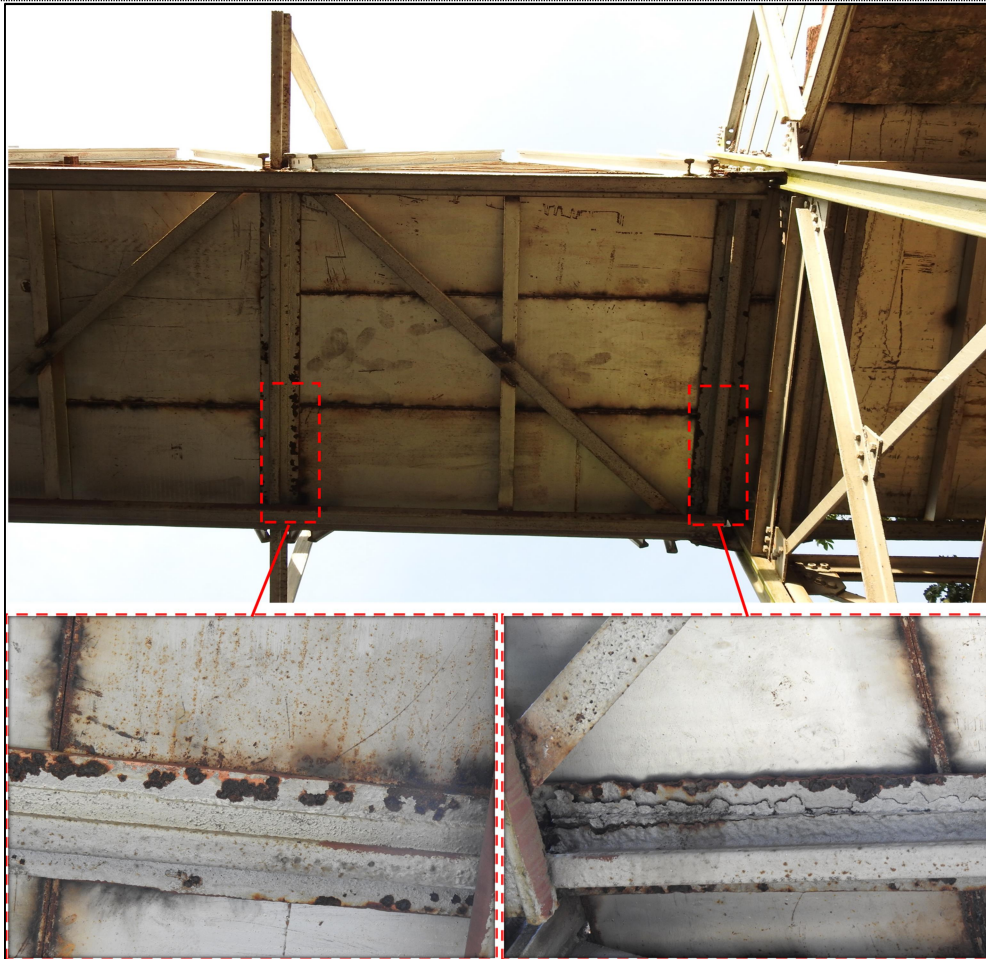
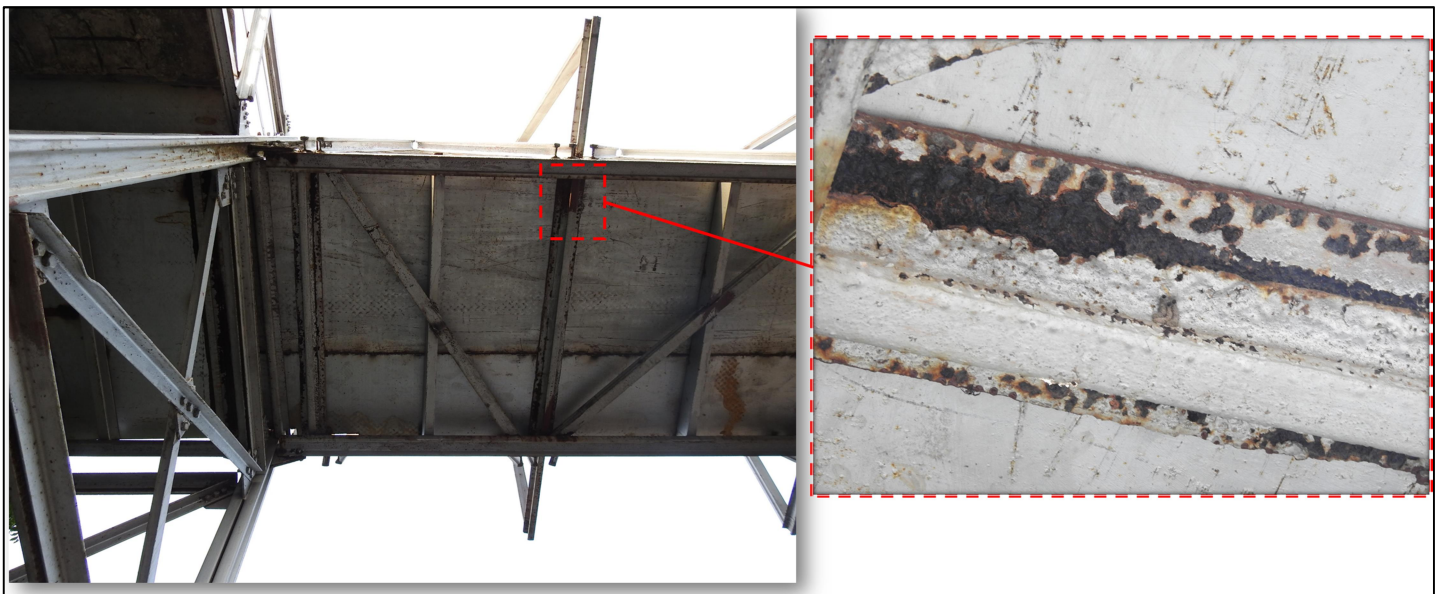
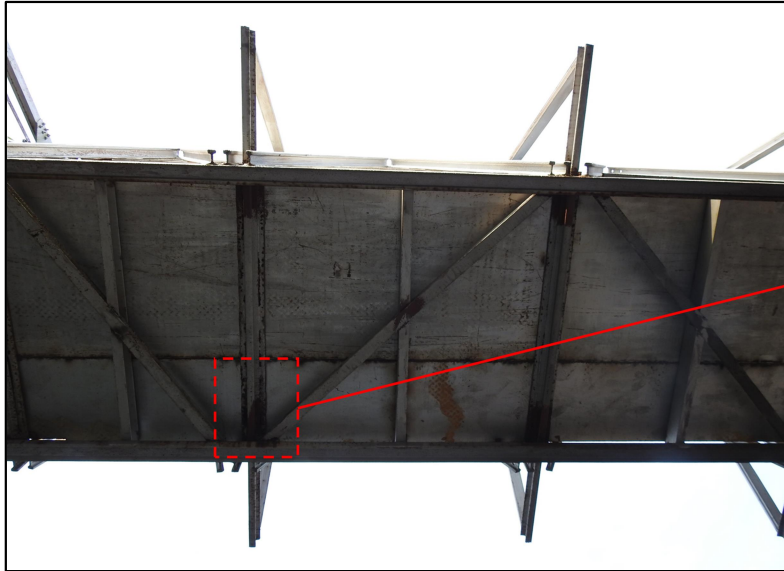
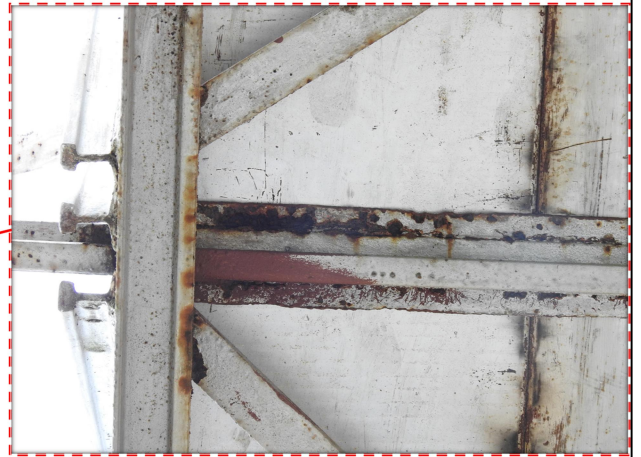
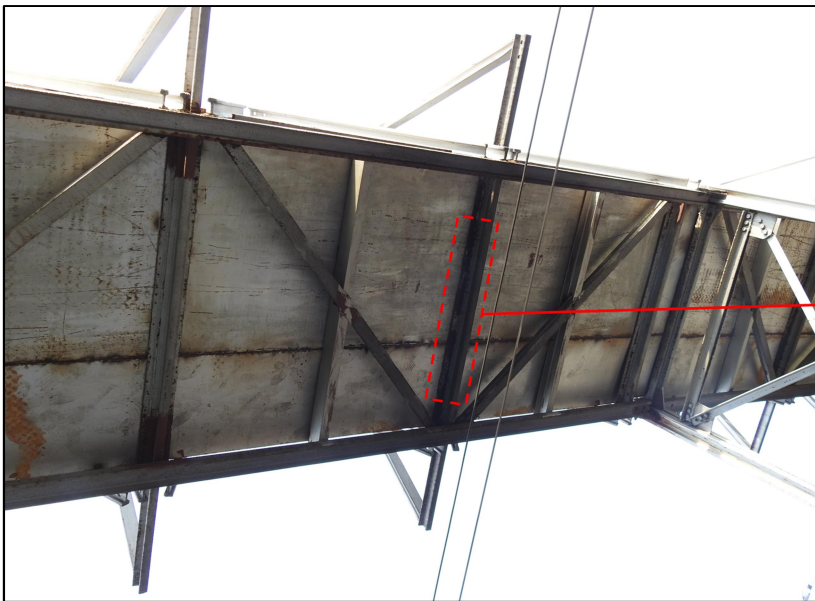
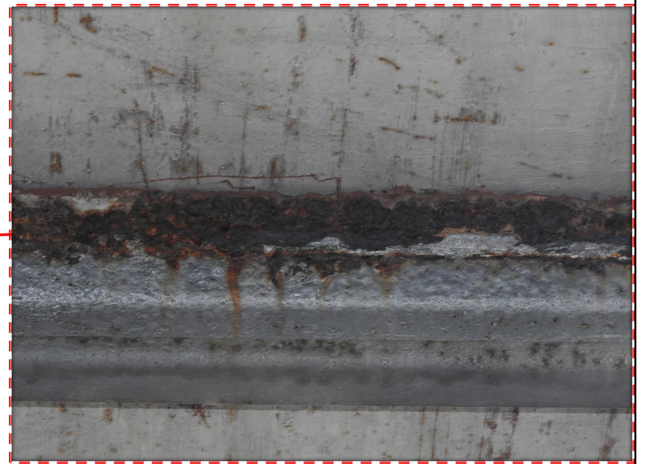
✓ Corrosion observed in floor beams all over the FOB.

Corrosion of Floor beams

| PART 4 SURVEY OF SIGNS OF DISTRESS, DEFORMATION IN BRIDGES | | | |
|---|---|---|---|
| | Rust straining | Floor Beams | Corrosion is observed at all the joints & floor beams of FOB. (Refer: <b>Part 4.1</b> ). |

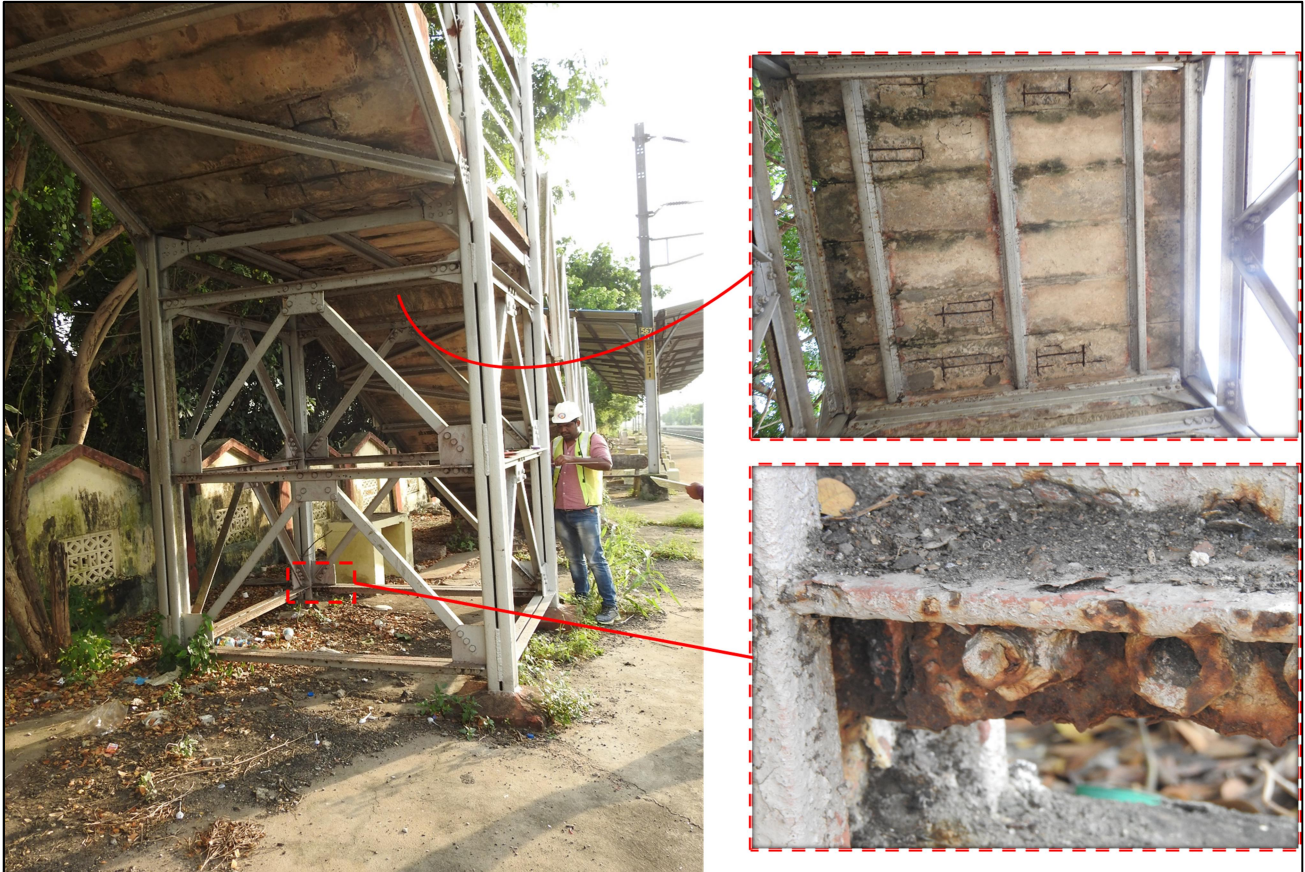
a) Exposed reinforcement and spalling in staircase-2 landing

| PART 4 SURVEY OF SIGNS OF DISTRESS, DEFORMATION IN BRIDGES | | | |
|---|---|---|---|
| | Cracking in RCC components | Staircase landing | Cracks are observed in Pre-cast RCC slab panels of Staircase & Main Slab. (Refer: <b>Part 4.2, Fig- a, b</b> ). |
| | Spalling | Staircase landing | Spalling is observed in staircase-pre-cast panels. (Refer: <b>Part 4.2, Fig- a, b</b> ). |

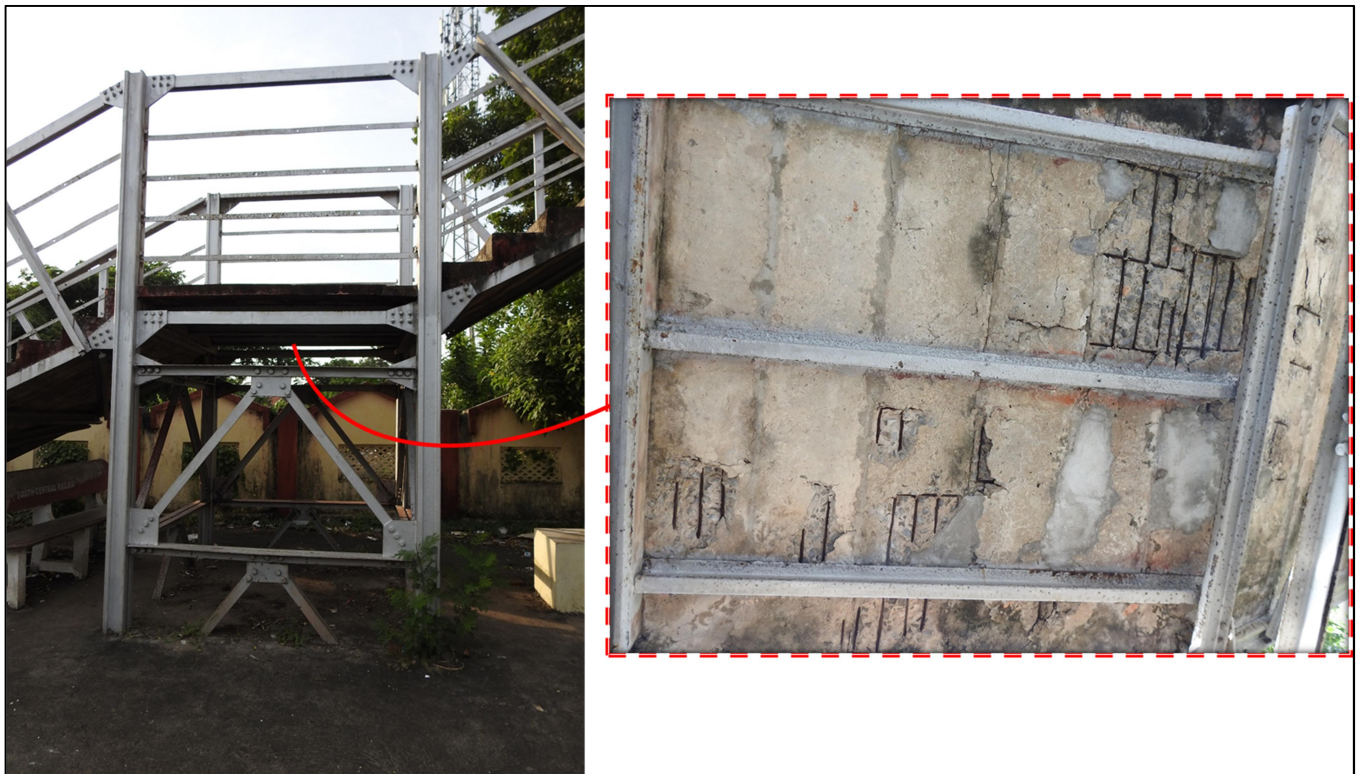
b) Exposed reinforcement and spalling in staircase-1 landing

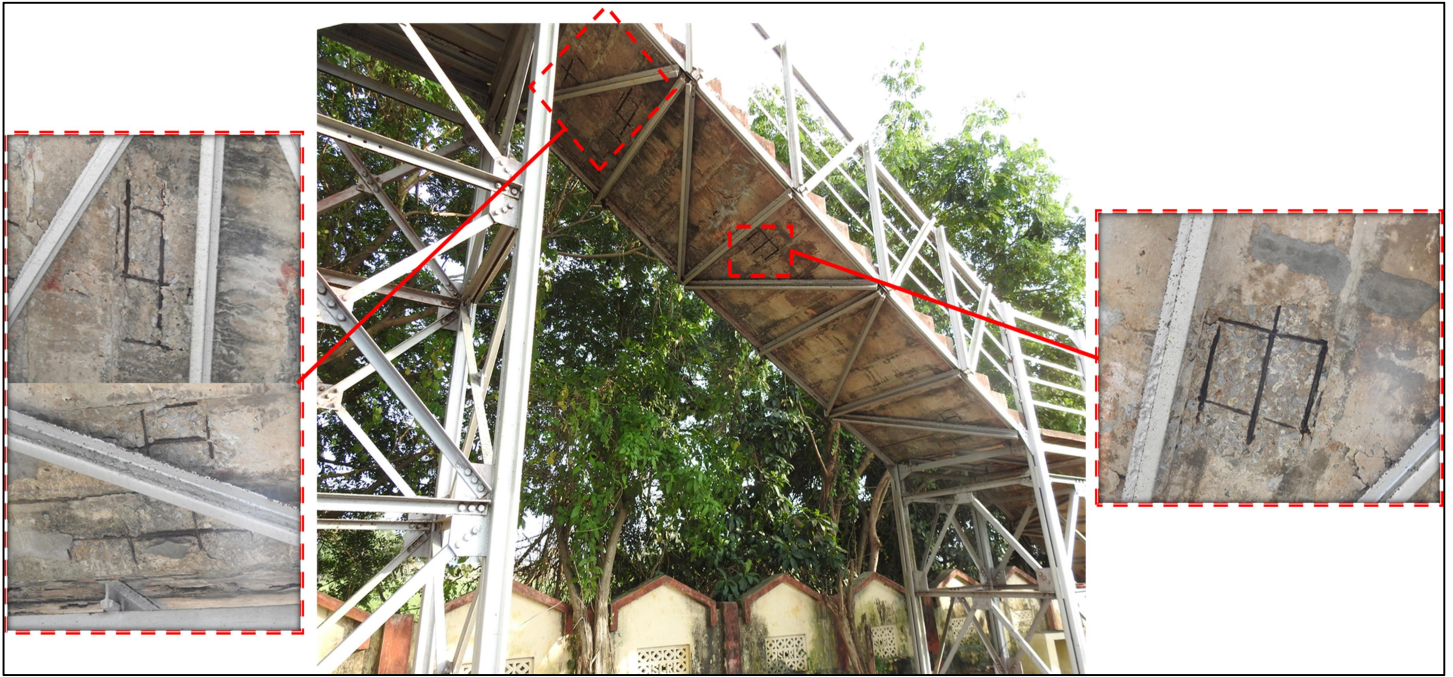
c) Exposed Reinforcement in staircase

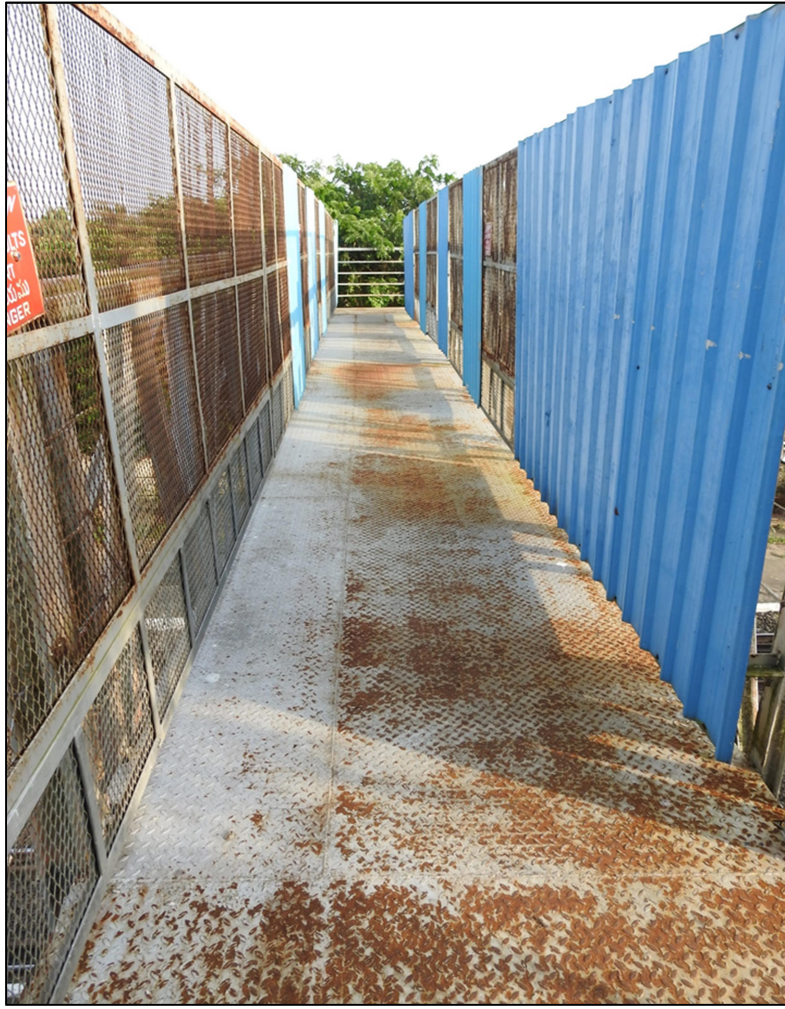
| | | Yes/No | Notes |
|---|---|---|---|
| | a) Additional wearing coat on Floor | Yes | Steel Plate provided as floor (Refer <b>fig :2</b> ) |

| | Condition of Slab from Top | Rusting of MS Steel plate | |

***Fig 2:*** MS Sheet pathway, protective screen

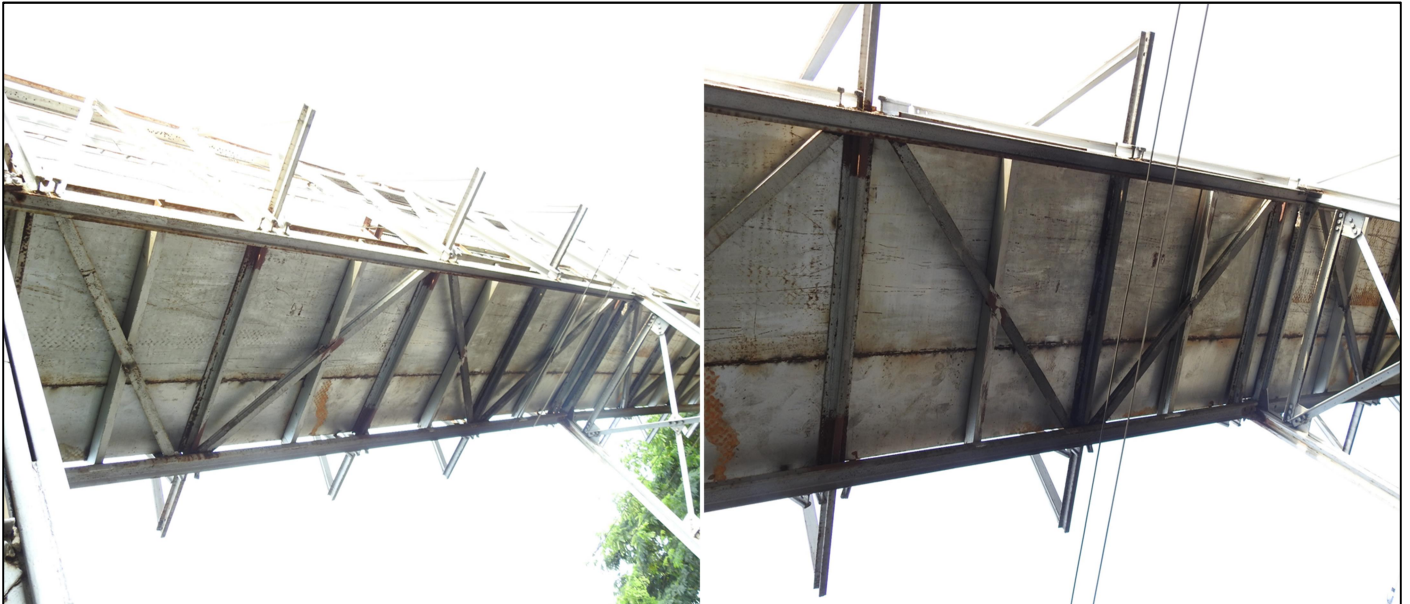
| | Condition of Slab from Bottom | Slight rusting near joints | |

***Fig 4:*** Bottom view of FOB

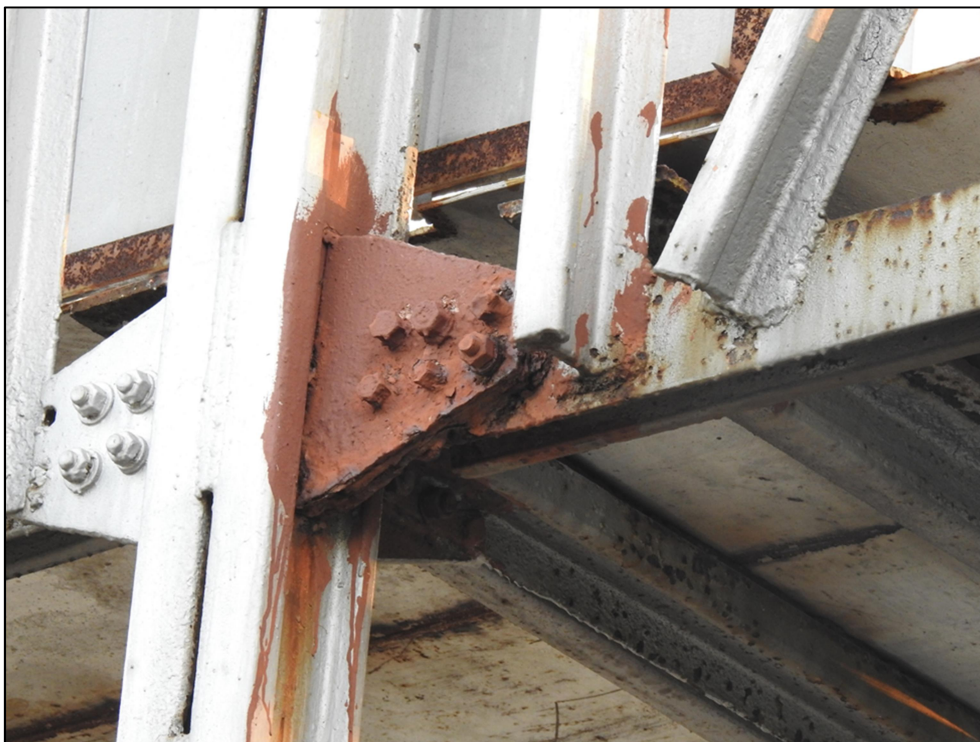
| PART 4 SURVEY OF SIGNS OF DISTRESS, DEFORMATION IN BRIDGES | | | |
|---|---|---|---|
| | Corrosion in Gusset plate | Gusset plates | corrosion is observed in Gusset Plates (Refer <b>fig :7</b> ) |

***Fig 7:*** Corroded gusset plate coated with red oxide paint
