| <b>Name of the Project</b> | <b>:</b> | <b>VISUAL INSPECTION OF FOB AT MUGAT RAILWAY STATION</b> |
| <b>Location</b> | <b>:</b> | <b>MUGAT RAILWAY STATION</b> |
| <b>Date of Inspection</b> | <b>:</b> | <b>22<sup>nd</sup> NOVEMBER 2019</b> |

### **VISUAL INSPECTION OF STEEL FOOT OVER BRIDGE**

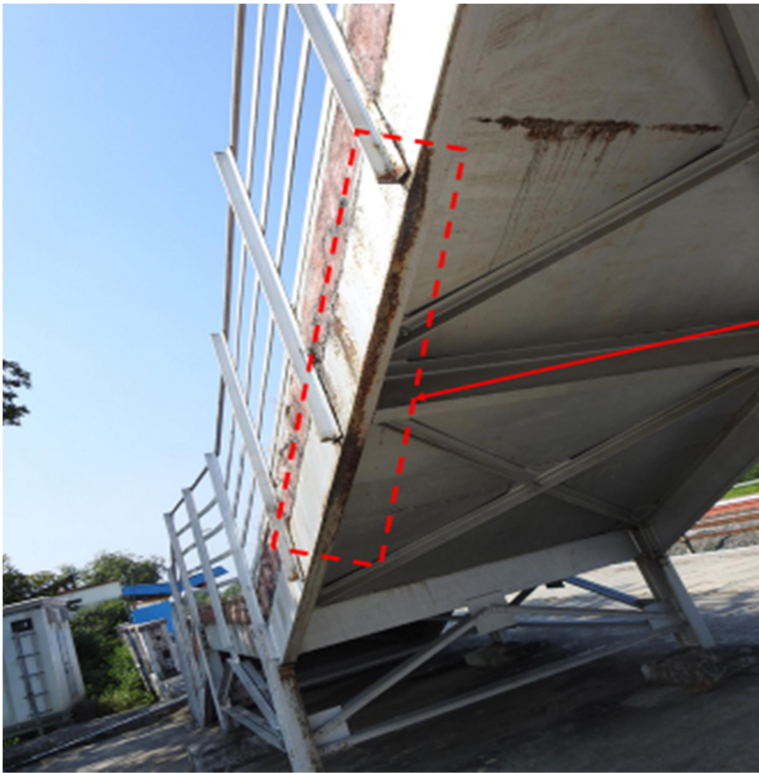
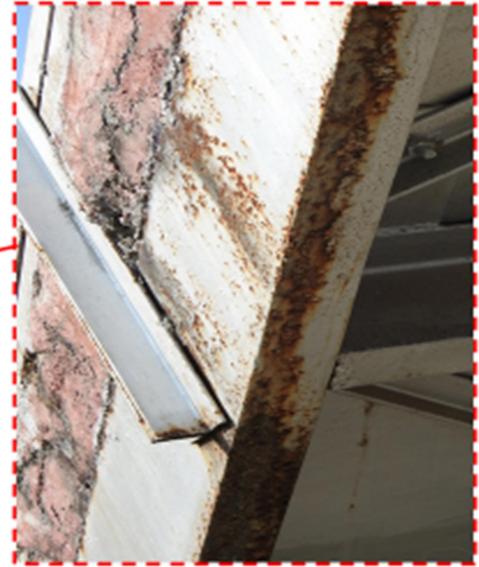
a) Rusting observed at Stringer beam of Staircase-1

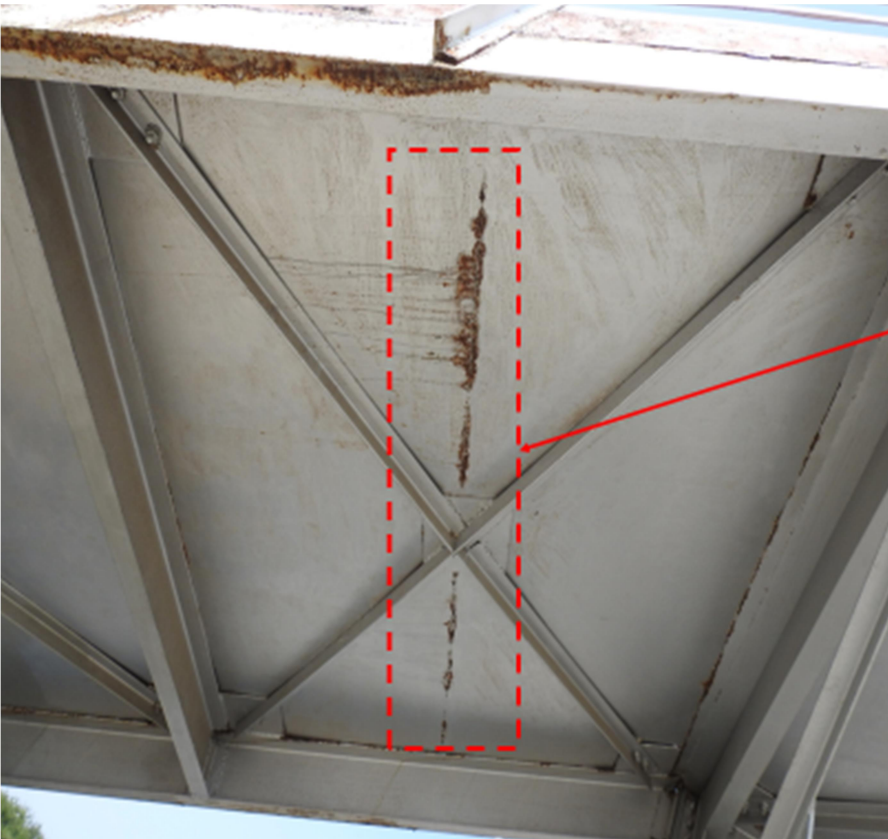
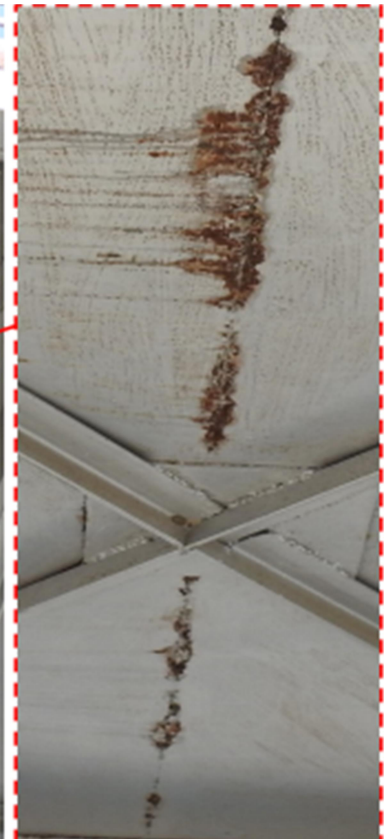
b) Rusting observed at landing of Staircase-1

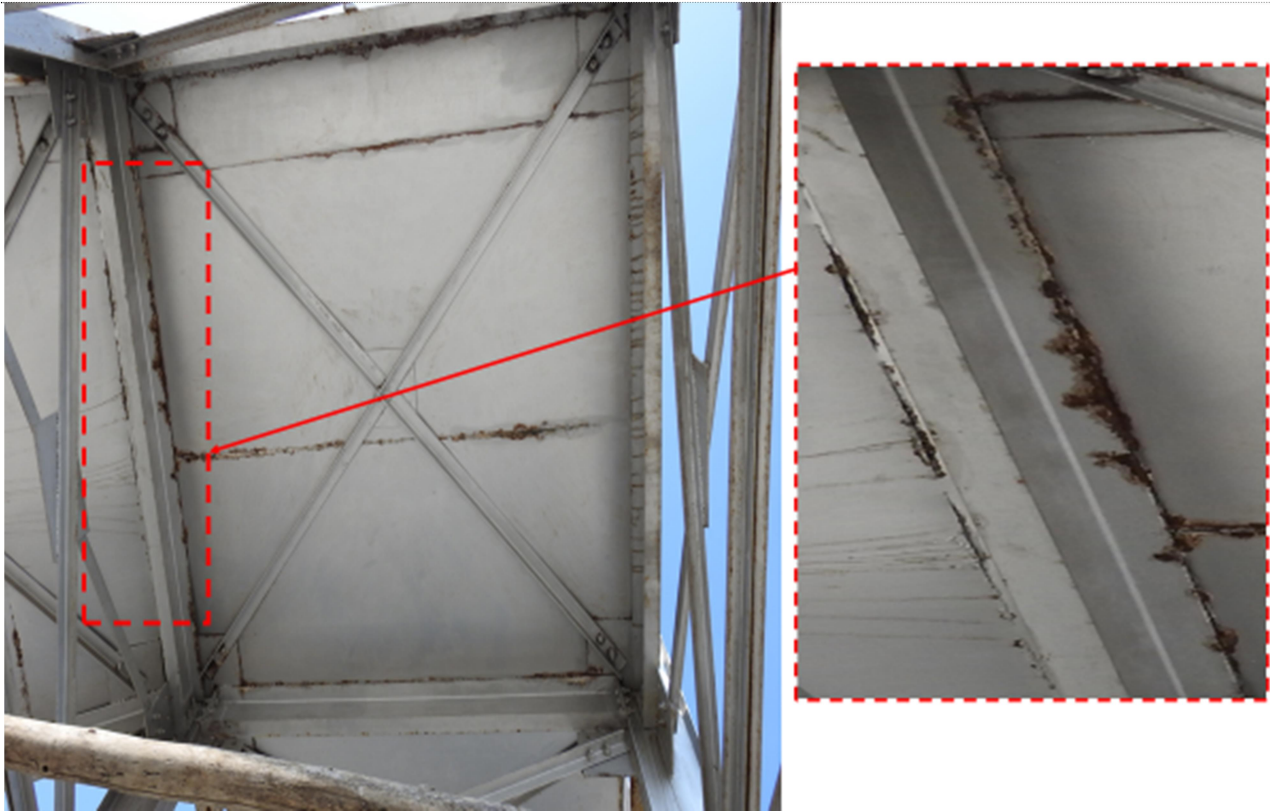
c) Rusting observed at landing of Staircase-1

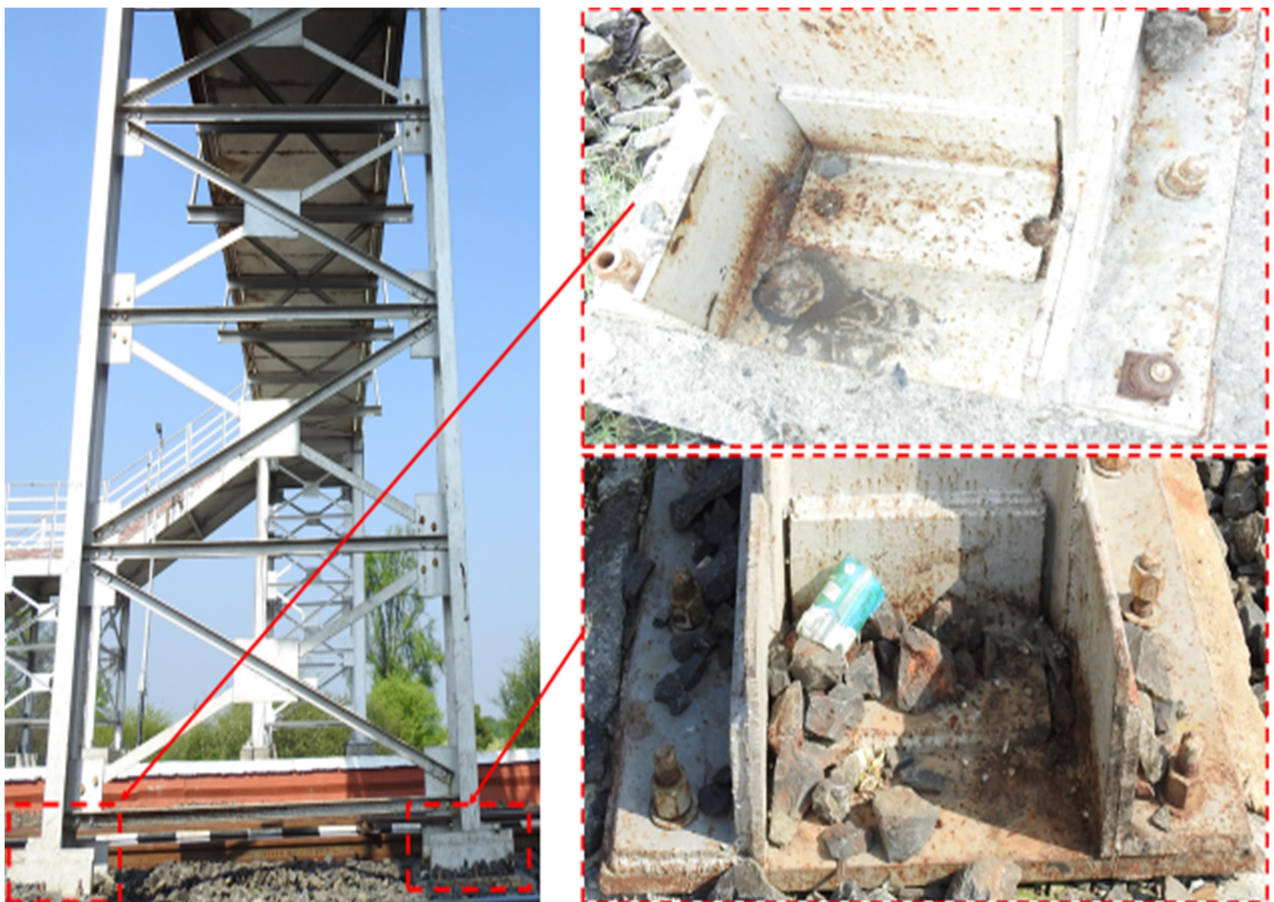
d) Rusting observed at base plate of stanchion

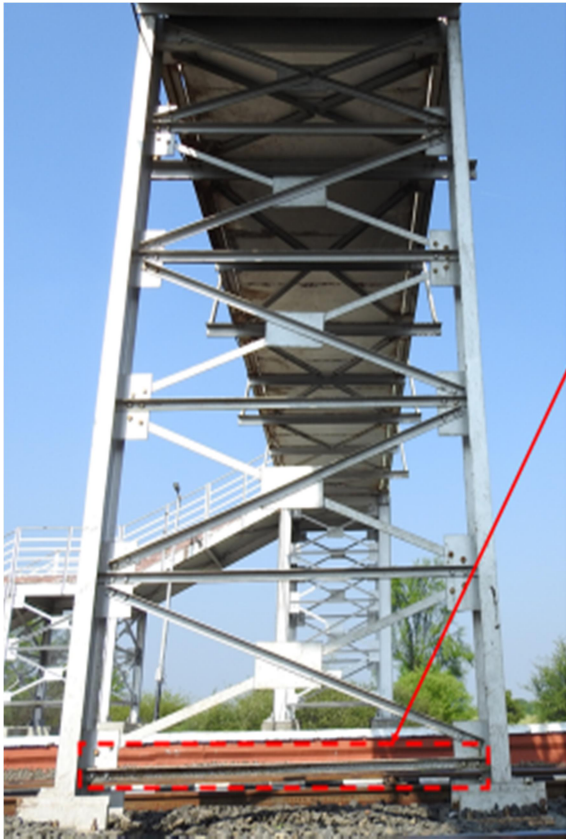
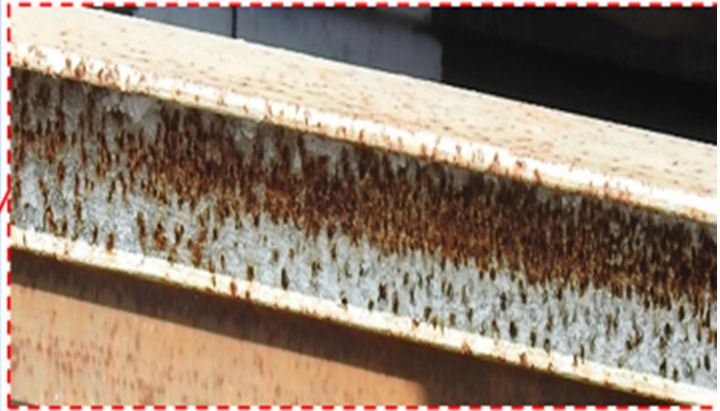
e) Rusting observed at stanchion column tie members

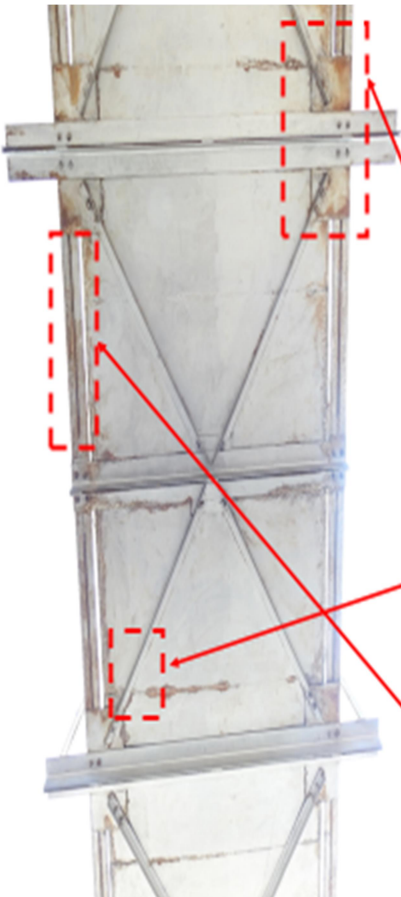
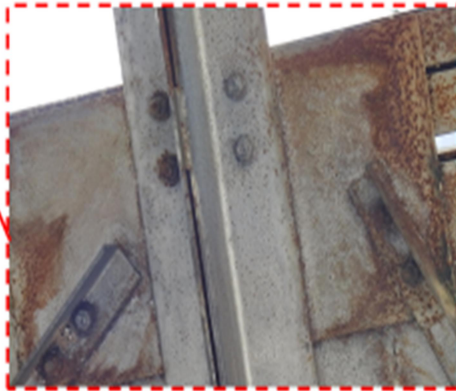
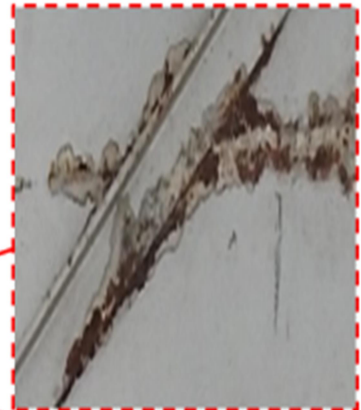
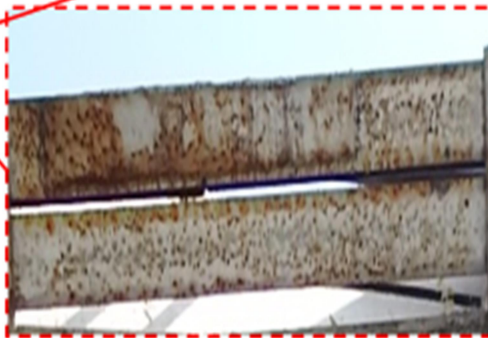
f) Rusting observed at bottom chord members, bracings and gusset plate of Span-1

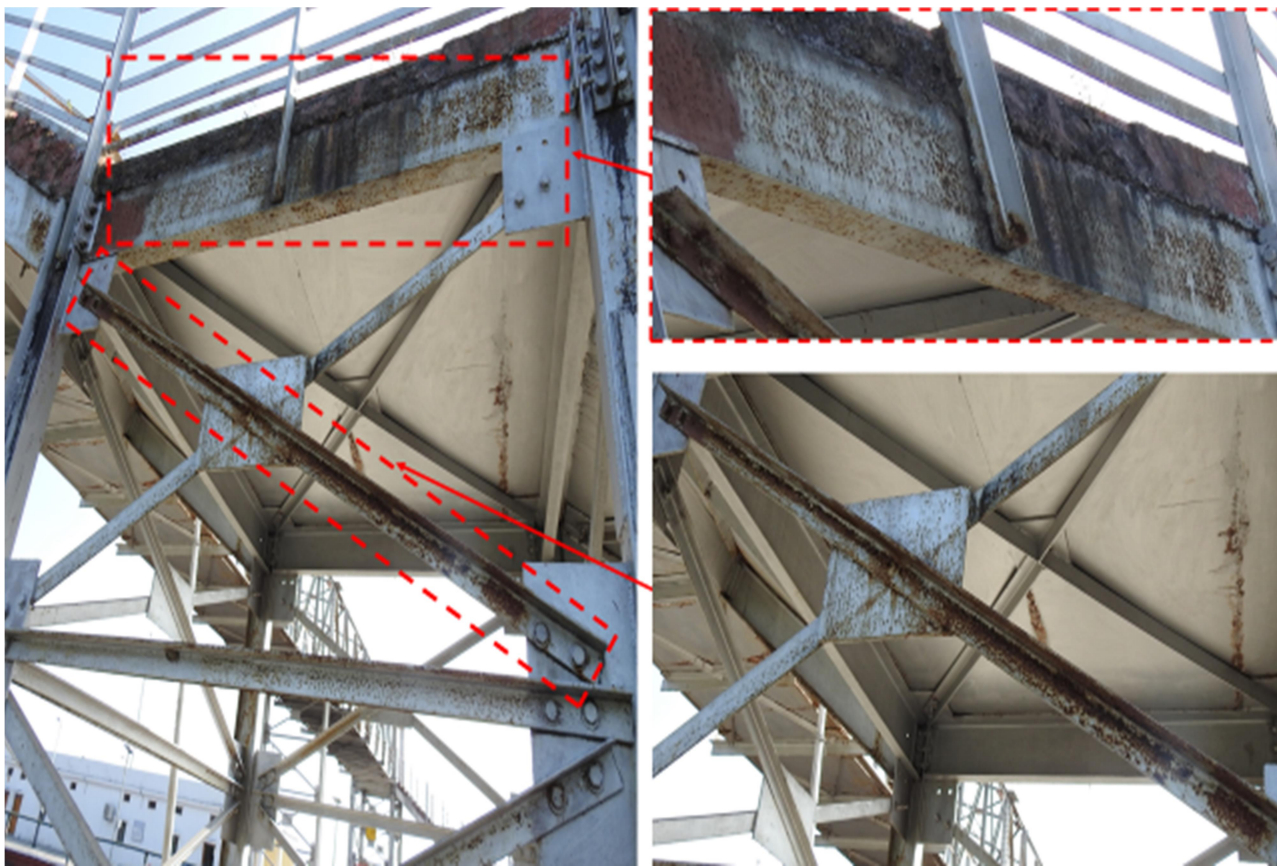
h) Rusting observed at stringer beam and landing in trestle-2

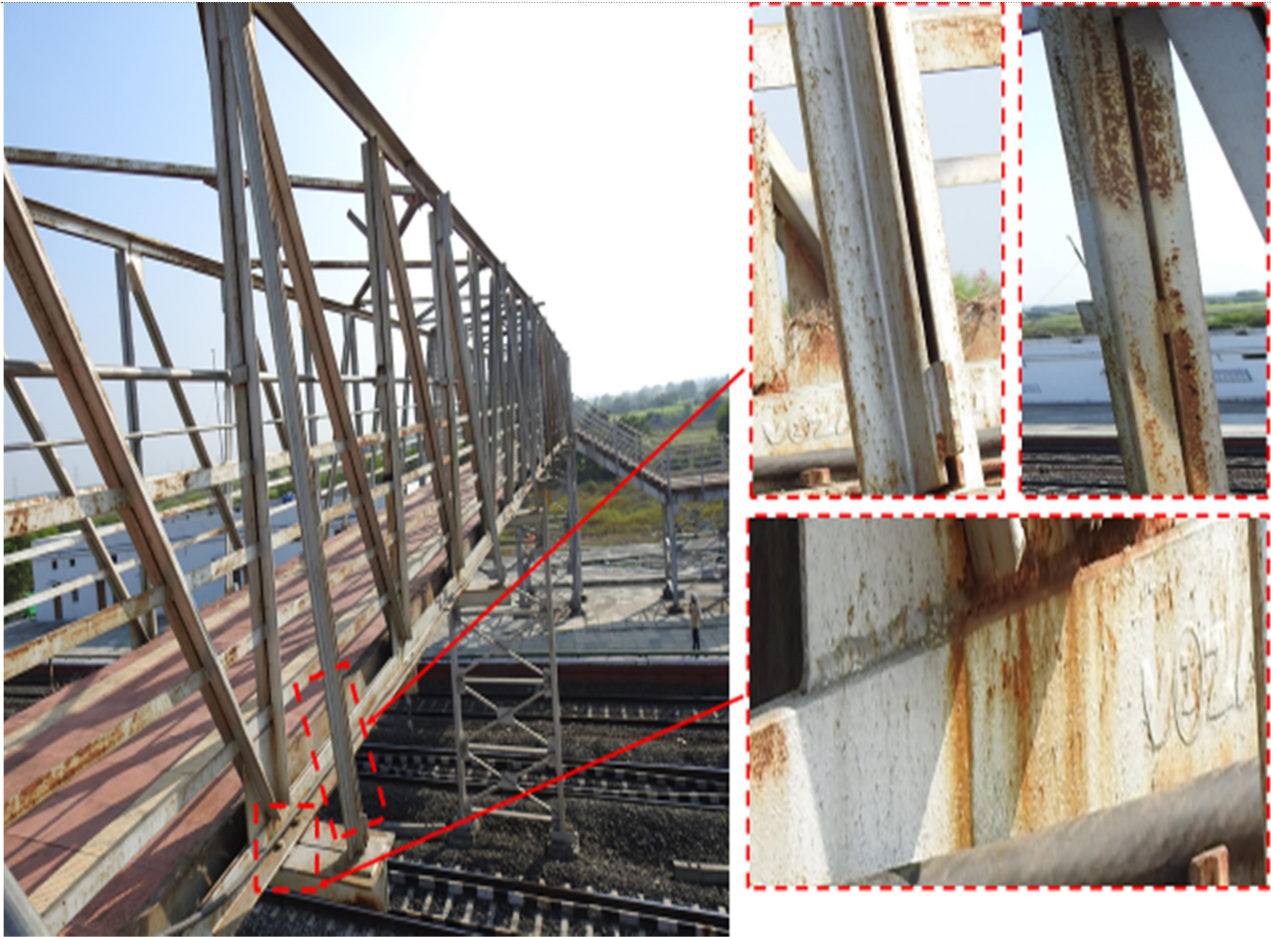
i) Rusting observed at knee bracing, bottom chord of Span-2

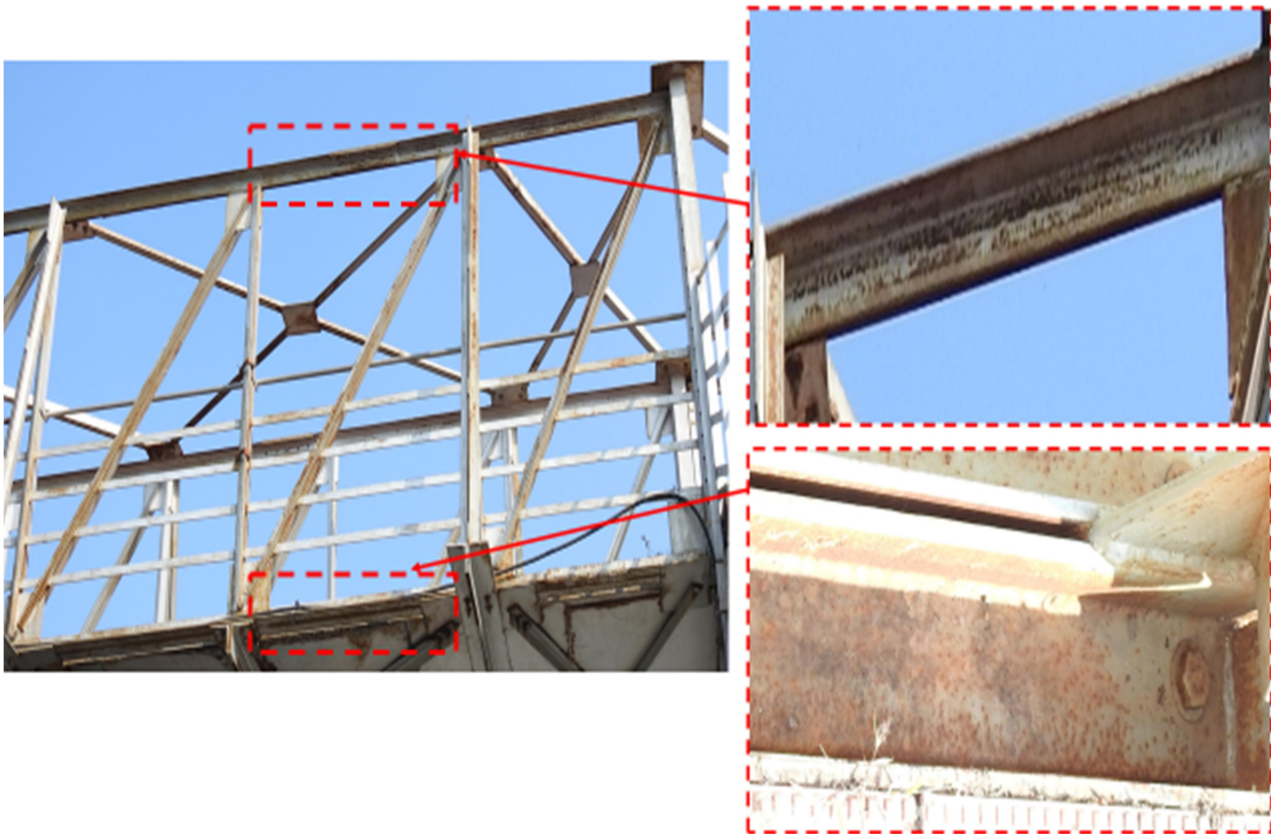
j) Rusting observed at top and bottom chord of span-2

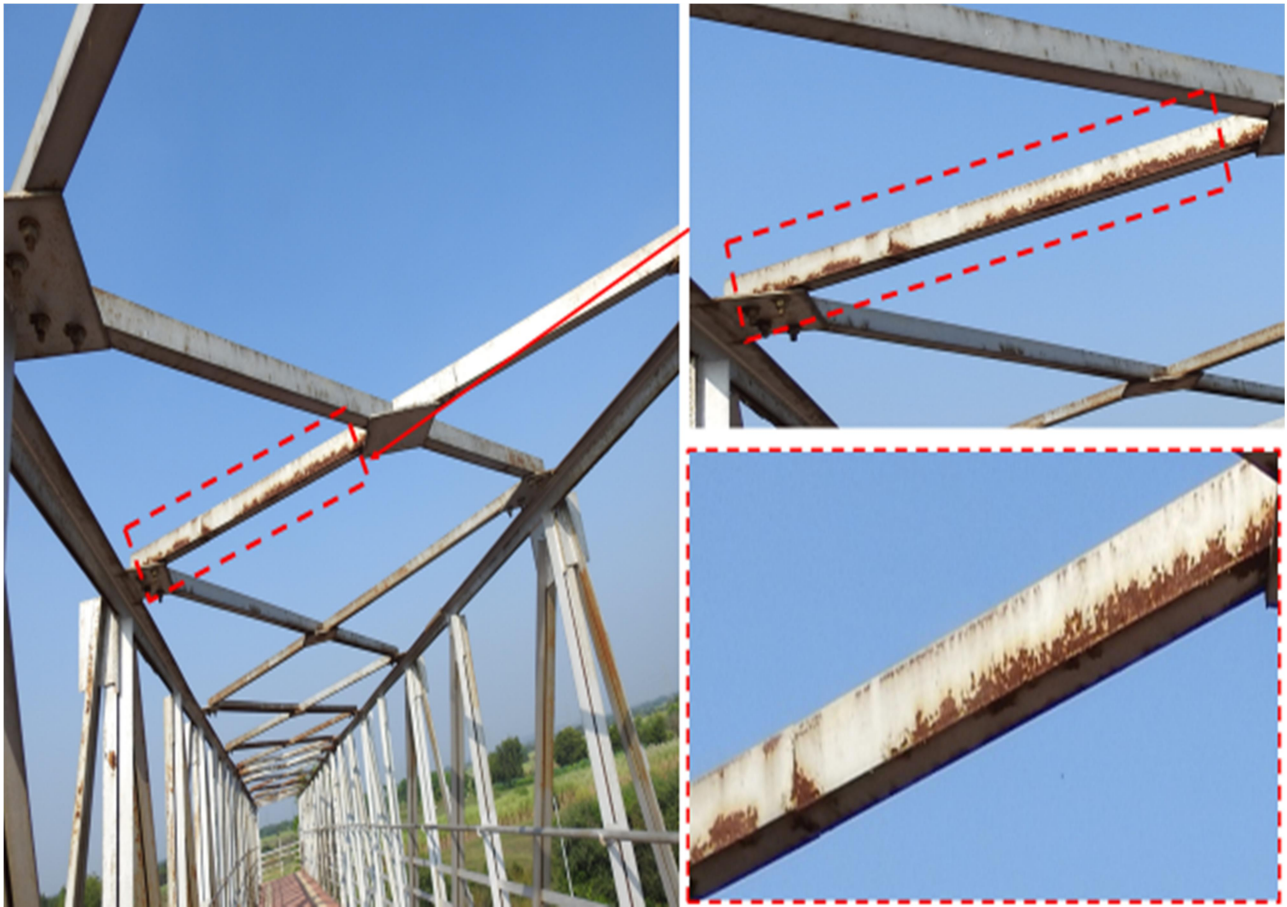
k) Rusting observed at top bracing of Span-2

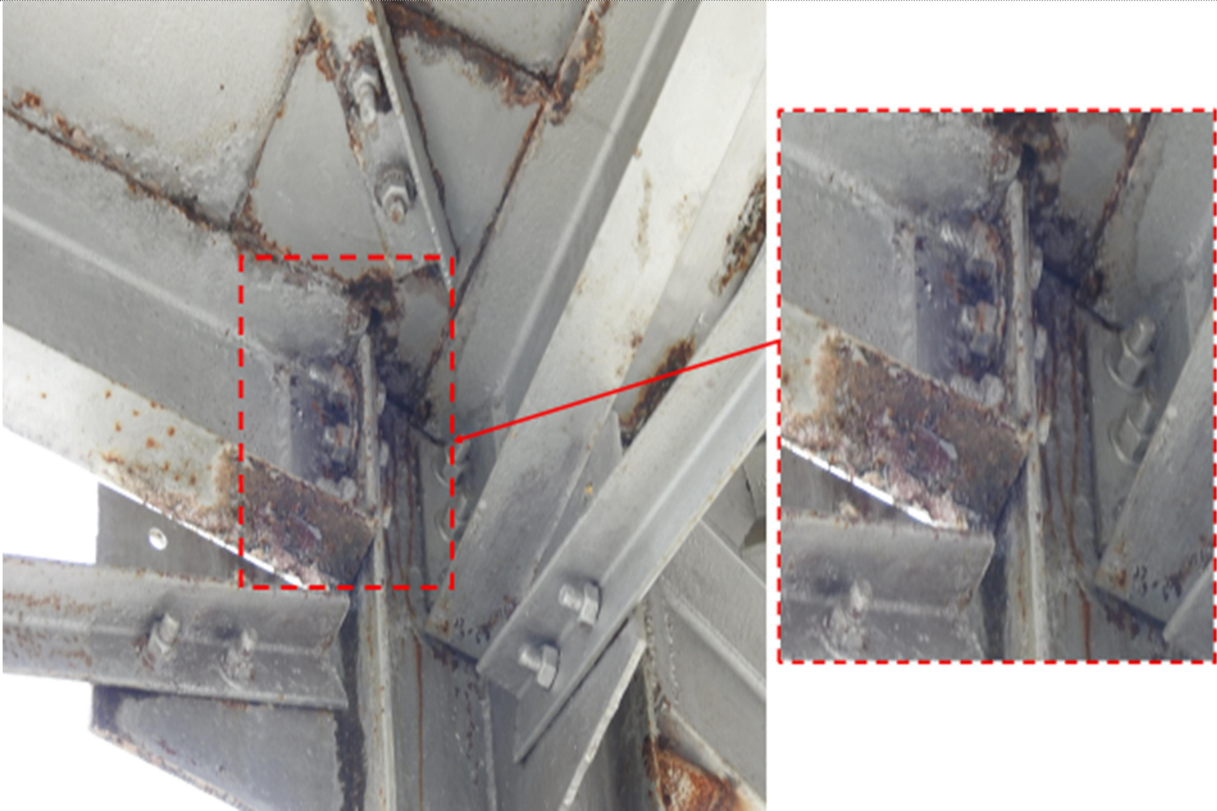
a) Corrosion observed at Stringer beam joint of Span-1

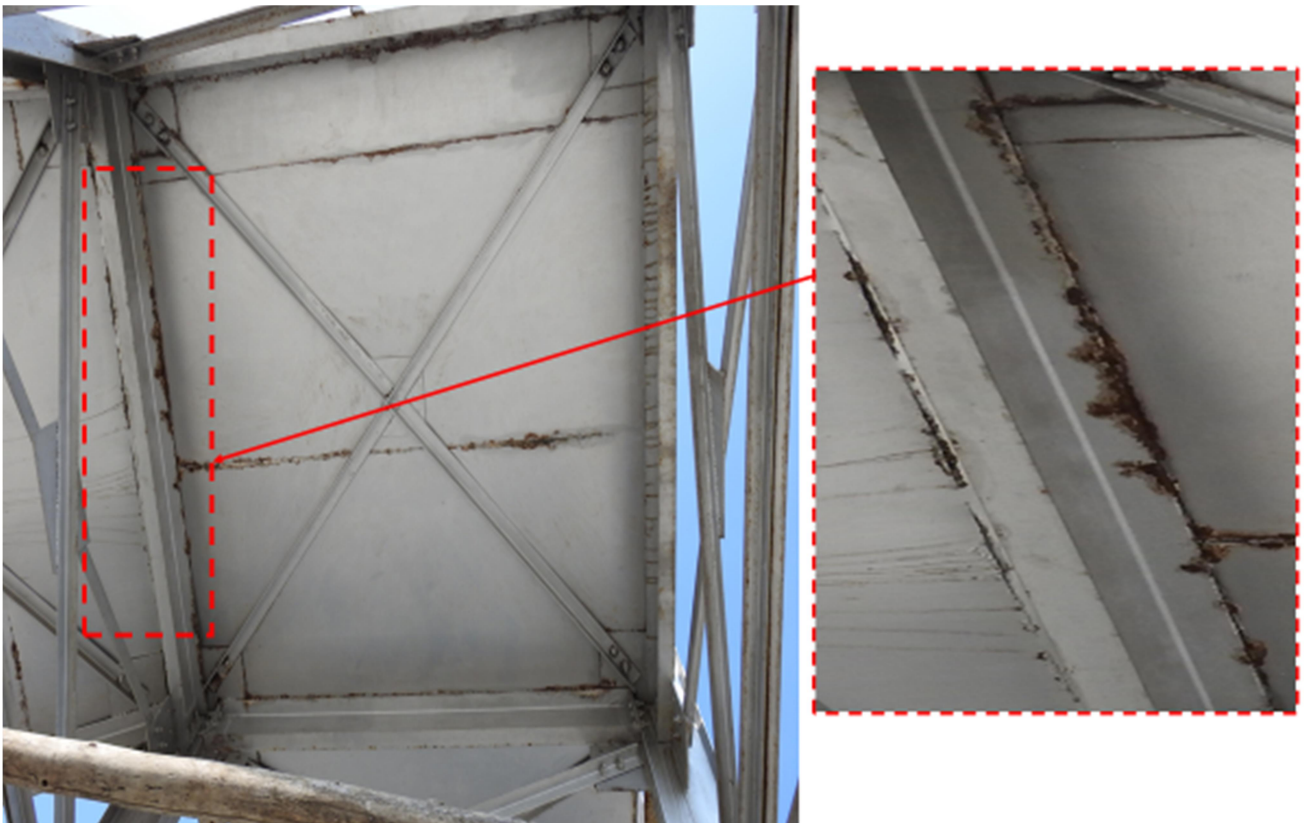
b) Corrosion observed at Main landing of floor beam in Span-1

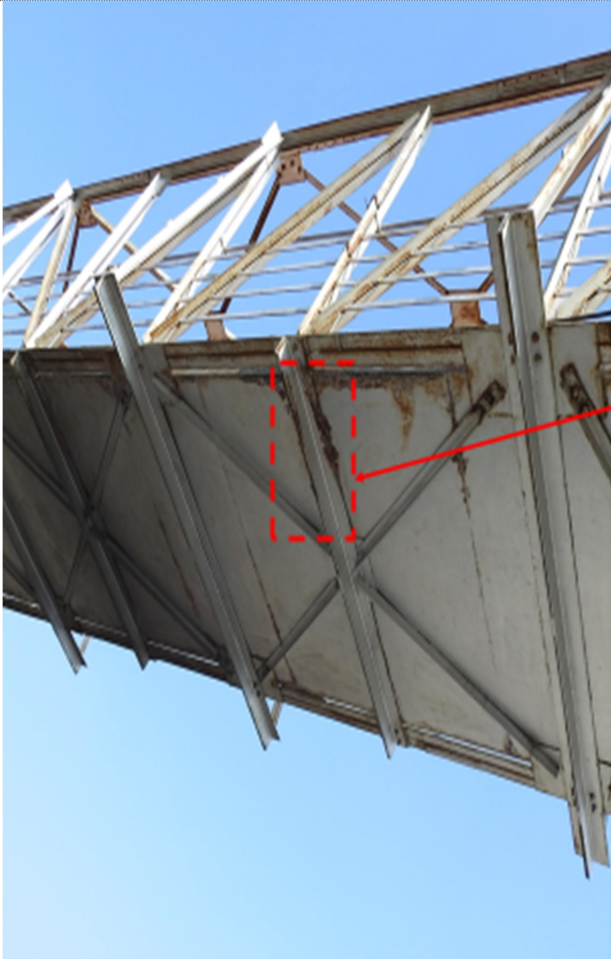
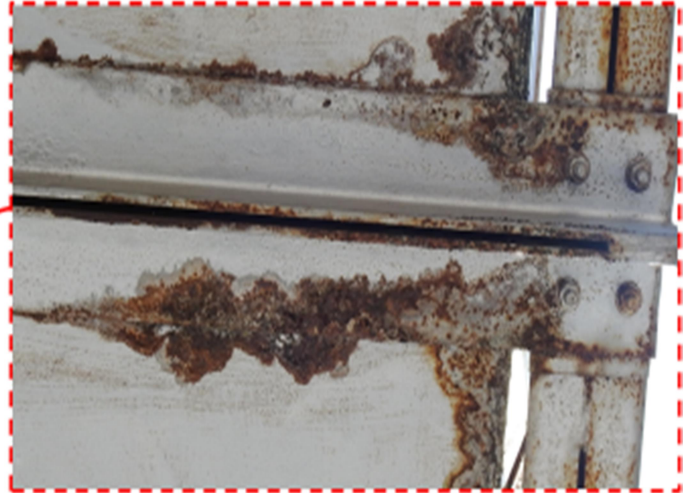
c) Corrosion observed at floor beam of Span-1

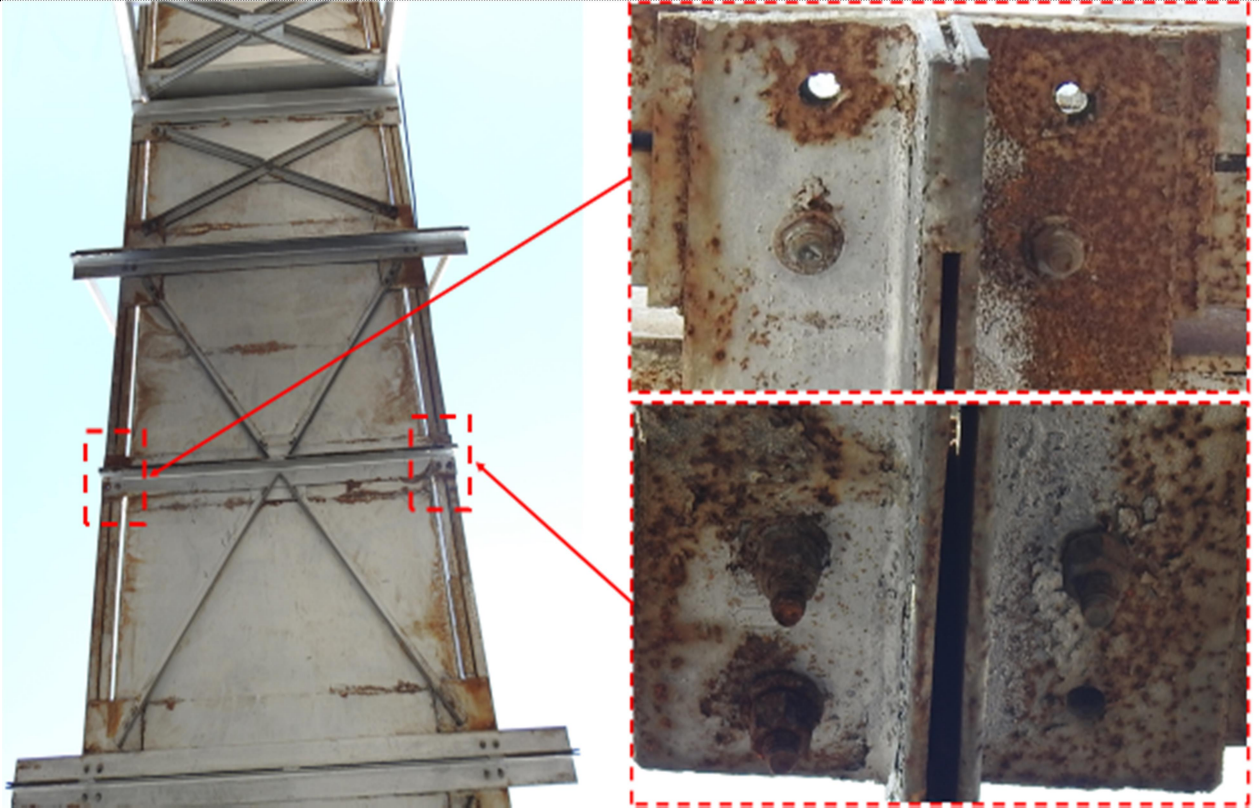
a) Missing bolts are observed at floor beam of Span-1

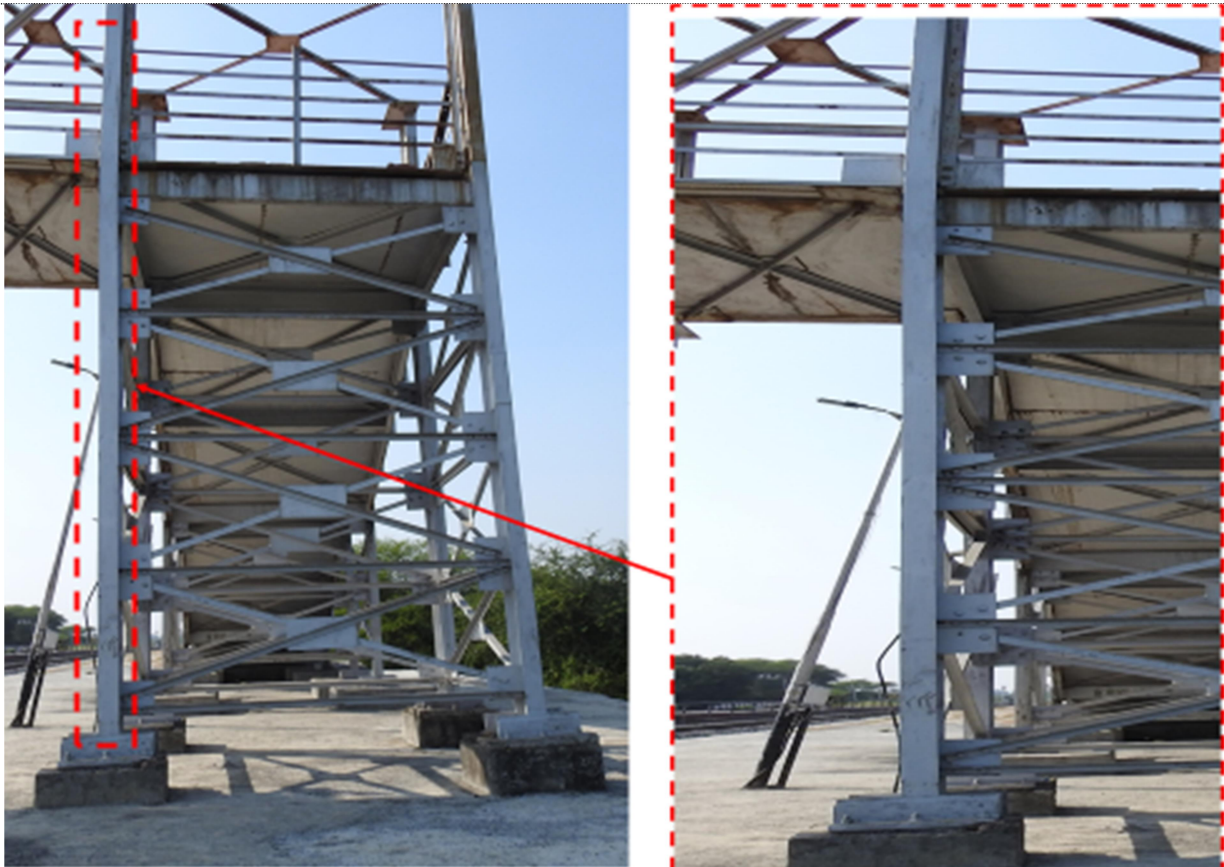
b) Deformation observed at Trestle 2

| PART 4 SURVEY OF SIGNS OF DISTRESS, DEFORMATION IN BRIDGES | | | |
|---|---|---|---|
| | Deformations | | Deformations are observed at column of Trestle 2 |
