| <b>Name of the Project</b> | <b>:</b> | <b>VISUAL INSPECTION OF FOB AT REPALLE RAILWAY STATION</b> |
| <b>Location</b> | <b>:</b> | <b>REPALLE RAILWAY STATION</b> |
| <b>Date of Inspection</b> | <b>:</b> | <b>09<sup>th</sup> NOVEMBER,2019</b> |

## **VISUAL INSPECTION OF FOOT OVER BRIDGE**

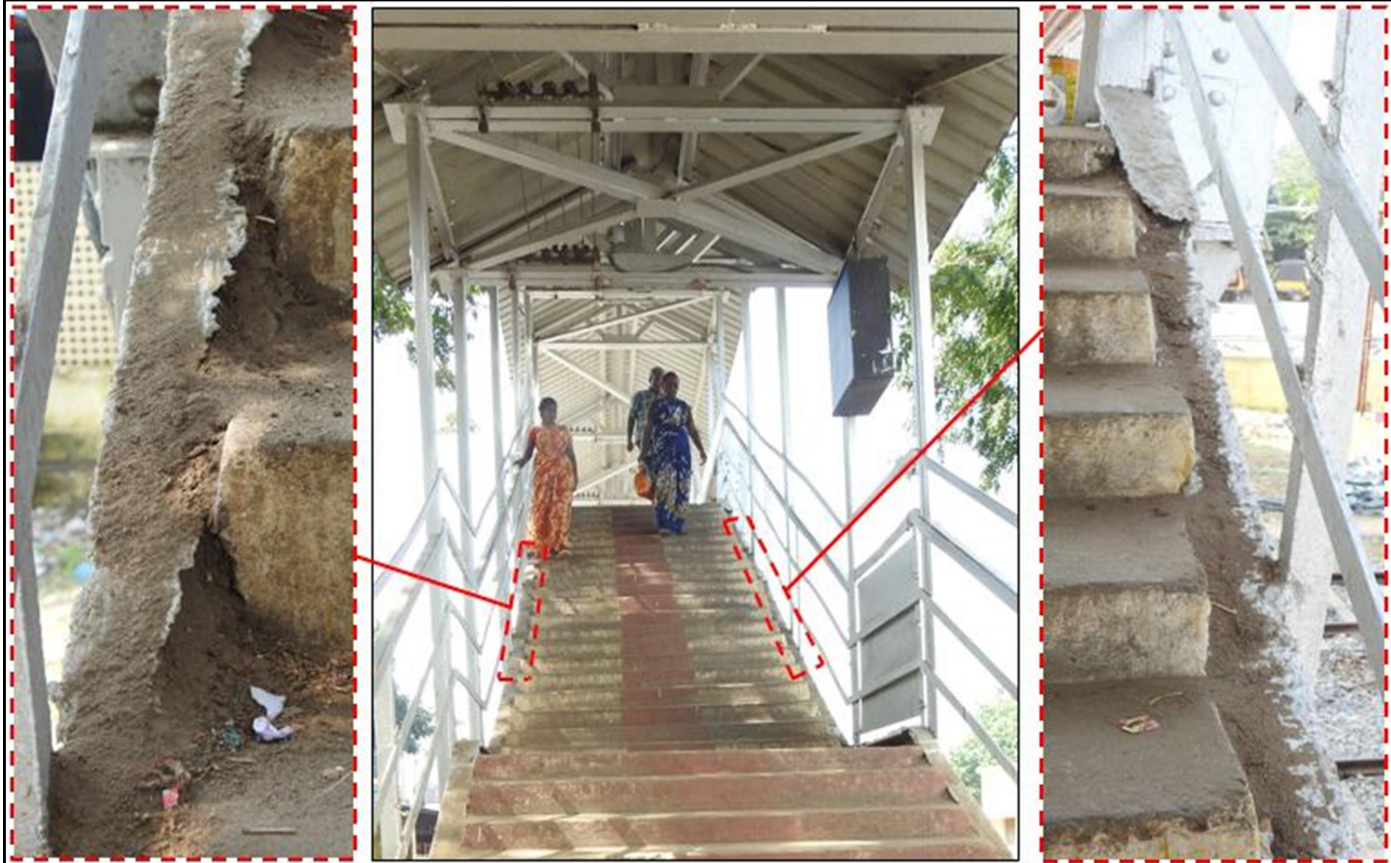
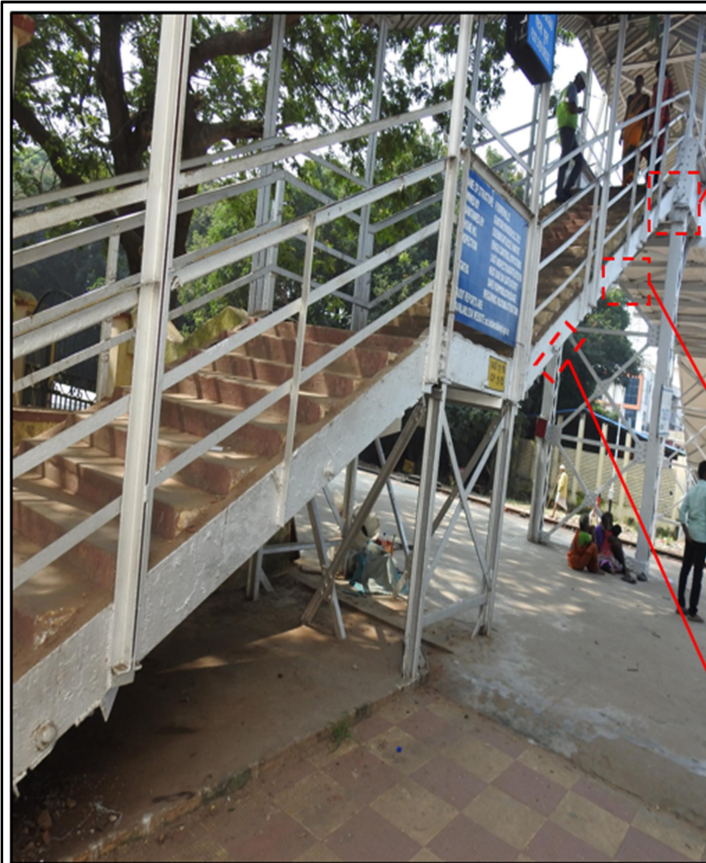
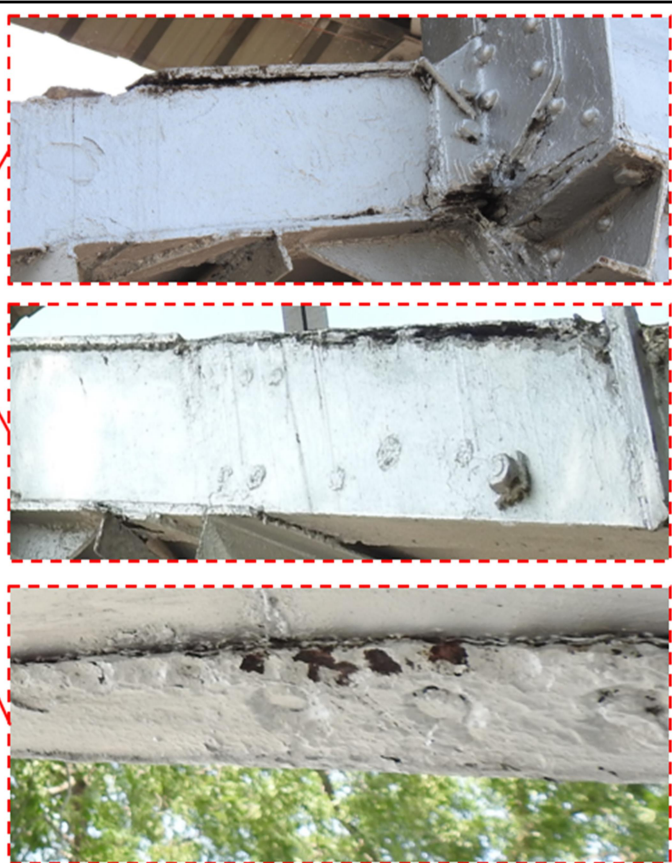
a) Corrosion observed at Staircase 1 Stringer beam

| PART 4 SURVEY OF SIGNS OF DISTRESS, DEFORMATION IN BRIDGES | | | |
|---|---|---|---|
| | Corrosion at steel-Concrete joint | | Corrosion is observed at Stringer beams of Stair case and at cleat angles connecting Stanchion and Stair case (Refer <b>Part 4.1 &amp; Part 4.2 b</b> ) |

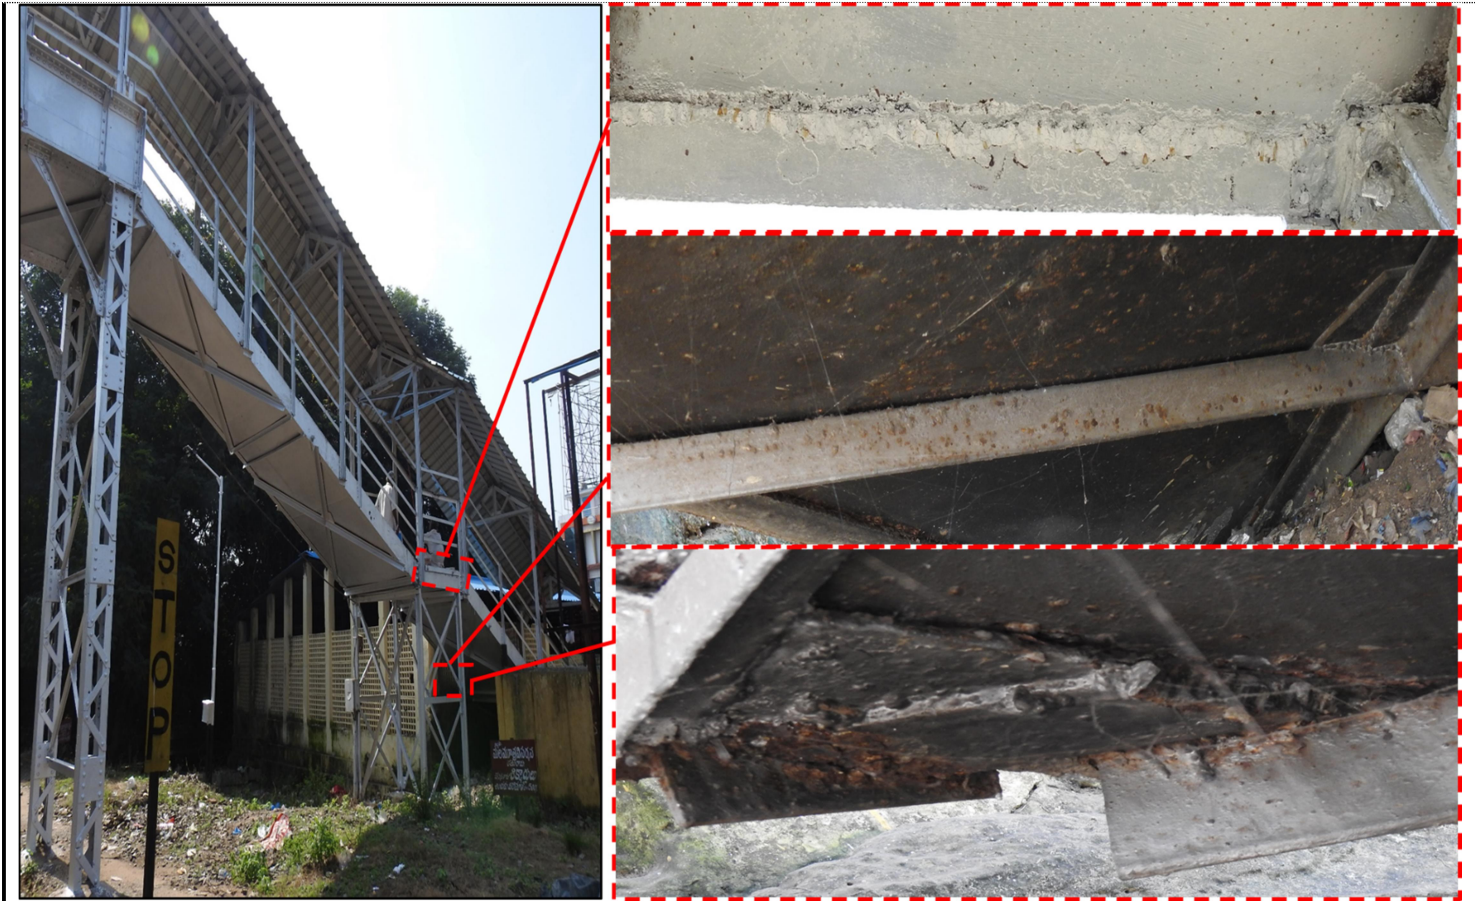
b) Corrosion observed at Staircase 2 Stringer beam and Rusting of cross bracing

| PART 4 SURVEY OF SIGNS OF DISTRESS, DEFORMATION IN BRIDGES | | | |
|---|---|---|---|
| | Rust straining | | Rusting is observed at Cross bracing Supporting Staircase Flight.<br>(Refer <b>Part 4.1 b</b> ) |

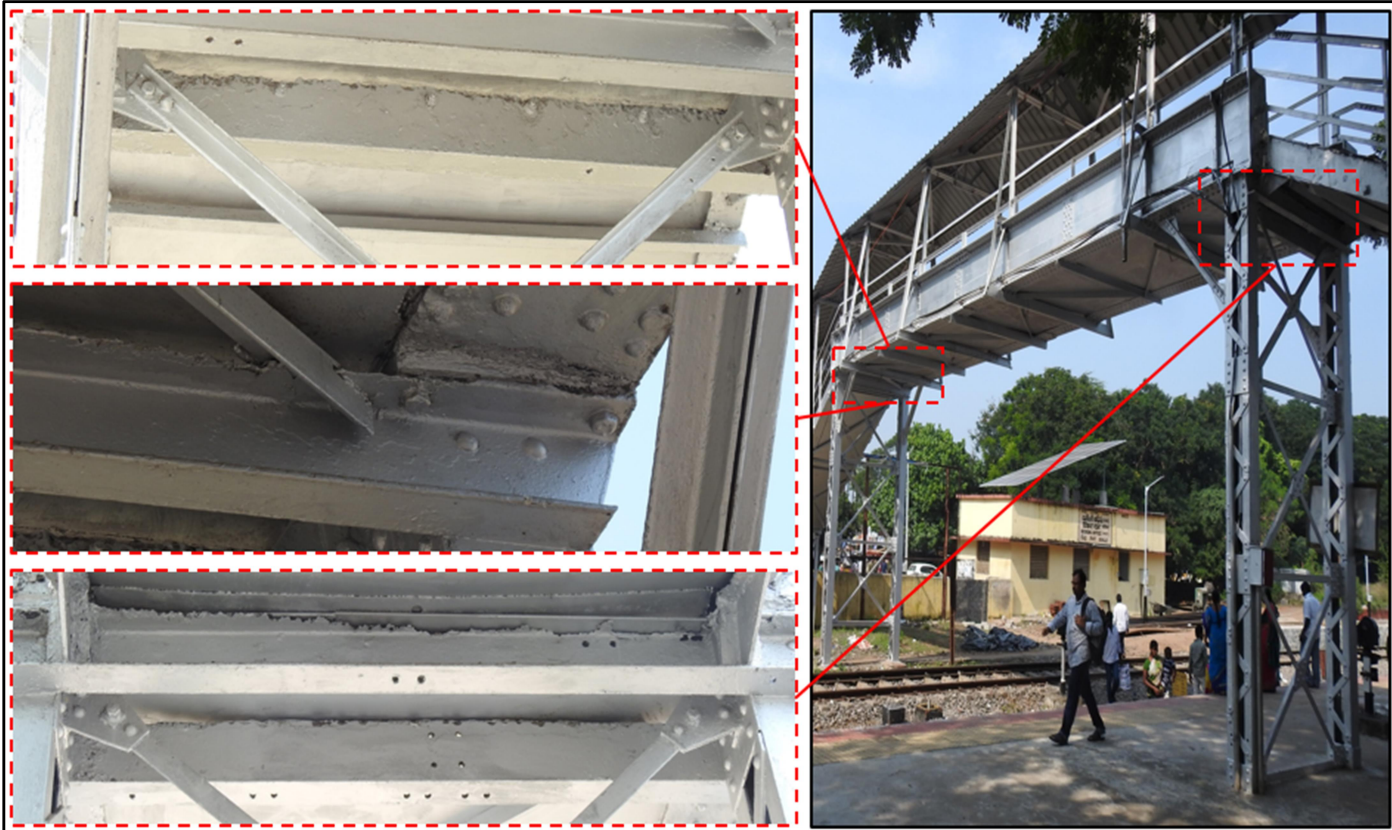
| 4.2 | ✓ Corrosion observed at floor beams of FOB |

a) Corrosion observed at floor beams of FOB

| PART 4 SURVEY OF SIGNS OF DISTRESS, DEFORMATION IN BRIDGES | | | |
|---|---|---|---|
| | Corrosion | Floor level | Corrosion is observed at the Floor Beams of FOB. (Refer <b>Part 4.2</b> ) |

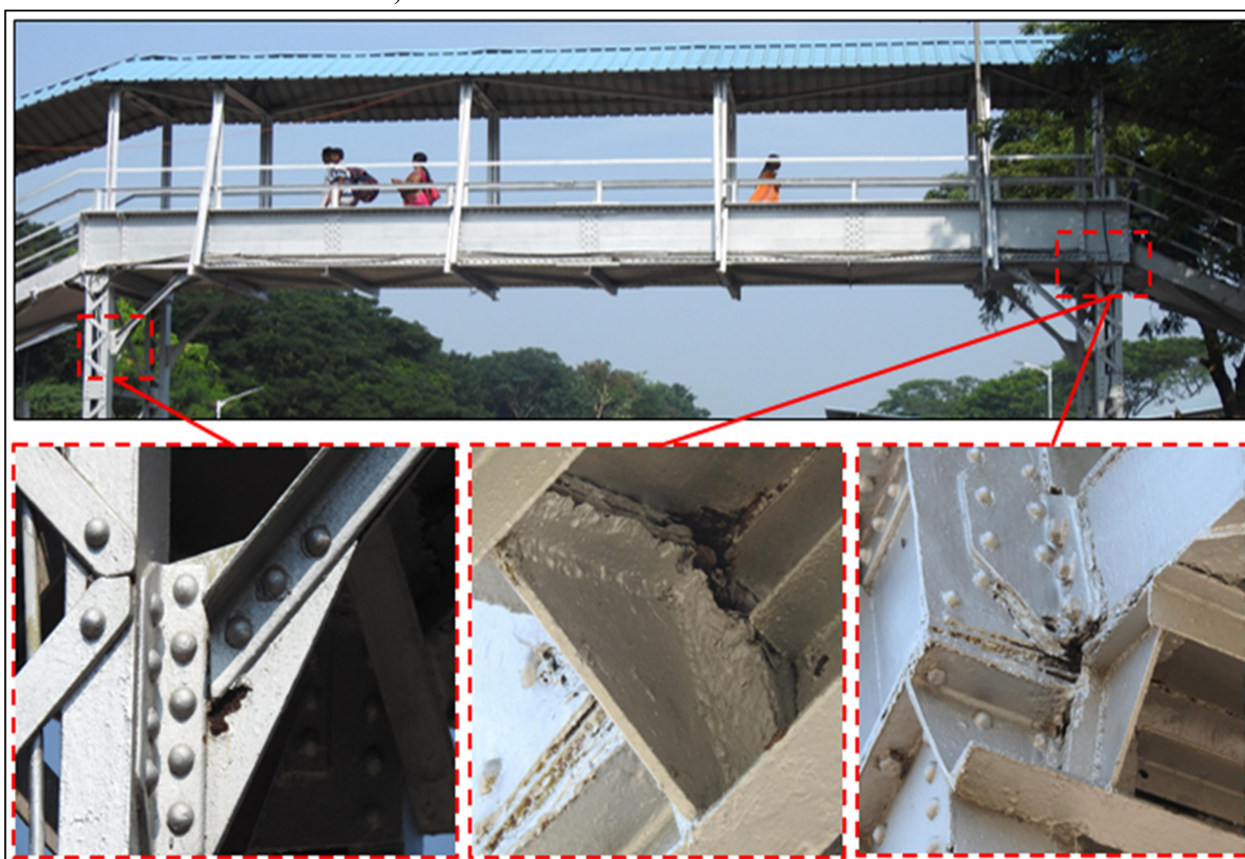
b) Corrosion observed at cleat angle connecting Stanchion and Stair and Gusset plates Joints
