| <b>Name of the Project</b> | <b>:</b> | <b>VISUAL INSPECTION OF FOB/ PF-1 - PF-2 AT AMMANBROLU RAILWAY STATION</b> |
| <b>Location</b> | <b>:</b> | <b>AMMANABROLU RAILWAY STATION</b> |
| <b>Date of Inspection</b> | <b>:</b> | <b>04<sup>th</sup>NOVEMBER, 2019</b> |

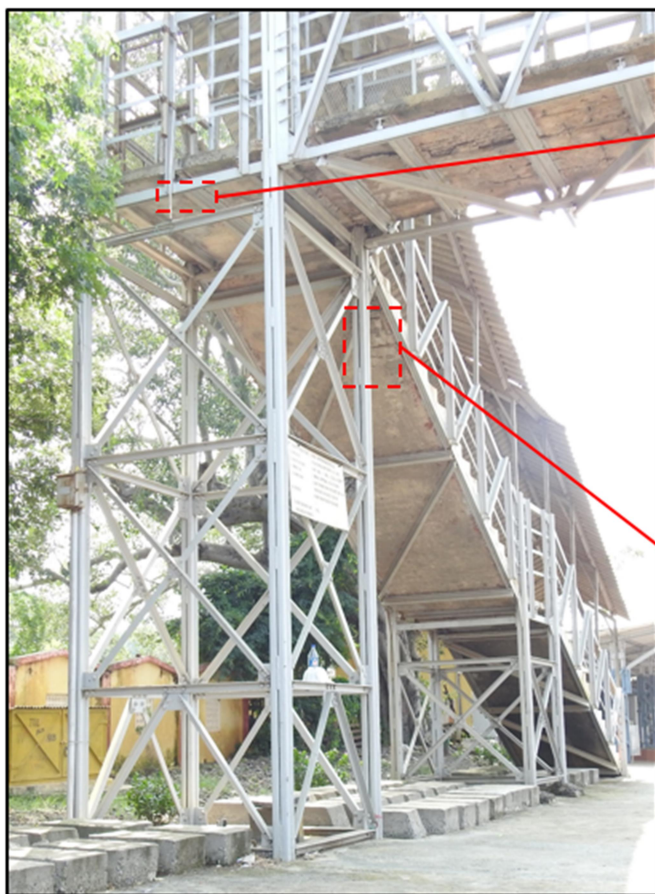
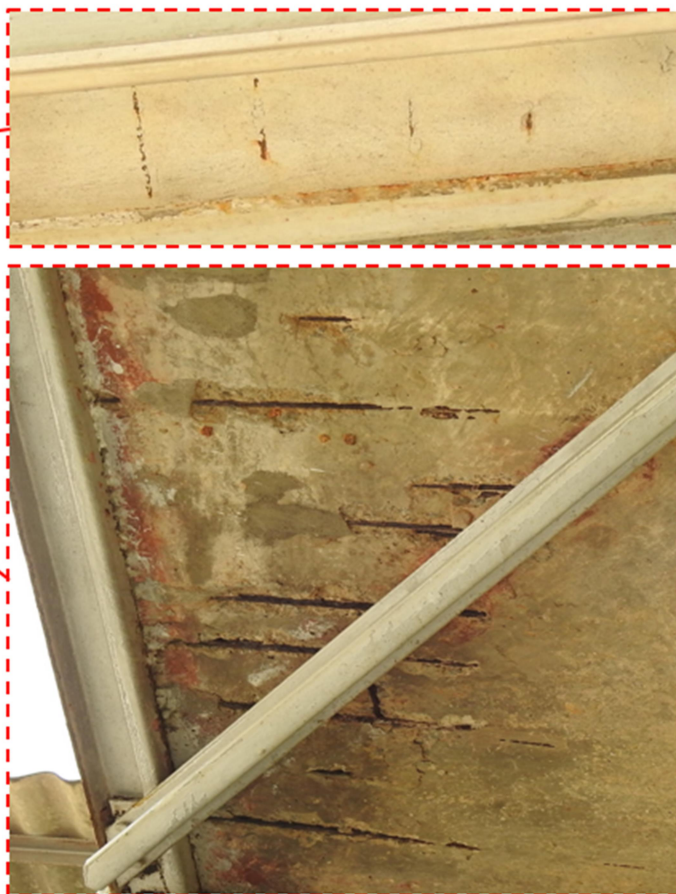
a) Reinforcement exposed observed at Staircase 1 Slab

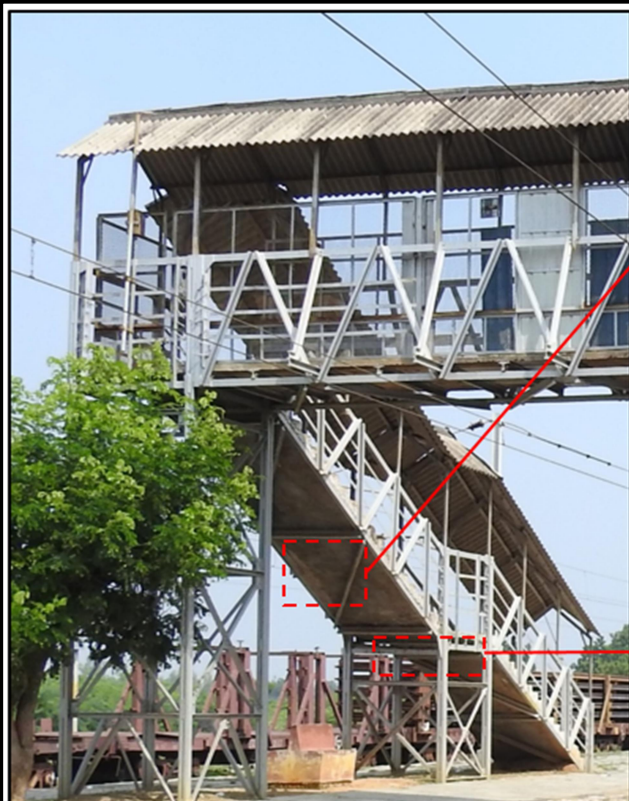
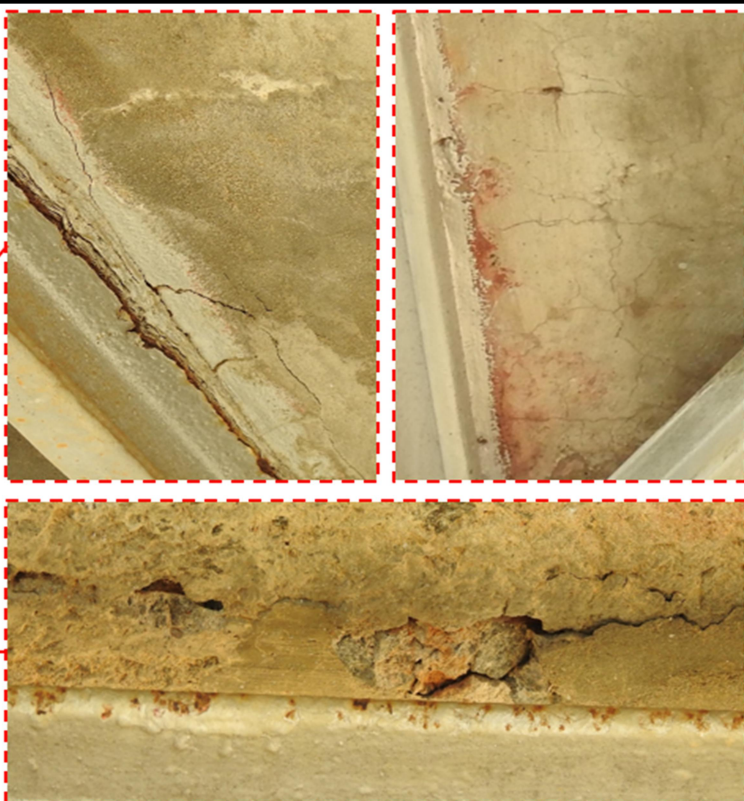
b) Cracks and reinforcement exposed observed at Staircase 2 Slab

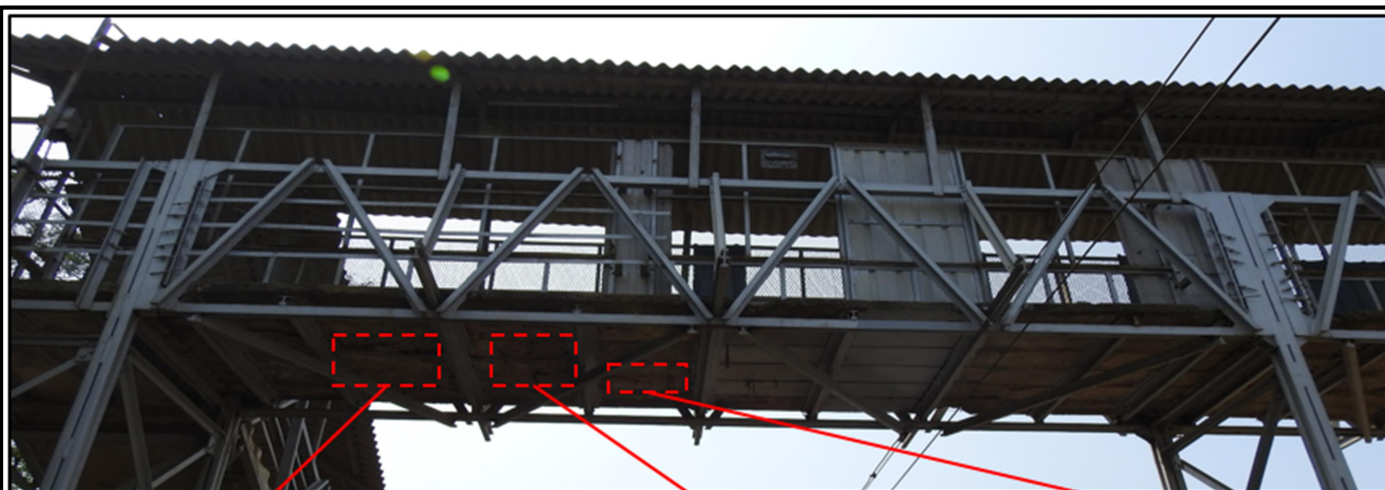
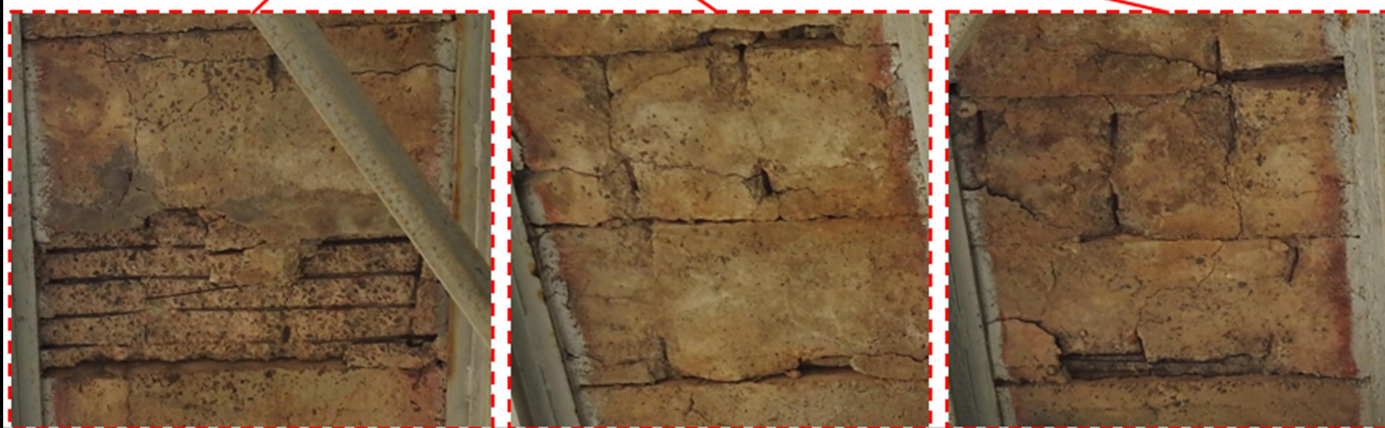
c) Reinforcement exposed and cracks observed on Span 1 slab bottom

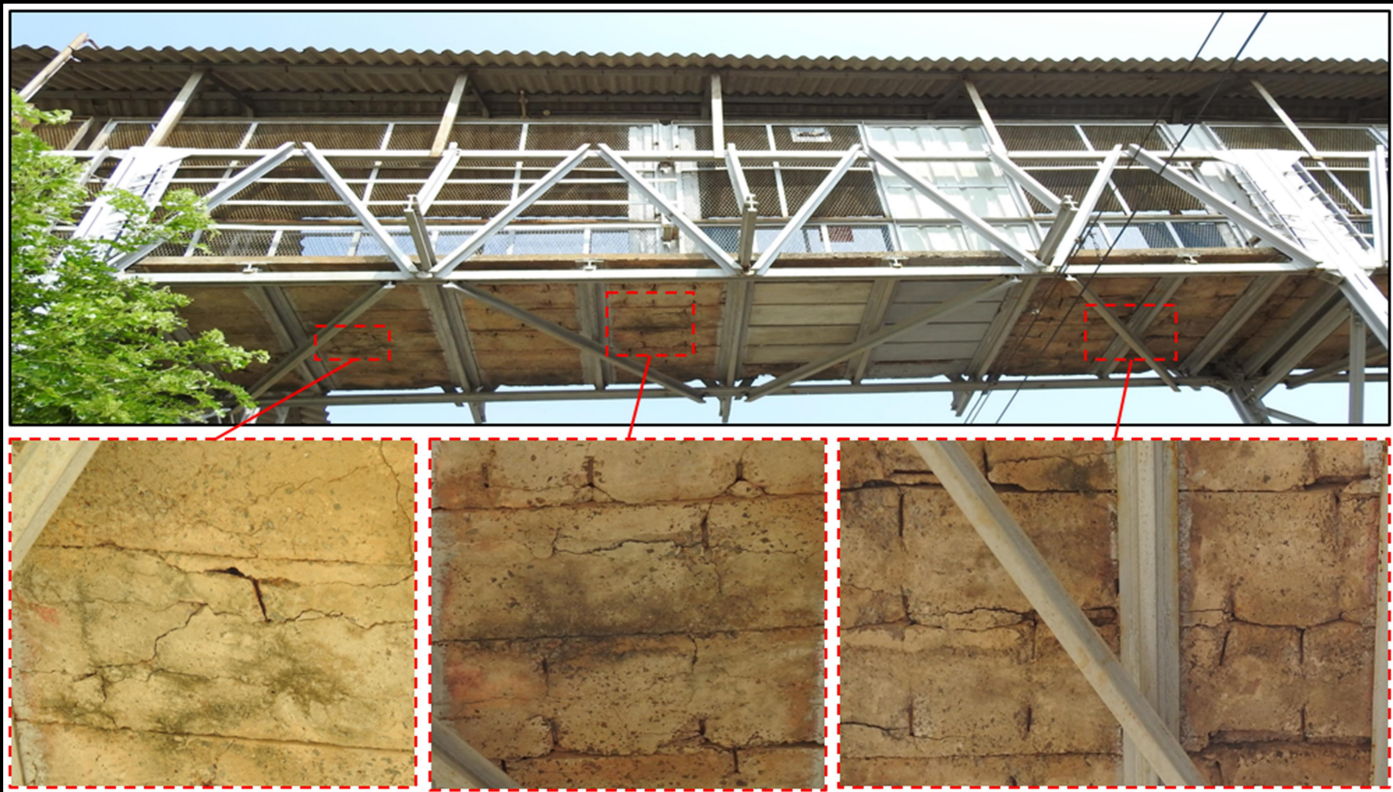
d) Reinforcement exposed , cracks and leaching observed on Span 2 slab bottom

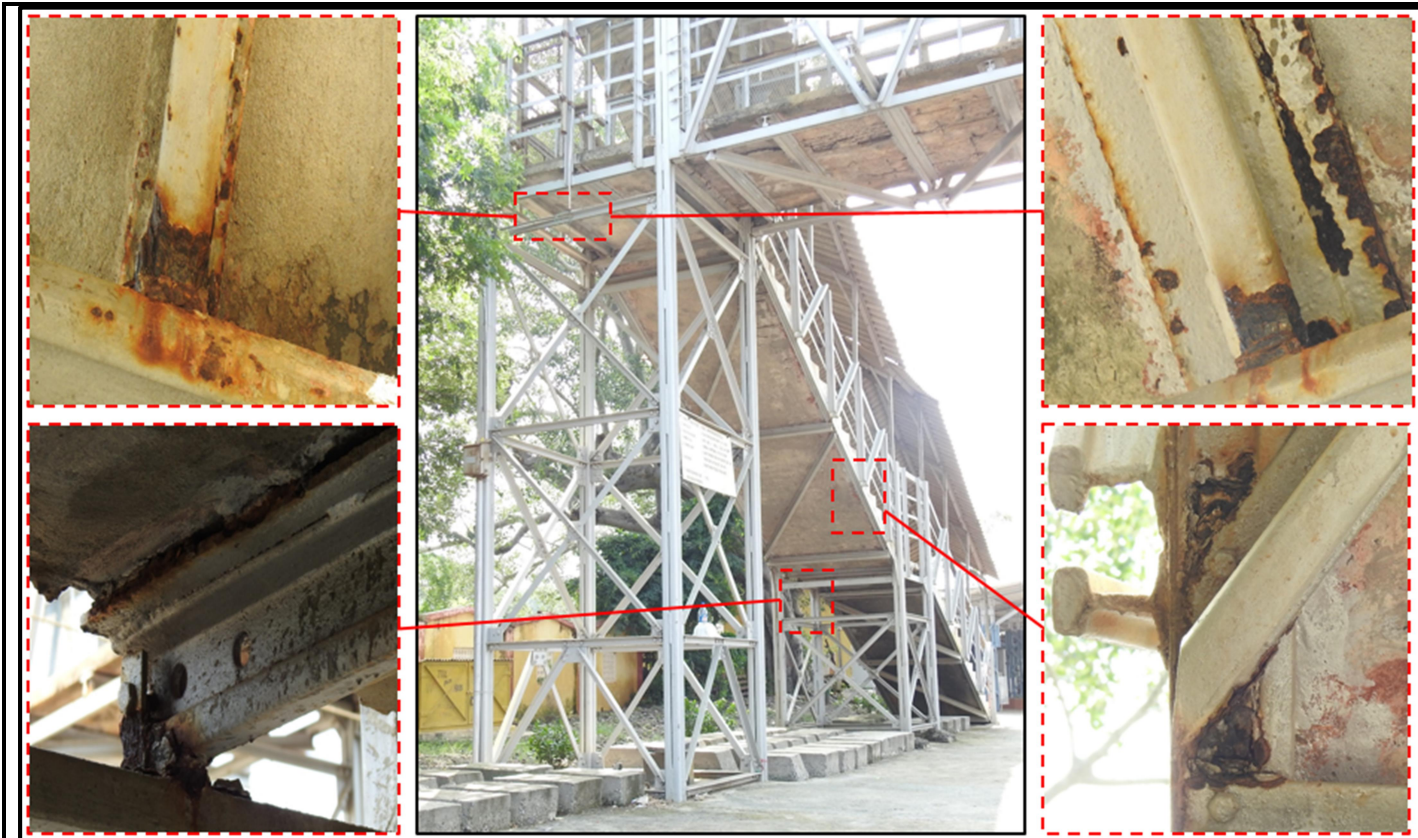
a) Corrosion observed at floor beams on staircase-1 Main landing and mid landing slab bottom

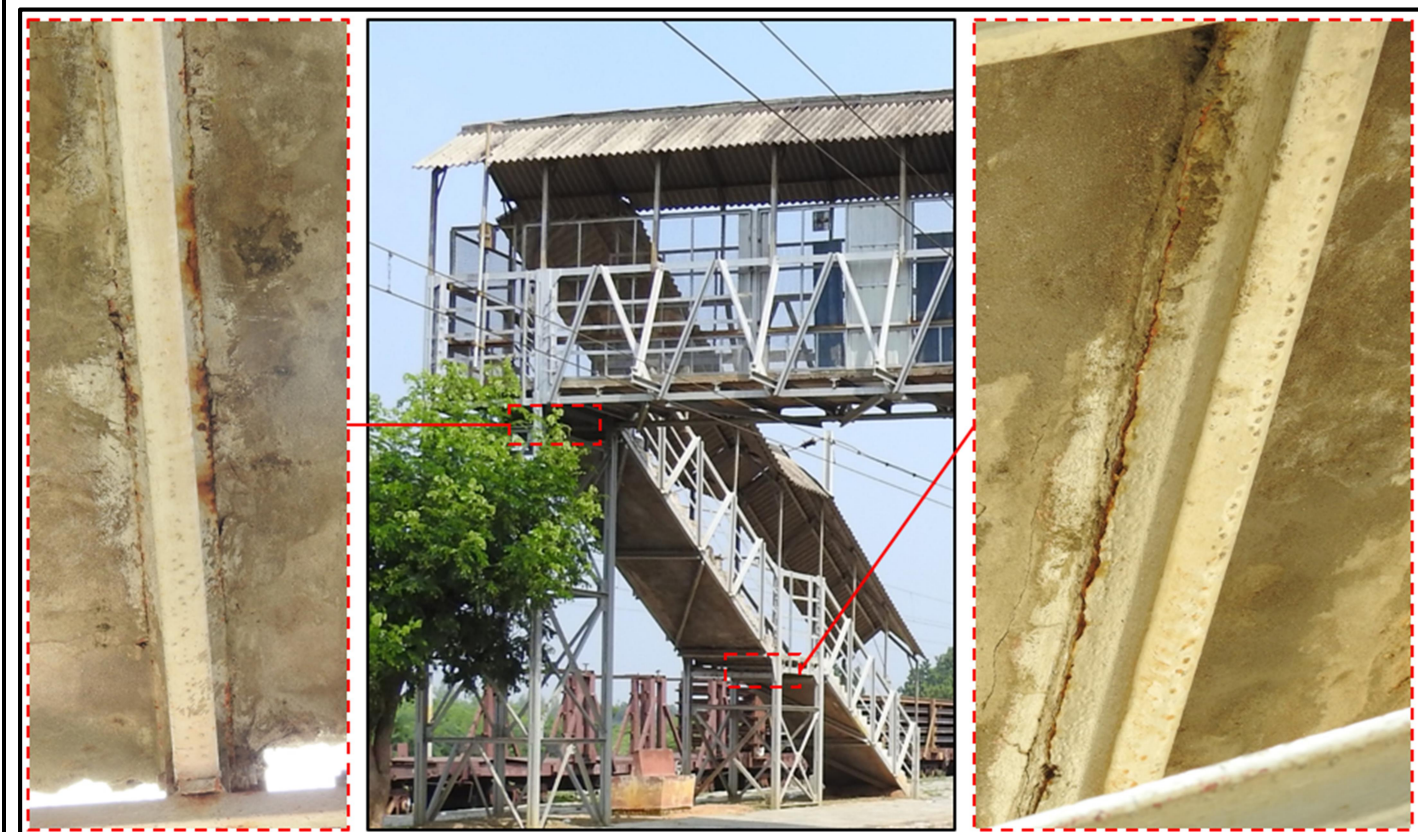
b) Corrosion observed at floor beams on staircase-2 Main landing and mid landing slab bottom

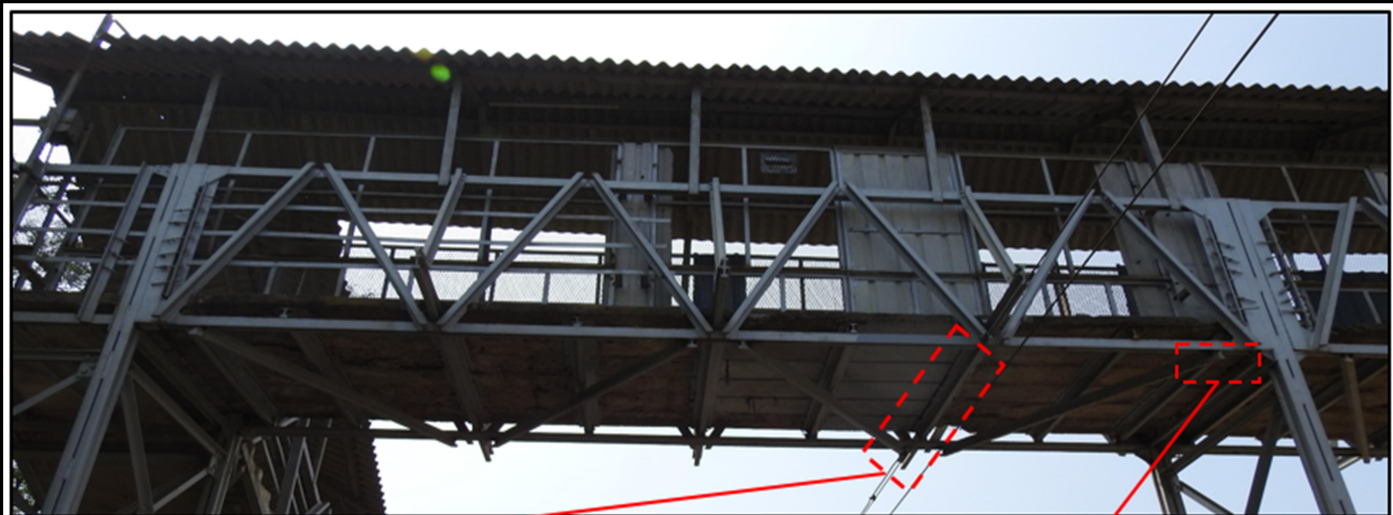
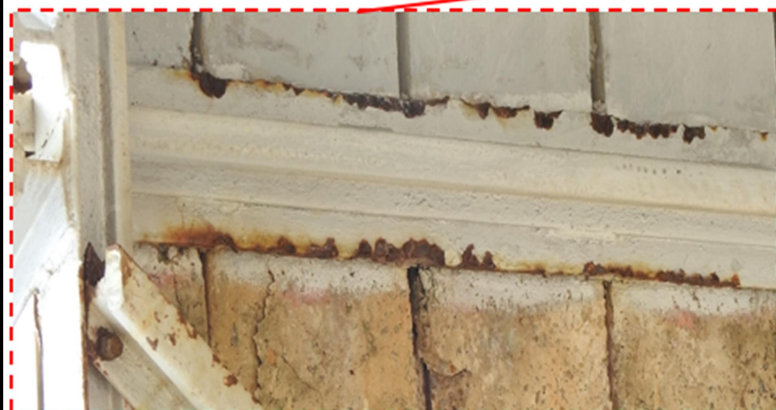
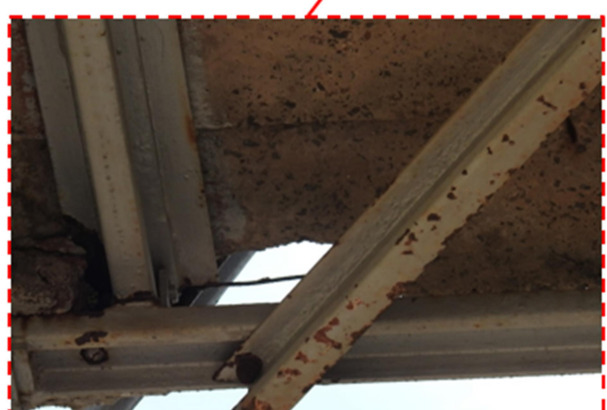
c) Corrosion observed at floor beams on Span 1

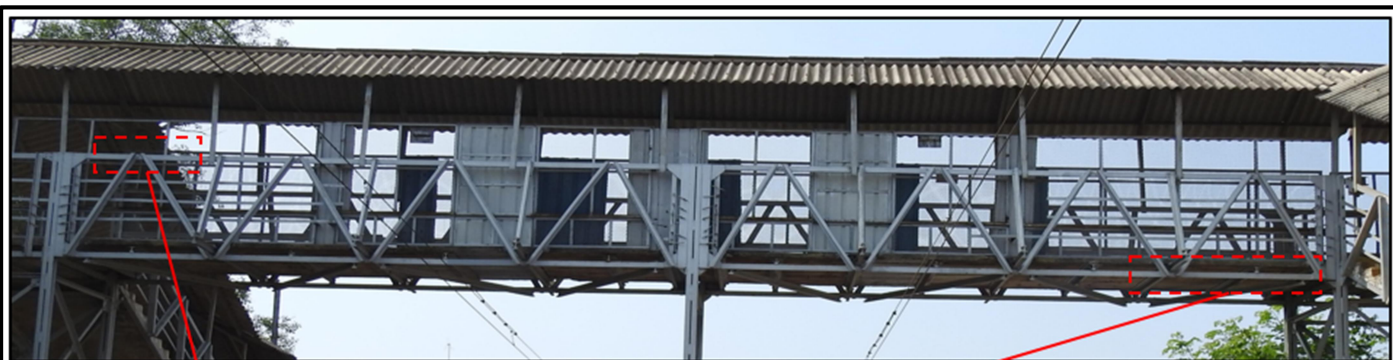
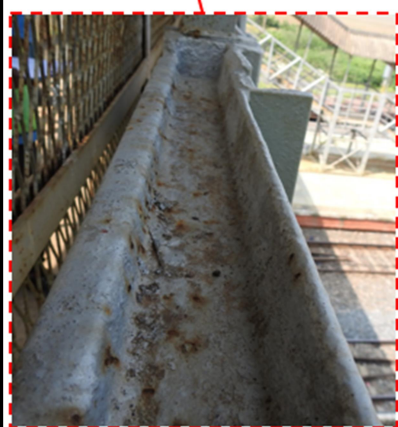
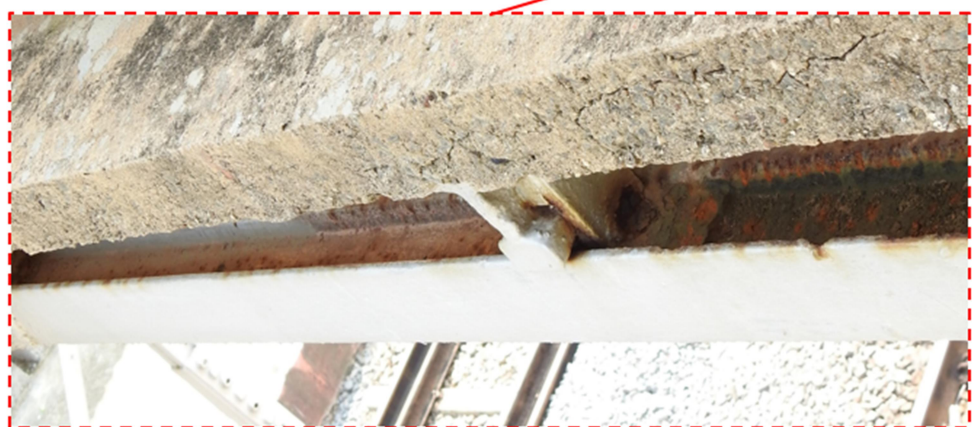
d) Rusting & Corrosion observed at Top & Bottom chord members of FOB

| | Defects | Location | Notes |
|--|---|---|---|
| | Rust straining | | Rusting is observed at Top and Bottom Chord members and all the joints(Refer <b>Part 4.2 d</b> ) |

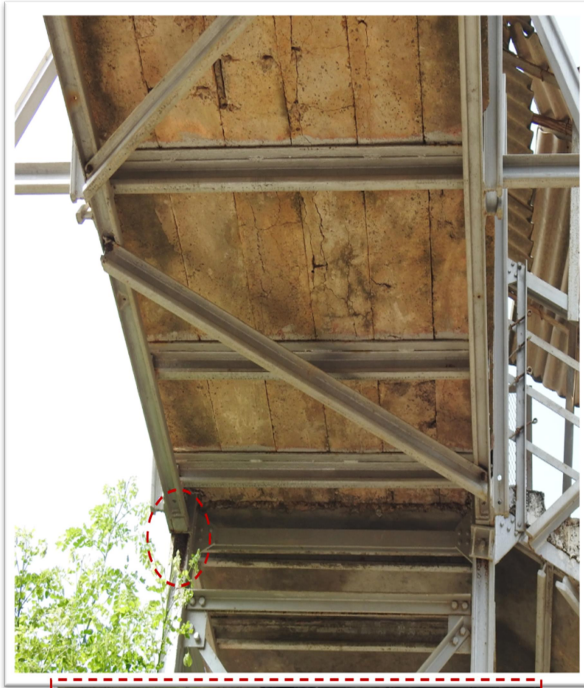
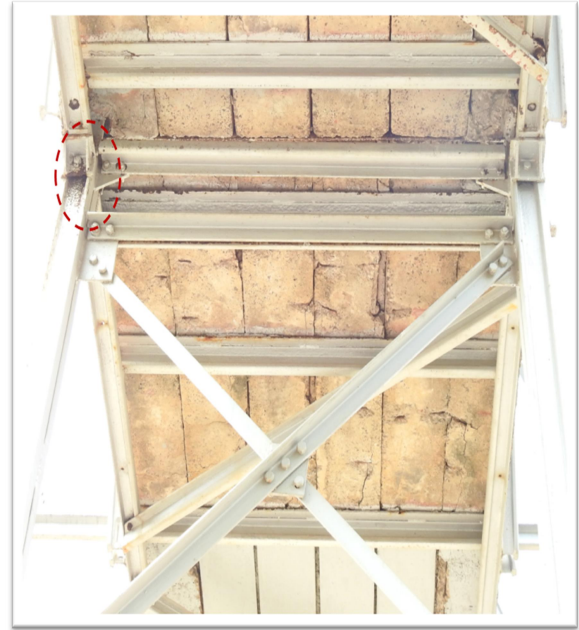
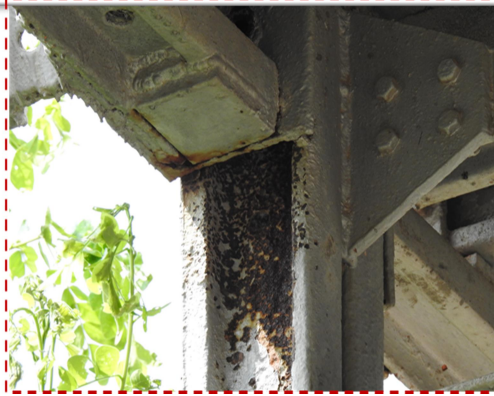
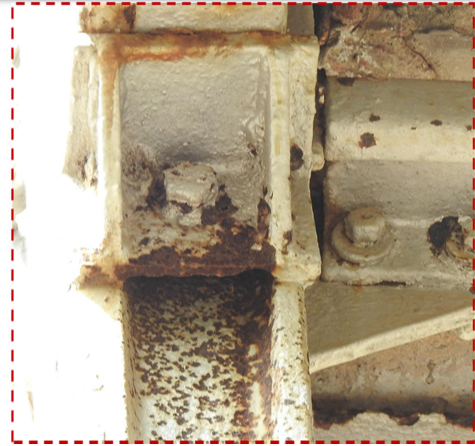
e) Corrosion of Cleat angles at Beam column joint of Trestle-2 and Stanchion

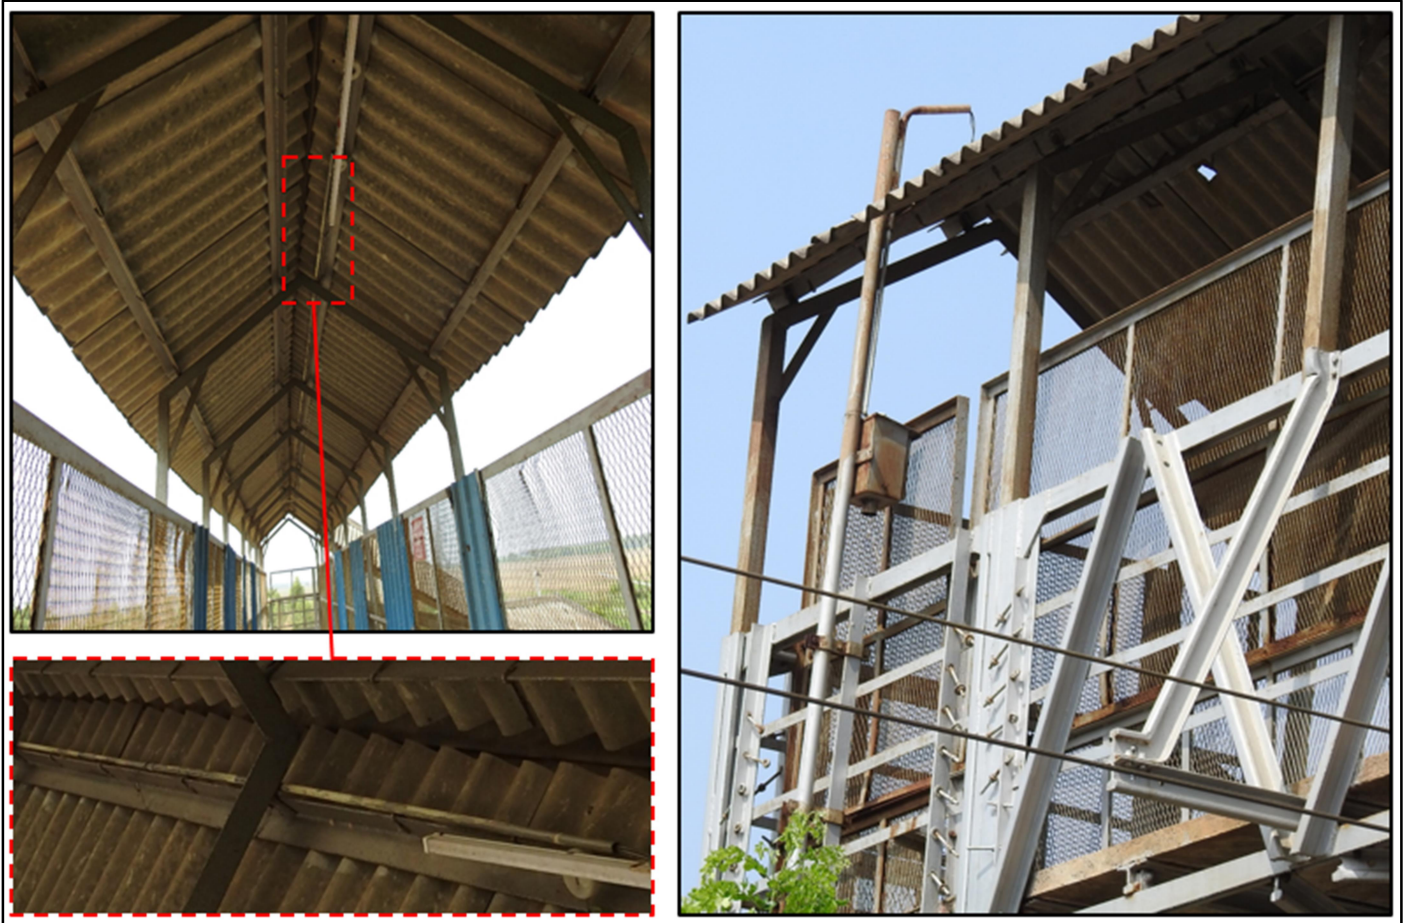
| | | Yes/No | Notes |
|---|---|---|---|
| | b) Cables | Yes | a. 1-inch GI pipe and 1-inch PVC pipe is supported on Roof Truss. (Refer <b>fig :3</b> )<br>b. Common Rafter Truss of 75 x 75 x 6 mm Angles are used as Roof truss(Refer <b>fig :2</b> )<br>c. Asbestos Sheet is used for Roof (Refer <b>fig : 2</b> ) |

**Fig 3:** Additional loads of GI, HDPE, PVC pipes

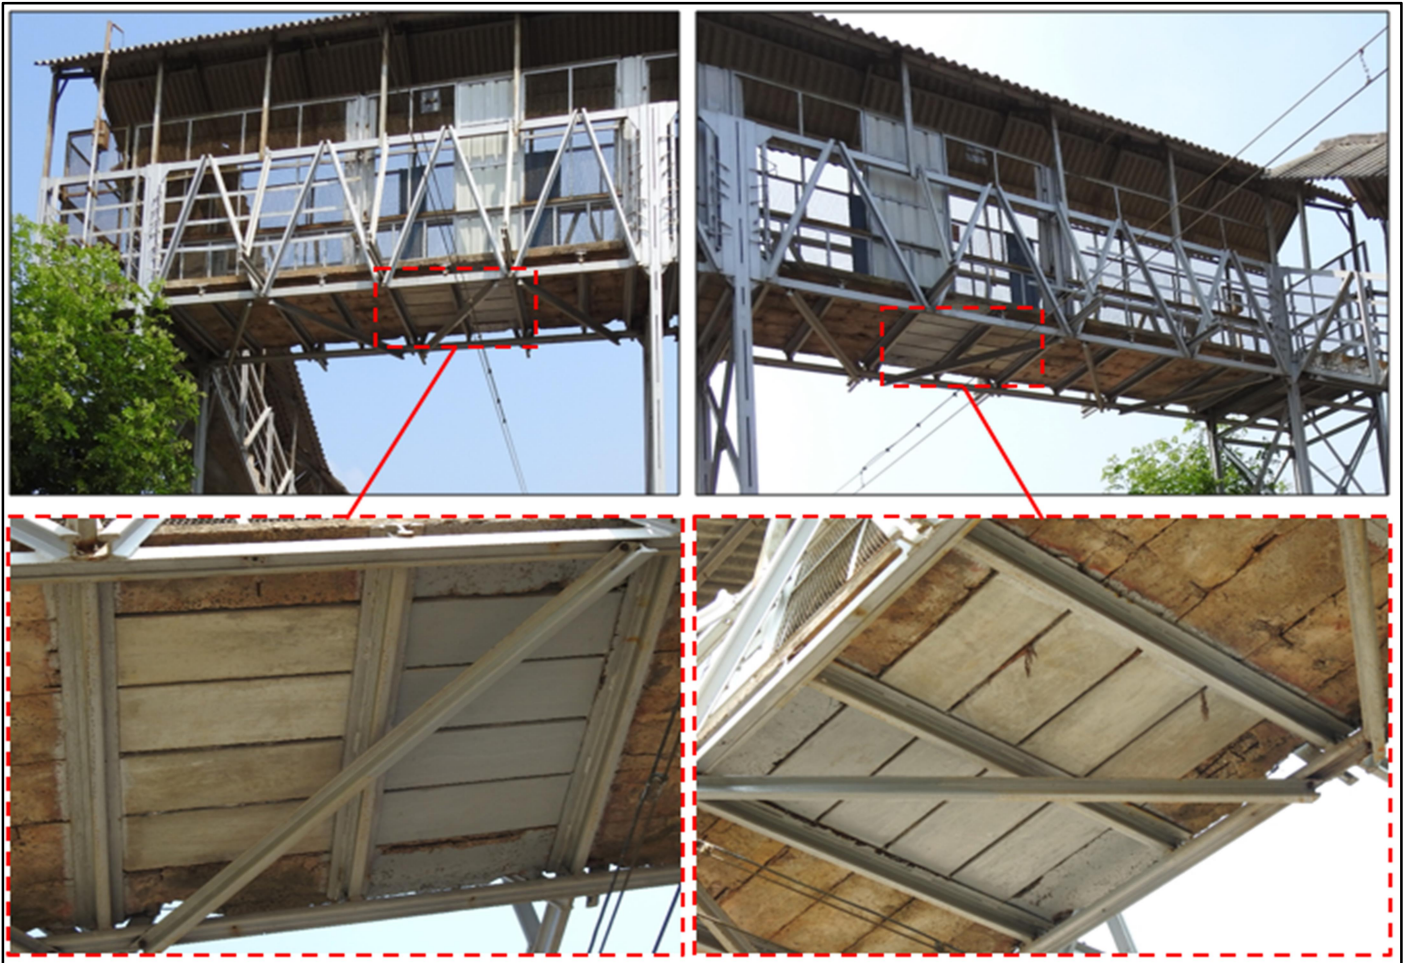
**Fig 8:**Slab panelsReplaced at Span 1 and 2

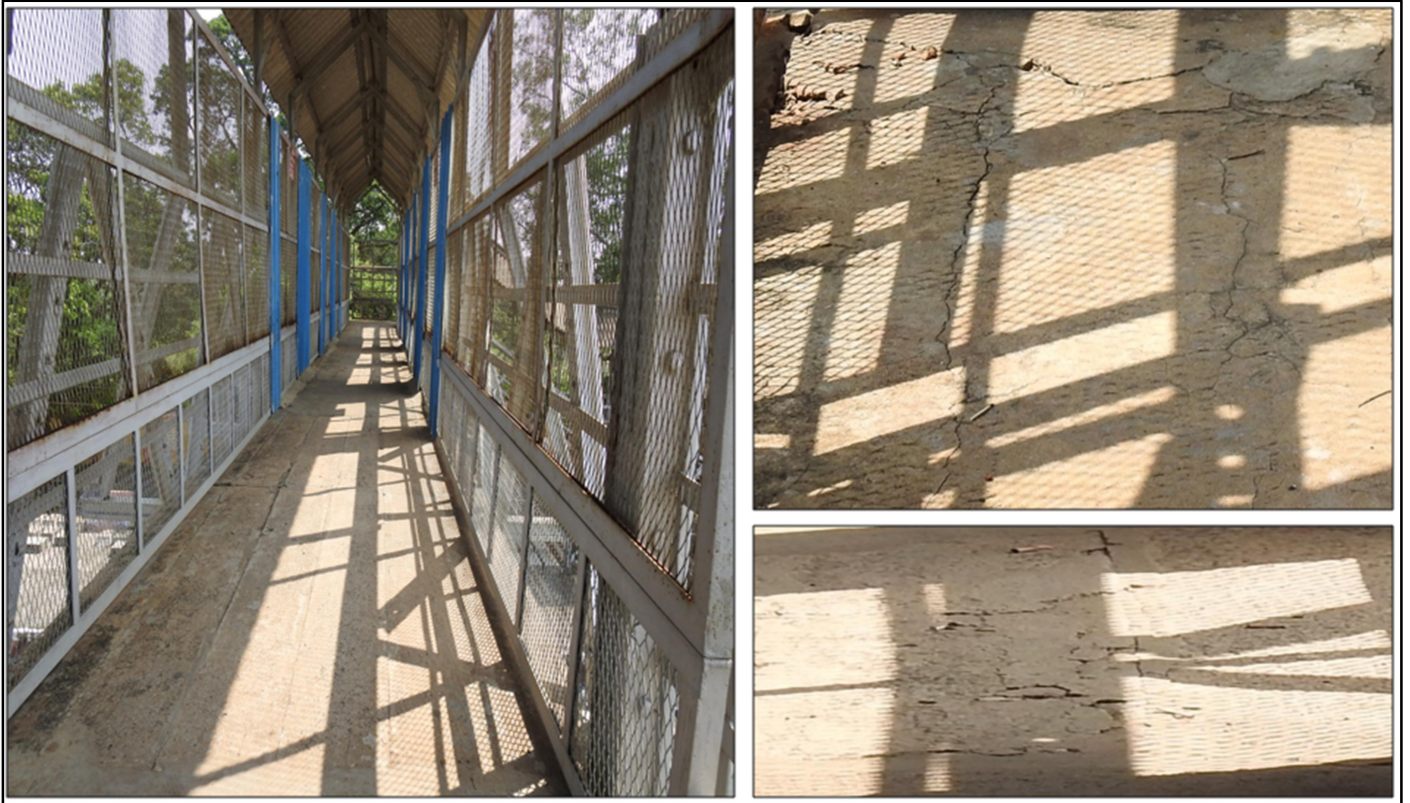
| | Condition of Slab from Top | Cracks observed | |

**Fig 9:**Cracks on top of Pathway Slab panels

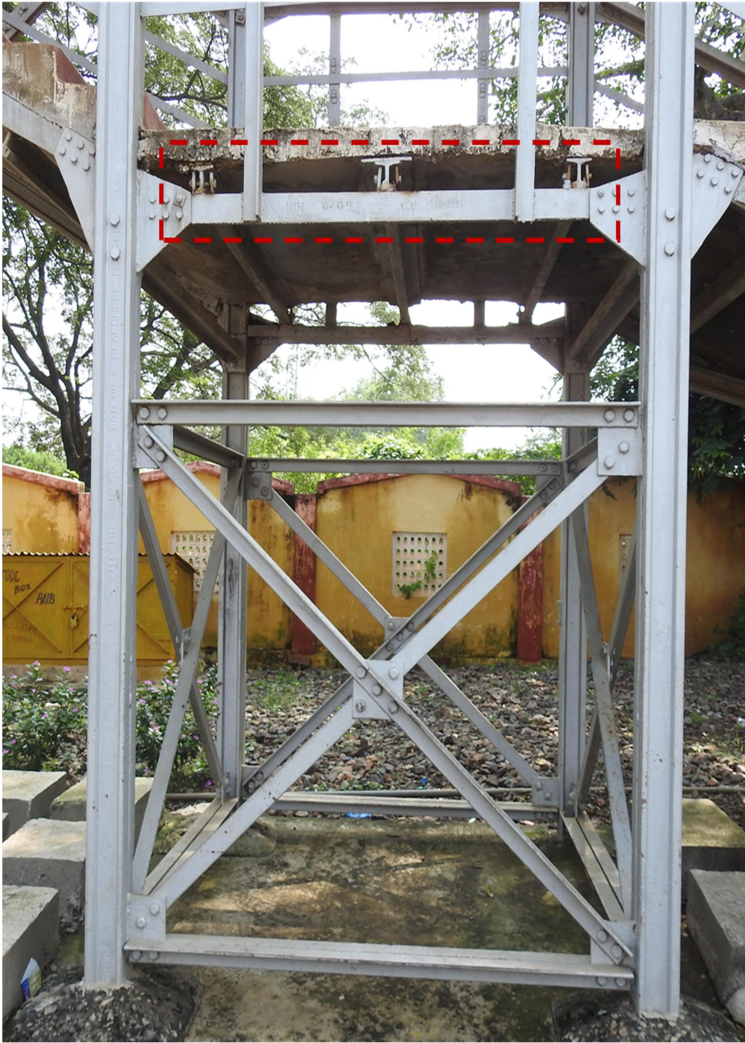
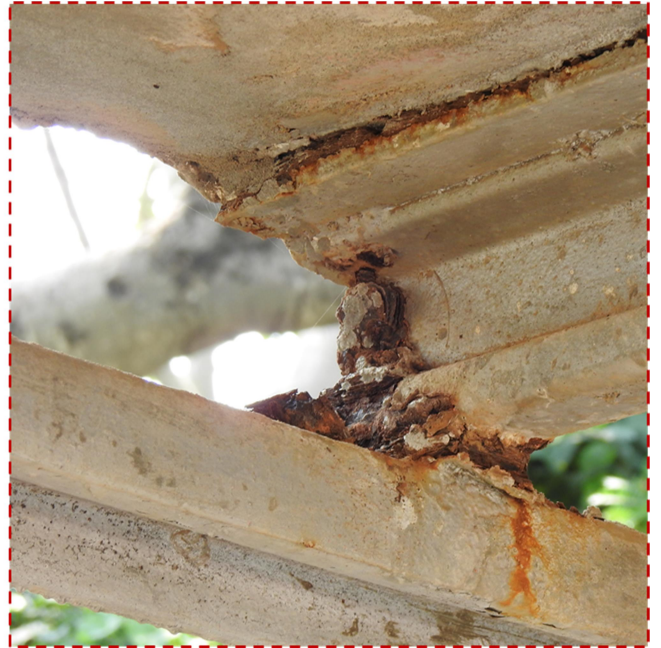
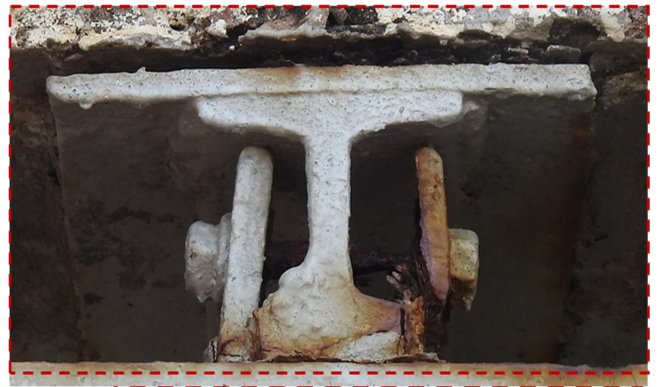
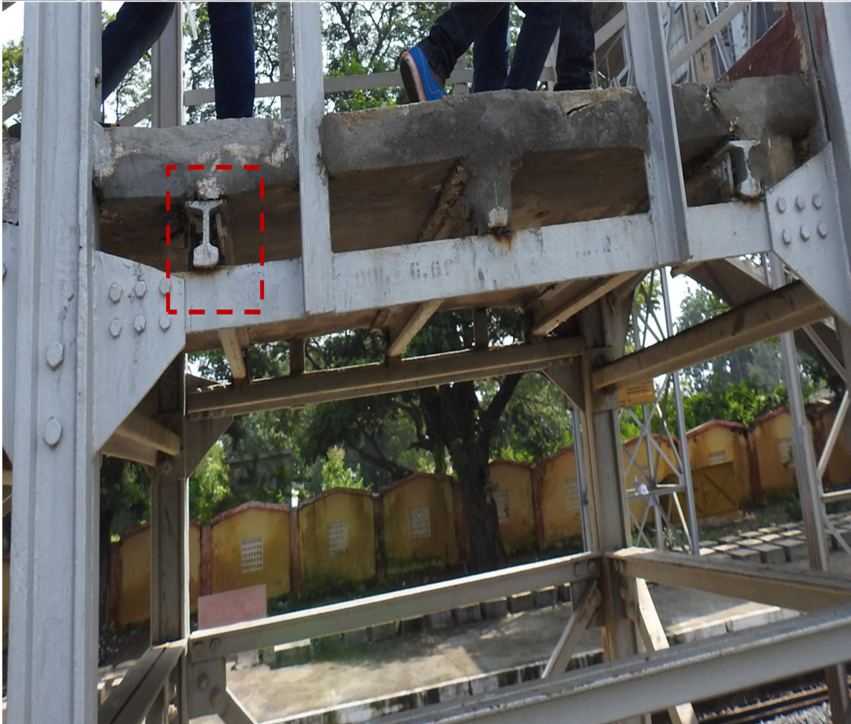
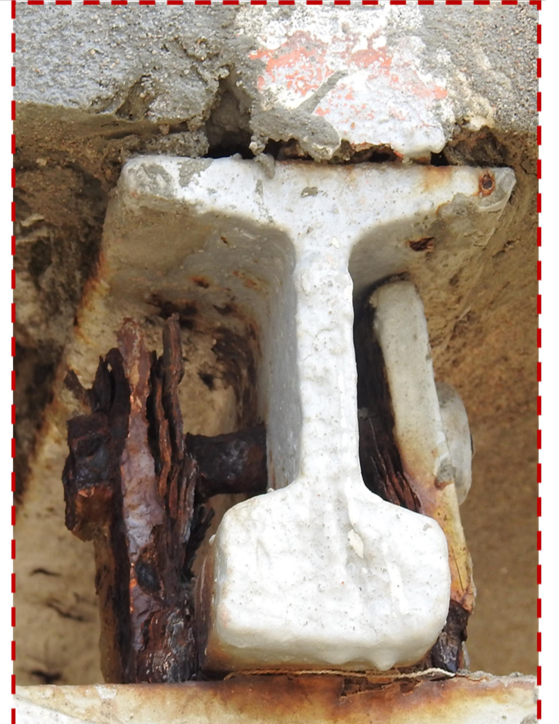
**Fig 10:** Corrosion of Floor beams joints at Midlandings of Staircase 1 and 2
