| <b>Name of the Project</b> | <b>: VISUAL INSPECTION OF ROB (171A) NEAR CEMENT NAGAR</b> |
| <b>Date of Inspection</b> | <b>: 24<sup>th</sup> NOVEMBER, 2019</b> |

## VISUAL INSPECTION OF ROAD OVER BRIDGE

| 1.1 | Name of the Bridge | ROB (171A) |

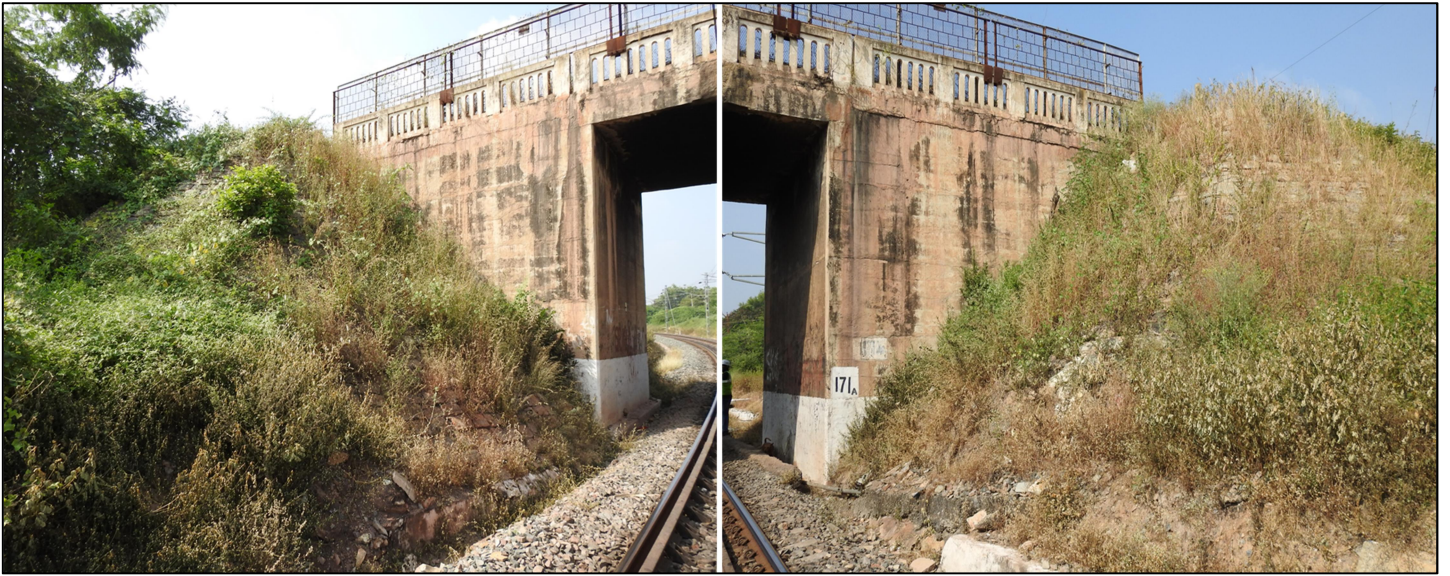
| PART 2 STRUCTURAL SYSTEM OF THE BRIDGE | | | |
|---|---|---|---|
| | Condition (Crack, Settlement, Scour, Tilting, Steel Corrosion, Strains and other damages etc...) | | Minor Cracks Observed in the Abutments |

| PART 3 SURVEY OF SIGNS OF DISTRESS, DEFORMATION IN BRIDGES | | | |
|---|---|---|---|
| | Cracking in RCC components | Abutments | Minor cracks are observed in Abutments |

***Fig 2: Abutment on both sides (A1 and A2)***

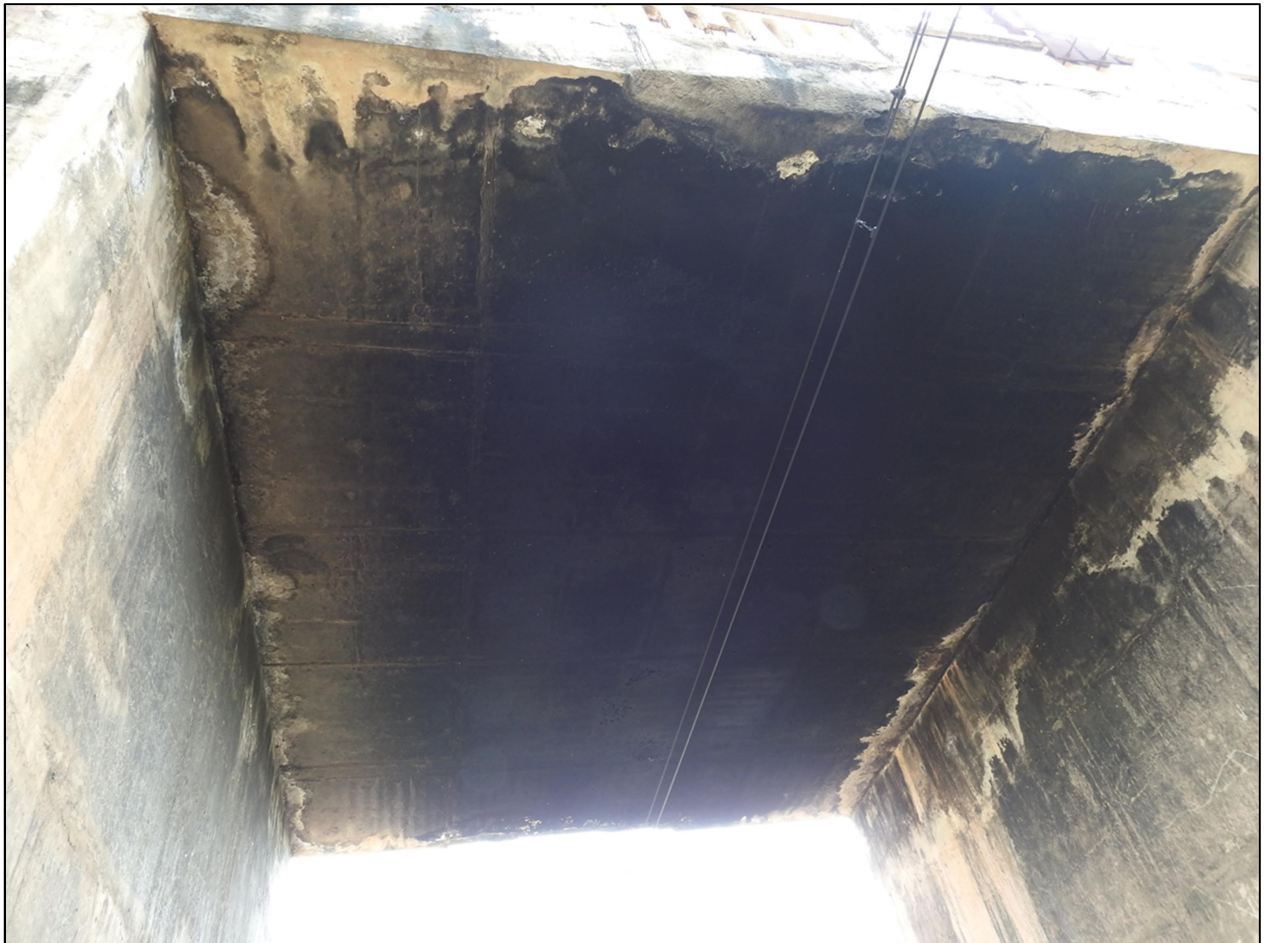
| | Condition of Slab from Bottom | | Spalling & patchwork observed. (Refer Fig-2) |

***Fig 3: Bottom view of Slab***

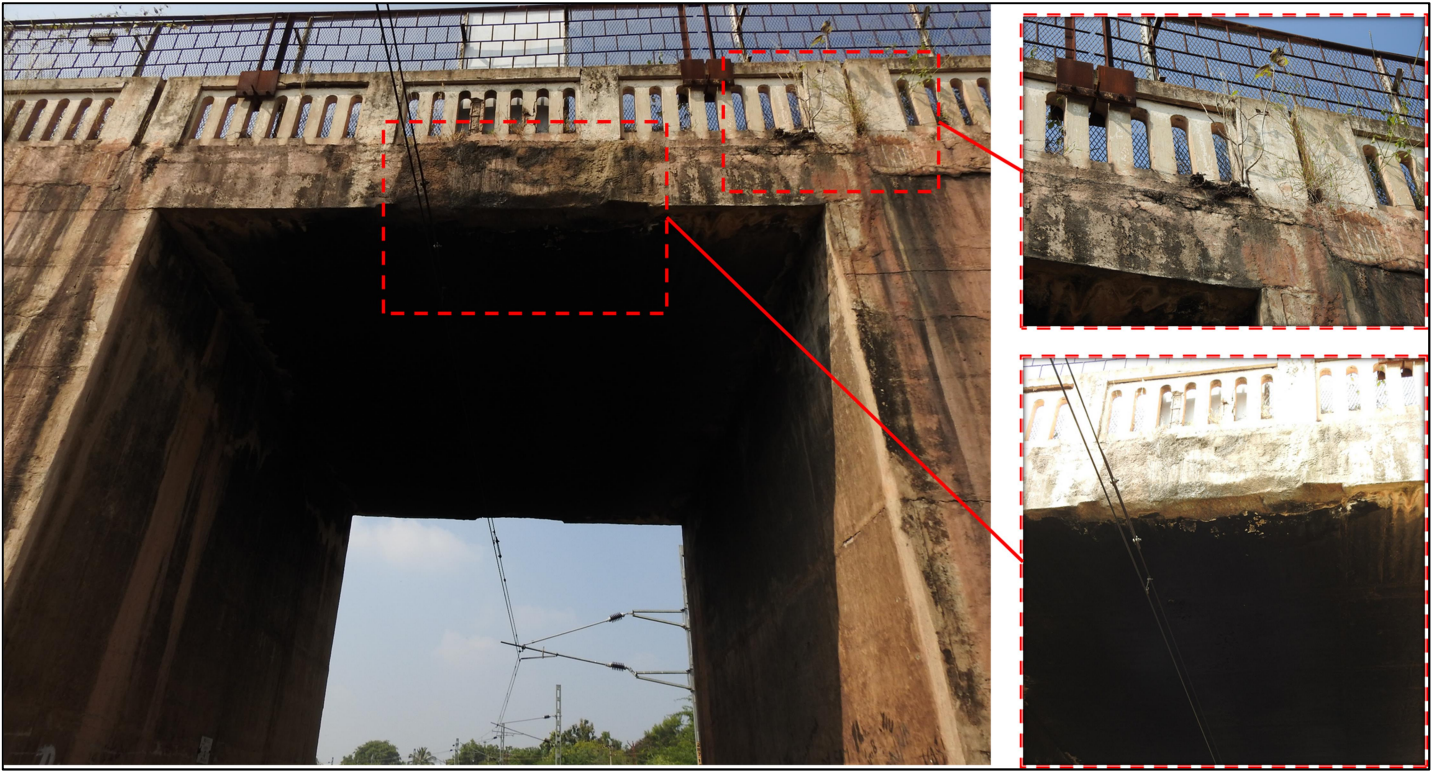
**Fig 4:** Chipped surface of slab bottom above OHE cable on both sides of ROB and vegetation at railing

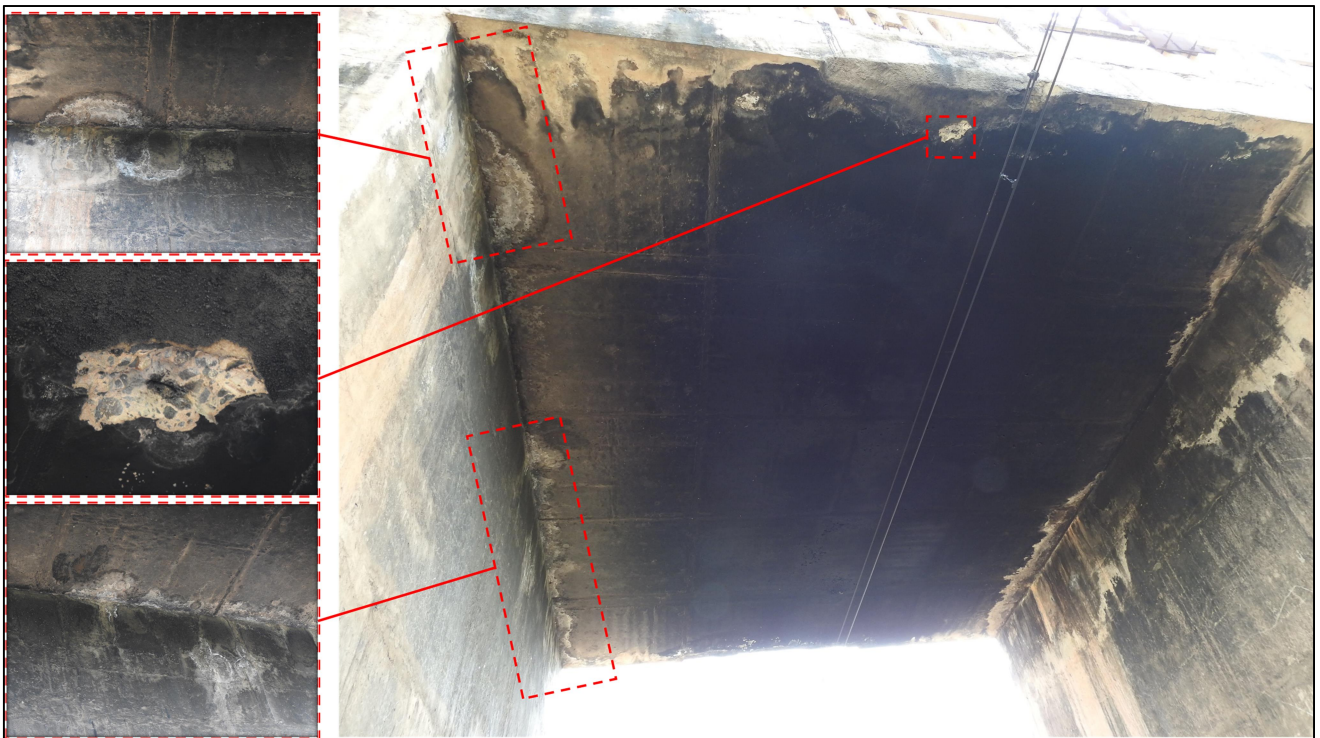
| PART 3 SURVEY OF SIGNS OF DISTRESS, DEFORMATION IN BRIDGES | | | |
|---|---|---|---|
| | Spalling | Slab | Slight Spalling is observed in Slab |
| | Reinforcement Exposure | Slab | Reinforcement Exposure is observed in Slab |

**Fig 5(a):** Leaching and slight spalling in slab

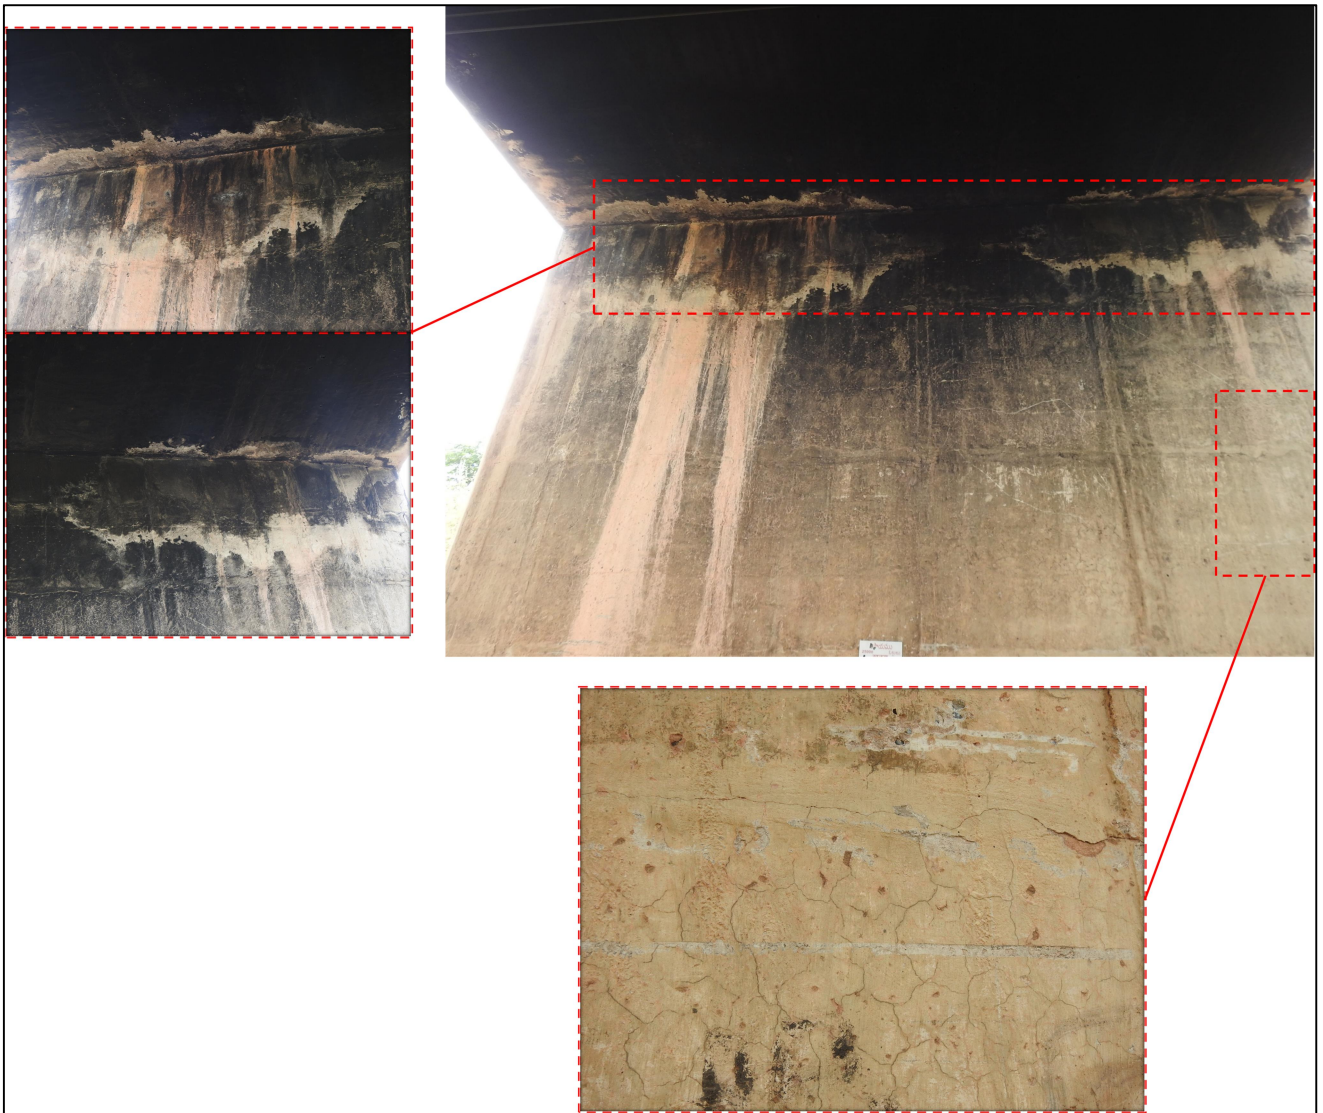
**Fig 5(b):** Leaching and Cracks observed on Abutment-2

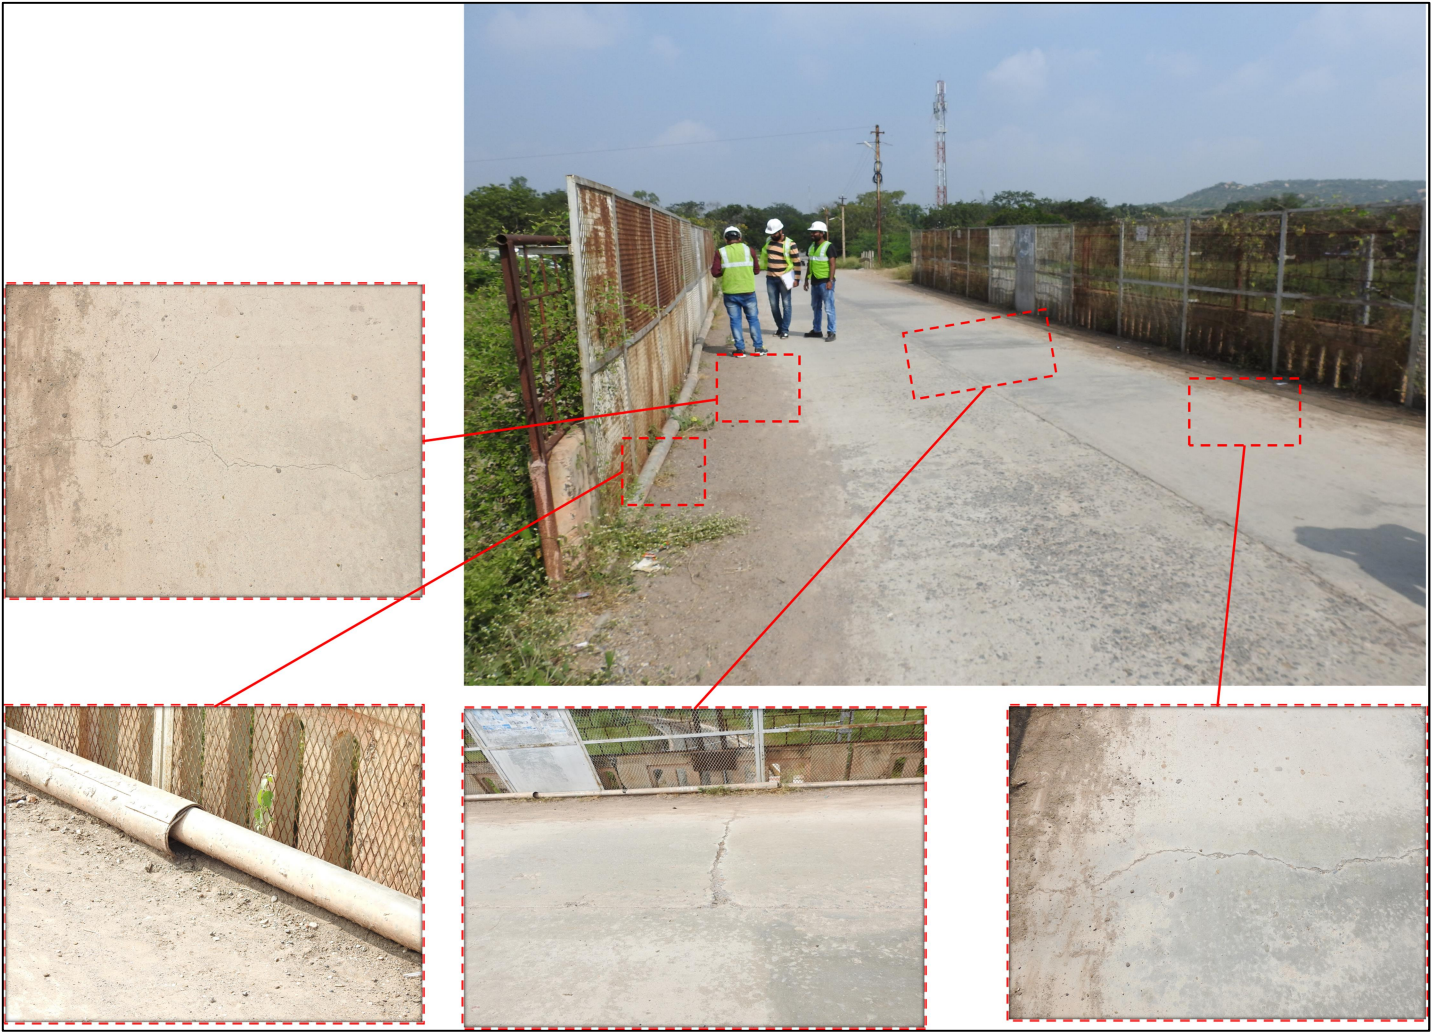
| | Condition of Flooring/Wearing Coat | Cracks observed | Cracks observed in the wearing coat |

**Fig 6:** Utility services passing on the Bridge and Wearing Coat condition
