**Name of the Project** : VISUAL INSPECTION OF ROB NO. 871A  
**Location** : NEAR GUNTAKAL RAILWAY STATION  
**Location Co-ordinates** : 15°10'23.3"N 77°22'19.6"E  
**Date of Inspection** : 25<sup>th</sup> NOVEMBER, 2019

## VISUAL INSPECTION OF ROAD OVER BRIDGE

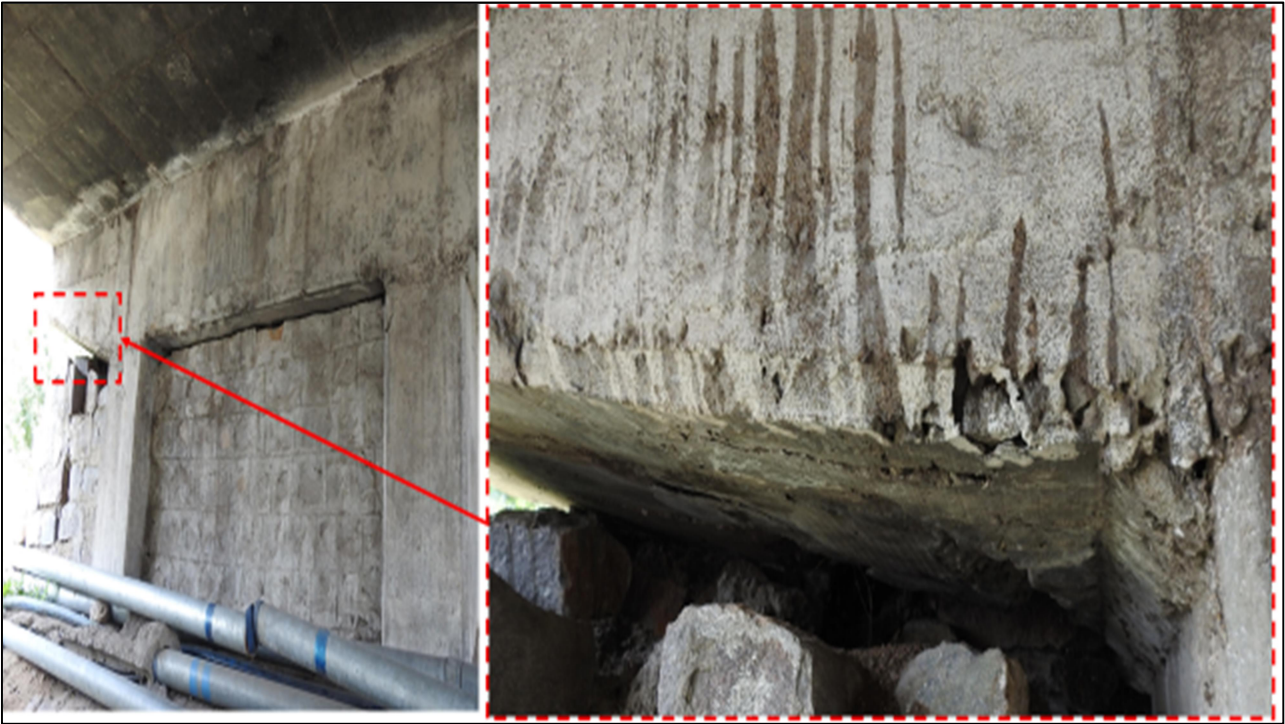
**Fig: 4** Deterioration of cantilever portion of bedblock observed at Abutment -2

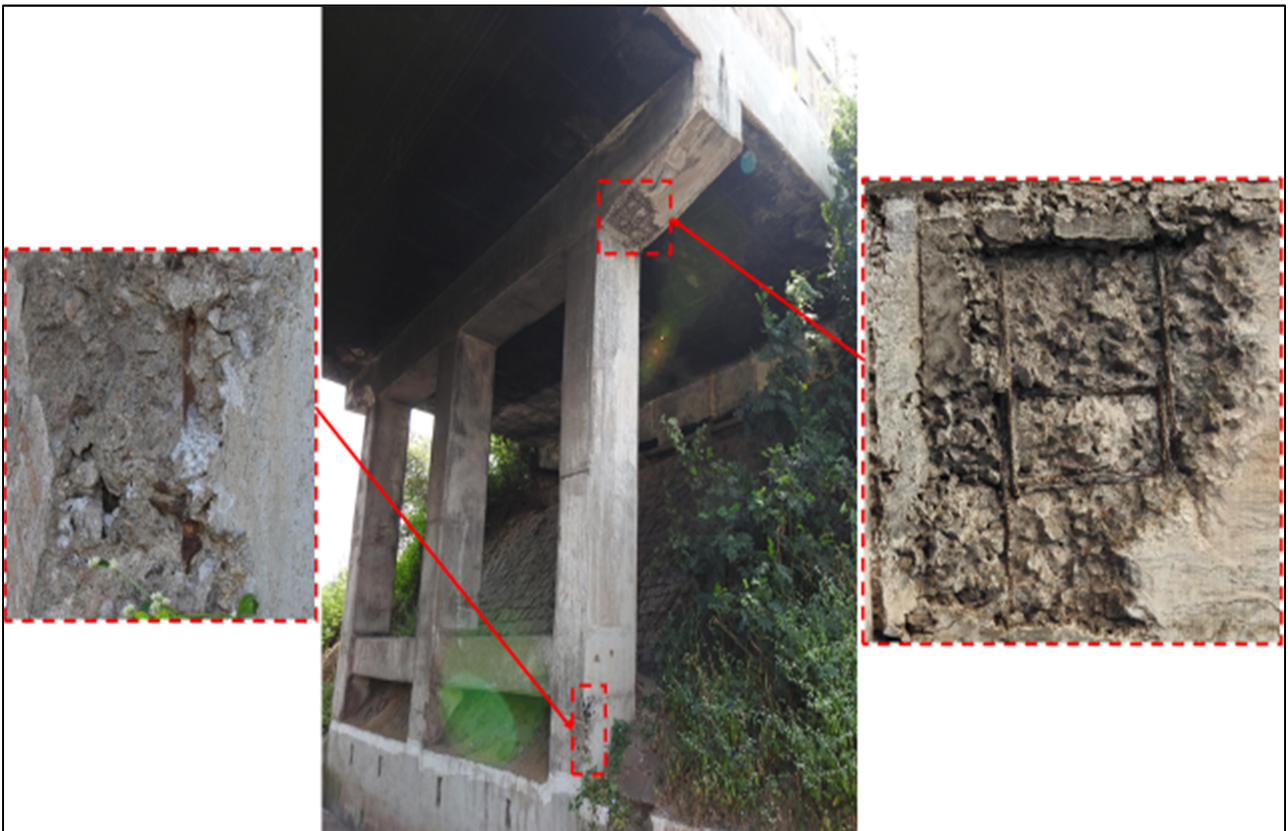
| PART 3 SURVEY OF SIGNS OF DISTRESS, DEFORMATION IN BRIDGES | | | |
|---|---|---|---|
| | Spalling | Slab & Piers | Spalling is observed at all the piers of Bridge ( <i>Refer Fig: 5, 6, 7, 9</i> ) and also at Span-5. ( <i>Refer Fig:16</i> ) |
| | Reinforcement Exposure | Slab, Piers | Reinforcement exposure is observed at Span-1, 3 & 5 slabs and also at piers-2, 3 & 4. ( <i>Refer Fig:5,6,7,9 and Fig:10,16</i> ) |

**Fig: 5** Reinforcement Exposure observed at Pier-1

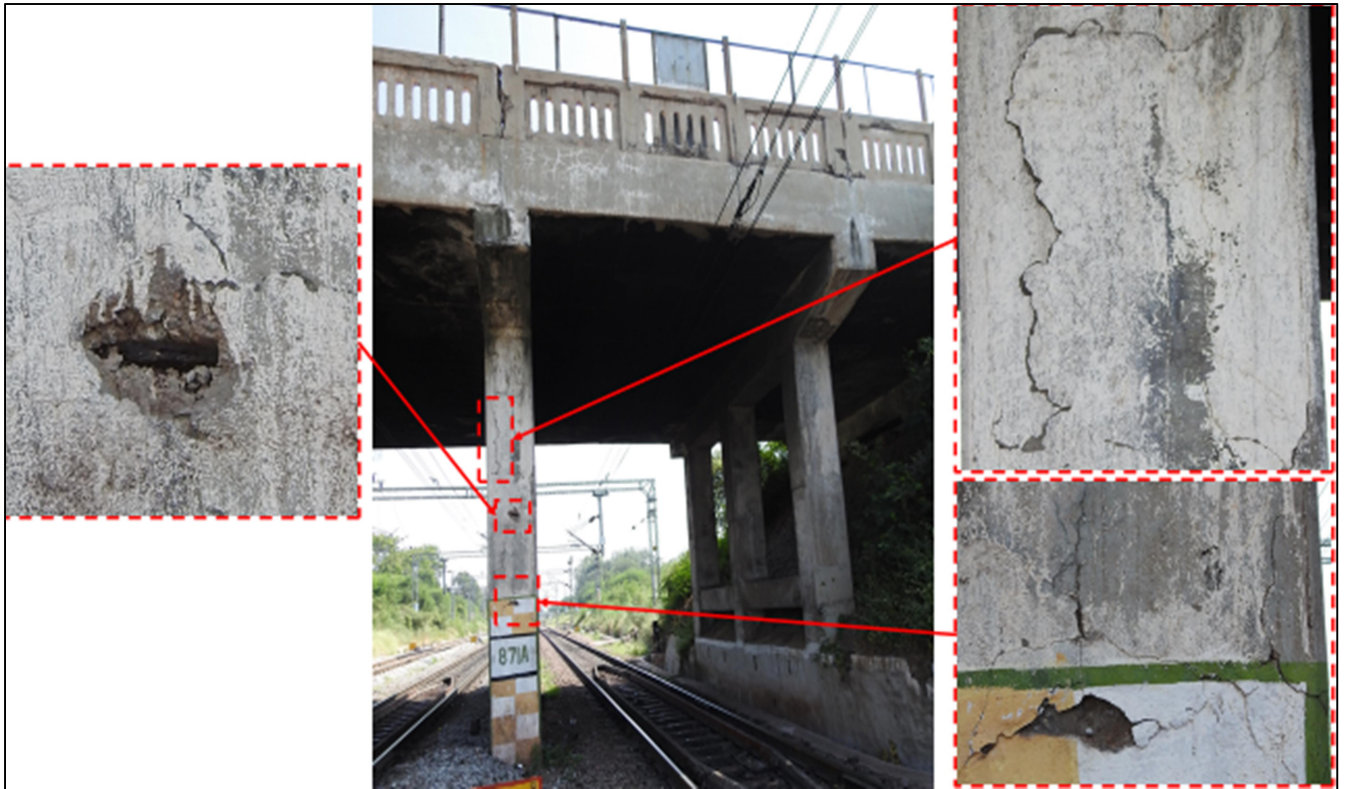
| PART 3 SURVEY OF SIGNS OF DISTRESS, DEFORMATION IN BRIDGES | | | |
|---|---|---|---|
| | Cracking in RCC components | Slab & Parapet | cracks are observed in Slab ( <i>Refer Fig:6,8</i> ) & Parapet ( <i>Refer Fig:17</i> ) |

**Fig: 6** Cracks observed and Reinforcement Exposure observed at Pier-2

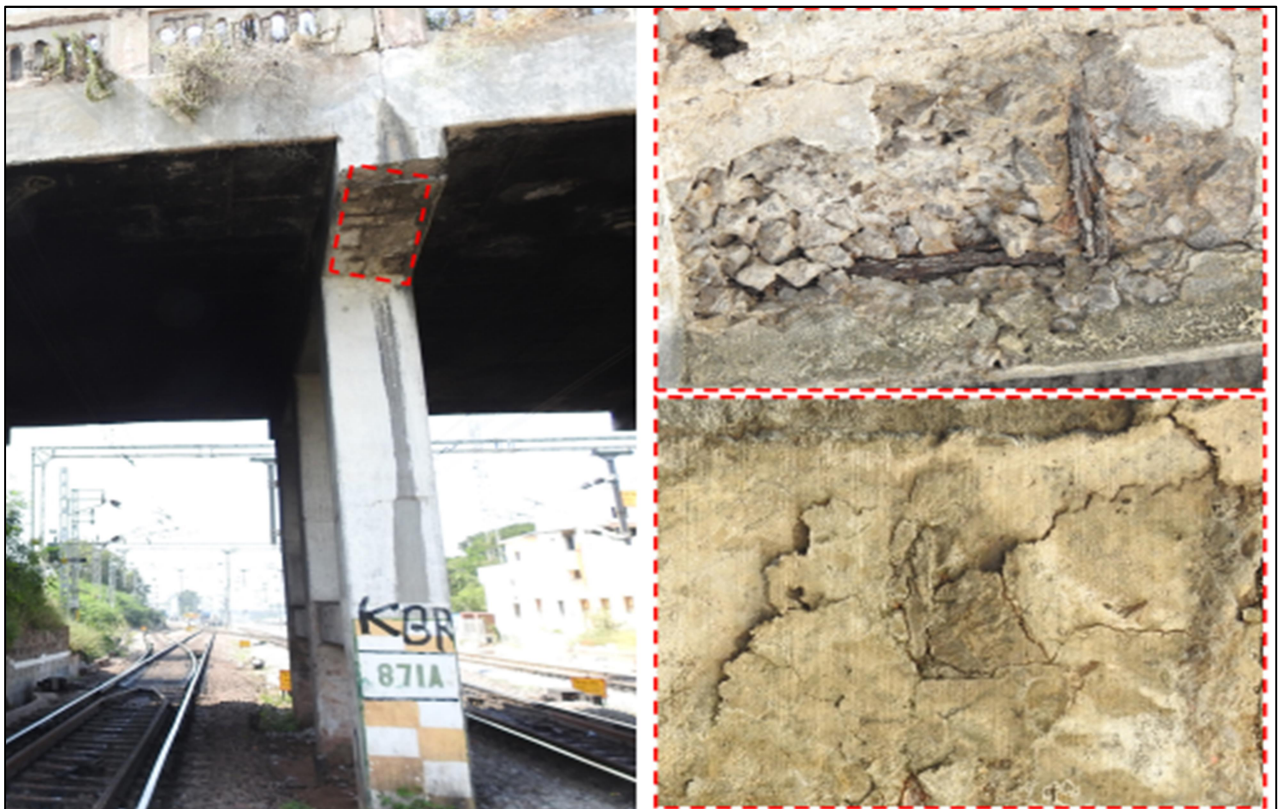
| 1.13 | History of Repair/ Maintenance | Patch work is observed. (Refer Fig-7) |

**Fig: 7** Reinforcement exposure & Patch work observed at Pier-3

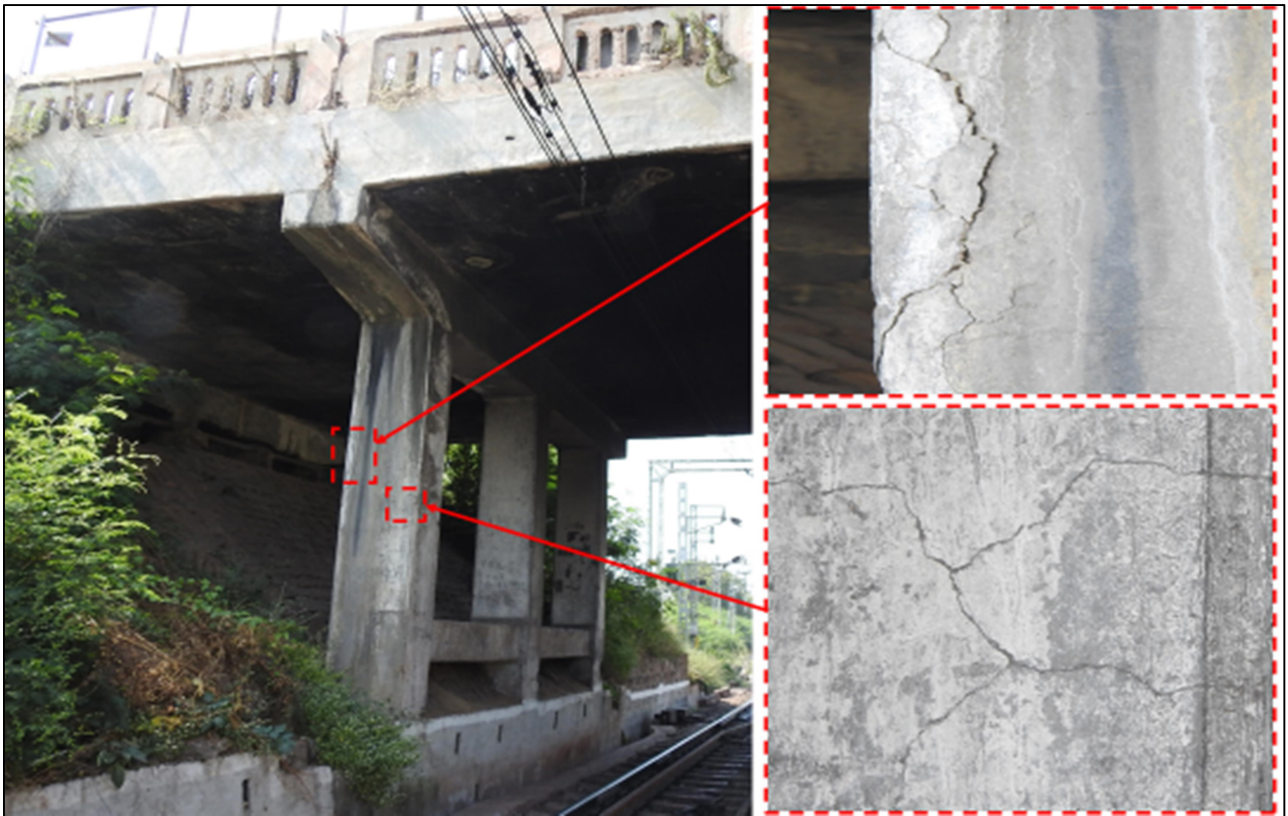
**Fig: 8** Spalling and Cracks observed at Pier-4

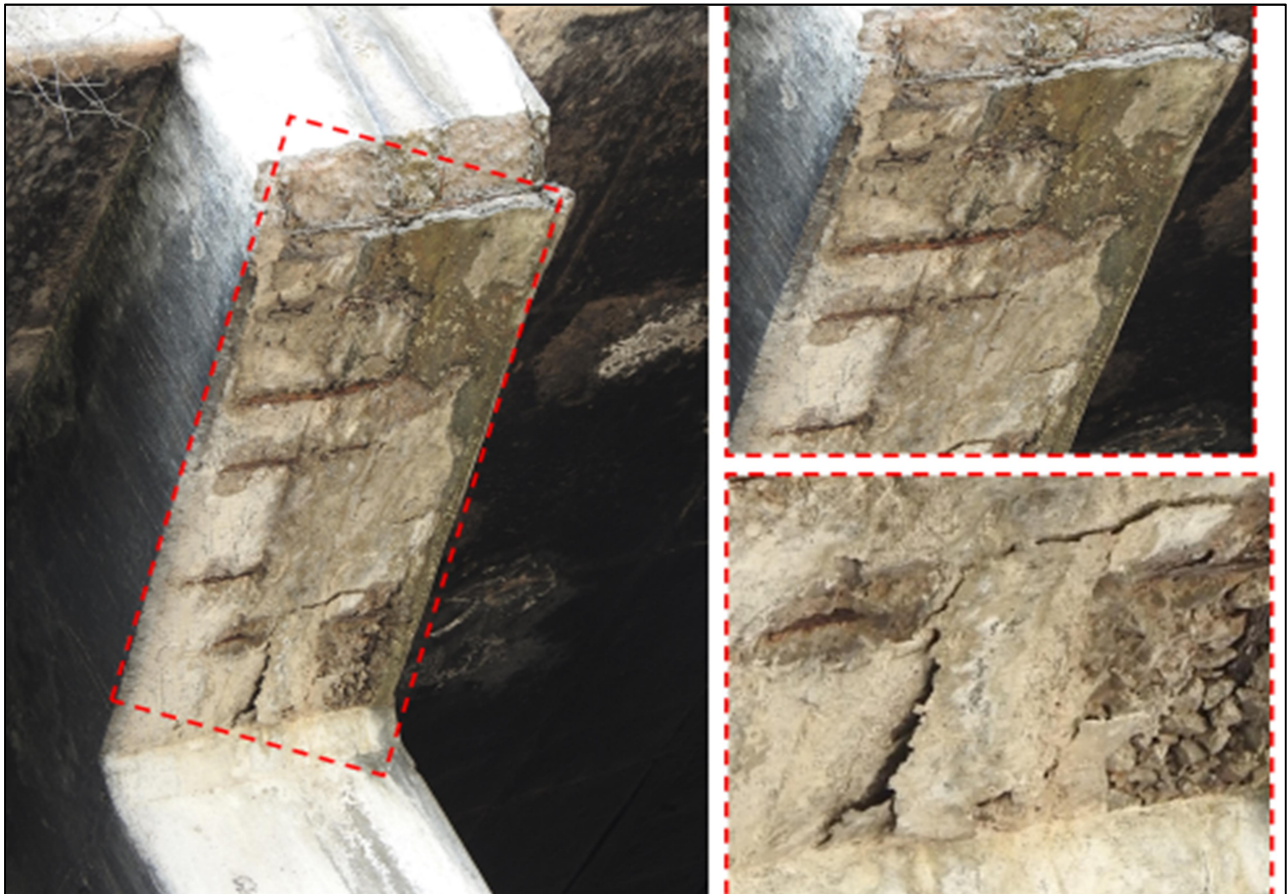
**Fig: 9** Reinforcement exposure & Spalling observed at Pier cap-4

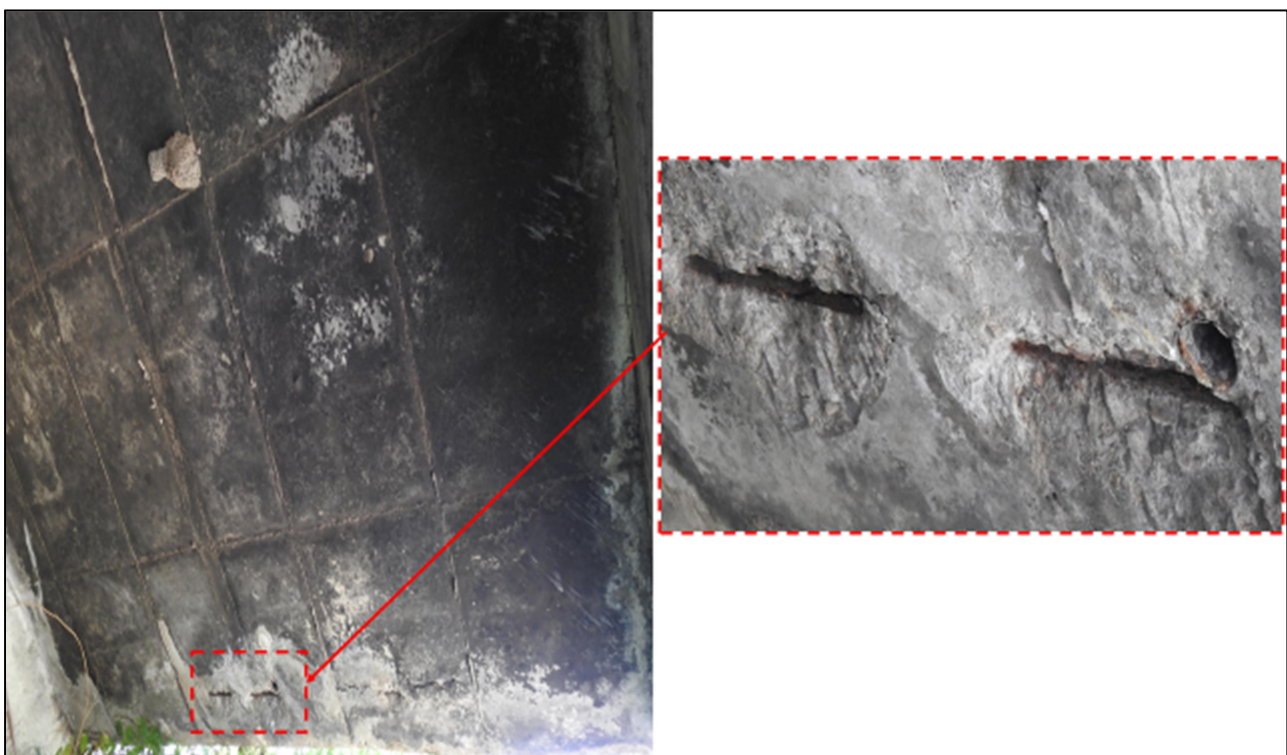
| | Condition of Slab from Bottom | Distress Found | Cracks, Spalling & Reinforcement exposure has been Observed. (Refer Fig:10, 15) |

**Fig: 10** Reinforcement exposure observed at Slab of Span-1

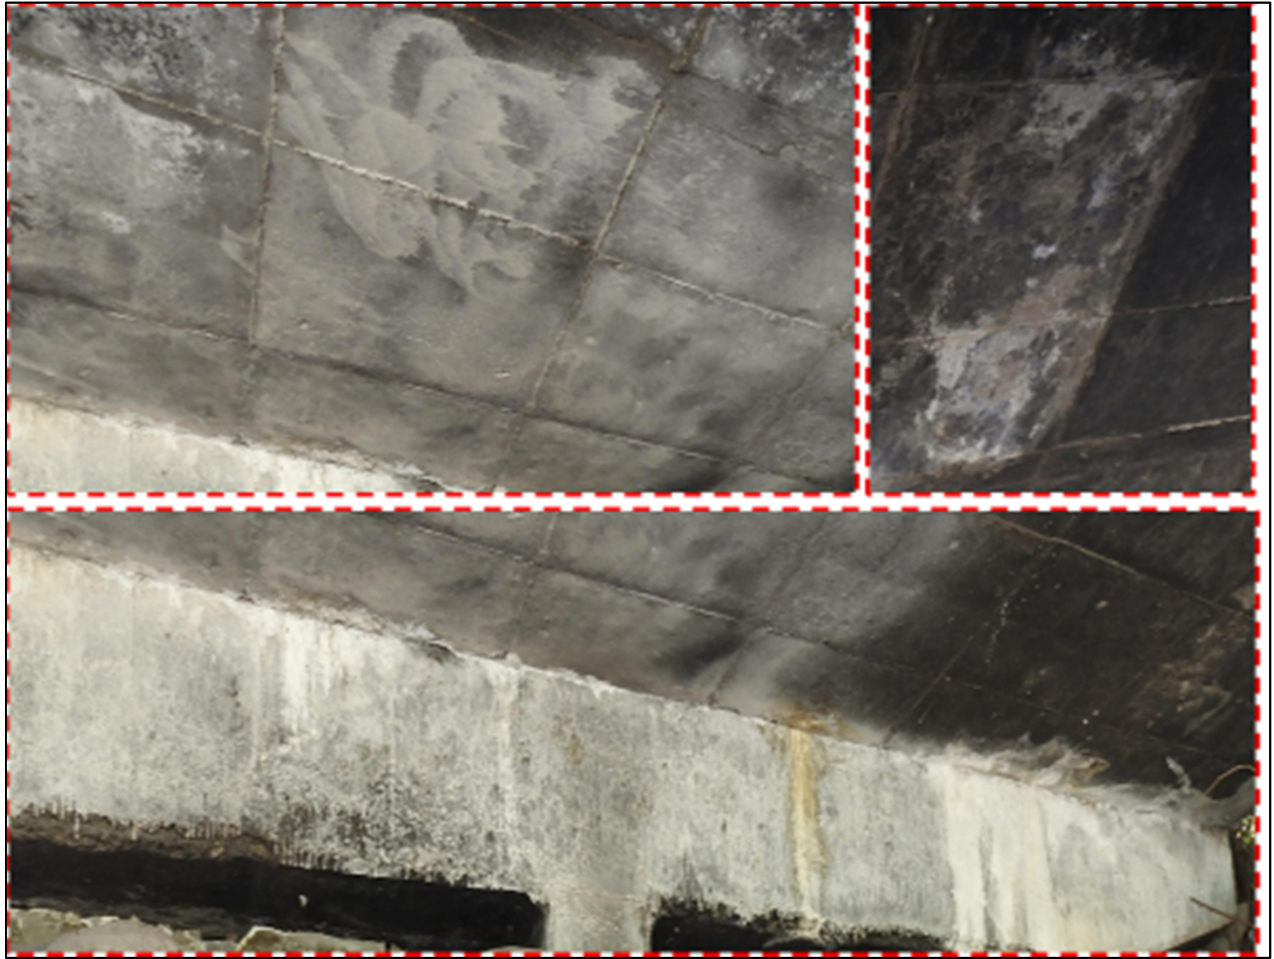
**Fig: 11** Leaching observed at slab of Span-1

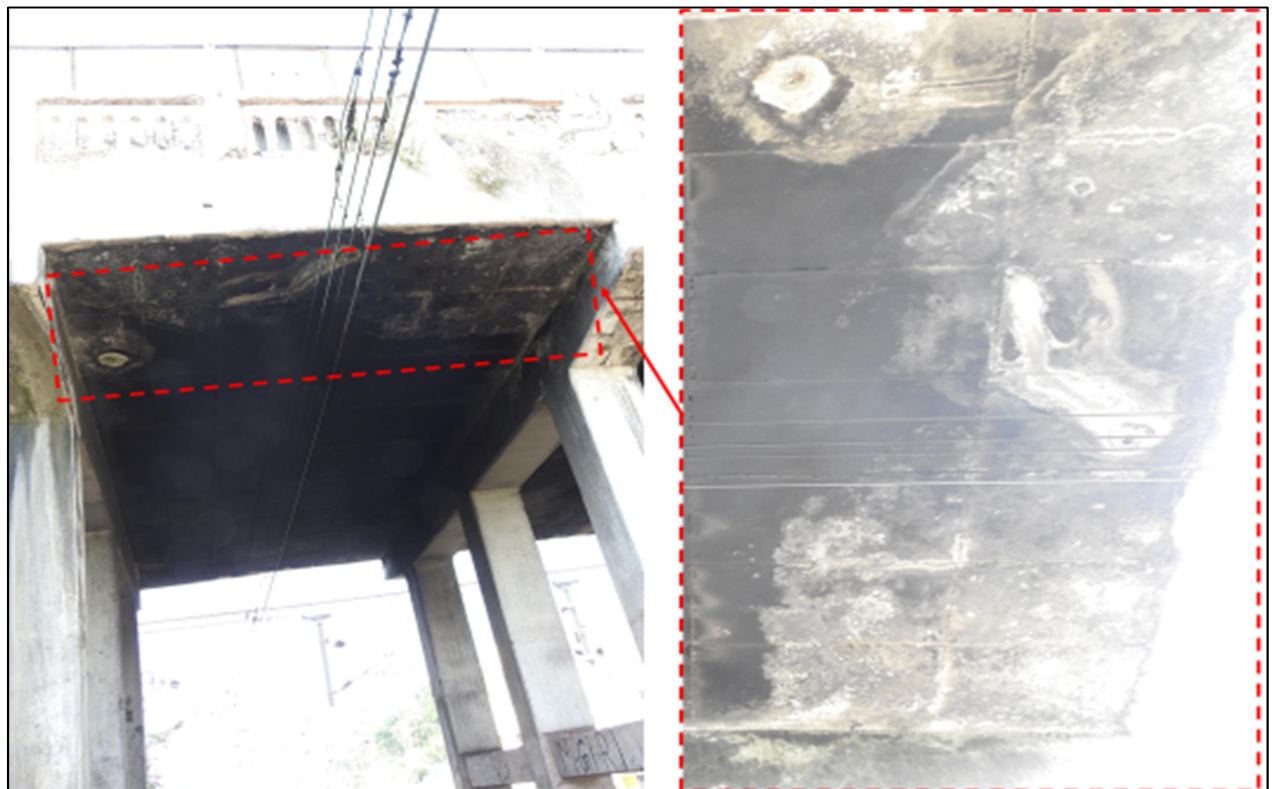
**Fig: 12** Leaching observed at slab of Span-2

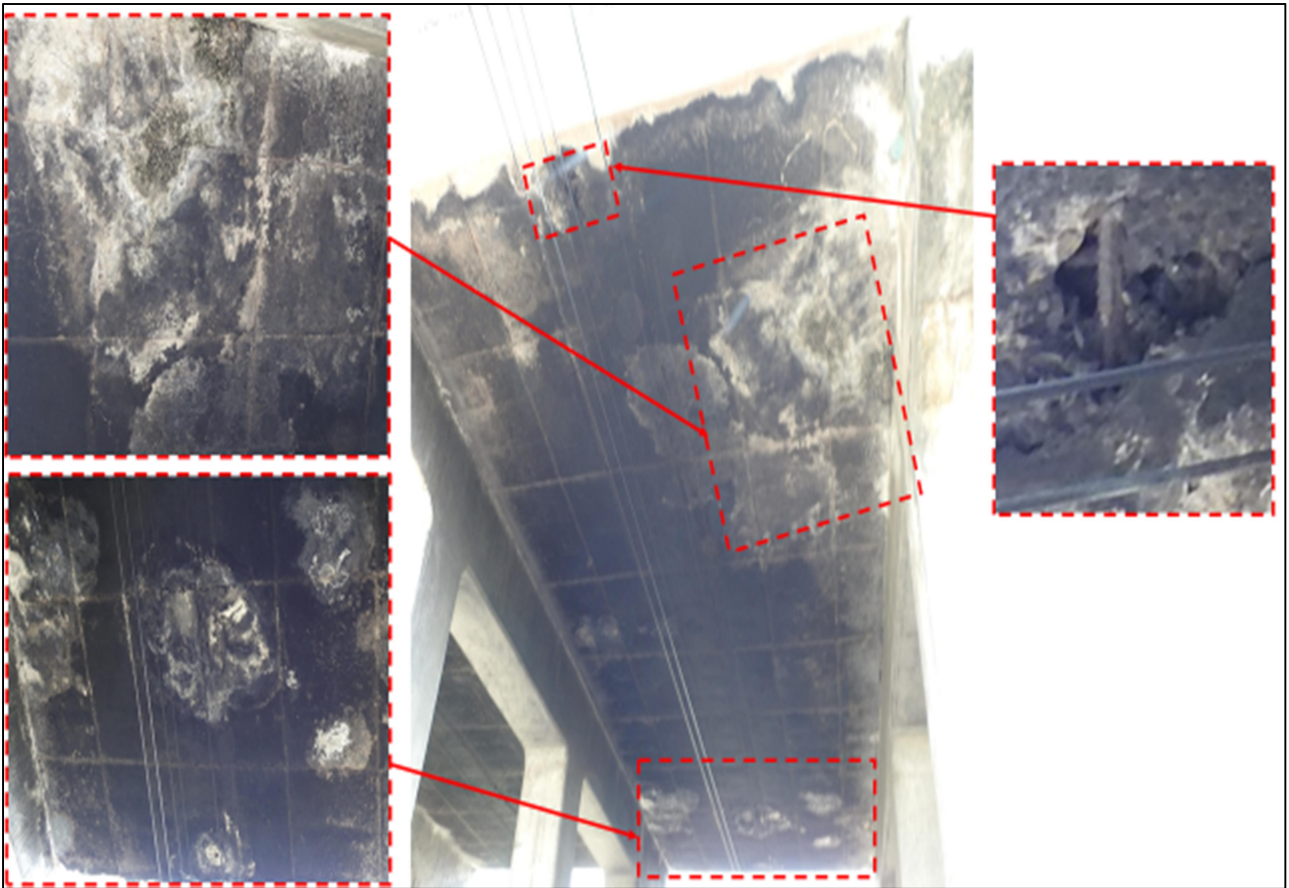
**Fig: 13** Leaching observed at slab of Span-3

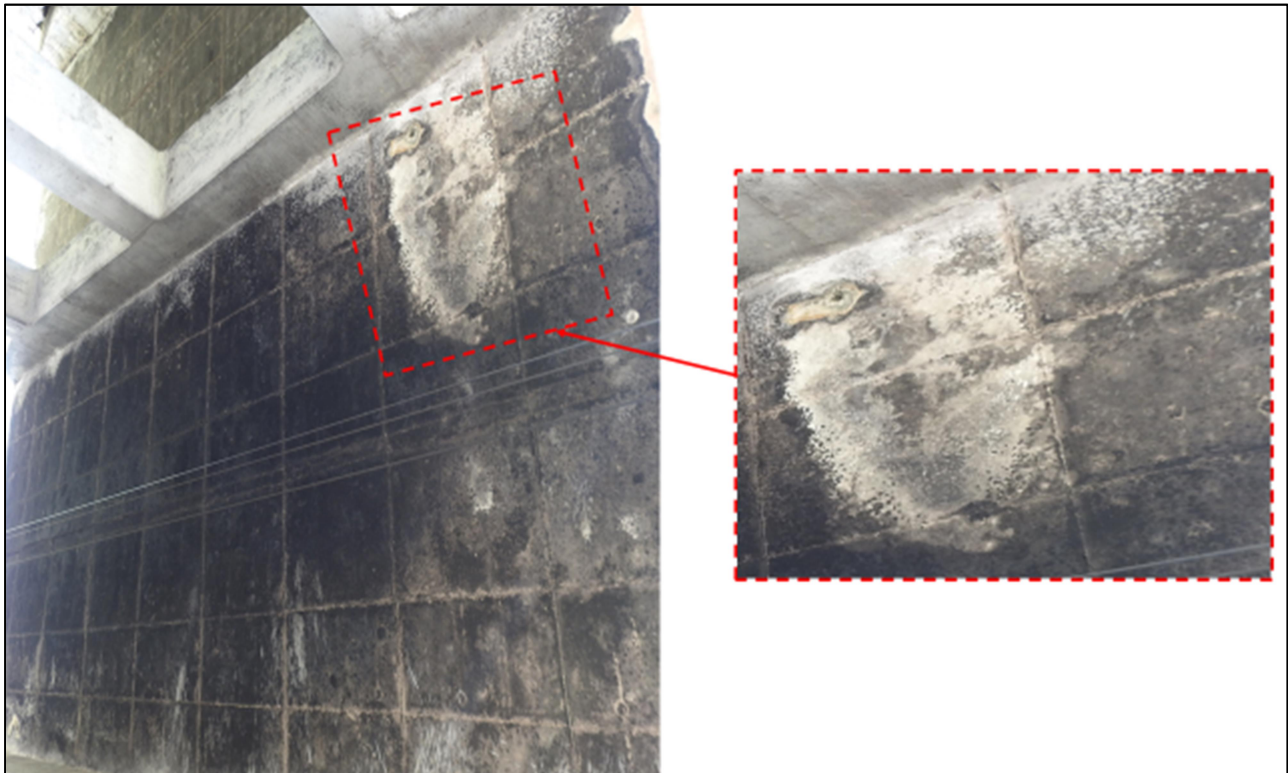
**Fig: 14** Leaching observed at slab of Span-4

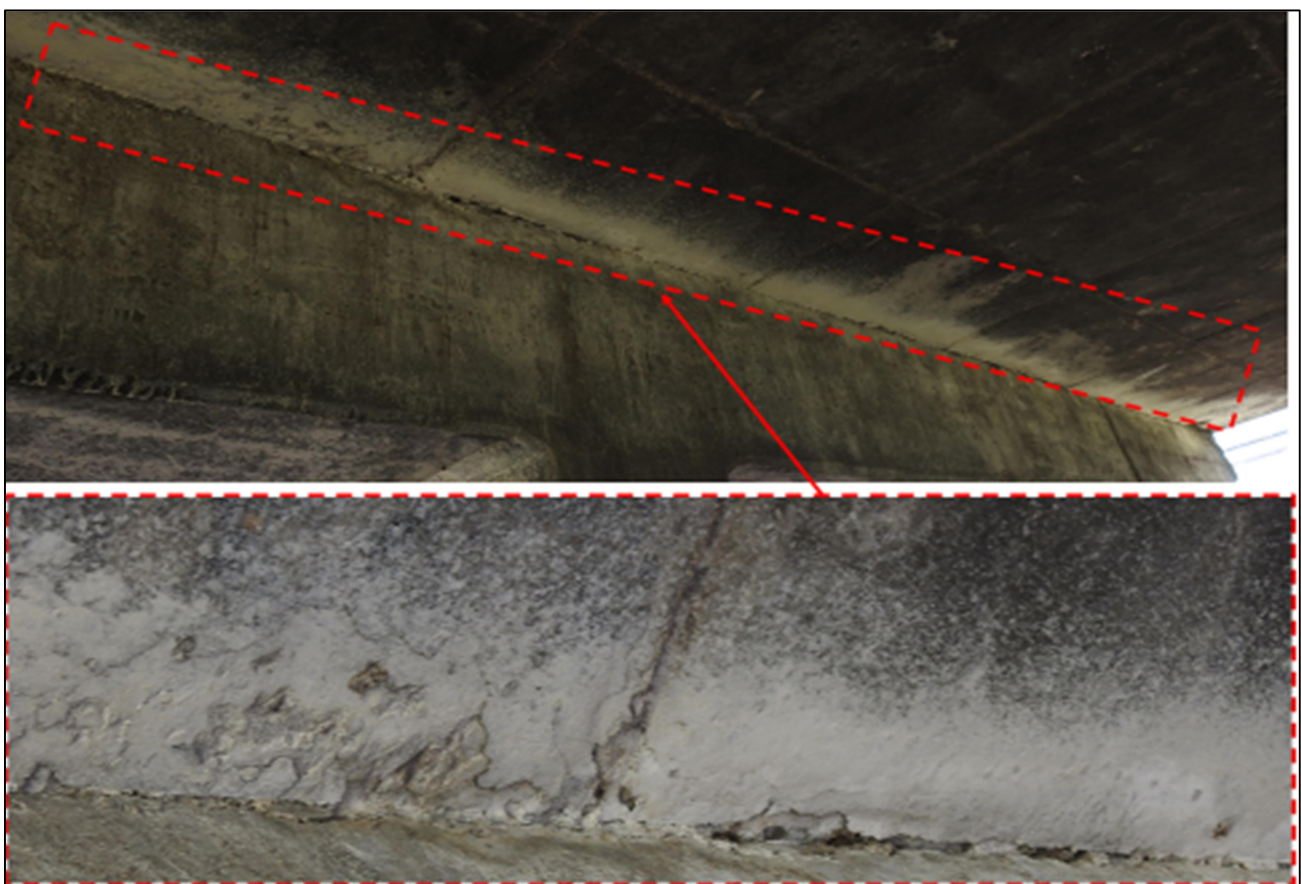
**Fig: 15** Leaching observed at slab of Span-5

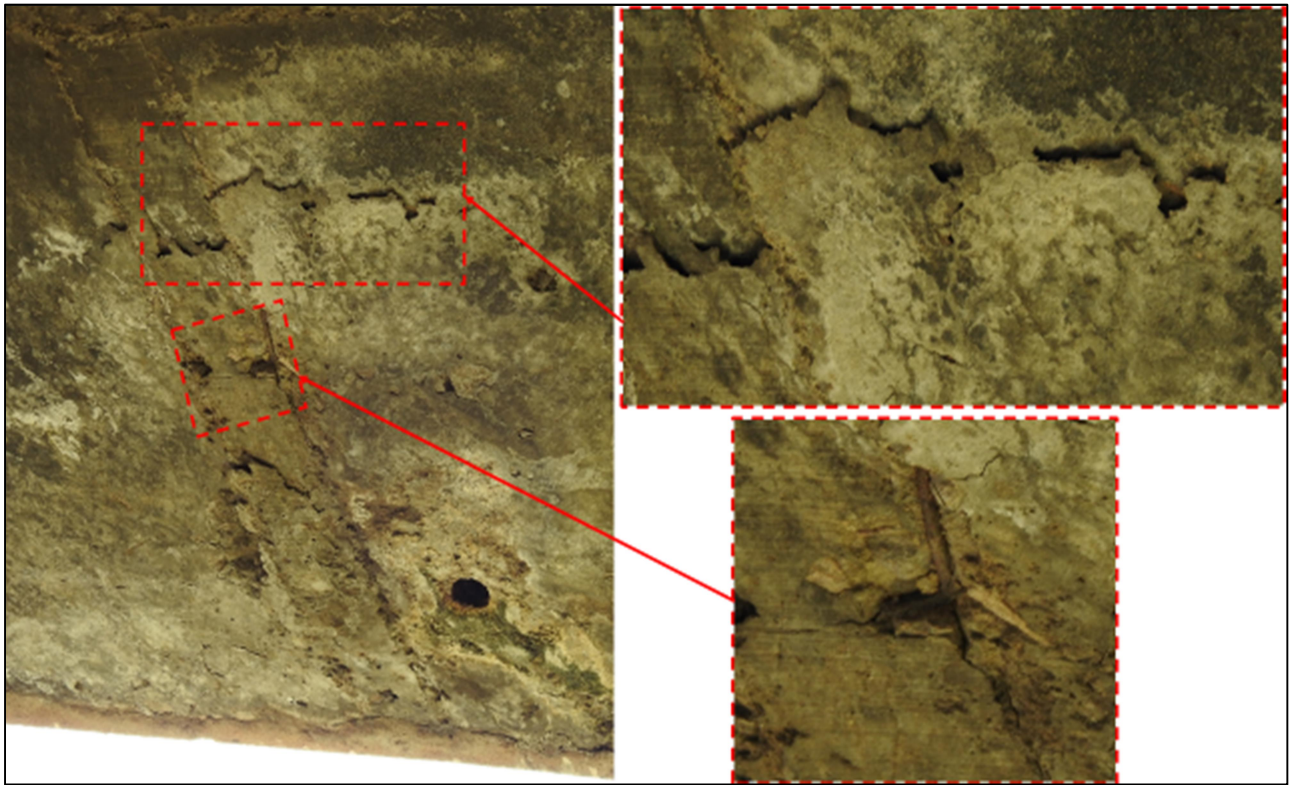
**Fig: 16** Spalling & Reinforcement exposure observed at slab of Span-5

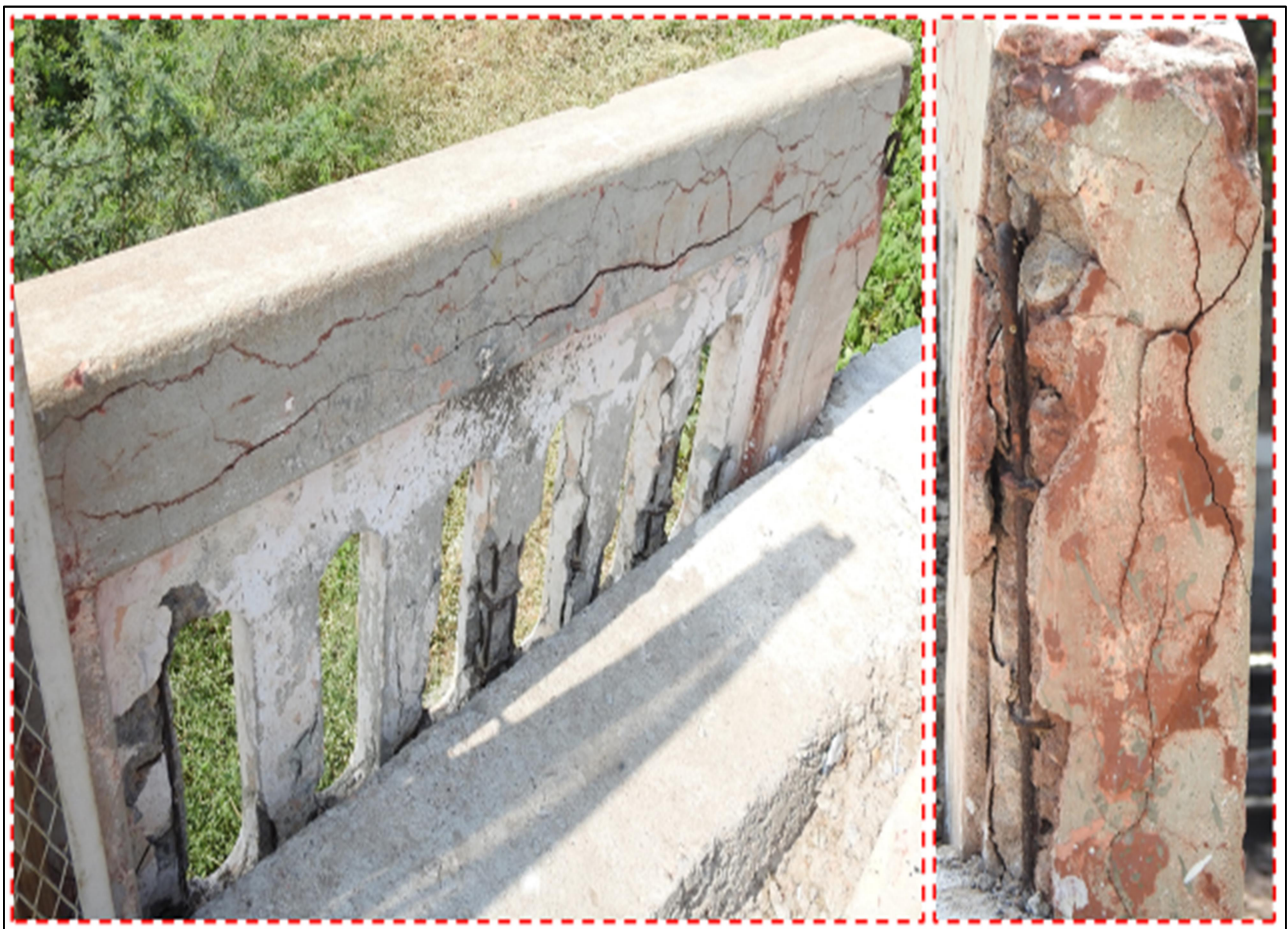
| | Condition of Wall/Railing | | Cracks and Reinforcement exposure observed. (Refer Fig:17) |

***Fig: 17*** Cracks & Reinforcement exposure observed in Railing

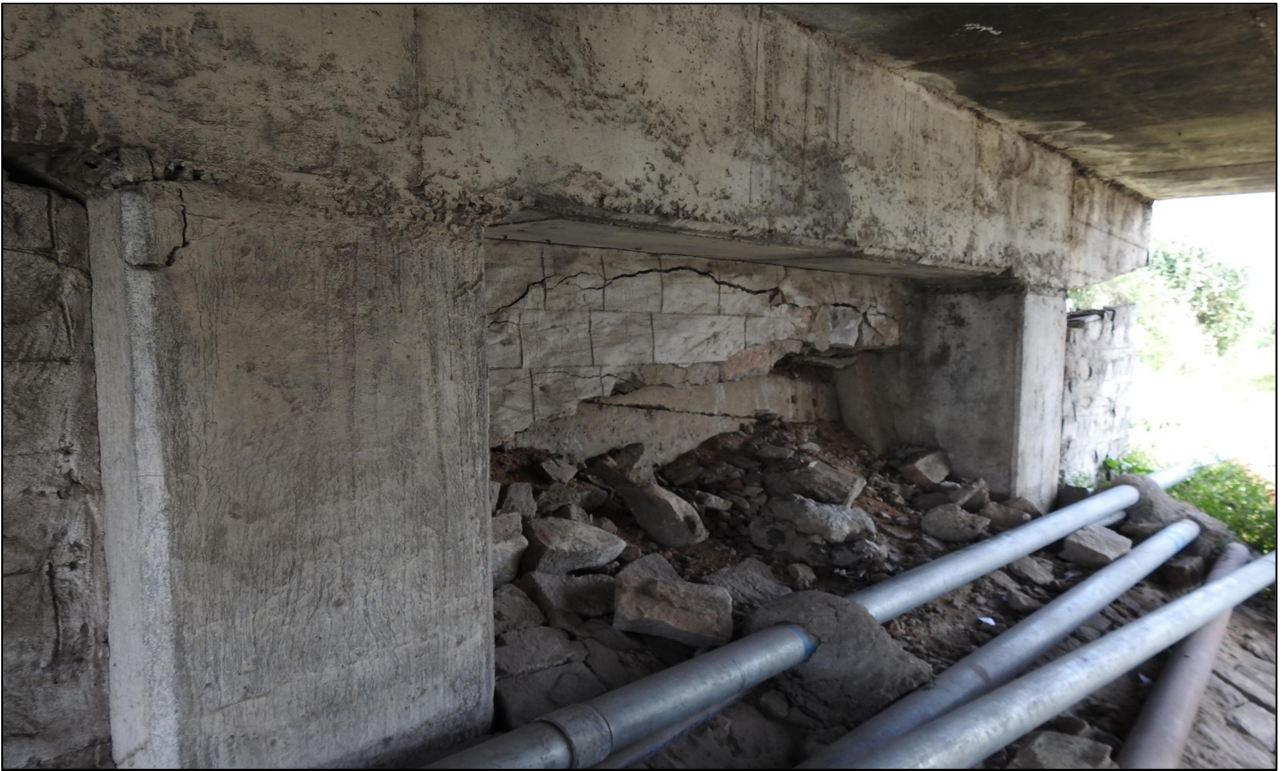
| PART 2 STRUCTURAL SYSTEM OF THE BRIDGE | | | |
|---|---|---|---|
| | Efficiency of drainage of backfill Behind Abutments (Check functioning of weep holes, evidence of moisture on Abutment faces, etc.) | No weep holes | Retaining wall at abutment-2 is damaged due to Earth Pressure. (Refer Fig:18) |

***Fig: 18*** Retaining wall damaged at Abutment-2
