| <b>Name of the Project</b> | <b>:</b> | <b>VISUAL INSPECTION OF ROB No 1216A<br/>NEAR YADGIR RAILWAY STATION</b> |
| <b>Location</b> | <b>:</b> | <b>YADGIR</b> |
| <b>Date of Inspection</b> | <b>:</b> | <b>23<sup>rd</sup> NOVEMBER, 2019</b> |

## VISUAL INSPECTION OF ROAD OVER BRIDGE

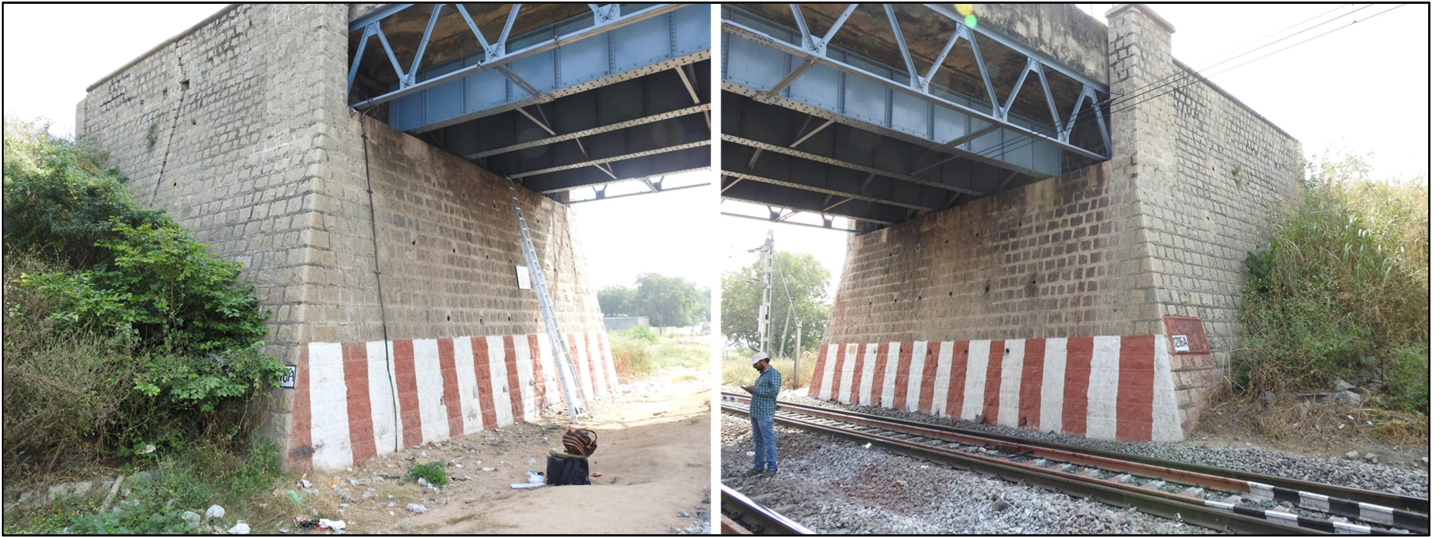
| PART 2 STRUCTURAL SYSTEM OF THE BRIDGE | | | |
|---|---|---|---|
| | Efficiency of drainage of backfill Behind Abutments (Check functioning of weep holes, evidence of moisture on Abutment faces, etc.) | | Weep holes are in dry condition. (Refer Fig:3) |

**Fig: 2** Abutment (A1 and A2) Stone Masonry

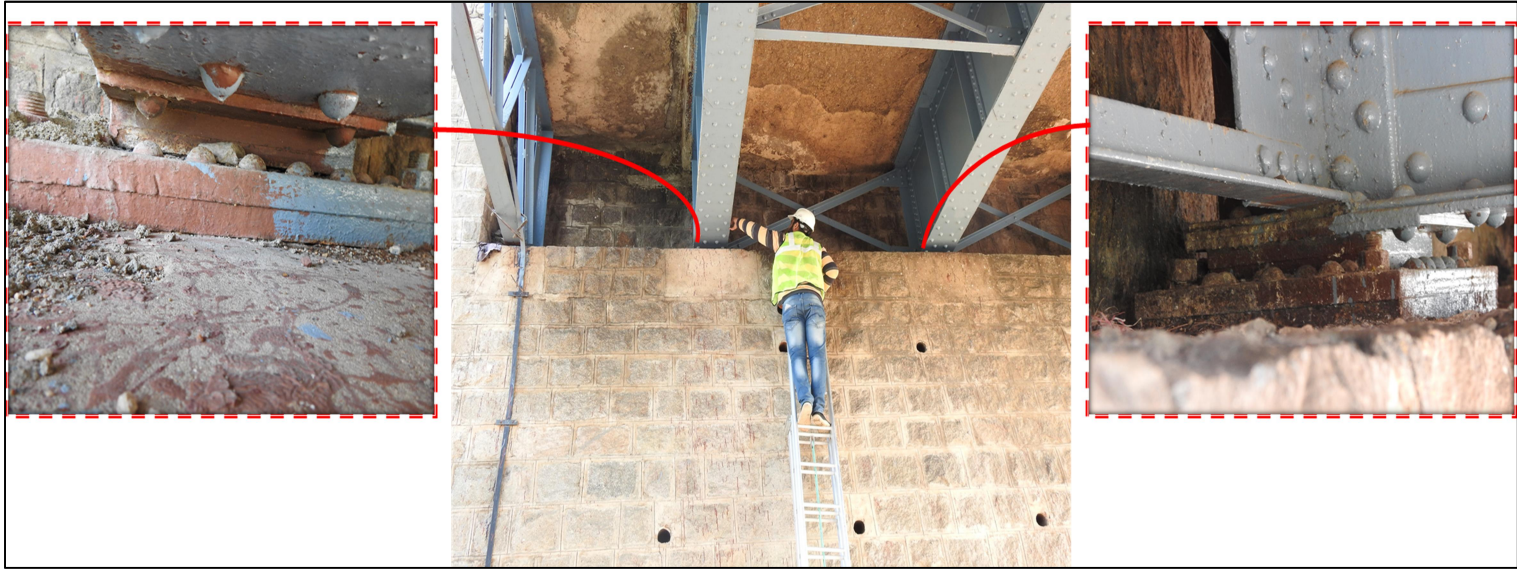
| | General condition<br>(Check Corrosion, cleanliness, seizing of plates silting, accumulations of dirt in case of submersible bridges) | | Debris accumulated at all bearings |

***Fig: 5*** Metal plate bearings

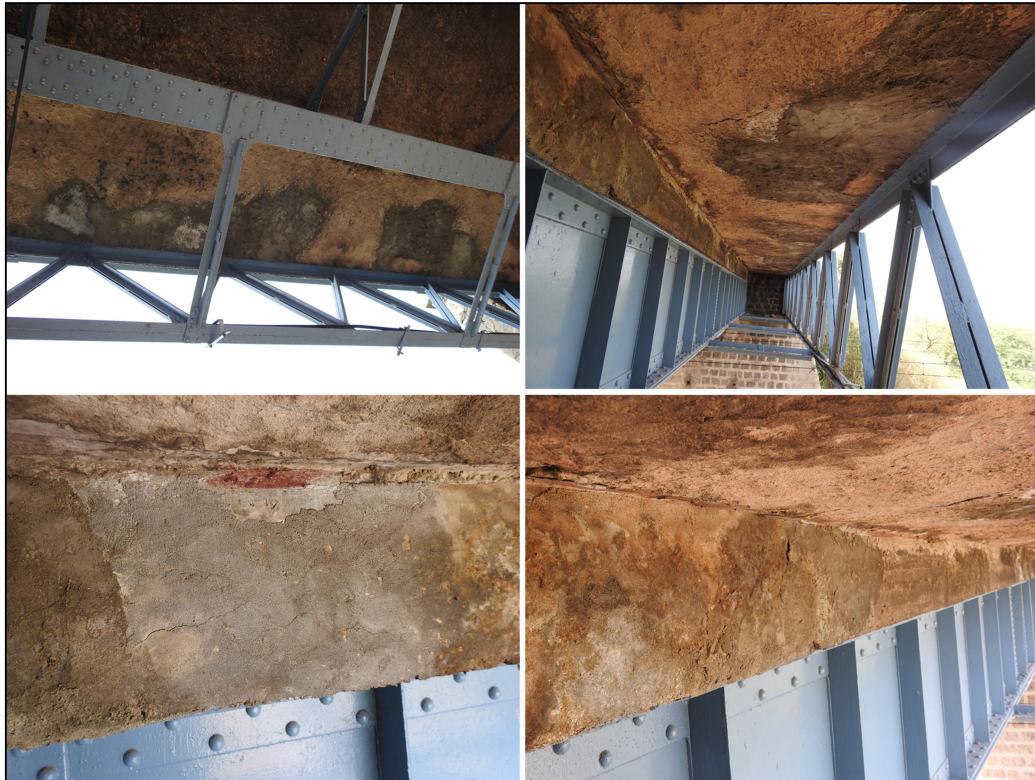
| PART 3 SURVEY OF SIGNS OF DISTRESS, DEFORMATION IN BRIDGES | | | |
|---|---|---|---|
| | Cracking in RCC components | Slab & Parapet | cracks are observed in Slab ( <i>Refer Fig:9</i> ) & Parapet ( <i>Refer Fig:6 and Fig:7</i> ) |
| | Spalling | Slab & Parapet | Spalling is observed in Slab & Parapet. ( <i>Refer Fig:6 and Fig:7</i> ) |

***Fig: 6*** Patch work observed in Slab

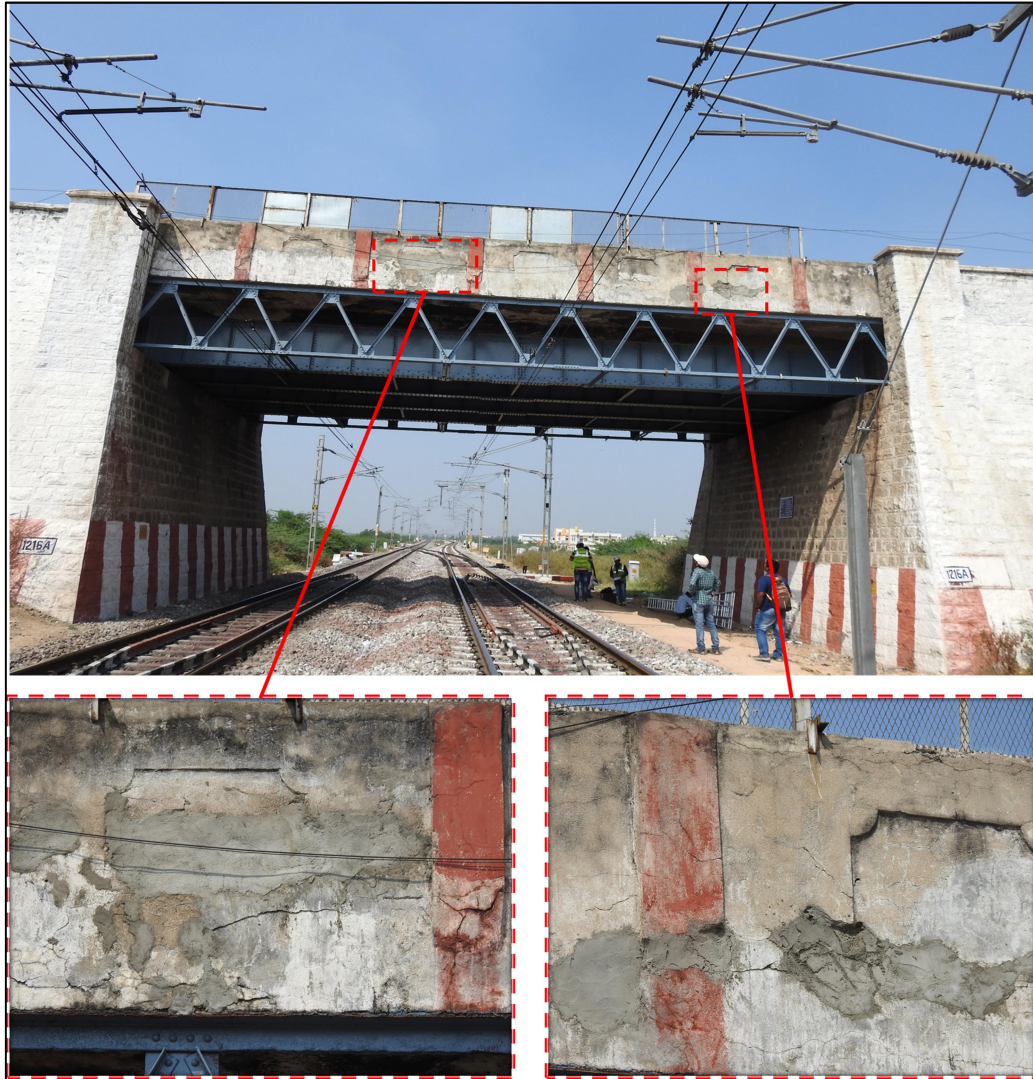
| | Condition of Wall/Railing | | Cracks and spalling observed |

**Fig: 7** Patch work observed in Parapet wall

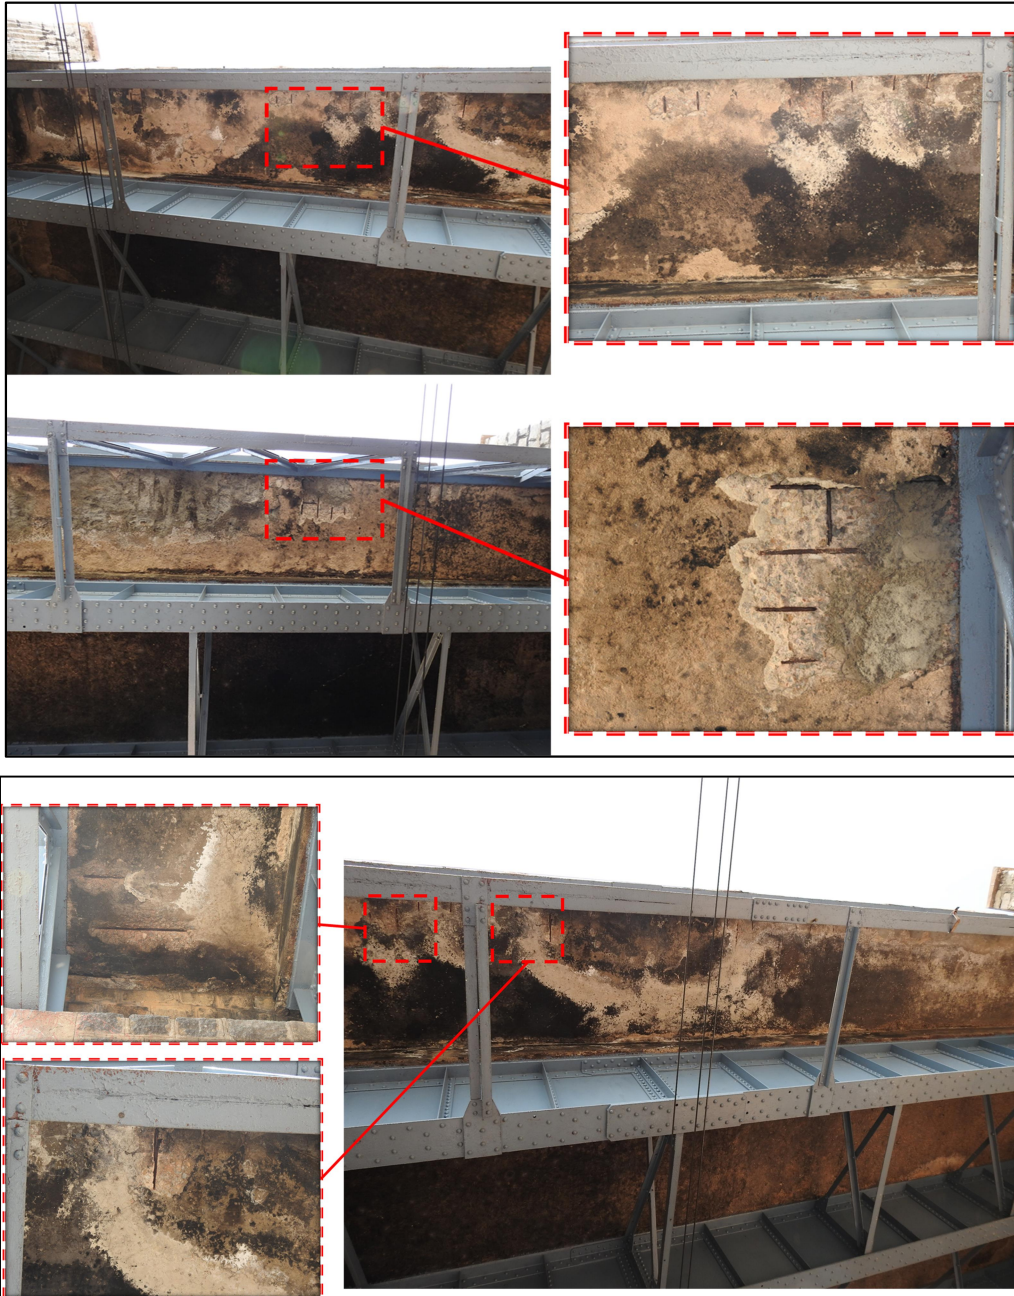
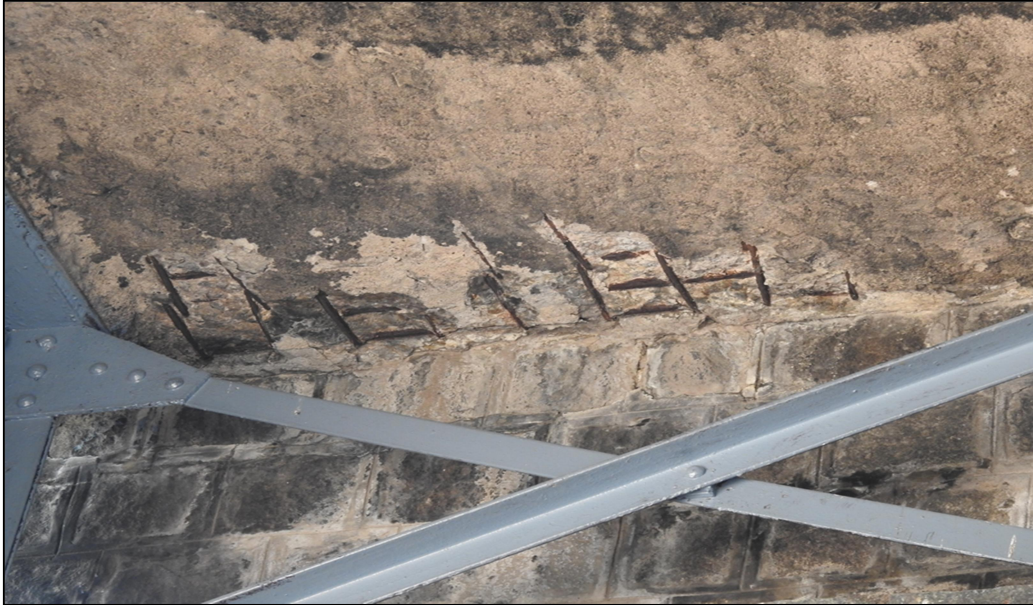
| | Condition of Slab from Bottom | Distresses Found | Spalling & Reinforcement exposure has been Observed. (Refer Fig:8) |

| PART 3 SURVEY OF SIGNS OF DISTRESS, DEFORMATION IN BRIDGES | | | |
|---|---|---|---|
| | Reinforcement Exposure | Slab | Reinforcement Exposure is observed in Slab ( <i>Refer Fig:8</i> ) |

**Fig: 8** Leaching and exposed reinforcement in slab

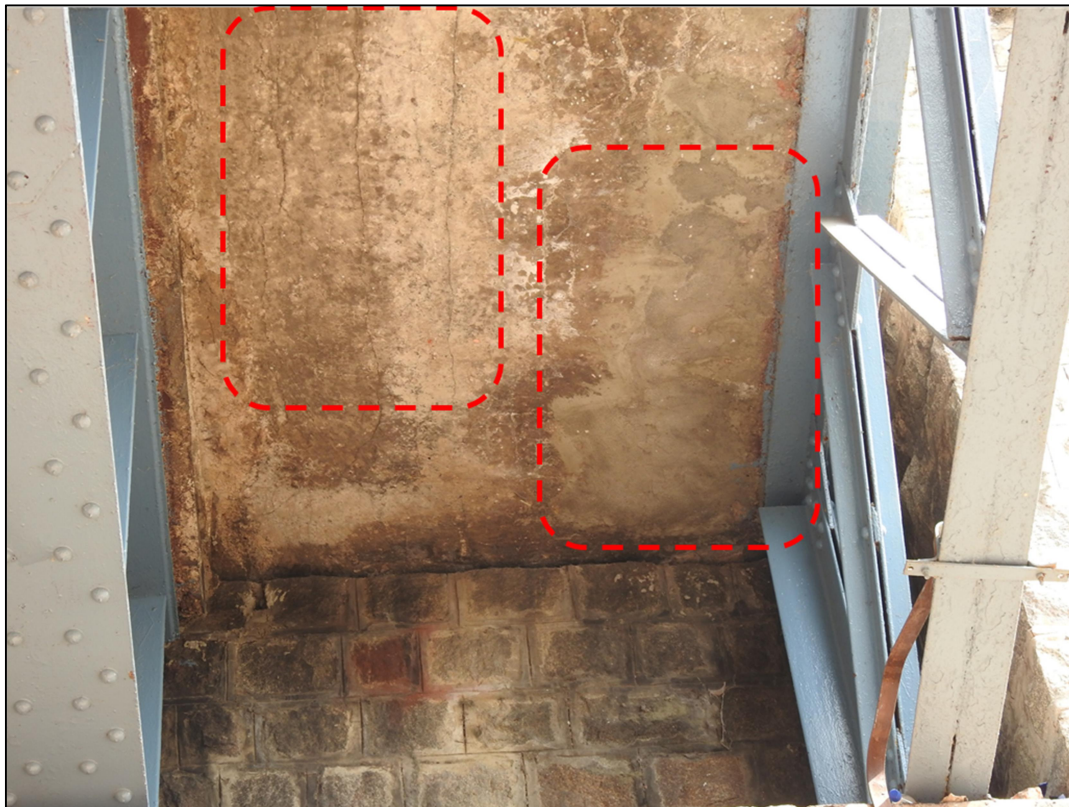
**Fig: 9** Cracks and patch work observed in slab.

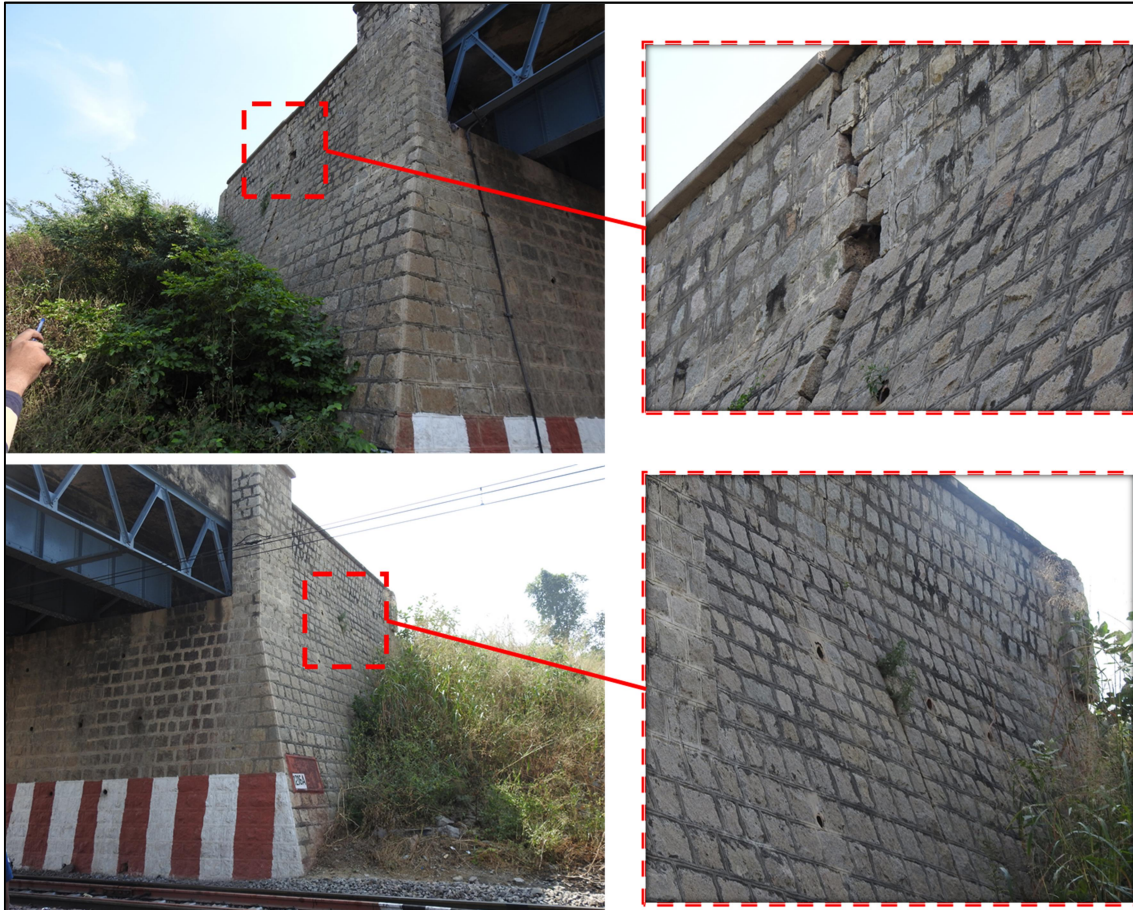
| PART 2 STRUCTURAL SYSTEM OF THE BRIDGE | | | |
|---|---|---|---|
| | Condition (Crack, Settlement, Scour, Tilting, Steel Corrosion, Strains and other damages etc...) | | Cracks are observed at abutments due to pointing Failure (Refer Fig:10) |

**Fig: 10** pointing and vegetation on Abutments on both sides

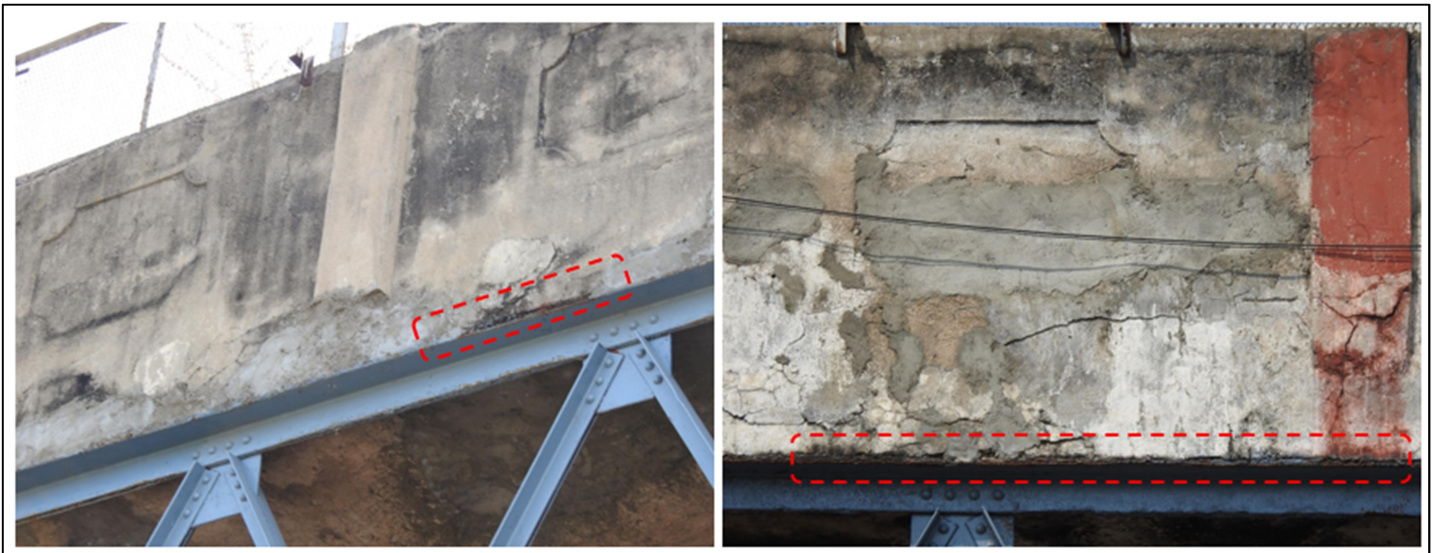
| PART 3 SURVEY OF SIGNS OF DISTRESS, DEFORMATION IN BRIDGES | | | |
|---|---|---|---|
| | Corrosion | Steel-Concrete Joints | Corrosion is observed at steel concrete joints of Exterior Support Truss ( <i>Refer Fig:11</i> ) |

**Fig: 11** Corrosion at the steel concrete joints of Exterior Support Truss.
