| <b>Name of the Project</b> | <b>:</b> | <b>VISUAL INSPECTION OF ROB (8B)</b> |
| <b>Location</b> | <b>:</b> | <b>NEAR GOOTY RAILWAY STATION</b> |
| <b>Date of Inspection</b> | <b>:</b> | <b>25<sup>th</sup> NOVEMBER, 2019</b> |

## VISUAL INSPECTION OF ROAD OVER BRIDGE

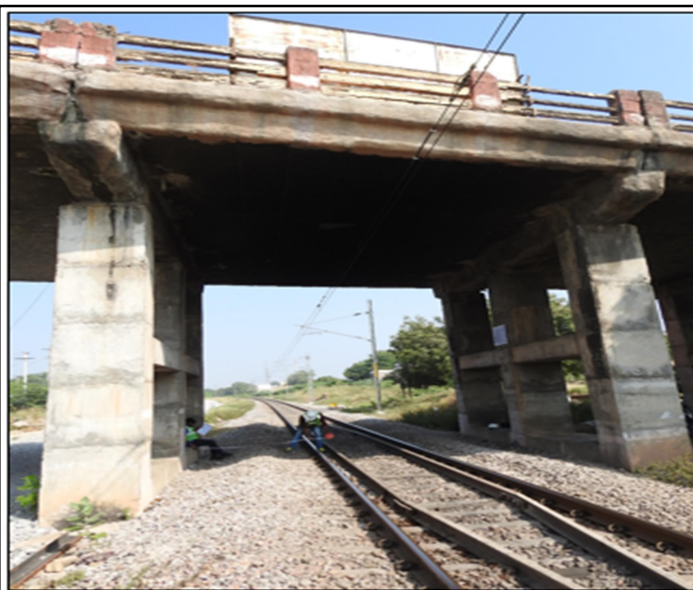
**Span 1**

**Fig.2:** Spans of the Bridge

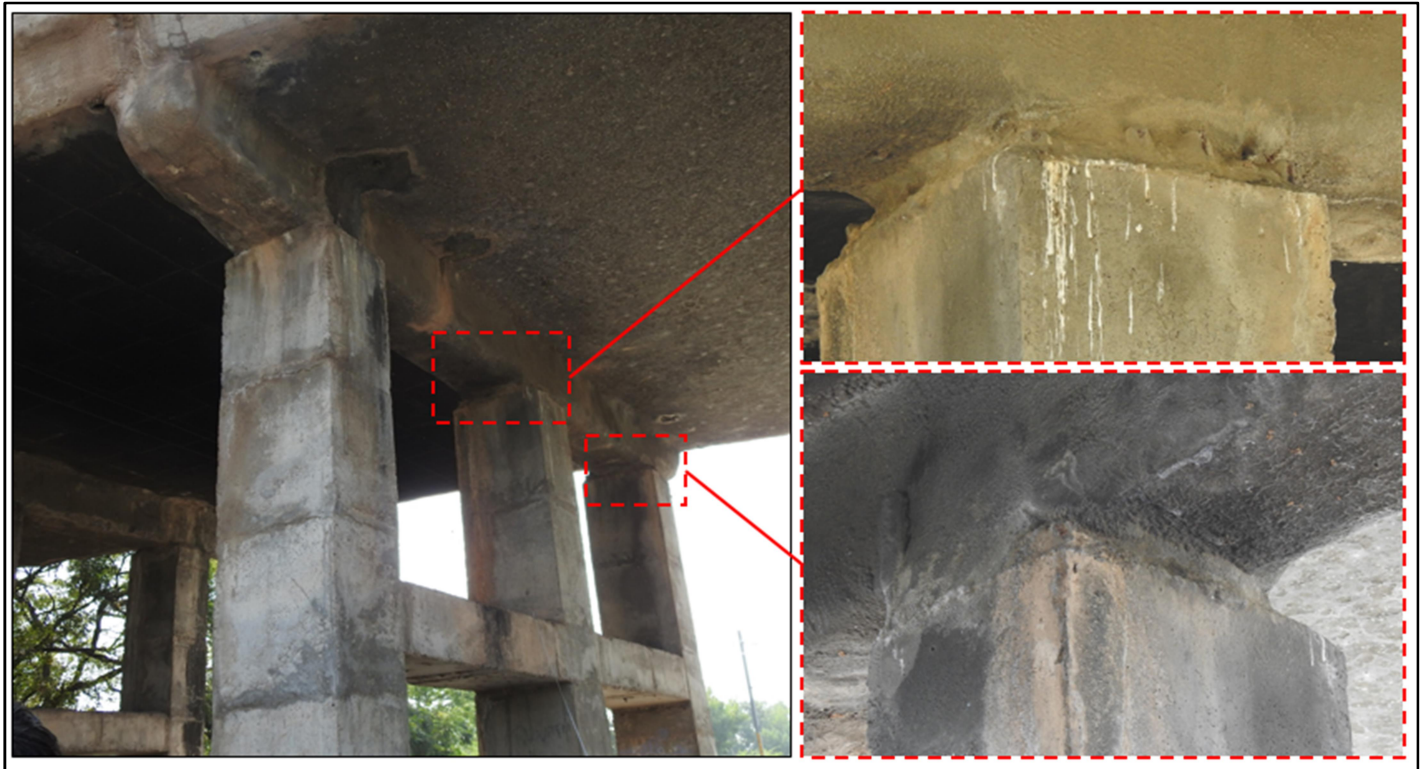
| PART 2 STRUCTURAL SYSTEM OF THE BRIDGE | | | |
|---|---|---|---|
| | Type (Shape) | Portal Pier | Portal Piers with 3 rectangular columns are provided.<br><br>Cracks, Spalling, Reinforcement exposure has been observed on Piers. <b>(Refer Fig-5 &amp; 7)</b><br><br>Patching/Jacketing/Shotcreting works have been done. <b>(Refer Fig-3 &amp; 4)</b> |

**Fig.3:** Patch works observed at Columns

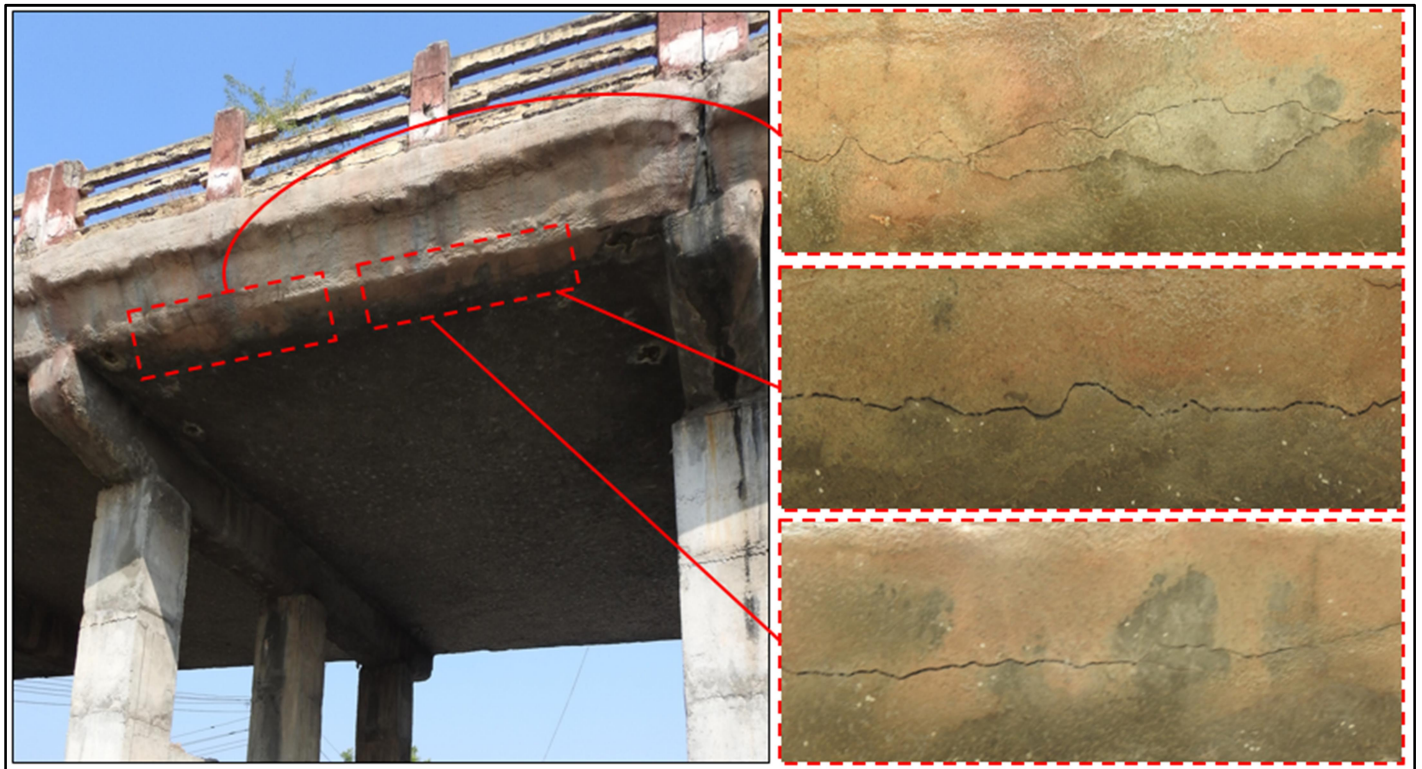
| | Condition of Slab from Bottom | | Cracks & Leaching has been Observed. (Refer Fig-4) |

**Fig.4:** Spalling and Cracks at slab bottom of span 2

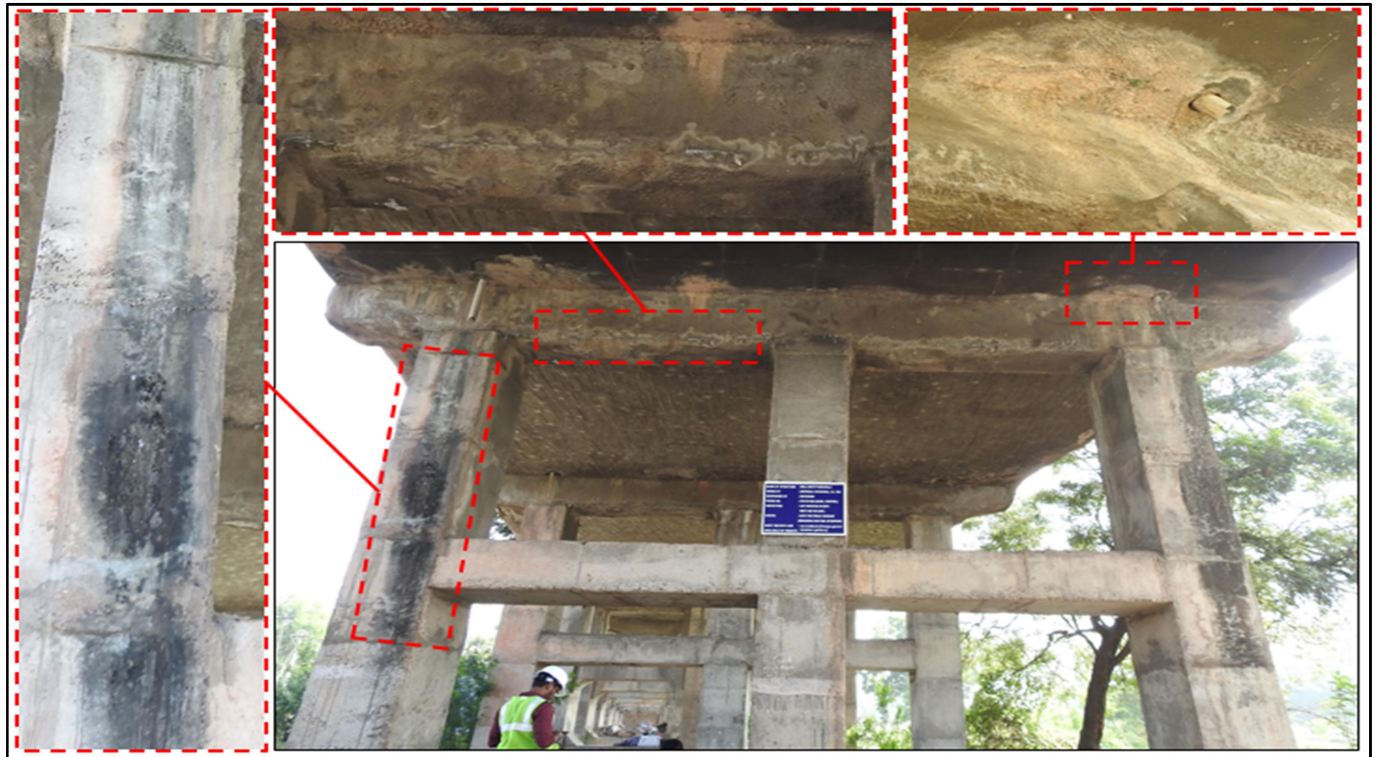
**Fig.5:** Spalling and leaching observed at columns and cap of pier-1.

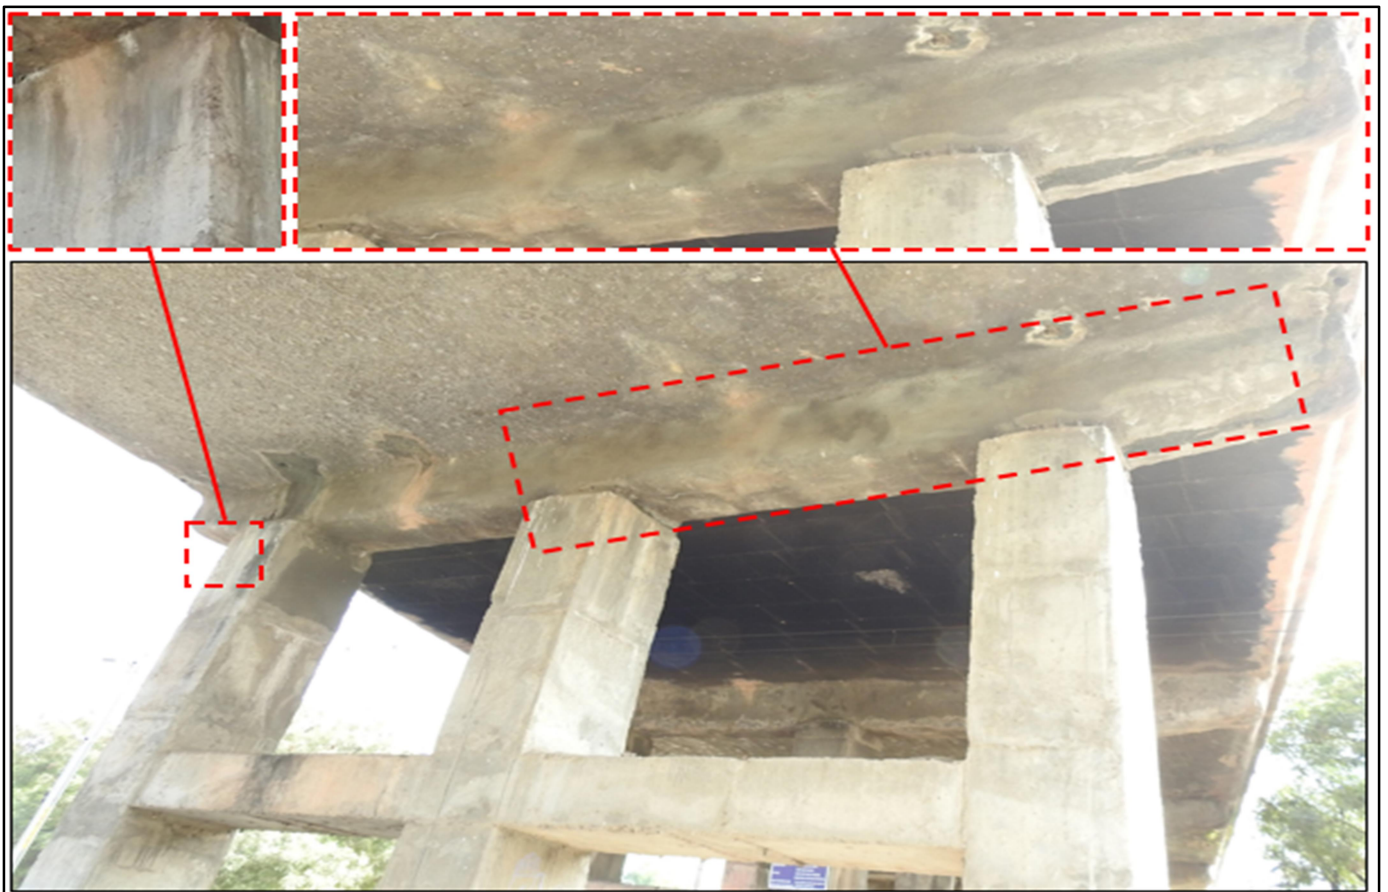
**Fig.6:** Cracks and patch works is observed at pier-2.

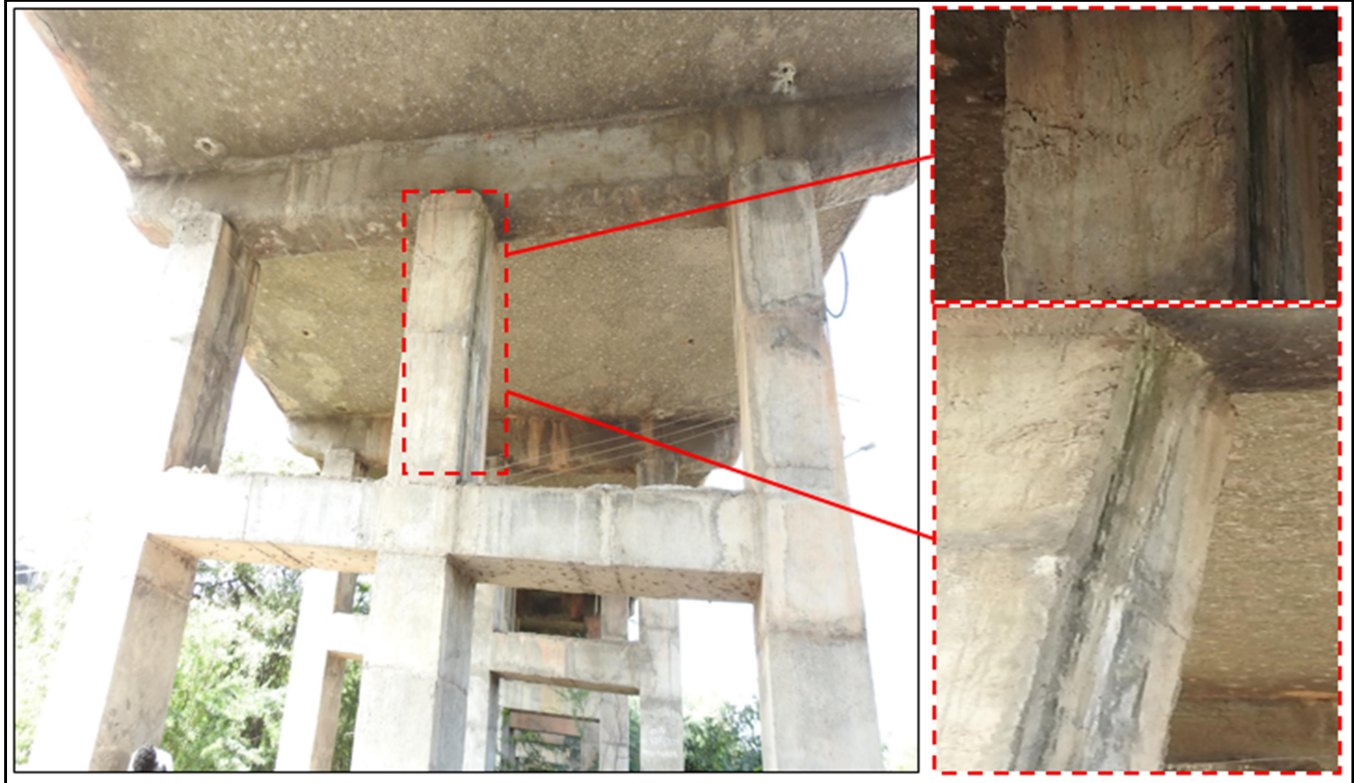
**Fig.7:** Cracks and leaching is observed at pier-3.

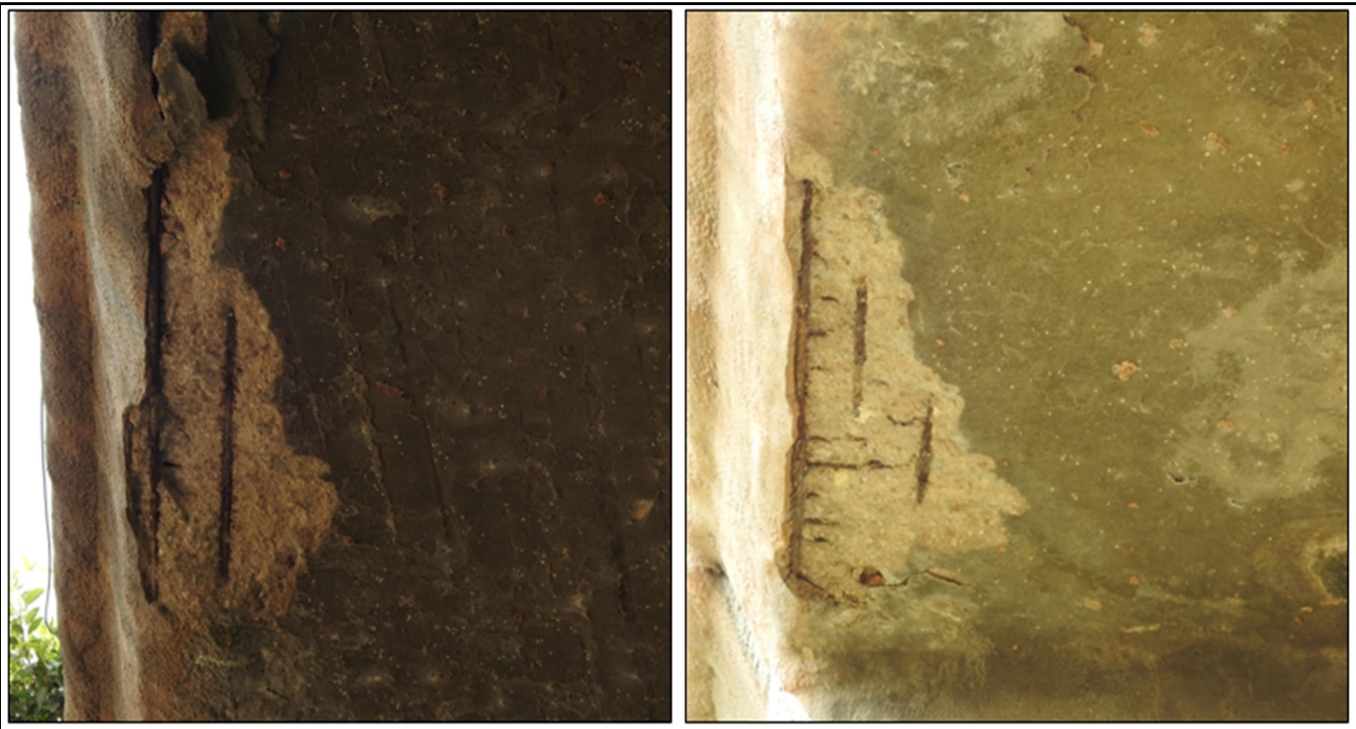
**Fig.8:** Reinforcement exposed and distresses at other spans of ROB.

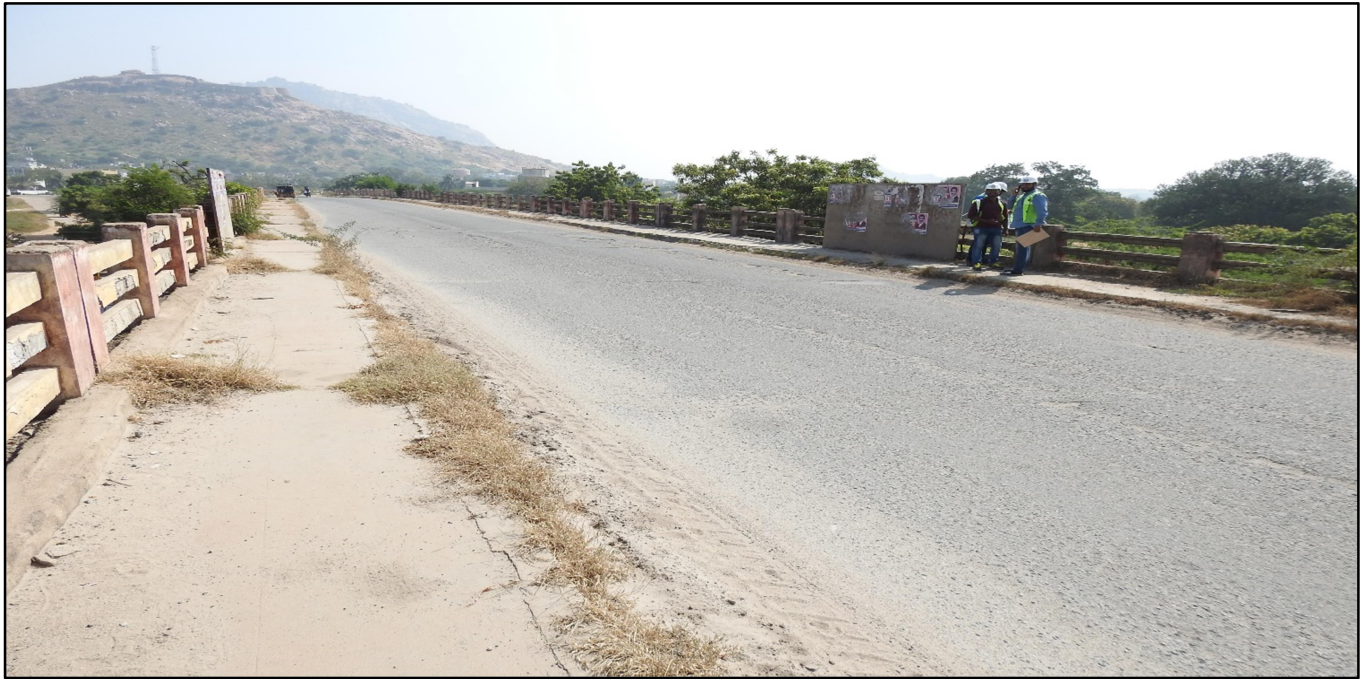
| | Condition of Flooring/Wearing Coat | Poor | Cracks and Potholes observed (Refer Fig-9) |

**Fig.9:** Wearing coat & ROB Top View.

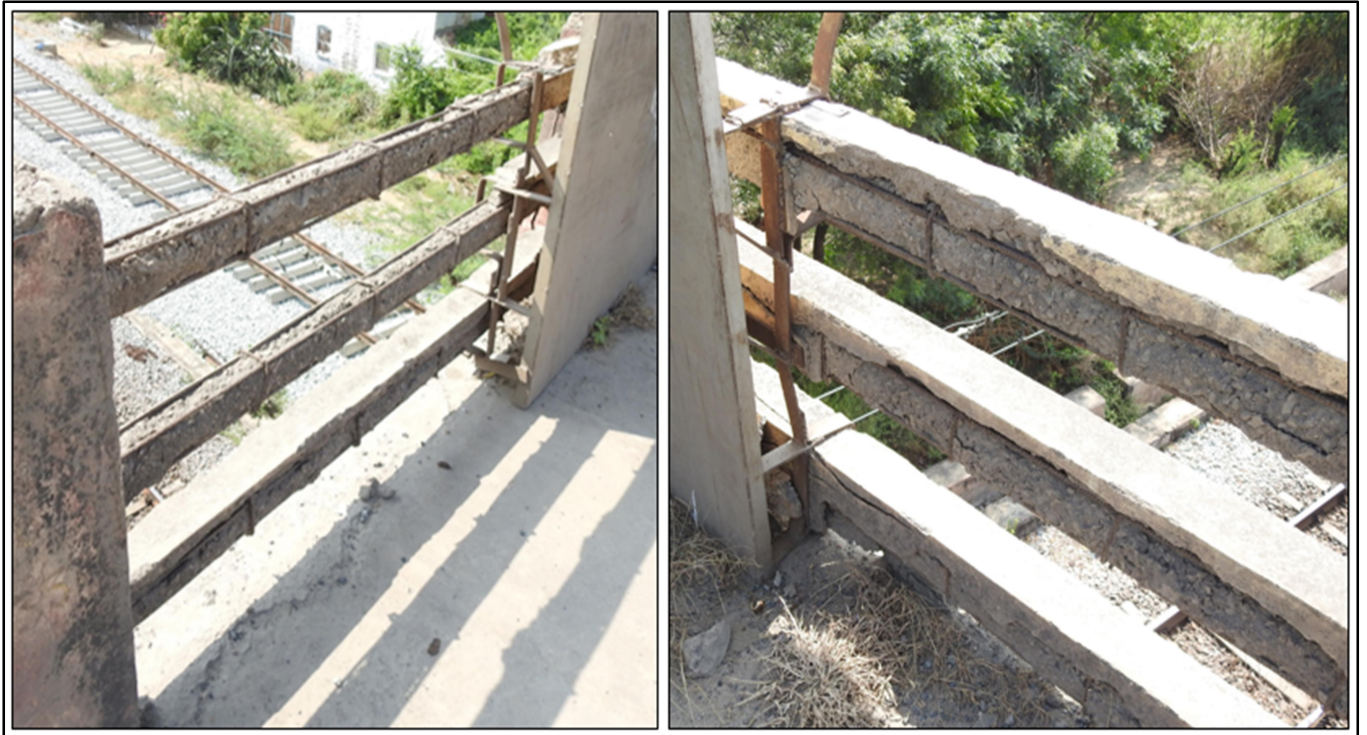
| | Condition of Wall/Railing | | Cracks and Reinforcement exposure has been observed (Refer Fig-10) |

**Fig.10:** Spalling & Reinforcement exposed on Railings.
