| <b>Name of the Project</b> | <b>:</b> | <b>VISUAL INSPECTION OF ROB 295A</b> |
| <b>Location</b> | <b>:</b> | <b>NEAR KOMMARAPUDI RAILWAY STATION</b> |
| <b>Date of Inspection</b> | <b>:</b> | <b>28<sup>th</sup> NOVEMBER, 2019</b> |

## VISUAL INSPECTION OF ROAD OVER BRIDGE

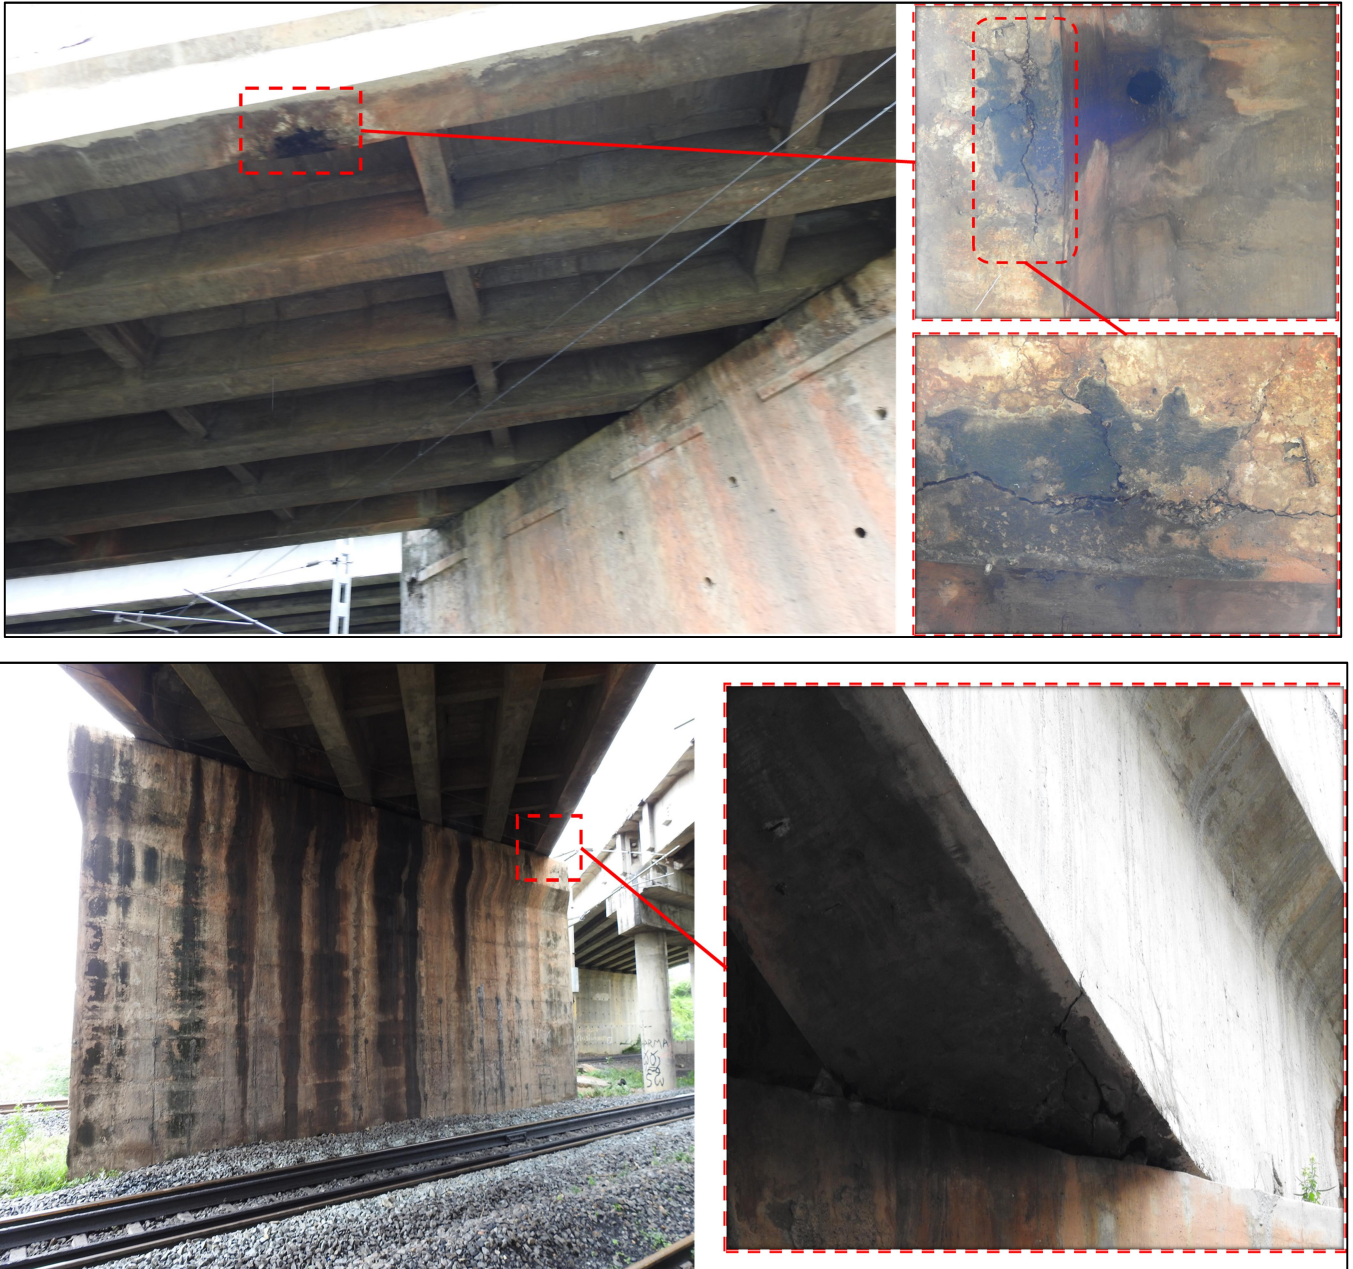
| | Condition of Girder | Distresses Found | Cracks, Spalling, Reinforcement exposure has been observed ( <b>Refer Fig-4 &amp; 5</b> ) |

**Fig 4:** Cracks observed in Exterior girder

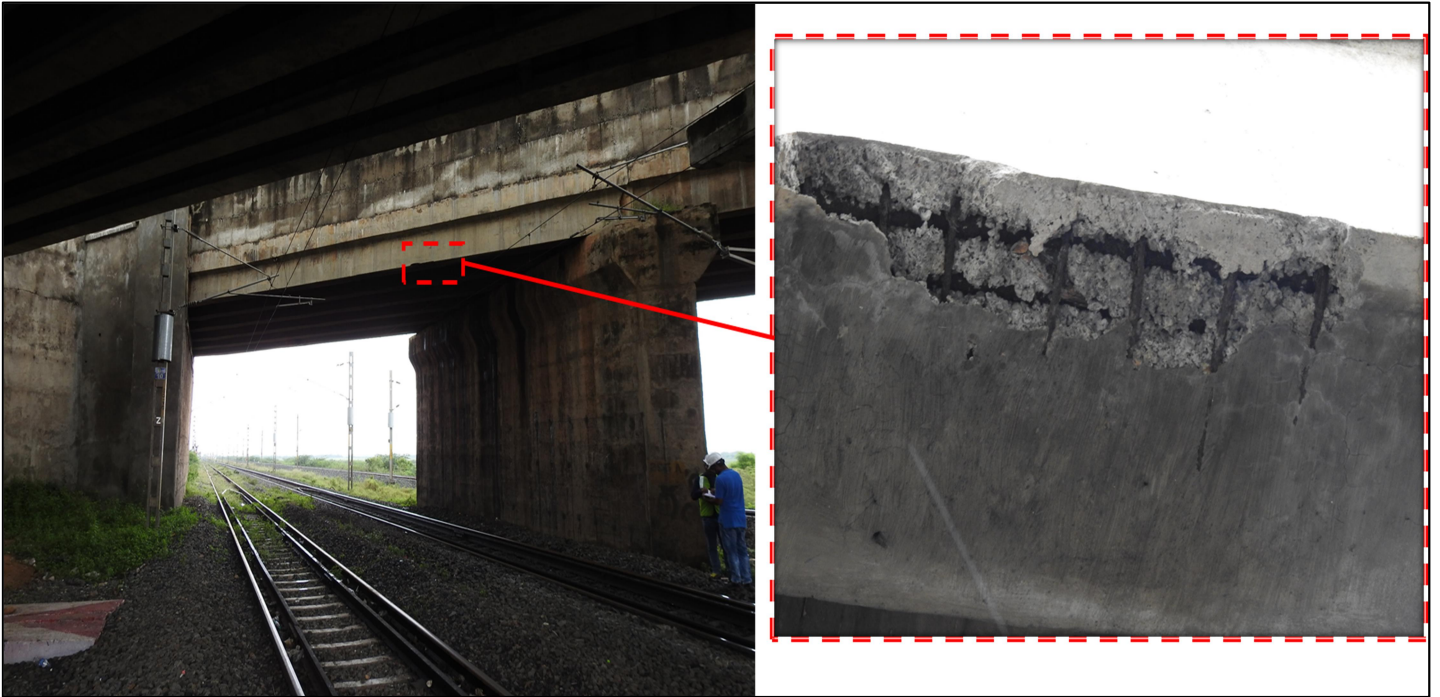
**Fig 5(a):** Reinforcement exposed in exterior girder

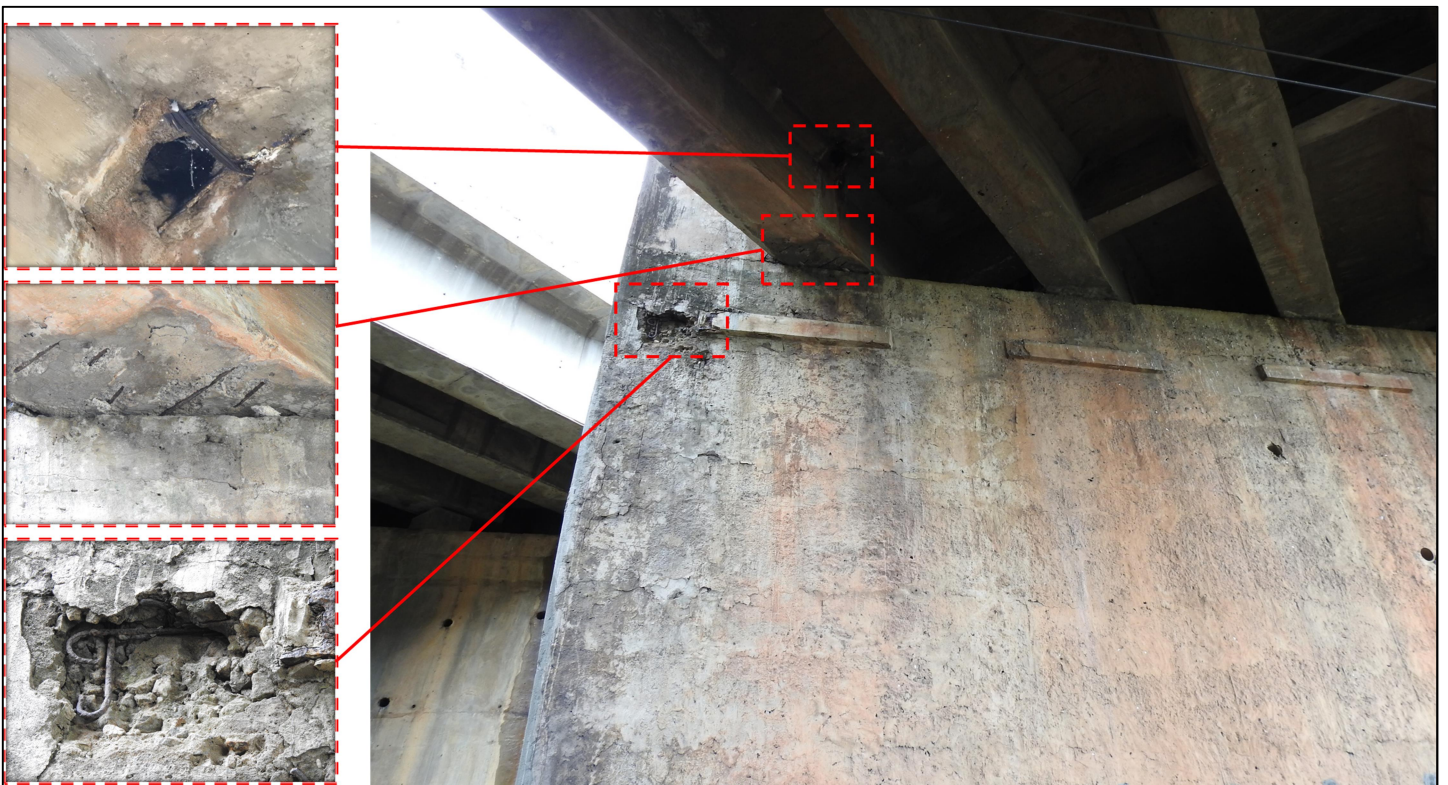
**Fig 5(b):** Reinforcement exposed in exterior girder, pier and slab at drainage spout

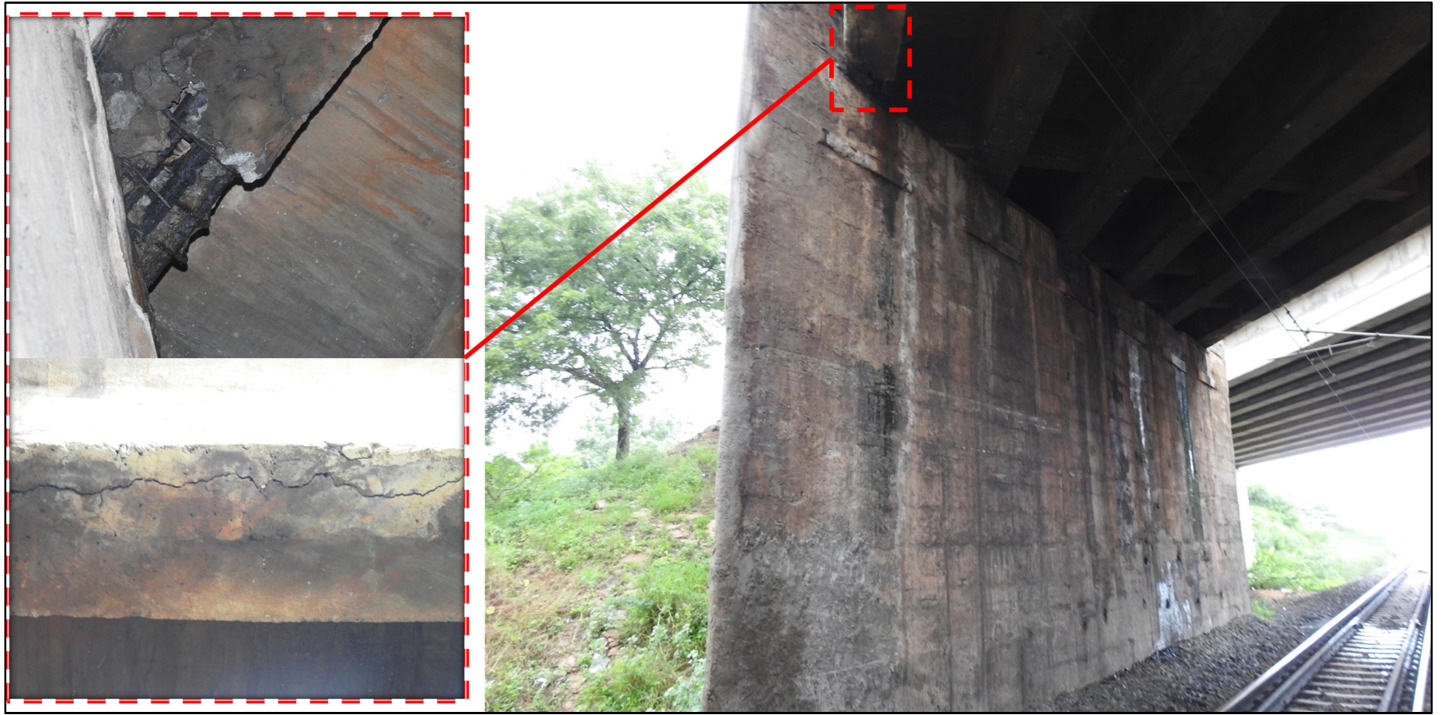
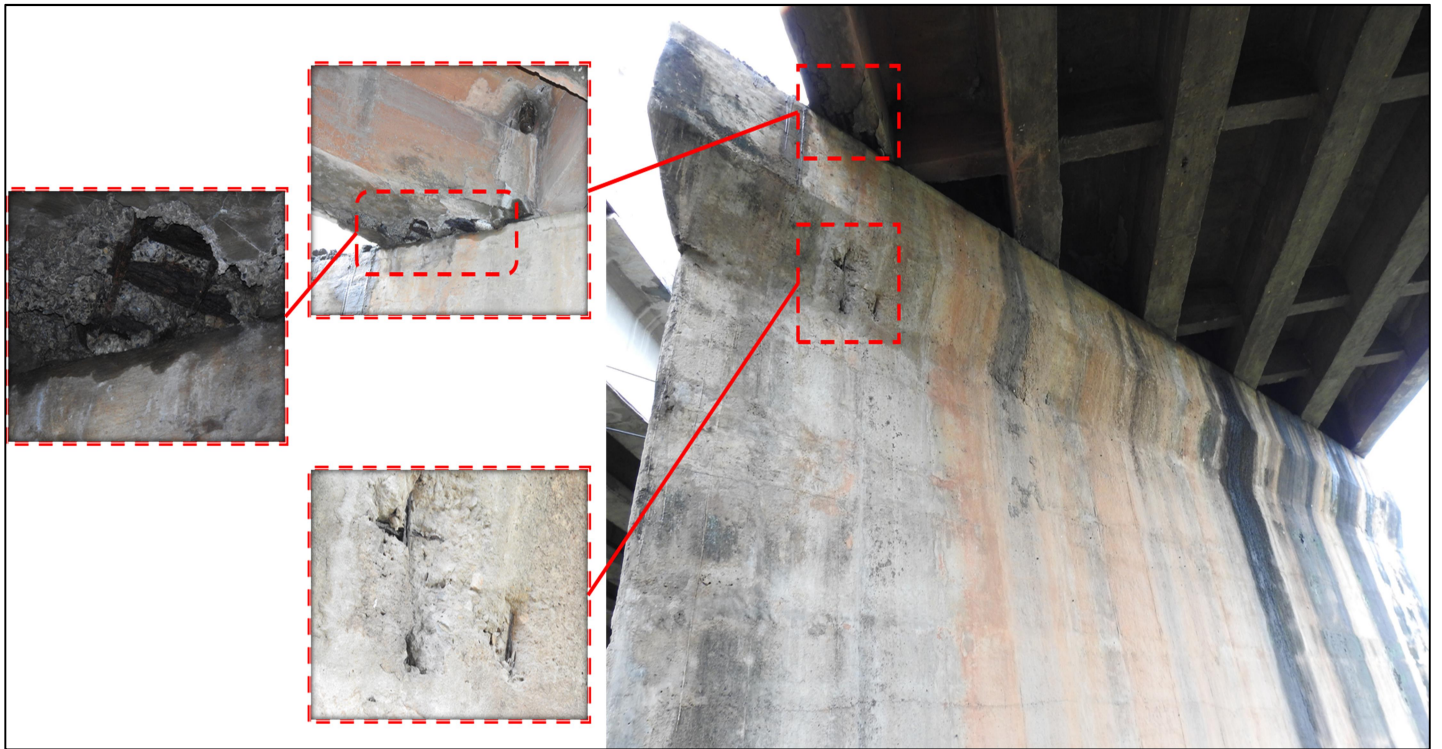
**Fig 5(c):** Reinforcement exposed, Leaching and cracks at girder end and Pier cap haunch

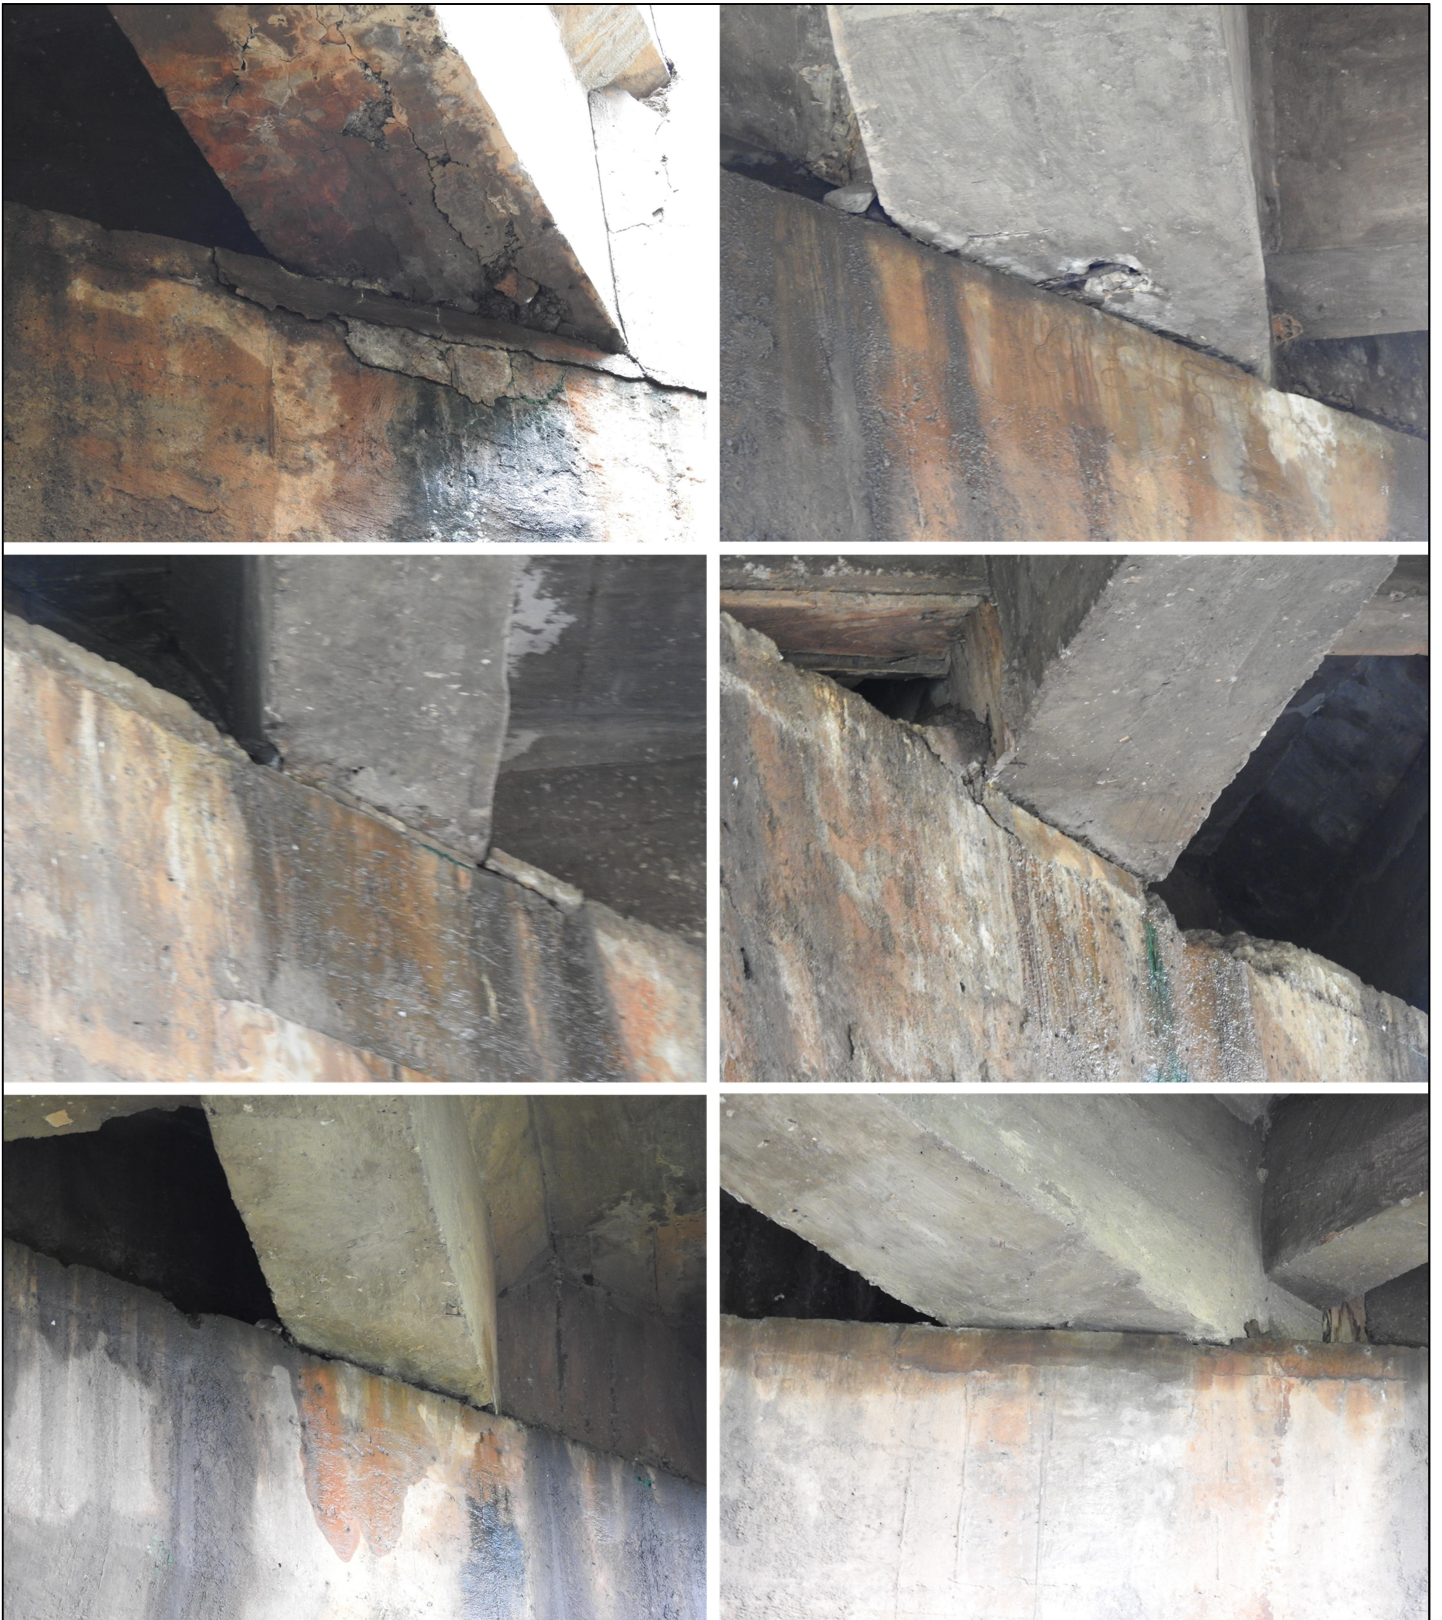
| | General condition<br>(Check Corrosion, cleanliness, seizing of plates silting, accumulations of dirt in case of Type/ shape of Pedestal) | | Debris accumulated at all bearings and filled with Mortar ( <b>Refer Fig-9</b> ) |

**Fig 6:** Distresses observed at Bearings

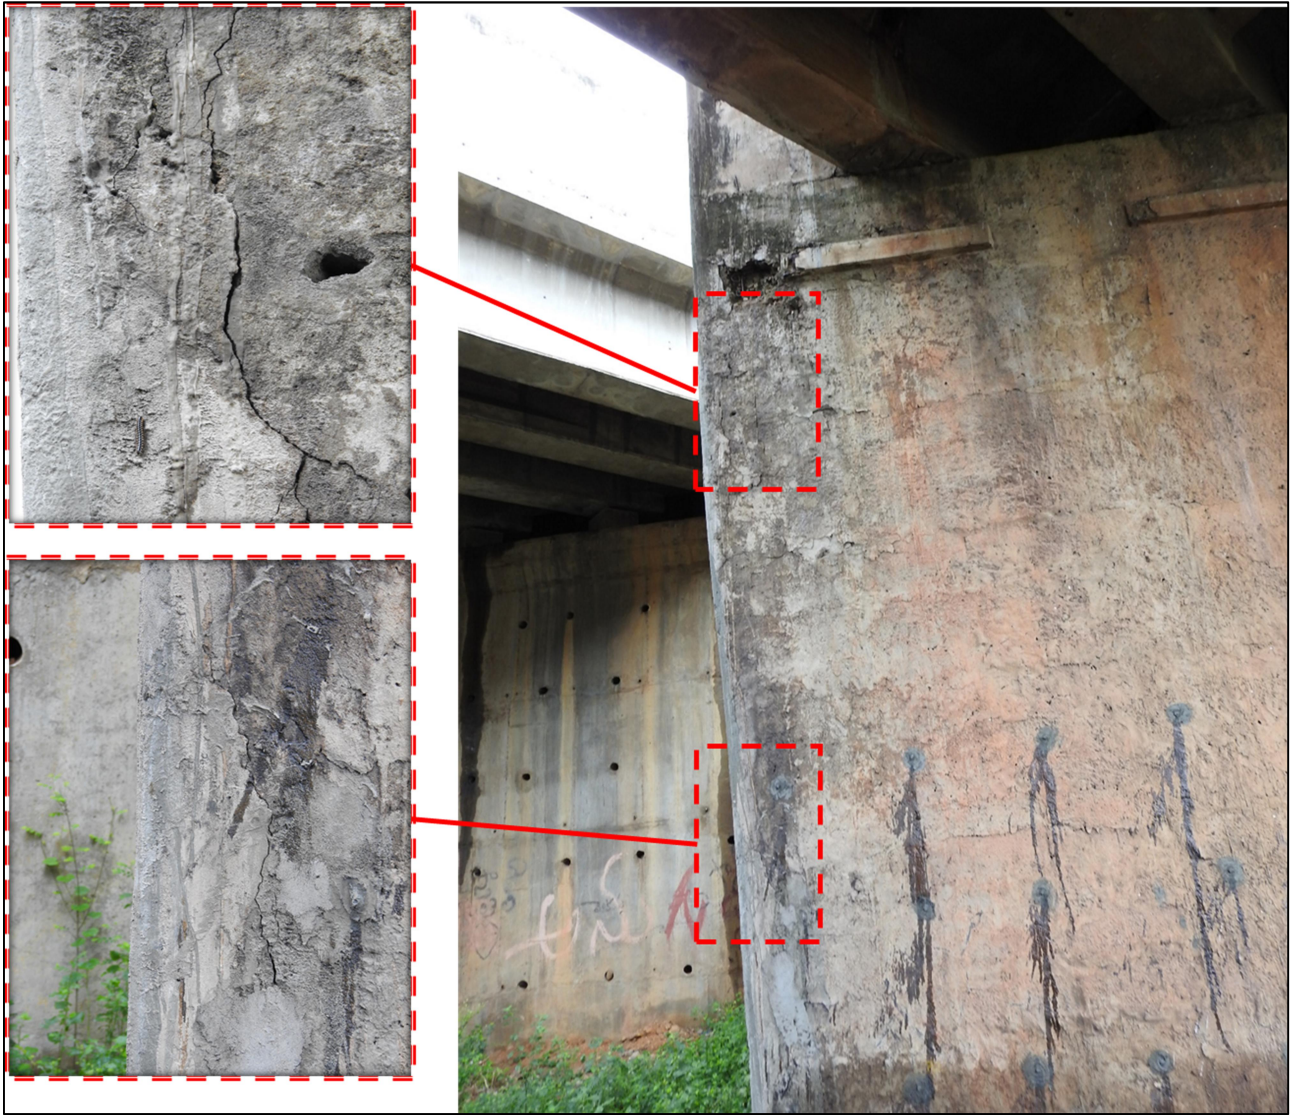
| PART 2 STRUCTURAL SYSTEM OF THE BRIDGE | | | |
|---|---|---|---|
| | Type (Shape) | Wall | Cracks, Spalling, Reinforcement exposure has been observed on Pier.<br><br>Patch repair works and Epoxy grouting done. |

**Fig 7:** Cracks observed on pier

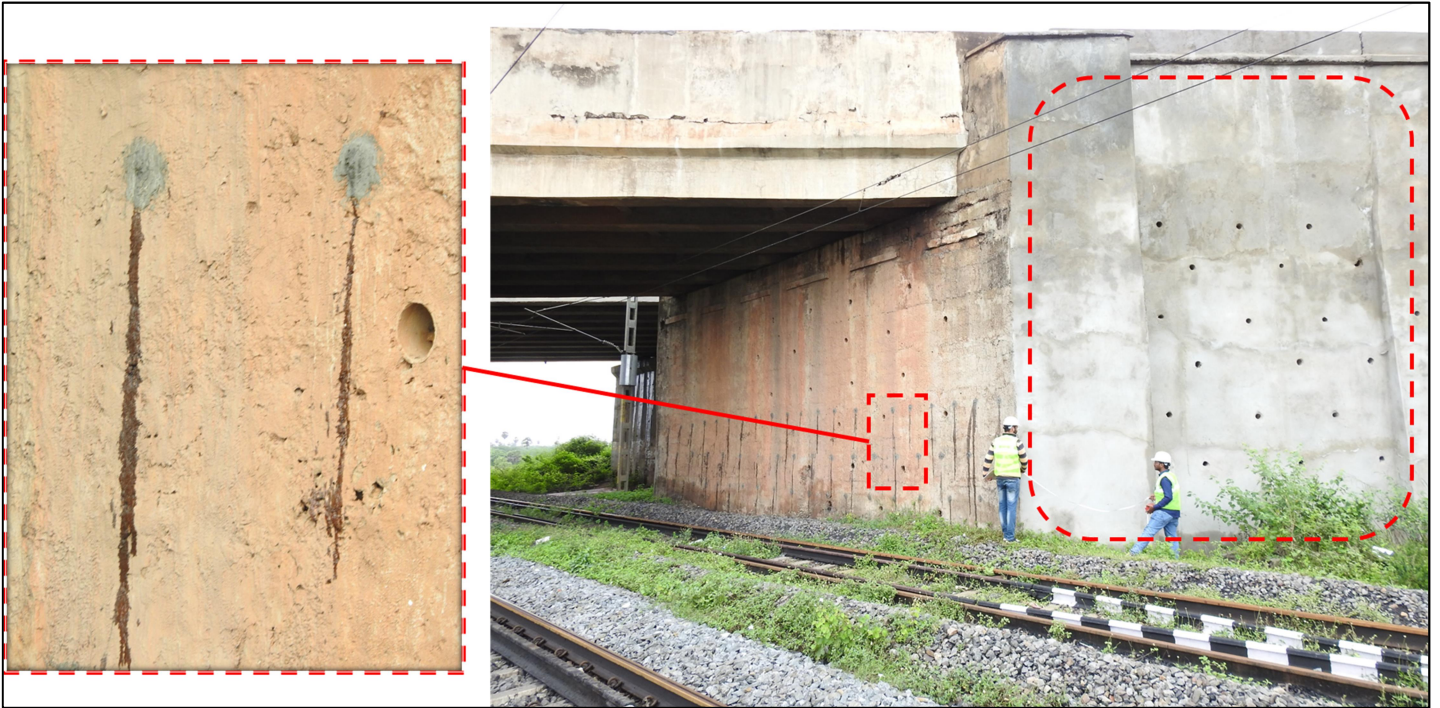
| PART 2 STRUCTURAL SYSTEM OF THE BRIDGE | | | |
|---|---|---|---|
| | Condition (Crack, Settlement, Scour, Tilting, Steel Corrosion, Strains and other damages etc...) | | Cracks, Spalling, Honeycombing, Reinforcement exposure are observed at Abutment<br><br>Patching works and Epoxy grouting done. |

**Fig 8:** Epoxy grouting on Abutment & newly constructed retaining wall

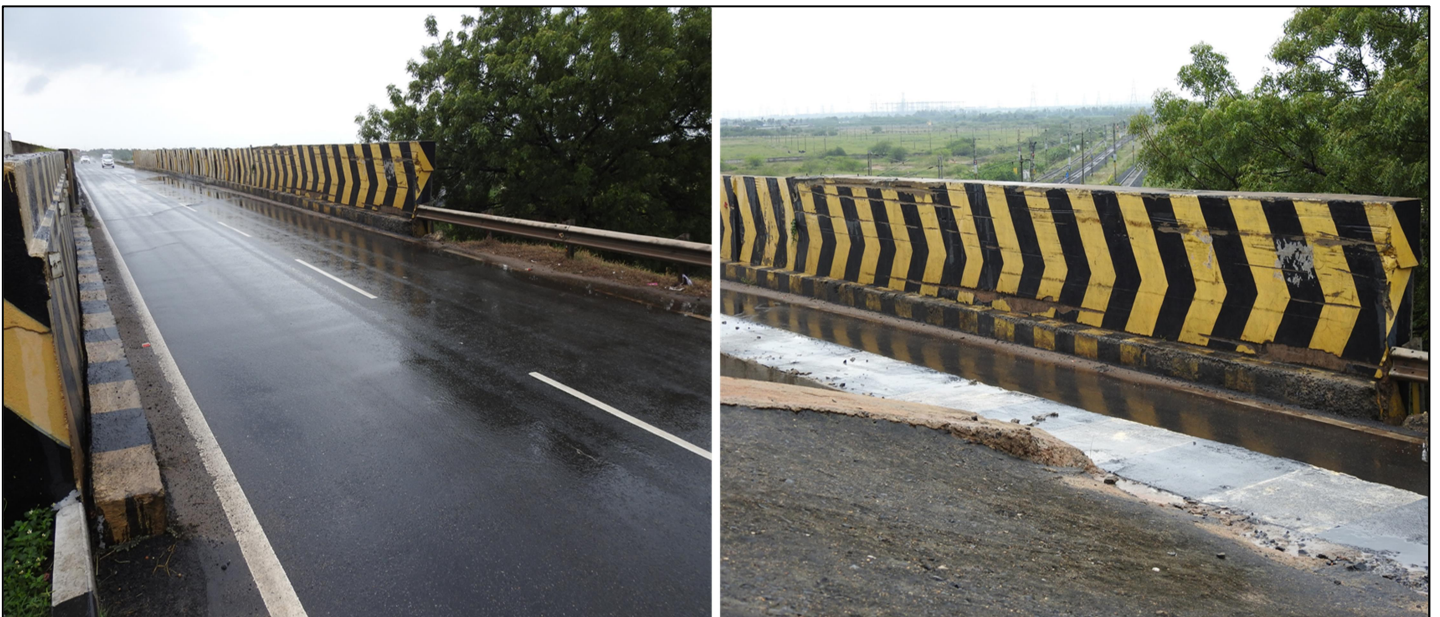
| | Condition of Flooring/Wearing Coat | Fair | ( <b>Refer Fig-9</b> ) |
| | Condition of Wall/Railing | | Accident hit marks are observed on Crash Barrier as Bridge is Narrow ( <b>Refer Fig-9</b> ) |

**Fig 9:** Wearing Coat condition & Accident hitting marks on Crash Barrier.
