| <b>Name of the Project</b> | <b>:</b> | <b>VISUAL INSPECTION OF ROB 70C</b> |
| <b>Location</b> | <b>:</b> | <b>NEAR ANANTAPUR RAILWAY STATION</b> |
| <b>Date of Inspection</b> | <b>:</b> | <b>26<sup>th</sup> NOVEMBER, 2019</b> |

## VISUAL INSPECTION OF ROAD OVER BRIDGE

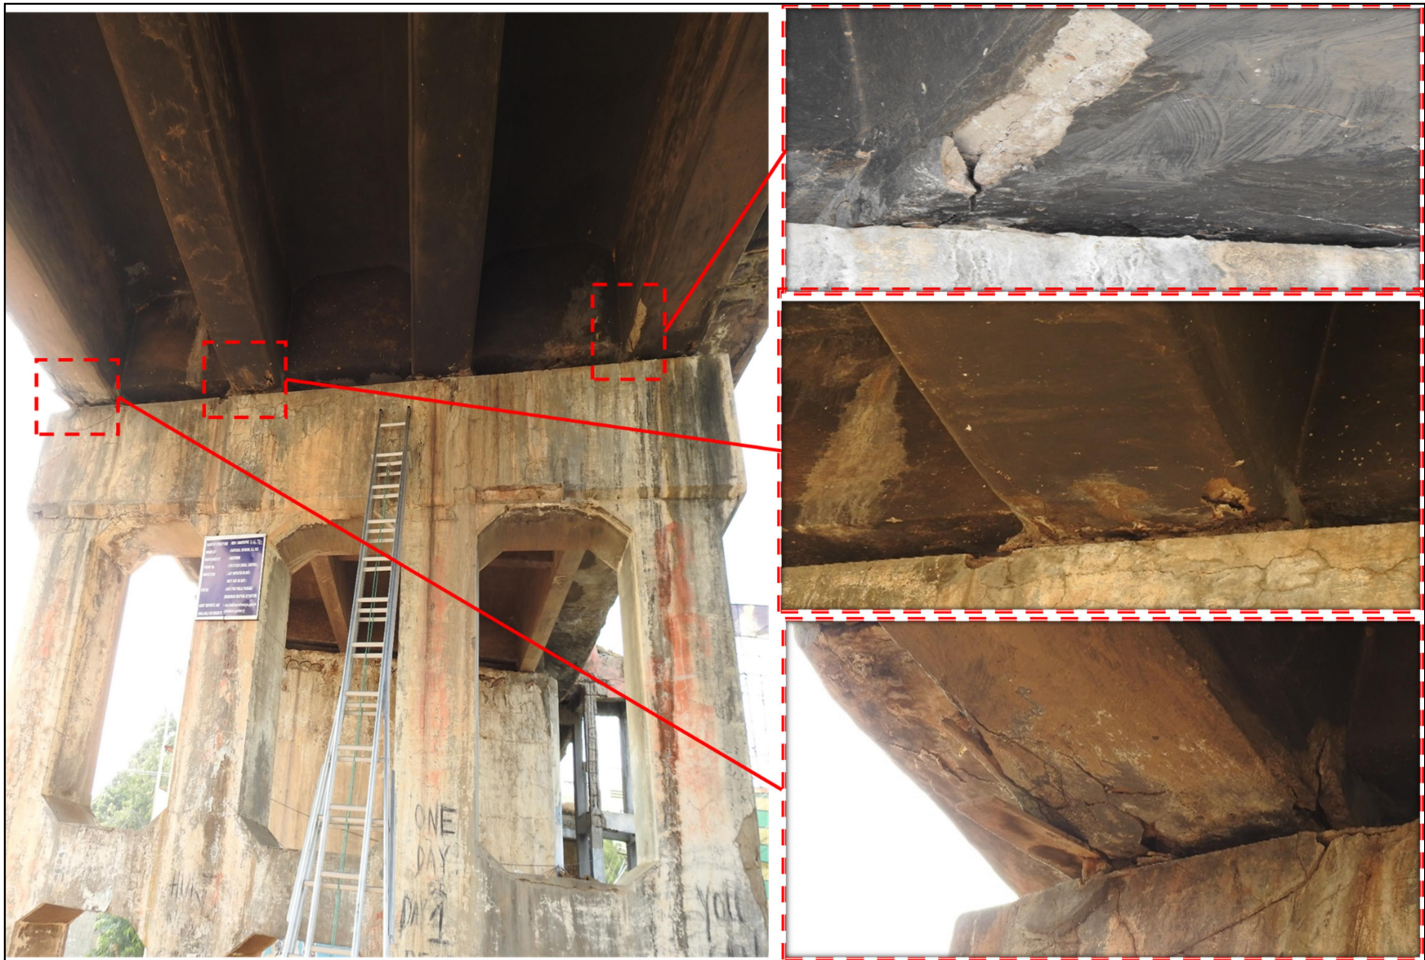
| | Condition of Girder | Distresses Found | Severe cracks, Spalling, Reinforcement exposure has been observed ( <b>Refer Fig-3</b> ) |

**Fig 3:** Cracks & Spalling observed in girders

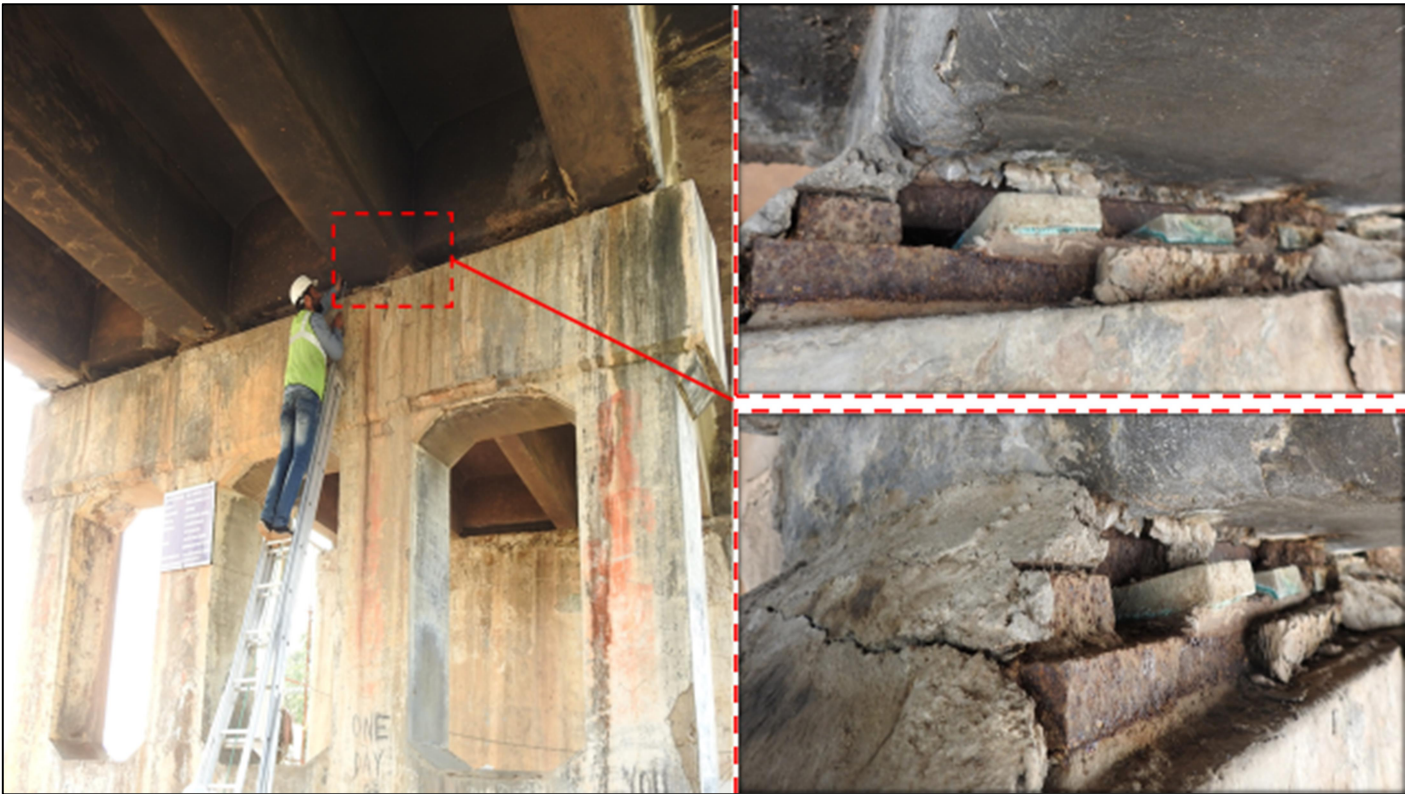
| | General condition (Check Corrosion, cleanliness, seizing of plates silting, accumulations of dirt in case of Type/ shape of Pedestal | | Debris accumulated at all bearings and filled with Mortar ( <b>Refer Fig-4</b> ) |

**Fig 4:** Mortar Patching & Distresses observed at Bearings

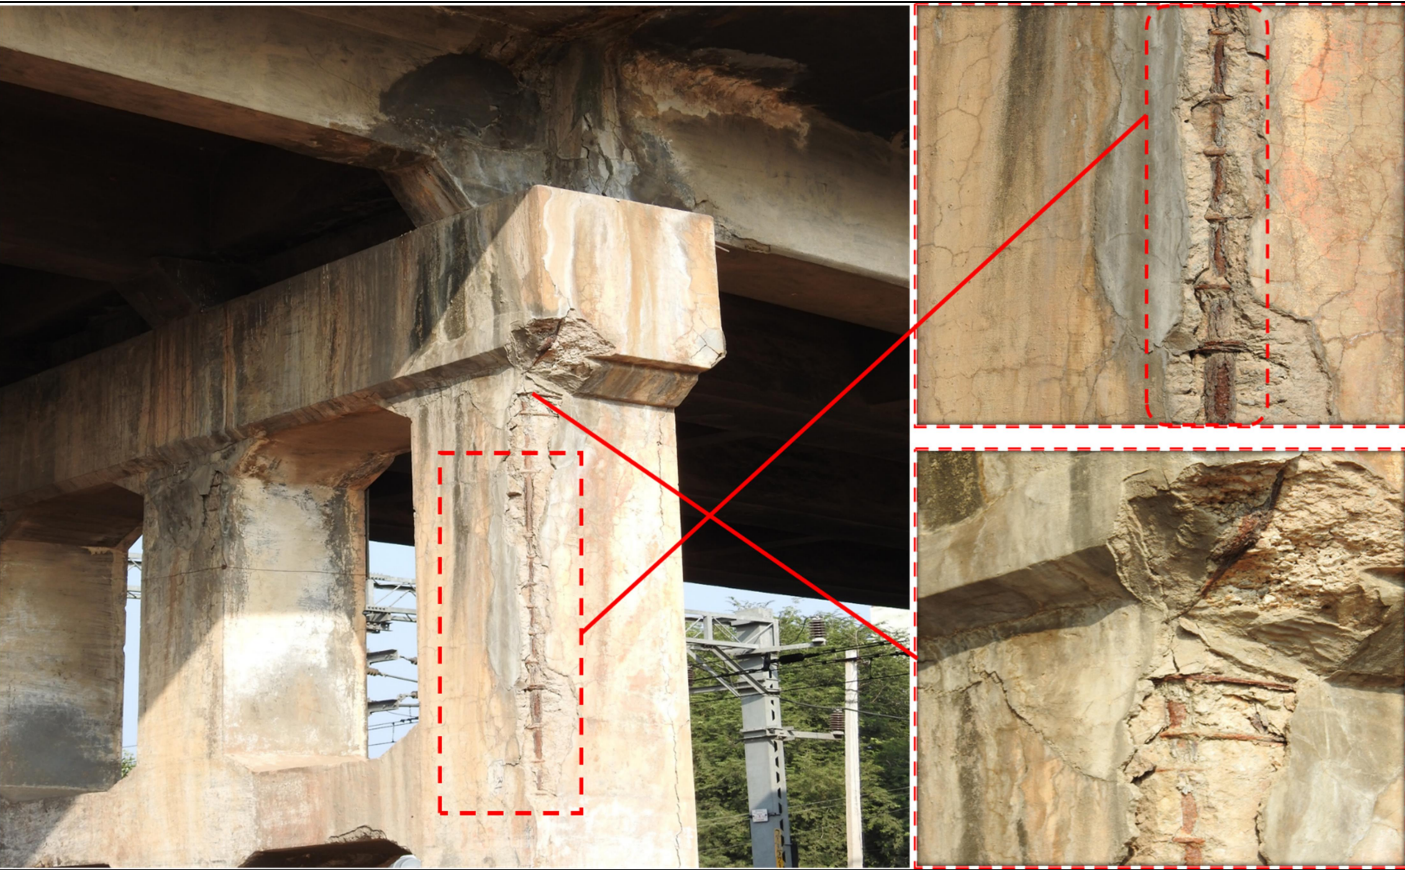
| PART 2 STRUCTURAL SYSTEM OF THE BRIDGE | | | |
|---|---|---|---|
| | Type (Shape) | Wall & Portal | <p>The Span 2 Piers are Portal type with 4 rectangular columns and remaining piers are wall type</p> <p>Severe cracks, Spalling, Reinforcement exposure has been observed on Pier.</p> <p>Corrosion is observed on exposed Reinforcement</p> <p>Patch repair works done on columns.</p> <p>....(Refer Fig-5)</p> |

**Fig 5(a):** Spalling & Reinforcement exposure in column and cap of Pier

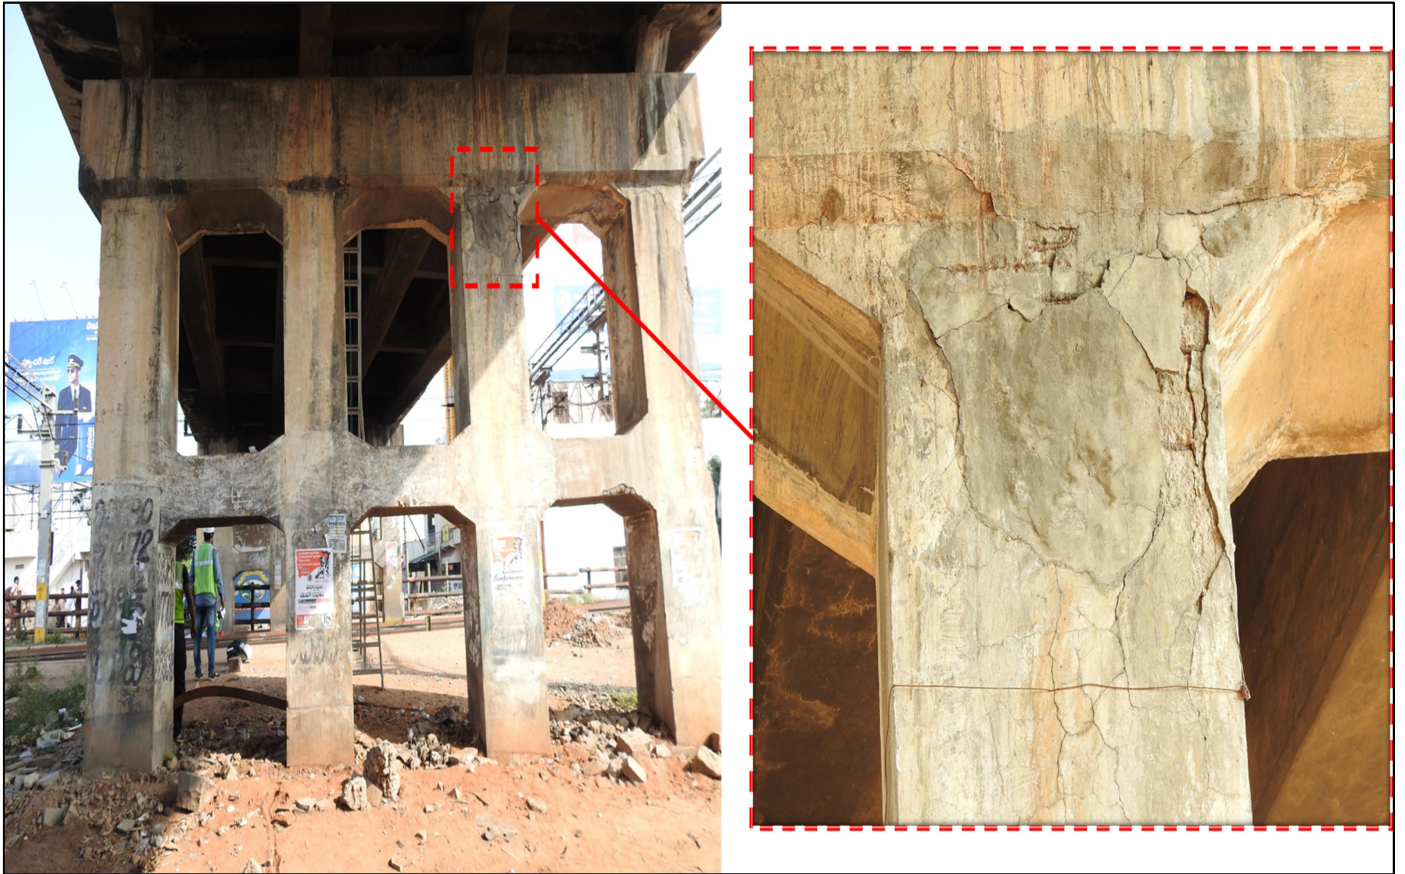
**Fig 5(b):** Cracks, Spalling & Patching works in column and cap of Pier

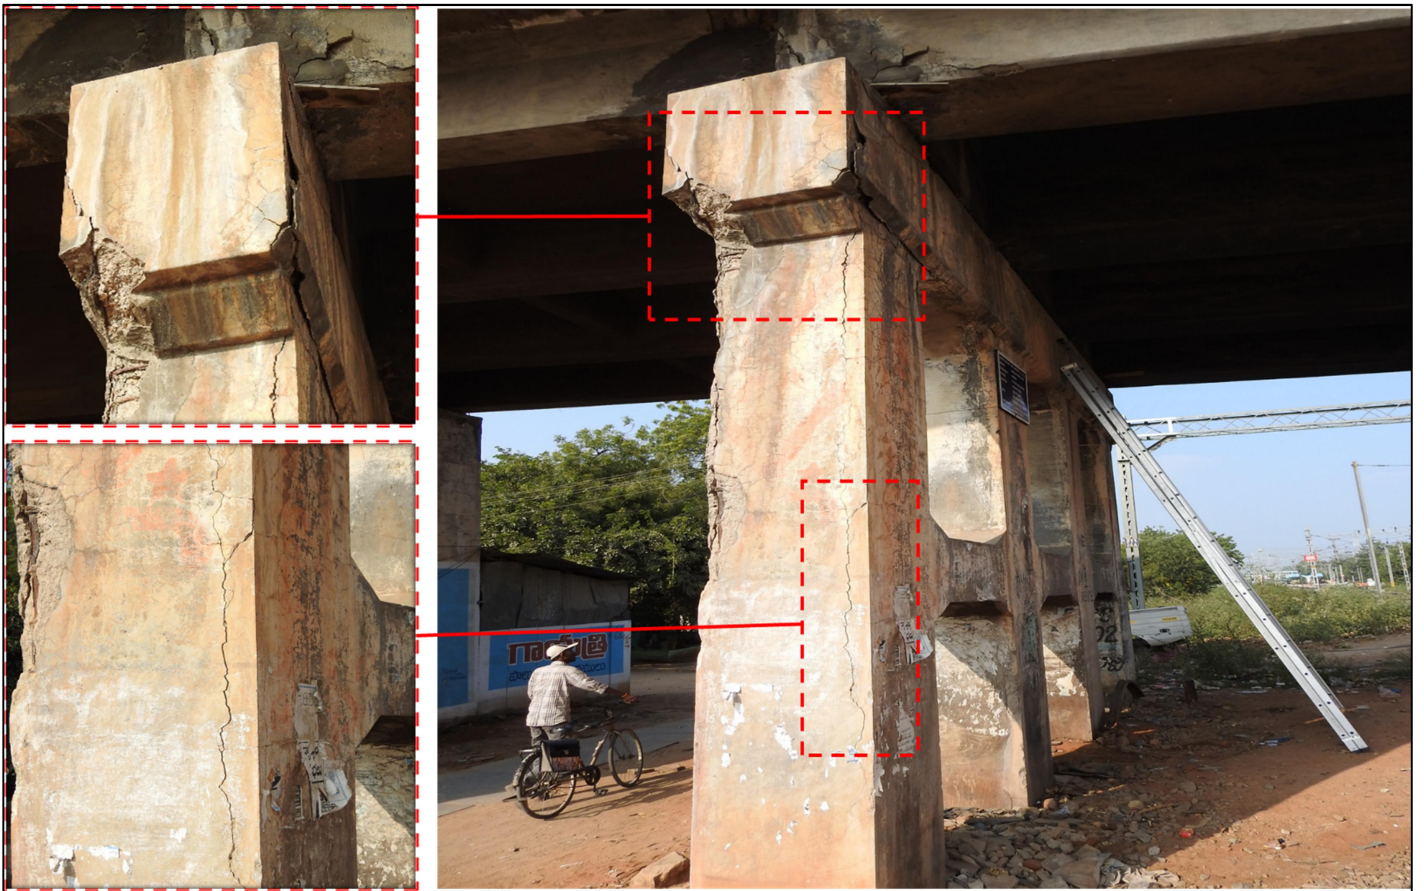
**Fig 5(c):** Damage & Reinforcement exposure on column and cap of Pier

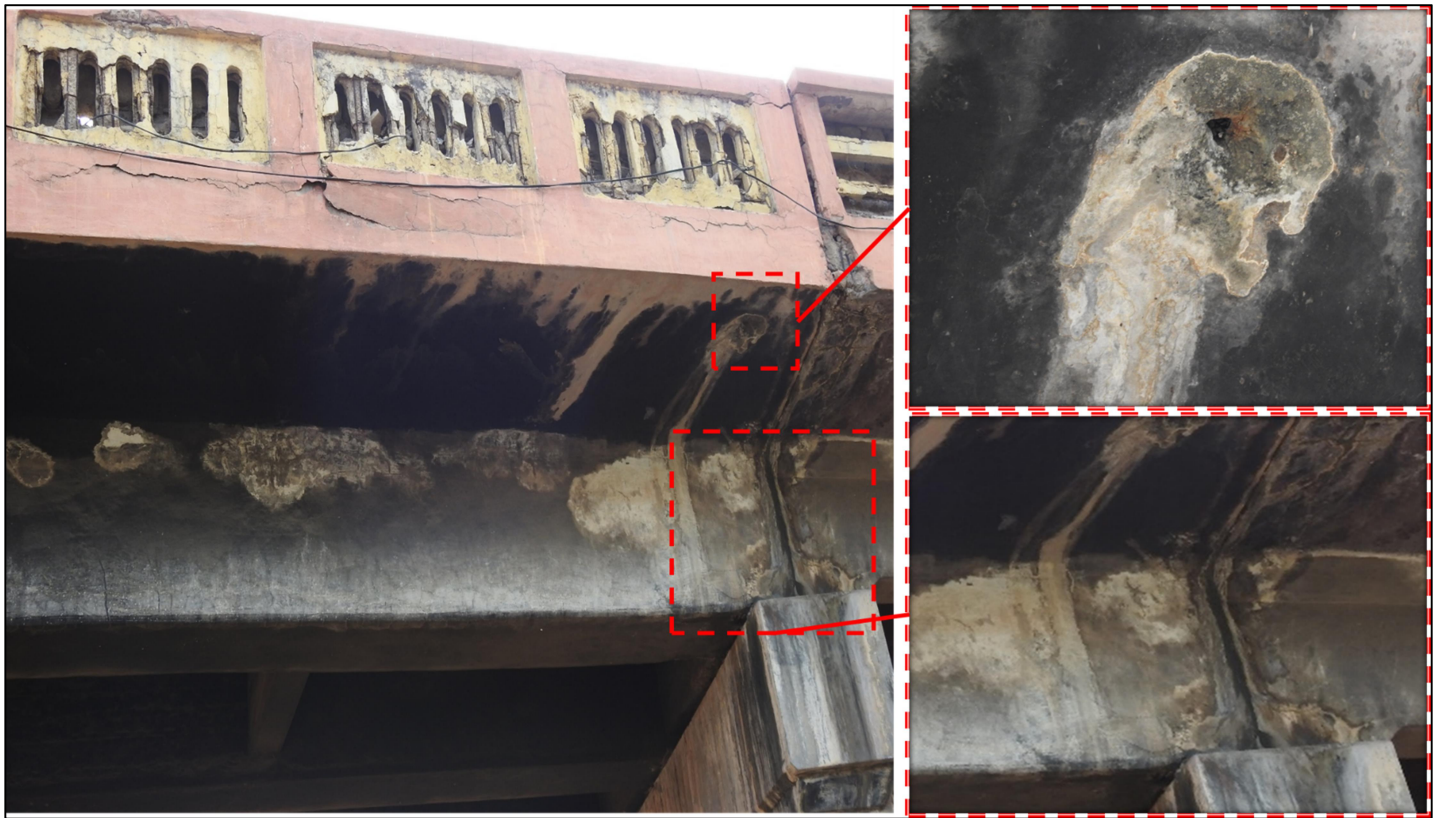
**Fig 5(d):** Leaching at girder and Slab at drainage spout location

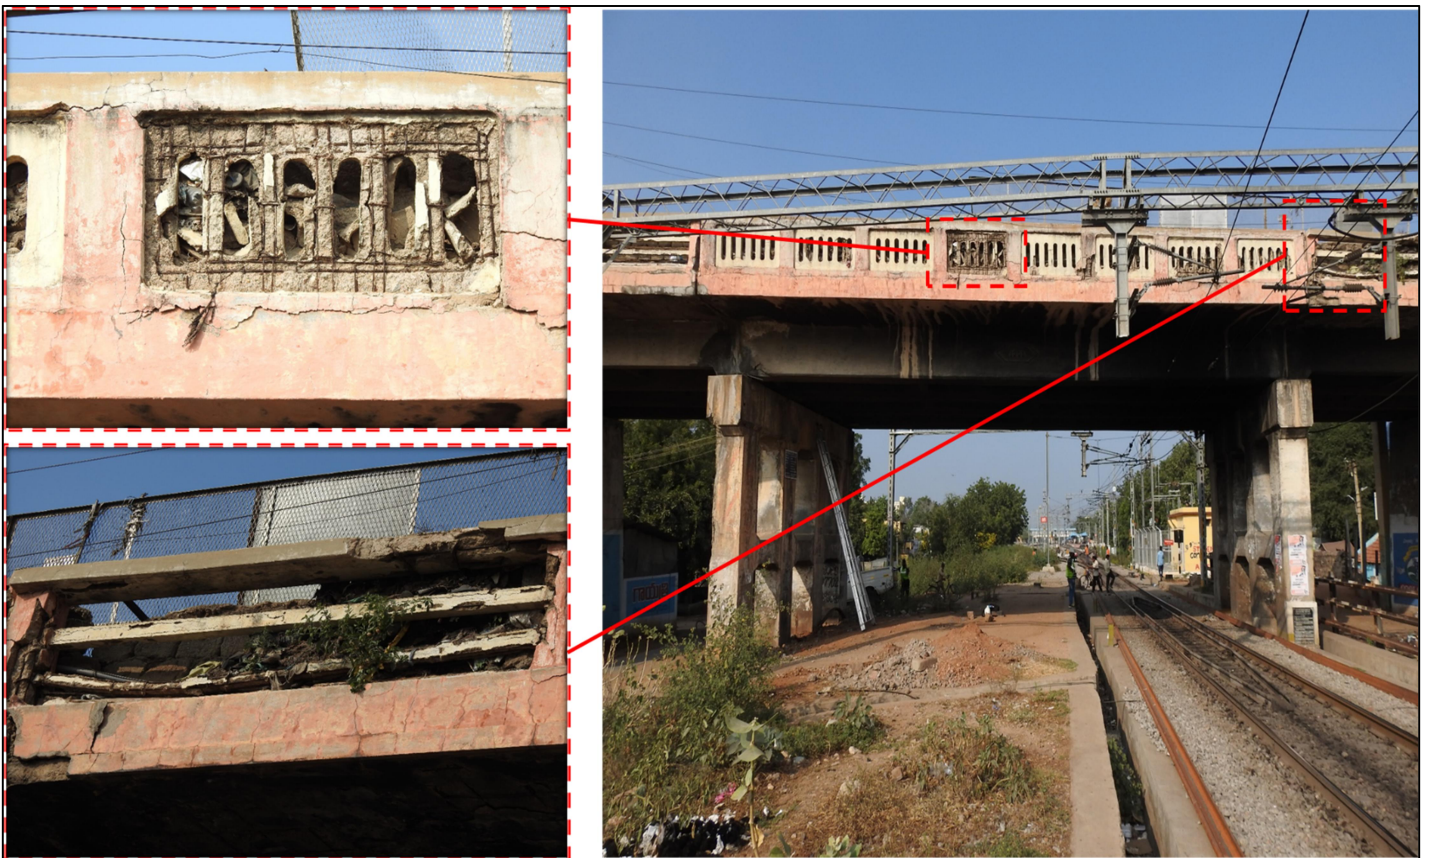
| | Condition of Wall/Railing | Distresses Found | Severe cracks, Spalling, Reinforcement exposure has been observed ( <b>Refer Fig-6</b> ) |

**Fig 6:** Distressed / Poor condition of Railing

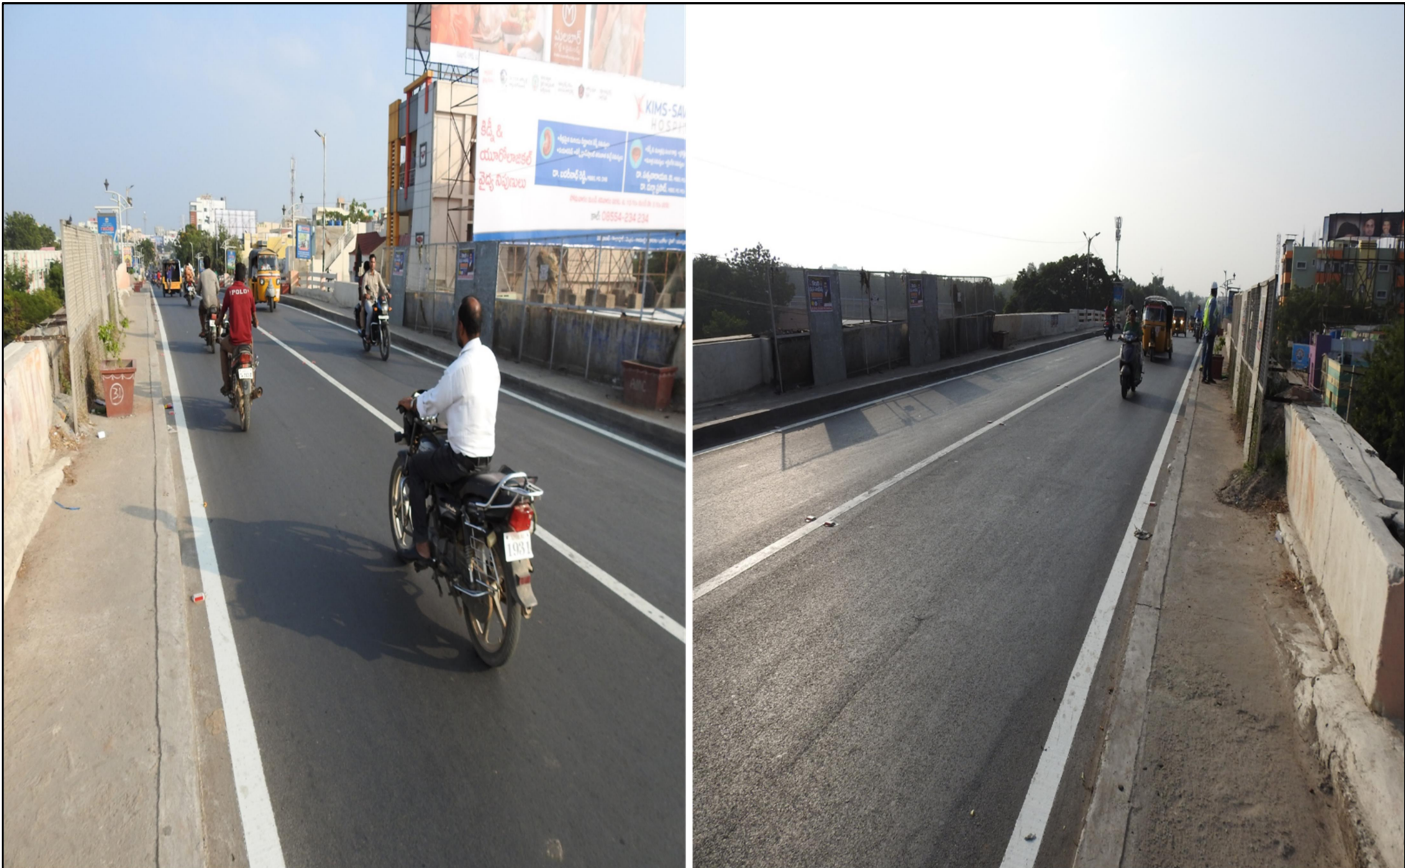
| | Condition of Flooring/Wearing Coat | Fair | Wearing coat is in fair condition ( <b>Refer Fig-7</b> ) |

**Fig 7: Top View / Wearing coat of the Bridge**

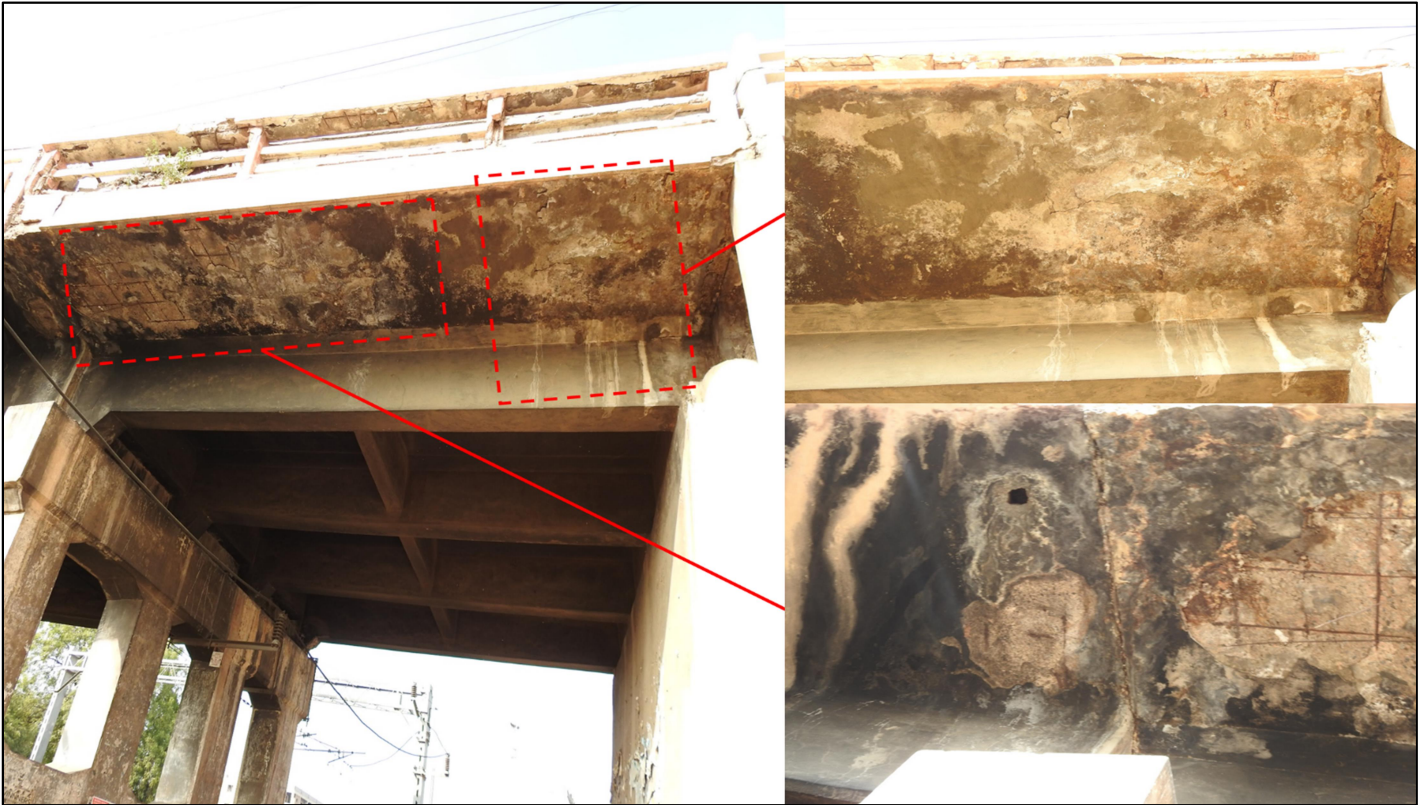
**Fig 8:** Spalling, Leaching & Reinforcement exposure on slab of Span-1

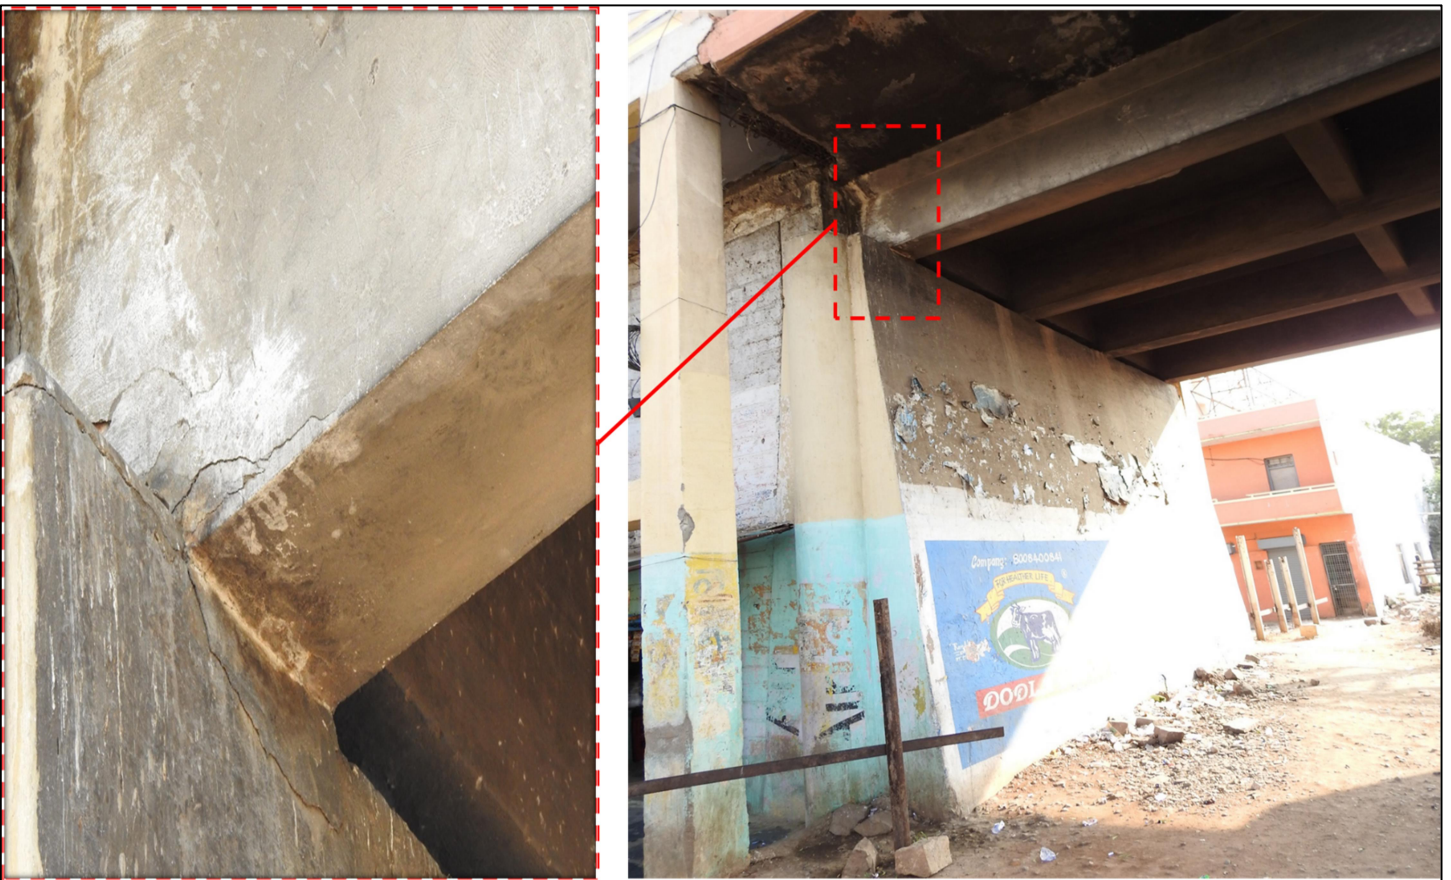
**Fig 9:** Cracks observed at girder seating location of Span-3.

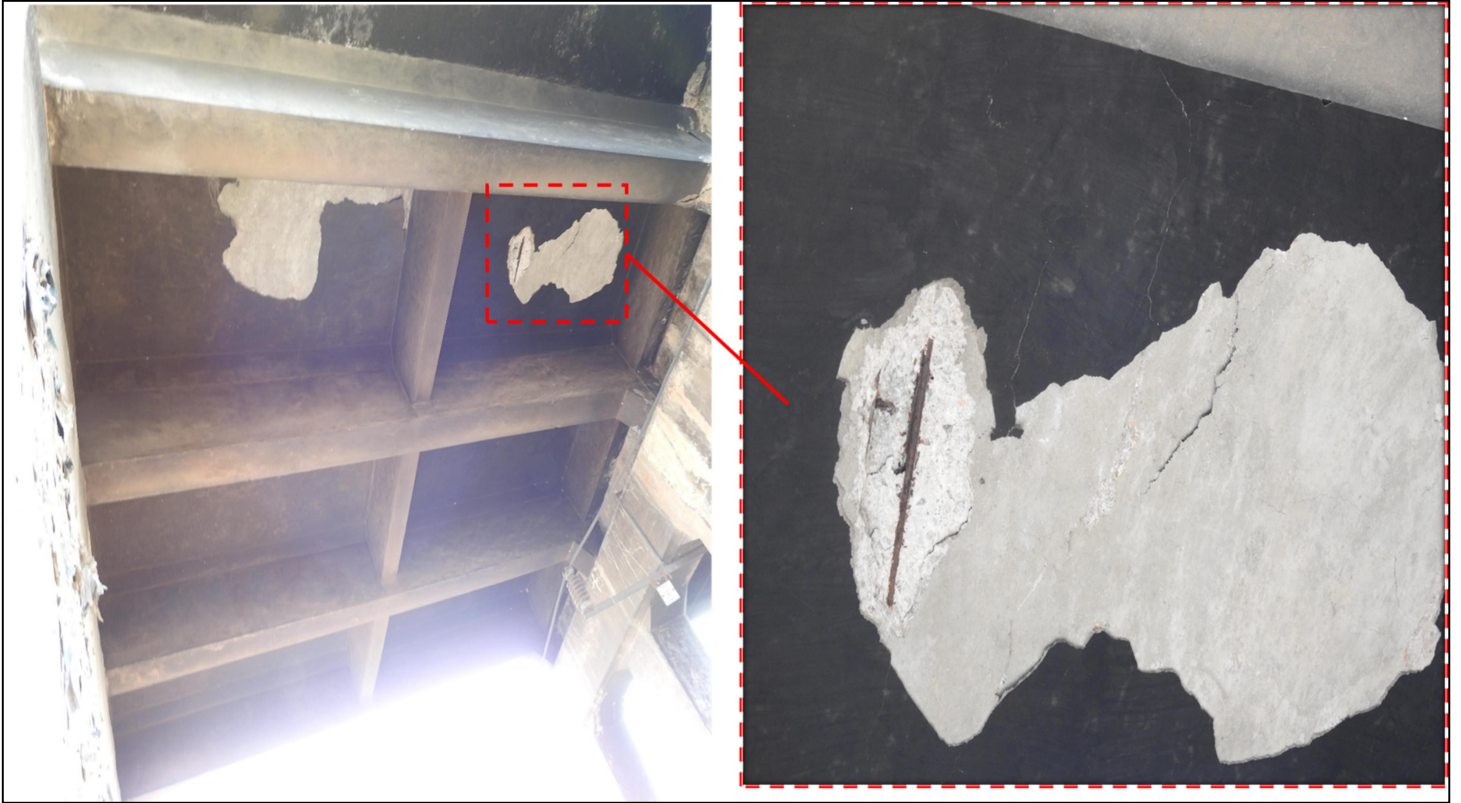
**Fig 9:** Spalling & Reinforcement exposure at Slab of span-3.
