**Name of the Project** : Visual Inspection of ROB No. 250

**Location** : Near Godavari Railway station

**Date of Inspection** : 2<sup>nd</sup> December, 2019

### **VISUAL INSPECTION OF ROAD OVER BRIDGE**

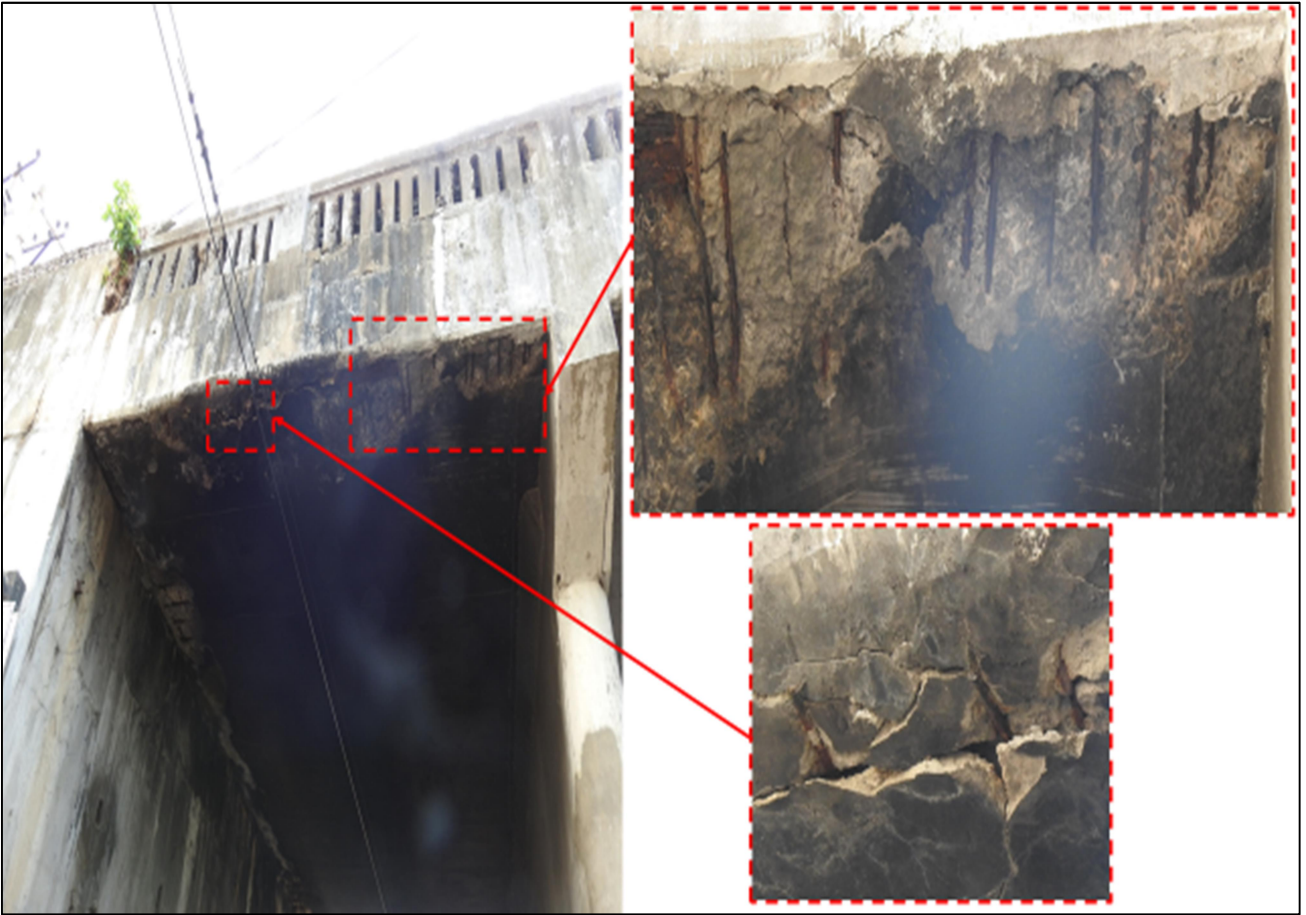
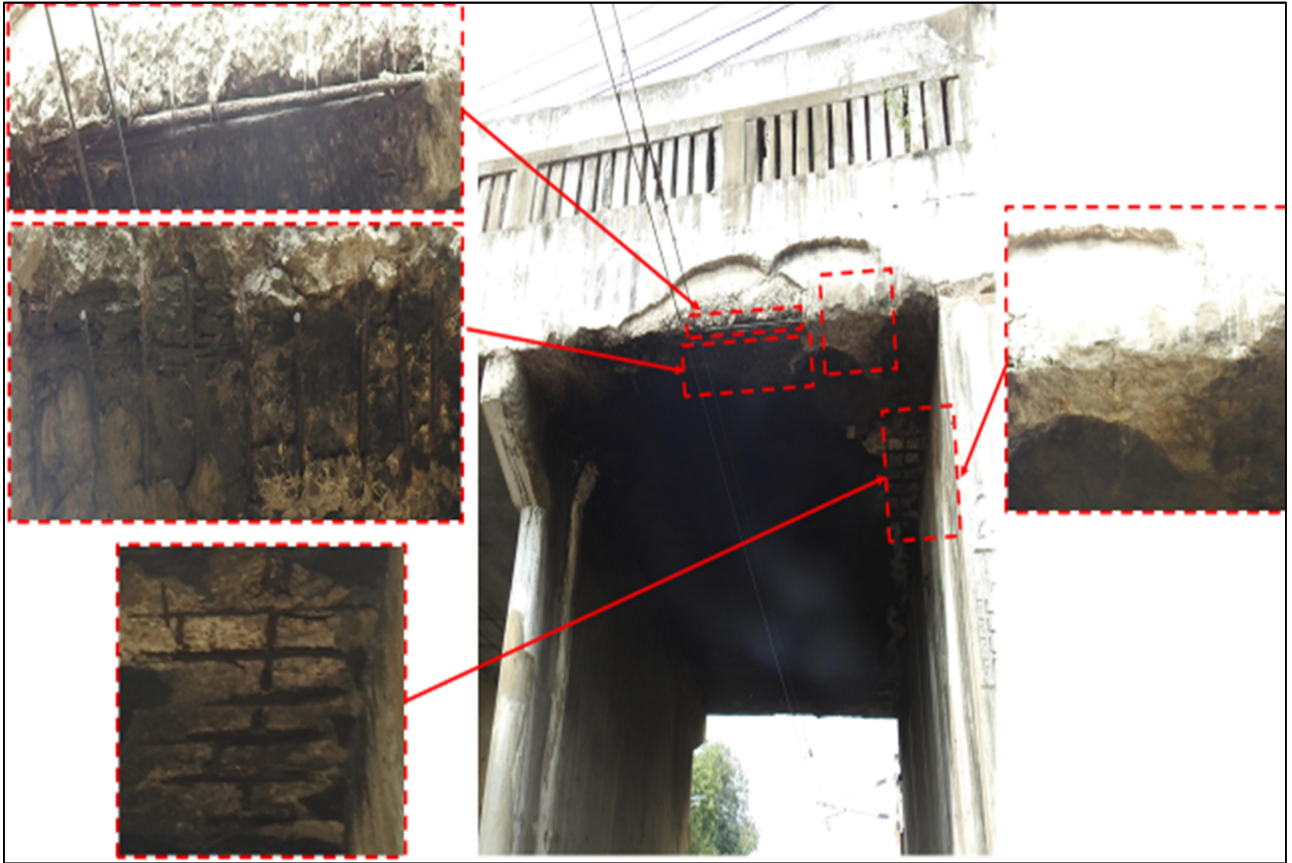
| | Condition of Slab from Bottom | Distresses Found | Spalling & Reinforcement exposure Observed. (Refer Fig: 4, 7) |

| PART 4 SURVEY OF SIGNS OF DISTRESS, DEFORMATION IN BRIDGES | | |
|---|---|---|
| Reinforcement Exposure | Slab | Reinforcement Exposure is observed in Slab ( <i>Refer Fig:4</i> ) |

Fig: 4 Reinforcement exposure and Spalling observed at Span-1

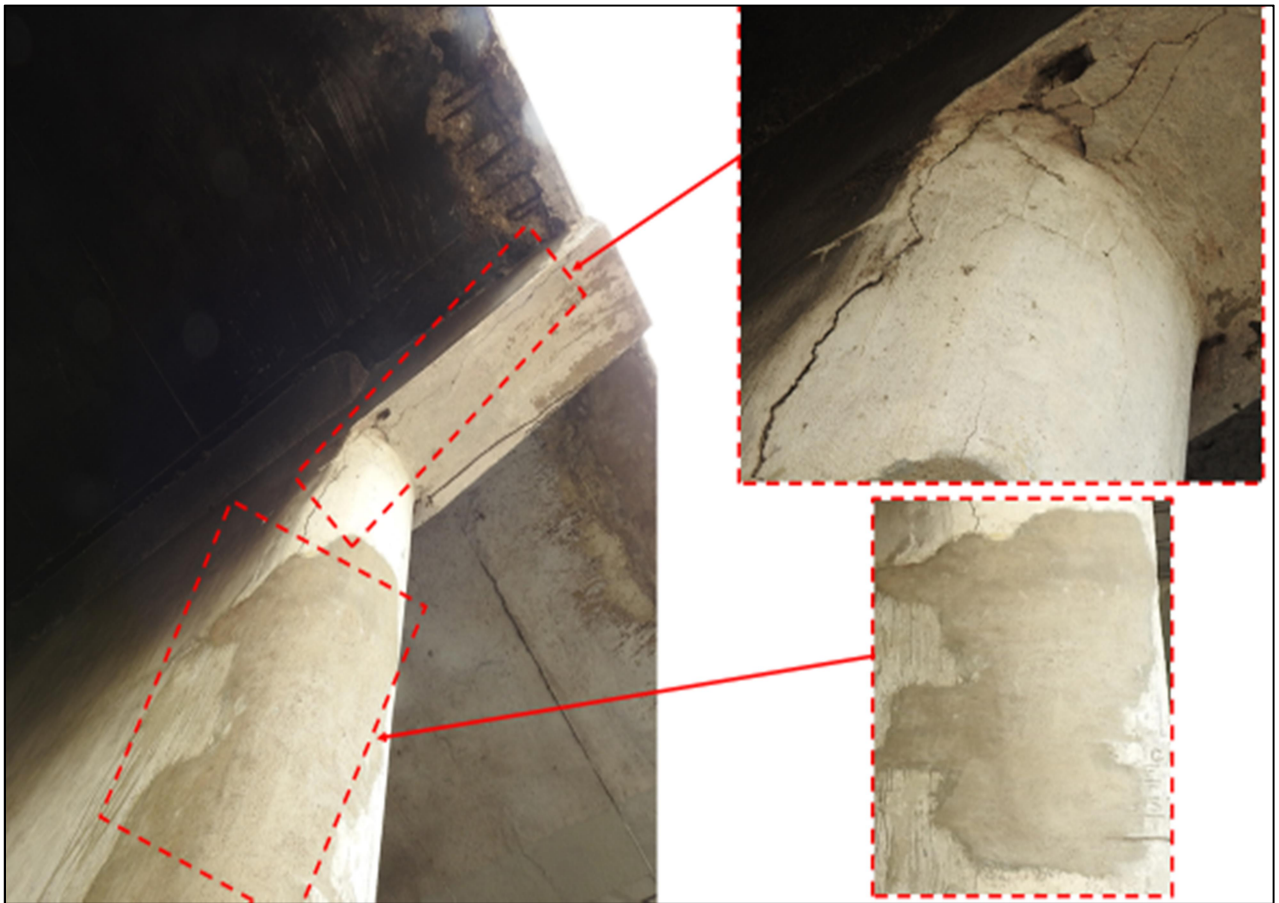
| PART 2 STRUCTURAL SYSTEM OF THE BRIDGE | | | |
|---|---|---|---|
| | Type (Shape) | Wall | Patch work, Spalling and Cracks observed on Piers and Pier cap |

| PART 4 SURVEY OF SIGNS OF DISTRESS, DEFORMATION IN BRIDGES | | |
|---|---|---|
| Cracking in RCC components | Slab | cracks are observed at Pier, pier cap & Abutment ( <i>Refer Fig:5,7</i> ) |

Fig: 5 Cracks & Patch repair work observed at Pier

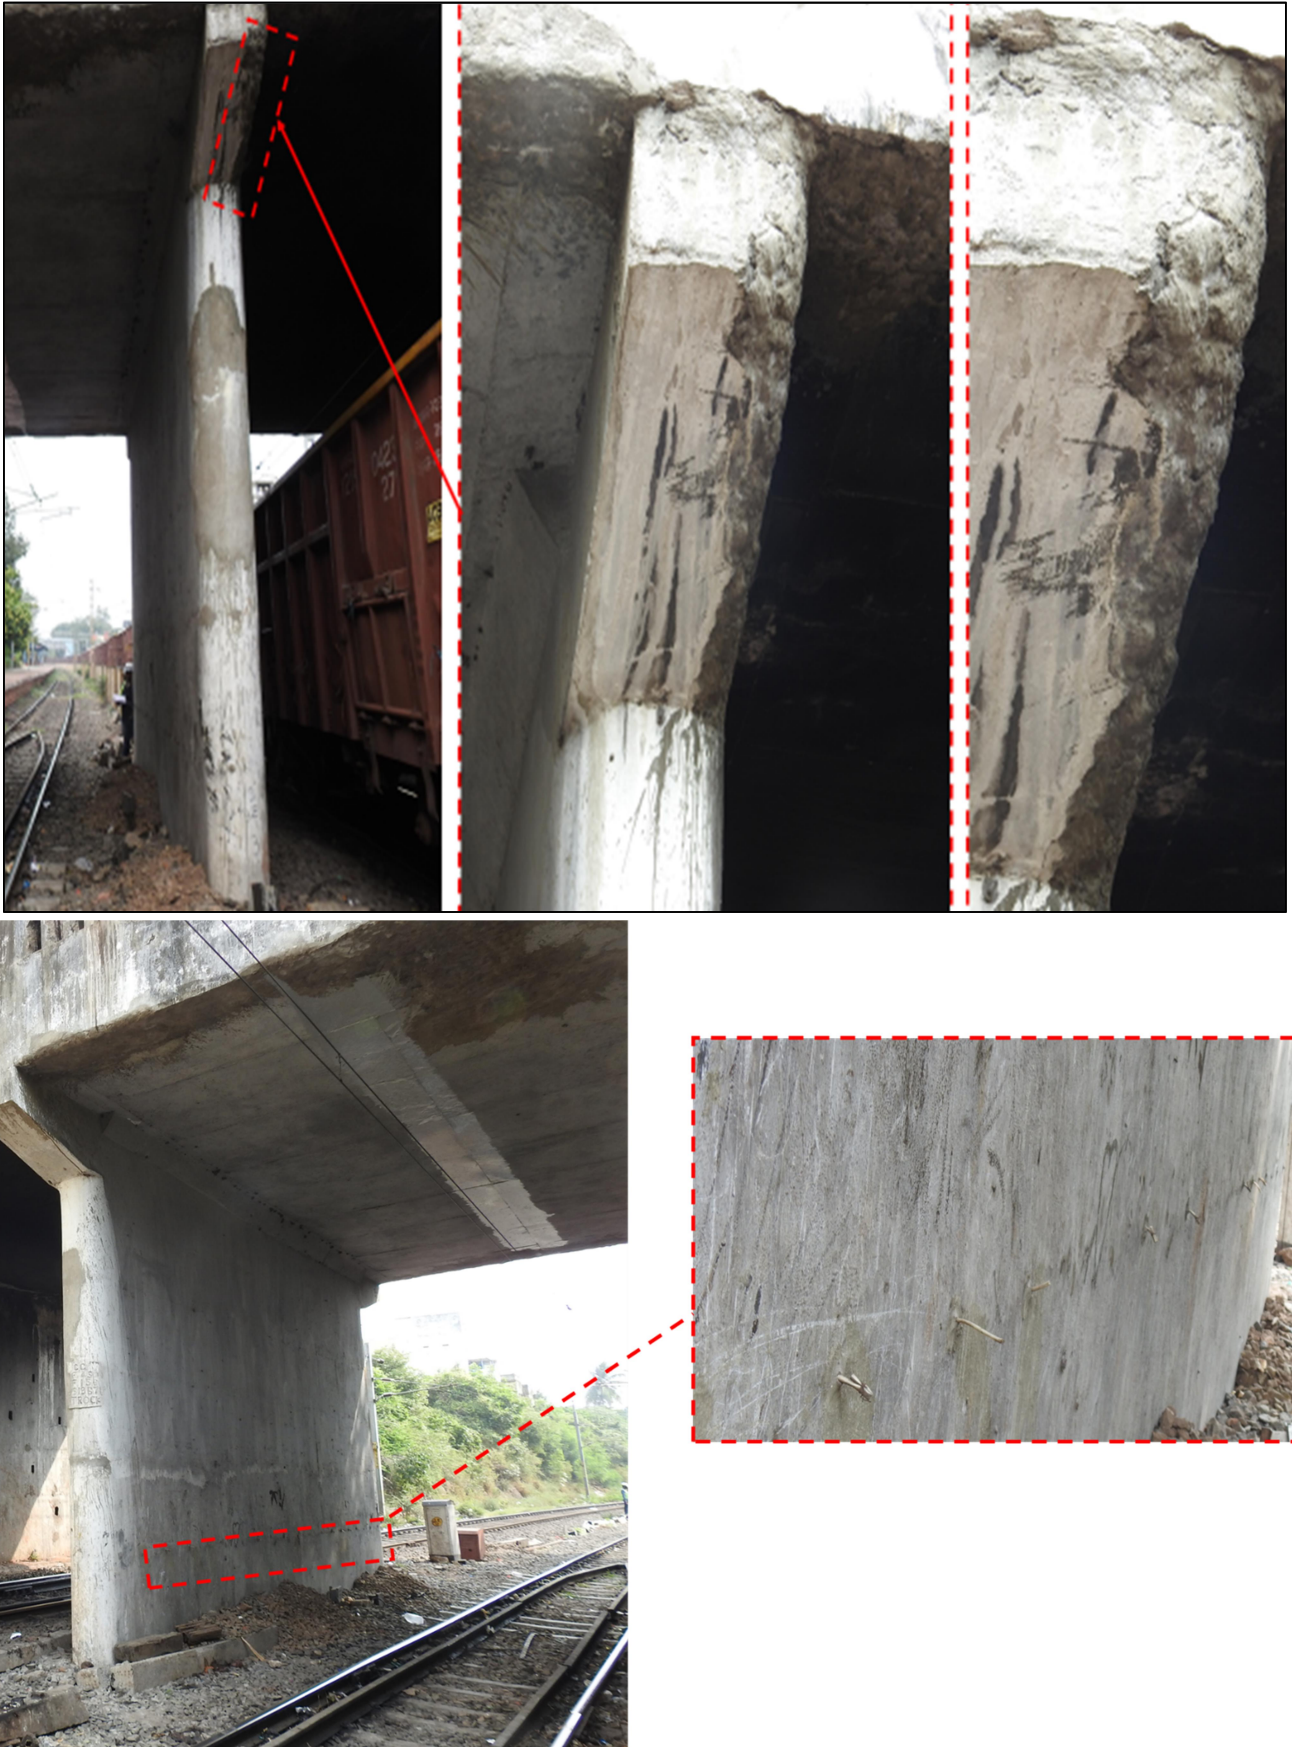
Fig: 6 Grouting observed at Pier

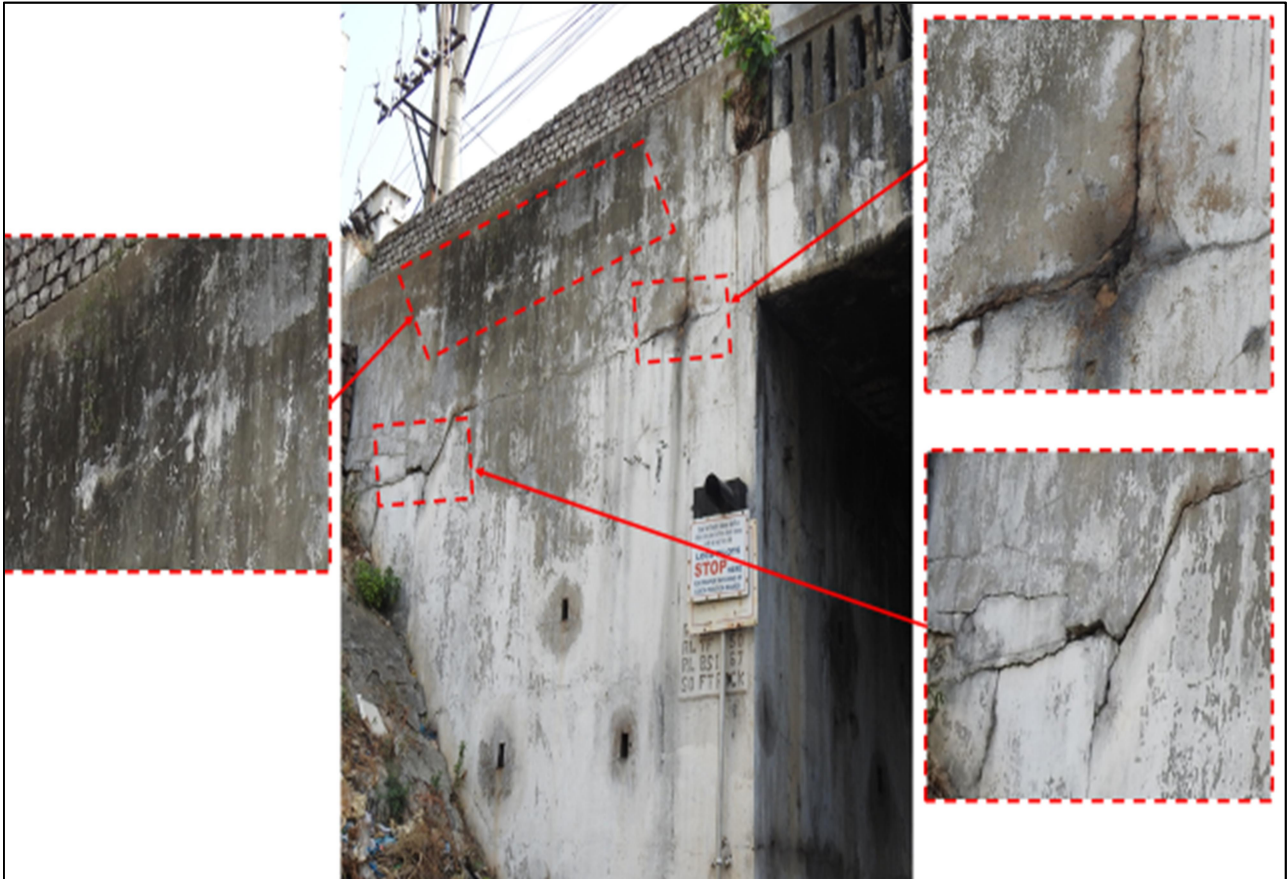
| PART 2 STRUCTURAL SYSTEM OF THE BRIDGE | | | |
|---|---|---|---|
| | Condition (Crack, Settlement, Scour, Tilting, Steel Corrosion, Strains and other damages etc...) | Distresses found | Leaching, Cracks, Spalling and Reinforcement exposure are observed (Refer <b>Fig:4, 7</b> ) |

| PART 4 SURVEY OF SIGNS OF DISTRESS, DEFORMATION IN BRIDGES | | |
|---|---|---|
| Spalling | Slab & Abutment | Spalling is observed in Slab & Abutment. ( <i>Refer Fig:4 and Fig:7</i> ) |

Fig: 7 Spalling, Cracks & Leaching observed at Abutment-1

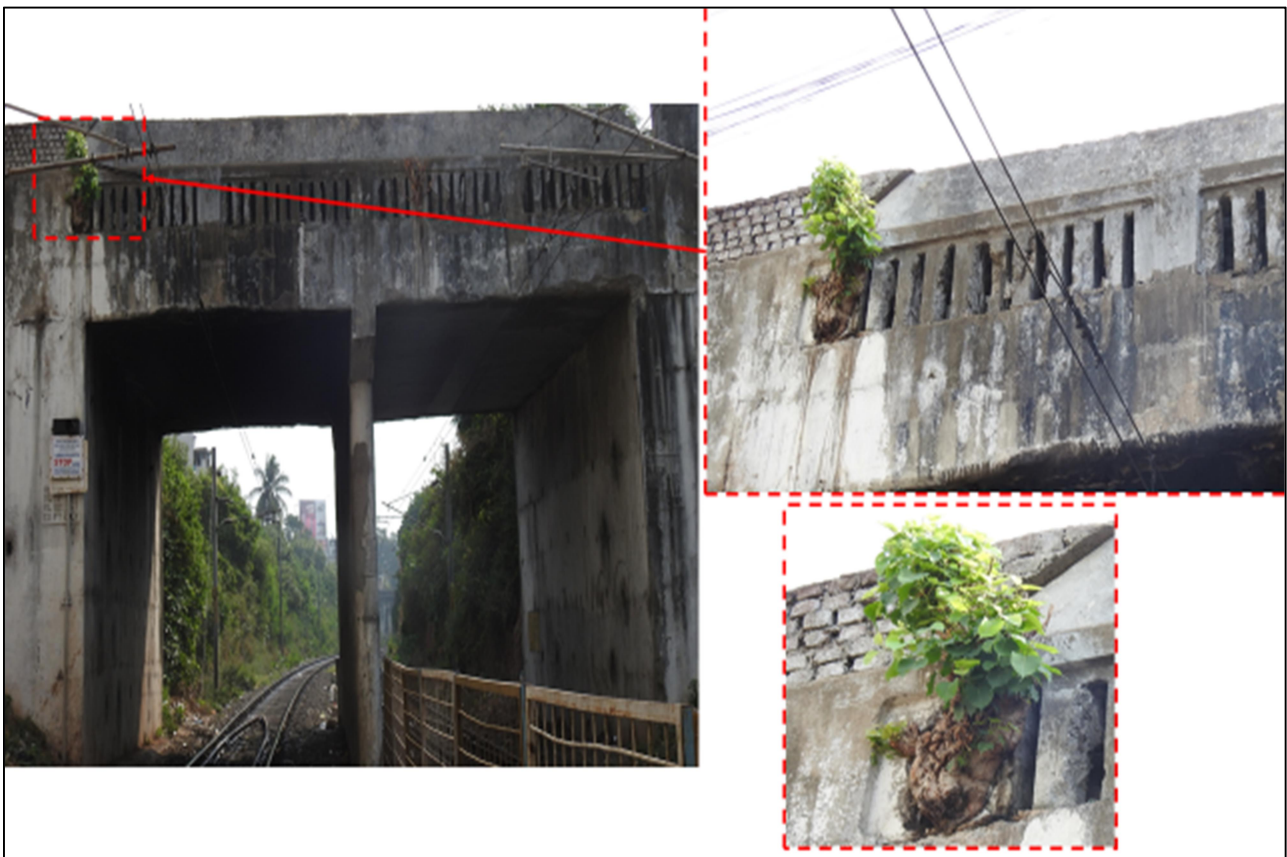
Fig: 8 Vegetation growth observed at Railing of ROB

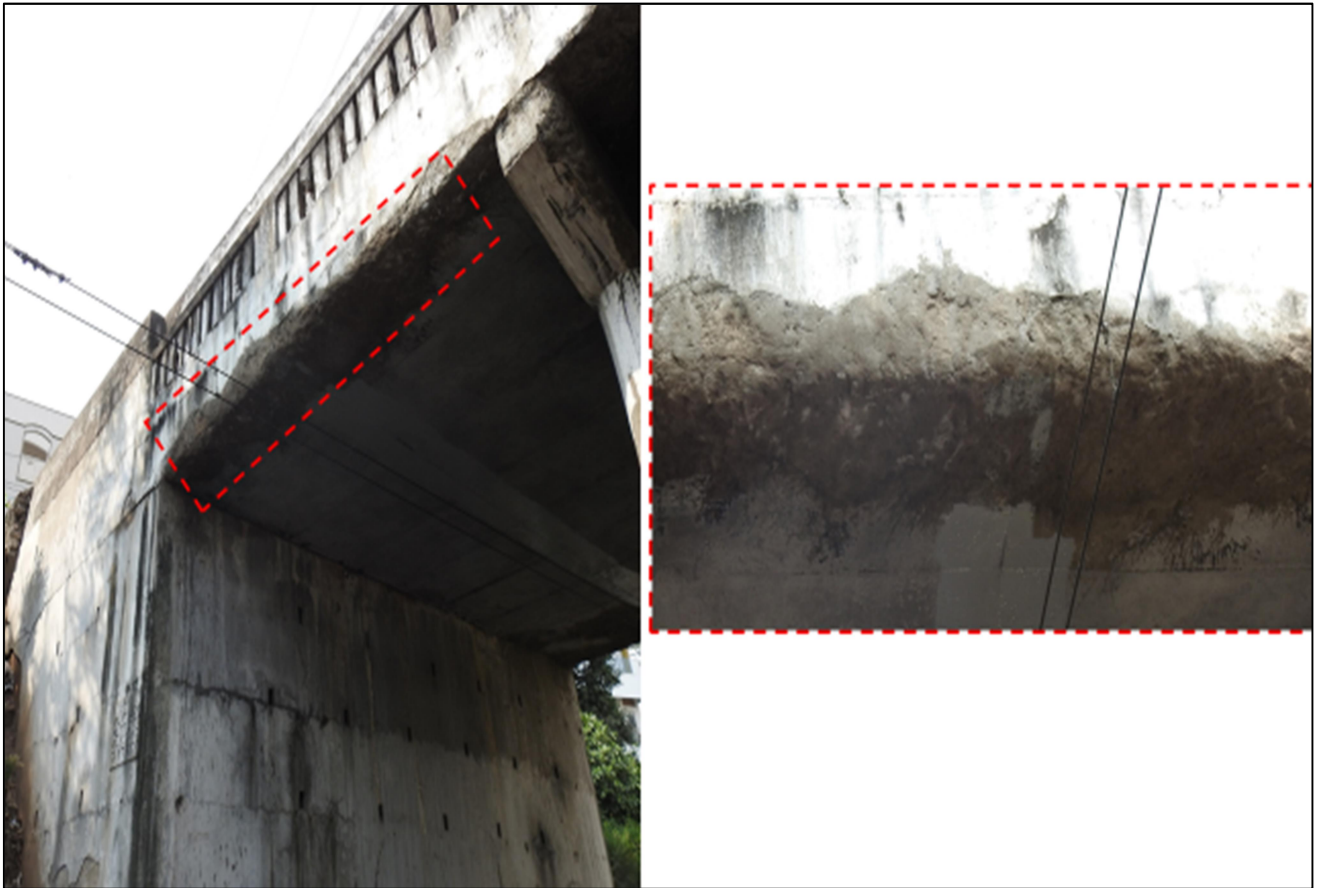
Fig: 9 Patch repair work observed at Span-2

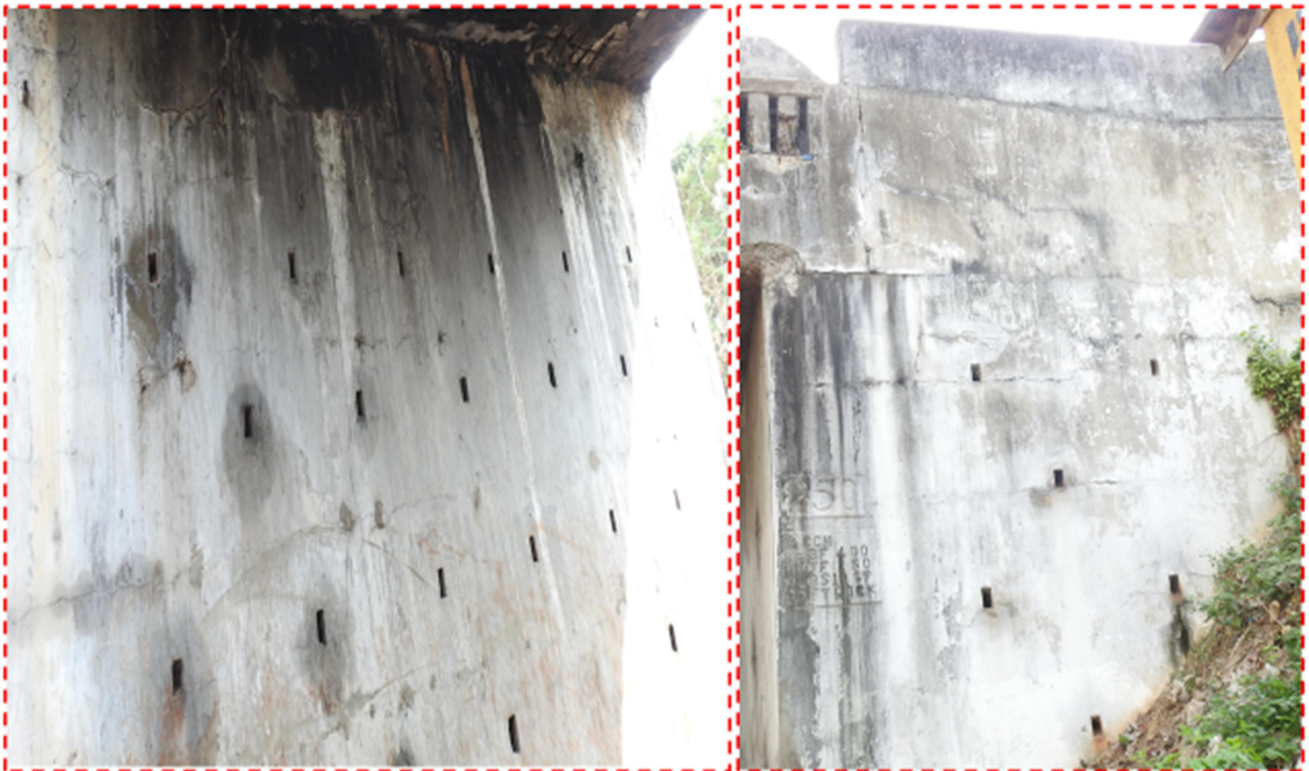
| PART 2 STRUCTURAL SYSTEM OF THE BRIDGE | | | |
|---|---|---|---|
| | Efficiency of drainage of backfill behind Abutments (Check functioning of weep holes, evidence of moisture on Abutment faces, etc.) | Good | Proper functioning of weep holes observed, evidences of moisture is also observed on abutment faces. |

Fig: 10 Weep holes at Abutments
