| <b>Name of the Project</b> | <b>:</b> | <b>VISUAL INSPECTION OF ROB - 251</b> |
| <b>Location</b> | <b>:</b> | <b>NEAR GODAVARI RAILWAY STATION</b> |
| <b>Date of Inspection</b> | <b>:</b> | <b>2<sup>nd</sup> DECEMBER, 2019</b> |

### **VISUAL INSPECTION OF ROAD OVER BRIDGE**

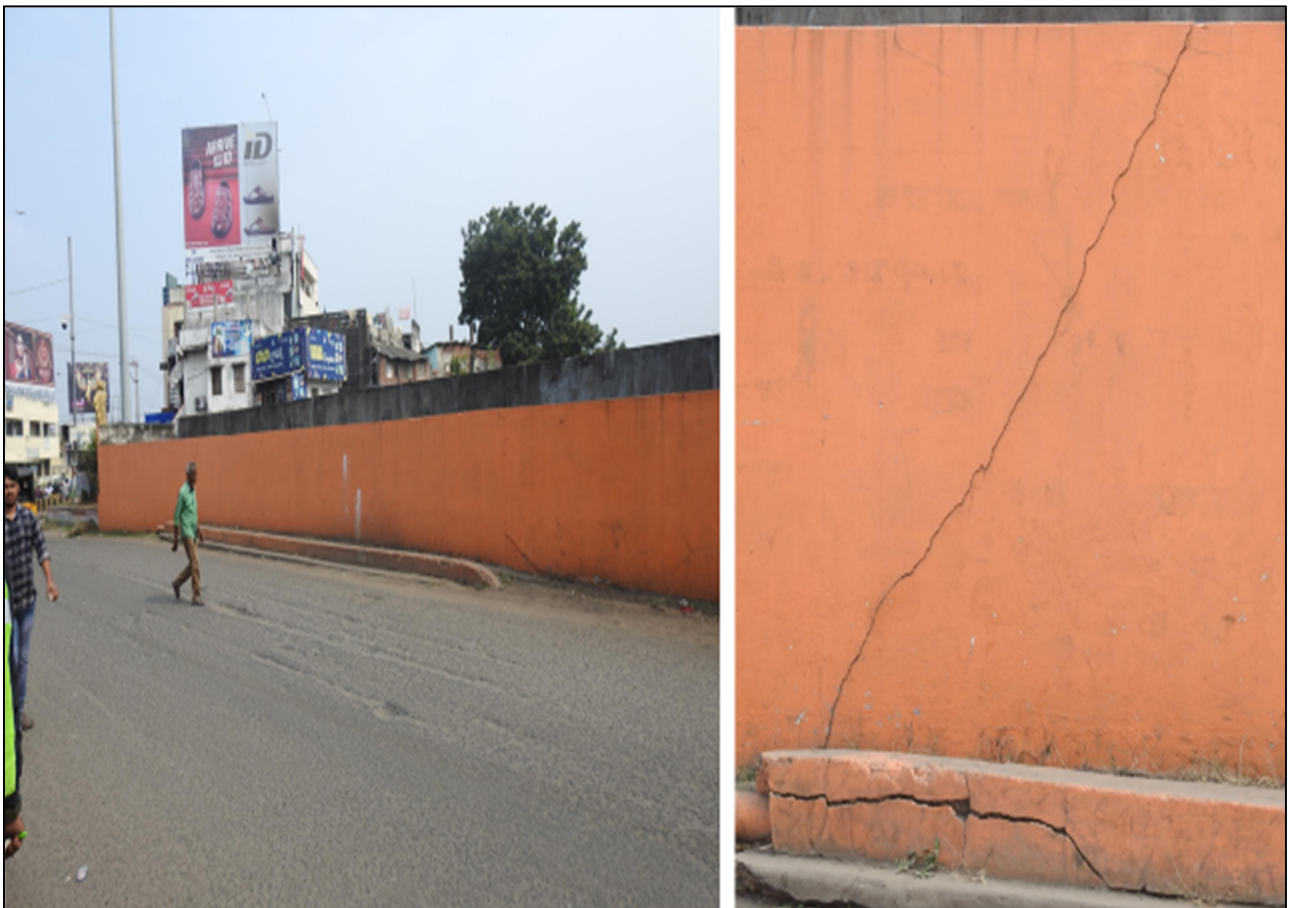
| | Condition of Slab from Top | | Not visible, as covered with wearing coat (Refer <b>Fig-3</b> ) |
| | Condition of Wall/Railing | | cracks are observed on Parapet wall. (Refer <b>Fig-3</b> ) |

**Fig: 3** Cracks observed on parapet wall

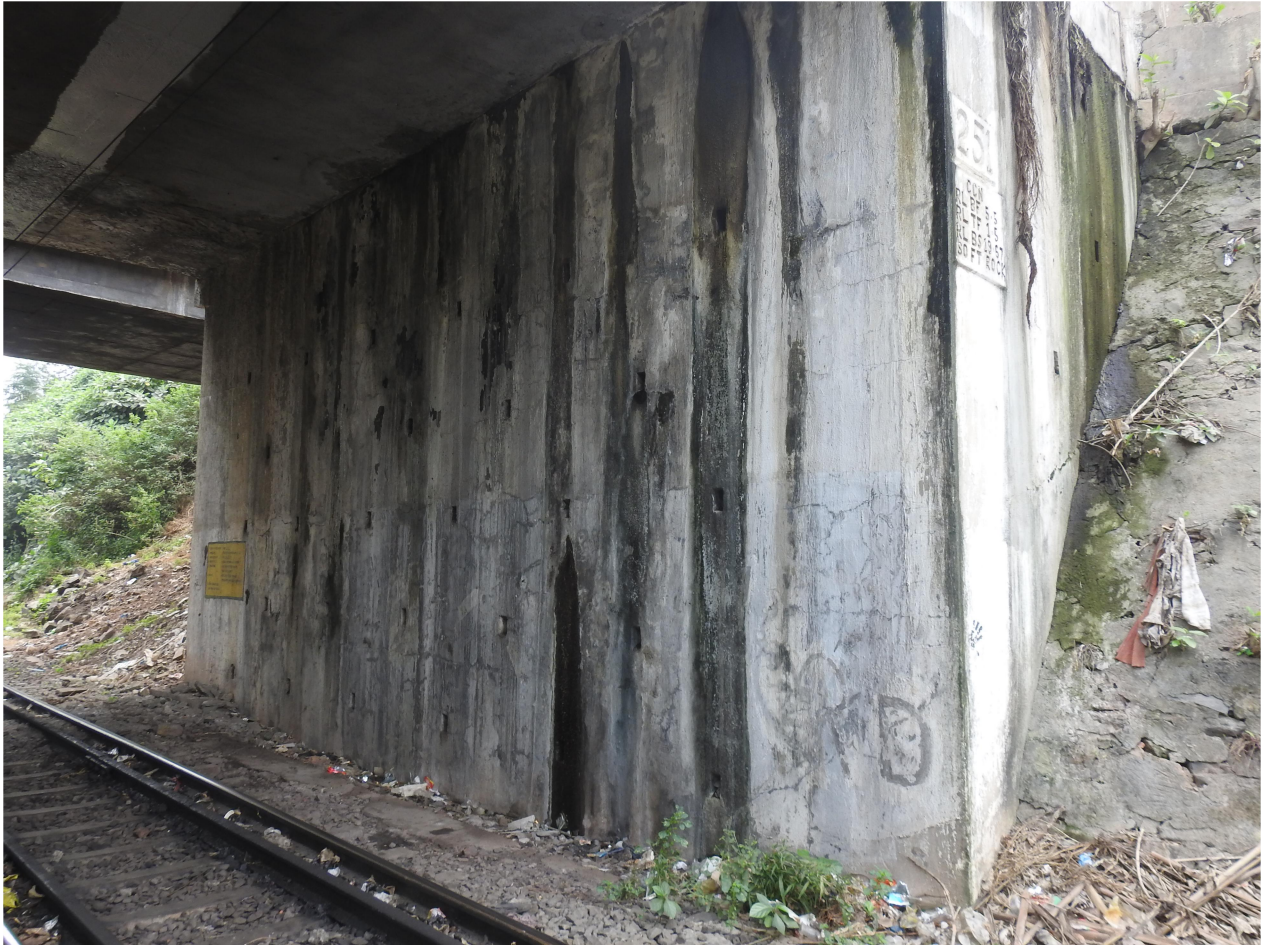
| PART 2 STRUCTURAL SYSTEM OF THE BRIDGE | | | |
|---|---|---|---|
| | Condition (Crack, Settlement, Scour, Tilting, Steel Corrosion, Strains and other damages etc...) | Distresses Found | Shrinkage Cracks and Leaching is observed<br><br>Water seepage is observed at abutments due to the flow of drain over ROB (Refer <b>Fig- 4, 15</b> ), |

***Fig: 4*** Water seepage at abutment

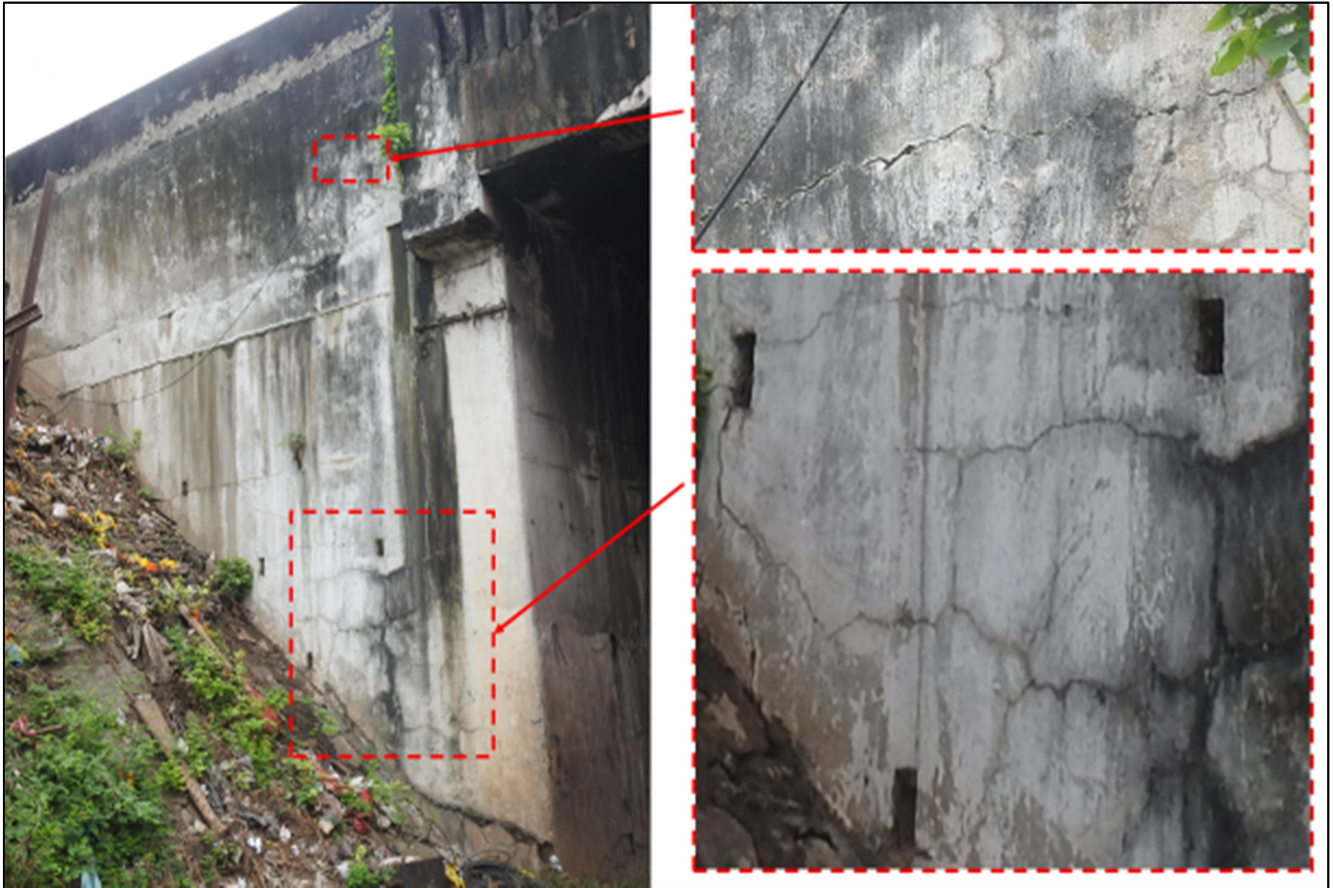
**Fig: 5** Cracks observed at Abutment 1

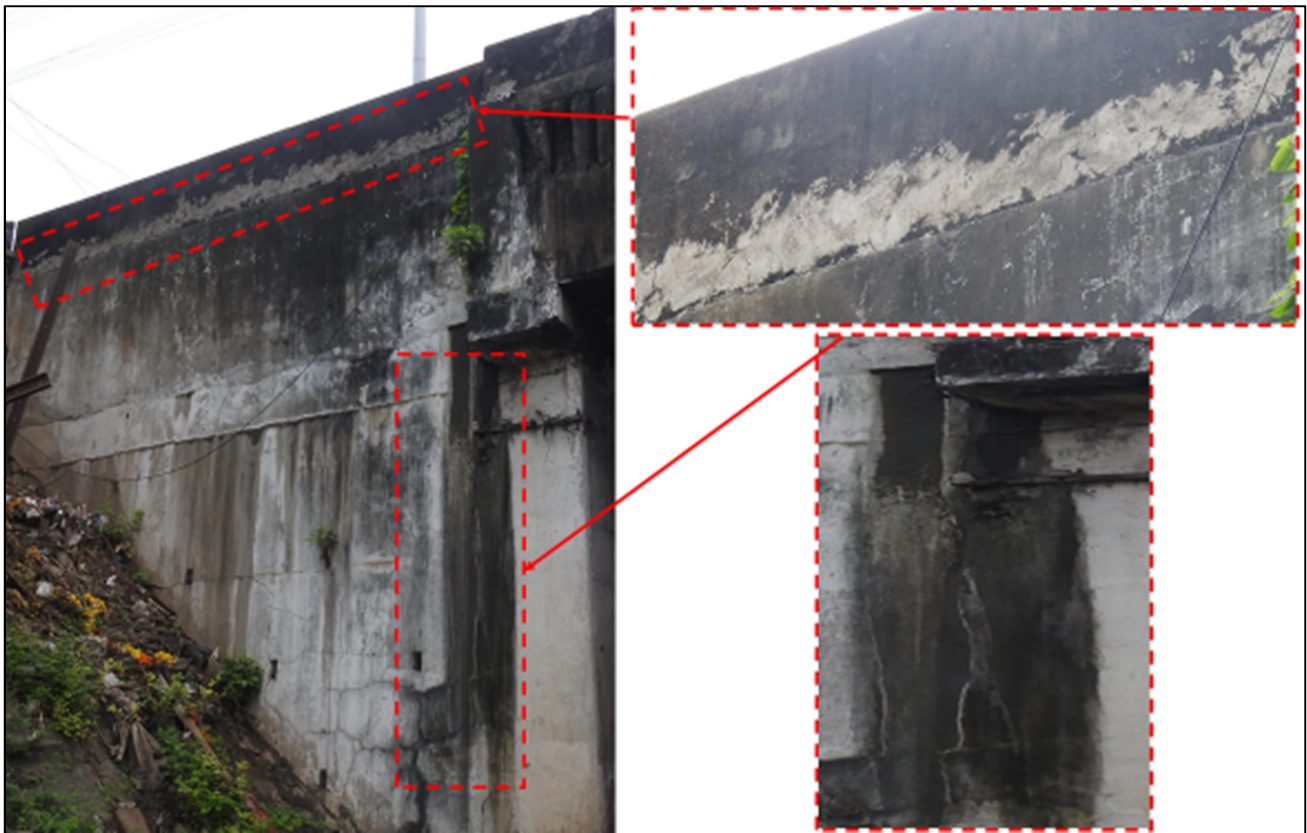
**Fig:6** Patch work & Leaching observed at Abutment-1

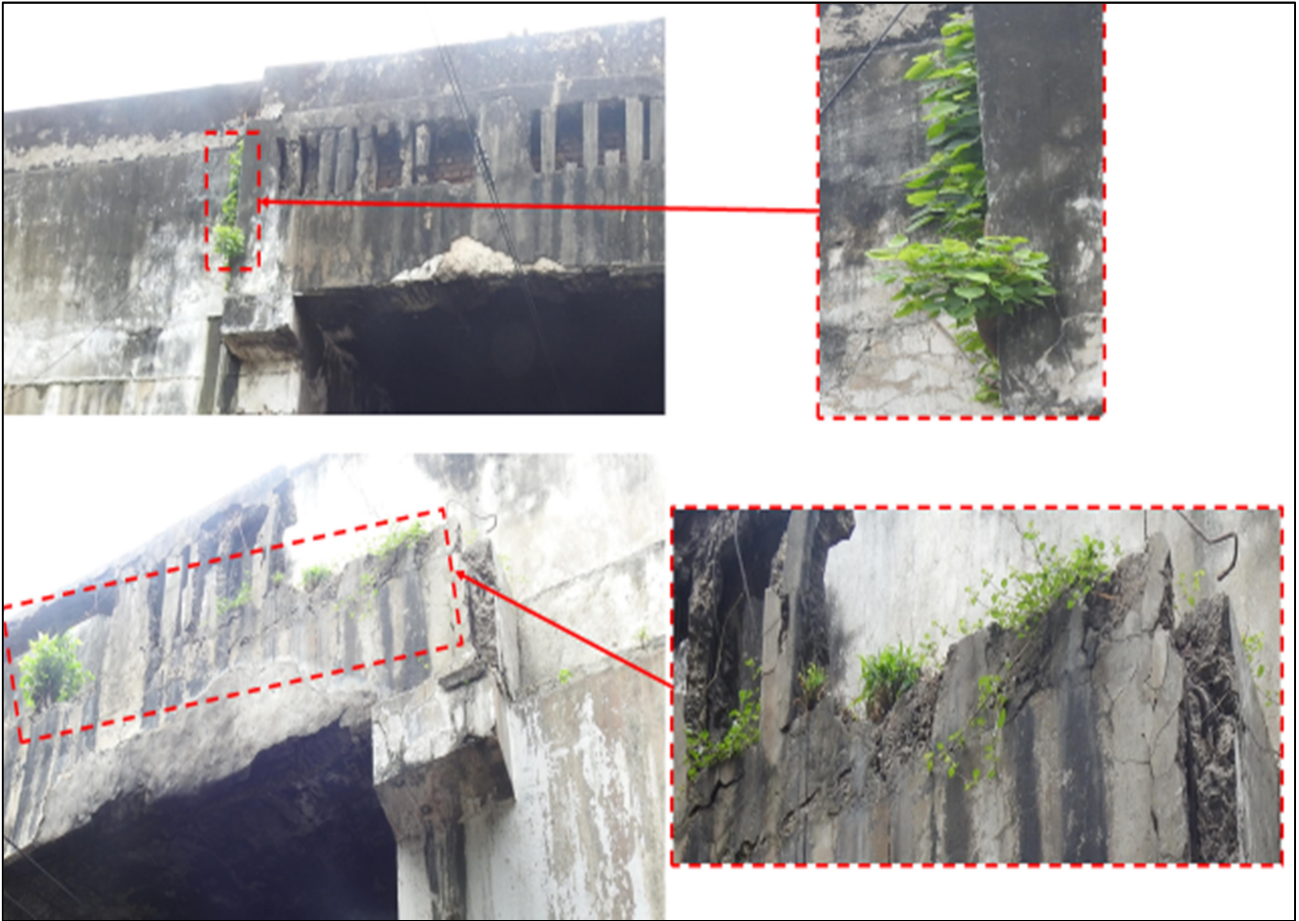
**Fig 7:** Vegetation growth observed at Abutment-1

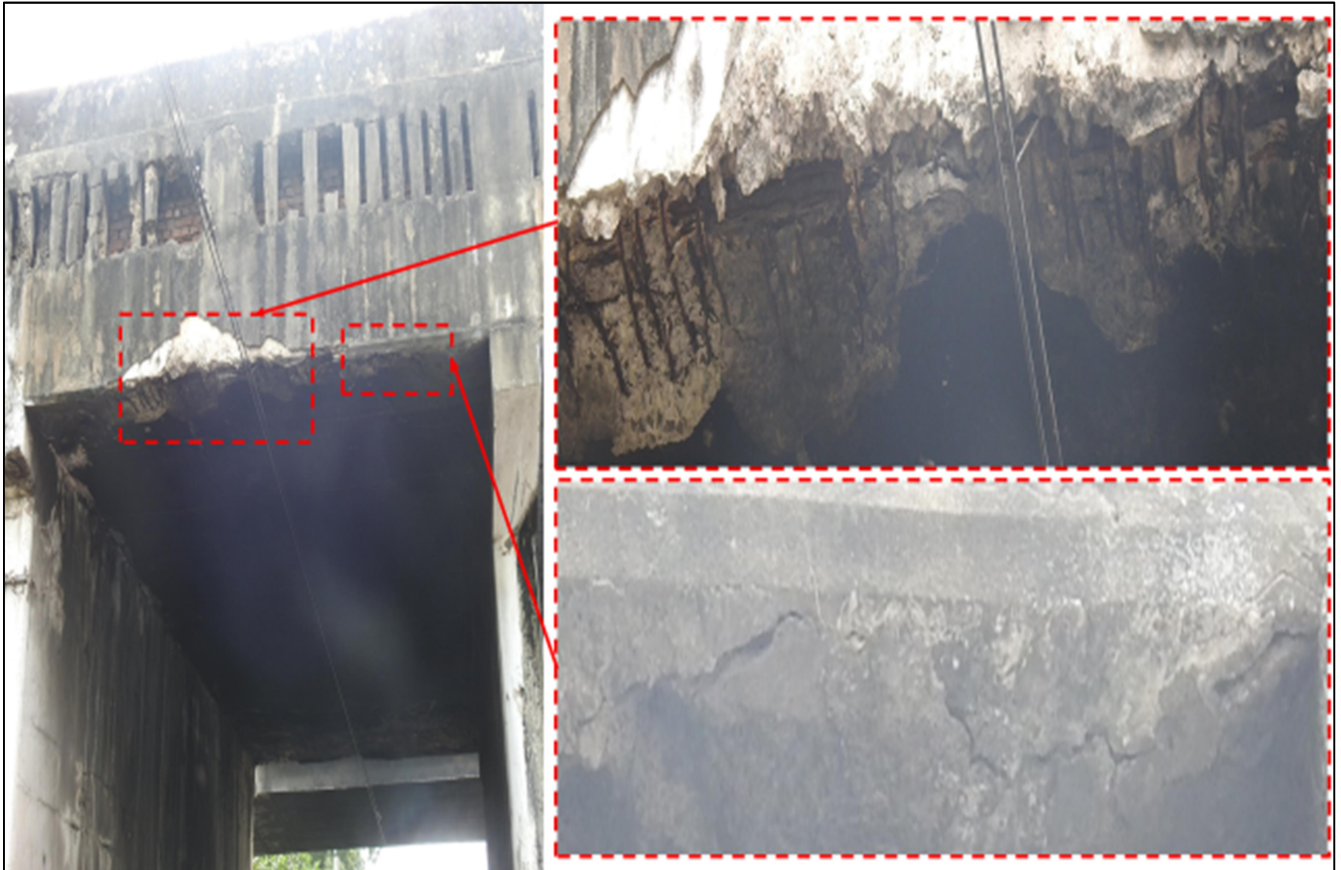
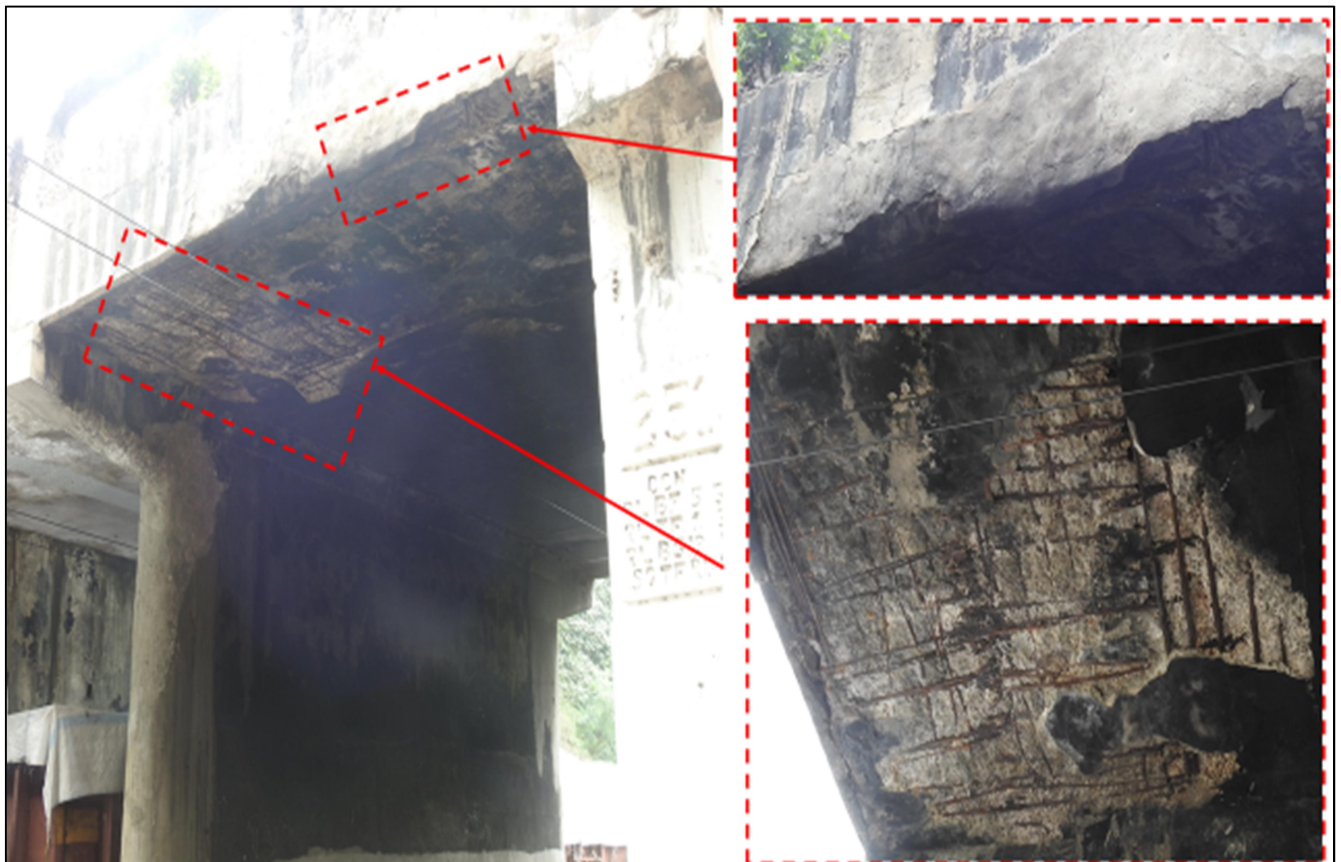
| PART 3 SURVEY OF SIGNS OF DISTRESS, DEFORMATION IN BRIDGES | | | |
|---|---|---|---|
| | Reinforcement Exposure | Slabs | Reinforcement Exposure is observed in Slabs |

**Fig 8:** Reinforcement exposure & Spalling observed at Span-1

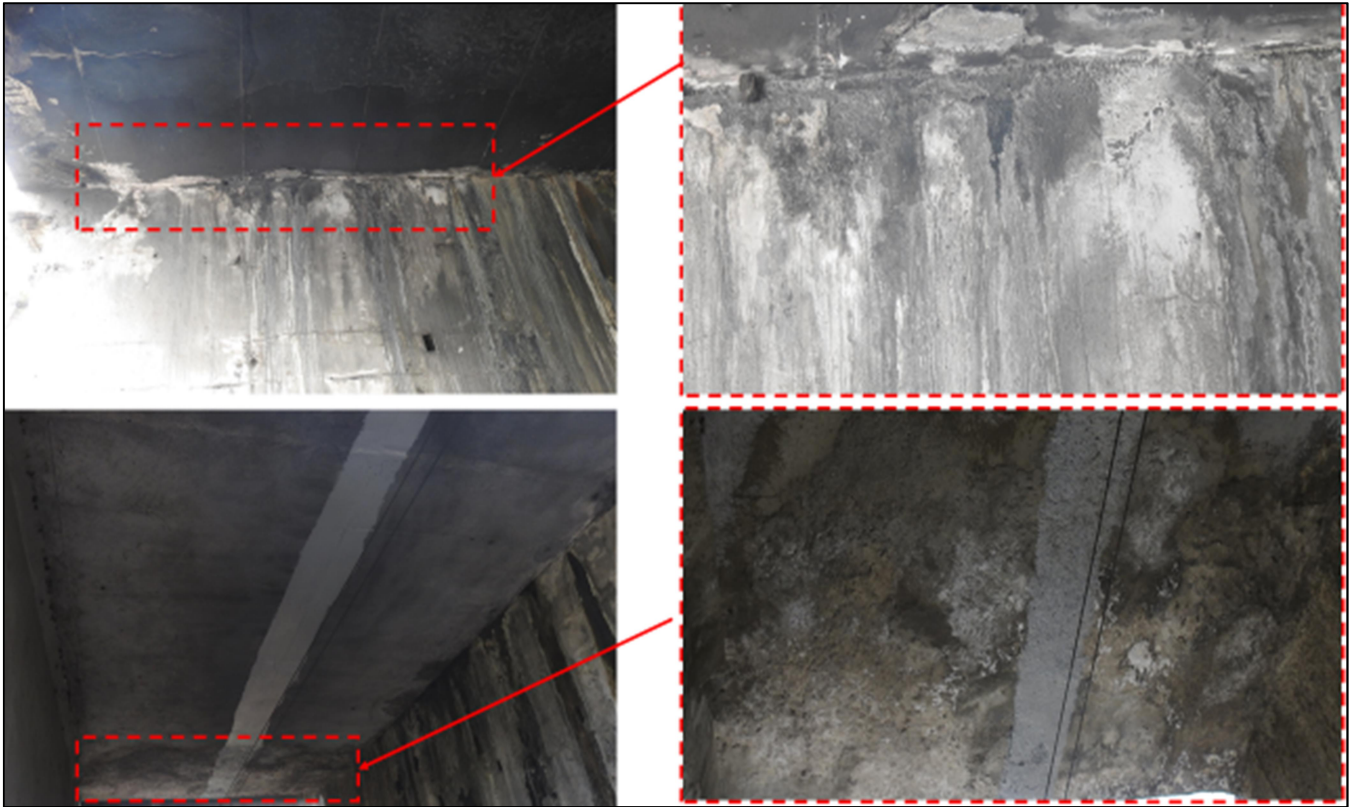
**Fig 9:** Leaching observed on Slab – 1 & Slab-2

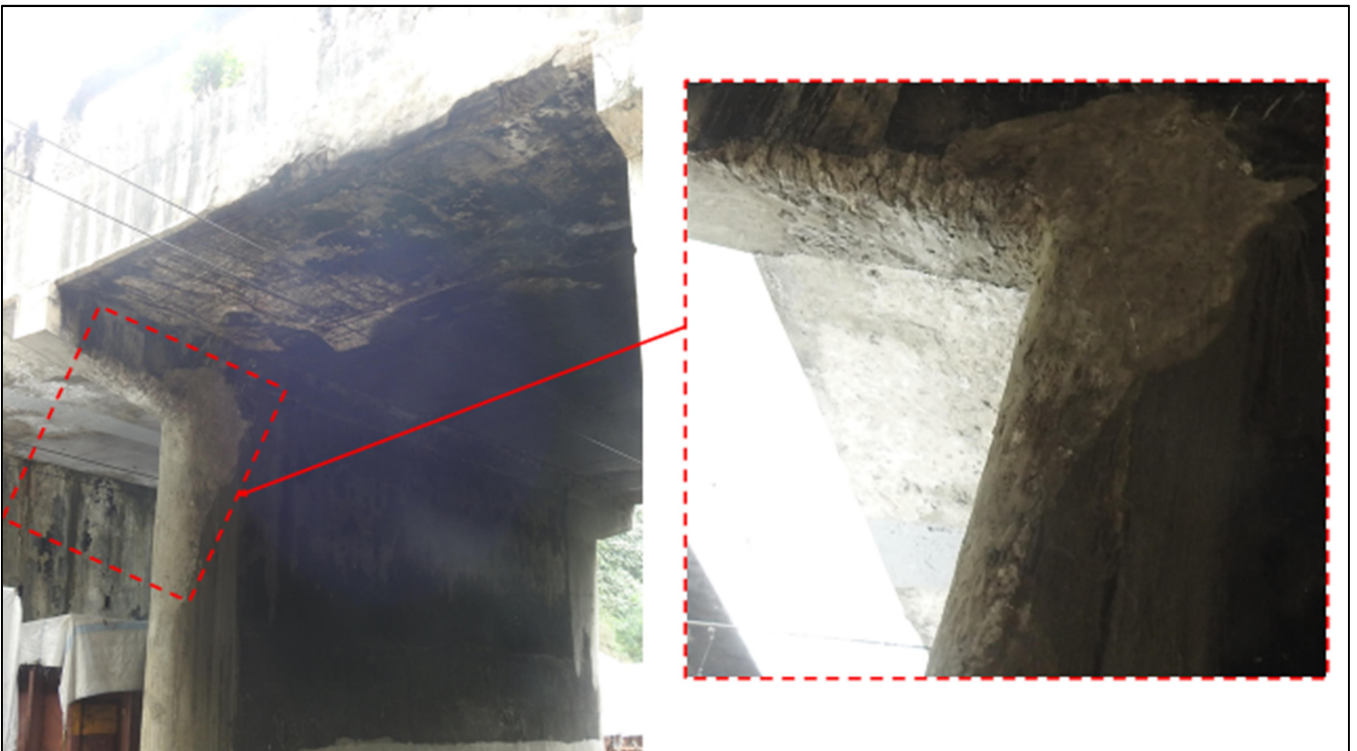
| | Type (Shape) | Wall | Leaching, patch work and cracks observed. |

**Fig 10:** Cracks & Spalling observed at Pier

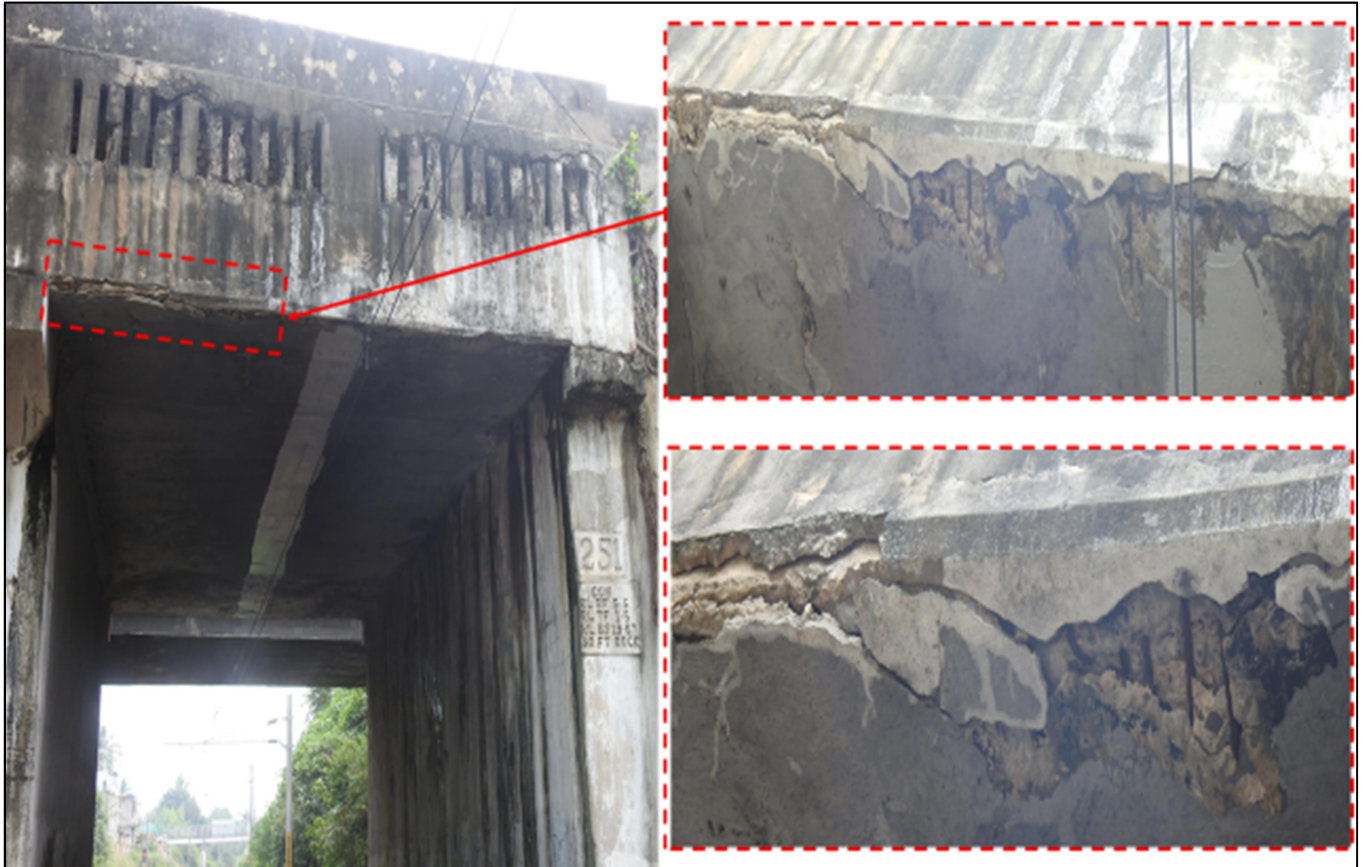
**Fig 11:** Reinforcement exposure observed at Span-2

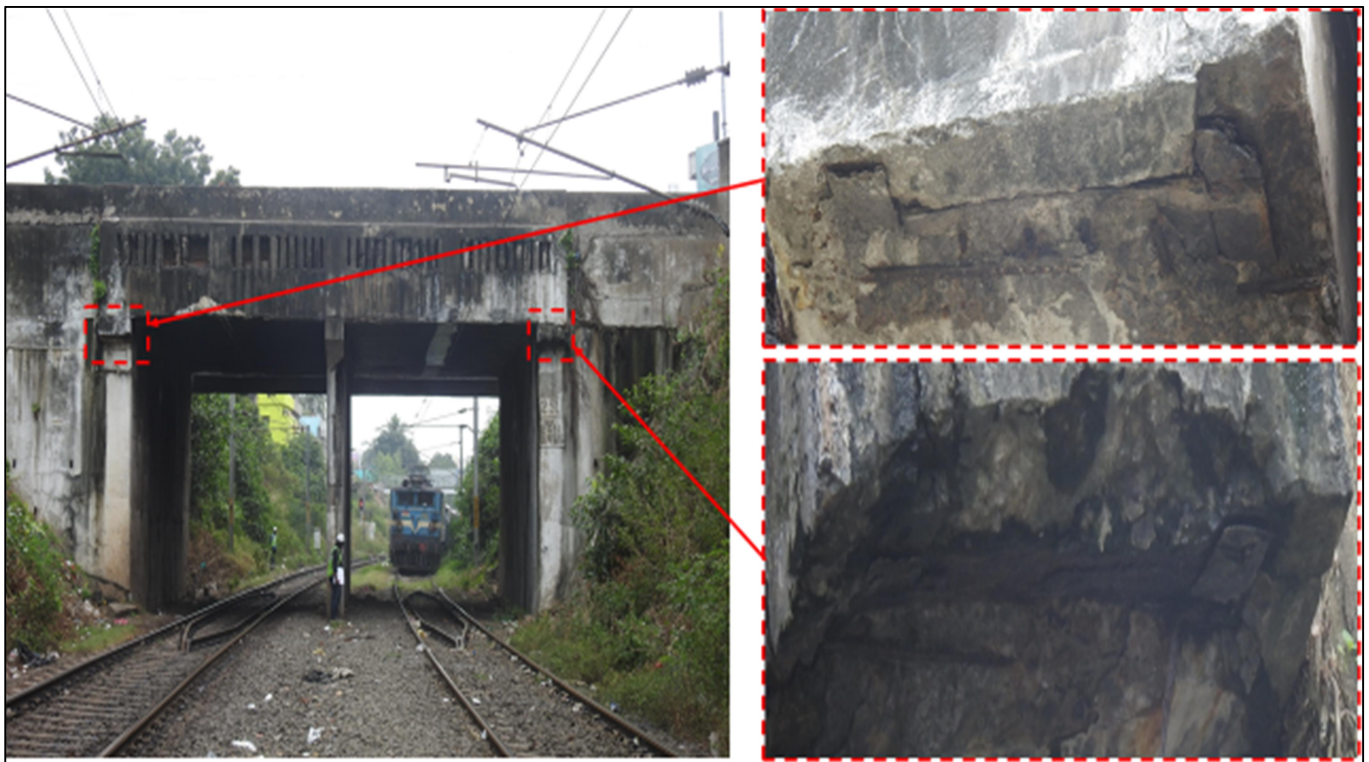
**Fig 12:** Spalling observed at both Abutment Pier caps

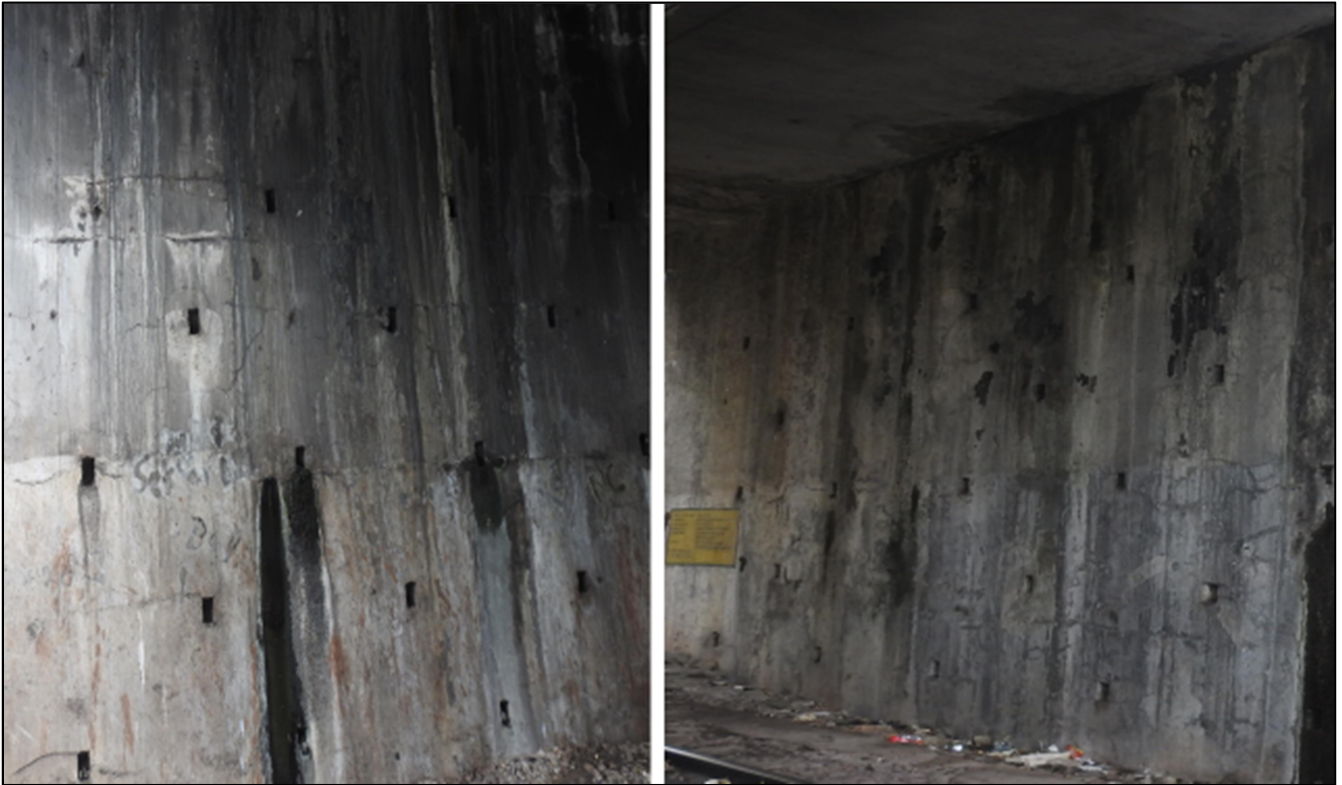
**Fig 13:** Shrinkage cracks observed on A1 & A2 Abutments

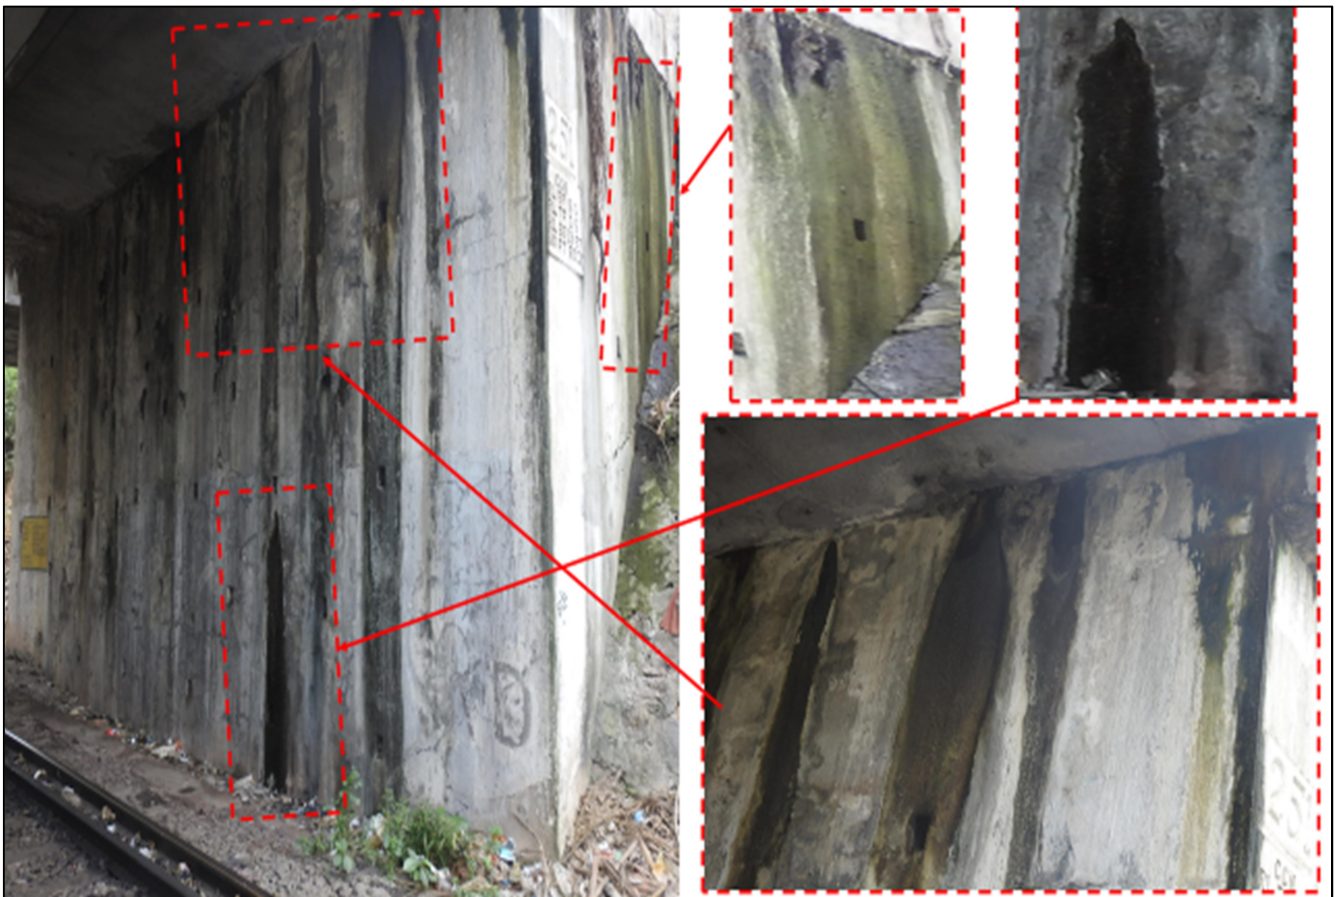
**Fig 14:** Algae observed on Abutment-2

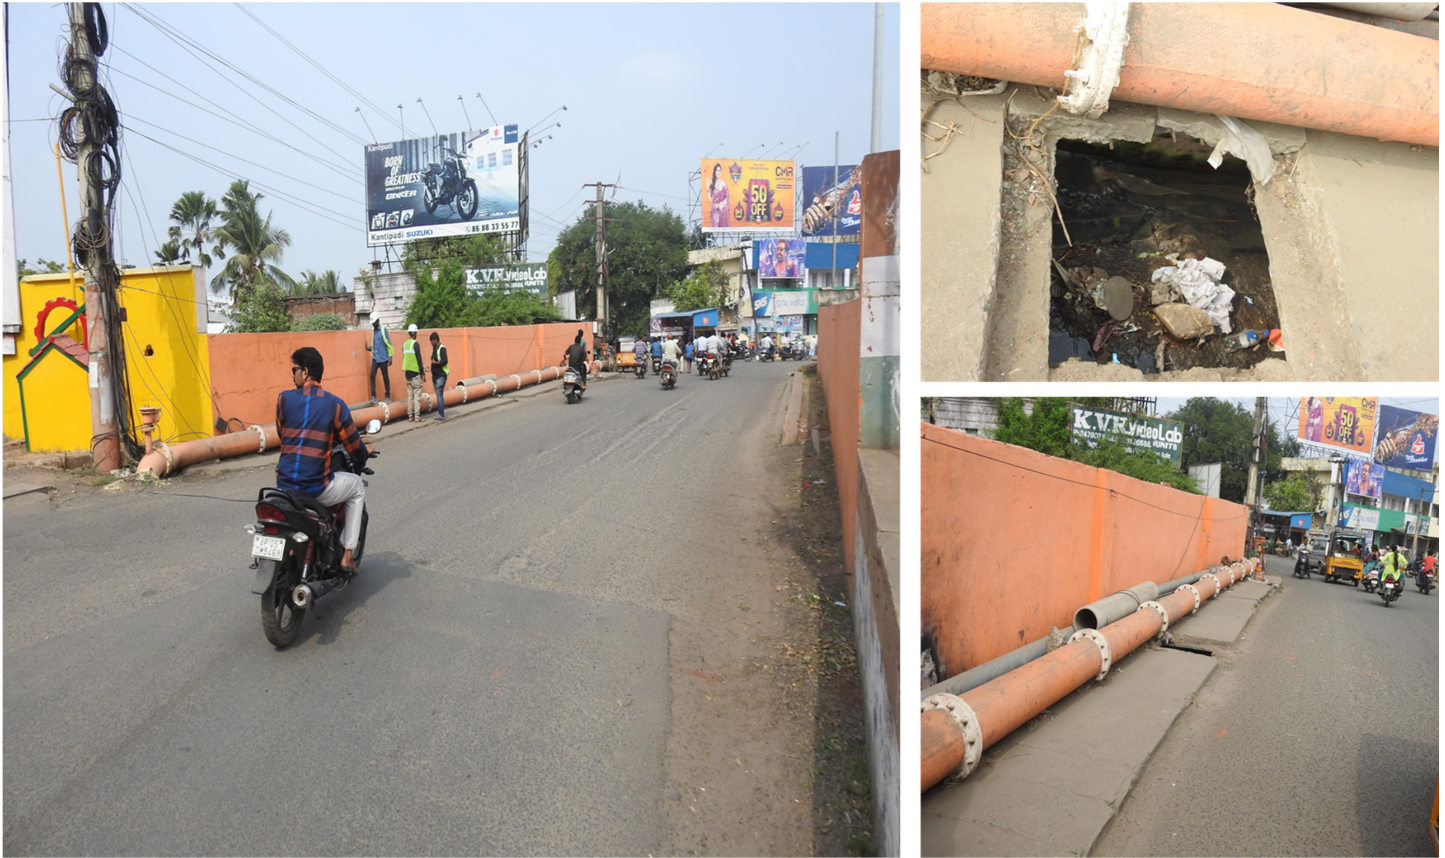
**Fig 15:** Road surface and drain on ROB
