| <b>Name of the Project</b> | <b>:</b> | <b>VISUAL INSPECTION OF ROB-377</b> |
| <b>Location</b> | <b>:</b> | <b>PODURU (NEAR KONDAGATTU)</b> |
| <b>Date of Inspection</b> | <b>:</b> | <b>30<sup>th</sup> NOVEMBER, 2019</b> |

## VISUAL INSPECTION OF ROAD OVER BRIDGE

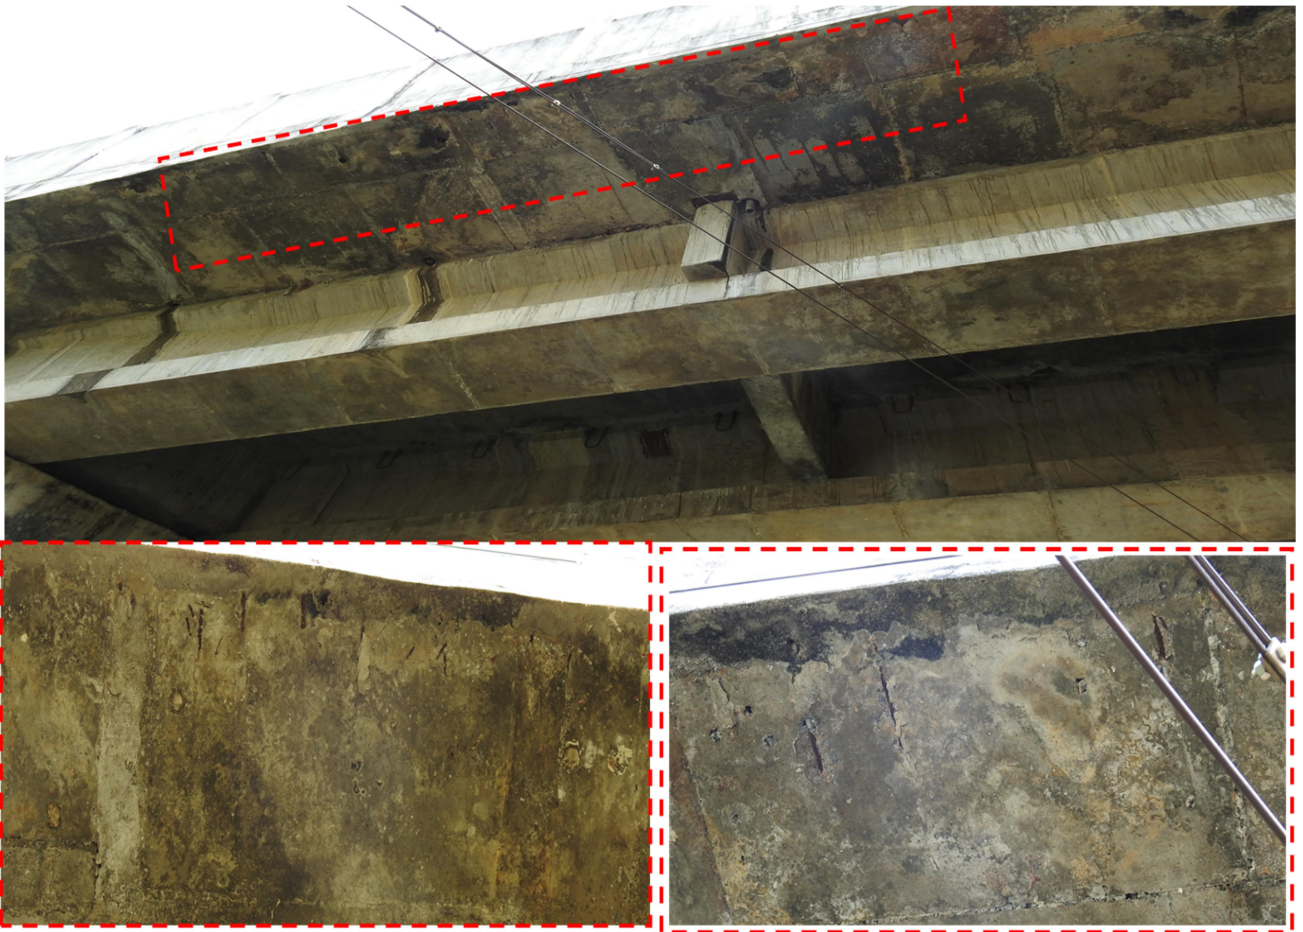
| | <b>Condition of Slab from Bottom</b> | | Leaching and minor spalling observed at overhang portion of slab. |

| PART 3 SURVEY OF SIGNS OF DISTRESS, DEFORMATION IN BRIDGES | | | |
|---|---|---|---|
| | Spalling | Slab | Minor spalling is observed. |
| | Reinforcement Exposure | Slab | Minor Reinforcement Exposure is observed. |

***Fig 4: Spalling at overhang portion of slab***

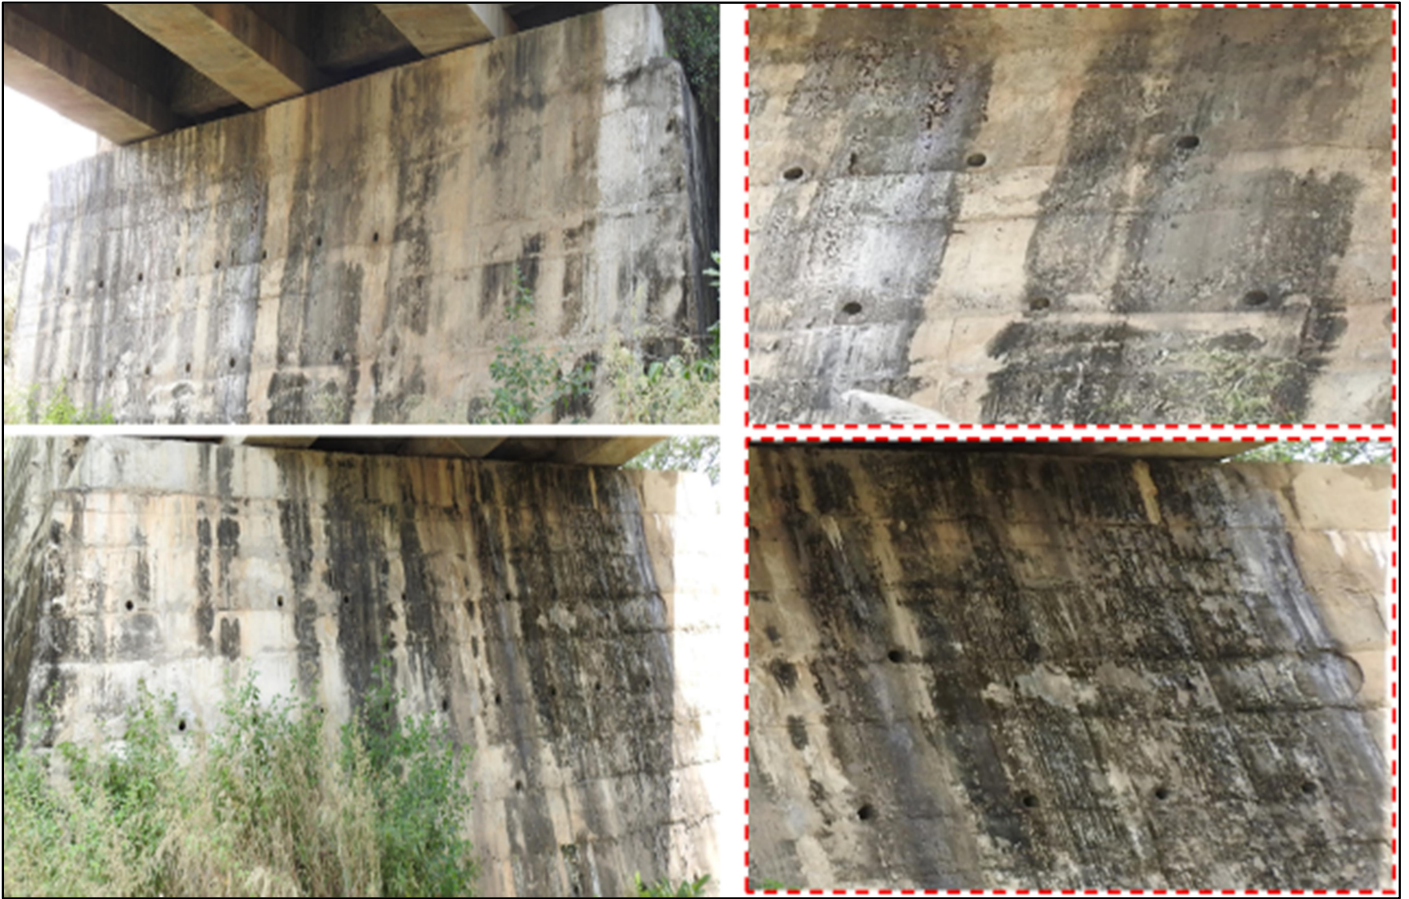
| PART 2 STRUCTURAL SYSTEM OF THE BRIDGE | | | |
|---|---|---|---|
| | Condition (Crack, Settlement, Scour, Tilting, Steel Corrosion, Strains and other damages etc...) | Leaching observed. | Minor spalling observed at dirt wall (Refer Fig-7) |

**Fig 5: Leaching observed at Abutment -1 & 2**

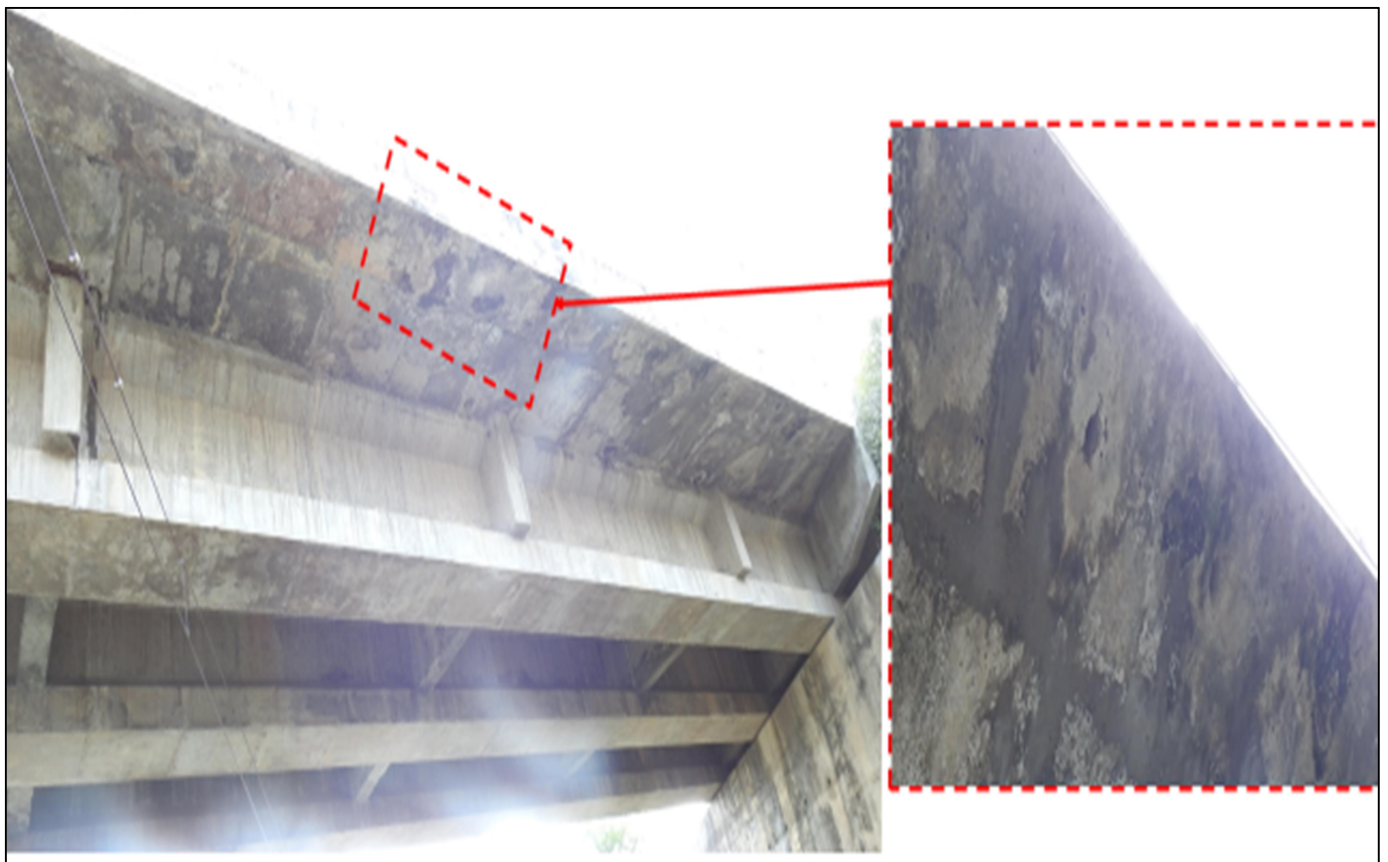
| | <b>Condition of Girder</b> | | Leaching has been observed (Refer Fig-6) |

**Fig 6: Leaching observed at Slab**

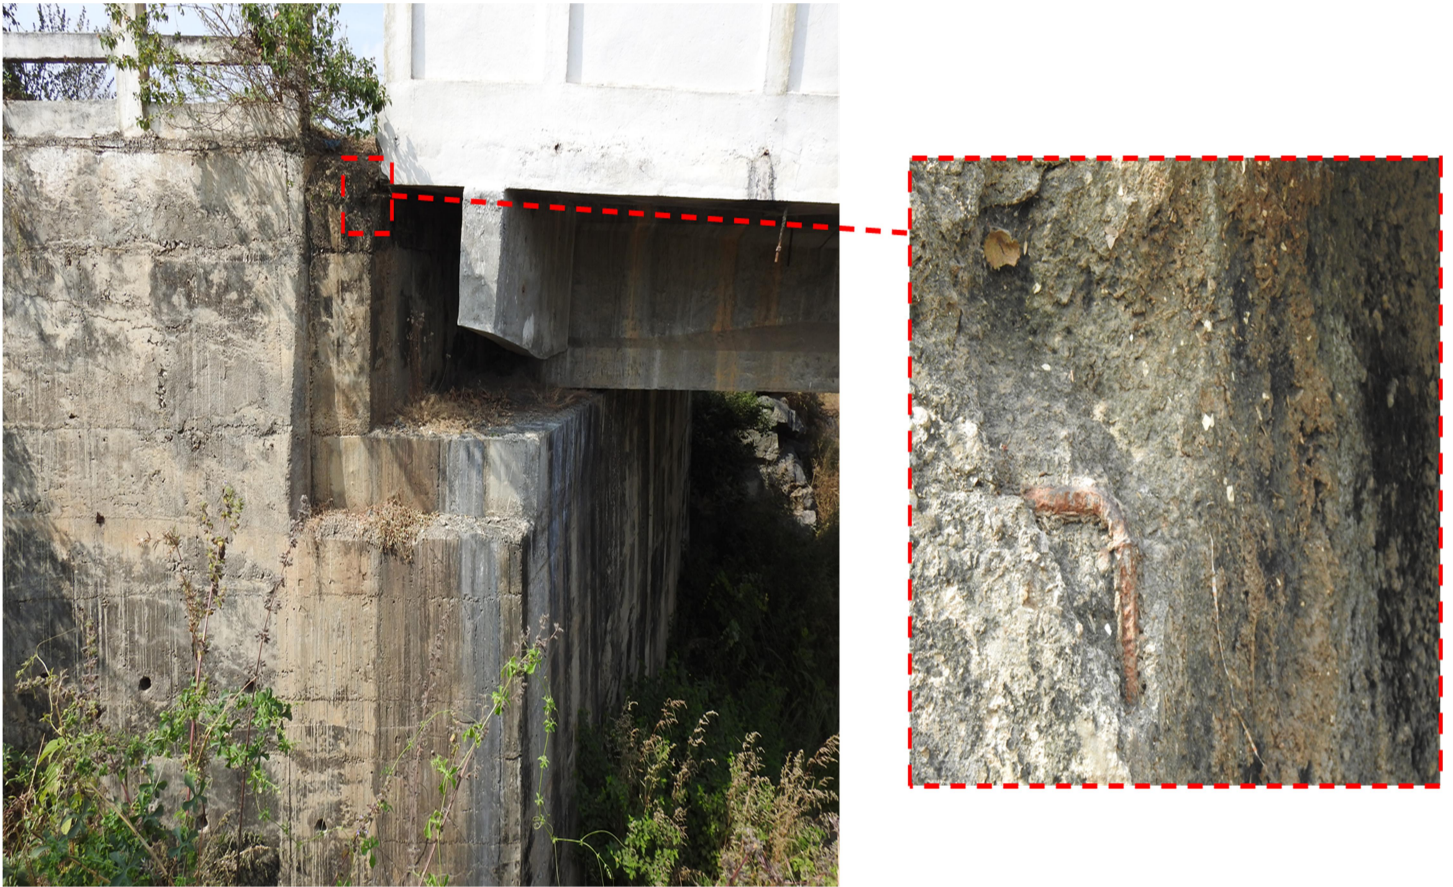
**Fig 7:** Spalling observed at dirt wall

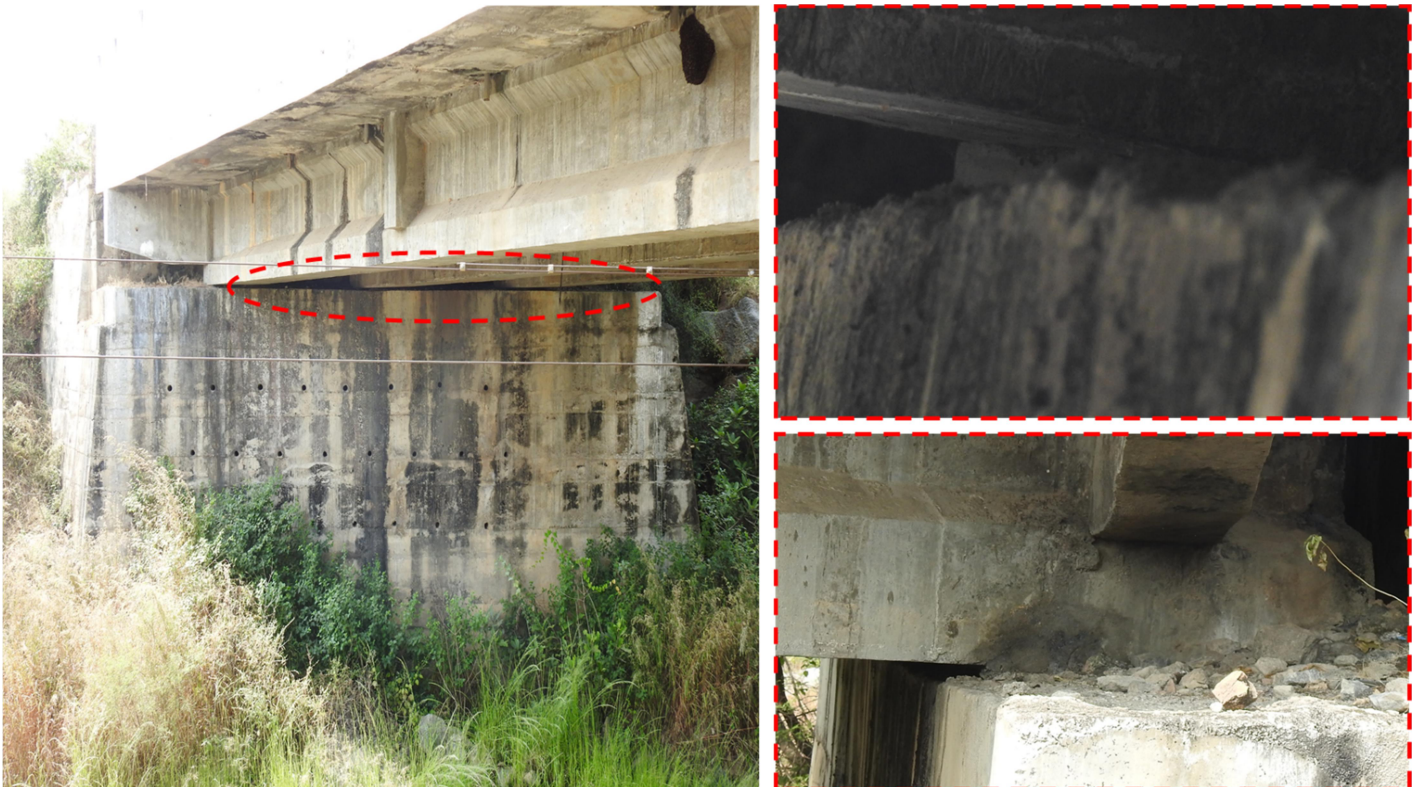
| | <b>General condition</b><br>(Check Corrosion, cleanliness, seizing of plates silting, accumulations of dirt in case of submersible bridges) | | Bearings settled (Refer Fig-8) |

**Fig 8:** Bearing details

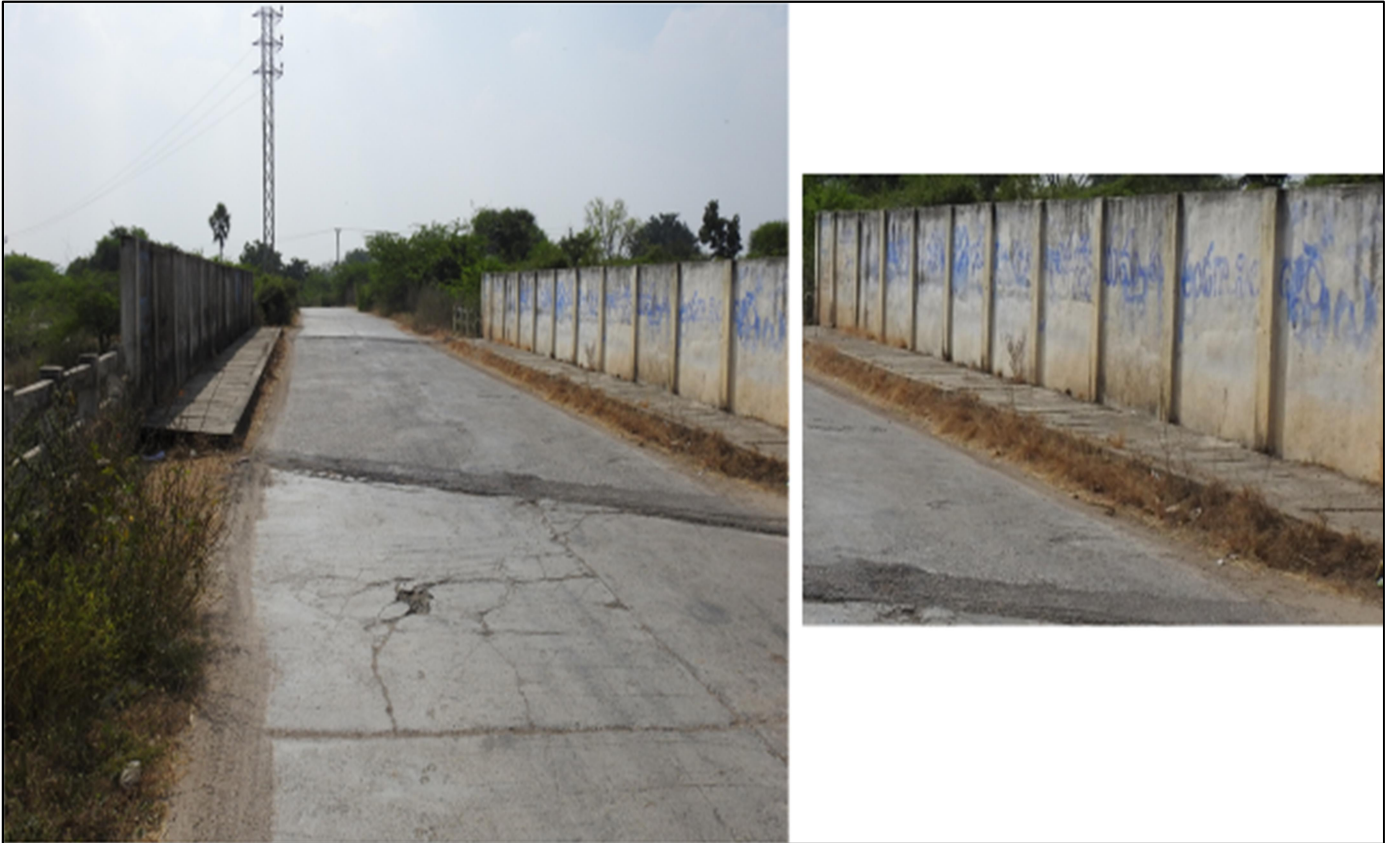
| | <b>Condition of Flooring/Wearing Coat</b> | | Minor pot holes observed (Refer Fig-9) |
| | <b>Condition of Wall/Railing</b> | | No Accidental hit marks are observed on wall(Refer Fig-9) |

***Fig 9: Condition of Road surface & Parapet wall***
