**Name of the Project** : VISUAL INSPECTION OF ROB-117/A  
**Location** : NEAR RAGHAVAPURAM  
**Location Co-ordinates** : 18°44'20.8"N 79°25'48.9"E  
**Date of Inspection** : 29<sup>th</sup> NOVEMBER, 2019

### VISUAL INSPECTION OF ROAD OVER BRIDGE

#### PART 1 GENERAL INFORMATION AND OBSERVATION

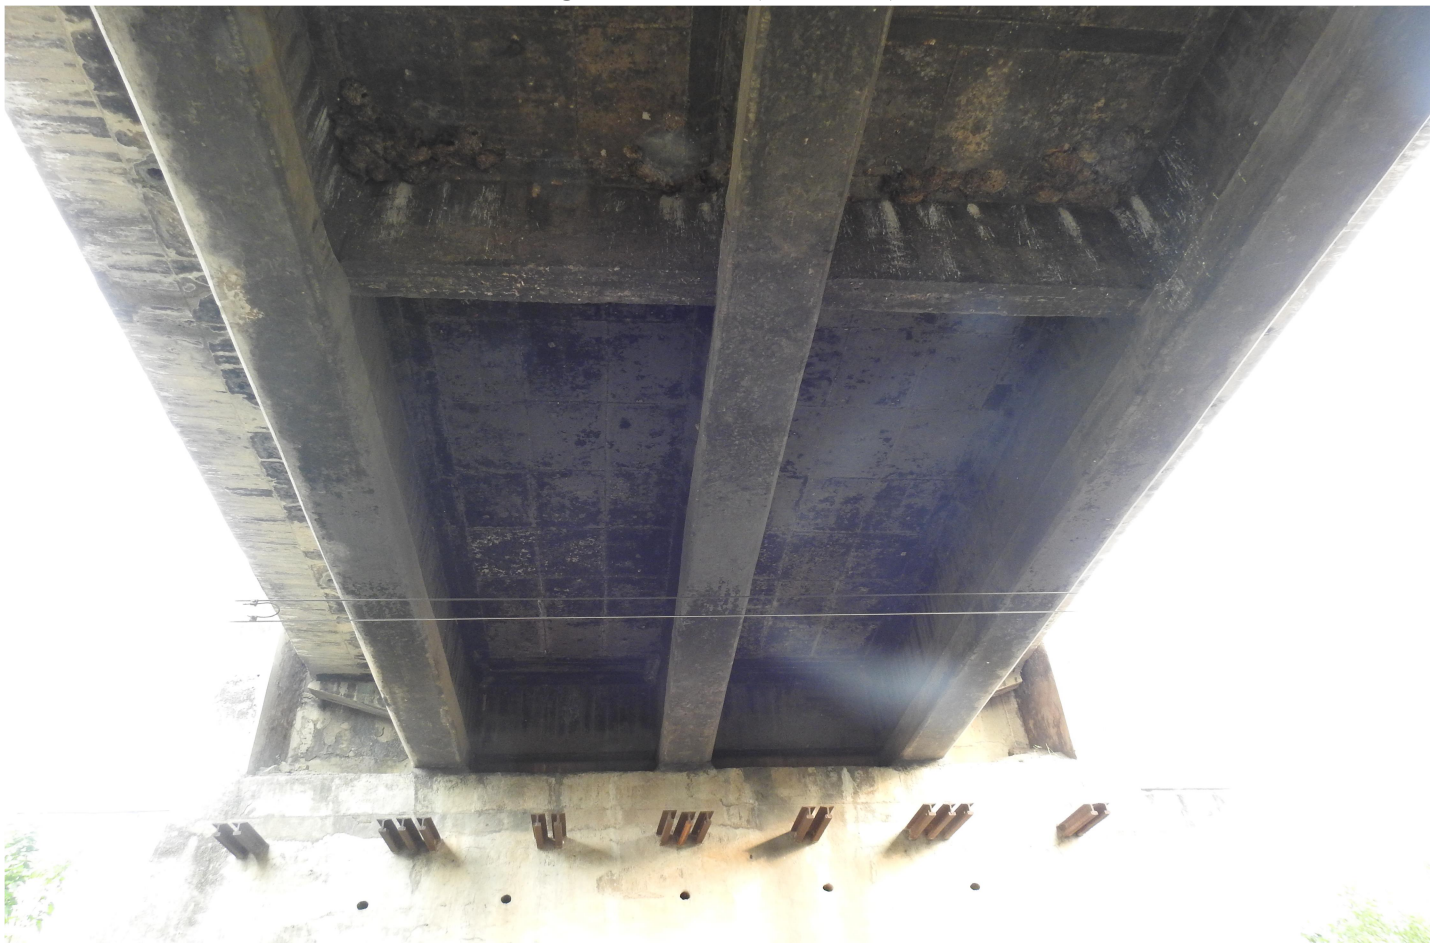
| | Condition of Slab from Bottom | | Leaching and vegetation growth observed. (Refer Fig-3,) |

**Fig: 3** Bottom view, Leaching observed

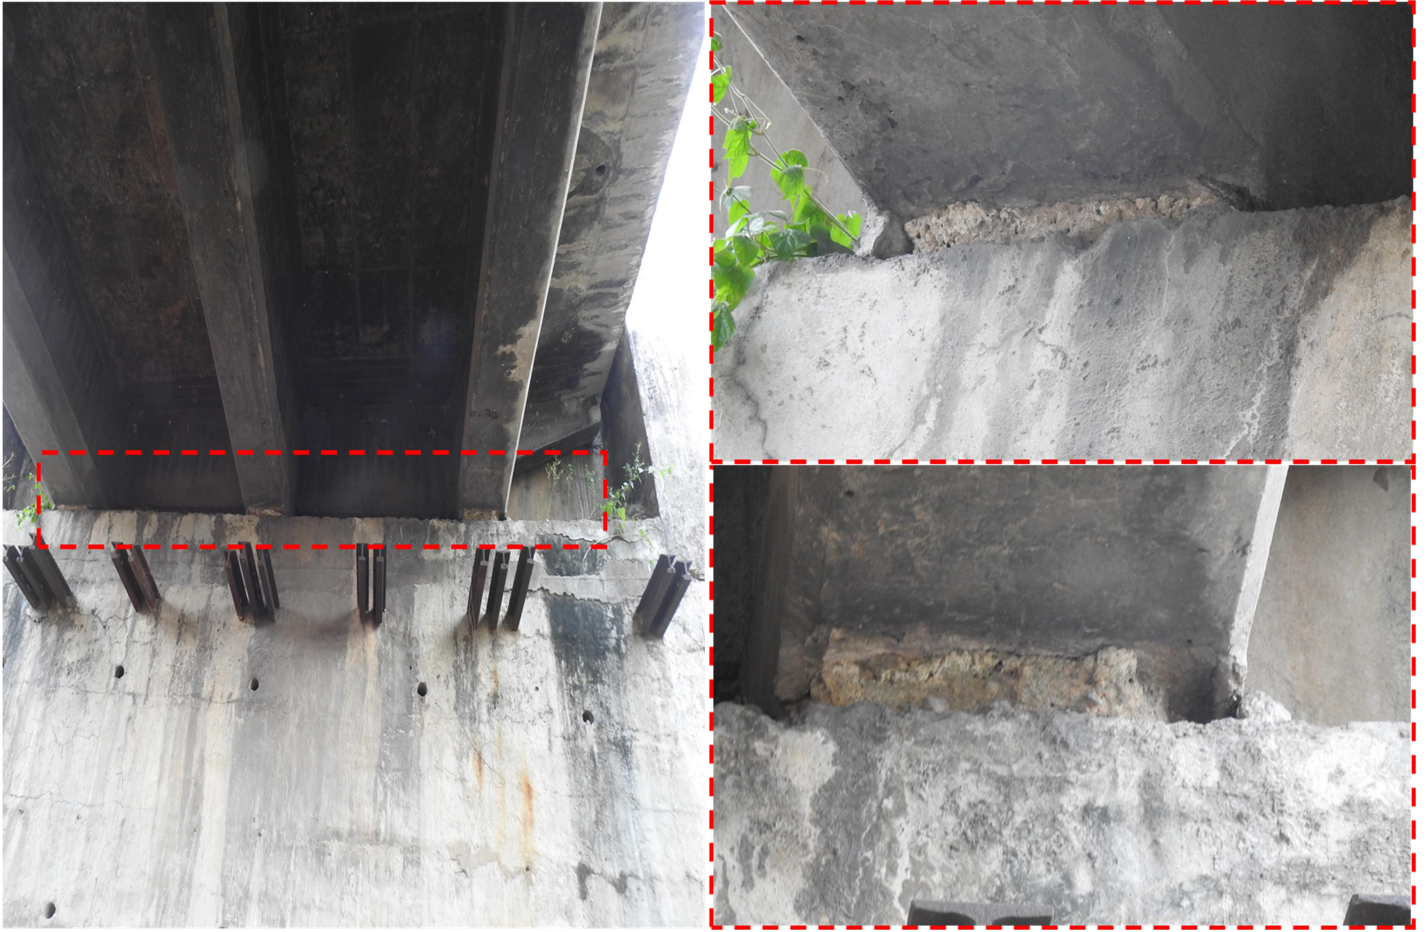
| | Type of Bearings | | Bearings are covered with mortar (Refer Fig-4,5) |

**Fig 4:** Bearings at Abutment 1

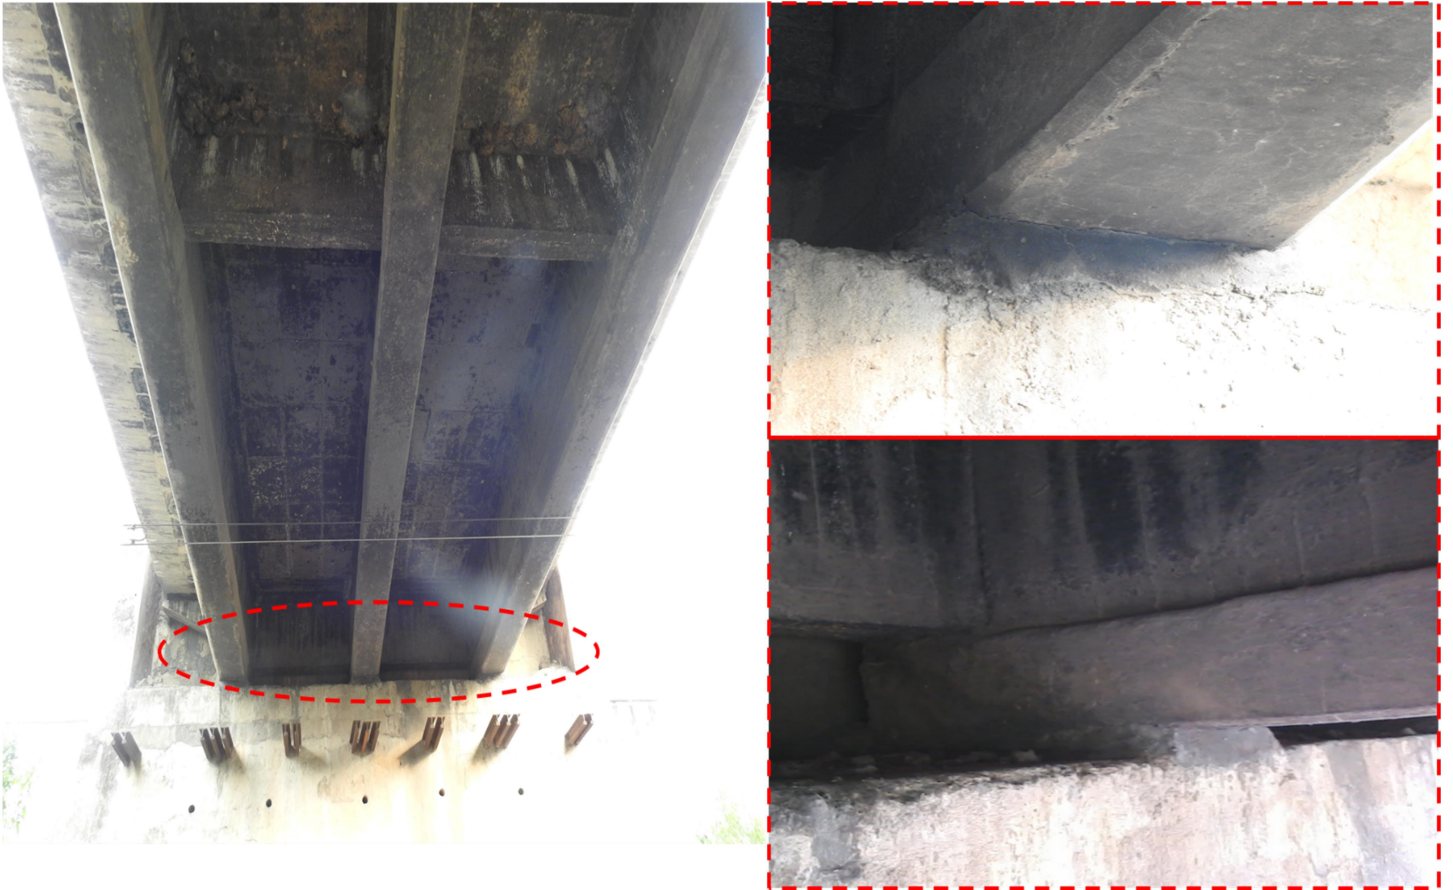
**Fig 5:** Bearings at Abutment 2

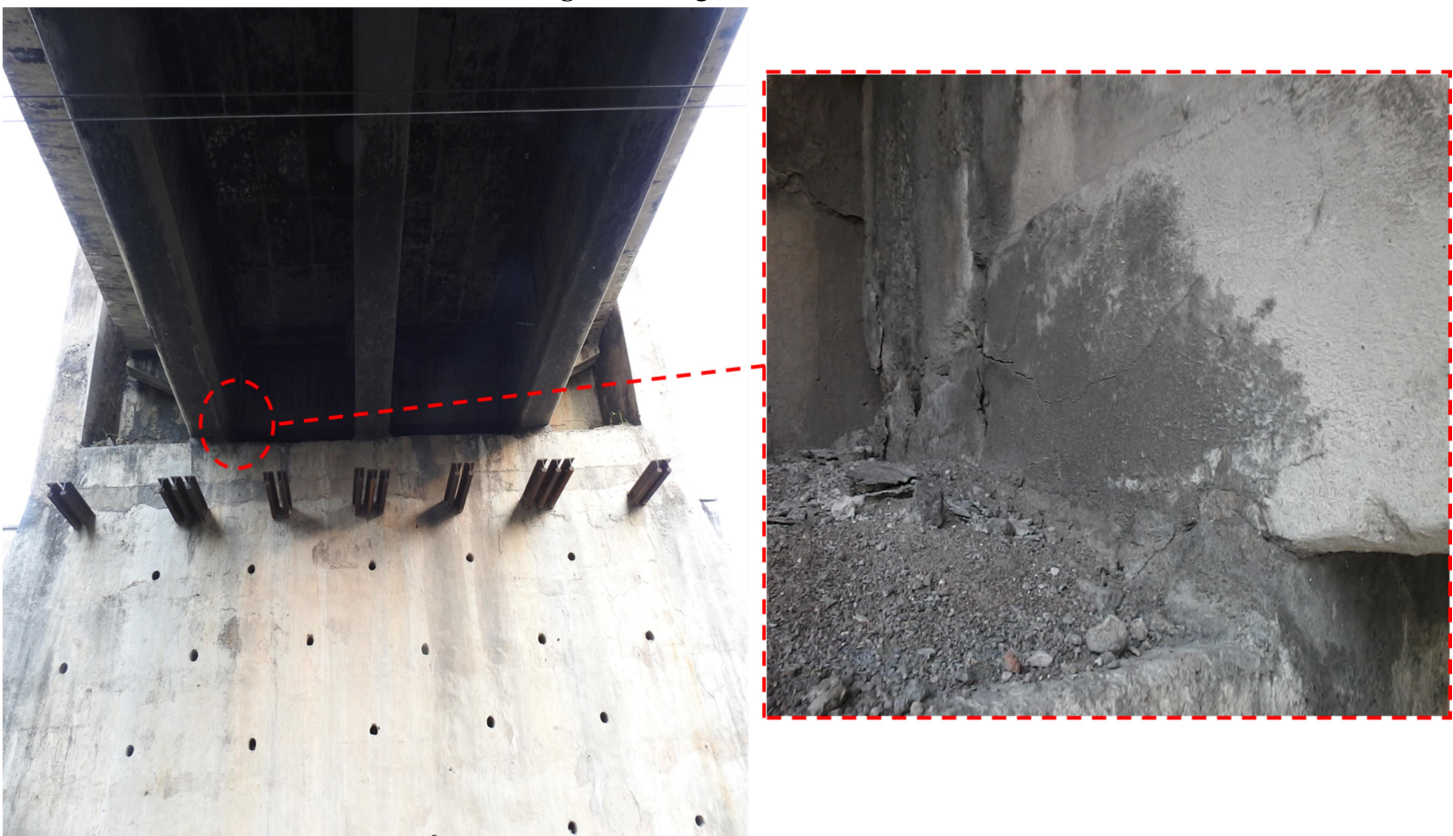
**Fig 6:** Spalling and crack at main girder resting location

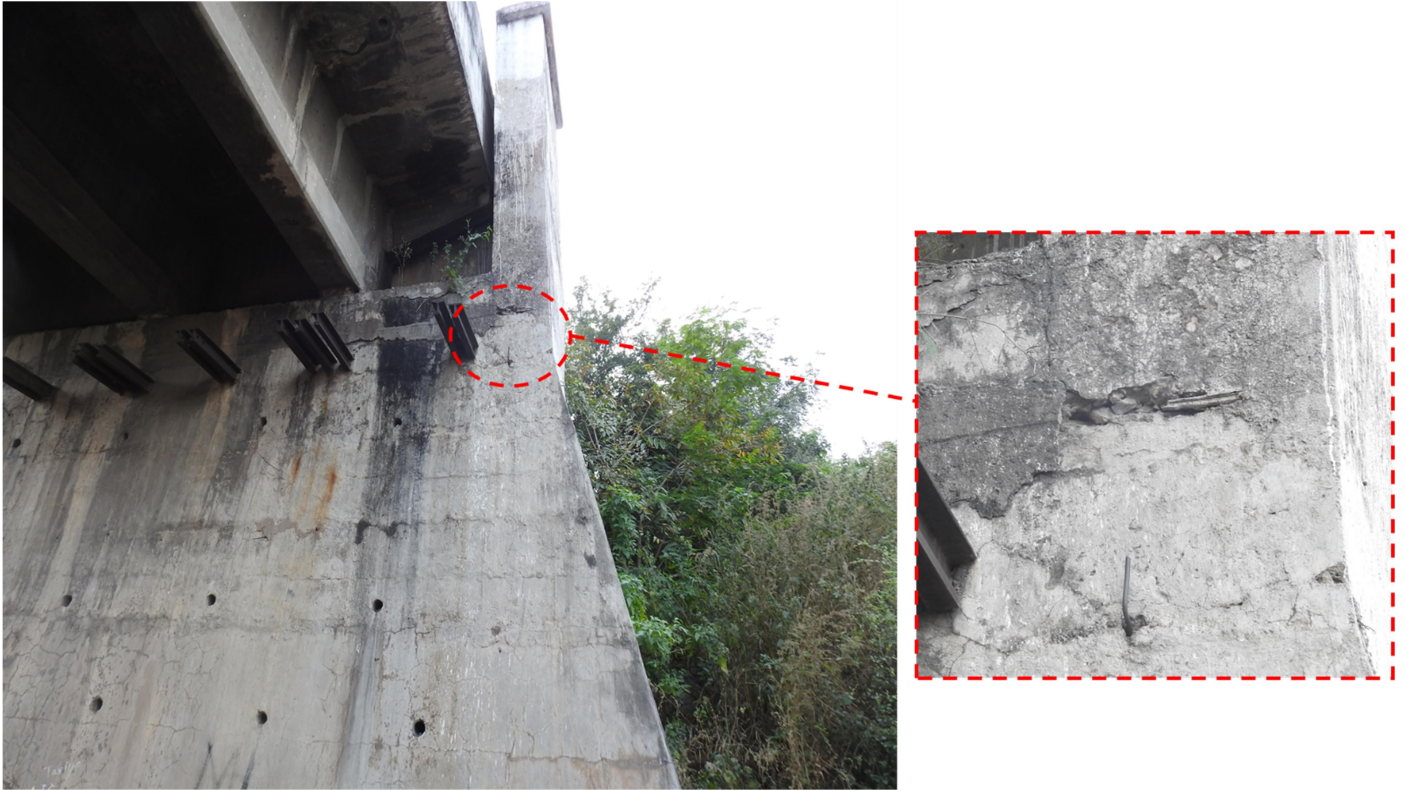
**Fig 7:** Minor Spalling, leaching at Abutment

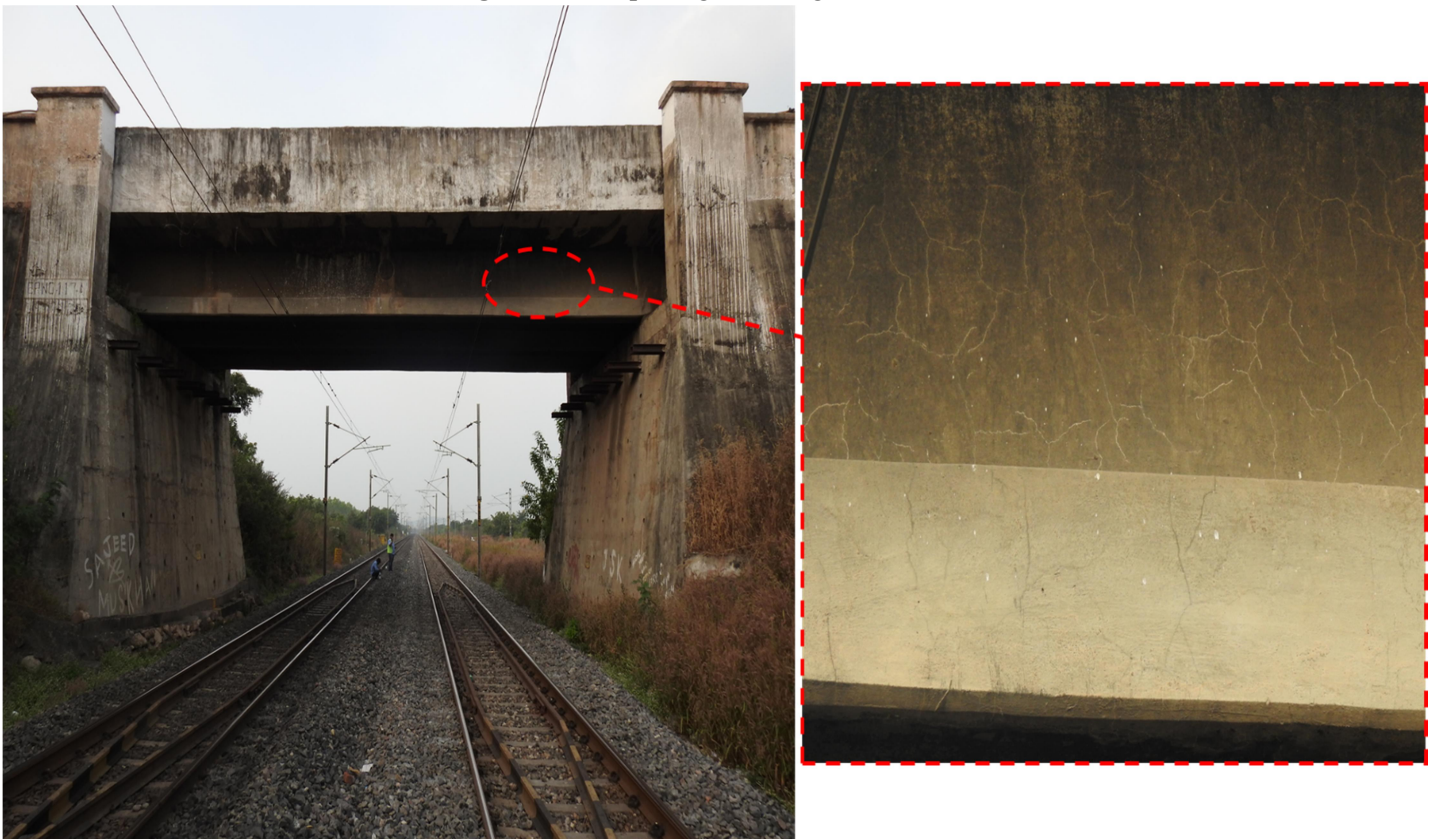
**Fig 8:** shrinkage cracks at main girders

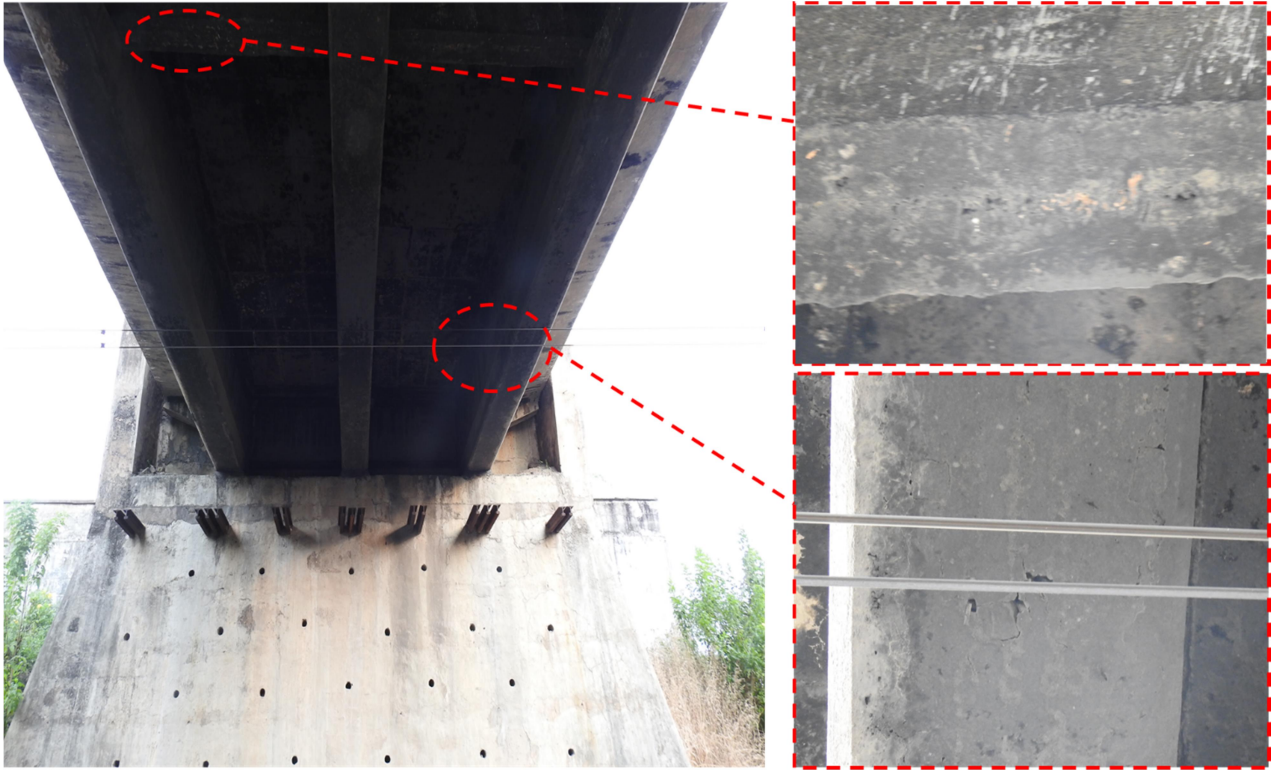
| | Condition of Secondary Girder | | Minor spalling observed. (Refer Fig-7) |

**Fig 9:** Minor spalling at secondary and main girder

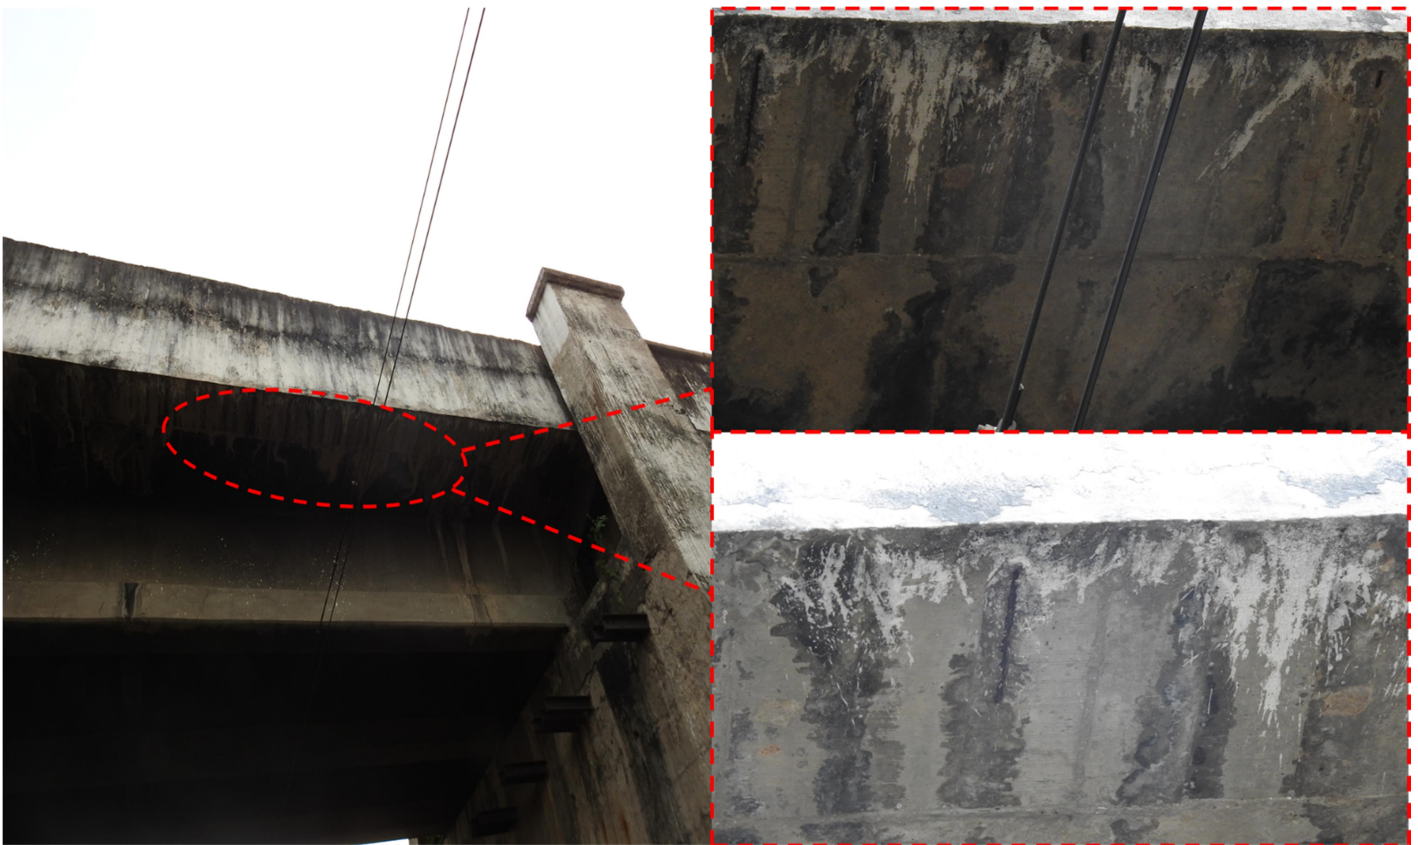
**Fig 10:** Spalling at Overhang Slab portion

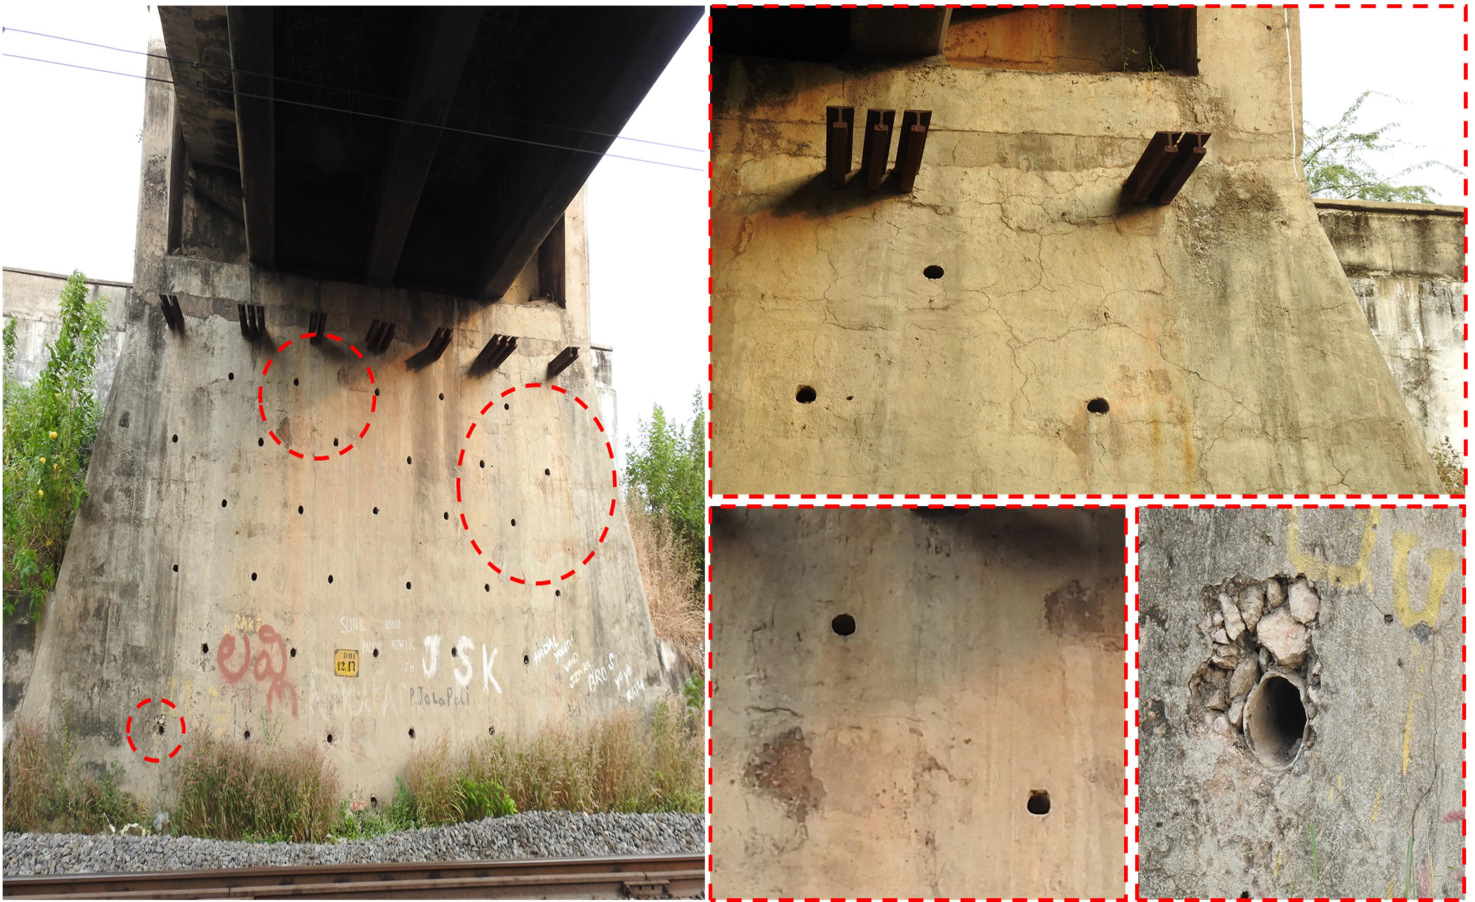
| PART 2 STRUCTURAL SYSTEM OF THE BRIDGE | | | |
|---|---|---|---|
| | Condition (Crack, Settlement, Scour, Tilting, Steel Corrosion, Strains and other damages etc...) | | Minor spalling and Shrinkage cracks observed |

**Fig 11: Shrinkage cracks and minor spalling at Abutment 1**

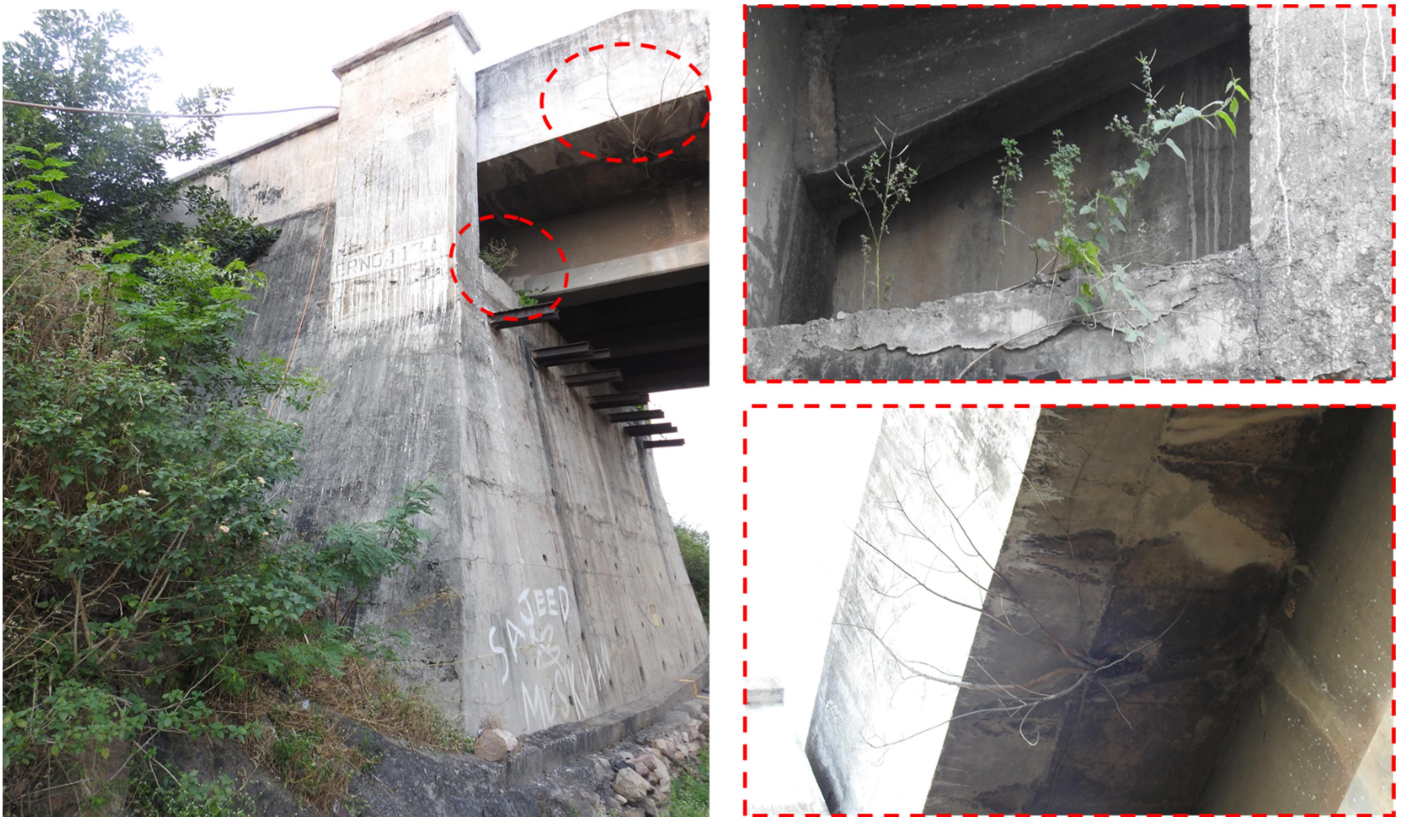
**Fig 12: Vegetation observed at abutment and Drainage spouts**

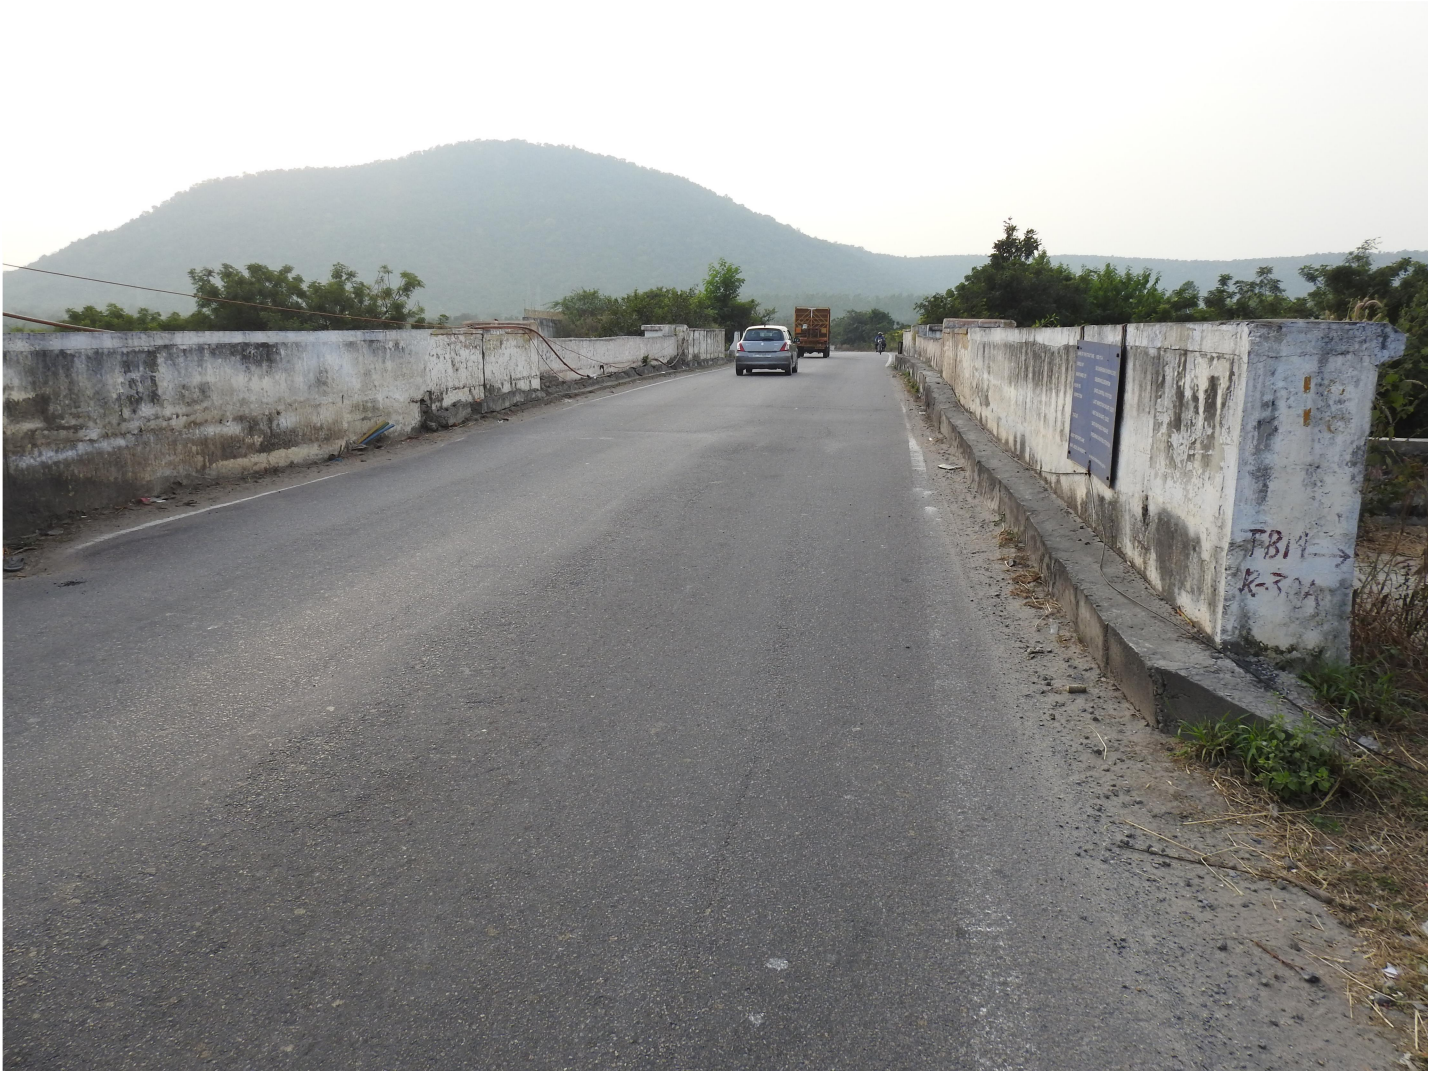
| | Condition of Flooring/Wearing Coat | | Good condition (Refer Fig-13) |

| Condition of Wall/Railing | No Accidental hit marks are observed on wall (Refer Fig-13) |

***Fig 13: Road surface & Parapet wall***
